## **NATIONAL TRANSPORTATION SAFETY BOARD**

# **AIRFRAME EXAMINATION**

**WPR16FA183**

Location: Gilbert, Arizona  
Date: September 17, 2016  
Aircraft: Cessna 182P, N20844, Serial #: 182261251  
NTSB IIC: Albert Nixon

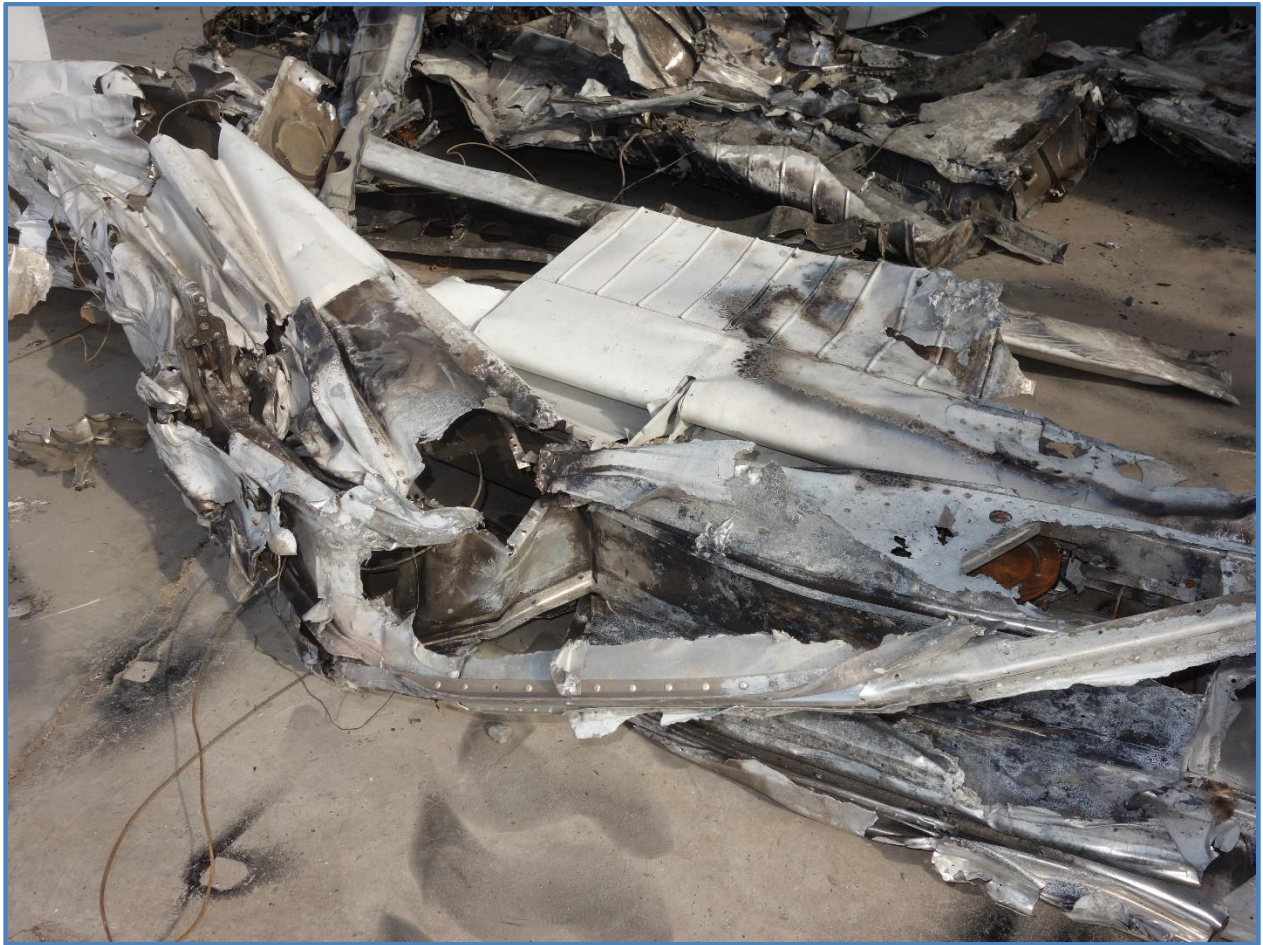
Examination of the airplane revealed that the remnants of the interior structure of the left wing, where the fuel tank was located, showed no outward buckling or other similar damage. Portions of upper and lower left wing skins and the entire left main fuel tank were destroyed by thermal damage.

**Figure 1:** Interior of left wing where left main fuel tank was located.

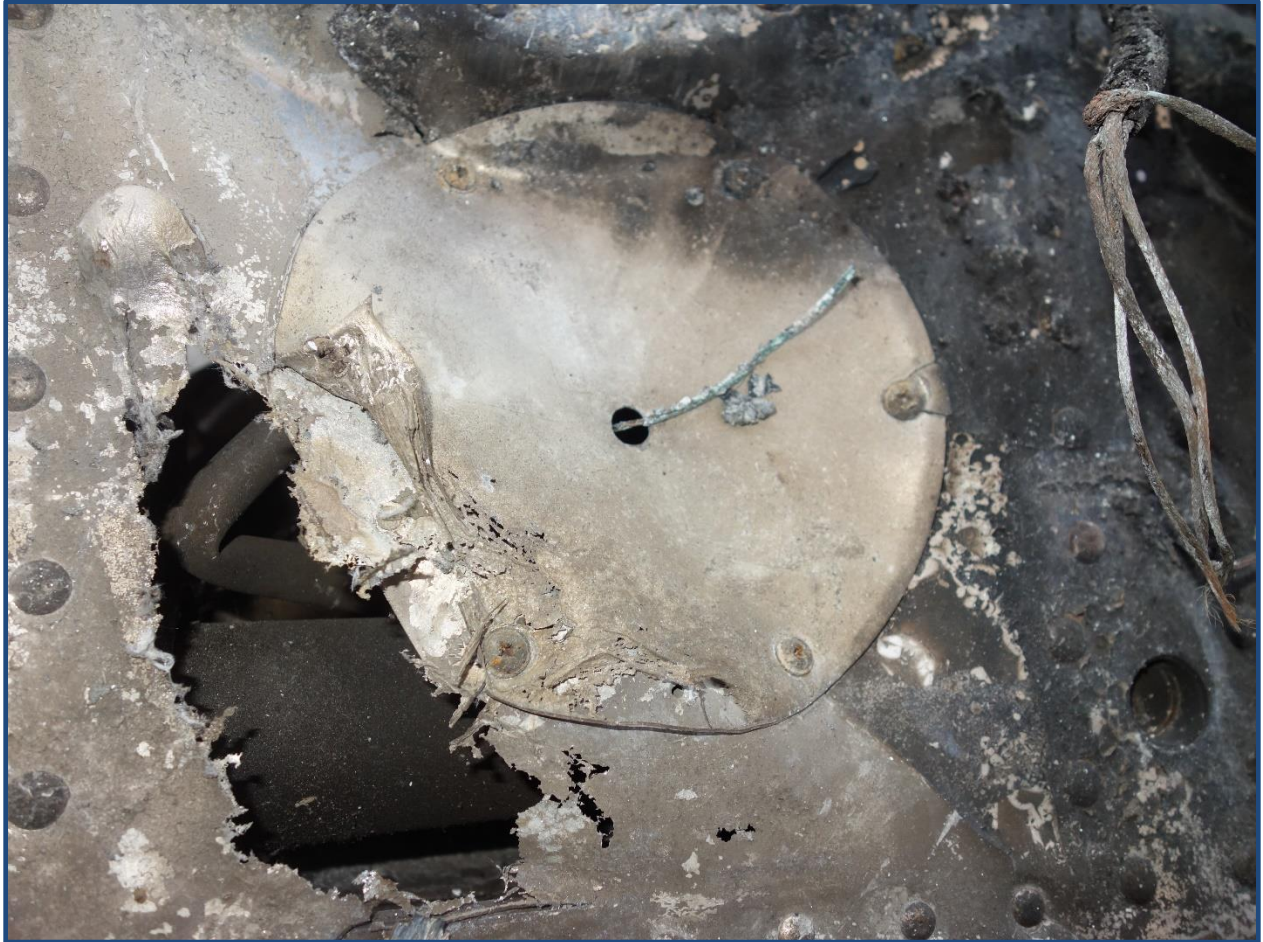
Examination of the left main landing gear arm revealed holes with wires that ran from the pyrotechnic box along the gear leg, under the gear leg fairing, through a hole in the landing gear bulkhead, and then through a hole drilled in the cabin floor inspection plate, into the cabin.

**Figure 2:** Wire coming through a hole drilled in a cabin floor inspection plate, into the cabin.

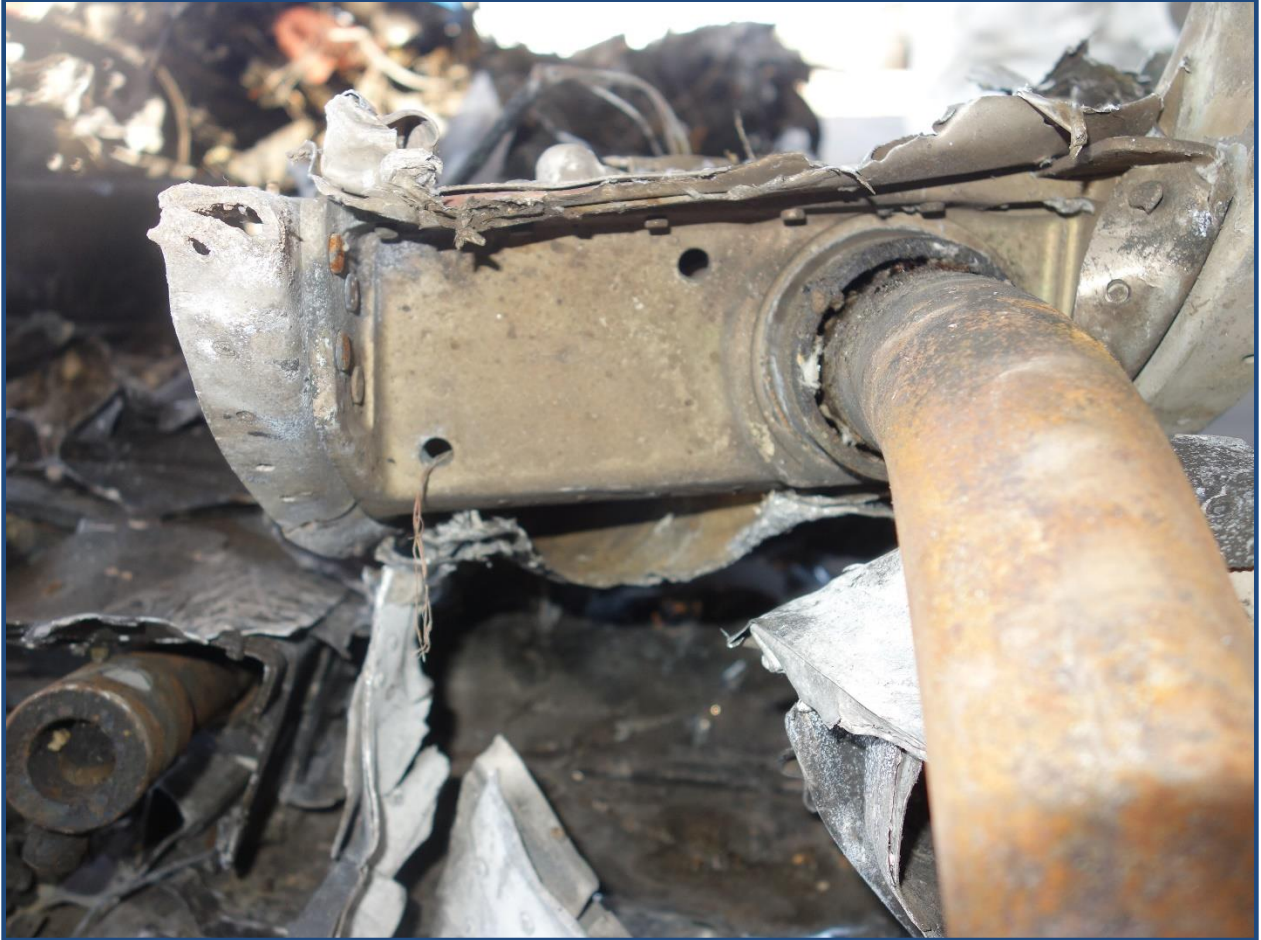
**Figure 3:** Wire running through a hole in the left landing gear bulkhead.
