## Air Safety Investigations Aircraft Incident/Accident Technical Report

| Aircraft Incident/<br>Accident Information | Year: 1972 | Make: Cessna | Model: 182P |
| Senior Air Safety Investigator: Henry J. Soderlund | | Report #: ASI-16-DG-T | Report date: 02-24-17 |

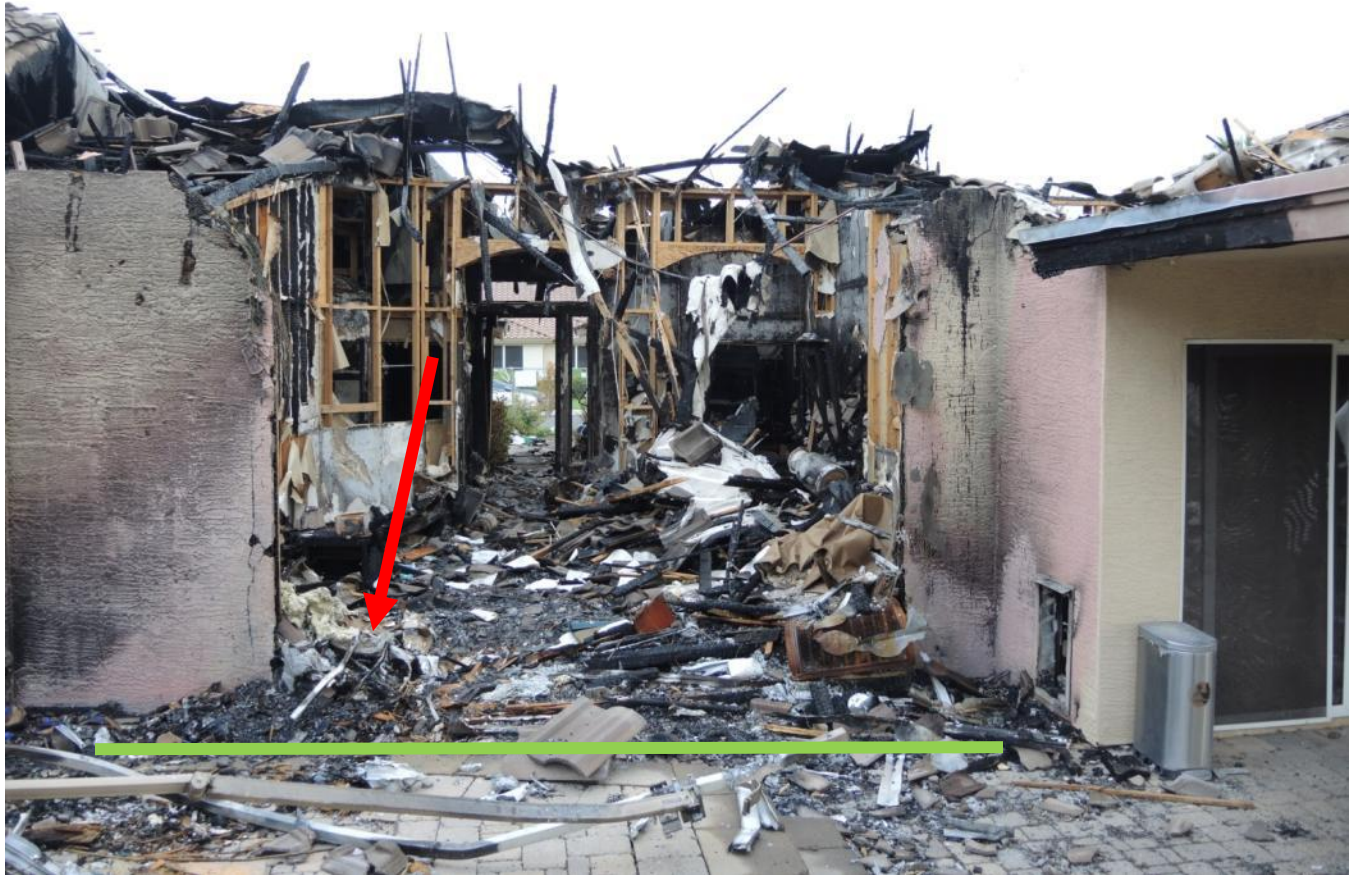
After the pilot exited the aircraft it descended nose down into a house. The nose of the aircraft impacted at the aft wall of the home (denoted by red arrow). A majority of the wings were found immediately outside of the house, in the backyard (denoted by green line).

House exam ASI-16-DG-004.jpg

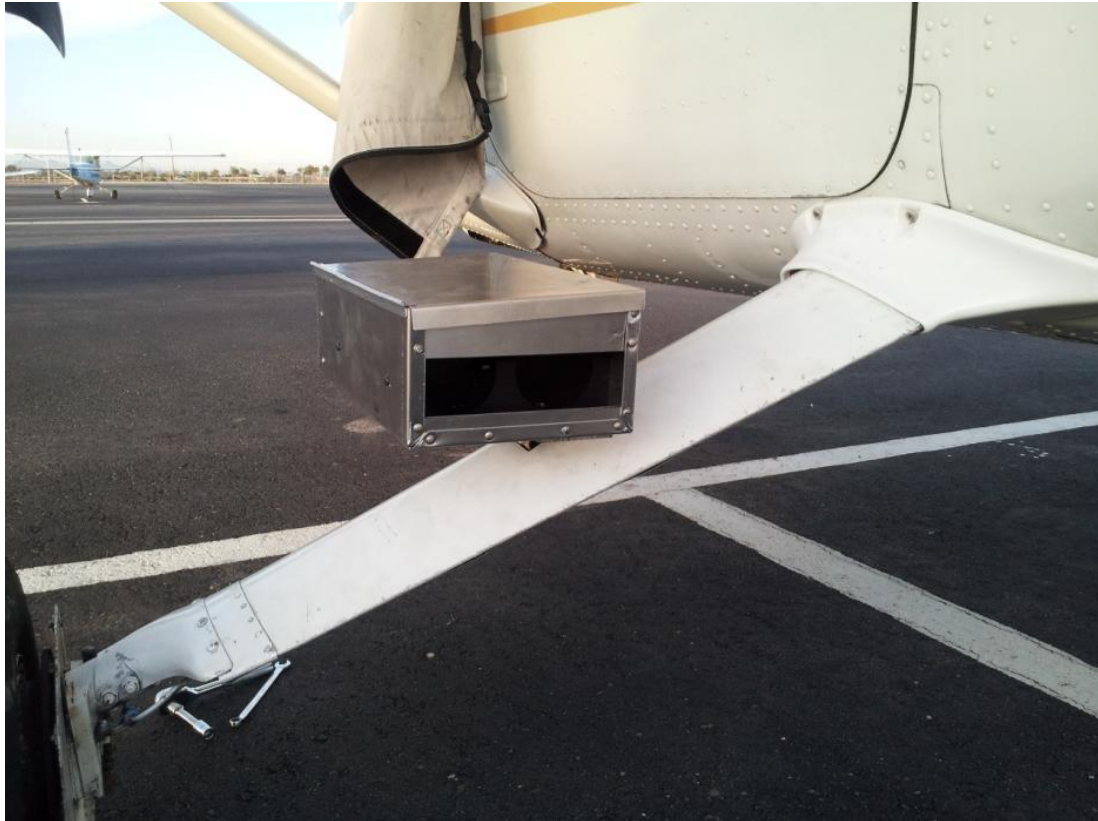
The aircraft owner had bolted a home-made pyrotechnic box to the left door step. Two firework tubes were reportedly installed in the box.

Aircraft owner supplied photograph of fireworks box installation

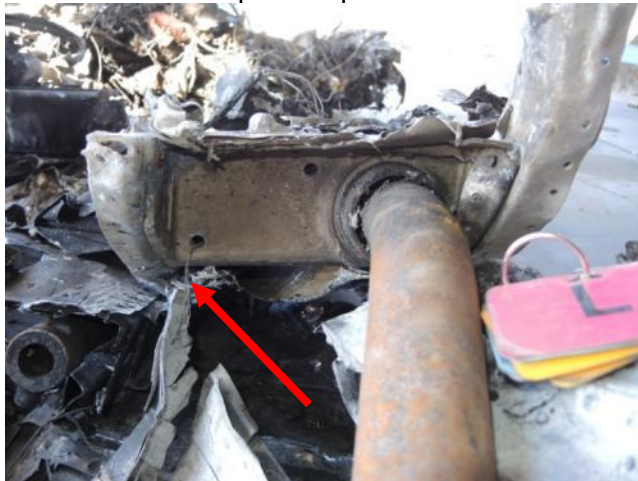
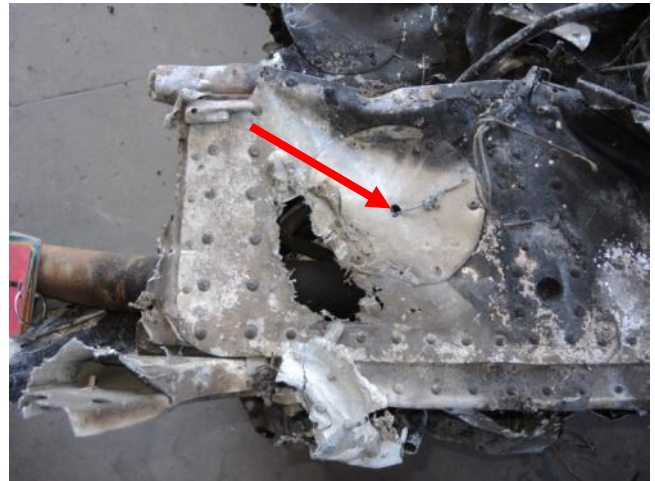
Wires (noted with red arrows in photographs below) ran from the pyrotechnic box along the gear leg, under the gear leg fairing, through a hole in the landing gear bulkhead, and then through a hole drilled in a cabin floor inspection plate into the cabin.

No records for the bolting of the pyrotechnic container to the aircraft's left door step or installation of the control wiring were found in the provided maintenance records.

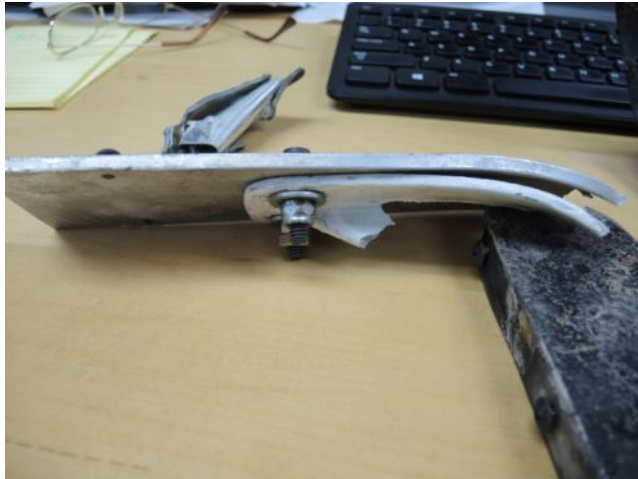
Pieces of the pyrotechnic box and door step were found near the drop zone.

Wreckage exam ASI-16-DG-041.jpg  
Pyrotechnic box attached to door step

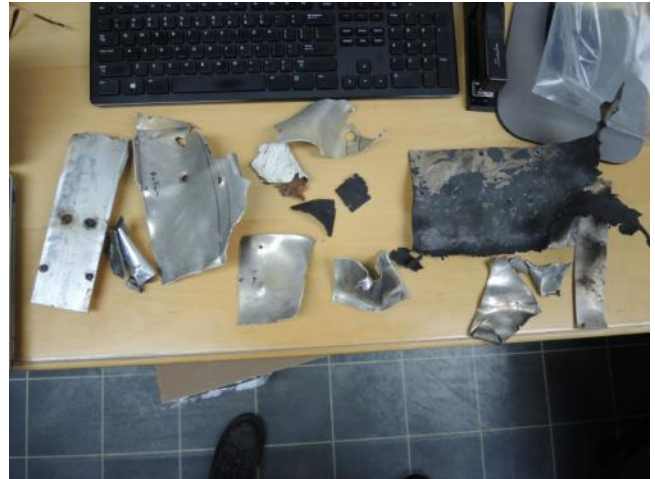
Wreckage exam ASI-16-DG-041.jpg  
Pieces found near drop zone.

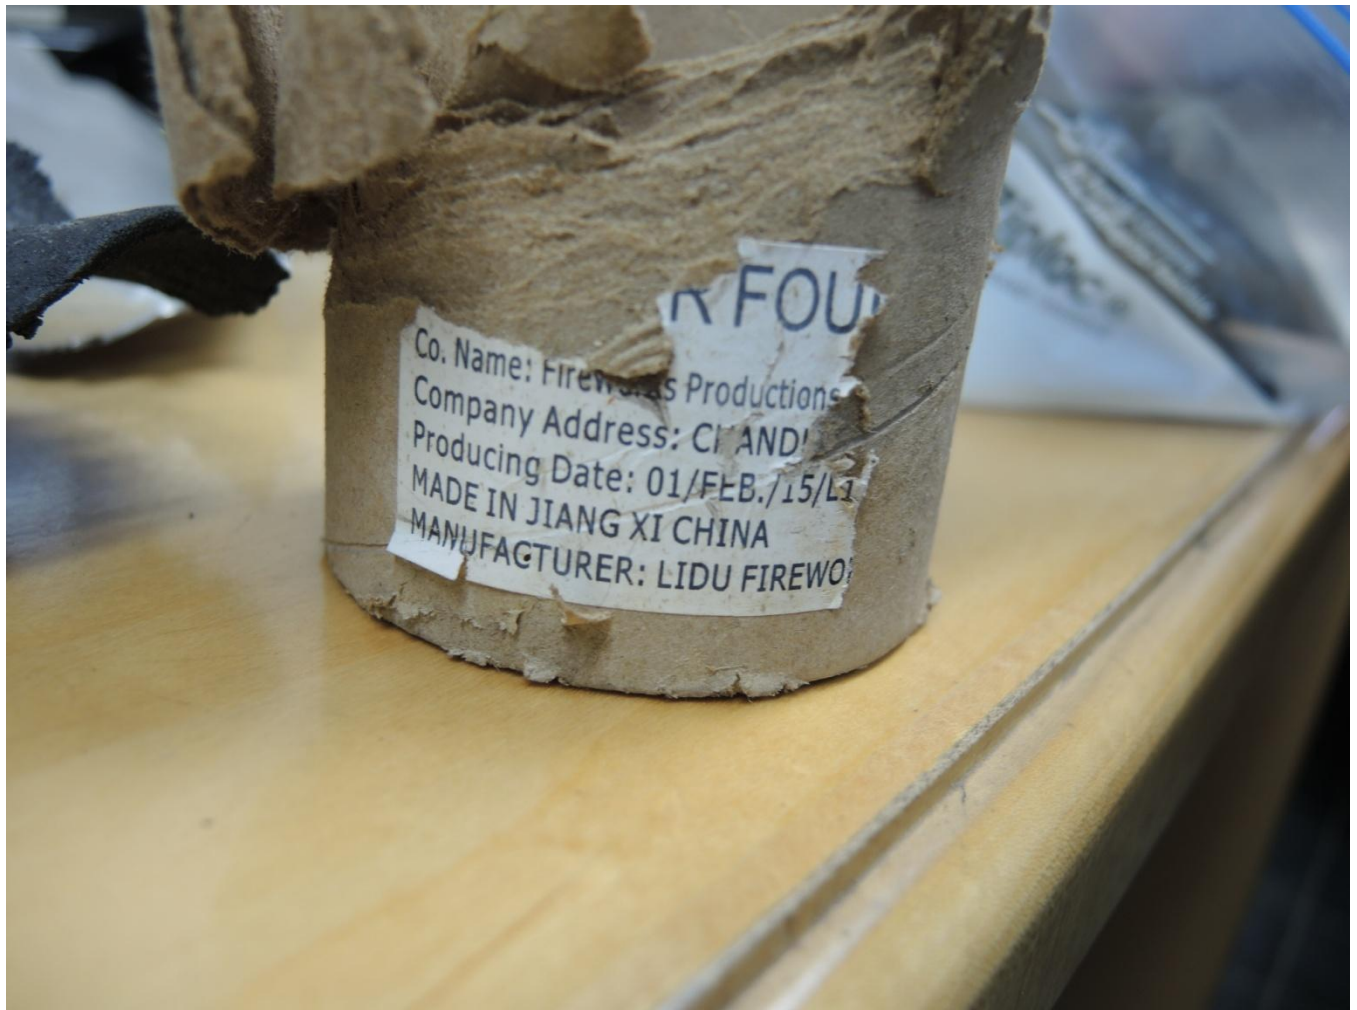
At the time this report was completed the NTSB lab had not completed the report on the pyrotechnic box.

Wreckage exam ASI-16-DG-040.jpg – Fireworks tube found near drop zone.
