# NATIONAL TRANSPORTATION SAFETY BOARD

## MATERIALS LABORATORY FACTUAL REPORT

Report No. 16-080

Place : San Carlos, California  
Date : April 29, 2016  
Vehicle : Piper PA-28R-200  
NTSB No. : WPR16IA100  
Investigator : Thomas Little, AS-WPR

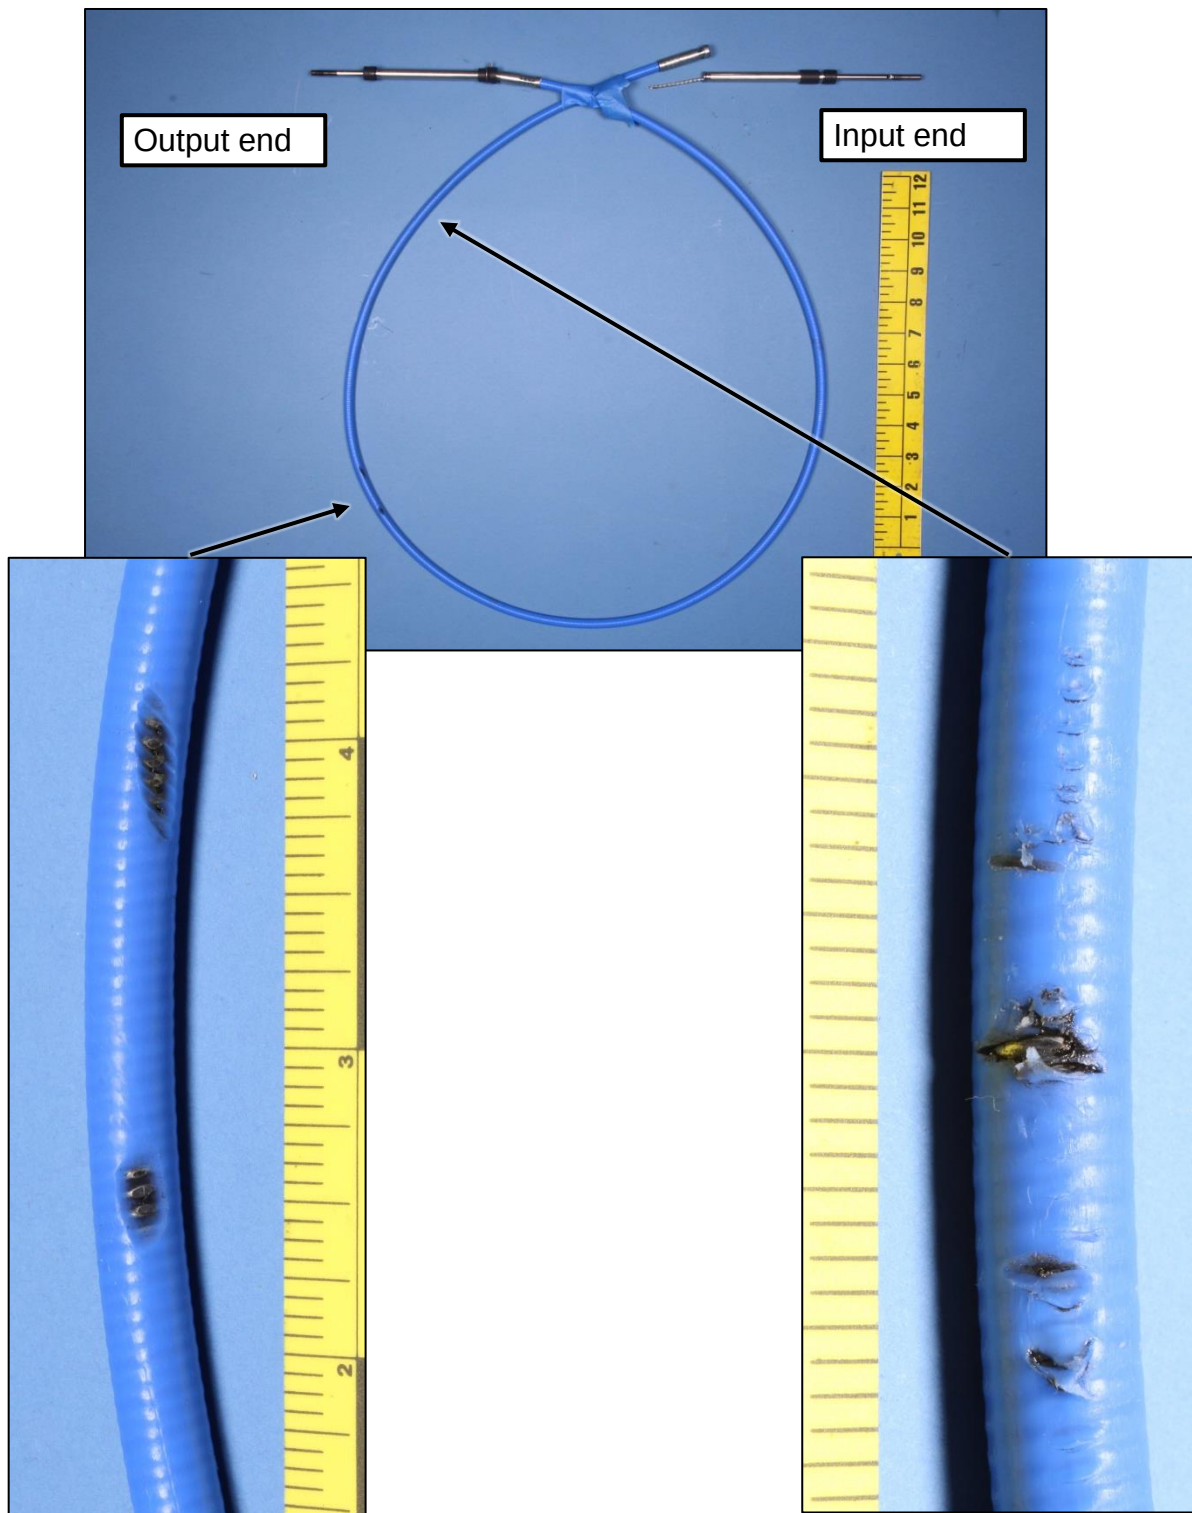
An overall view of the throttle cable assembly is shown in figure 1. The cable was fractured near the input end as shown in figures 1 through 3. The cable was an FAA-PMA part and had 1,653 hours time in service since installation about 12 calendar years before the accident.

Damage to the conduit was also observed as shown in figure 1. Two areas of wear contact are shown in the lower left image in figure 1. The smaller of the two areas in the lower left image had a flat wear pattern corresponding to contact with a smooth surface. The larger of the two areas had a ridged pattern consistent with contact with another cable. The damaged area shown in the lower right image in figure 1 had sharper edges with displaced conduit material at the edges consistent with contact with a sharp edge.

Figure 1. Overall view of the submitted throttle cable with closer views of damaged areas on the conduit.

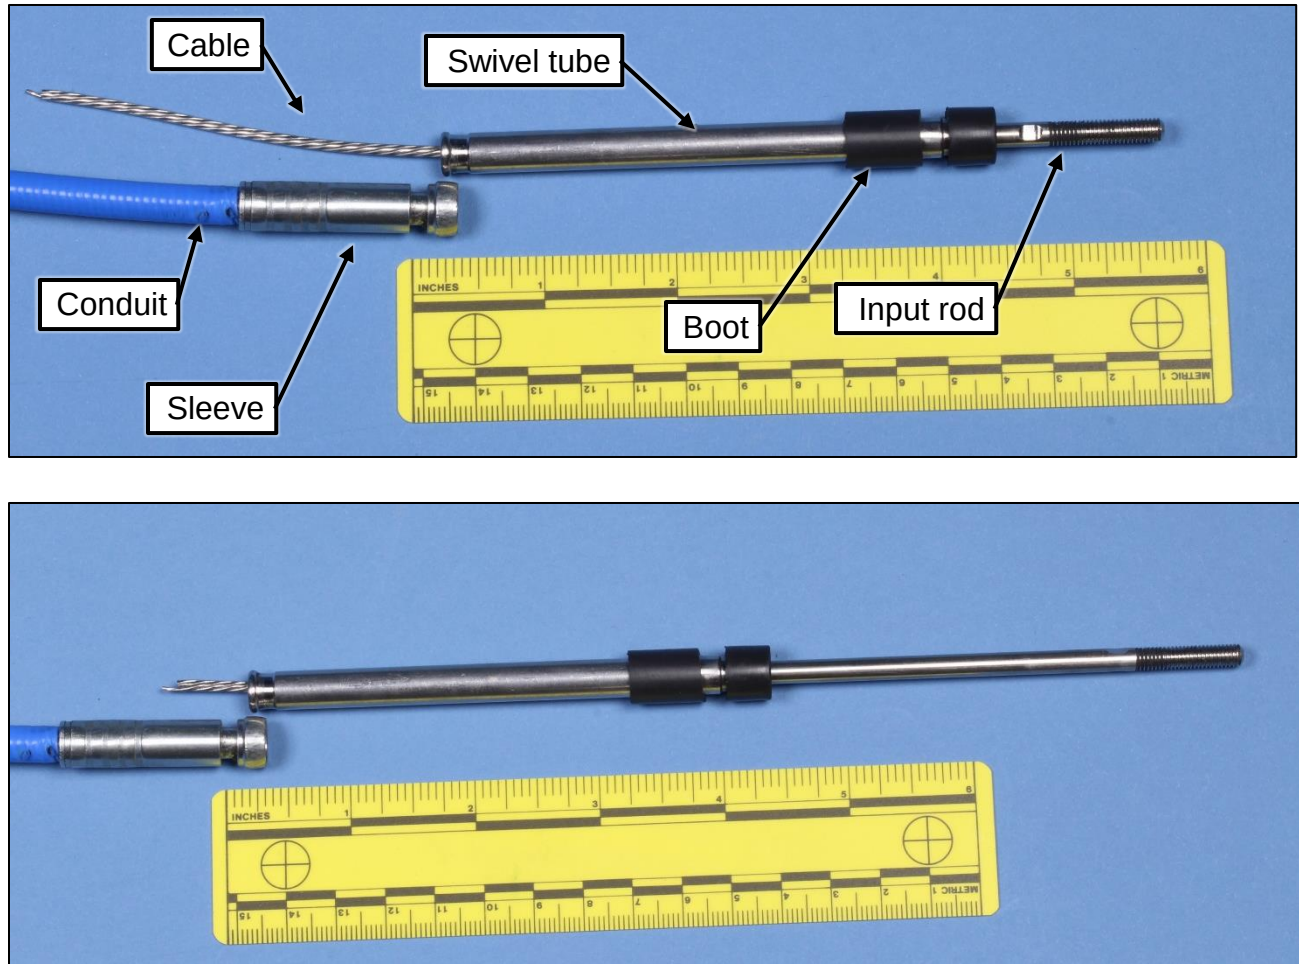
Overall views of the input end of the cable assembly are shown in figure 2. The cable was fractured 8.55 inches from the end face of the input rod, and the swivel tube was separated from the sleeve at the swivel joint. The overall length of the cable assembly between the end faces of the input and output rods was 70.229 inches. According to a representative of the cable manufacturer, for reference, the cable assembly should be approximately 70.33 inches long. The diameter of the cable adjacent to the fracture measured 0.0875 inch.

In figure 2, the input rod is shown positioned approximately in the full open throttle position (upper image) and in the closed position (lower image). The positions of the rod were determined using measurements from a drawing of the throttle cable installation provided by a representative from Piper Aircraft. The drawing did not show

As assembled, an elastomeric boot covers the swivel joints at each end of the cable assembly. As received, the boot at the input end swivel joint was displaced onto the swivel tube (see figure 2). In comparison, the boot at the output end was received covering the joint, and a hose clamp was in place on the boot. No hose clamp was observed at the input end. During the course of the examination, the hose clamp was removed from the boot at the output end swivel joint, and the boot was displaced onto the output swivel tube as shown in figure 9. The portion of the boot that had been covering the swivel joint was flared outward relative to the other end of the boot, and an impression was observed where the hose clamp had been installed. More than two months after the hose clamp was removed, the hose-clamp impression remained visible on the surface, and a slight flare was present at the end that had been covering the swivel joint (see figure 10). By contrast, the boot for the input swivel joint had a uniform outer diameter with no evidence of a flared end or hose clamp impression (see figure 11). In addition, a photograph of the input swivel tube with a date stamp 6 days after the accident showed similar features for the boot with no evidence of a hose-clamp impression or flared end.

Figure 2. Input end of the control cable assembly shown positioned in the full open (upper image) and closed positions (lower image).

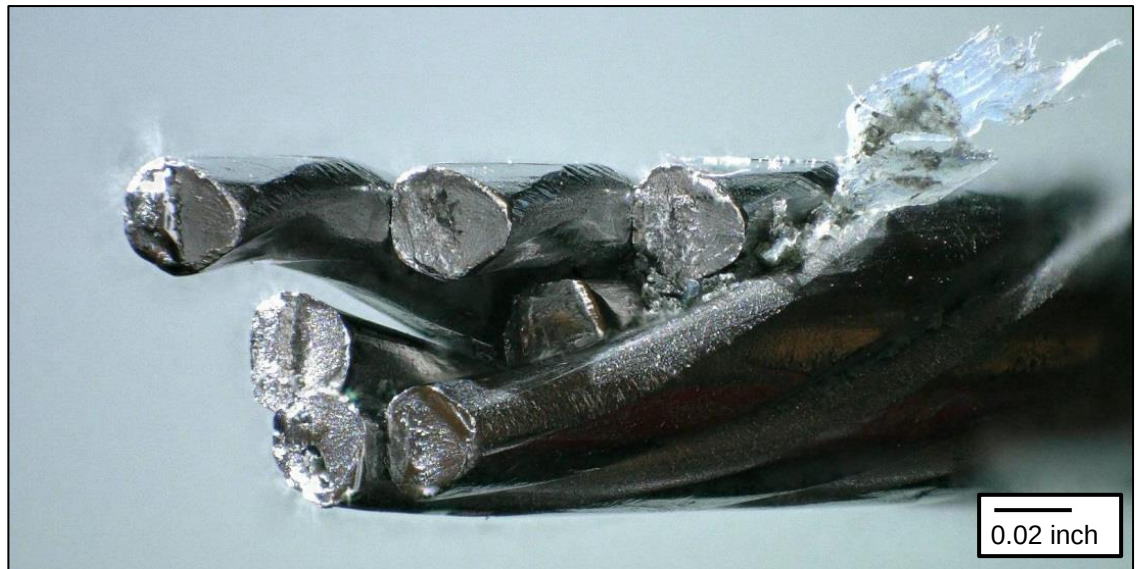
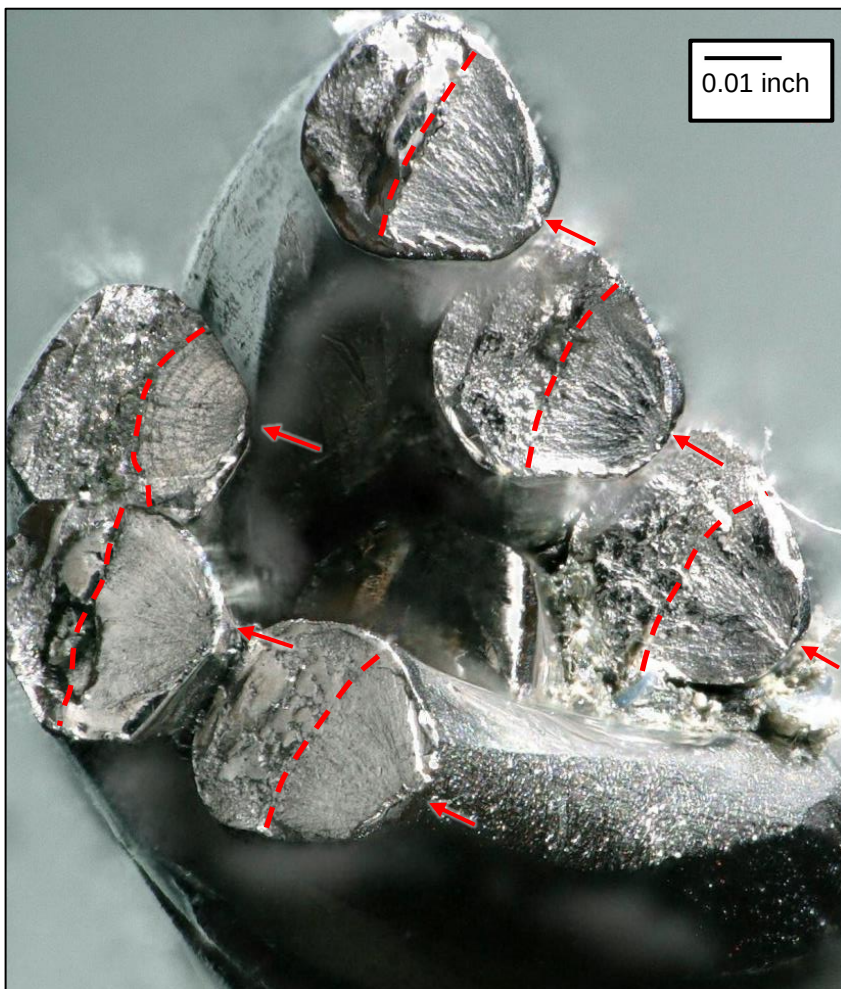
Views of the cable fracture are shown in figure 3. Individual wires of the cable were fractured at locations within approximately  $\frac{1}{2}$  of a lay length.<sup>1</sup> Portions of the fracture surface on each of the outer wires had relatively smooth fracture features oriented perpendicular to the outer surface with curving boundaries, features consistent with fatigue. In the lower image in figure 3, dashed lines indicate the fatigue boundaries, and arrows indicate the locations of the fatigue origins. The origin for each individual wire was located at the same side relative to the overall cable, and the fatigue region extended across approximately half the diameter in each wire. The core wire fracture features appeared rubbed, and the fracture mechanism for the core wire was not determined.

Figure 3. Magnified views of the cable fracture as imaged using the “Depth Up” feature on a Keyence VHX-5000 microscope. Unlabeled arrows indicate fatigue origins, and dashed lines indicate fatigue boundaries on individual wires of the cable.

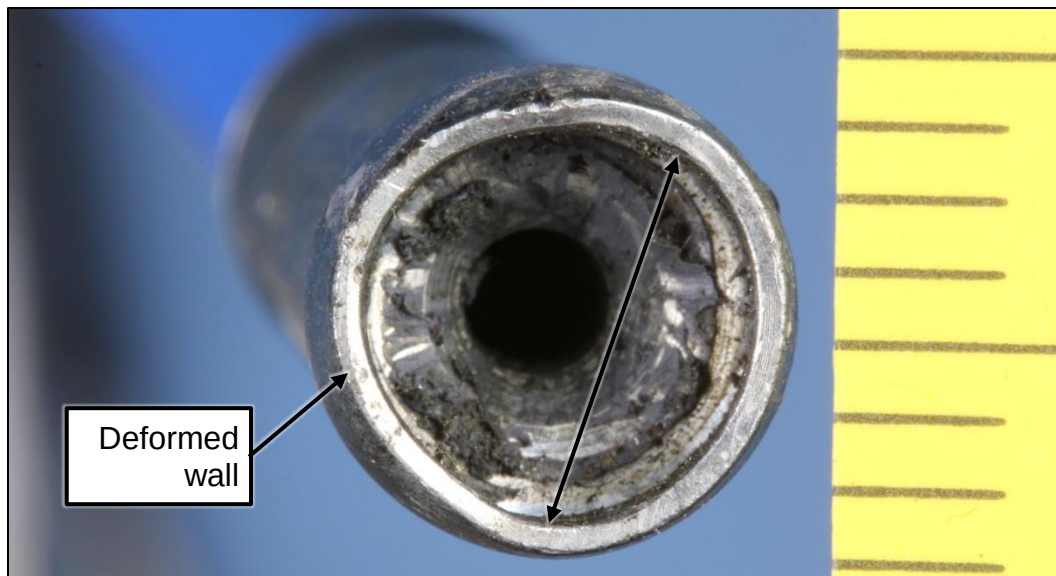
An end view of the sleeve at the separated swivel joint is shown in figure 4. The wall of the sleeve was deformed into an oblong shape with varying inner radius values. Arrows in figure 4 indicate areas where the inner radius was the smallest. The wall was deformed outward at the side opposite the chord marked by the arrows. The overall features of the swivel joint were consistent with bending deformation. In figure 5, a curving deformation mark (indicated with a bracket) was observed on one side of the swivel tube corresponding to contact with the wall of the sleeve under bending loads on the joint. According to the mechanic that worked on the airplane after the incident, the mechanic “snapped the sleeve from the swivel tube” with force applied by a screwdriver while removing the cable assembly from the control quadrant.

Figure 4. End view of the sleeve showing wall deformation at the input end swivel joint. Arrows point to areas with relatively smaller inner radius.

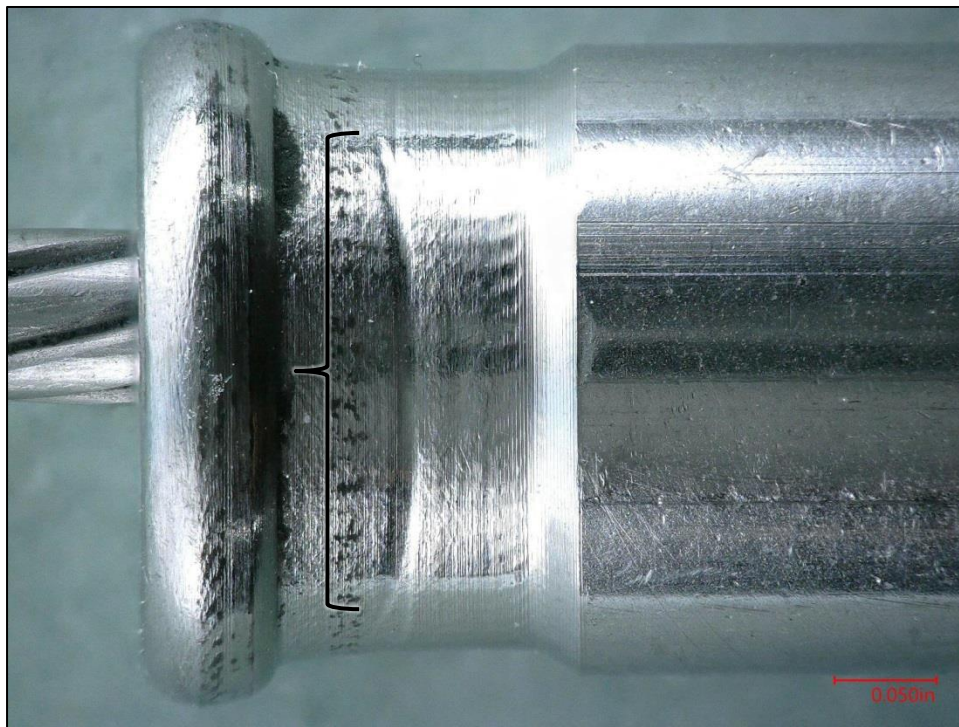
Figure 5. Close view of the sleeve end of the swivel tube. A bracket indicates a curving depression corresponding to contact with the wall of the sleeve.

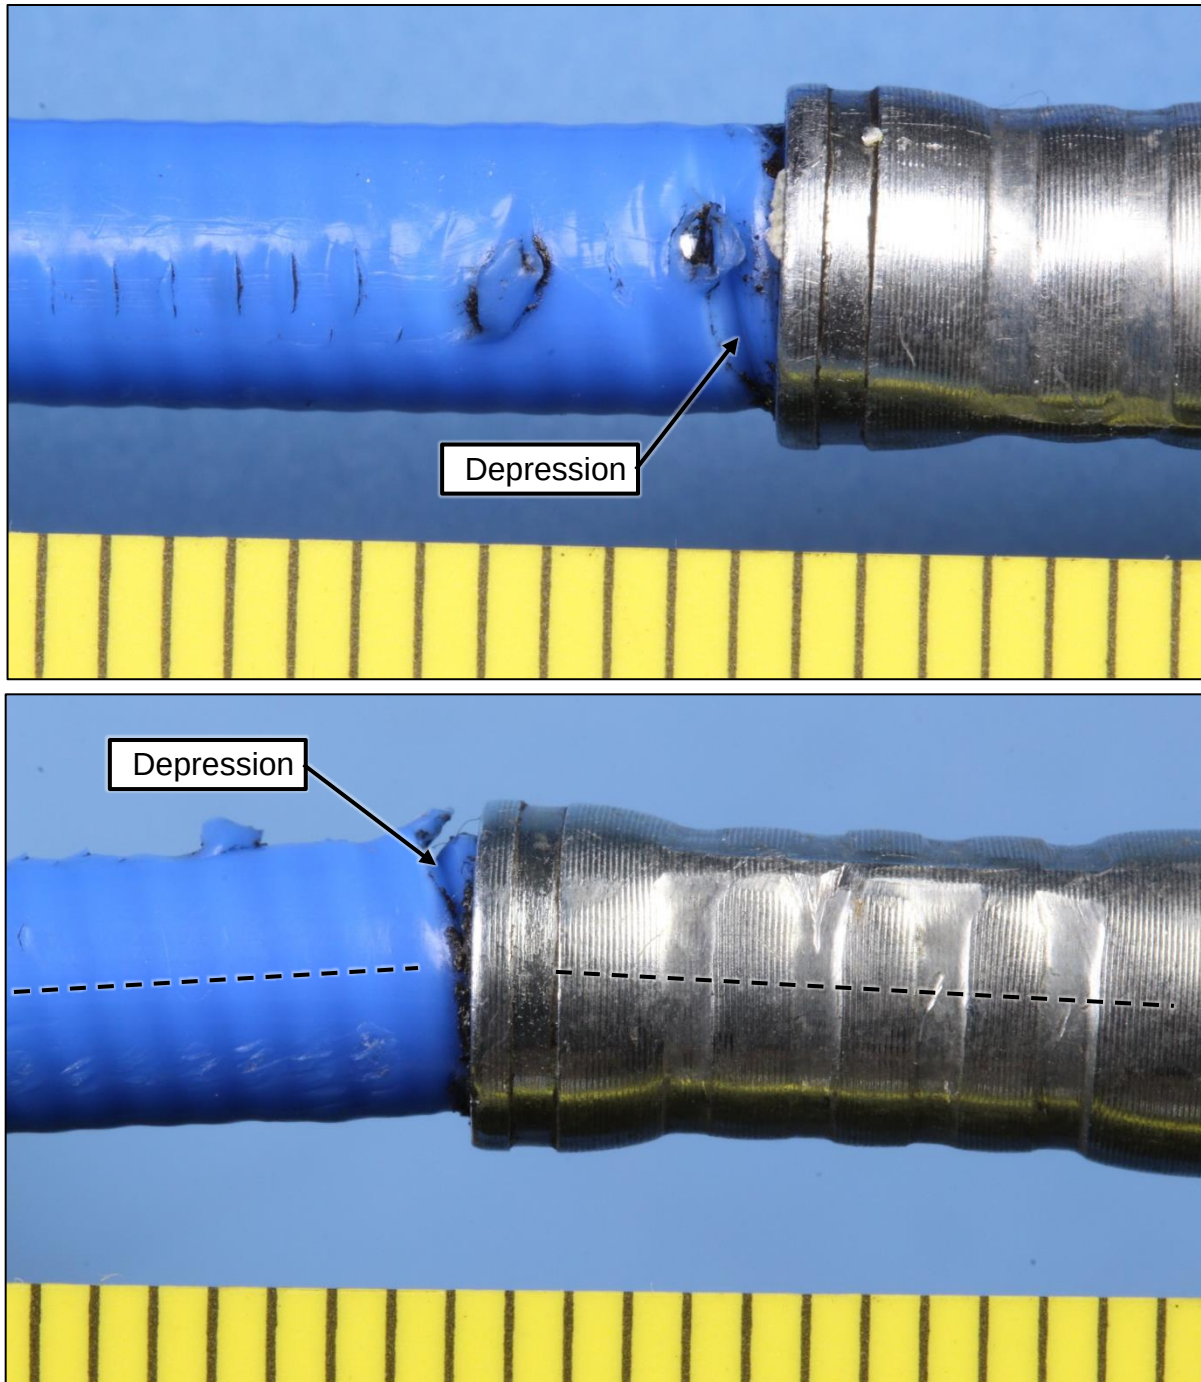
Close views of the conduit where it intersected the sleeve are shown in figure 6. As shown in the lower image in figure 6, the axis of the conduit was angled (bent) relative to the axis of the sleeve. Adjacent to the sleeve, the blue outer sheath of the conduit was depressed inward at the outside of the bend as indicated in figure 6. The depression in the outer sheath of the conduit was also visible in a radiograph of the part (see figure 7). At the location of the depression, the diameter of the double-helix coil structure of the conduit was reduced, and a gap was present in the spacing between the coils.

Figure 6. Close views of conduit damage and deformation adjacent to the sleeve at the input end of the cable assembly. The conduit and sleeve were rotated 90 degrees in the lower image relative to the upper image. Dashed lines in the lower images indicate axes of the conduit and sleeve.

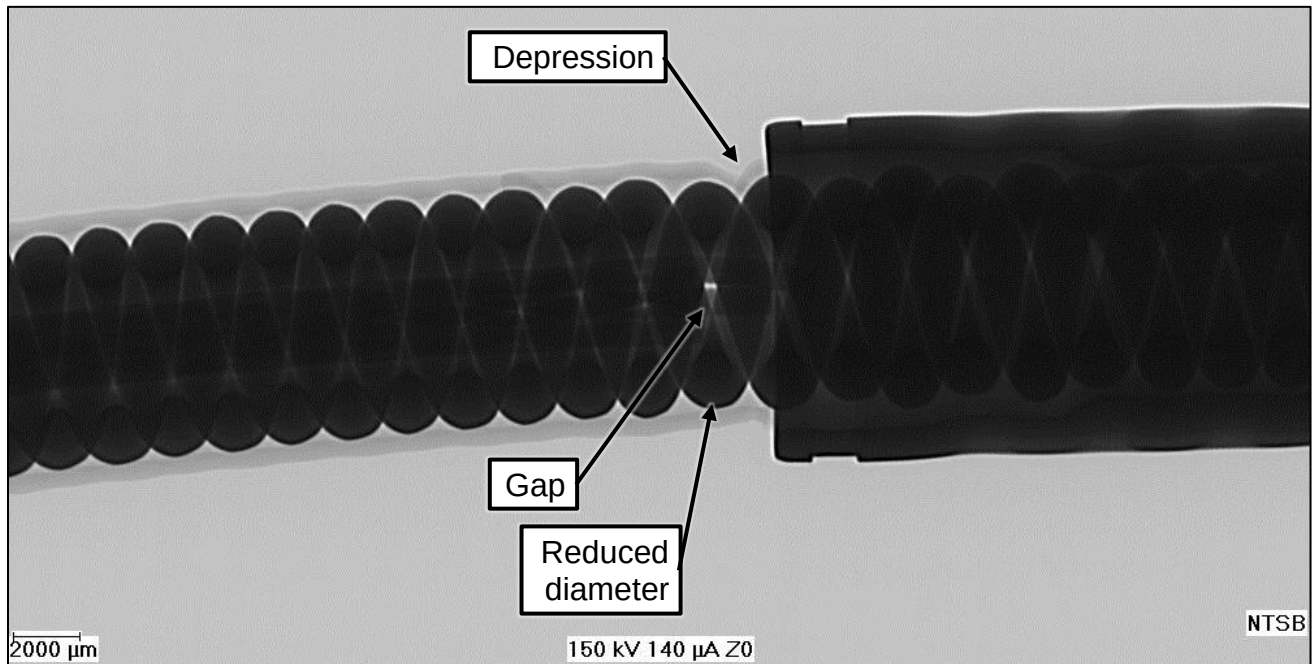
Figure 7. Radiograph of the intersection between the conduit and the sleeve at the input end of the cable assembly. The depression at the exterior of the conduit (see figure 7) is indicated. The location corresponded to a reduced diameter and gap in the spiral reinforcement, also indicated.

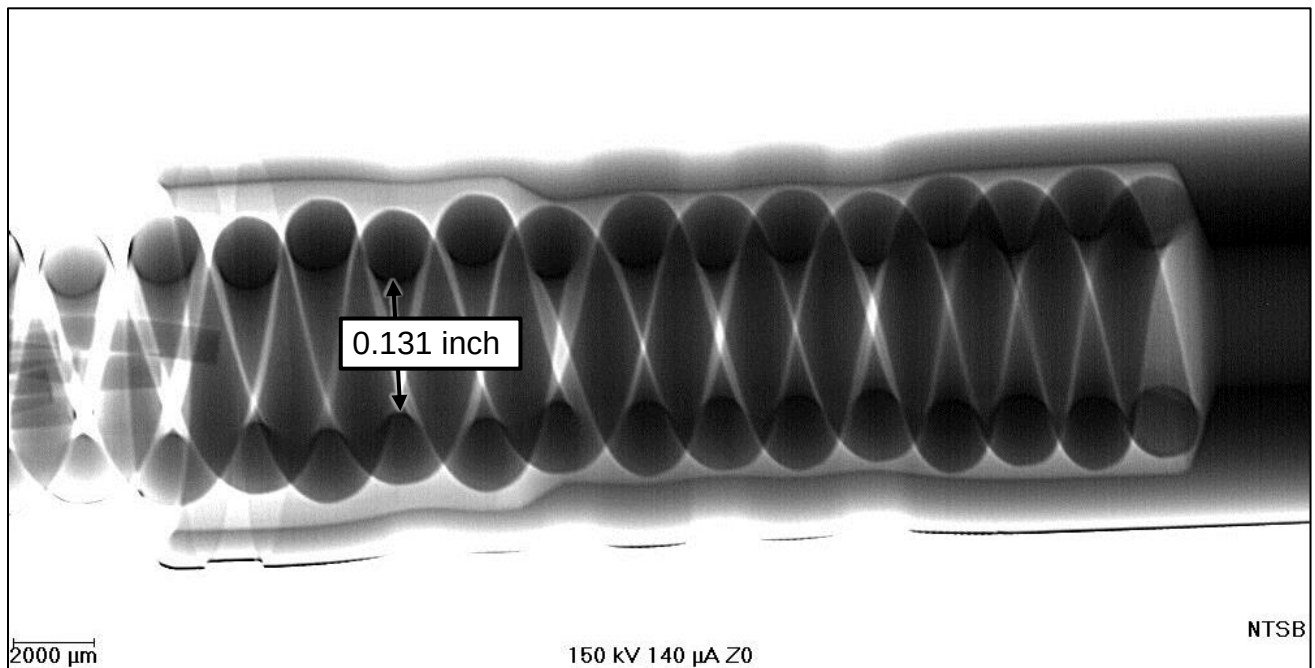
Another radiograph of the conduit and sleeve is shown in figure 8, where the brightness is increased to reveal more of the coil features within the sleeve. The sleeve is crimped onto the conduit, and the radiograph showed the inner diameter of the coil

and the spacing between coils varied along the length of the sleeve. The minimum diameter measured within the sleeve was 0.131 inch at the location indicated in figure 8.

Figure 8. Radiograph of the crimped portion of the sleeve at the input end of the cable assembly.

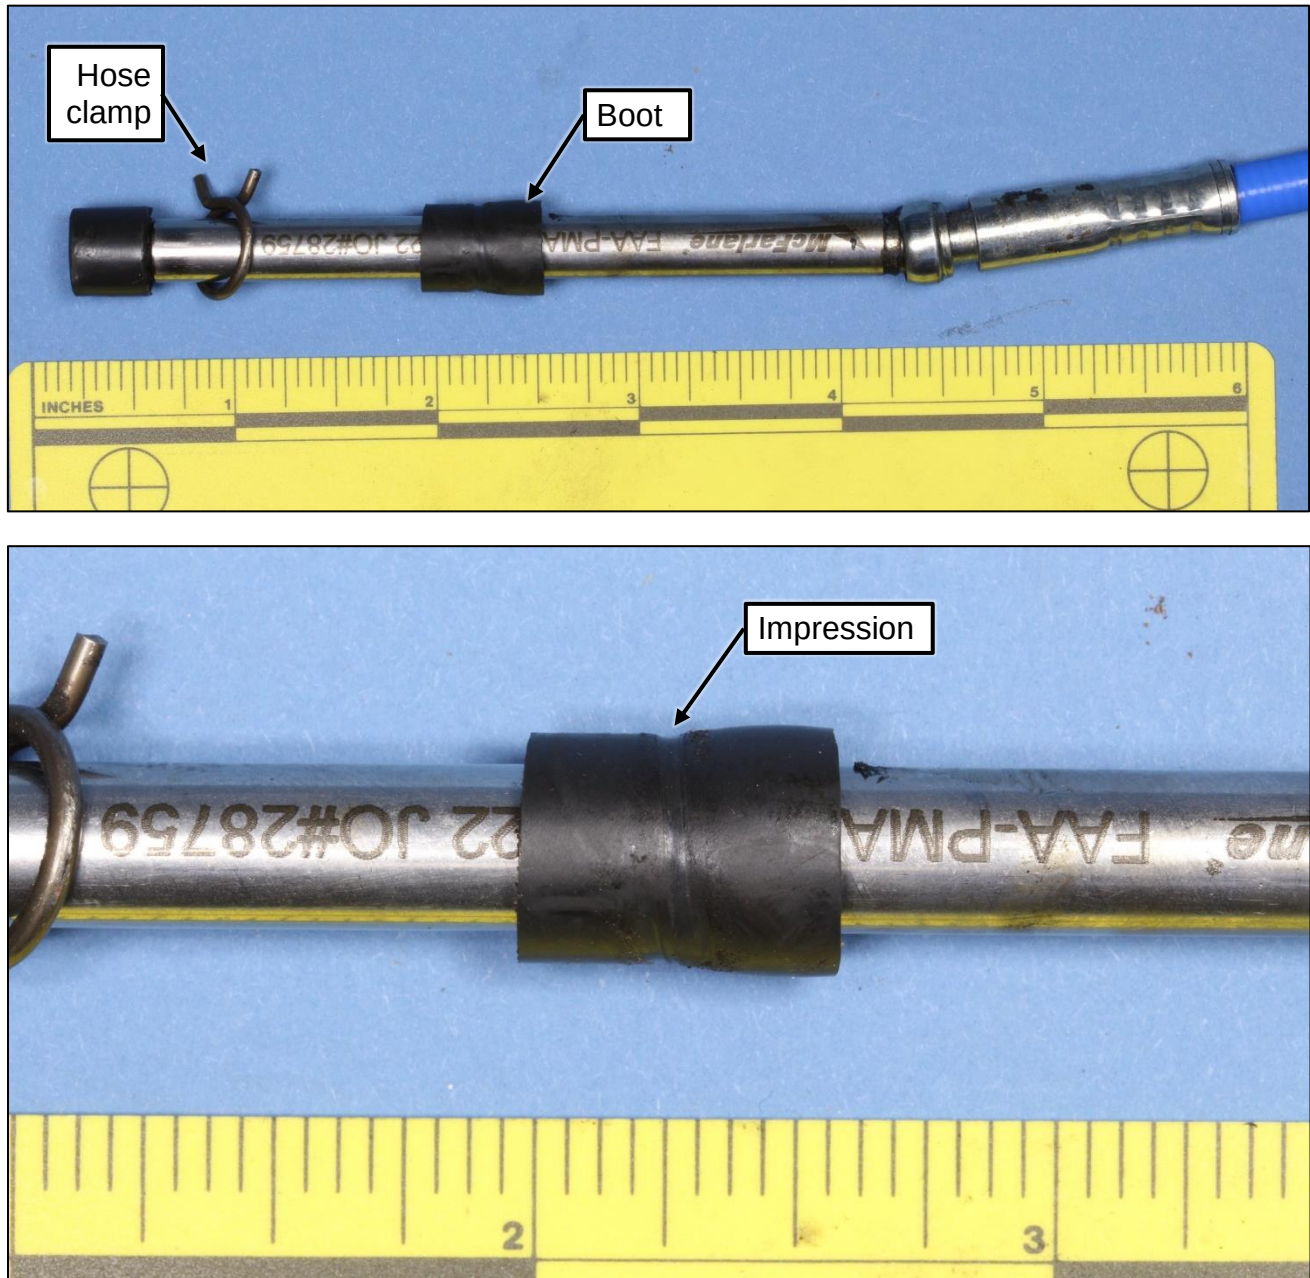
Figure 9. Output end of the control assembly after the cable was removed from the conduit and after removing the boot from the swivel joint. In the upper image, the swivel tube is shown at the maximum deflection for the joint, an angle of 8.2 degrees between the sleeve axis and the swivel tube axis.

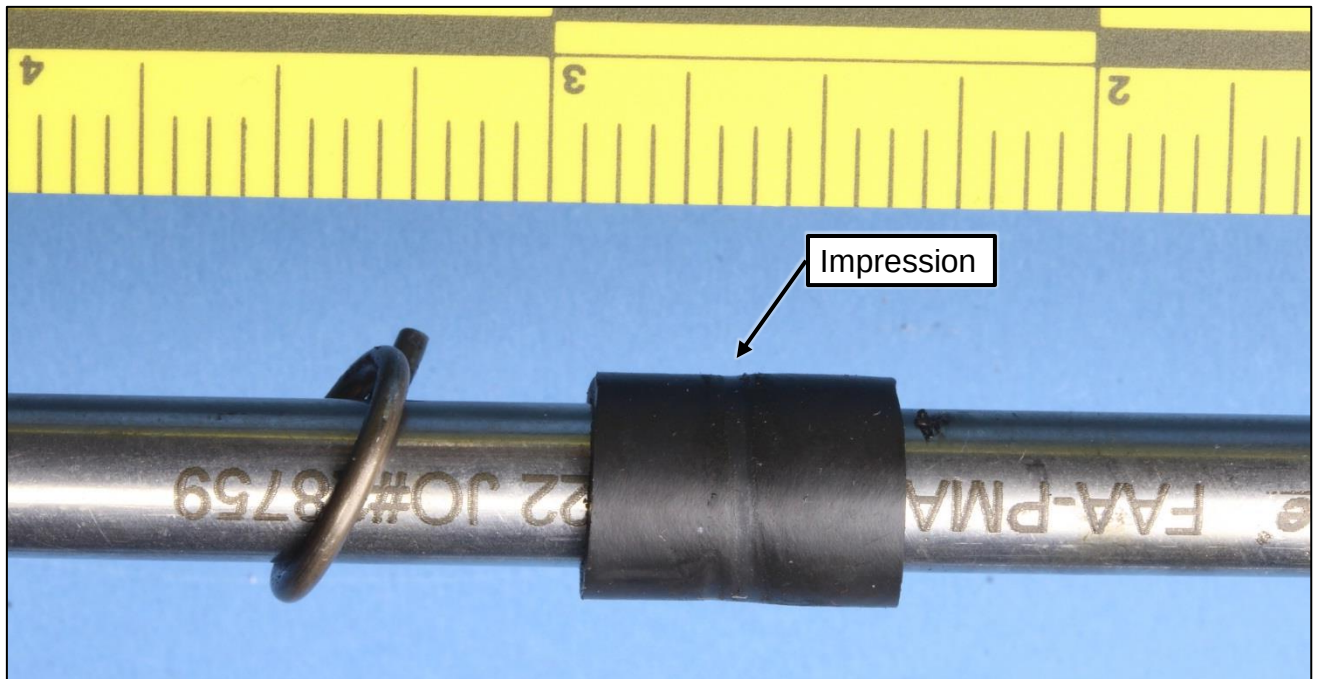
Figure 10. Close view of the boot on the output end of the cable photographed over 2 months after the hose clamp was removed. The hose clamp impression is still visible.

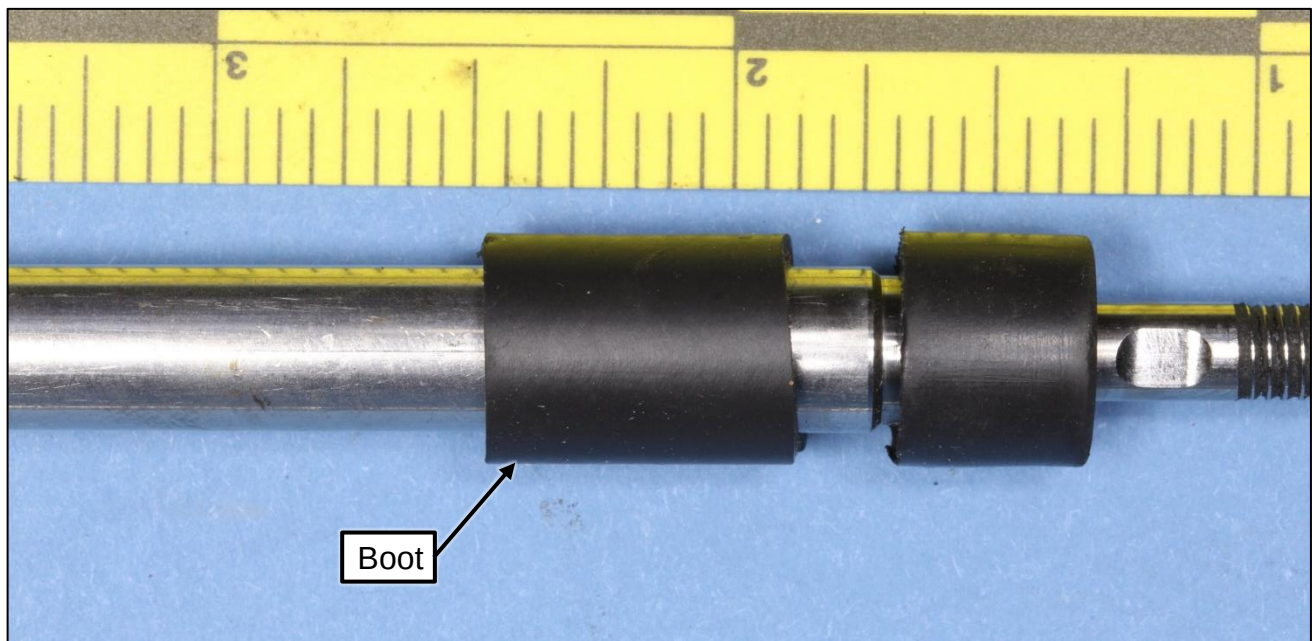
Figure 11. Close view of the boot at the input end of the swivel tube. An impression consistent with an installed hose clamp was not observed on the boot.
