# Continental Motors

## ENGINE FIELD INSPECTION REPORT

| ENGINE MODEL | TSIO-520-M |
| FILE NUMBER | 12-214 |

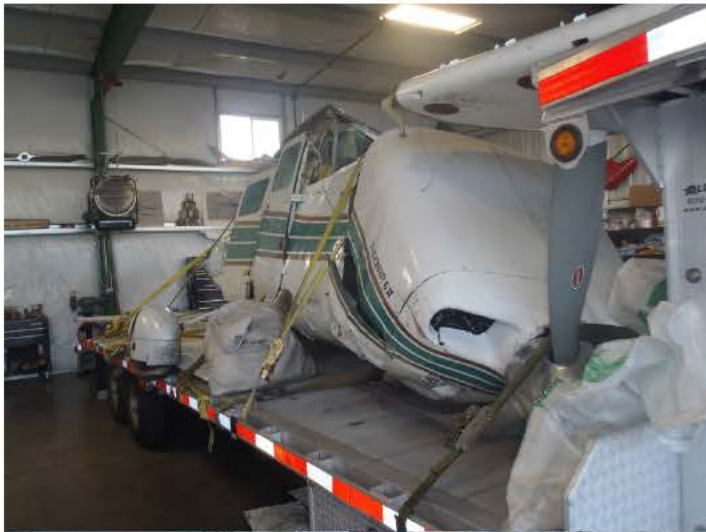
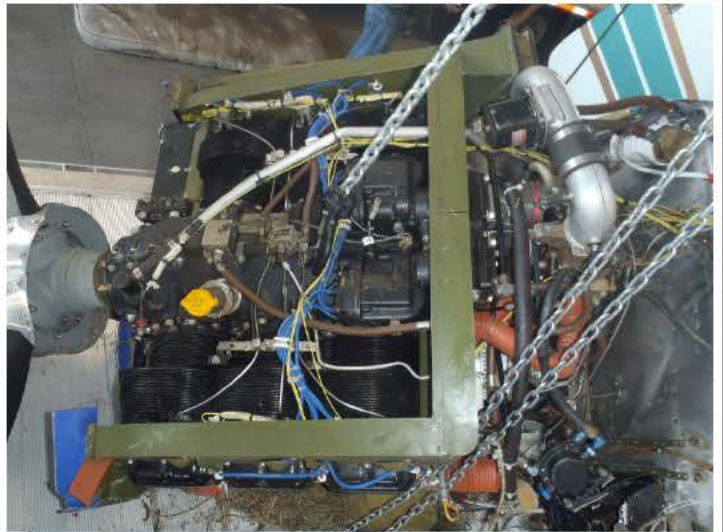
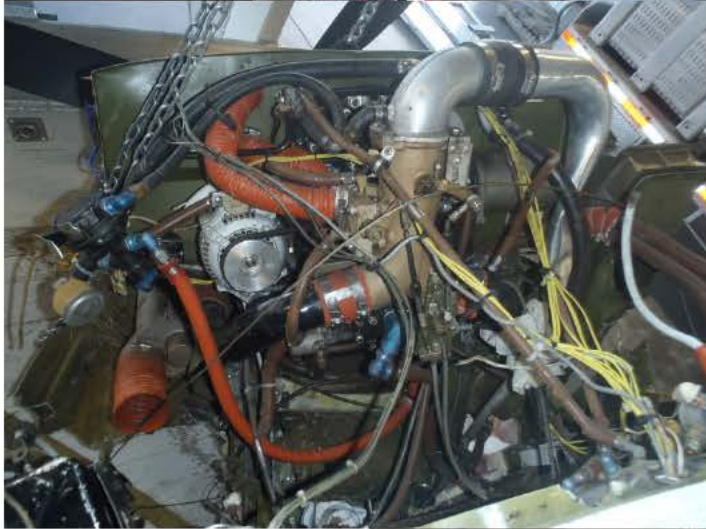
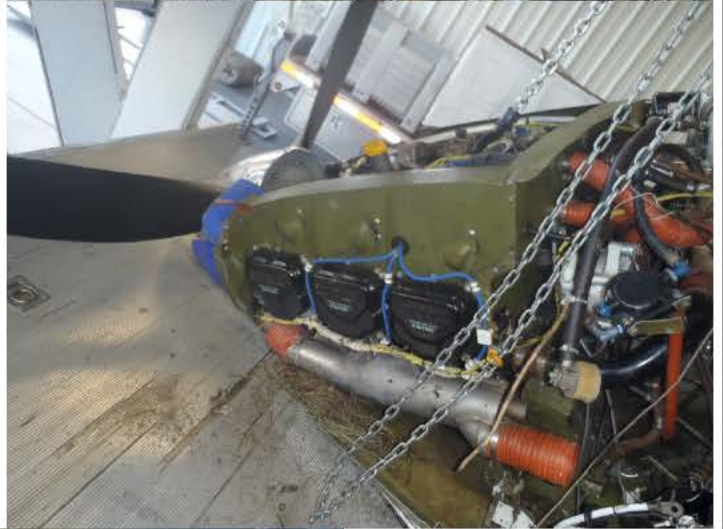
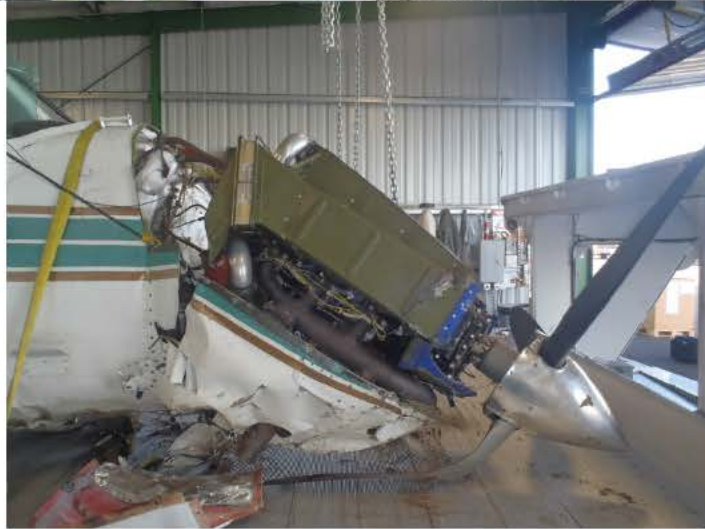
The engine remained attached to the airframe through the engine mounts, cables, wires, and hoses. The engine remained intact and displayed minor impact damage signatures. All six cylinders remained attached to the engine and were undamaged. There were no holes noted in the crankcase and no impact damage noted to the crankcase. The three blade, constant speed propeller remained attached to the crankshaft and displayed damage consistent with impact damage. Two of the propeller blades displayed chordwise scratches and aft bending deformation; the third propeller blade was undamaged.

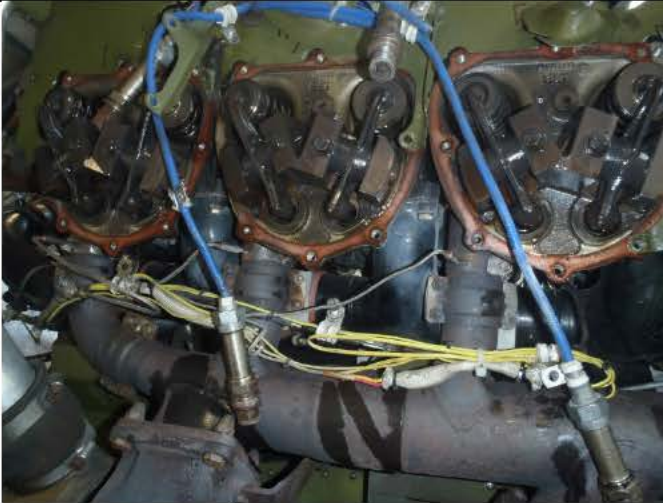
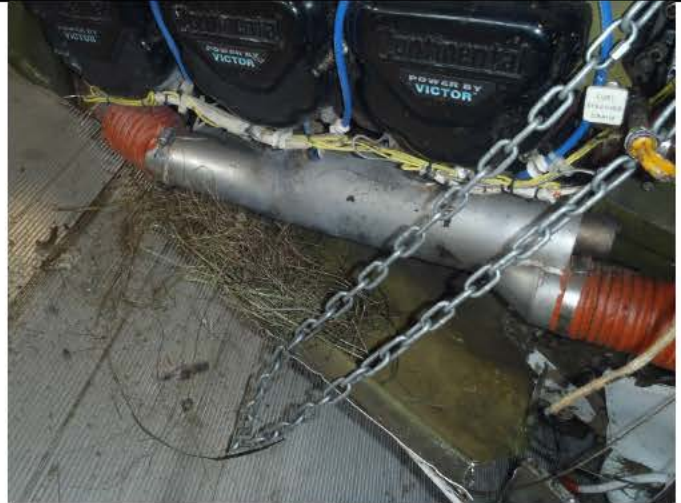
The exhaust system remained secured to each of the cylinders and to the turbocharger. The exhaust system displayed minor damage consistent with impact damage. There were no abnormalities noted with the exhaust system.

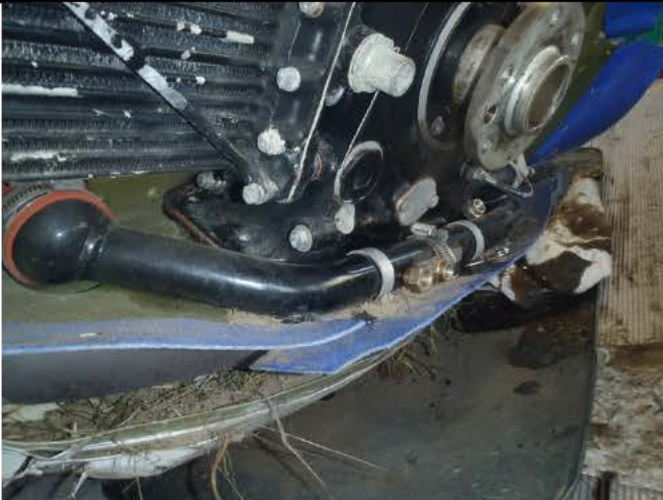
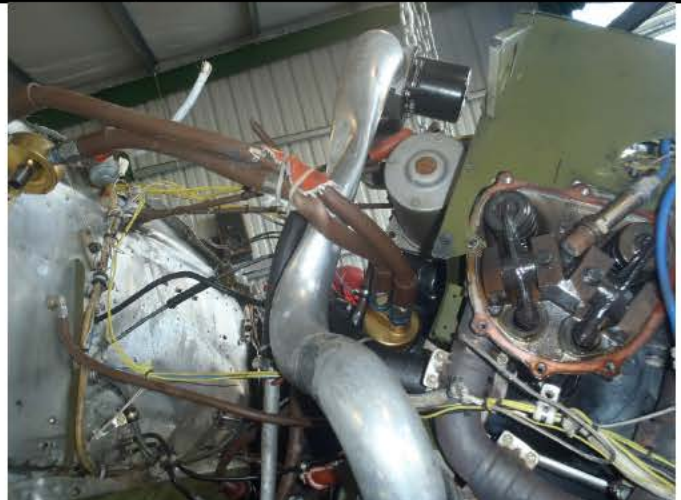
The induction system sustained some damage consistent with impact damage. All of the induction tubes and clamps were secure and there were no signs of induction leaks. There were no abnormalities noted with the induction system.

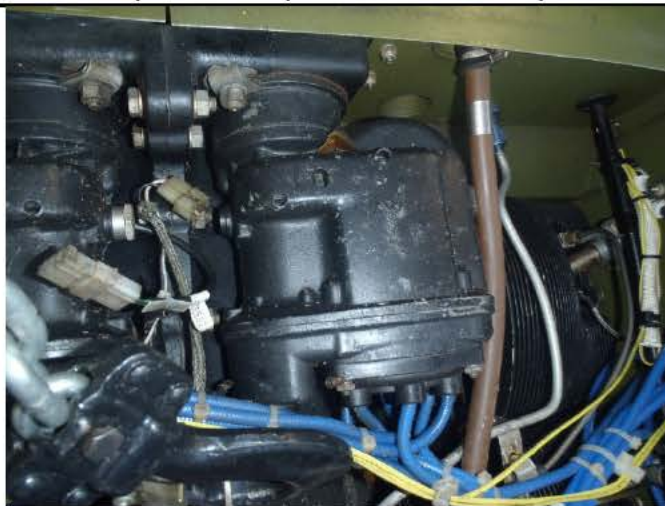
The left magneto remained attached to its mounting location and was undamaged. During crankshaft rotation it was noted that the impulse couplings operated normally. During impulse coupling operation it was noted that the magneto was capable of producing a spark on all six posts and would fire in the correct order. It was noted that the left and right magnetos would produce a spark for the same cylinder at the same time.

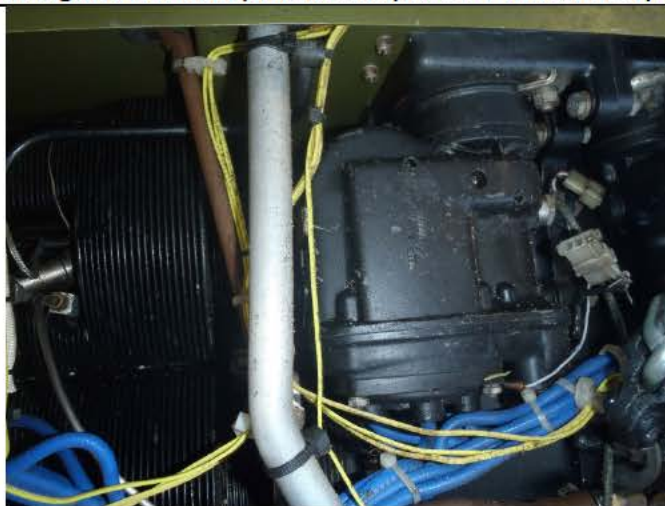
The right magneto remained attached to its mounting location and was undamaged. During crankshaft rotation it was noted that the impulse couplings operated normally. During impulse coupling operation it was noted that the magneto was capable of producing a spark on all six posts and would fire in the correct order. It was noted that the left and right magnetos would produce a spark for the same cylinder at the same time.

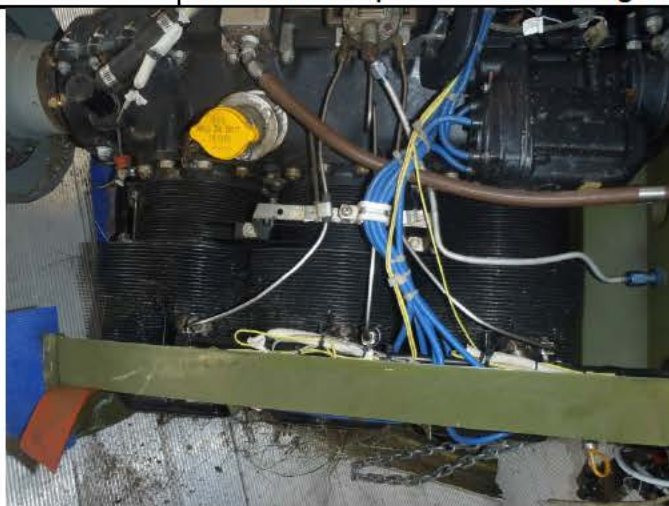
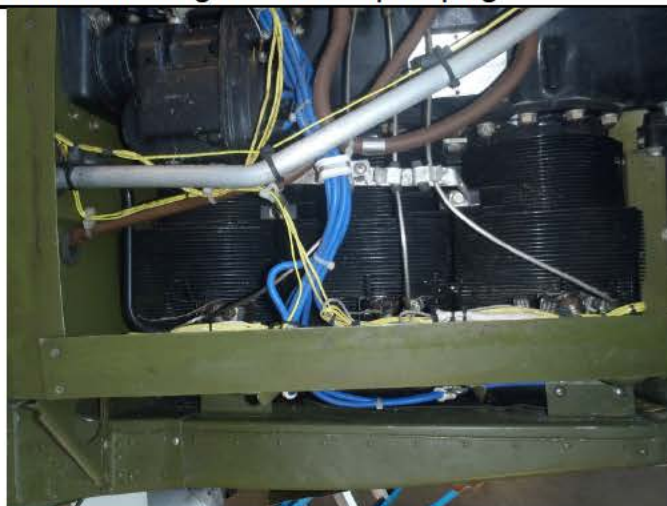
The ignition harness remained secured to both of the magnetos and to each of the spark plugs. During magneto impulse coupling operation it was noted that all of the ignition leads were capable of conducting a spark from the magneto to the spark plug.

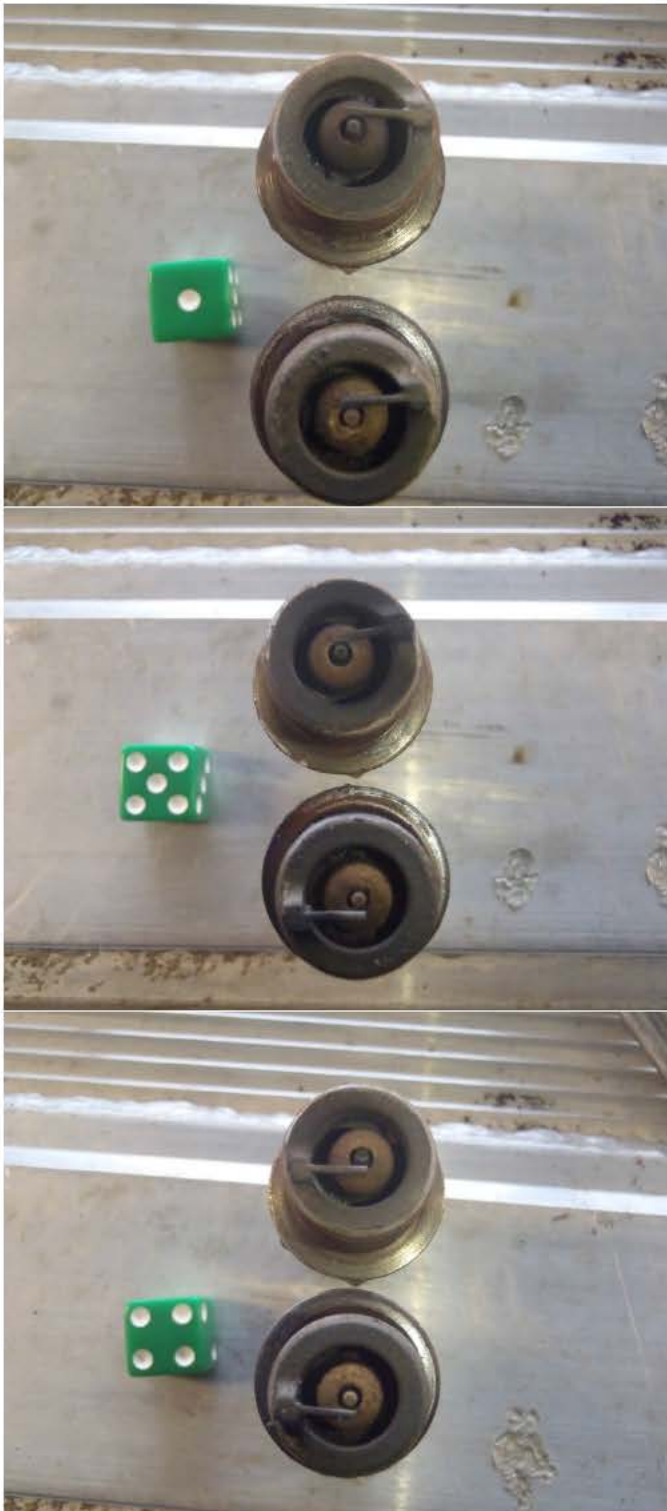
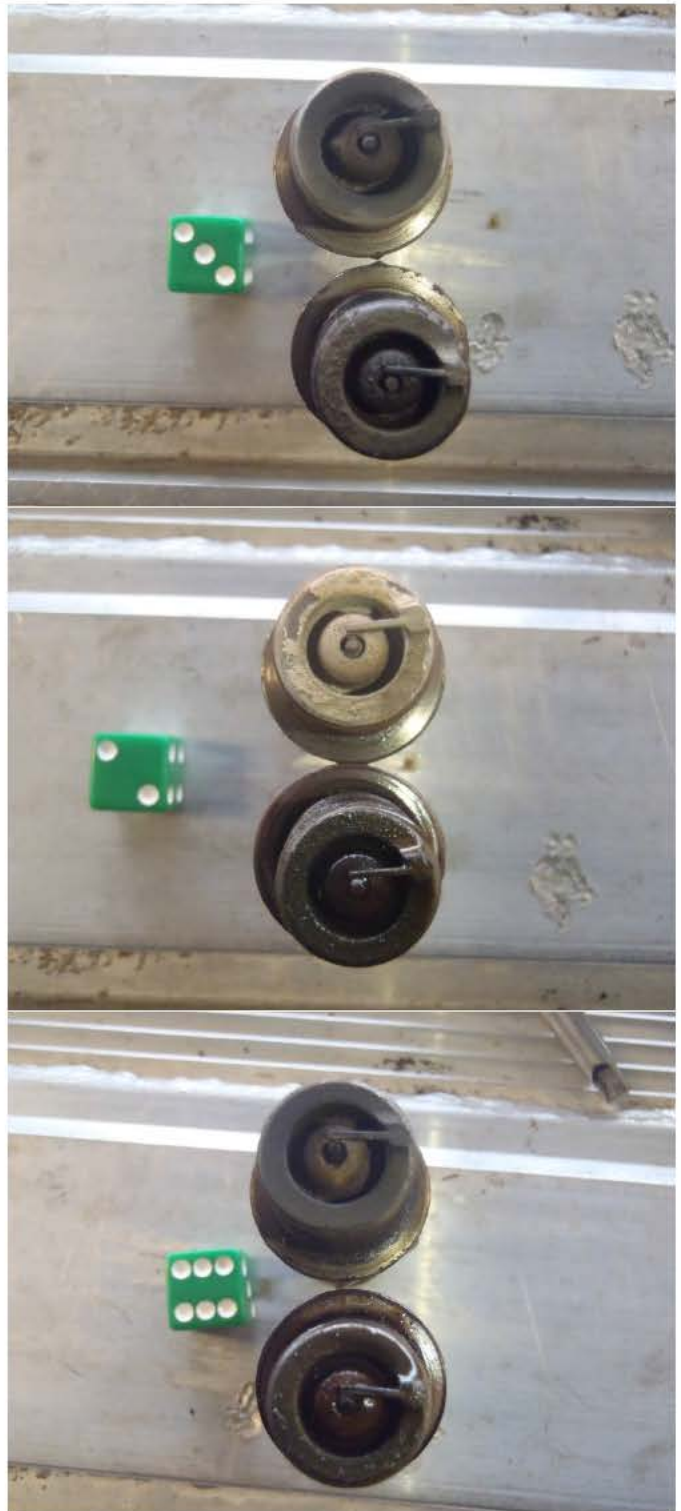
All of the spark plugs were secured to their cylinders and to their ignition leads. All of the spark plugs were removed for inspection and testing. It was noted that the #2 top spark plug insulator was broken inside the spark plug and the spark plug electrodes displayed a significant accumulation of combustion deposits. The inside of the #2 top spark plug and insulator displayed discoloration consistent with the ignition lead arcing to the inside of the spark plug. All of the other spark plugs displayed normal operating and wear signatures. All of the spark plugs were reattached to their ignition leads. During impulse coupling operation it was noted that the #2 top spark plug would not conduct a spark between the center and ground electrodes; all of the other spark plugs were capable of conducting a spark between the center and ground electrodes. There were no further anomalies noted.

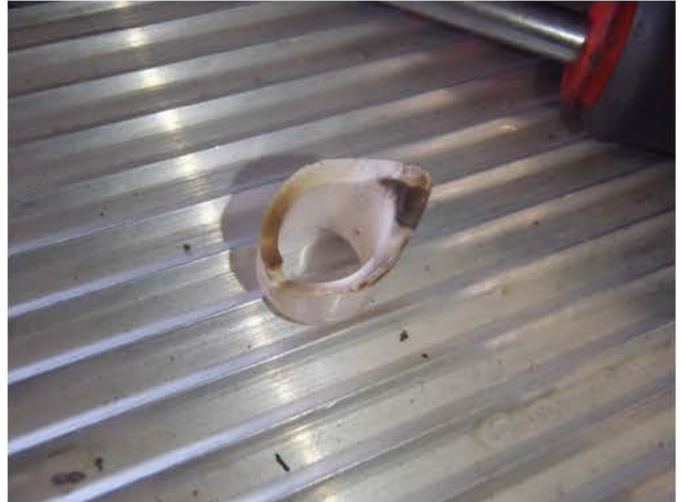
#2 Top Spark Plug Insulator

The examination of this engine revealed the #2 top spark plug was inoperative and displayed a significant amount of combustion deposits on the electrodes. There were no further anomalies that would have prevented normal operation of the engine.

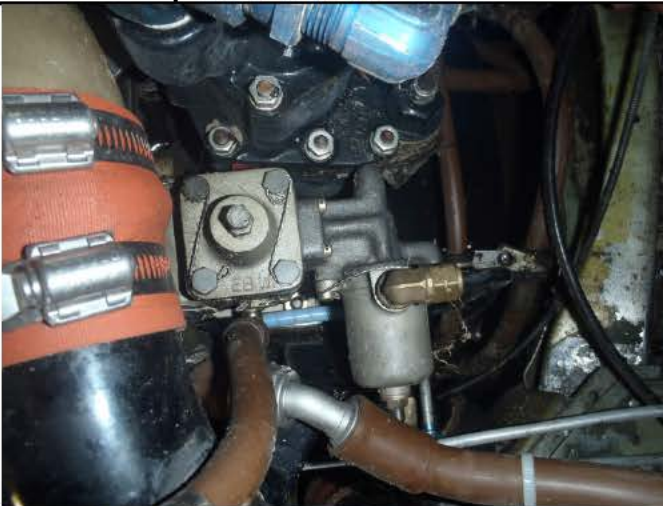
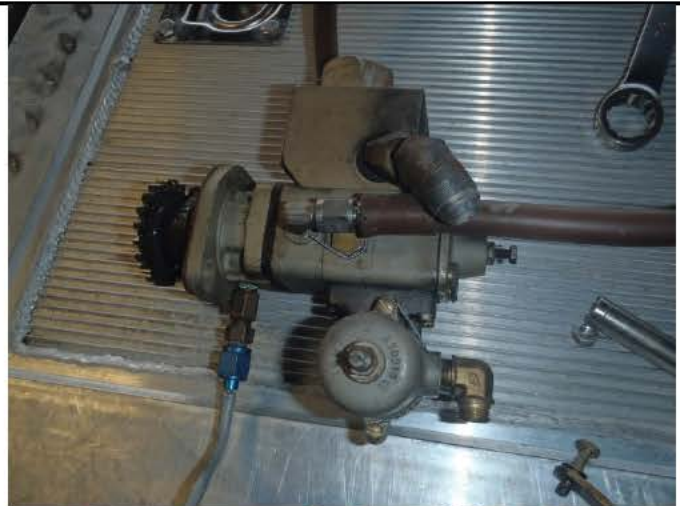
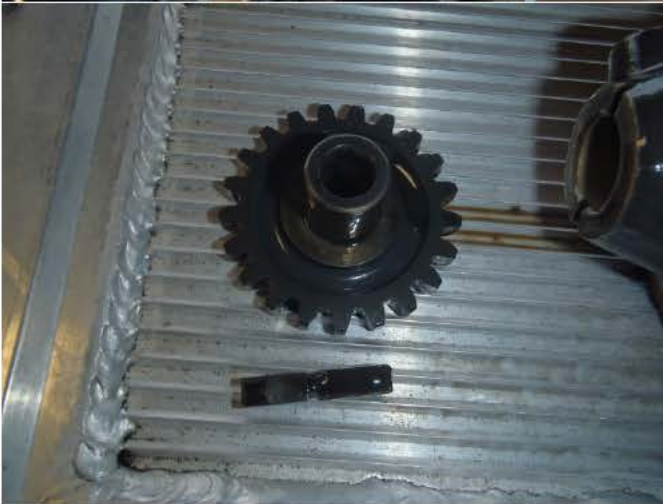
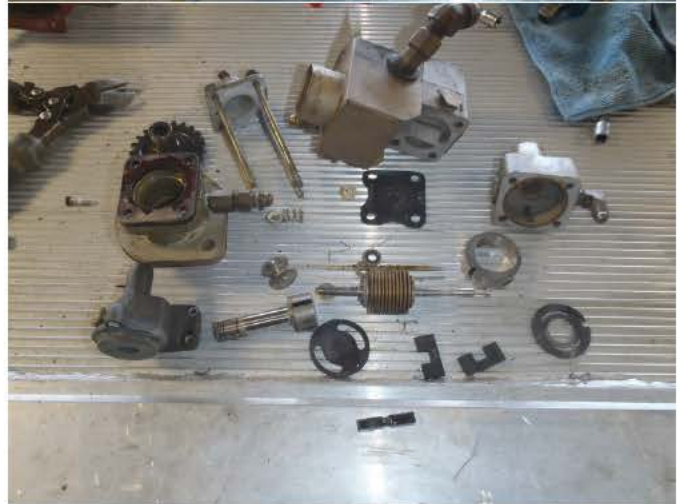
The fuel pump remained attached to its installation point and was undamaged. The fuel pump was removed and it was noted that the fuel pump drive coupling was intact and the fuel pump drive was capable of rotation by hand; it was noted that during hand rotation of the fuel pump drive a small amount of fuel was pumped out. The fuel pump was disassembled and the internal components were visually inspected. The internal components displayed normal operating signatures. There were no anomalies noted with the fuel pump.

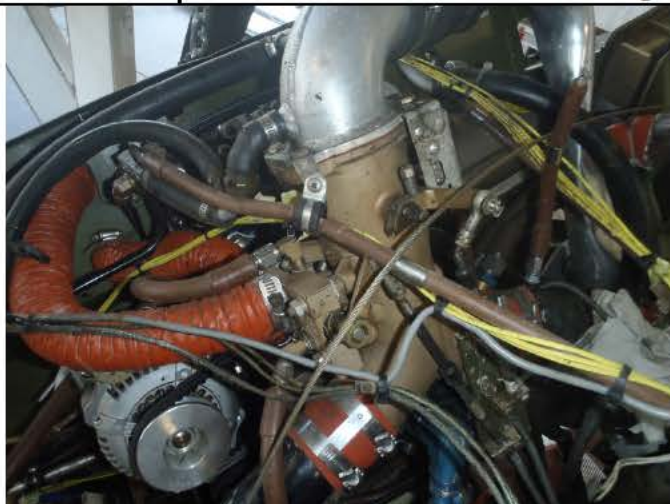
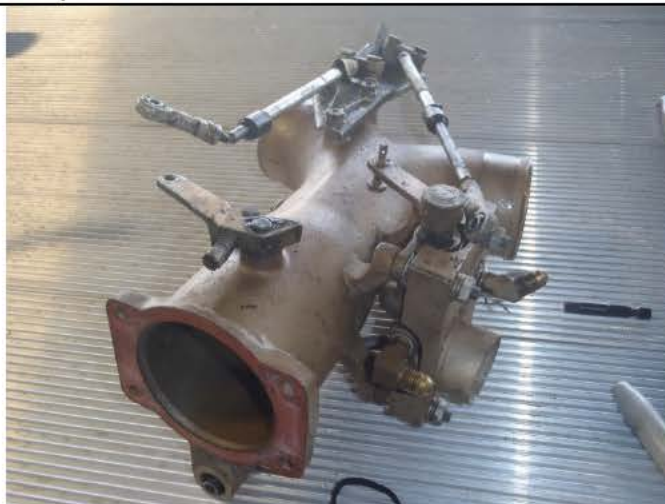
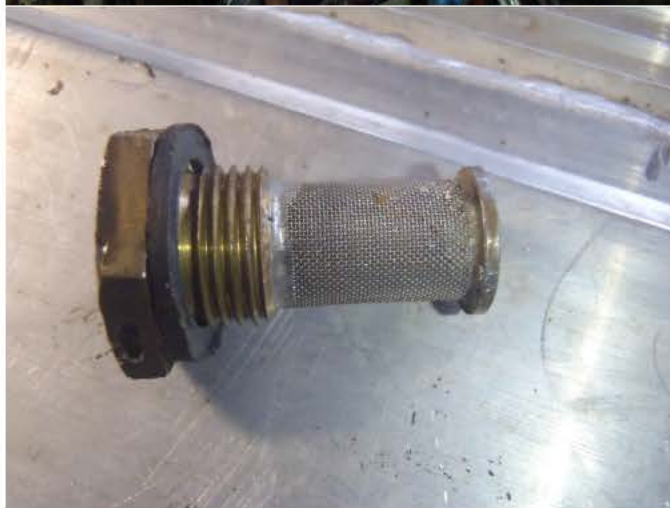
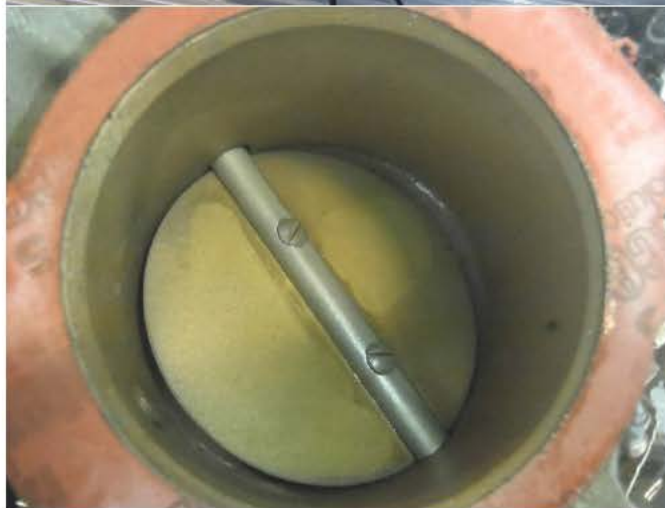
The throttle and fuel metering assembly remained attached to its mounting location and displayed some impact damage signatures. Both of the control arms remained secured to their shafts and the control cable rod ends were secured to the control shafts. The throttle control rod end was bent at an approximate 45° angle; the damage was consistent with impact damage. The throttle and fuel metering assembly was removed and disassembled for a visual inspection. The internal components displayed normal operating signatures and the fuel inlet screen was clear of any contaminants. There were no anomalies noted with the throttle and fuel metering assembly.

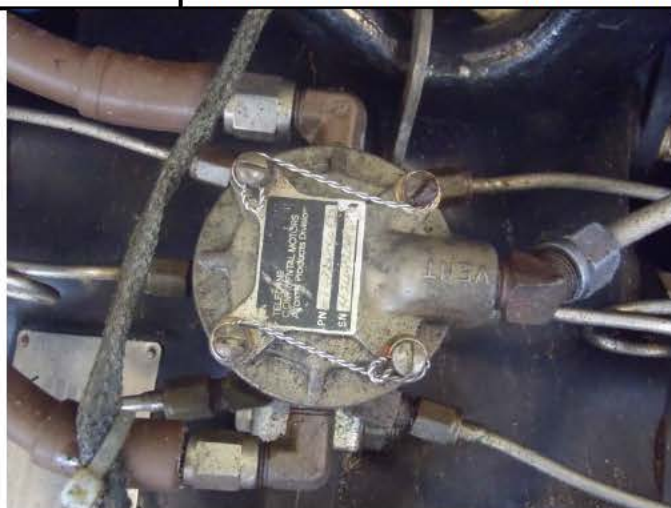
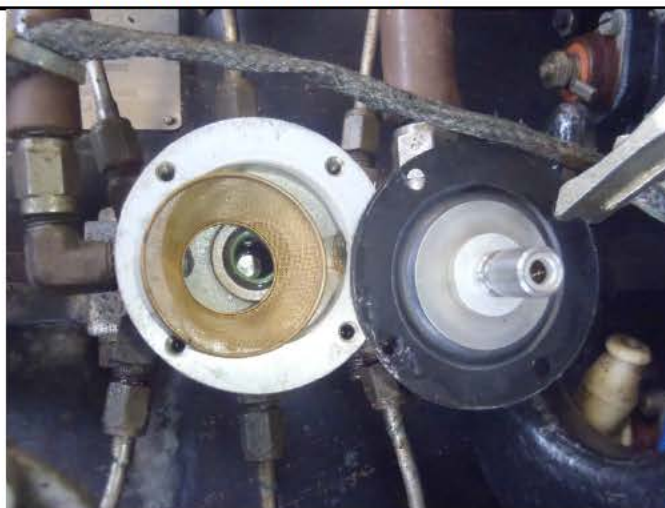
| FUEL MANIFOLD VALVE | Manufacturer: CMI | P/N: 6343274A22 | S/N: H244208CR |
|---|---|---|---|
| Condition: | The fuel manifold valve remained attached to its installation point and was undamaged. The manifold valve was disassembled and the internal components were inspected. All of the internal components displayed normal operating signatures and the screen was clear of contaminants. There were no anomalies noted with the manifold valve. | | |

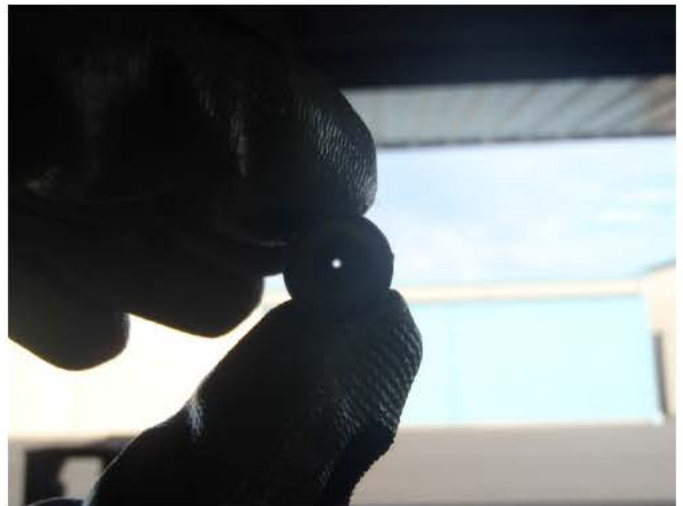
| FUEL NOZZLES AND LINES | Manufacturer: CMI | | | | | |
|---|---|---|---|---|---|---|
| Condition: | All of the fuel nozzles remained installed in their cylinders and were undamaged. The fuel nozzles were removed and visually inspected; it was noted that the #6 fuel nozzle displayed a significant amount of oxidation on the outside of the nozzle. All of the nozzles were found to be clear of any blockages. | | | | | |

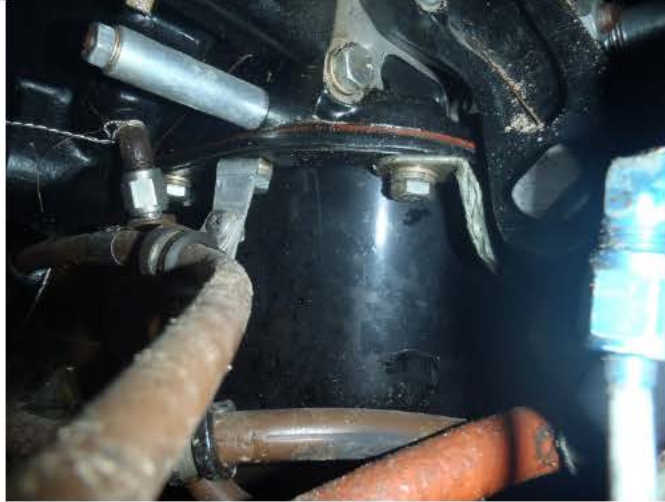
Only a small portion of the oil sump was visible to the investigators. The visible portion of the oil sump was undamaged and there were no anomalies noted.

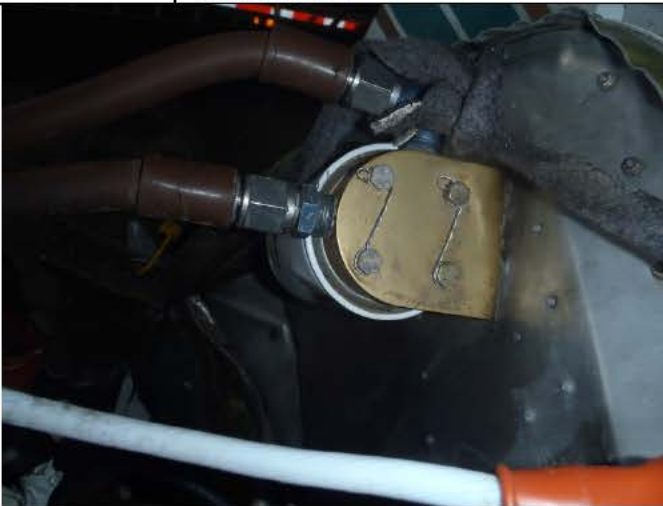
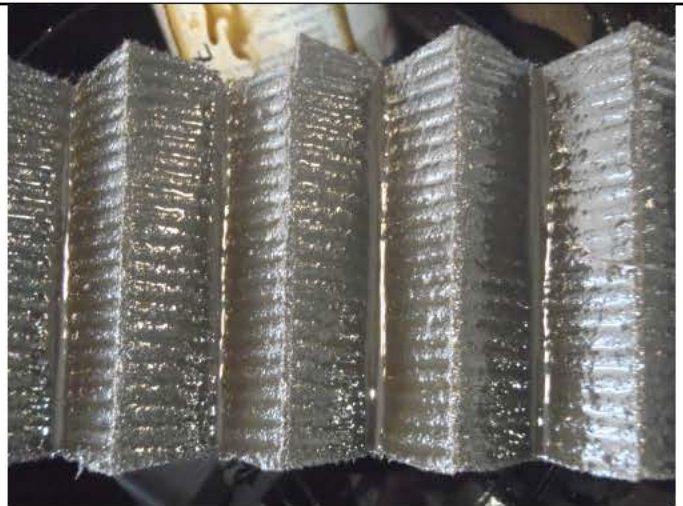
The remote oil filter was removed and the oil filter element was removed from the housing. There were no metallic particles or other abnormal contaminants noted in the oil filter pleats.

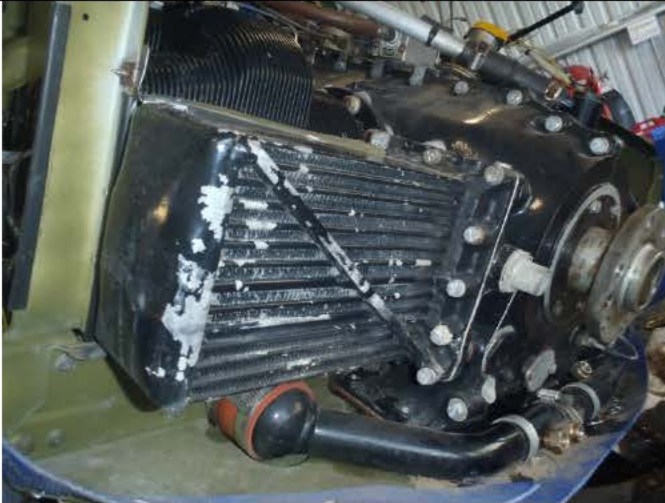
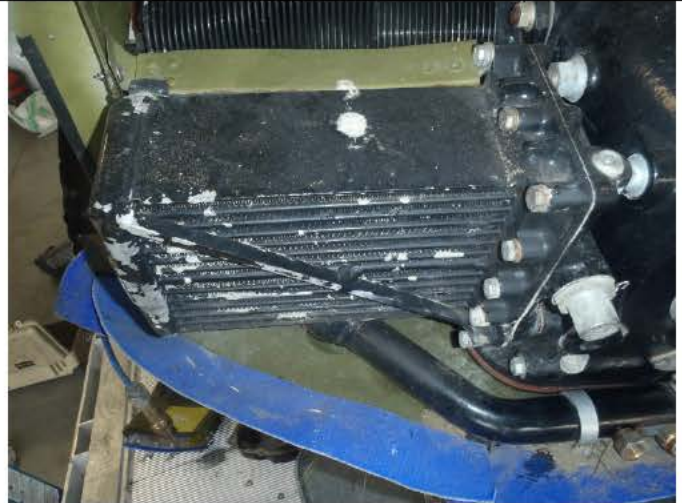
The oil cooler remained attached to its installation point and was undamaged. There were no anomalies noted with the oil cooler.

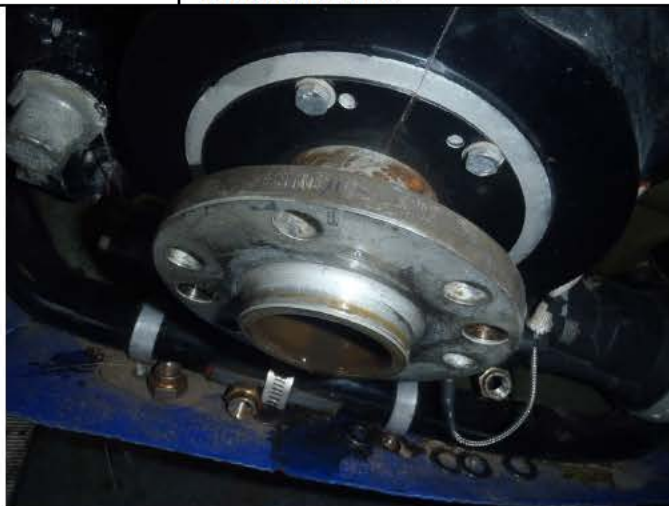
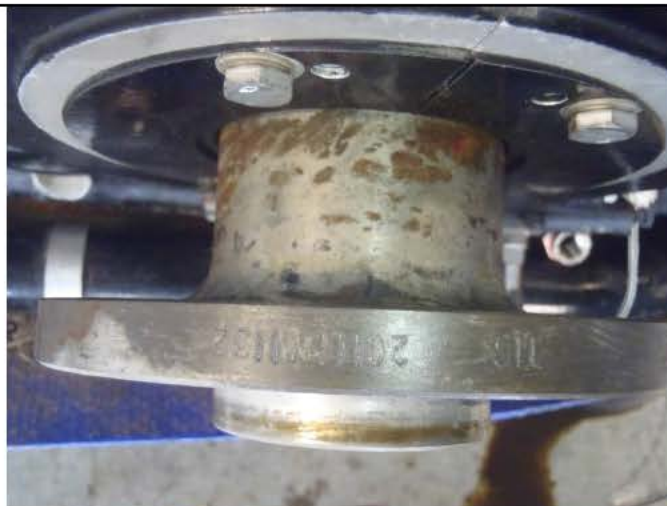
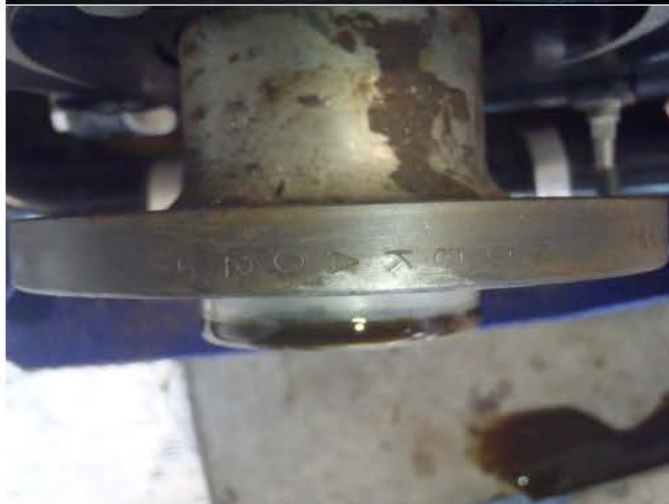
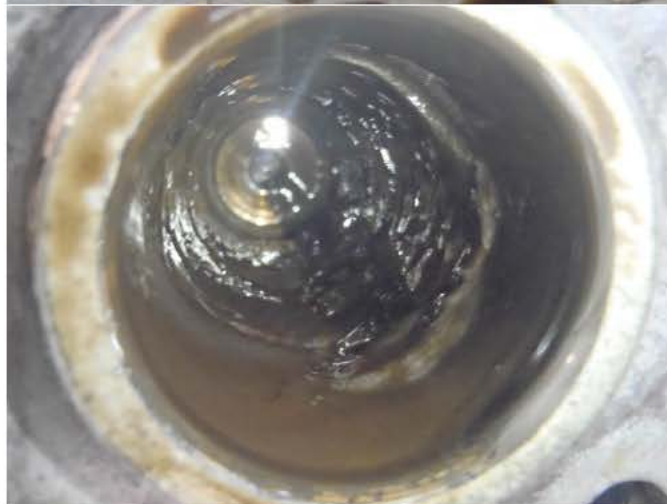
| CRANKSHAFT | Forging: Inaccessible | S/N: N08KA028 | Heat code: Inaccessible |
|---|---|---|---|
| Condition: | The propeller flange remained attached to the rest of the crankshaft and there were no visible cracks in the crankshaft. The propeller was removed from the crankshaft and the crankshaft was rotated using a hand tool; continuity was established between the crankshaft, camshaft, connecting rods, and all associated components. It was noted that the crankshaft was significantly corroded aft of the propeller flange and forward of the crankshaft seal. | | |

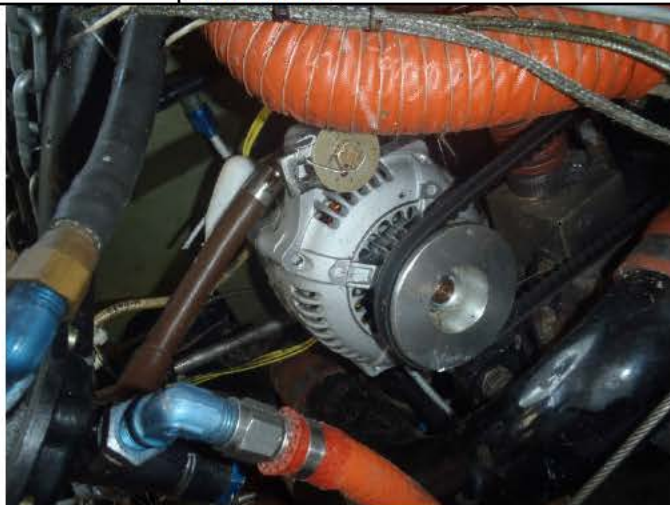
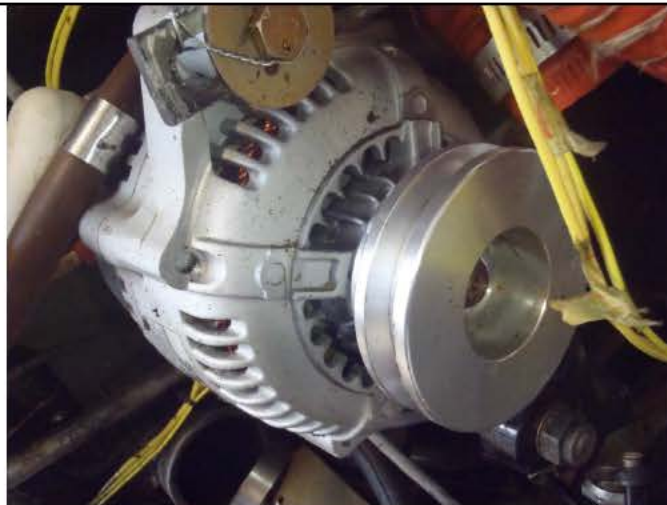
The alternator remained attached to its mounting brackets and displayed minor impact damage signatures to the alternator pulley. There were no anomalies noted with the alternator.

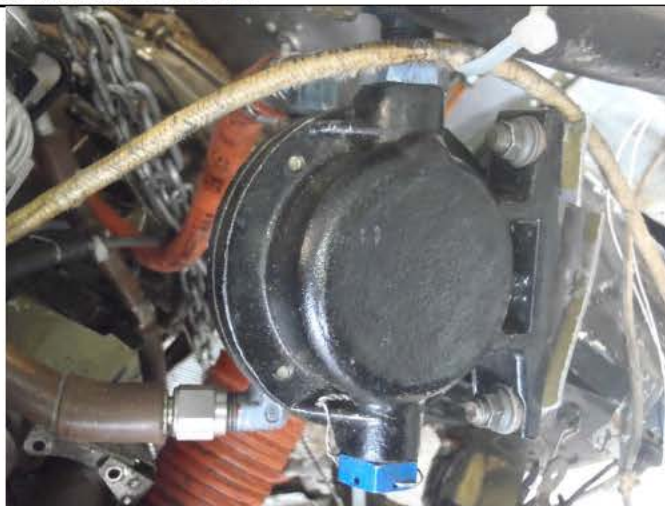
The turbocharger controller had broken free from its mounting location and displayed some impact damage signatures. All of the lines remained secured to the controller and there were no anomalies noted.

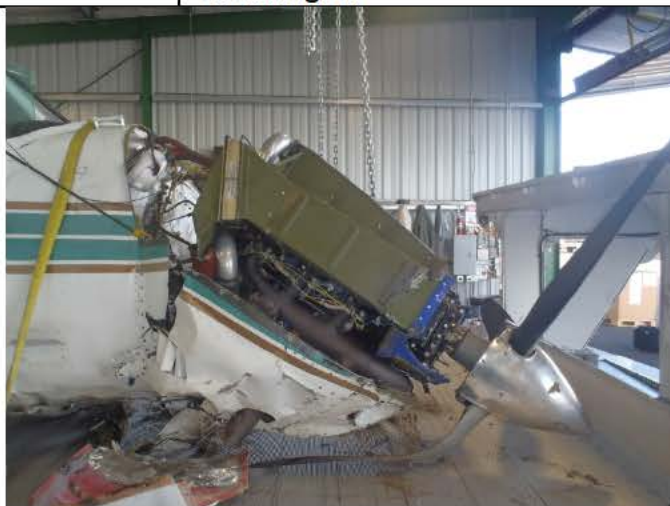
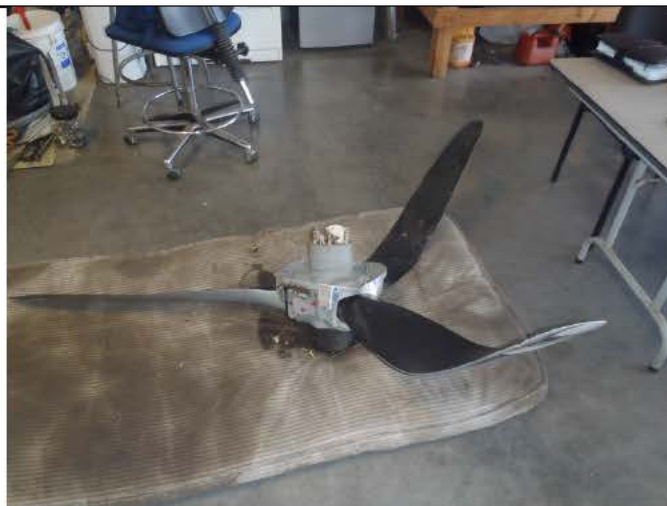
The three blade, constant speed propeller remained attached to the crankshaft and displayed damage consistent with impact damage. Two of the propeller blades displayed chordwise scratches and aft bending deformation; the third propeller blade appeared undamaged.
