## EXAMINATION NOTES

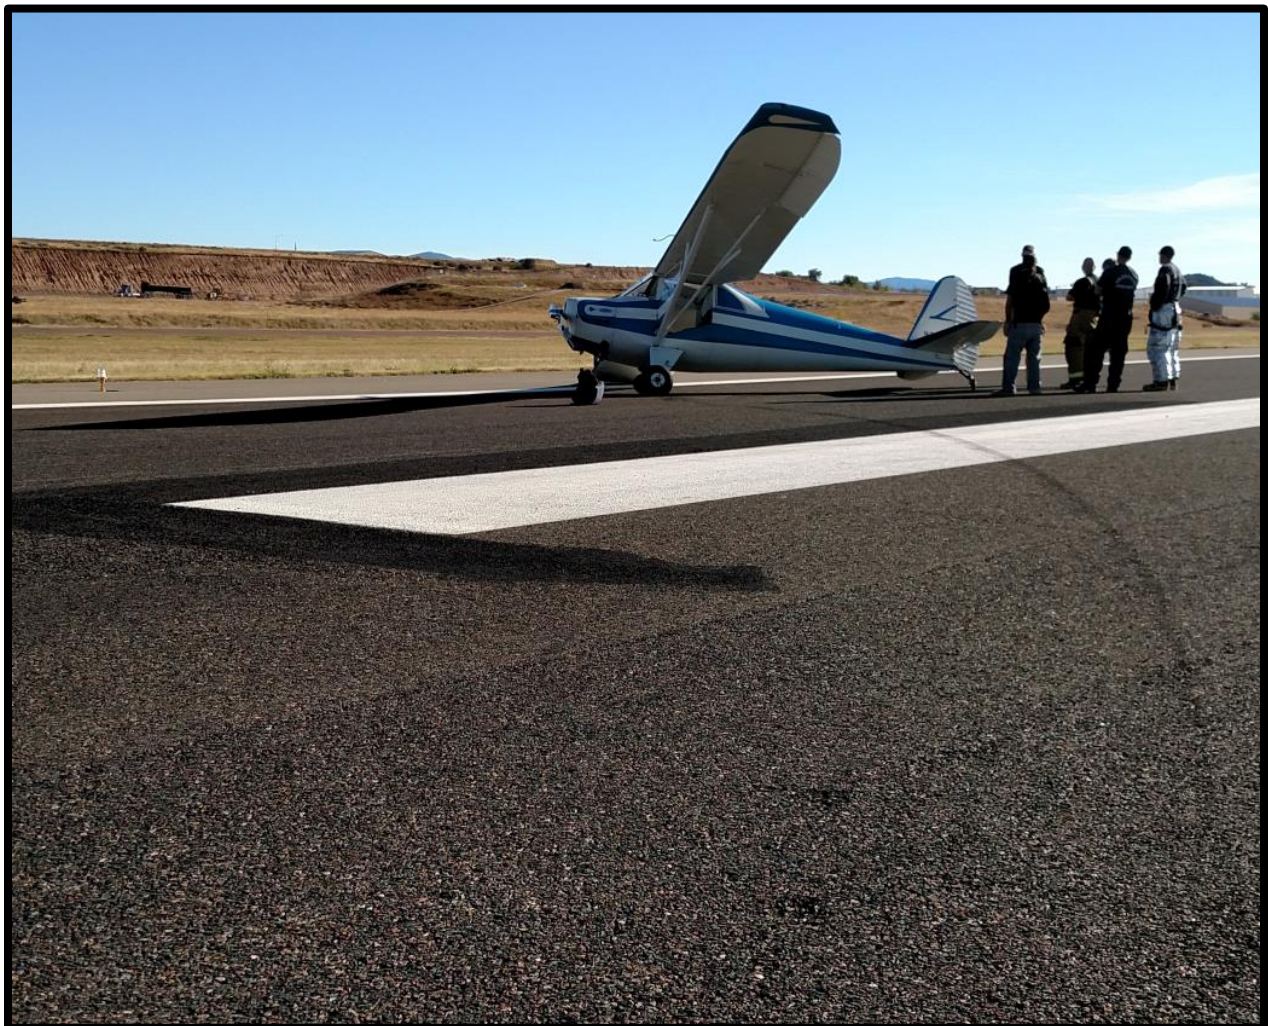
The Luscombe 8a was equipped with a Scott 3-24B tailwheel (now Scott 2000), with a steerable six-inch rubber tire that has full-swivel capability. The airplane came to rest on the edge of the runway with the right landing gear collapsed and folded under the fuselage. The tailwheel steering chains remained affixed to their respective rudder horns as well as their respective steering arms mounted on the tailwheel body. The tailwheel had rotated over 180-degrees and was canted to the left leaving the chains crossed over one another.

*Picture 1: Accident Site*

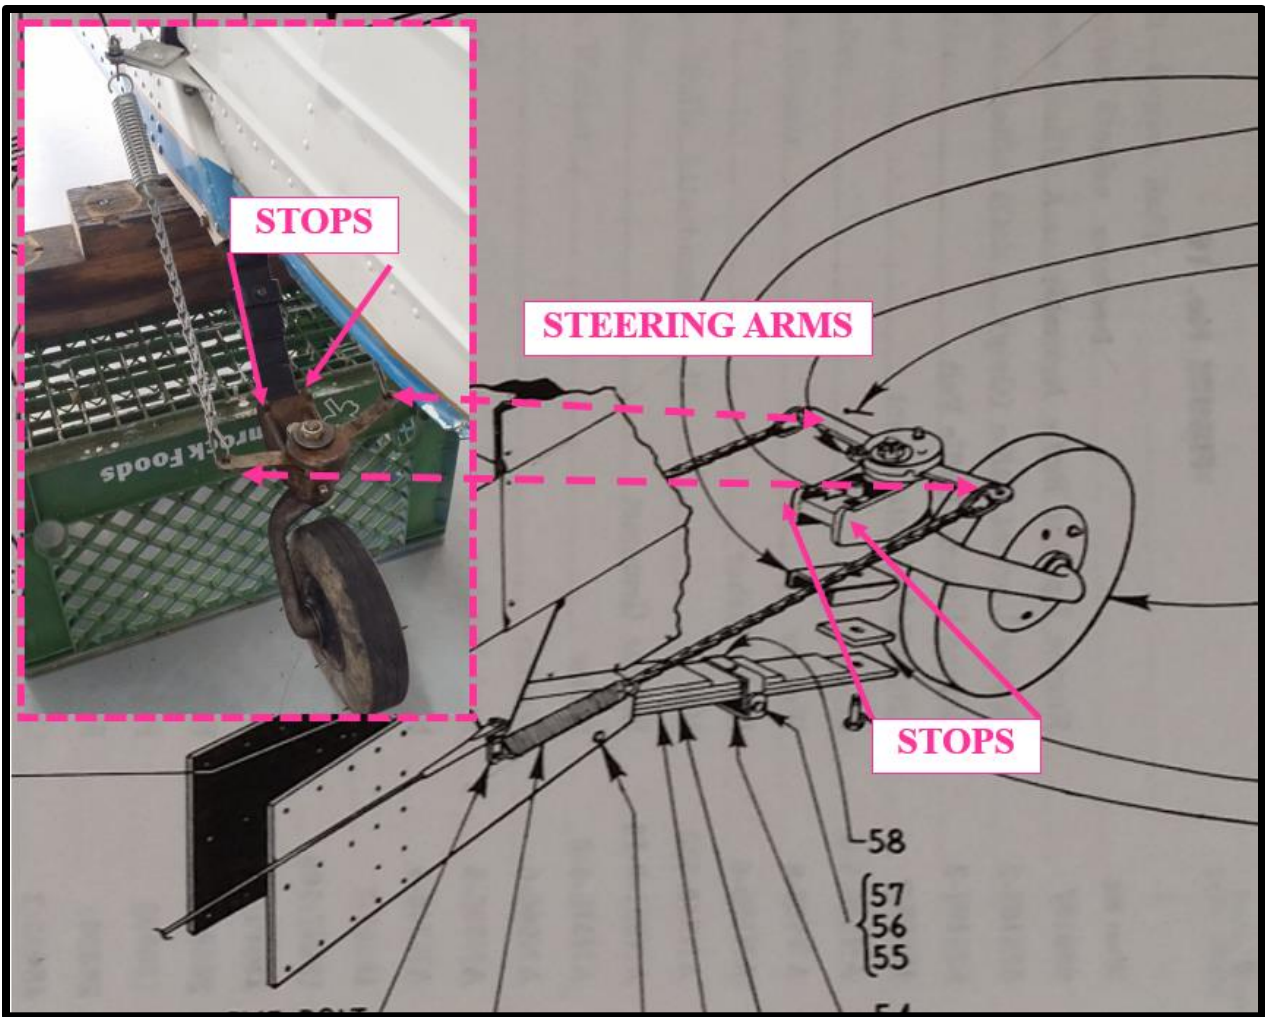
Picture 2: Illustrated Parts Catalog and Airplane After Recovery

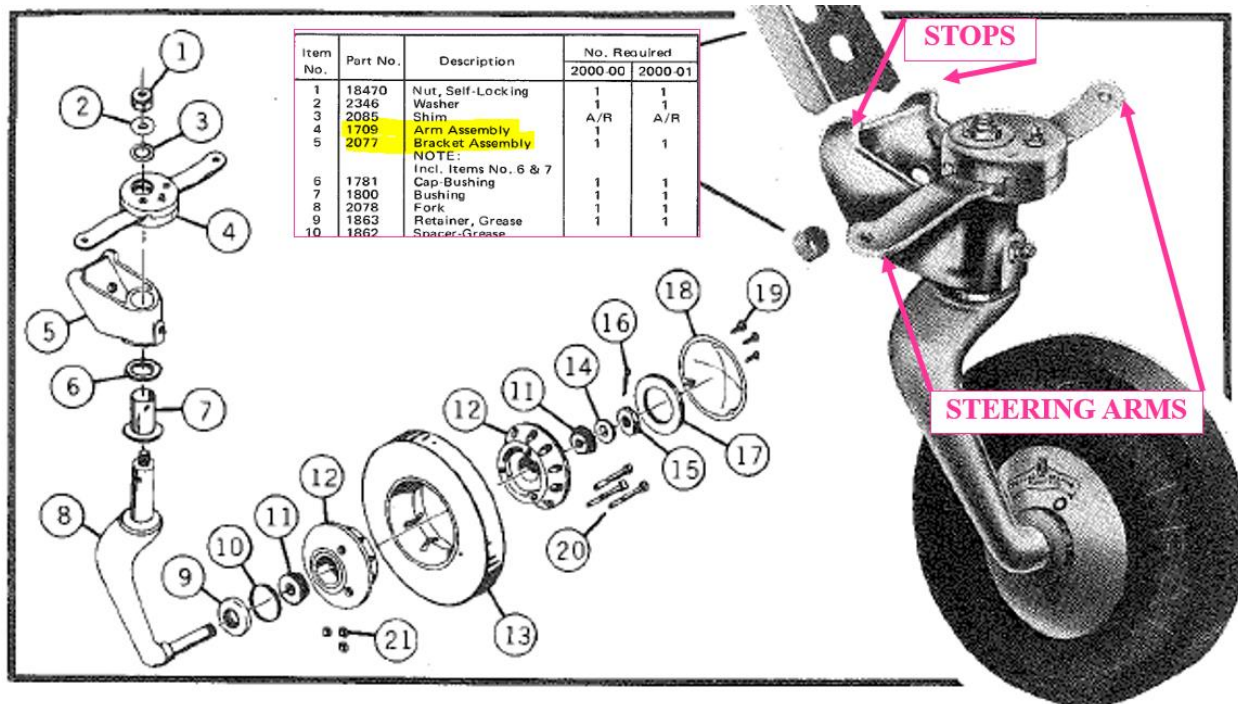
According to the Scott 3-24B Handbook, "The tail wheel assemblies provide directional control throughout full rudder travel of the aircraft while the tailwheel is in contact with the ground. The assemblies will automatically full-swivel only well after the maximum point of air rudder control is reached in either direction... The tailwheel steering and release mechanism is so designed that 65-degrees of tailwheel turn (or travel) is provided either right or left from neutral steering position before the mechanism begins to release."

Picture 3: Diagram of the Scott tailwheel

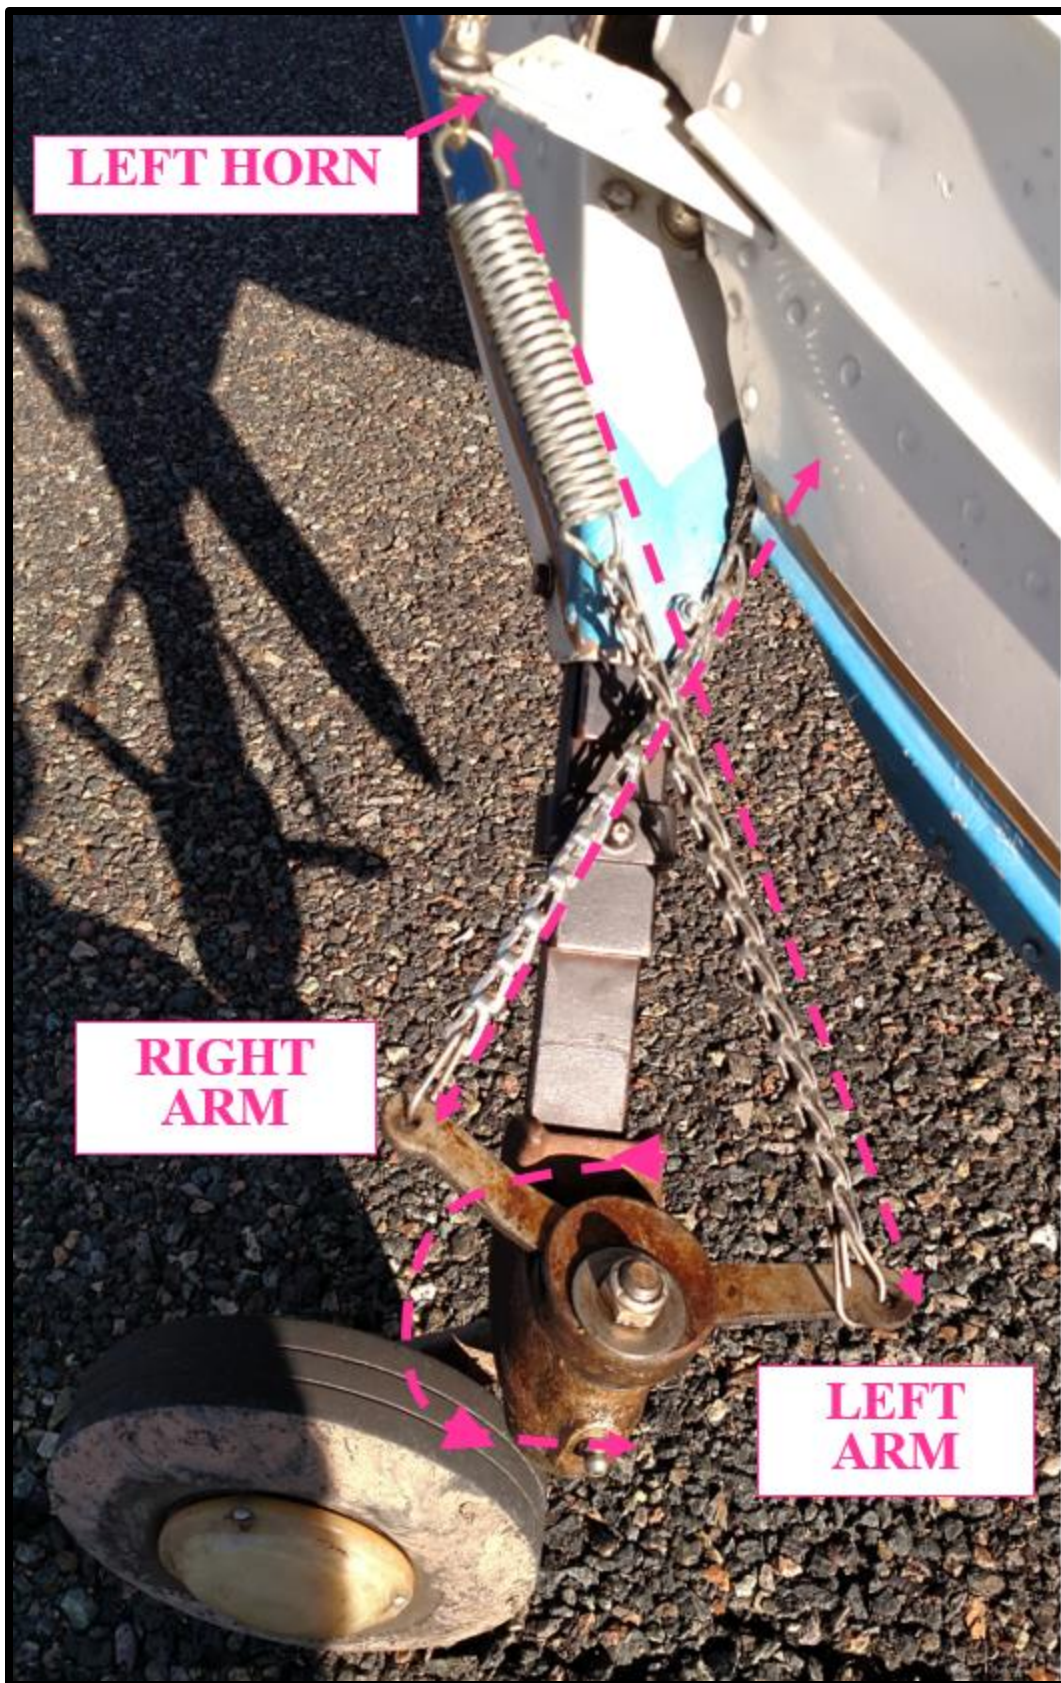
Picture 4: At Accident Site (rotated over 180-degrees)

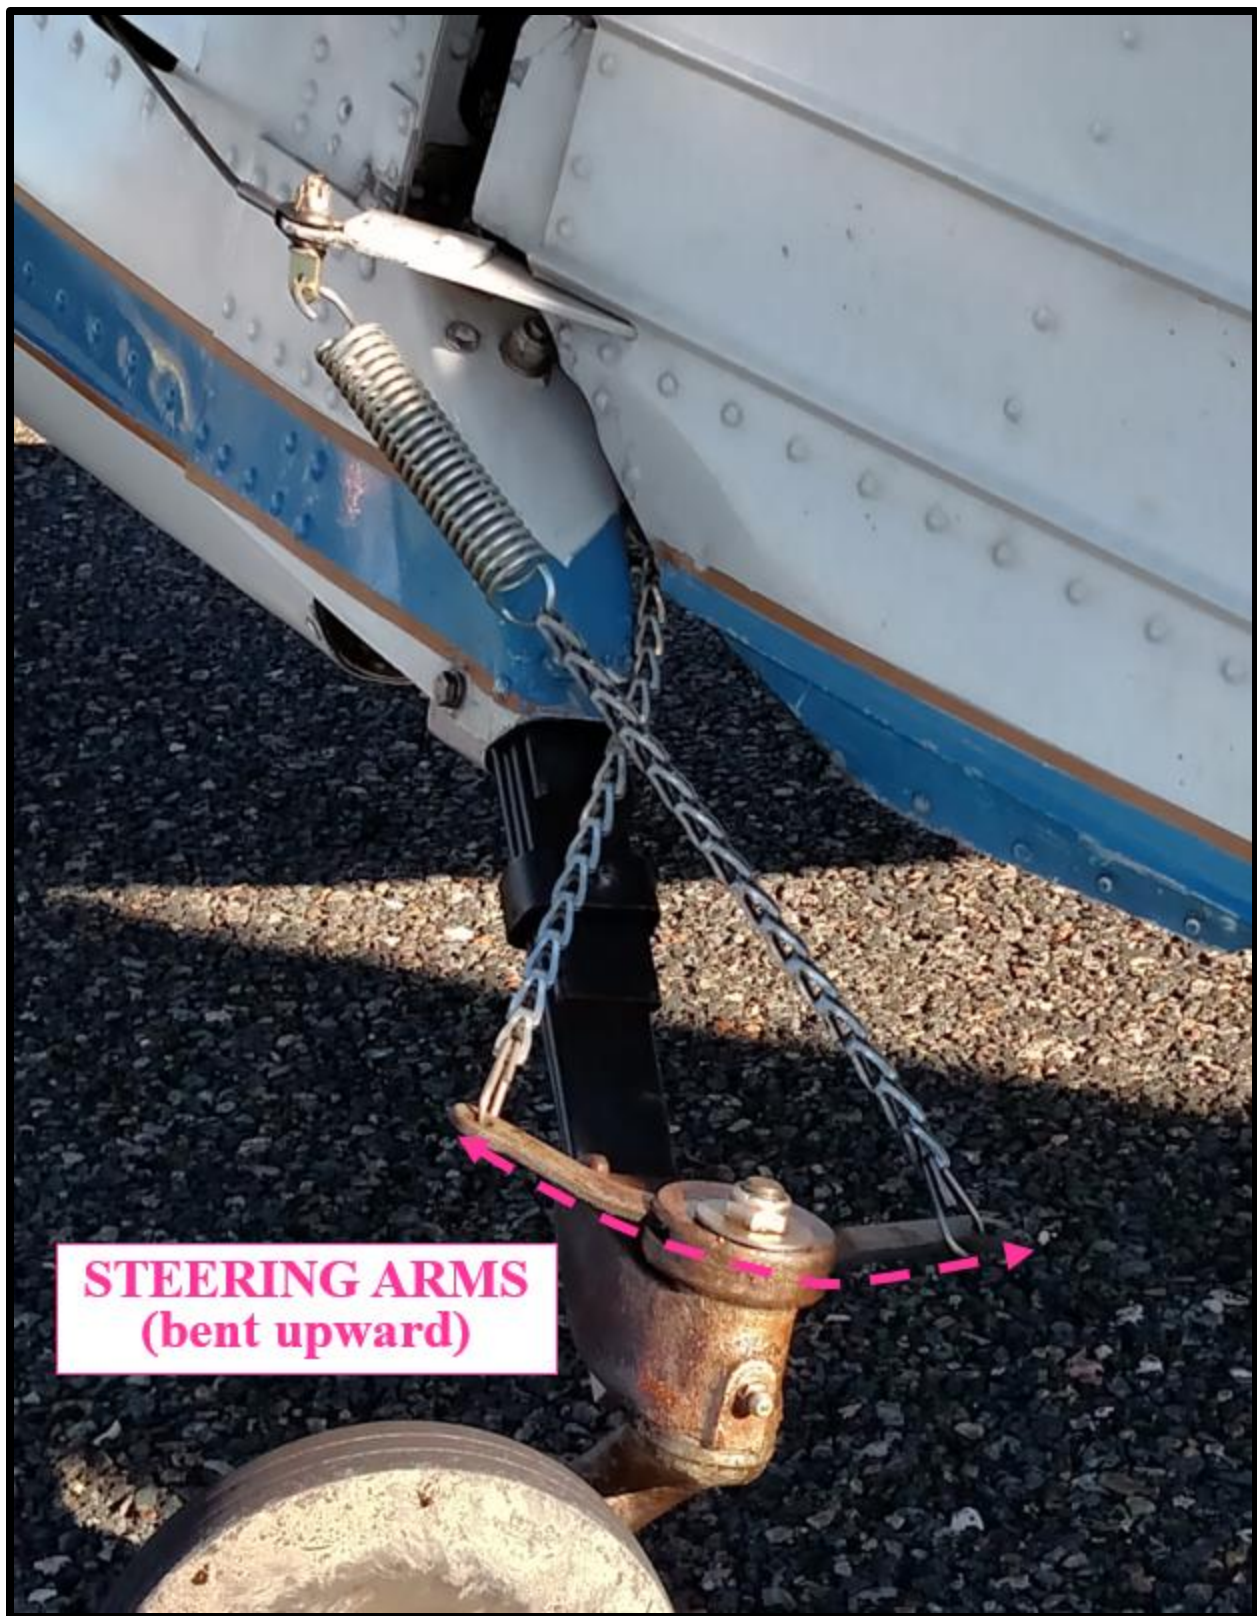
A post accident examination revealed that arms of the steering arm were bend upward; the right arm more excessively. The bend was significant enough that the arm was able to clear over the stop allowing the steering head to continue on around to the reversed position. This prohibited the wheel from releasing into the freely castering mode. Additionally if the wheel continued past the stops, the steering would become reversed with the chains crossed.

*Picture 5: At Accident Site (steering arm bent upward)*

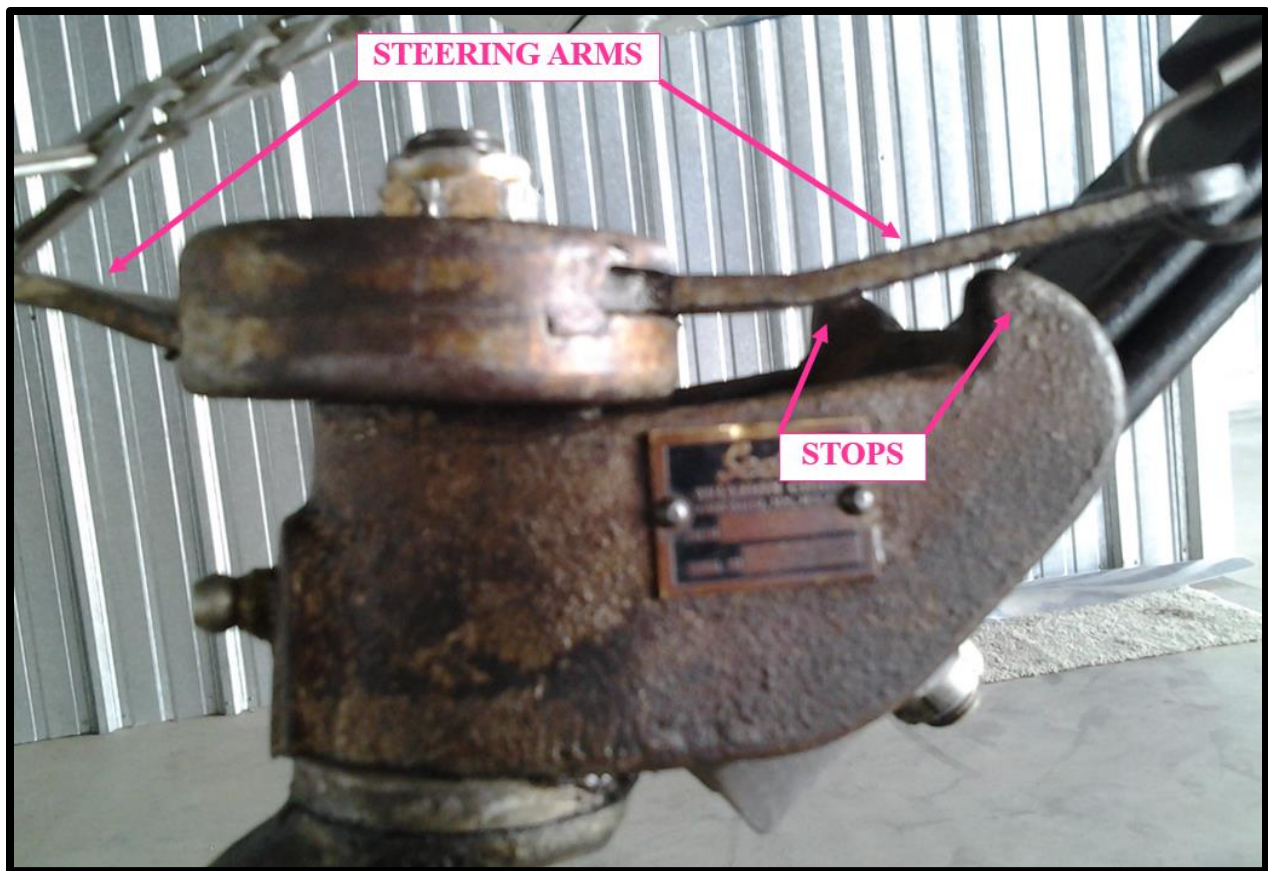
*Picture 6: Steering arm bent upward (profile)*

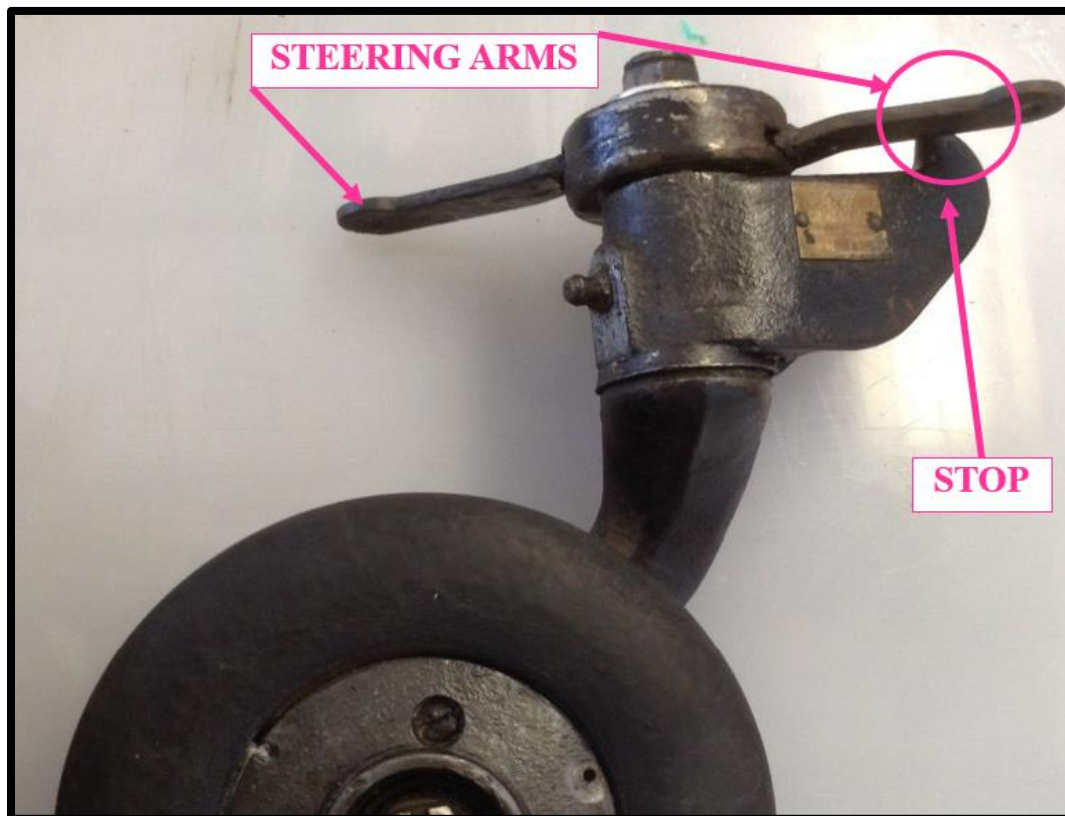
*Picture 7: Exemplar steering arm contacting stop (profile)*

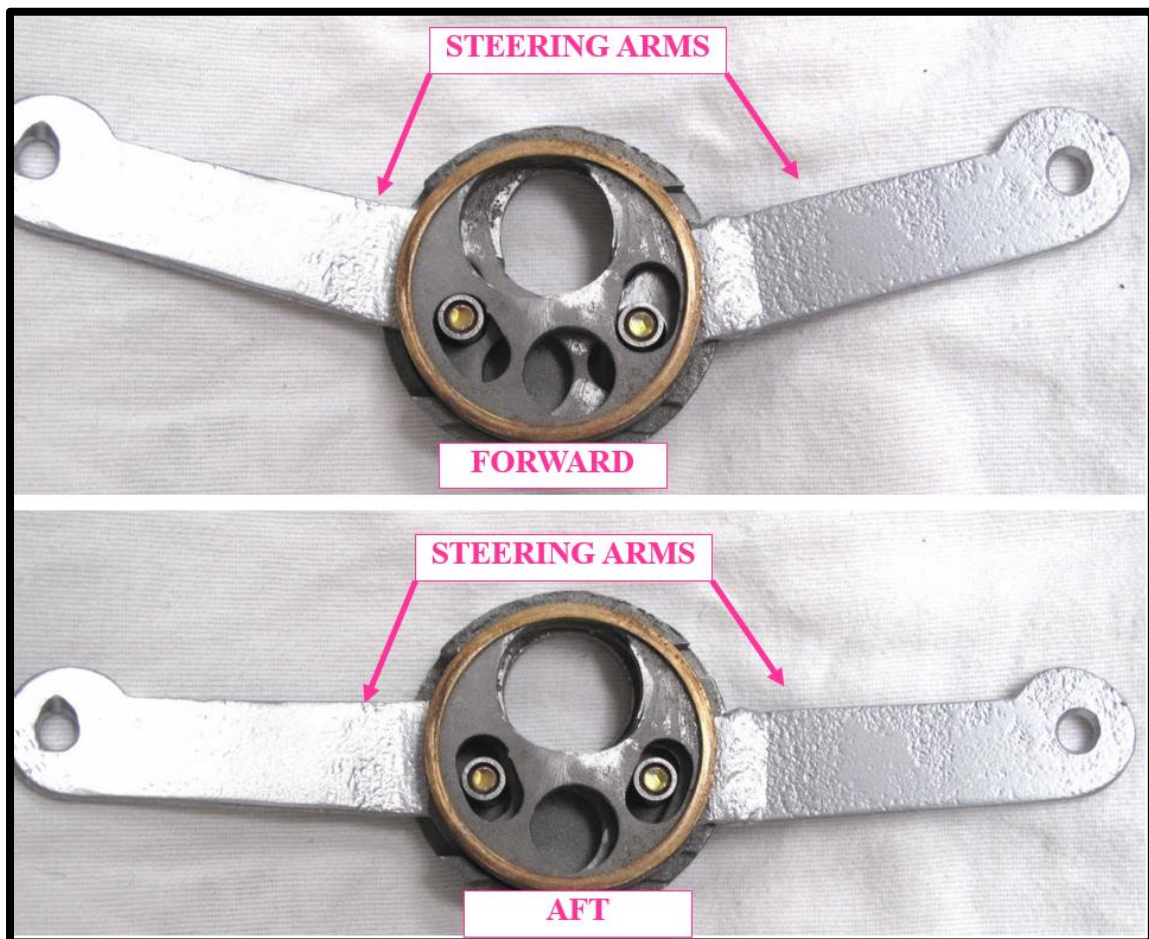
Picture 8: Exemplar steering arm inside (slides in grooves with tension of springs when attached)

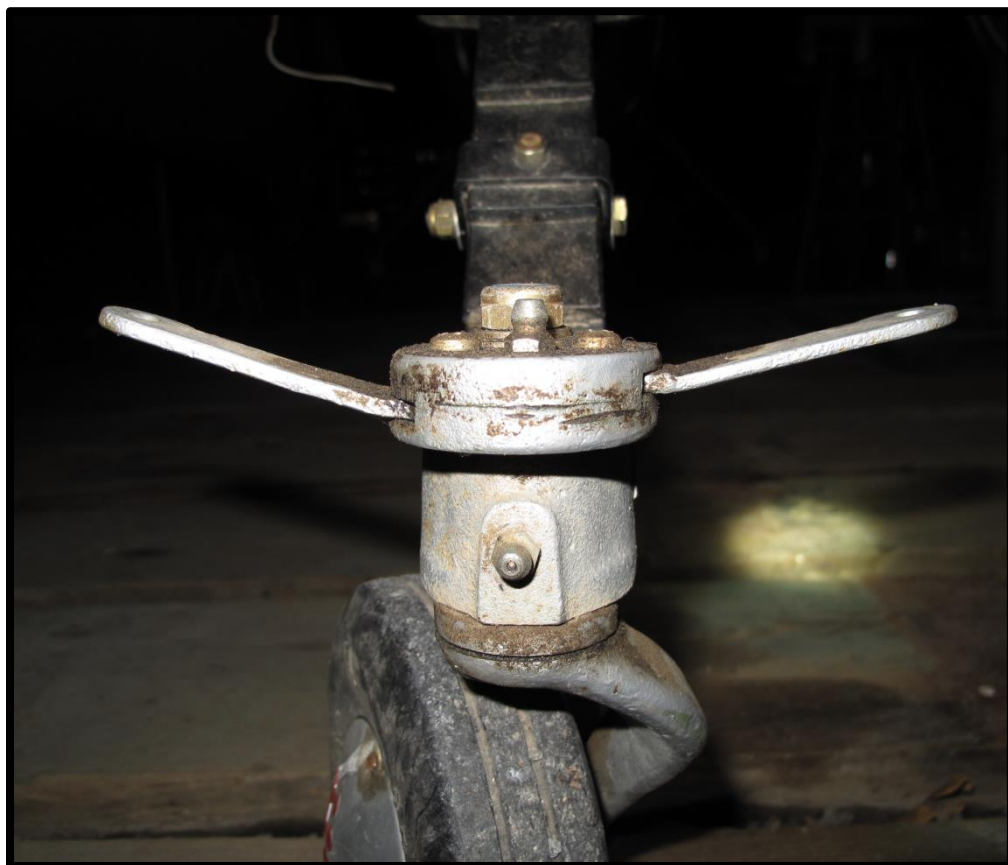
Picture 9: Exemplar steering arms bent upward

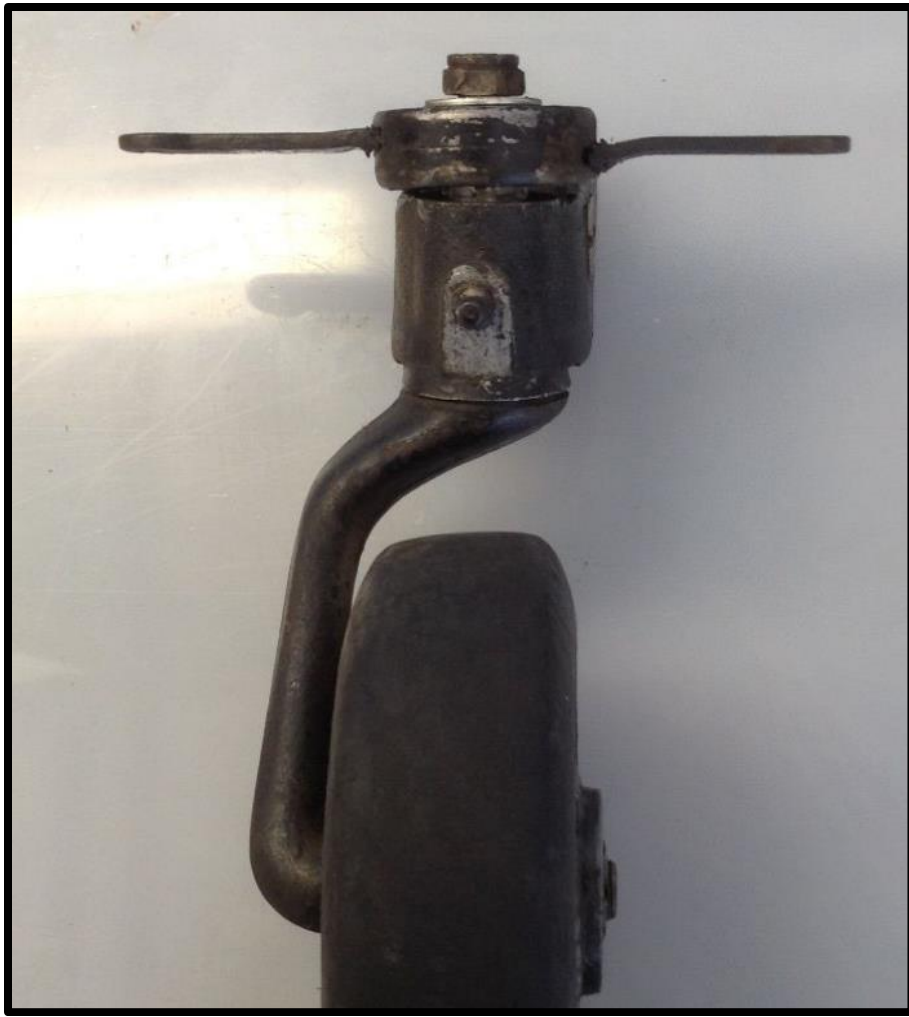
*Picture 10: Exemplar steering arms misaligned*
