Following the aircraft recovery of N91HC from Pomona's Brackett Field (POC) an FAA Inspector from the Los Angeles FSDO examined the aircraft at the Aircraftsmen Inc. Hangar B-350 at Chino Airport, on January 5, 2015. The contractor engine teardown was supervised by Mr. Mark Wilson the President of Aircraftsmen Inc located at Chino Airport, CA.

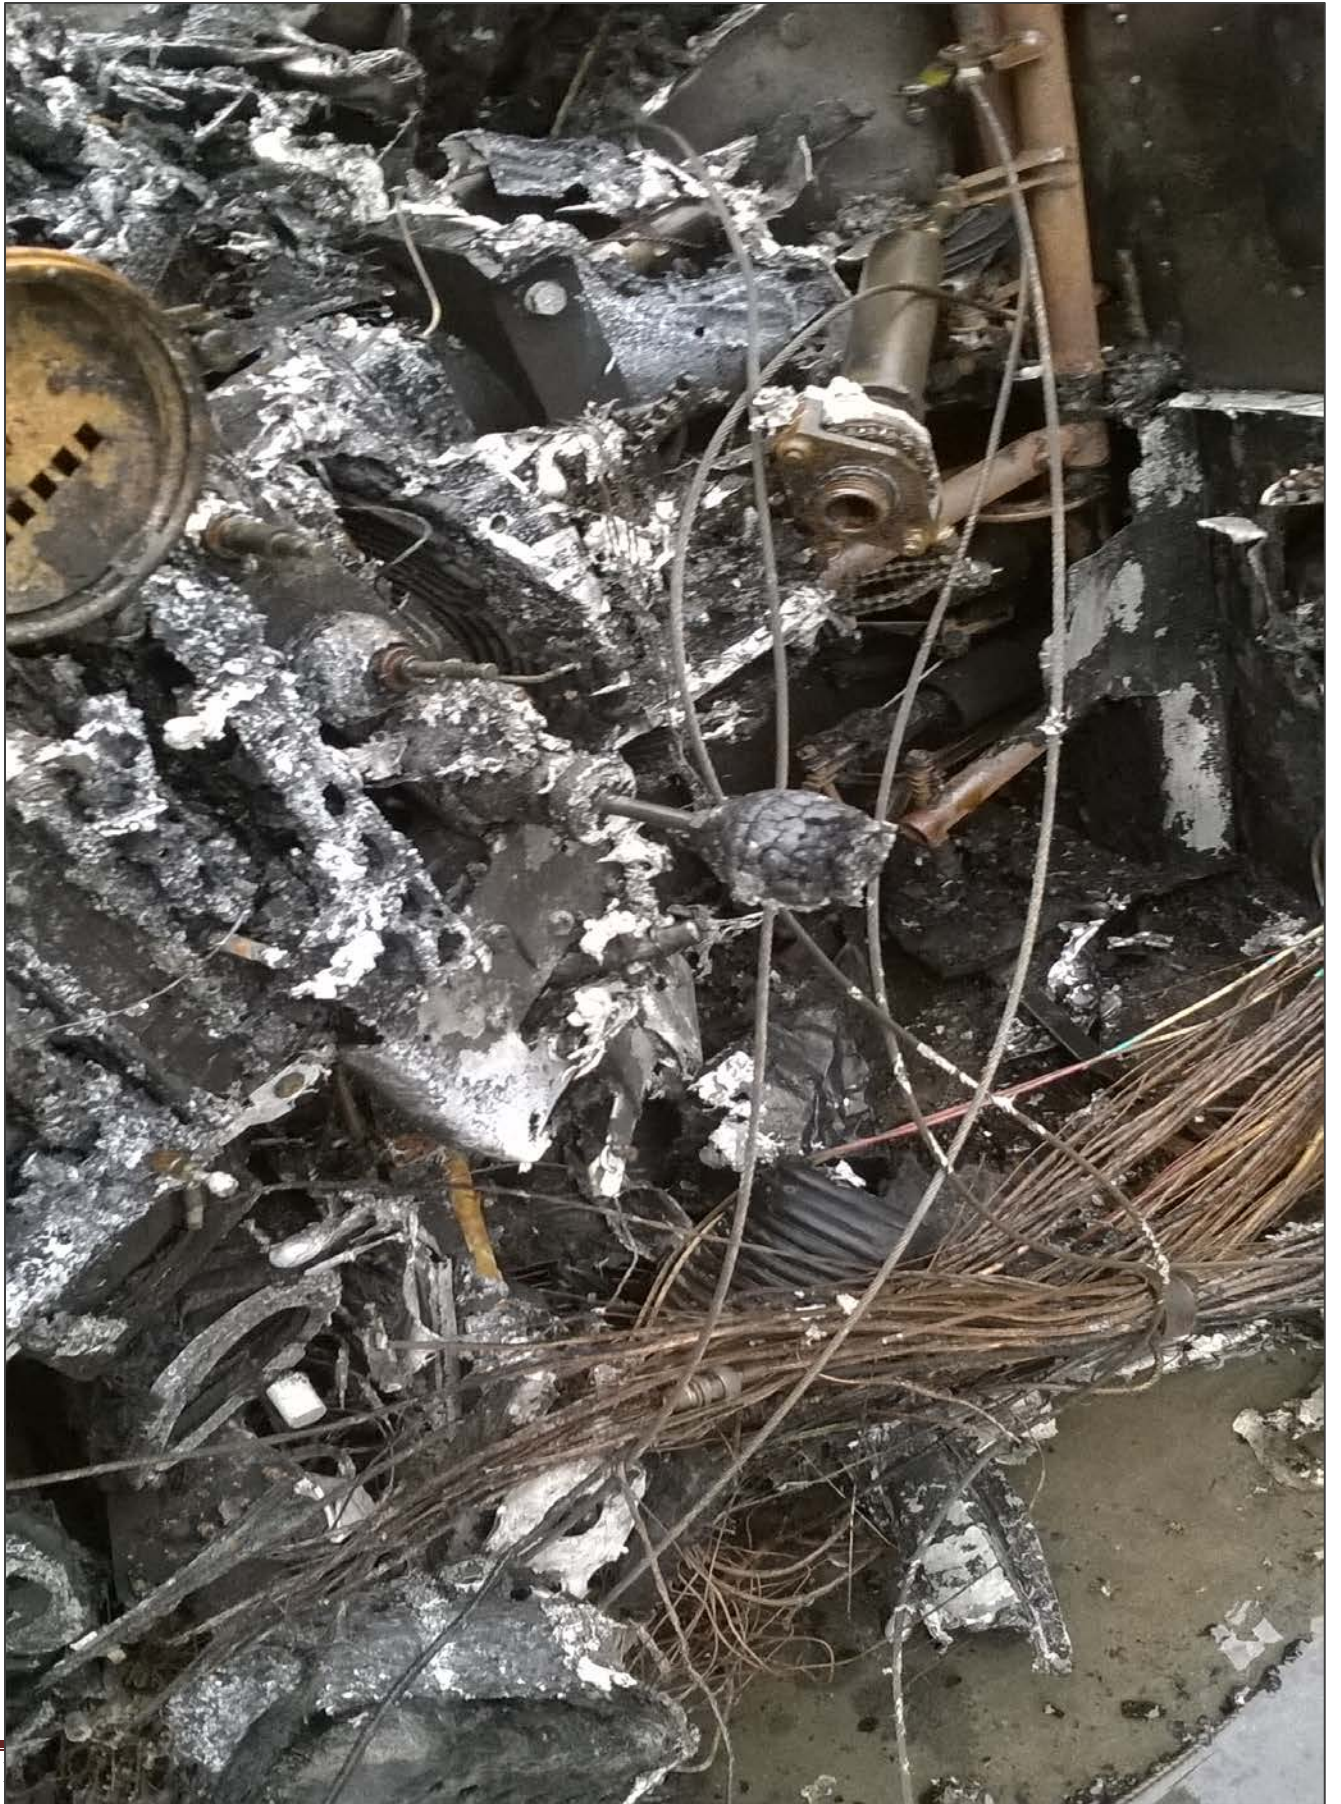
The main cabin area (FS.18 aft to FS.138.0) had been consumed by fire, with only remnants of the instrument panel (Figure 1) remaining as recognizable, cabin structural integrity was lost.

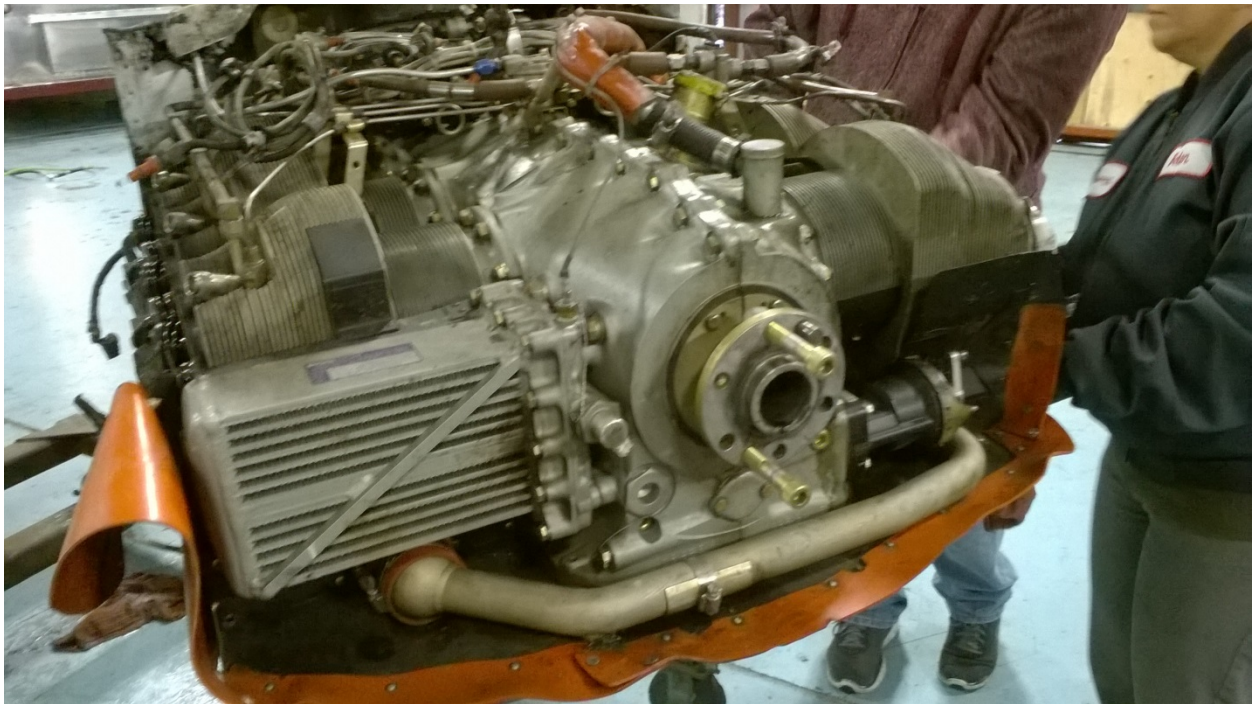
The Teledyne Continental TSIO-520-R1B had been converted to an M variant per the data plate – the fuel injected engine was examined following recovery of the wreckage; the serial number was recovered from the data plate because it was found intact. S/n: 512148. An external examination of the engine revealed that cylinder fins and outer cooling fins were crushed and bent on the left side of the engine. After the spark plugs had been removed the cylinder heads were bore-scoped with no internal cylinder anomalies identified during that internal inspection. The right magneto was removed from the engine and it produced spark and there was continuity to the spark plug wires ends. The exhaust system was observed to have sustained ductile bending and crushing aft of the turbo-charger. The turbo-charger exhibited no apparent damage and rotated freely by hand.

Figure 2 – Teledyne Continental TSIO- 520-RCM, S/n: 512148, Engine Exhibit from N91HC examination 01/05/2016.

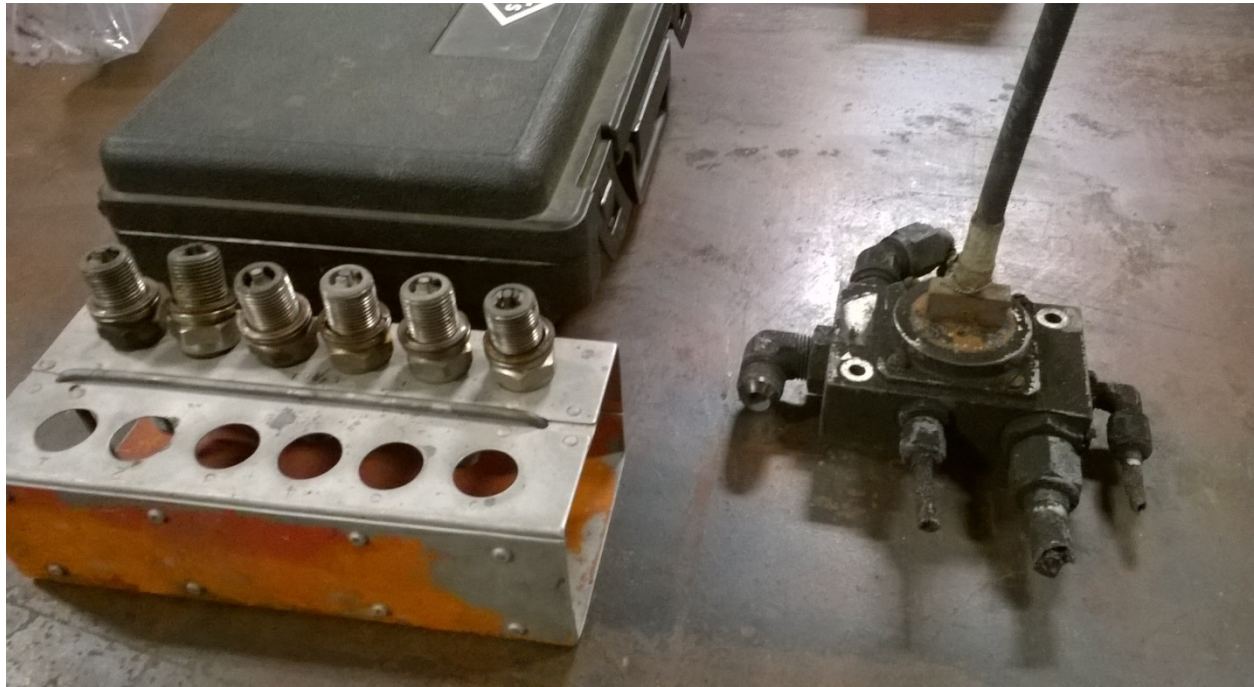
The ignition harnesses were attached from both magnetos to their respective spark plugs. The magnetos remained securely attached to their respective mounts. Investigators removed the right magneto and attempted to test their internal continuity via hand rotation. The top spark plugs were removed; no mechanical damage was noted and the electrodes and posts exhibited no abnormal or remarkable color markings. Figure 3. The fuel injection mechanical linkage was unremarkable to where all of the linkage was burned below the engine. Continuity of the fuel system was indeterminate.

repair station (Mike's A/C Fuel Metering Service, Tulsa, OK.) the selector was frozen as depicted in Figure 3.

Figure 3 - Shows Top Sparkplug Exhibit's and Fuel Selector Valve from N91HC examination 01/05/2016.
