# Continental Motors

## ENGINE FIELD RUN REPORT

| ENGINE MODEL | IO-470-K11B |
| FILE NUMBER | 15-357 |

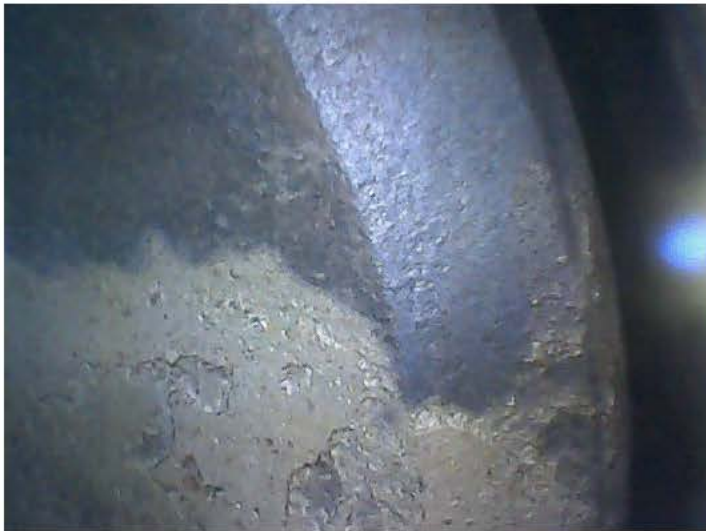
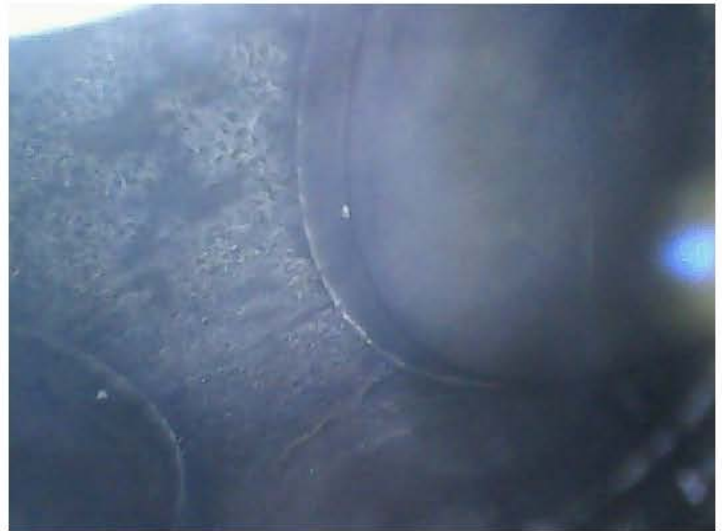
Cylinder #1

With the sparkplugs removed the cylinders were borescope inspected with no anomalies noted with the pistons, cylinders, valves, or valve seats. A thumb compression test was conducted and each cylinder produced compression and suction during propeller rotation confirming crankshaft and camshaft continuity.

**NOTE:** The following photographs depict the piston, intake, and exhaust valve of the cylinders, in that order.

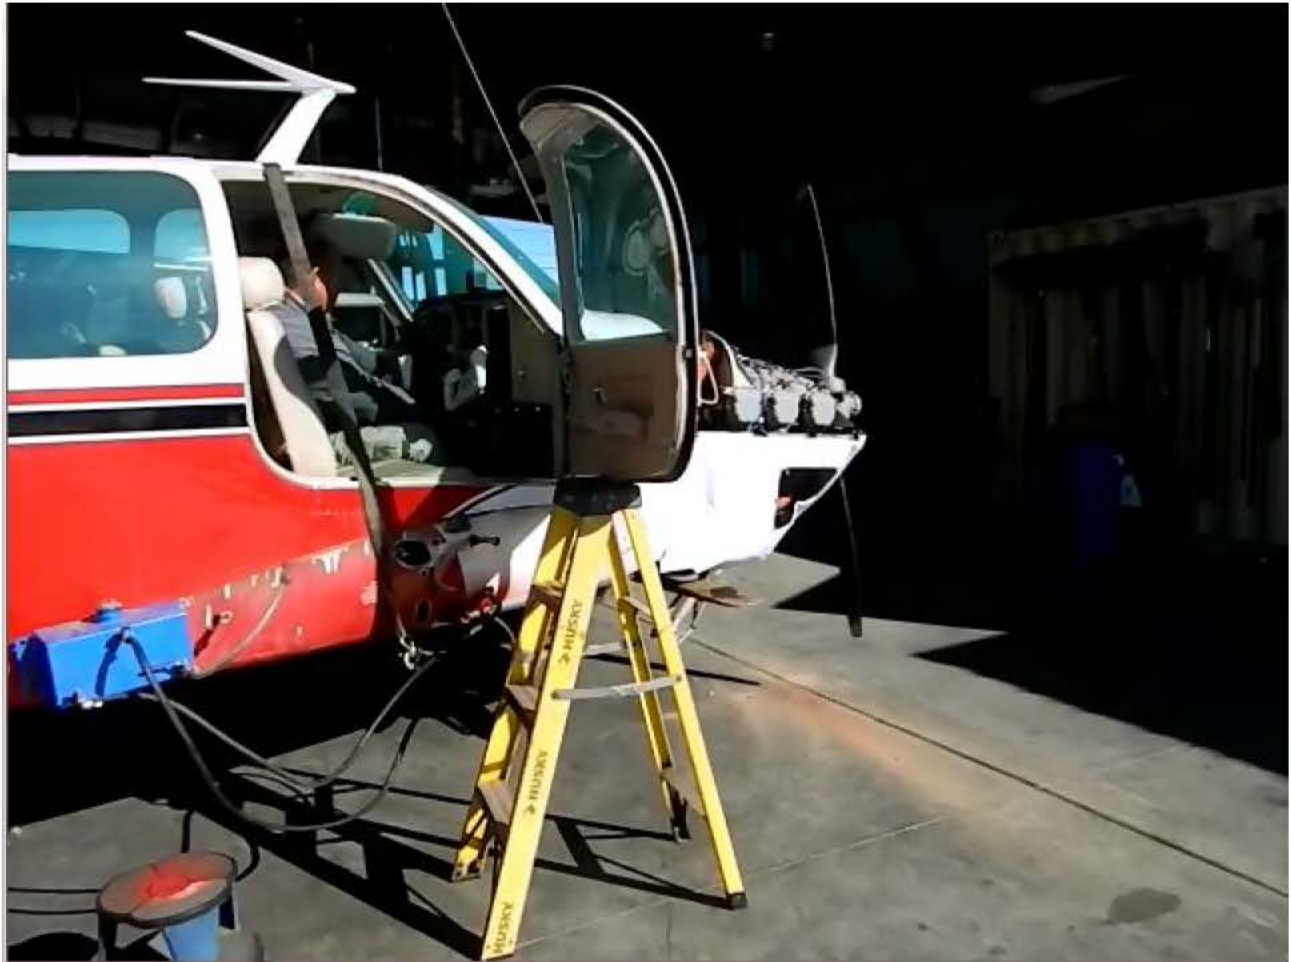
The top sparkplugs were reinstalled in their respective cylinders and their ignition leads were reattached. The propeller that was installed at the time of the accident was removed and replaced with a substitute two-blade propeller. An auxiliary fuel tank was plumbed into the right tank's fuel screen/supply line. The fuel selector was moved from the OFF position to the RIGHT fuel selector position.

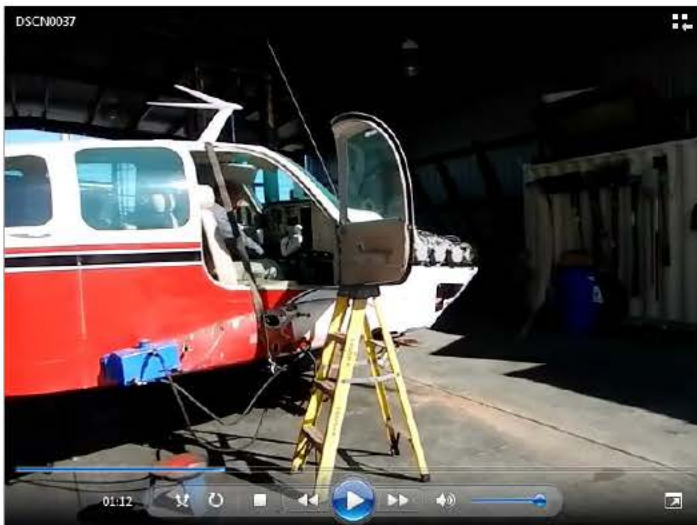
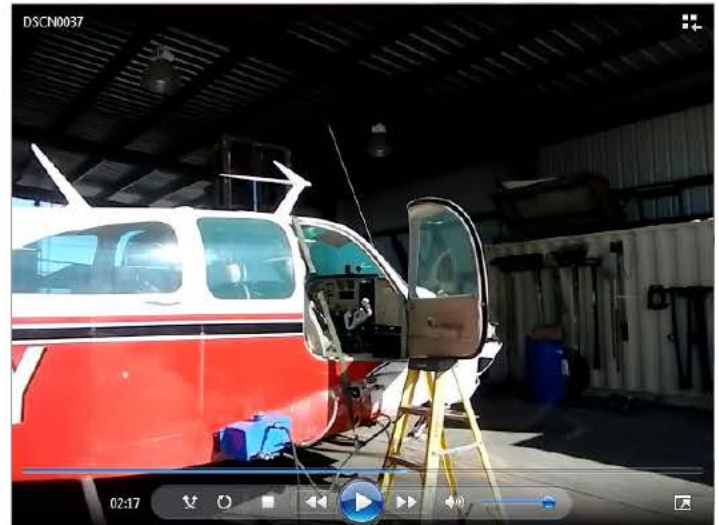
The engine fuel system was primed using the fuel in the auxiliary tank and the aircraft's electric fuel pump. The engine started and ran roughly at idle until the mixture was adjusted toward lean. The throttle was then advanced toward full power and was able to produce full power by richening the fuel/air mixture. The remaining engine operation was conducted by applying a coinciding movement of the throttle and mixture (i.e. as the throttle was retarded, the mixture had to be leaned; as the throttle was advanced, the mixture had to be richened). The engine produced a maximum of 2,700 RPM and ran smoothly with the richened mixture. The engine idled roughly with smoke observed coming from the exhaust system. The magneto check was conducted and a drop of 100 RPM was observed on both the left and right magnetos. The engine was run for a total of about five minutes and a decision was made to remove the fuel system components and have them examined and tested at the Continental Motors factory.

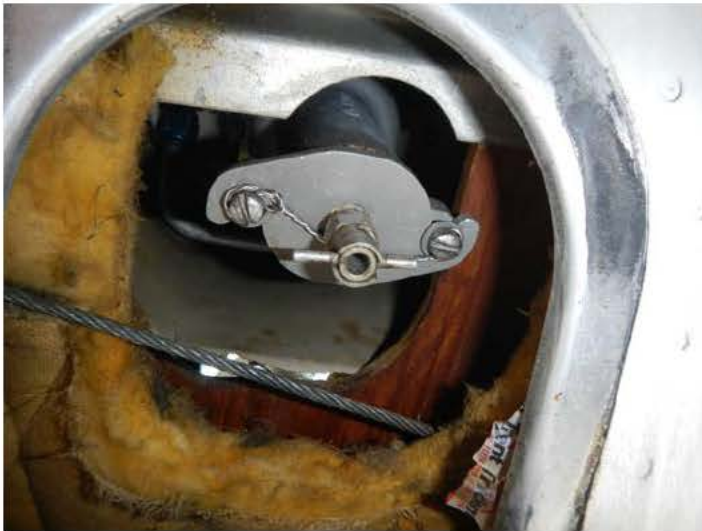
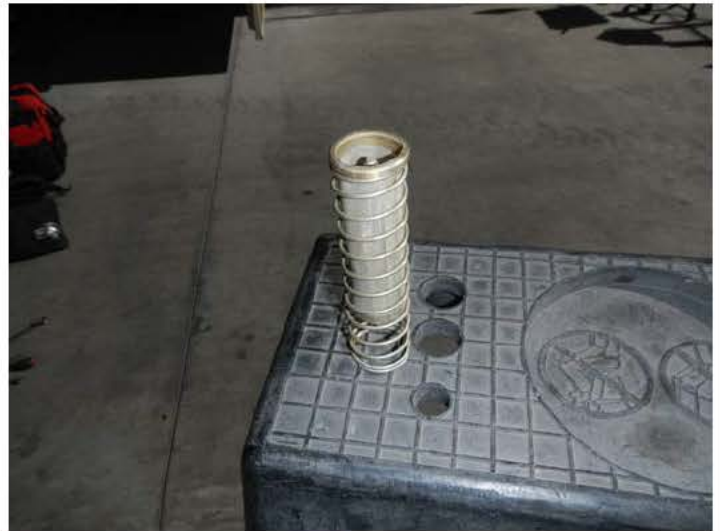
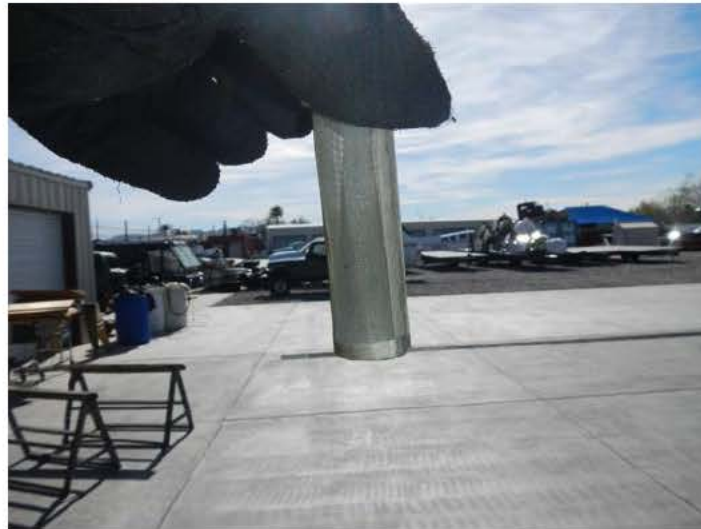
No pre-accident anomalies were noted with the engine core components or the engine ignition system. A decision was made to flow test and further examine the engine's fuel system. The engine's fuel system components were removed from the engine and were boxed for shipment to Continental Motors for testing and examination.

The electric boost pump was operated after the engine test run to ensure it was cutting out of the system when the switch was in the OFF position. The electric boost pump functioned normally. The aircraft's fuel screen was examined and was found to be free of any debris.

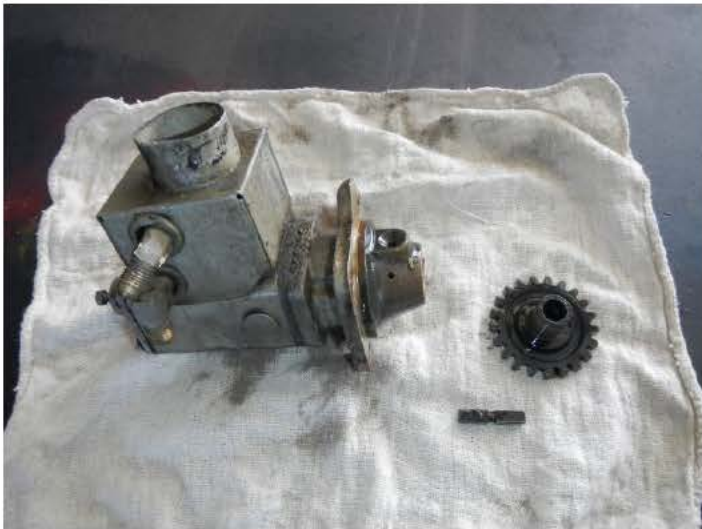
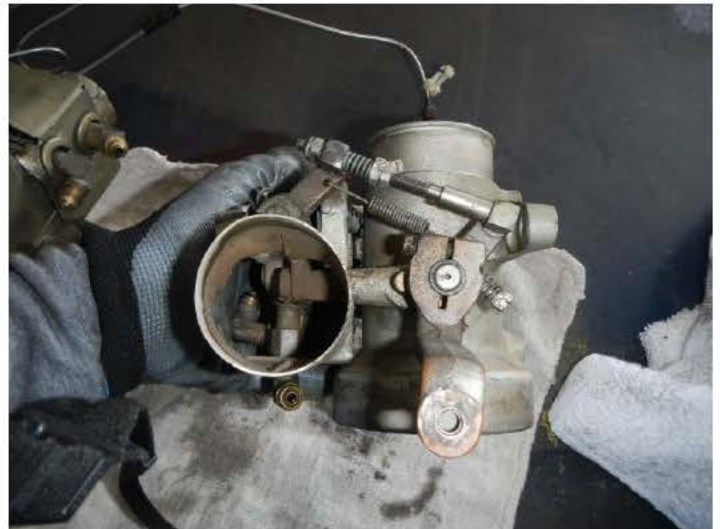
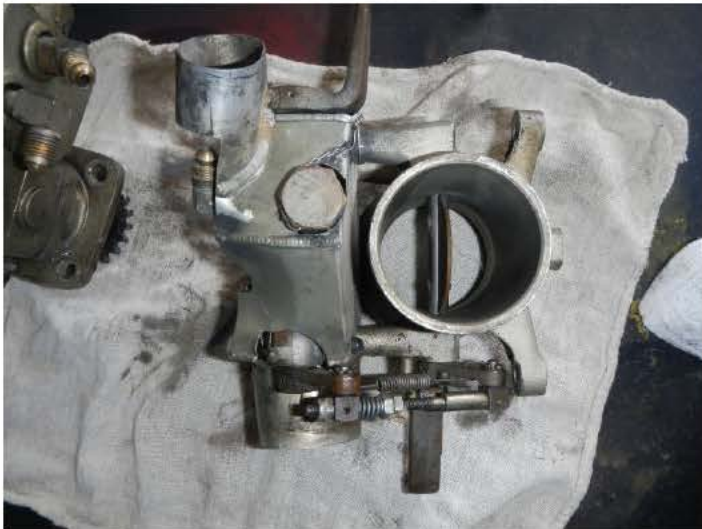
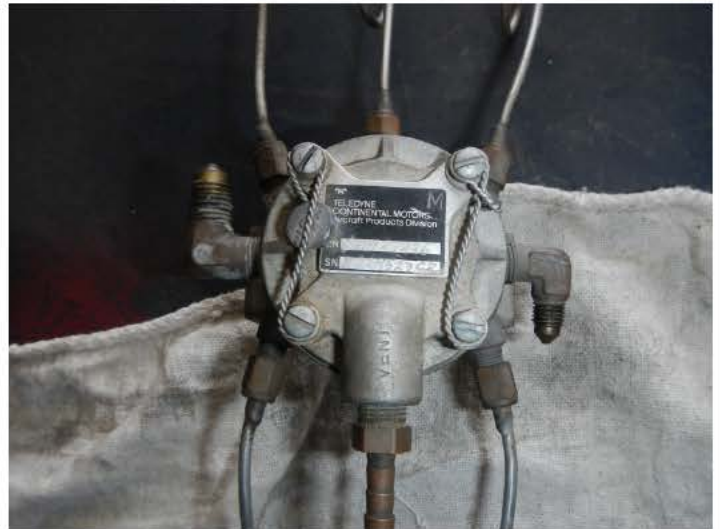
The following components were removed and boxed:

Engine-Driven Fuel Pump – PN: 646212-12, SN: E229521BR

Throttle Body/Fuel Metering Unit – PN: 625219-1, SN: E229521AR

Fuel Manifold Valve – PN: 631427A26, SN: E229523CR
