## **NATIONAL TRANSPORTATION SAFETY BOARD**

### **ON-SCENE & EXAMINATION INFORMATION**

**NTSB Accident: WPR16LA056  
Accident Date: January 22, 2016**

Location: North Las Vegas, NV  
Date: January 22, 2016  
Aircraft: Robinson R22, N7020U, Serial # 2837  
NTSB IIC: Michael Huhn

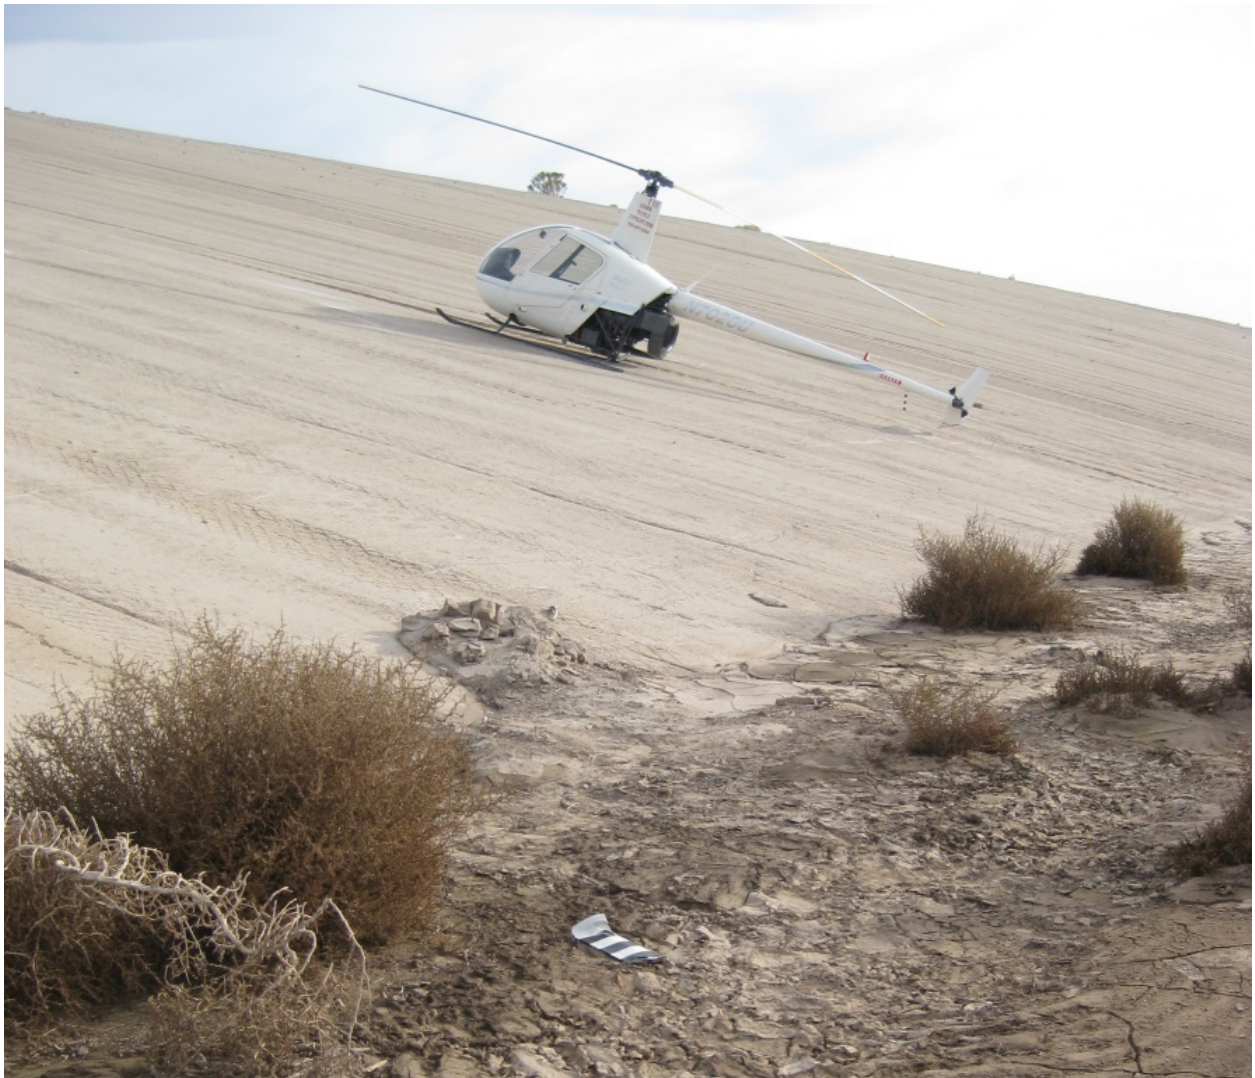
An FAA Inspector traveled to the accident location on the day of the accident, and conducted a follow-up examination 3 days later. The helicopter came to rest upright, facing uphill, approximately 2/3 of the way down the sloped levee wall.

**Figure 1 - Helicopter on Sloped Levee Wall**

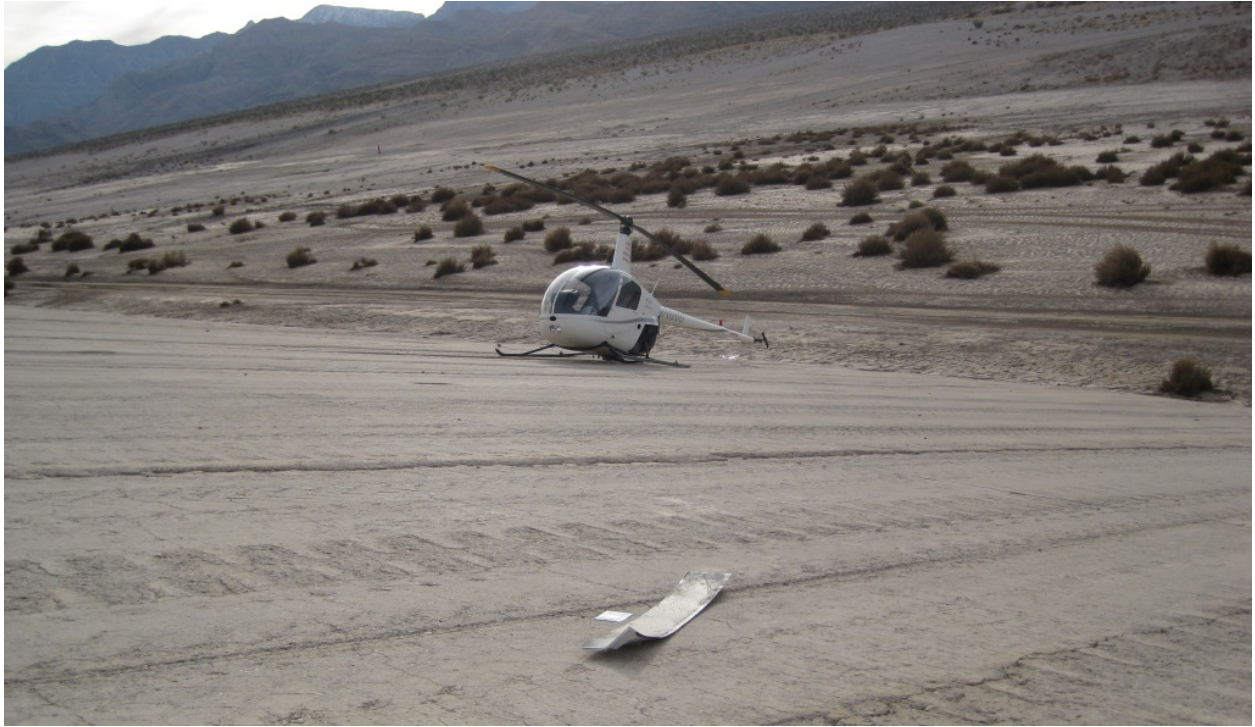
**Figure 2 - Helicopter and Airframe Sheet Metal**

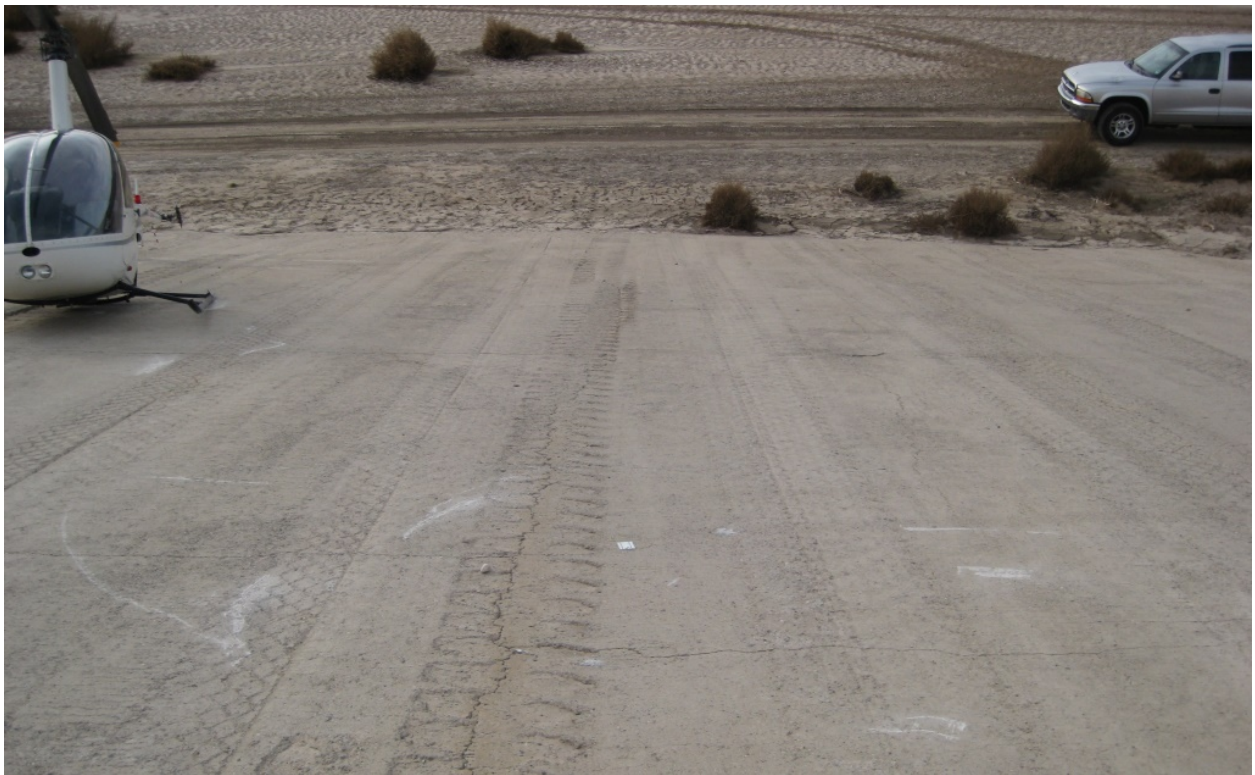
The pilot was practicing along the level upper portion of the levee, and lost control there. Scrape marks from inadvertent ground contact were limited to the sloped portion of the levee. The lower vertical stabilizer was bent towards the helicopter starboard (right), consistent with ground contact while spinning helicopter nose right.

**Figure 3 - Scrape Marks on Levee**

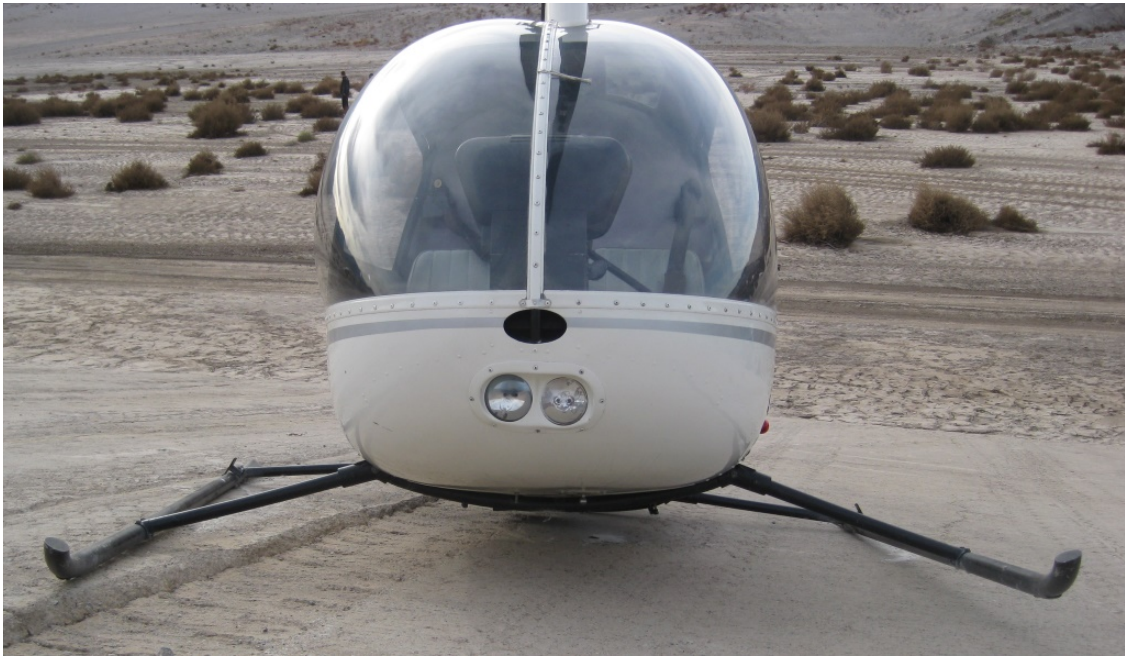
**Figure 4 - Front View of Helicopter**

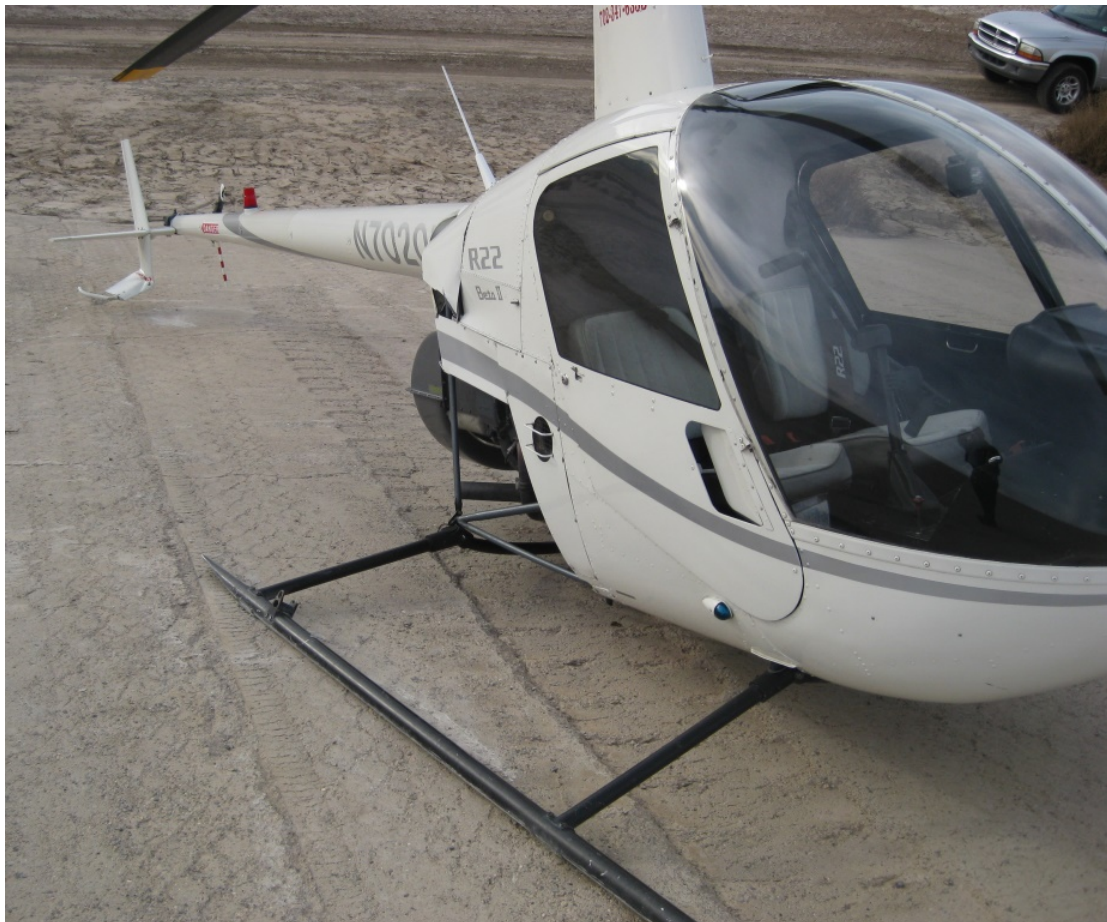
**Figure 5 - Front Right View of Helicopter**

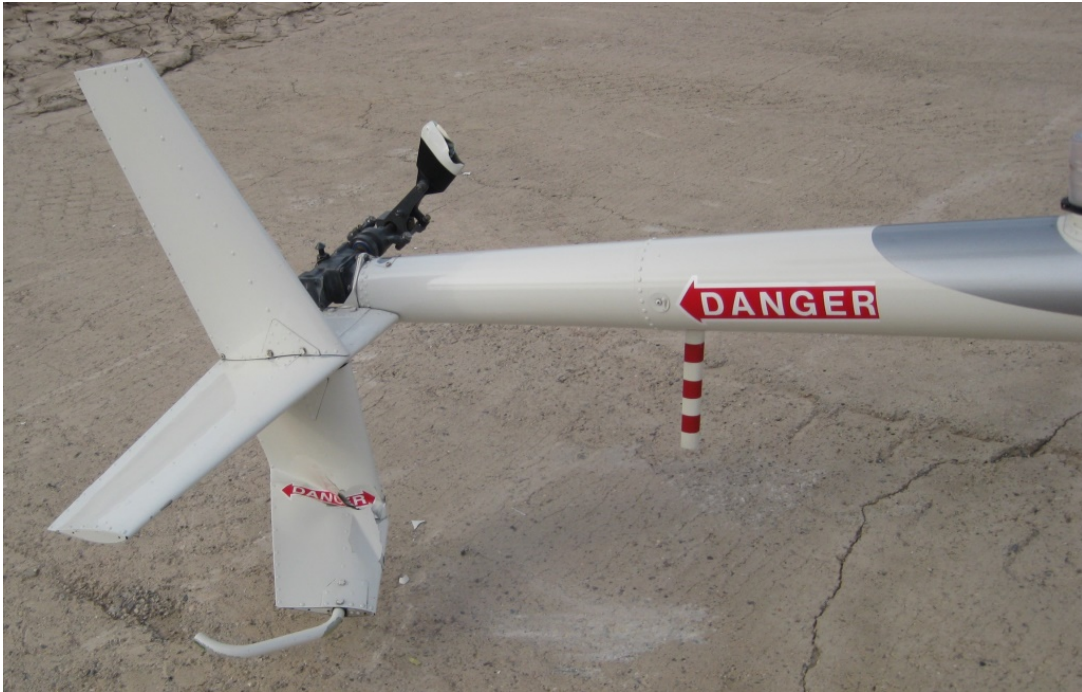
**Figure 6 - Right View of Tail**

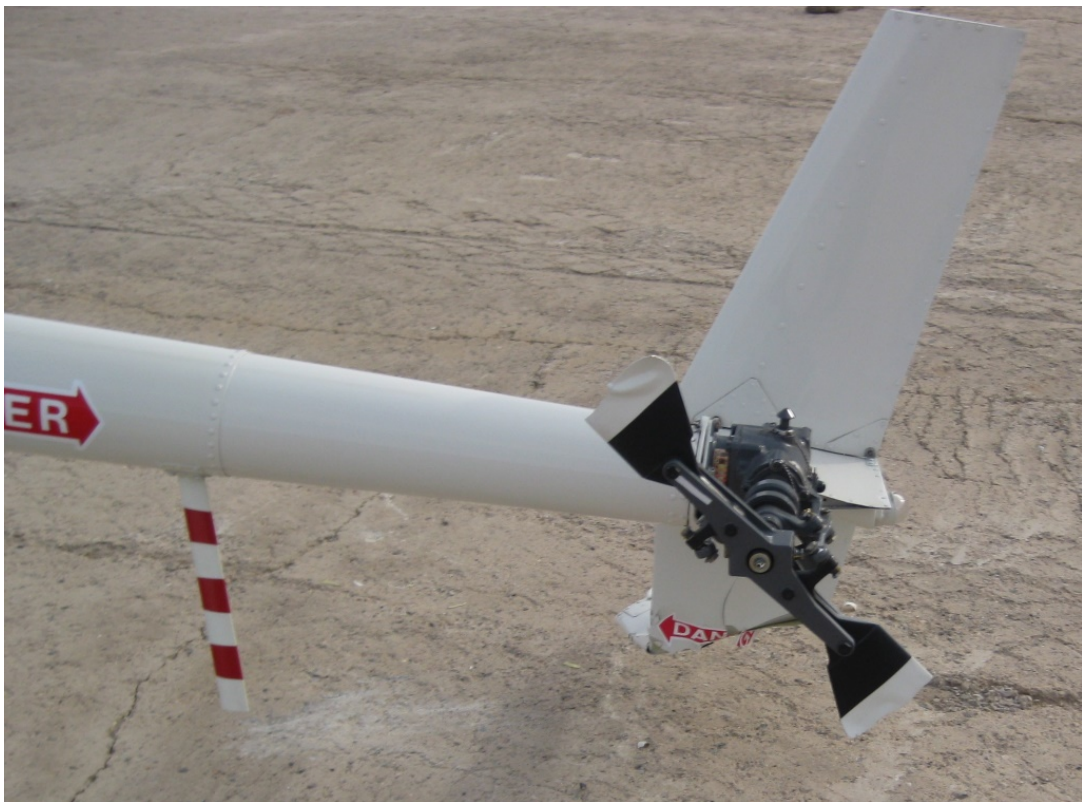
**Figure 7 - Left View of Tail**

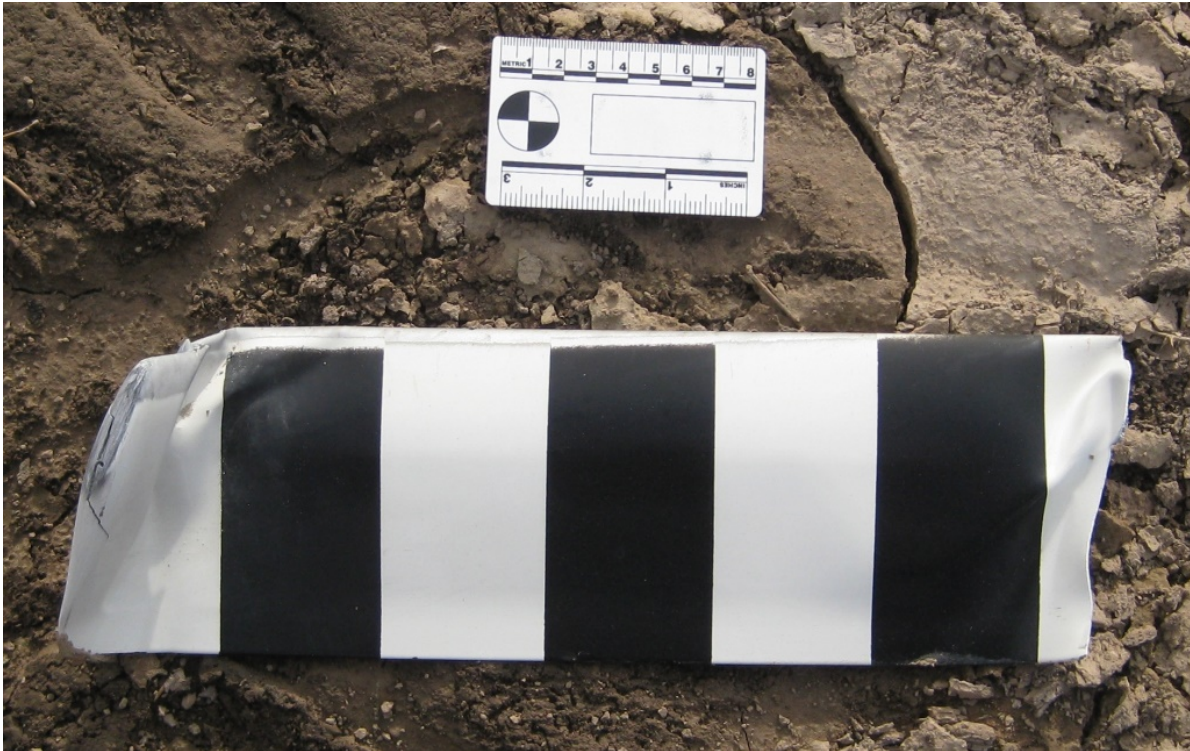
**Figure 8 -Fracture-Separated Tail Rotor Blade Segment**

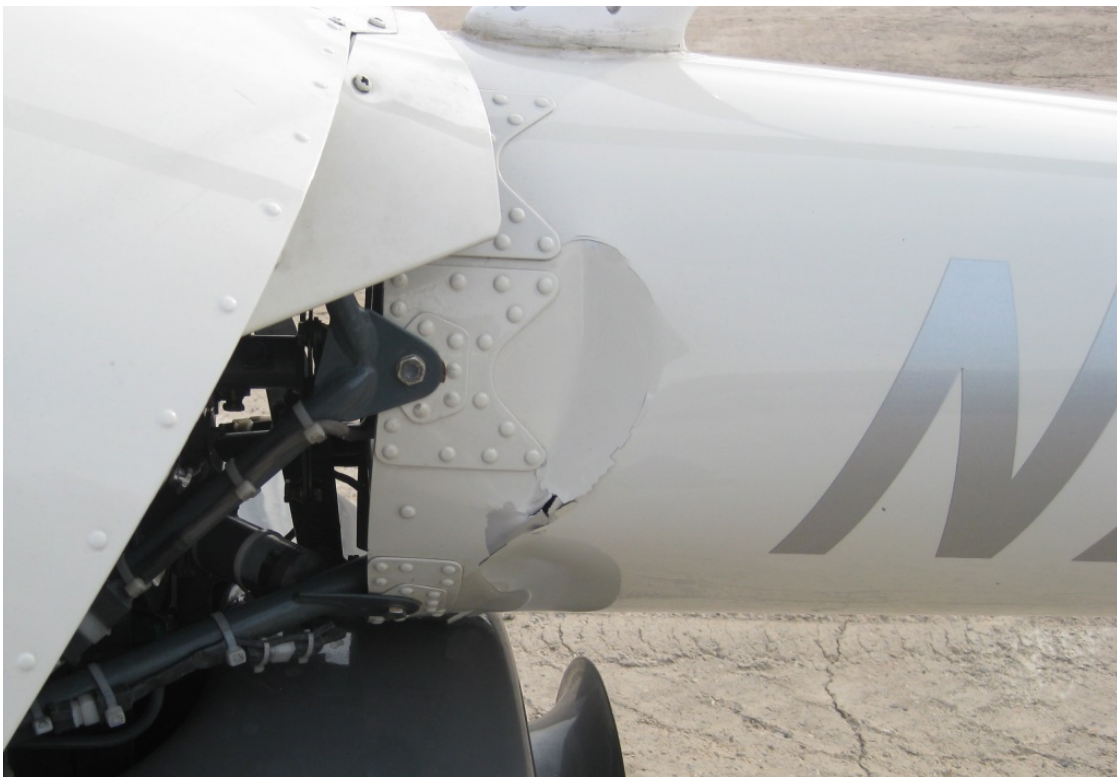
**Figure 9 - Buckled Tail Boom**

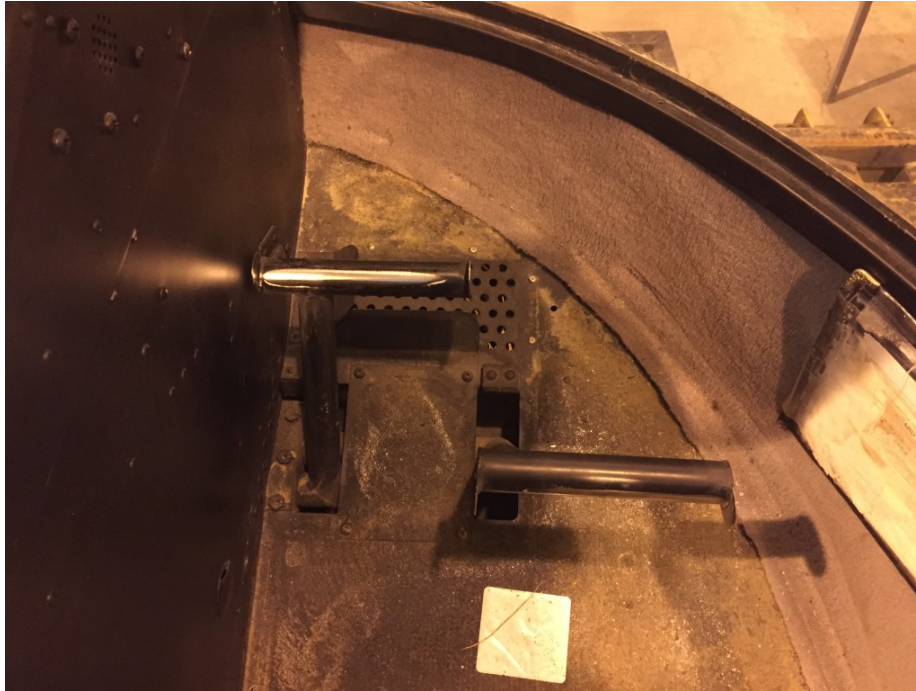
**Figure 10 - Full Left TR Pedal Travel**

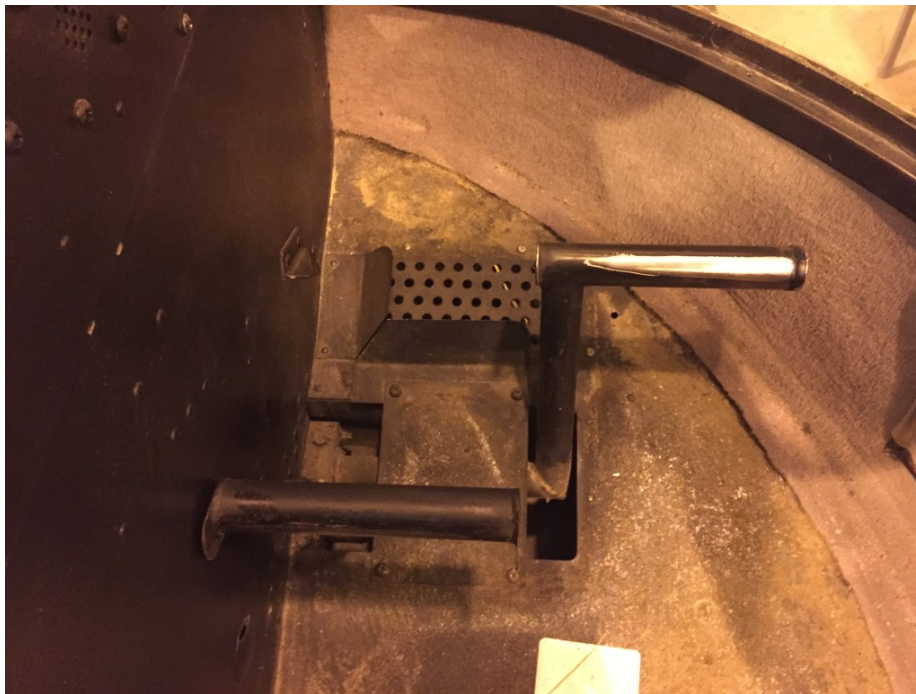
**Figure 11 - Full Right TR Pedal Travel**

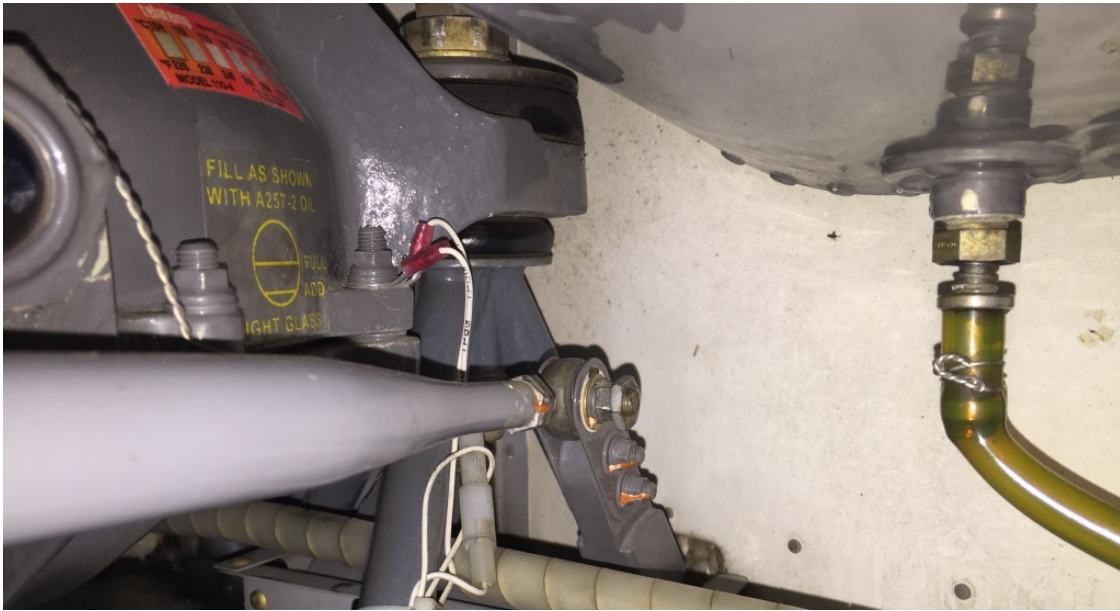
**Figure 12 - Full Travel TR Linkage**

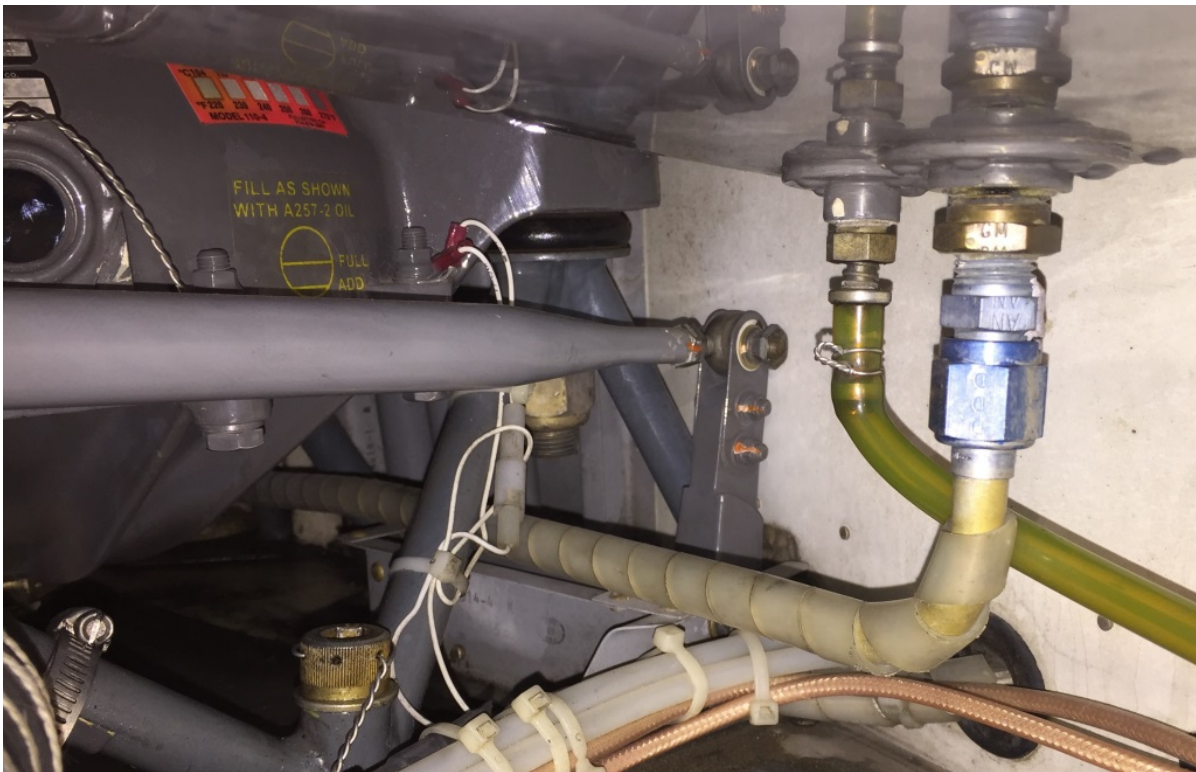
**Figure 13 - Full Travel (Opposite Direction) TR Linkage**

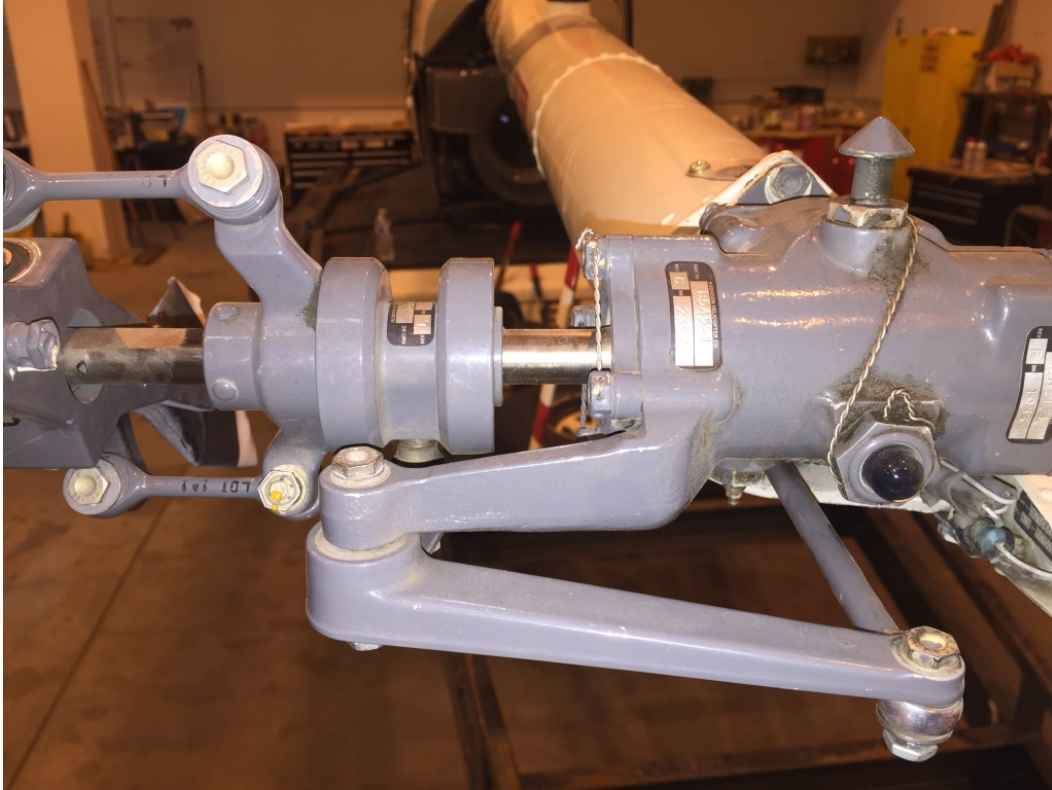
**Figure 14 - Full Travel TR Linkage**

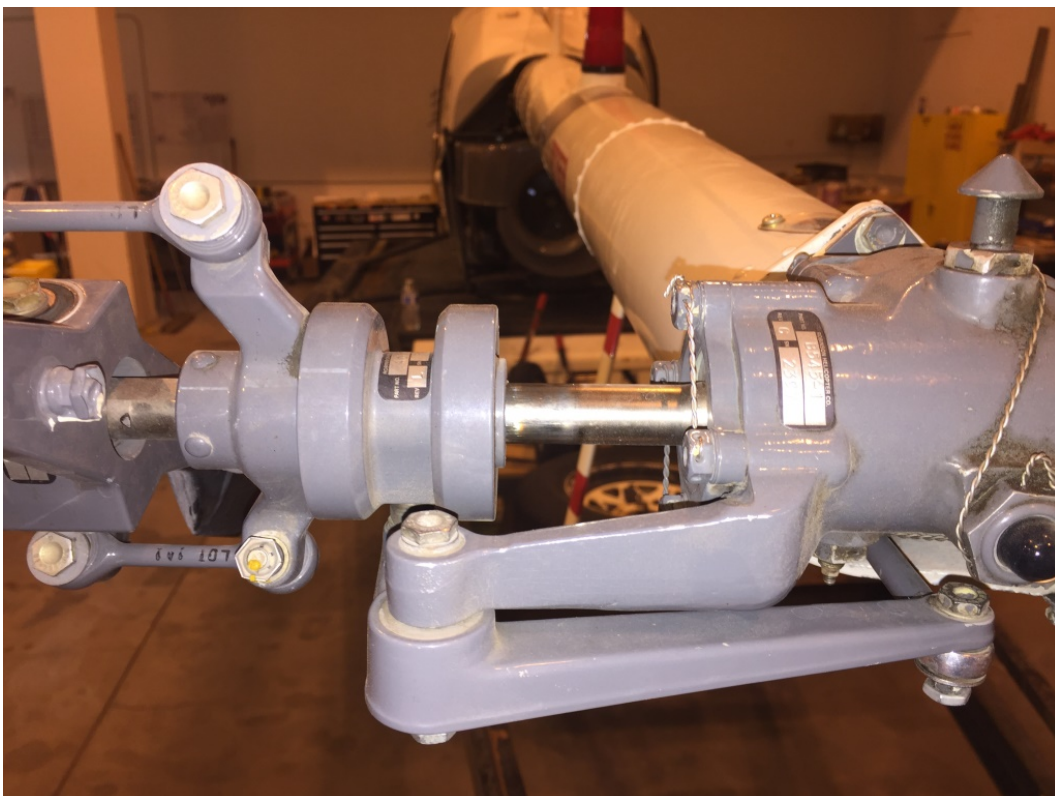
**Figure 15 - Full Travel (Opposite Direction) TR Linkage**

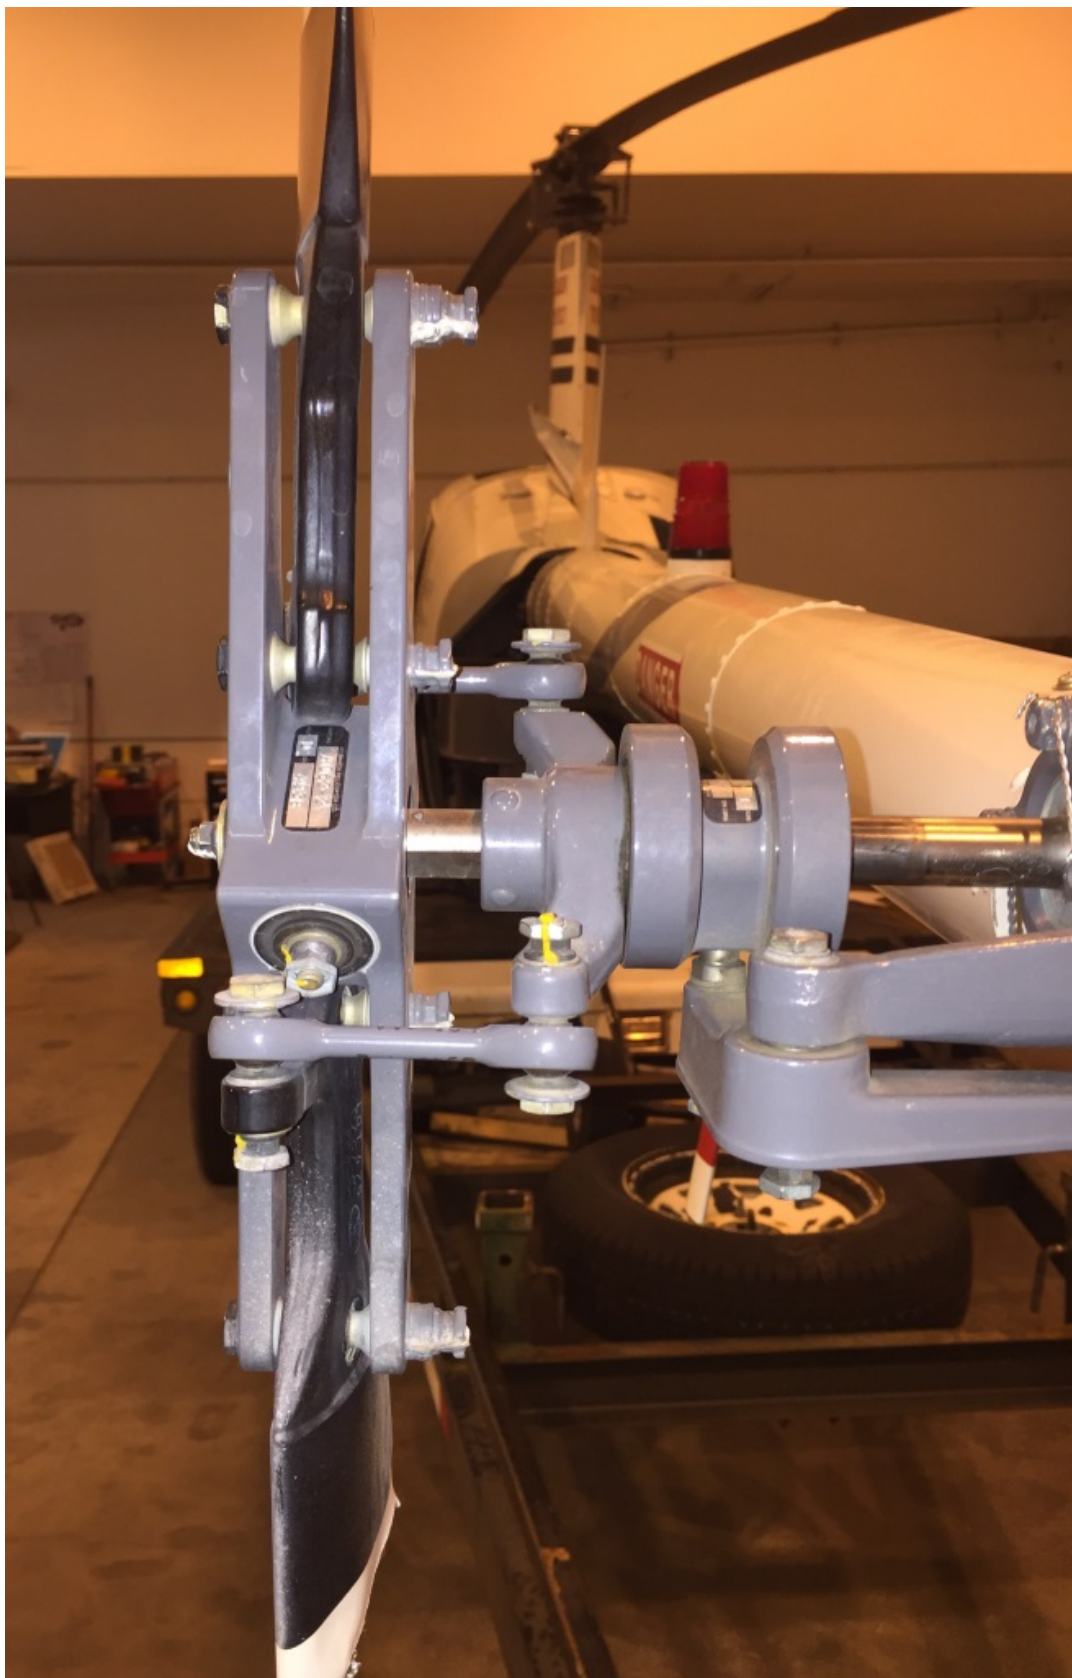
**Figure 16 - Full Travel TR Blades**

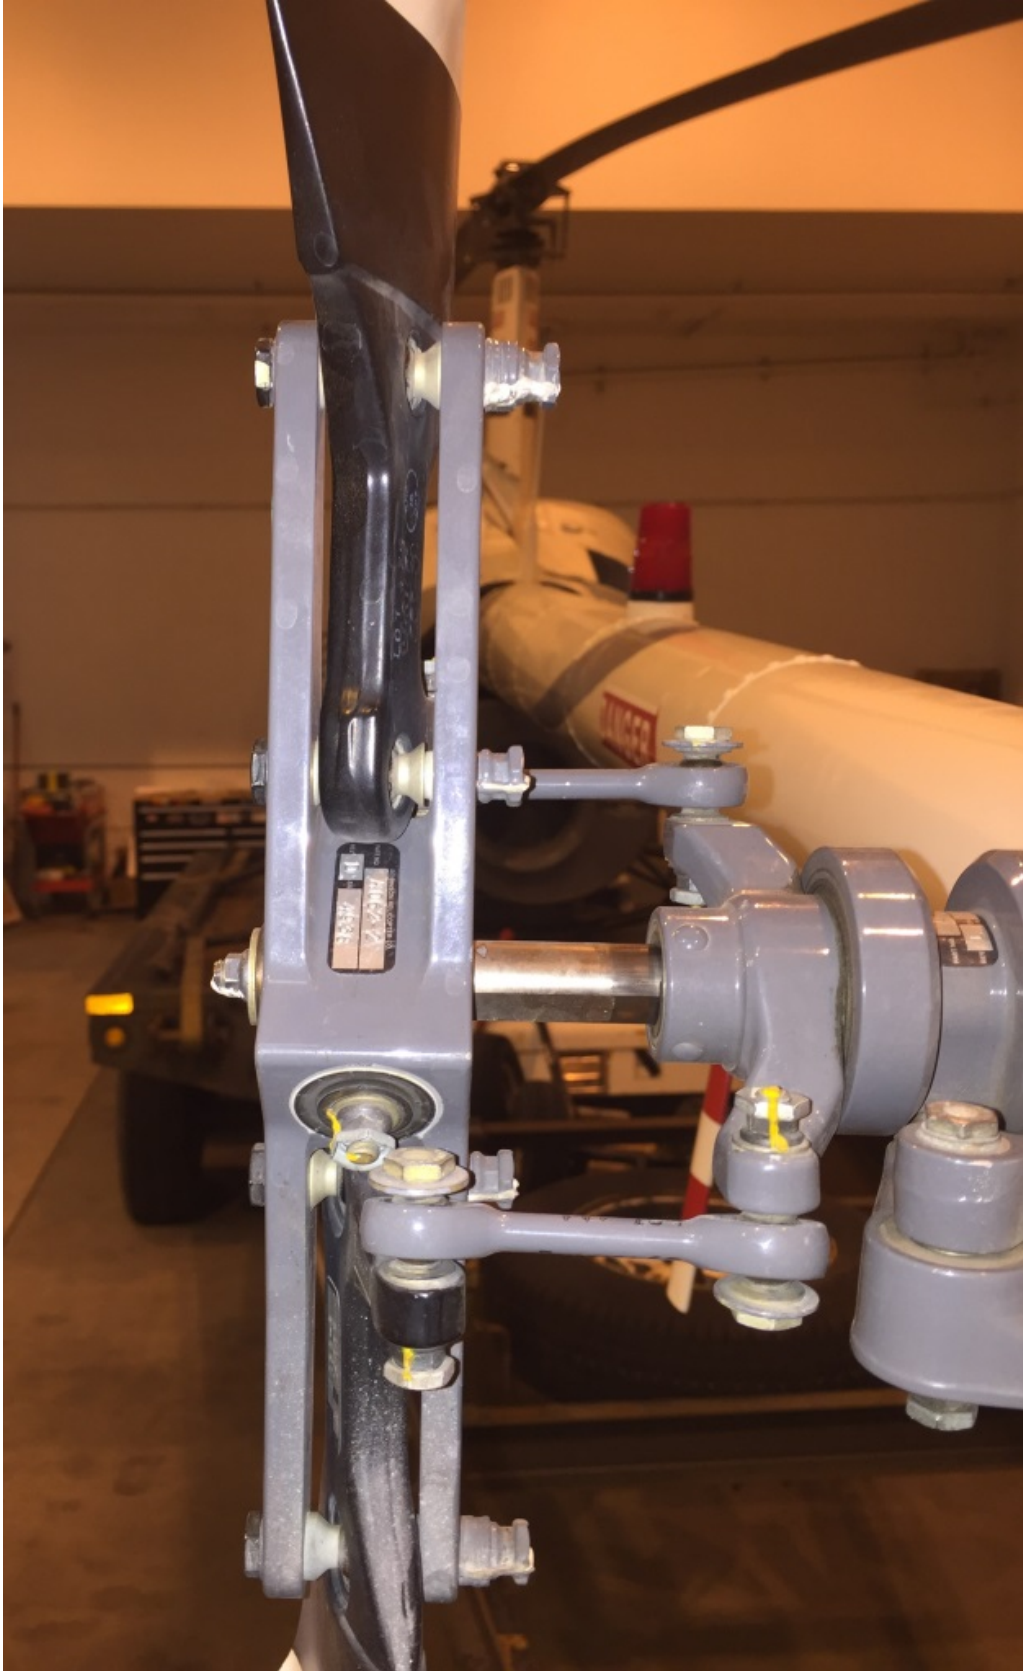
**Figure 17 - Full Travel (Opposite Direction) TR Blades**

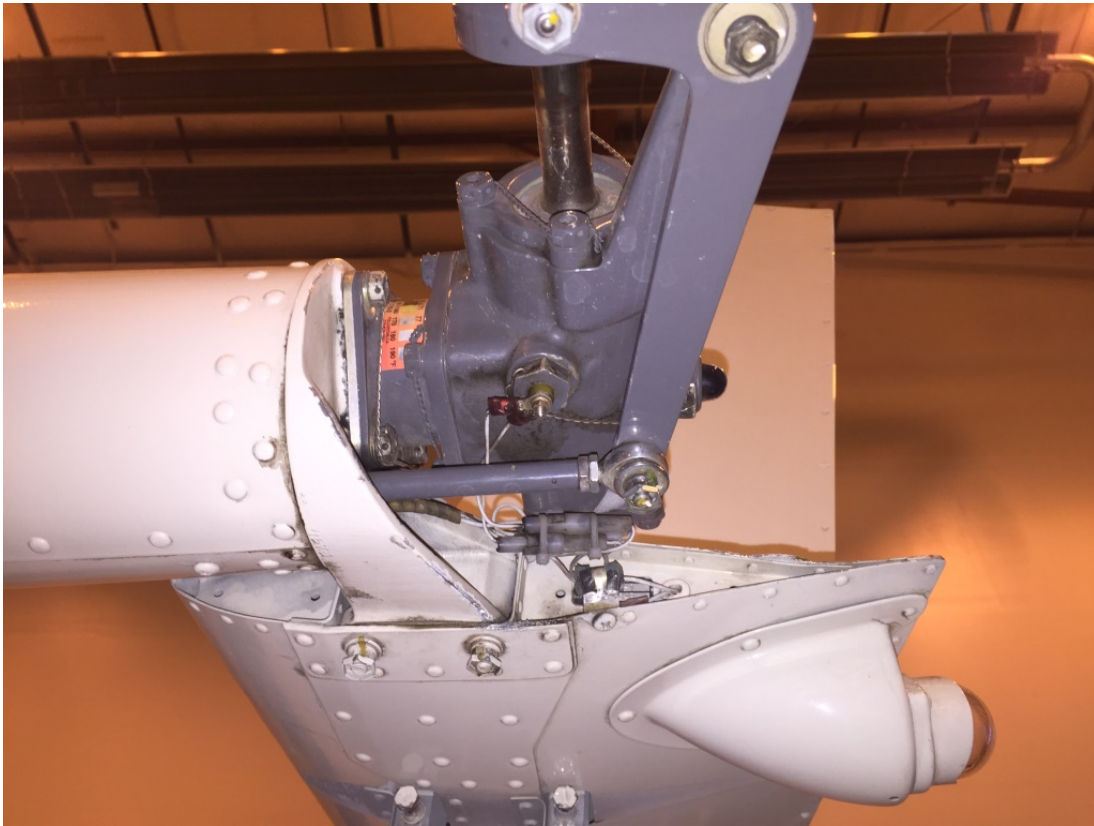
**Figure 18 - Underside of TR Gearbox and Linkage**

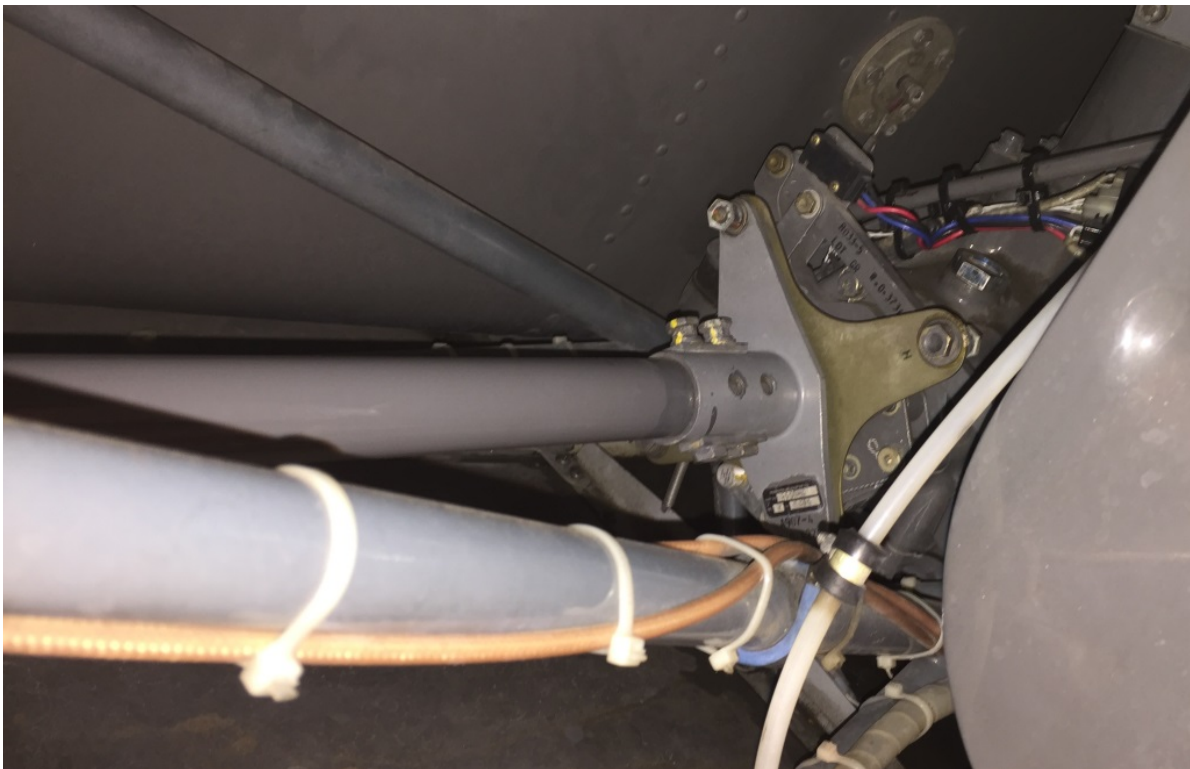
**Figure 19 - TR Drive Shaft and Flex Coupling**

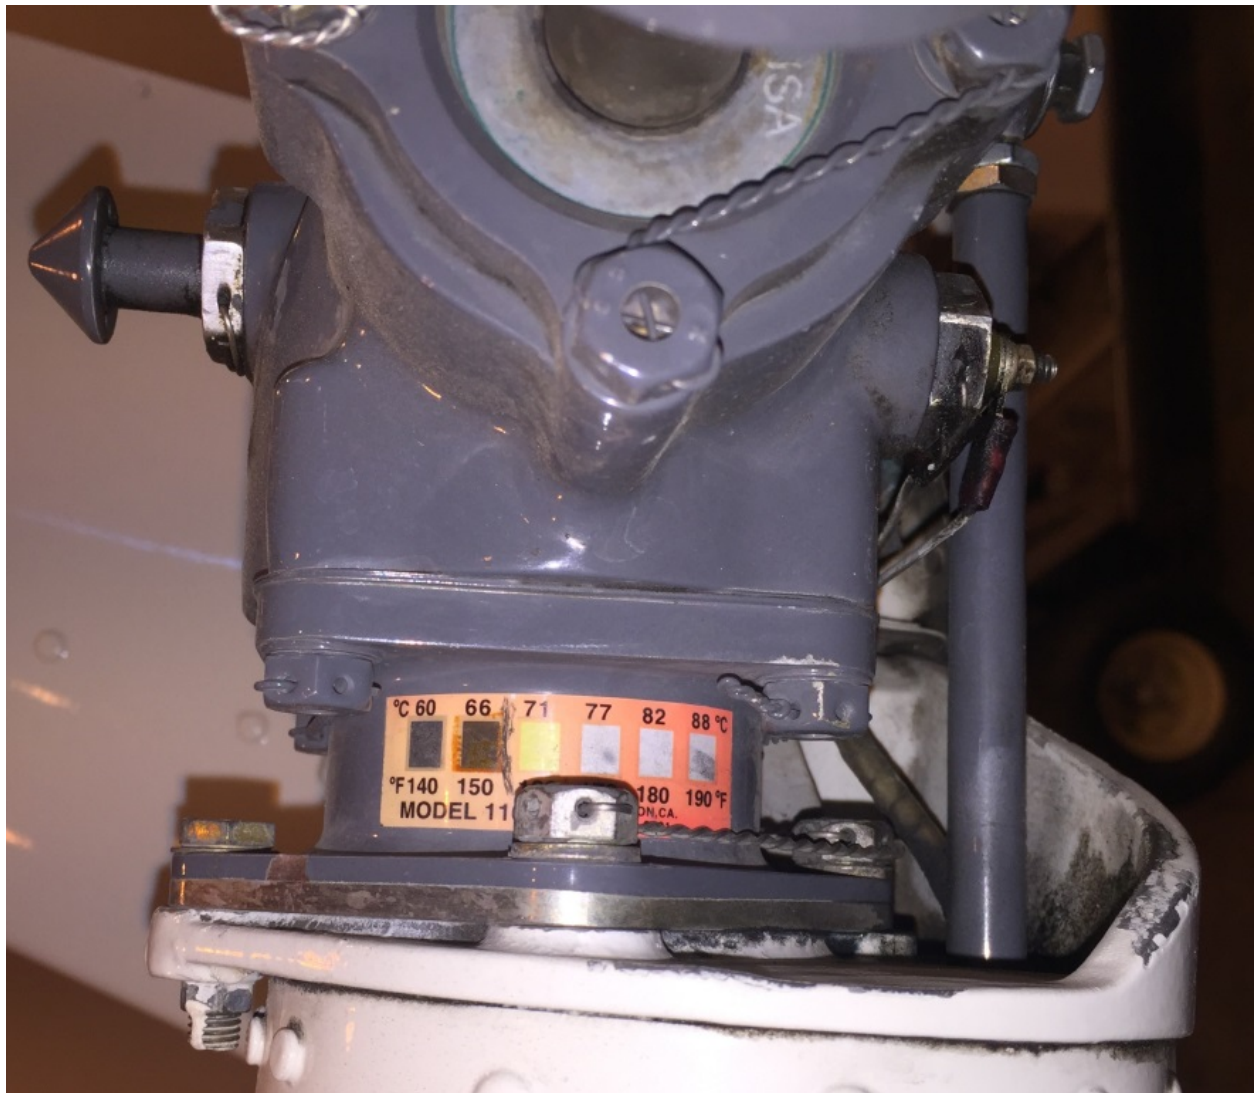
The FAA inspector examined the recovered helicopter 3 days after the accident, at the facility of Apex Aviation at North Las Vegas airport. All "Telatemp" indicators indicated normal operating temperatures (no exceedances), and all flight controls exhibited unrestricted and full travel throughout their design ranges.

Figure 20 - Telatemp on TR Gearbox

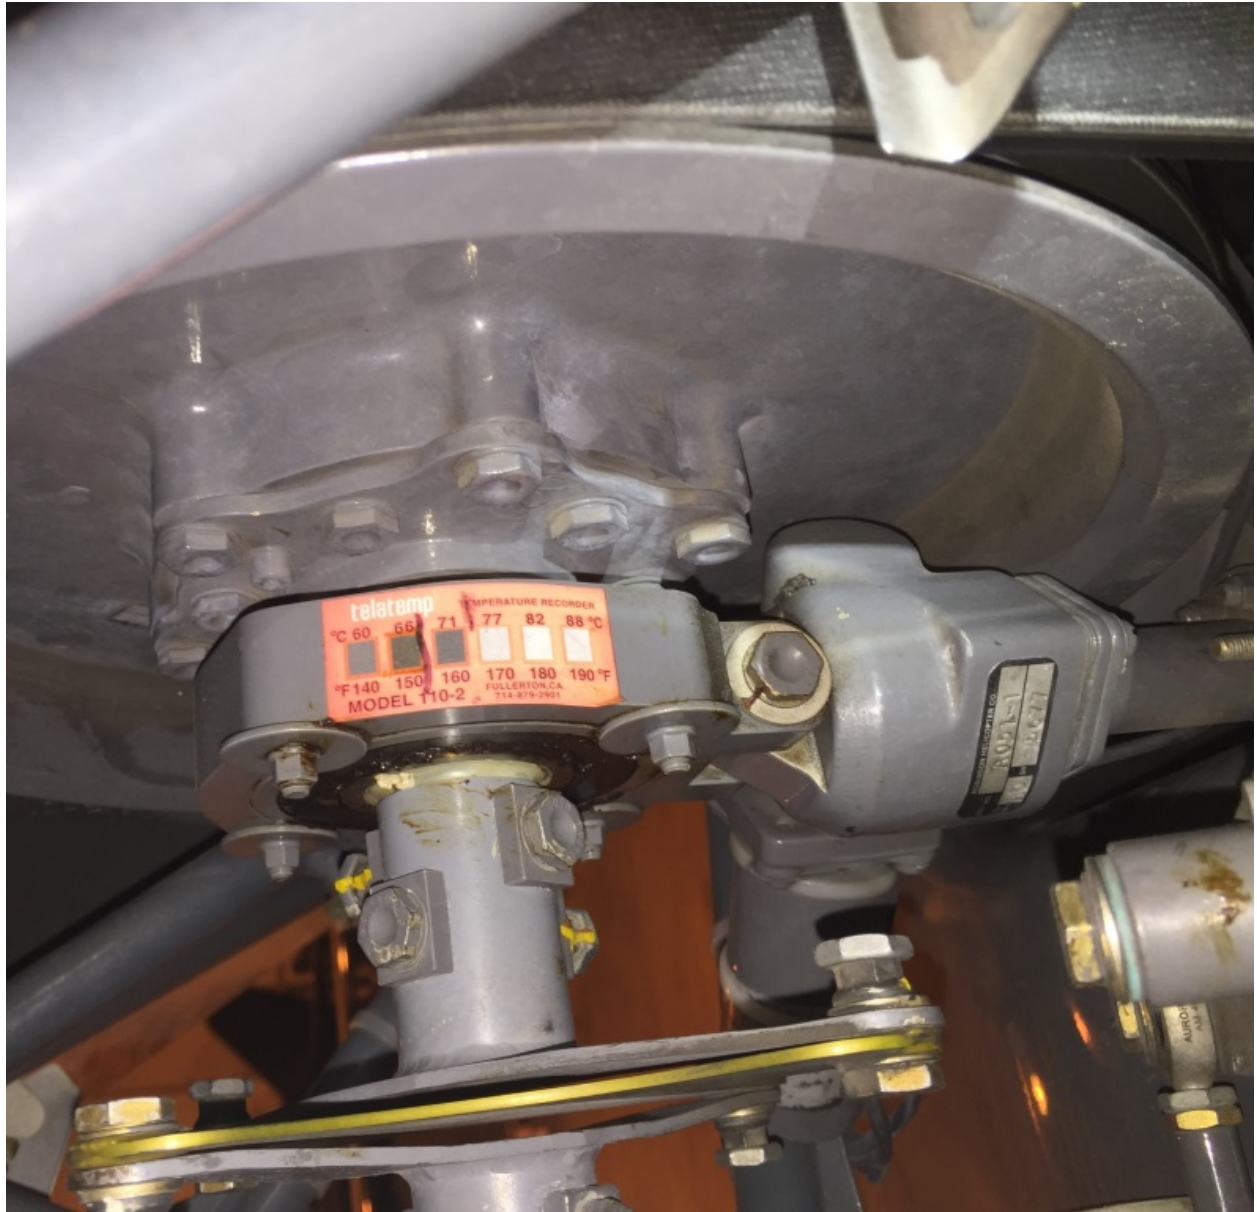
**Figure 21 - Telatemp on Clutch Actuator Sheave at Intermediate Flex Coupling**
