## **NATIONAL TRANSPORTATION SAFETY BOARD**

### **COMPONENT EXAMINATIONS & TESTING**

**NTSB Accident: WPR16LA056  
Accident Date: January 22, 2016**

Location: North Las Vegas, NV  
Date: January 22, 2016  
Aircraft: Robinson R22, N7020U, Serial # 2837  
NTSB IIC: Michael Huhn

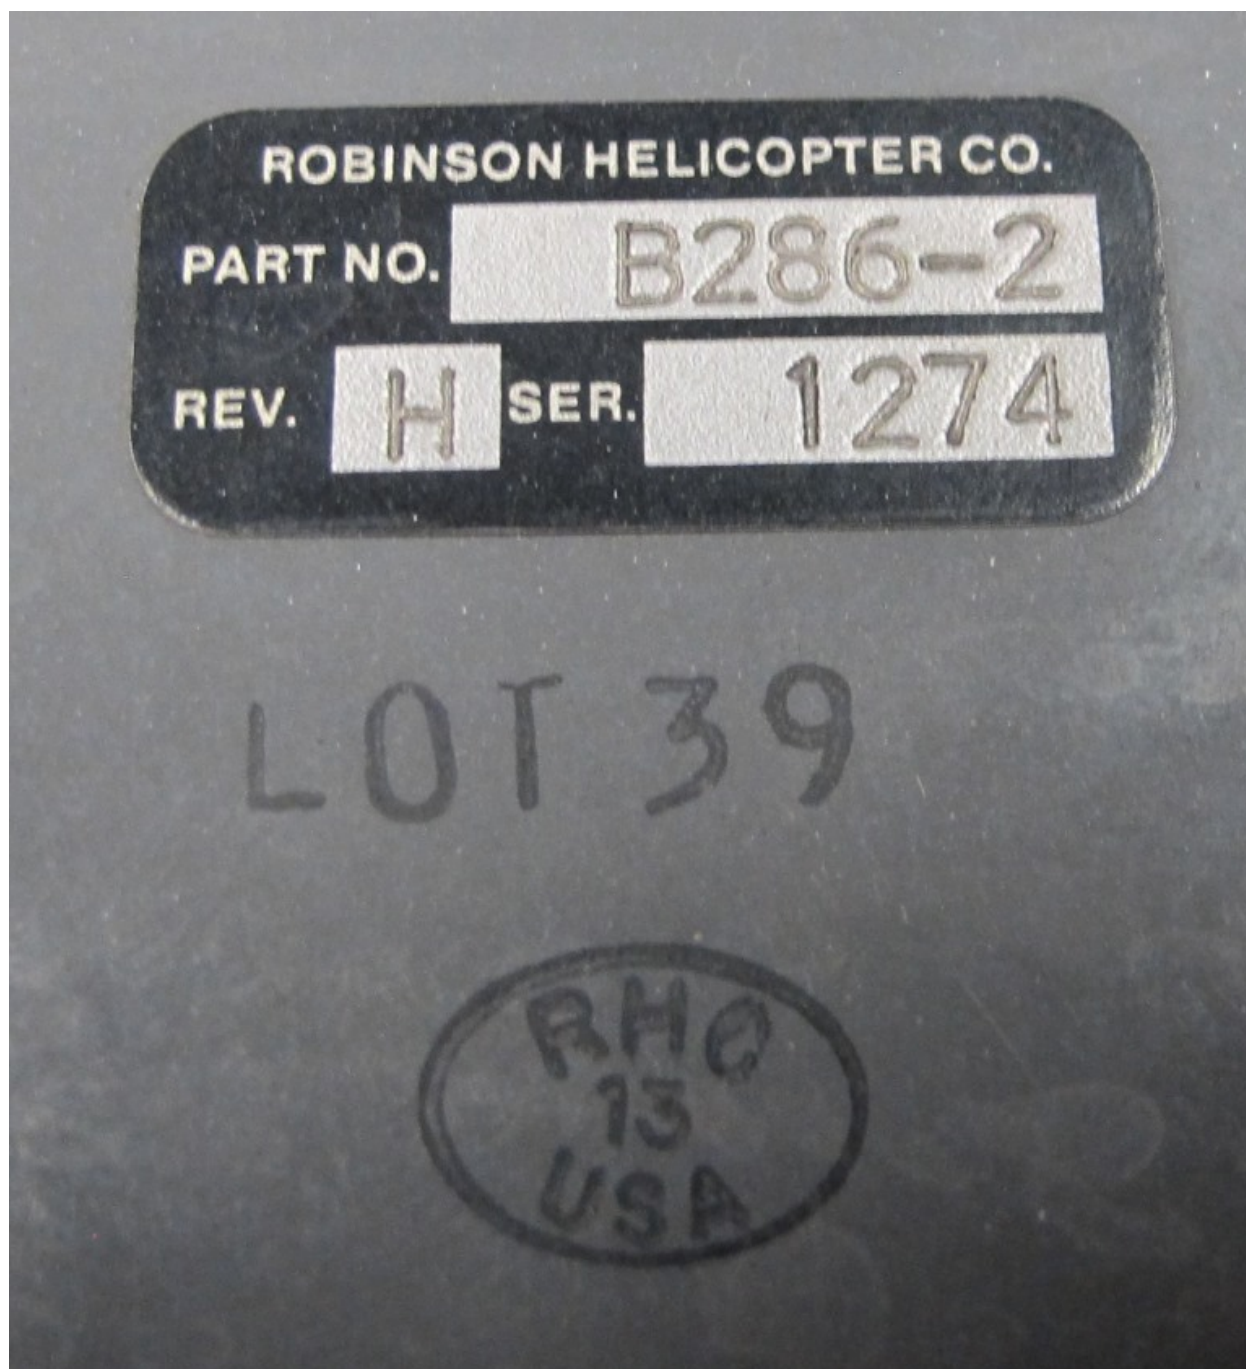
Figure 2 - Control Box Data Plate

The first component examined was a Governor Controller Box, part number B286-2, serial number 1274, Rev H, Lot 39. A visual inspection of the box revealed that the box had not been opened or overhauled since its production. No external damage, with the exception of a small area of bubbled paint, was present. The electrical connector was clean and undamaged. A functional test was performed using the production acceptance criteria. The Controller satisfactorily met (passed) all of the test criteria. A copy of the test results is attached.

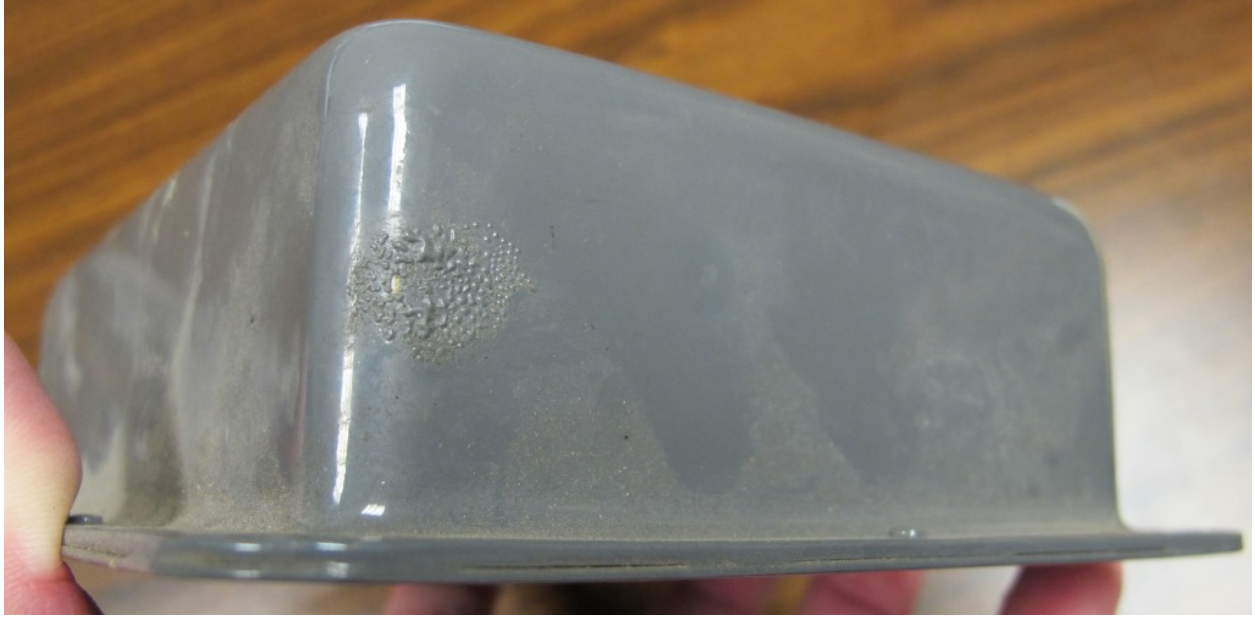
Rivets that secured the box cover plate were drilled out, and the box was opened. A visual examination found no indication of heat coming from the internal circuitry that would account for the bubbled paint. No abnormalities were observed with the internal components.

**Figure 6 - Bubbled Paint on Control Box**

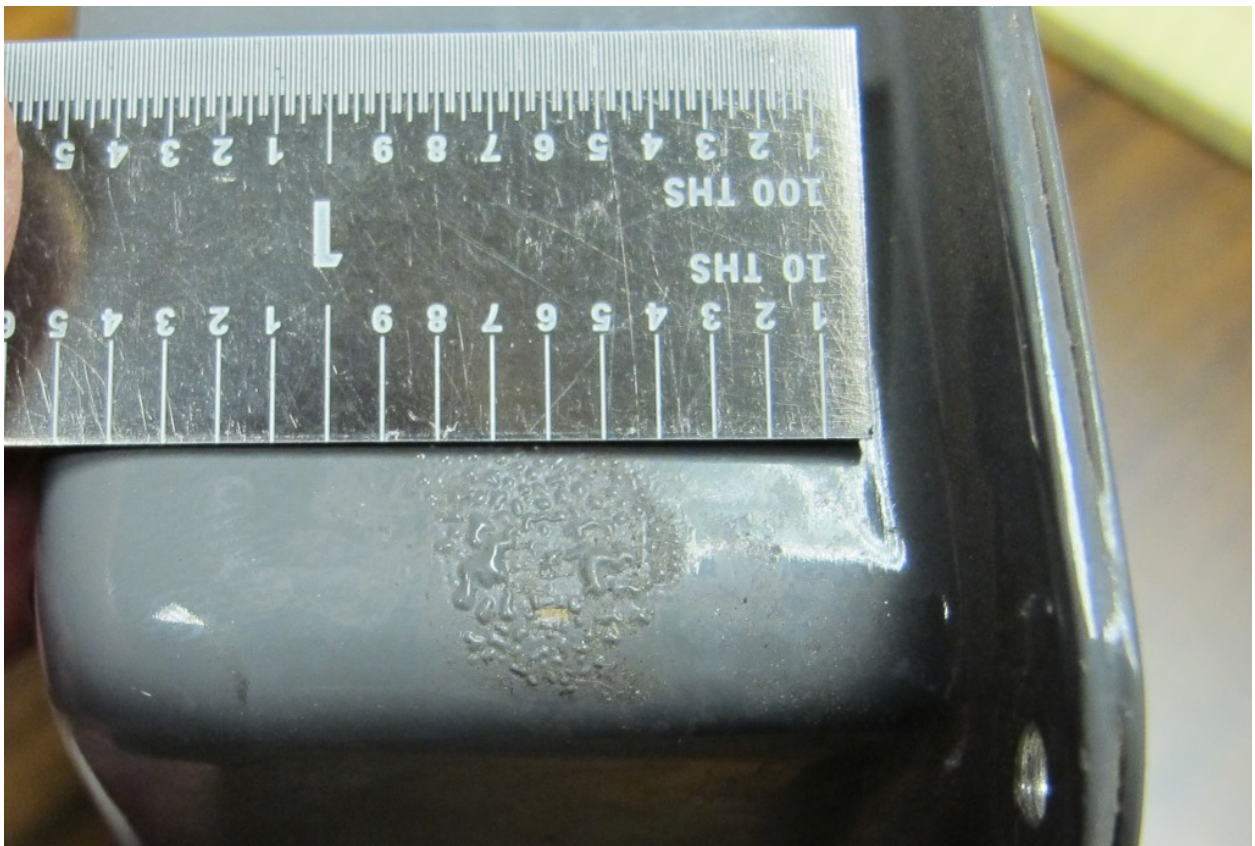
**Figure 7 - Bubbled Paint Dimensions**

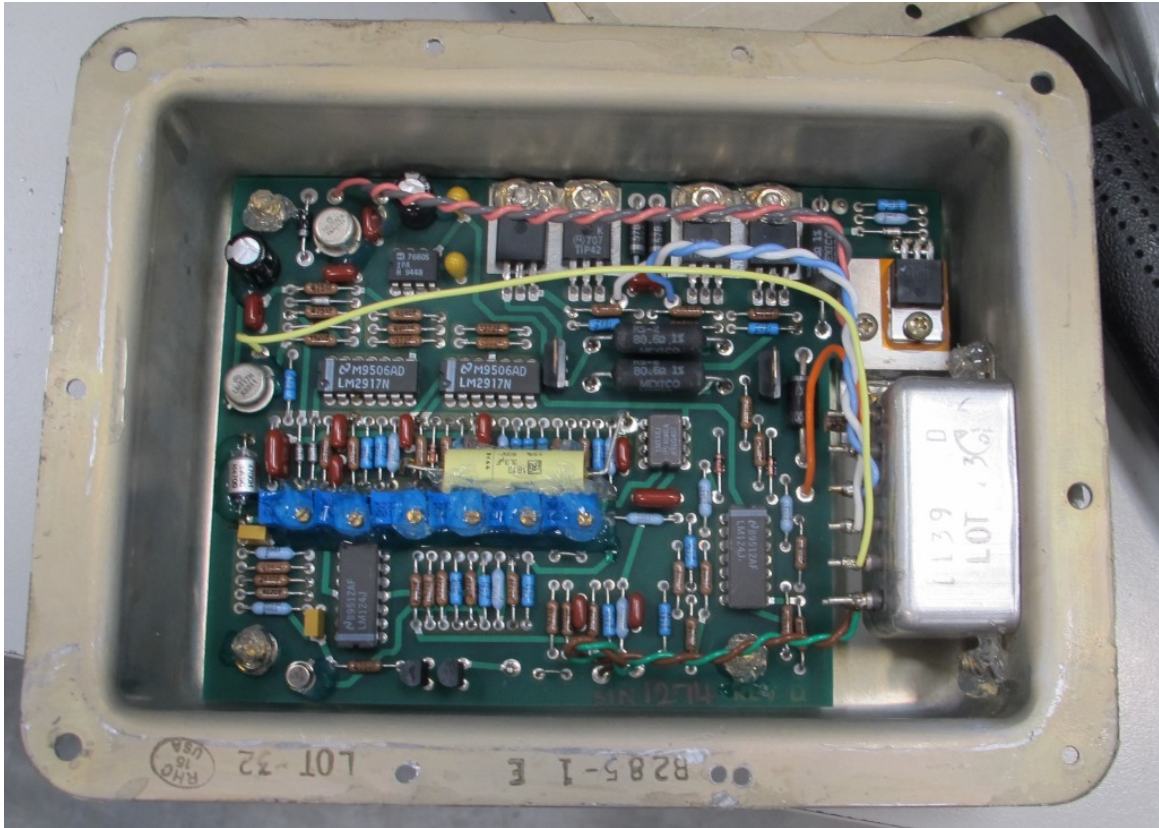
Figure 8 - Control Box Internal Components

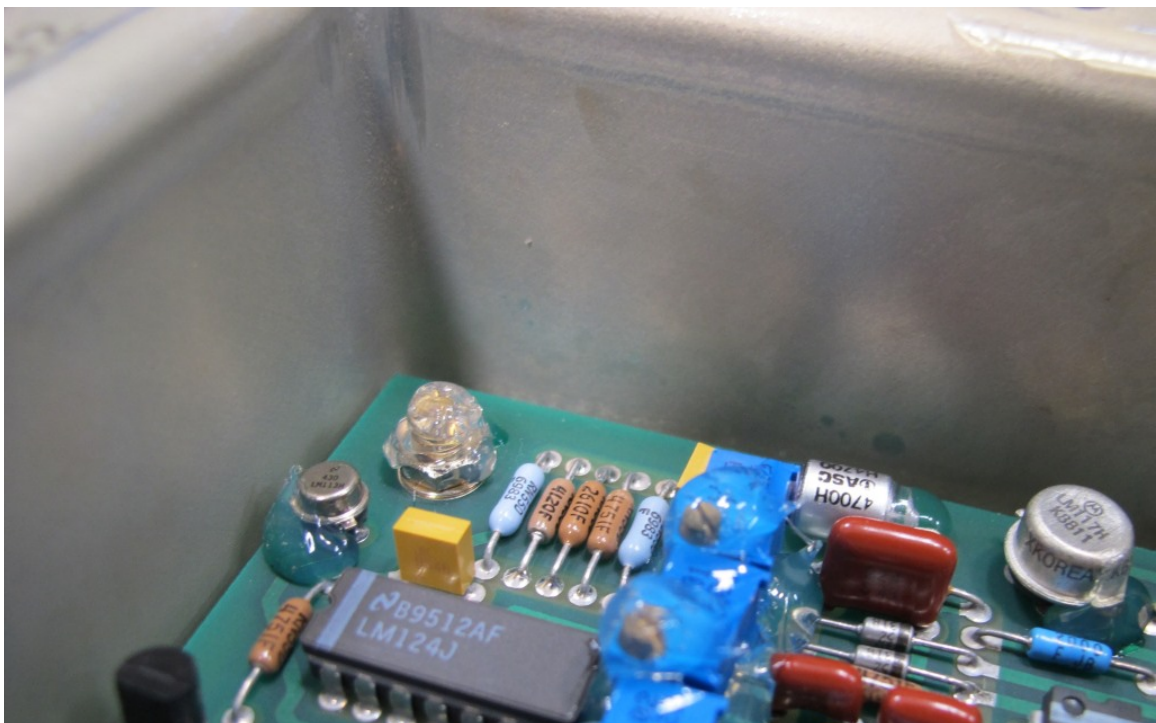
Figure 9 - Control Box Interior Behind Bubbled Paint

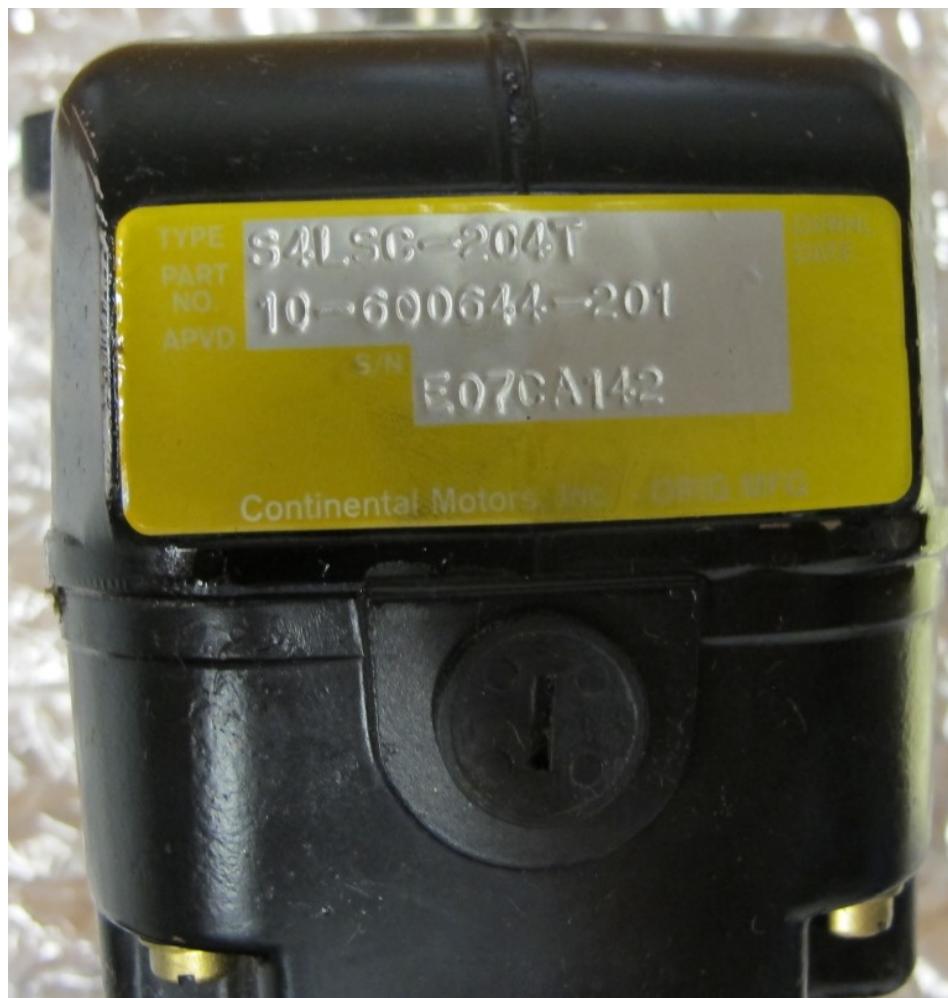
The second component to be examined was the (right) engine (helicopter left) Magneto, part number 10-600644-201, serial number EO7CA142. A visual inspection of the Magneto revealed that the data plate was yellow in color, indicating that it had been overhauled in the field (not by the manufacturer). No external damage was noted. The point cover was removed. There was no oil or grease contamination on or near the points. Although at least one point base holddown screw appeared to be slightly under-torqued, the tachometer ("tach") point base was secure, and all the proper hardware was in place. The points opened and closed on manual magneto rotation. The tach points, which provide a signal to the tachometer and the governor, had a gap between the contact points of less than .012 inches (manufacturers specification is  $.019 \pm .003$  inches). The tach points were removed for inspection. The points appeared undamaged and the contact pads were clean and smooth. The insulator spacers were undamaged.

Figure 10 - Magneto Data Plate

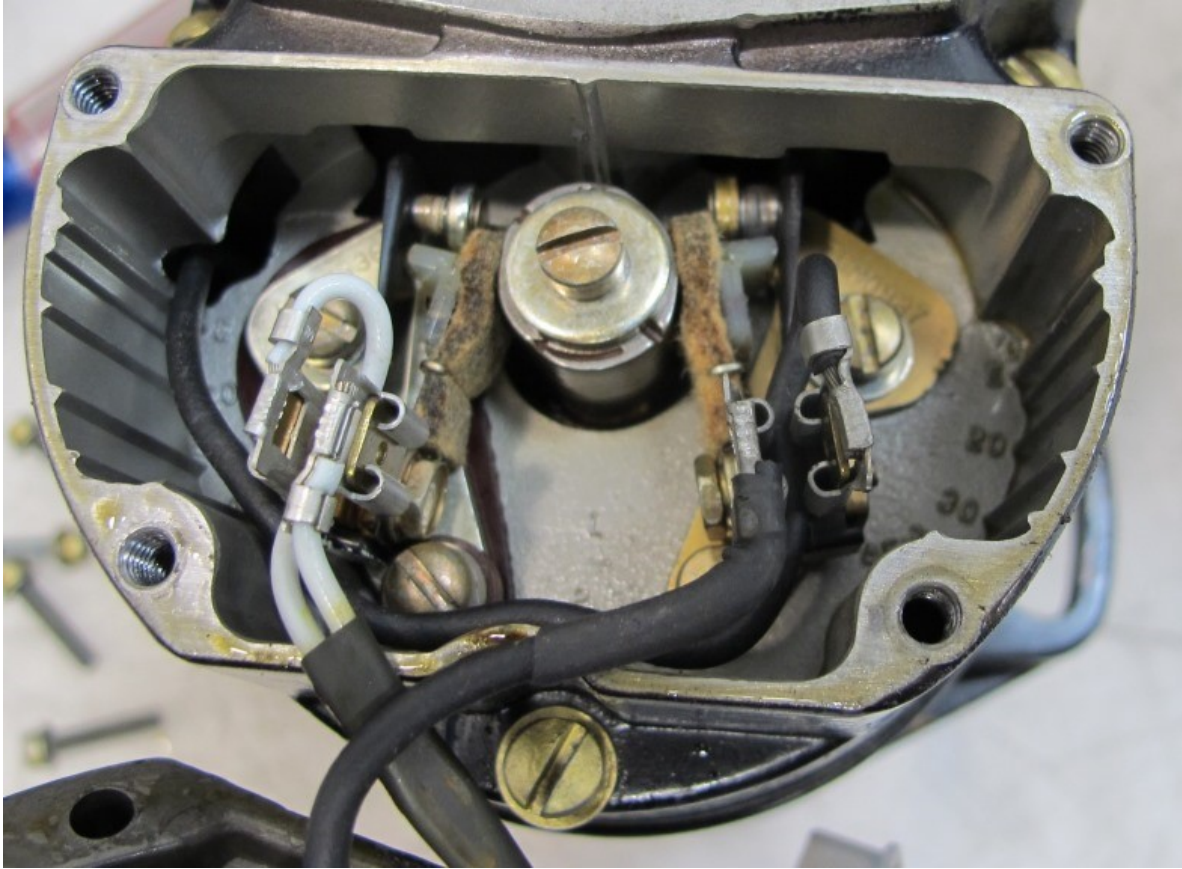
**Figure 13 - Magneto Points (Tach points on left side)**

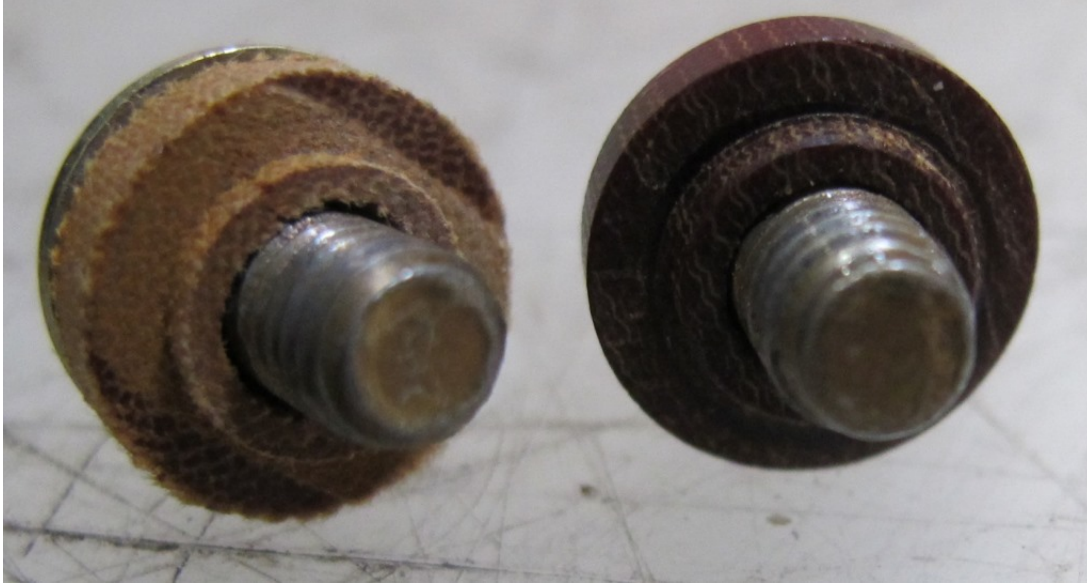
**Figure 15 - Intact Insulator/Spacers**

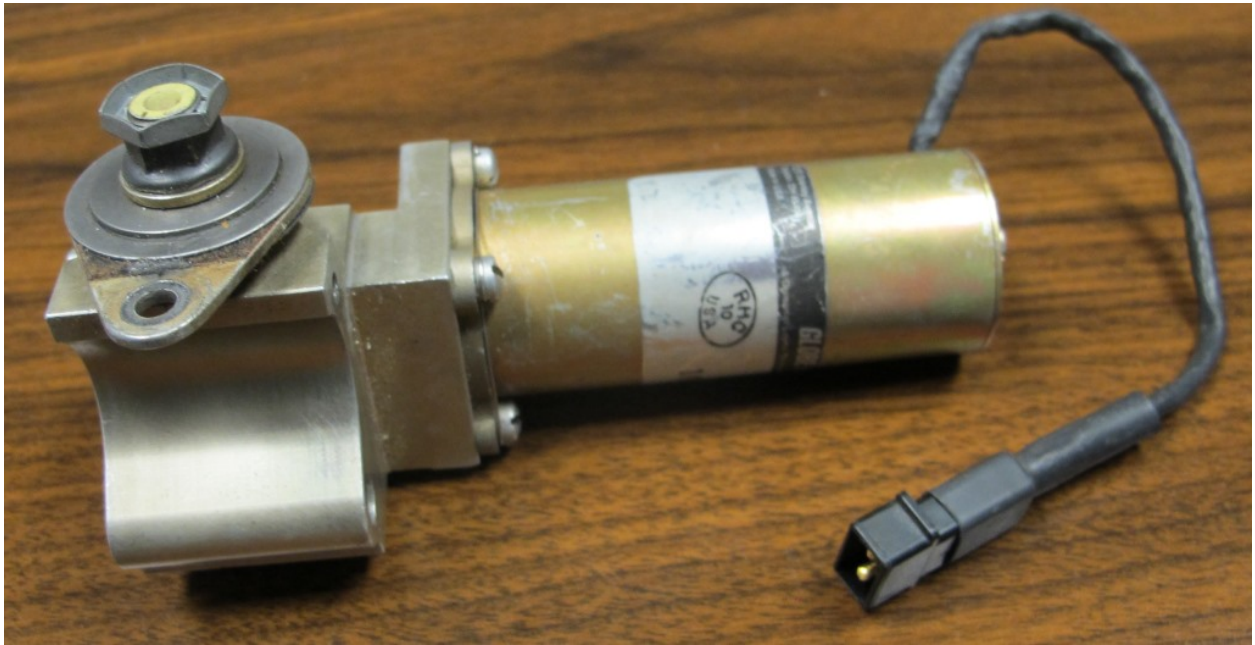
Figure 17 - Governor Motor

The third component to be examined was a Governor Motor, part number B247-5, Lot 50. Visual inspection revealed no external damage. A functional test was performed on the motor with satisfactory results when compared to production specifications. The functional test included directionality, and appropriate "friction disc slippage," as indicated by motor current draw with a jammed actuator link at two power settings, 100% and 20 %. Maximum allowable draw was 0.7A; observed maximum values were typically 0.23A.
