**WPR16LA058**

**Cessna 340A – N346MC**

## **Landing Gear Examination Factual Report**

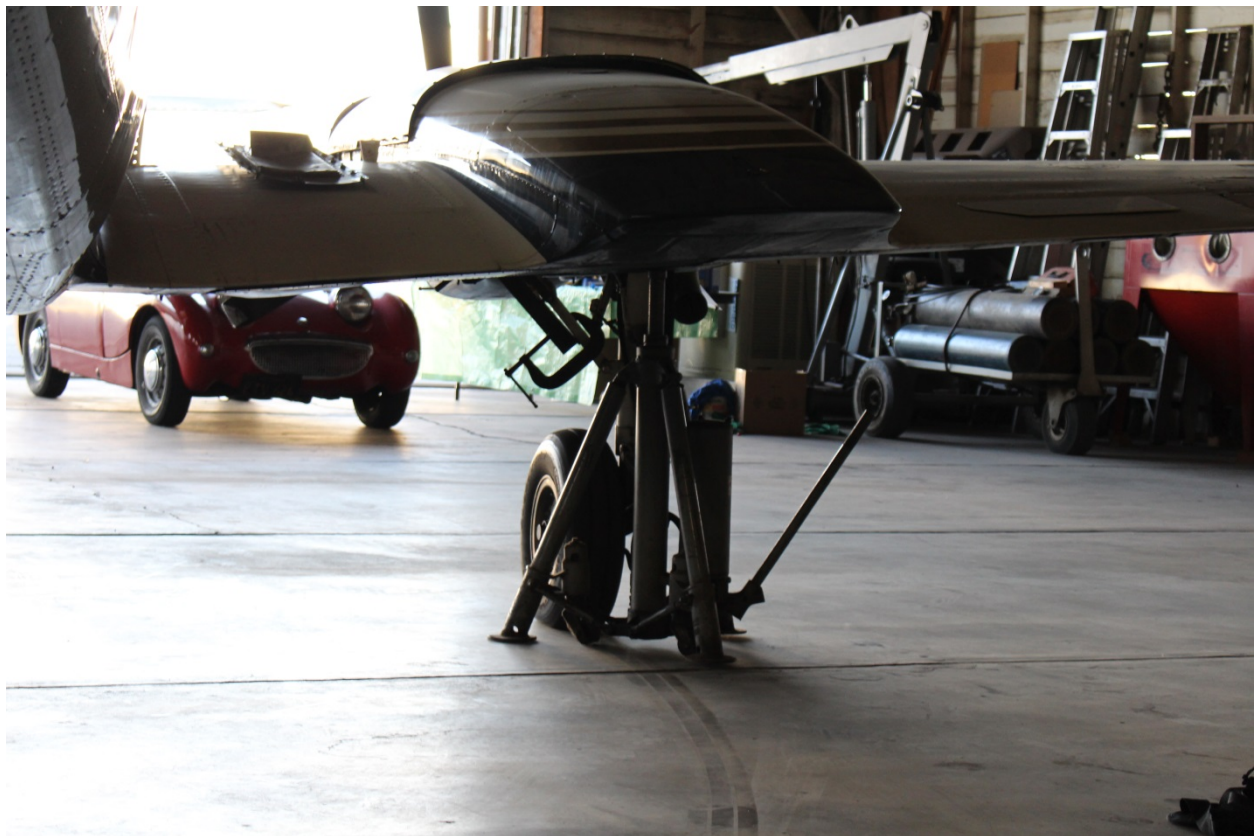
The examination team was comprised of two airframe and powerplant mechanics with oversight from the NTSB. Prior to the NTSB's arrival, the mechanics installed a wood plank to stabilize the right main landing gear (*see photograph 1*). An initial inspection of the landing gear system revealed the right main landing gear aft tube rod end, which normally connects to a bellcrank, had broken about mid-span (*see photograph 2*). The left main landing gear aft tube rod end was stiff at the trunnion bearing, but the assembly remained intact. The overcenter adjustment for both main landing gear appeared normal, but displayed different thread measurements; the right main landing gear aft tube measured 14/32 at the fork bolt and the left main landing gear aft tube measured 10/32 at the fork bolt. Both main landing gear fork bolts appeared turned slightly away from being centered with the aft tube.

Photograph 1: Right Main Landing Gear Prior to Examination

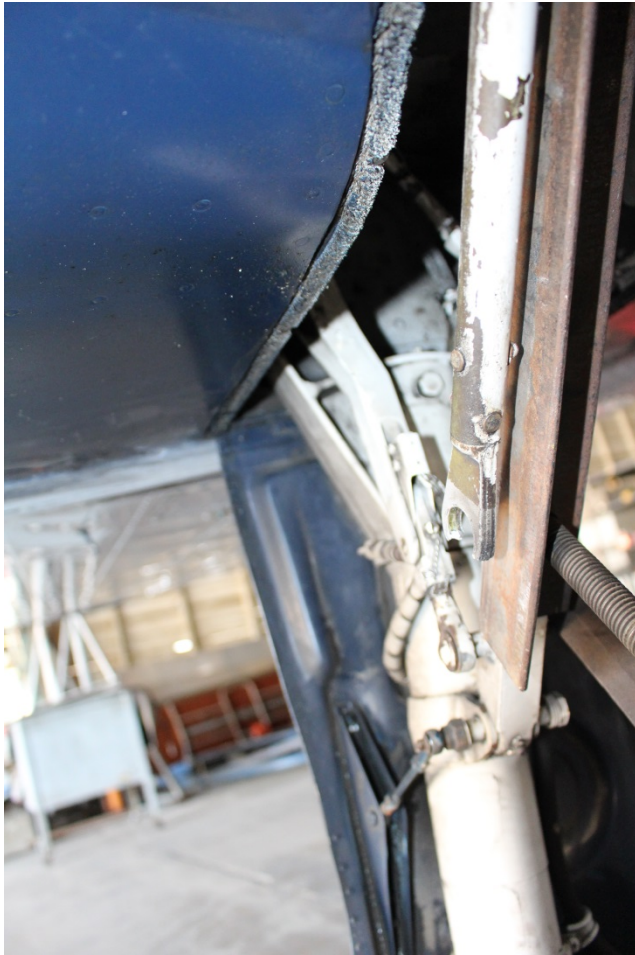
Both main landing gear fork bolt connections were visually inspected. The inboard attachment end of the aft tube to the left main landing gear did not move freely at the rod end, but did rotate at the jam nut. The right main landing gear aft tube rod end moved freely at the inboard rod end attachment.

Photograph 2: Right Main Landing Gear Aft Tube Rod End

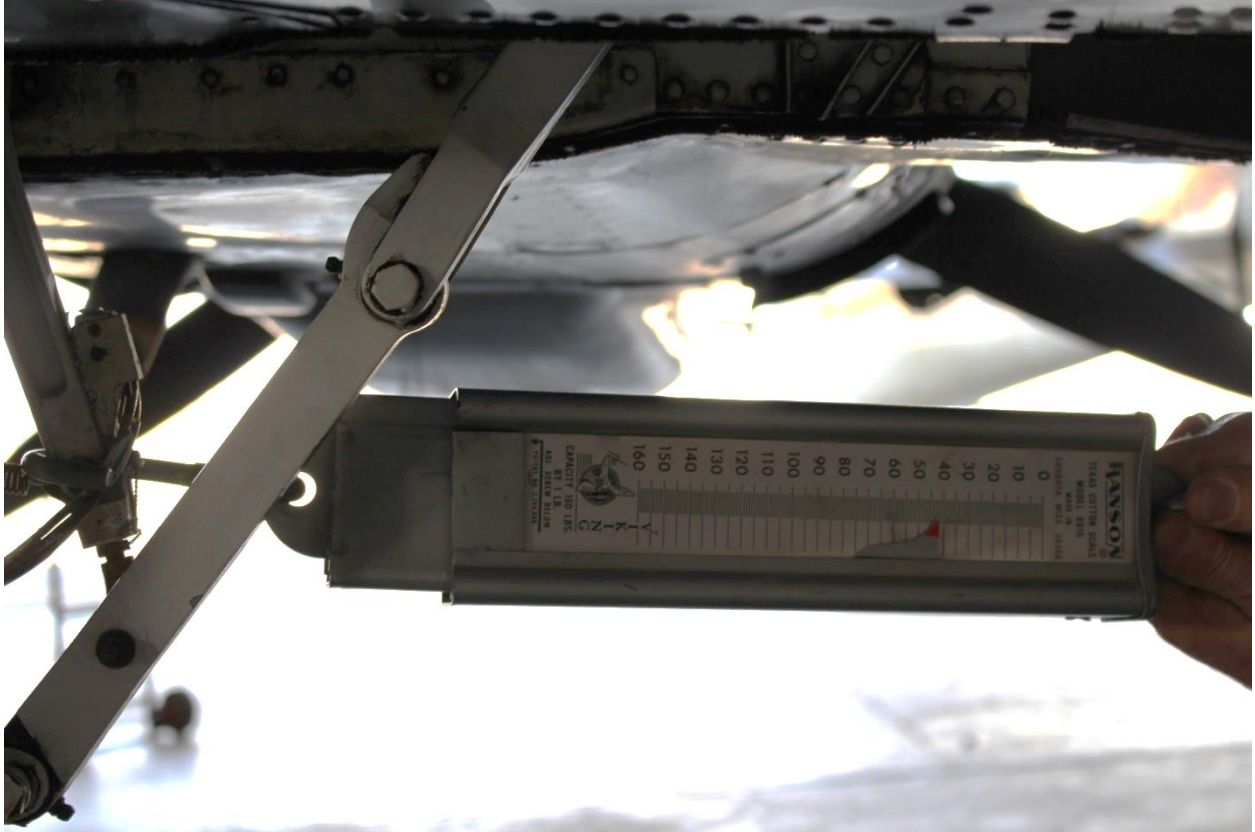
A hanging scale was used to measure the over center tension for the left main landing gear only as the right main landing gear aft tube had failed. The hook end of the hanging scale was attached to the lock link and pulled at a right angle. The left main landing gear down lock tension was about 43 lbs. (*see photograph 3*). According to the manufacturer, the prescribed tension is 40 to 60 lbs. for proper engagement and tension.

Photograph 3: Right Main Landing Gear Downlock Tension
