## **NATIONAL TRANSPORTATION SAFETY BOARD**

### **AIRFRAME AND ENGINE EXAMINATION**

**NTSB Accident: WPR16LA071  
Accident Date: February 16, 2016**

Location: Buckeye Airport, Buckeye AZ  
Date: February 16, 2016  
Aircraft: Evolution Aircraft Revo, N107SB, Serial # 000608  
NTSB IIC: Michael Huhn

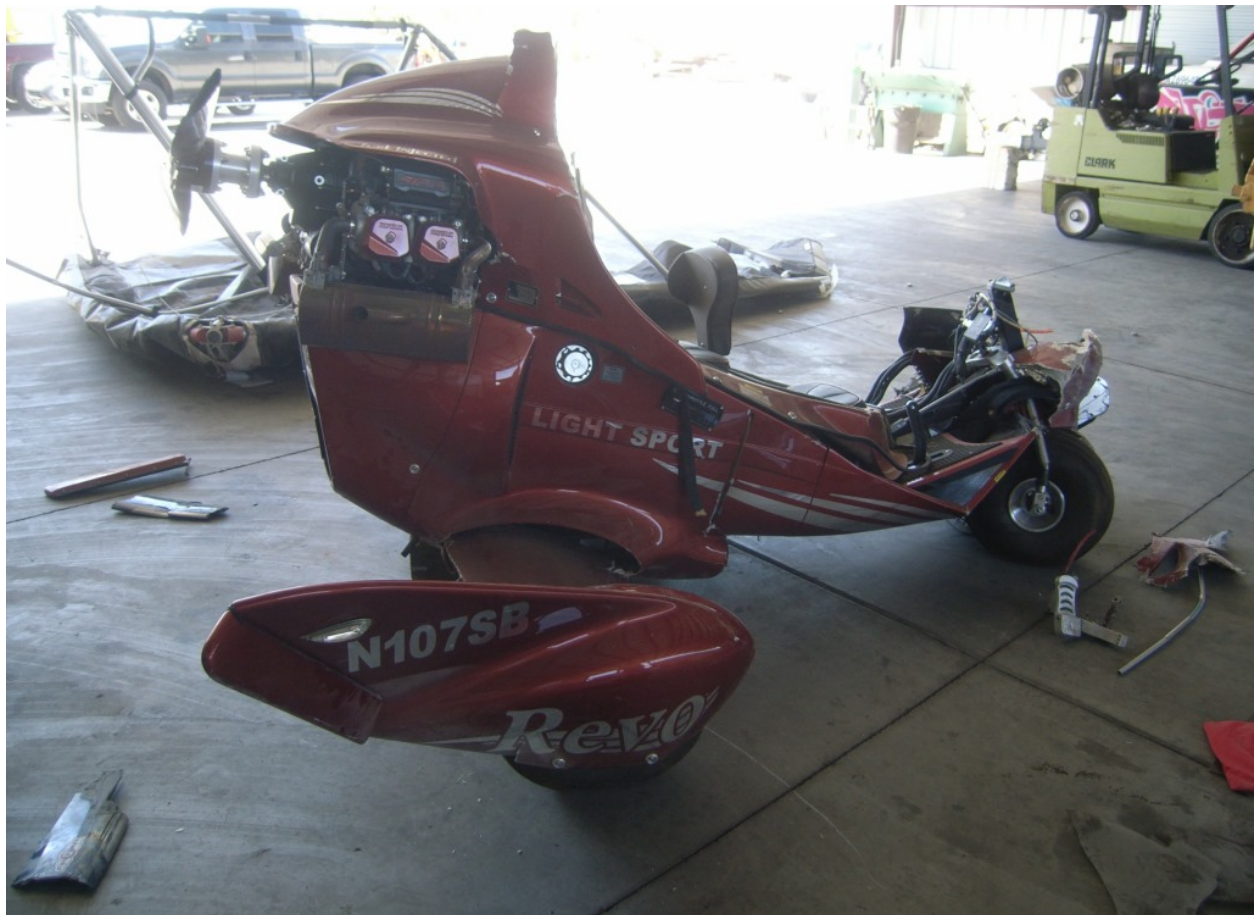
- The aircraft was in two major pieces (wing assembly and carriage) with an accompanying bag of fracture- separated parts (windscreen, carriage fairings, propeller fragments, foot pedal, etc)
- There was no evidence of fire, either pre- or post-impact
- The carriage damage was consistent with a front and left-side ground impact, with fore-aft scraping also

Figure 1 - Carriage Right Side

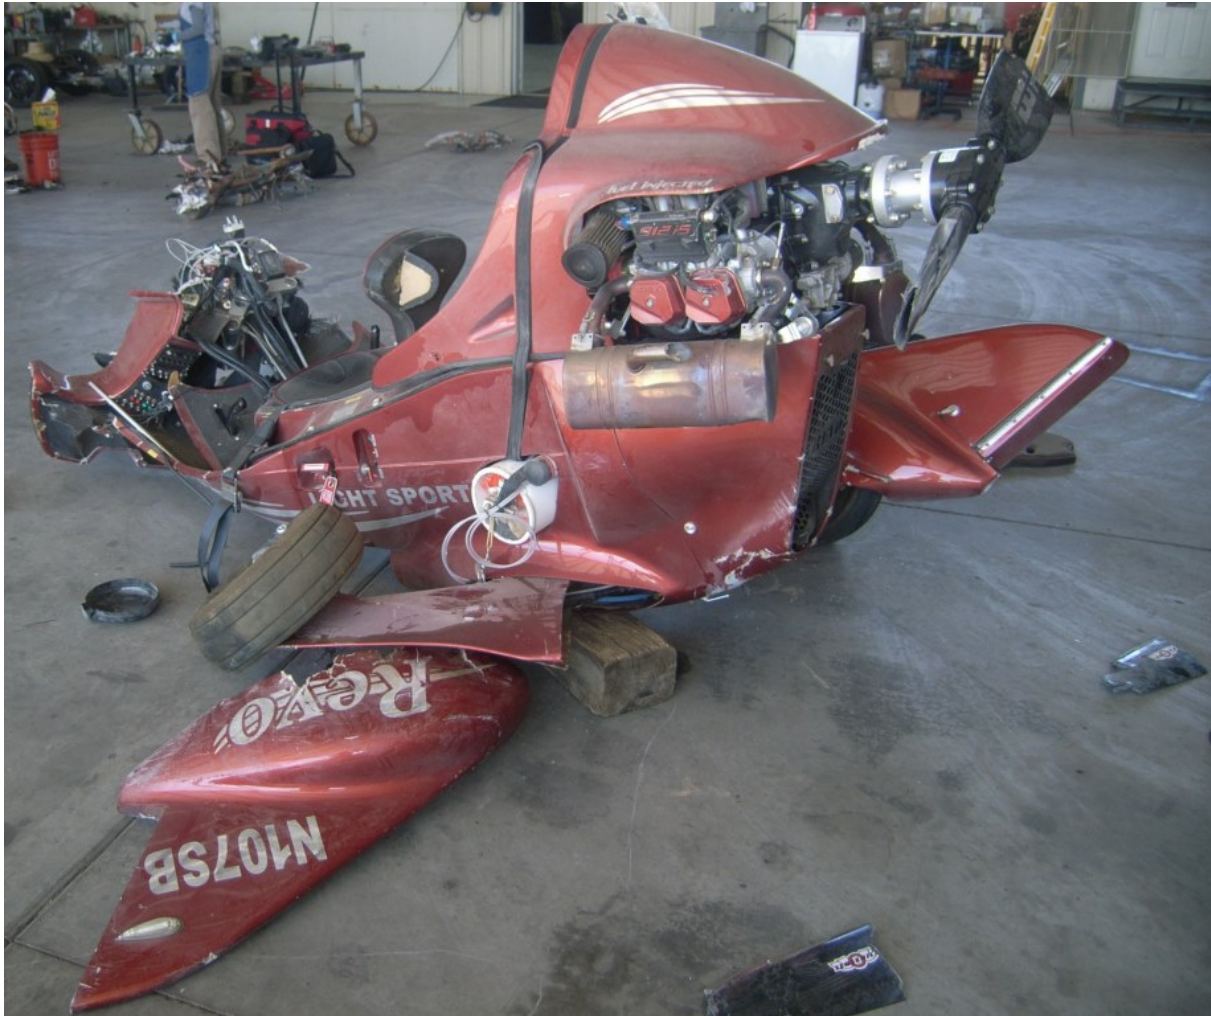
Figure 2 - Carriage Aft Left Side

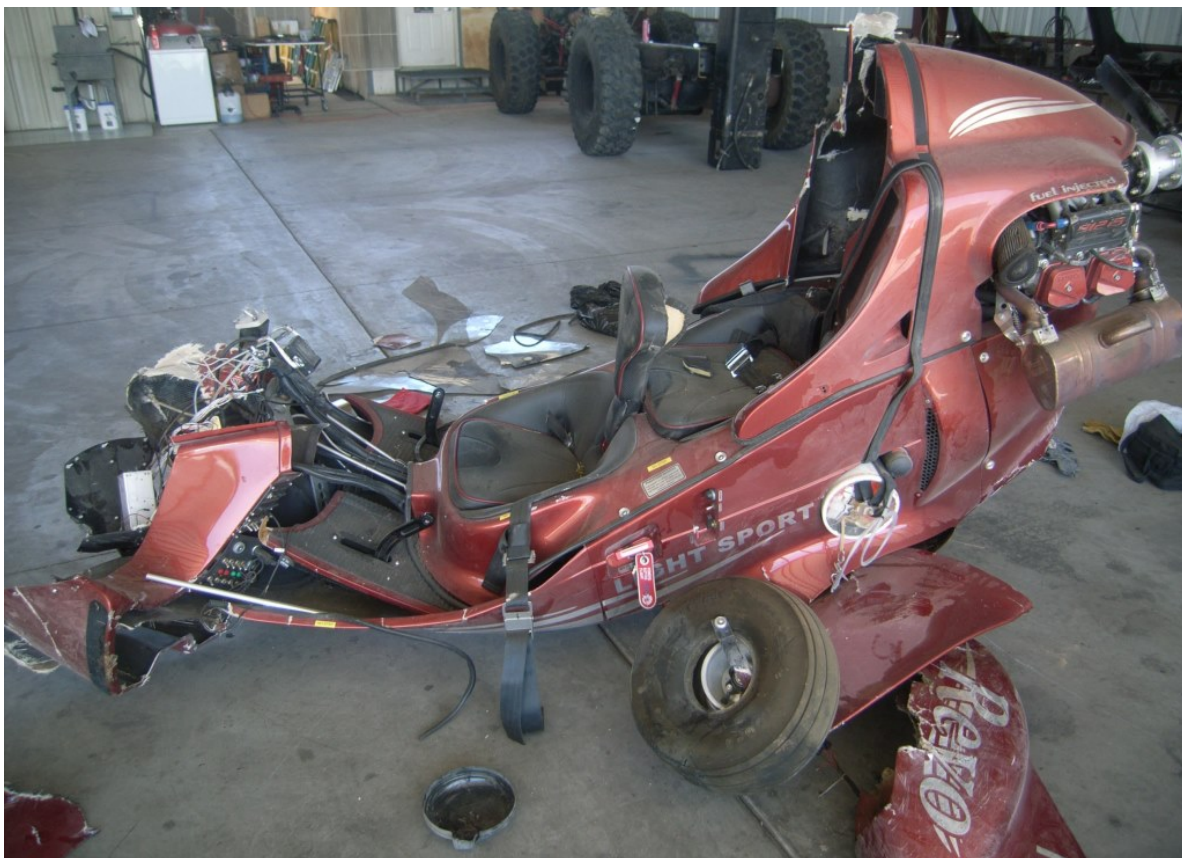
Figure 3 - Carriage Left Side

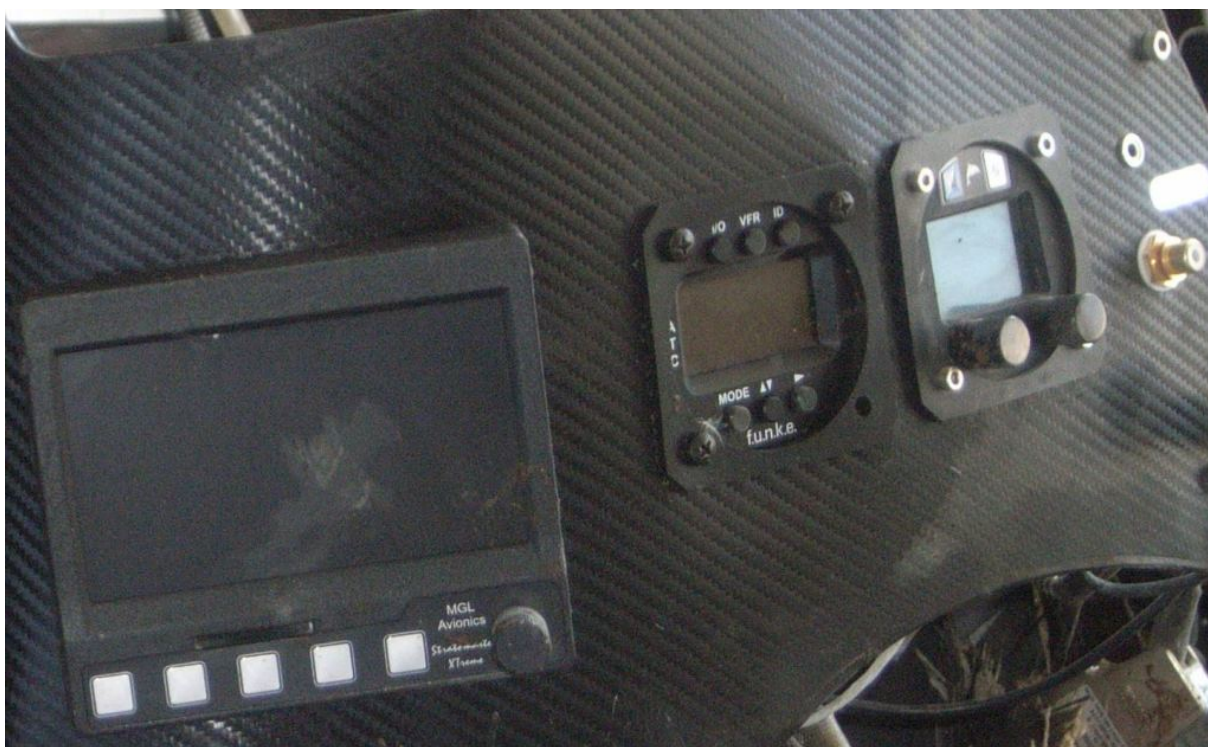
- The instrument panel was dislodged from its carriage mounts, and severely deformed
- All 3 instruments were present and affixed in the panel. They included

Figure 4 - Instrument Panel

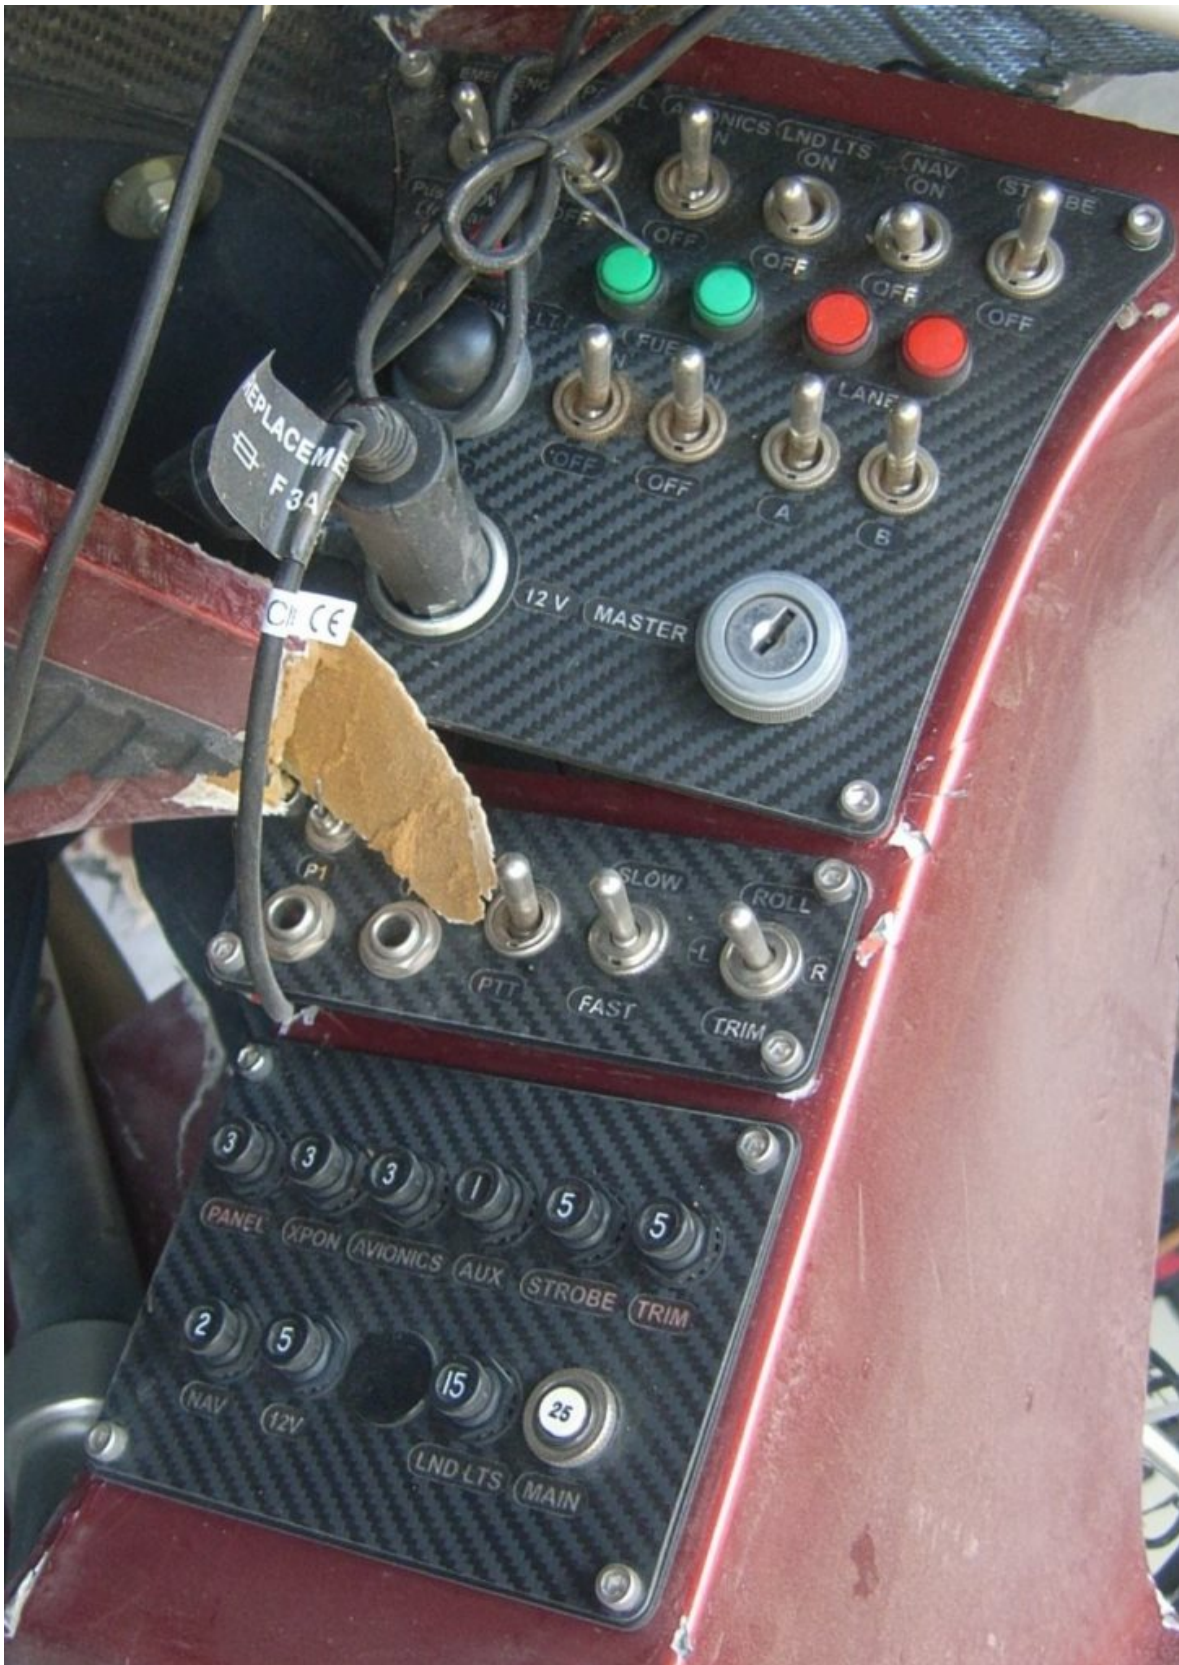
- o MGL Stratomaster Xtreme EFIS
  - o f.u.n.k.e. communications radio (PN TRT800H, SN 30761514)
  - o Hour meter/clock
- Given the exposure of the switch panel, the level of damage, and the fact that the wreckage was transported from the accident site to the salvage facility, and then from its storage location to the exam location, the switch positions were deemed to be unreliable.

Figure 5 - Switch Panel

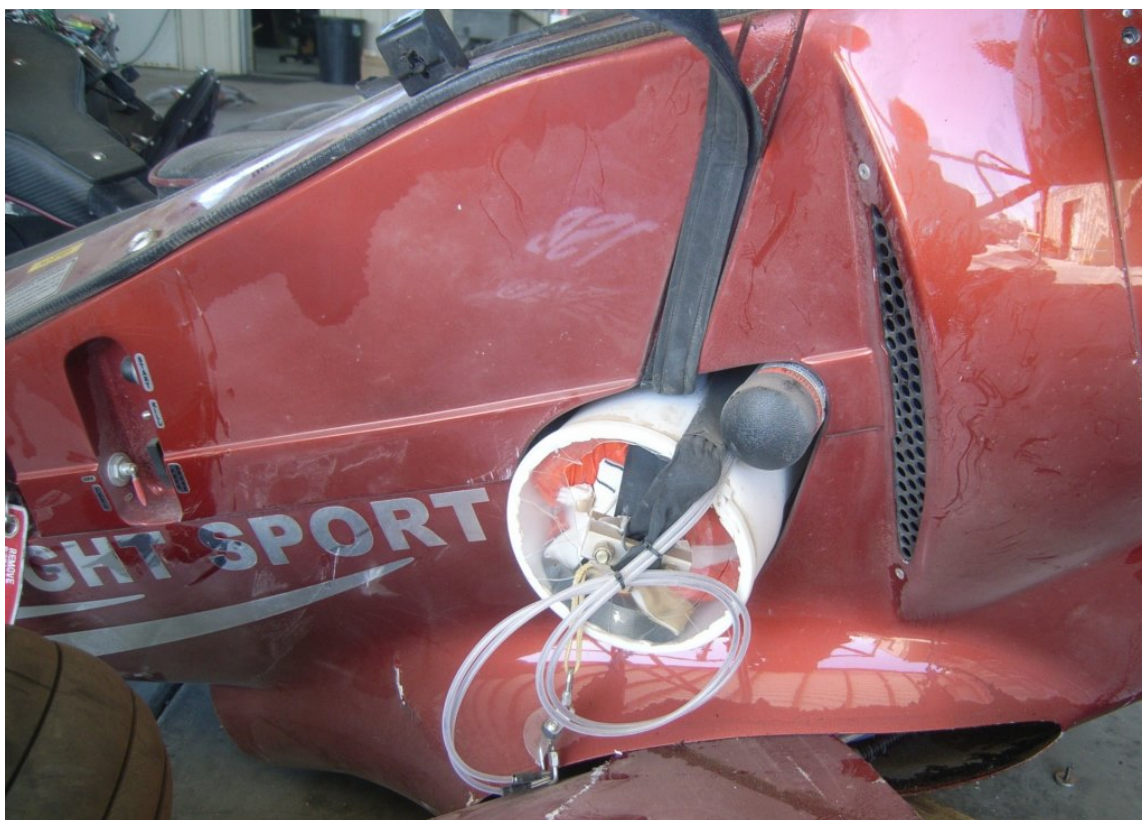
- Fuel was observed in the fuel tank
- The rocket powered ballistic parachute was still in its case, and the extraction rocket had not been fired
- The aircraft was not equipped with any placards advising or warning first responders or any other personnel of the presence of the rocket

**Figure 6 - Parachute and Rocket**

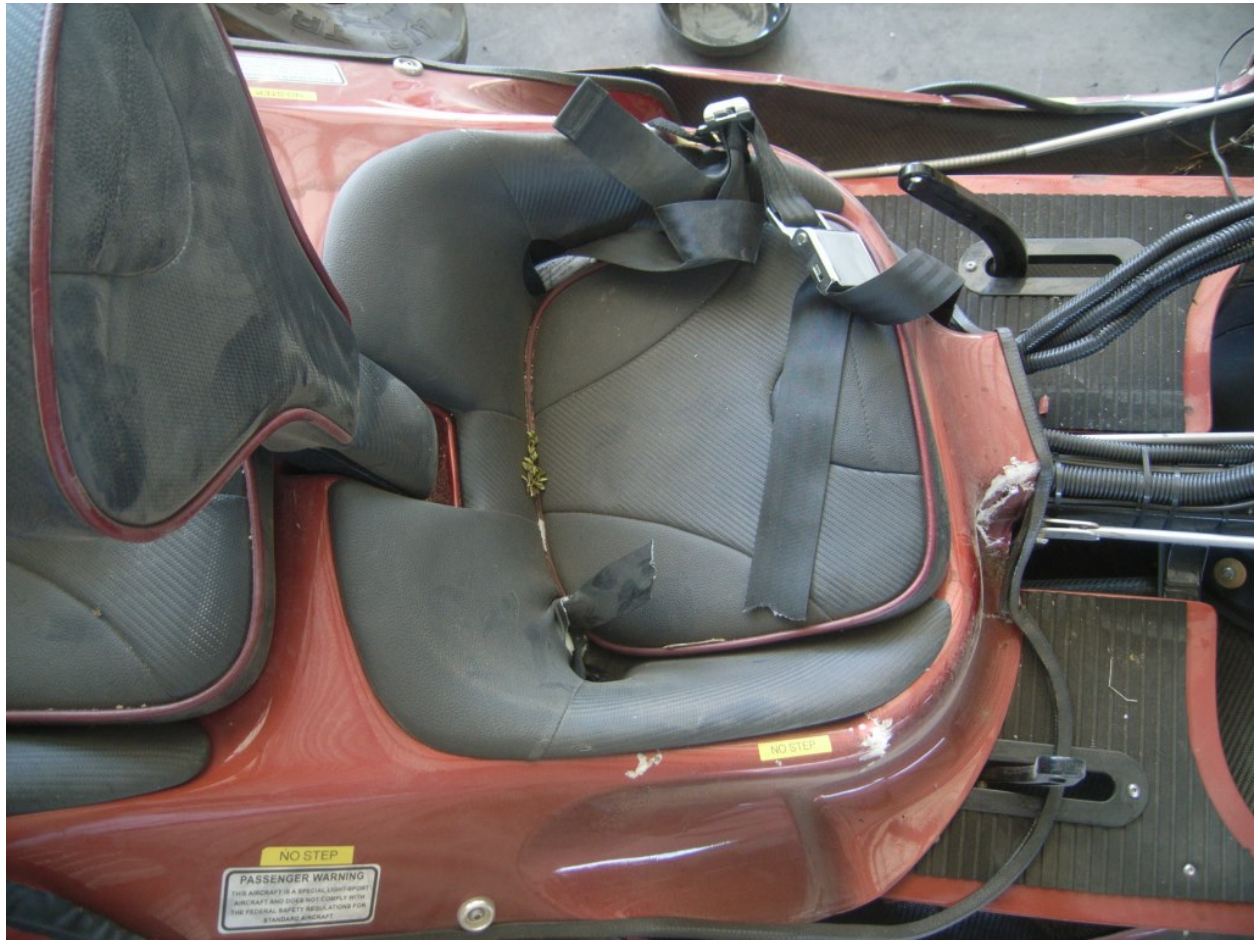
- The front restraint harness belts had been cut to extract the pilot

**Figure 8 - Forward Seat (note cut belt)**

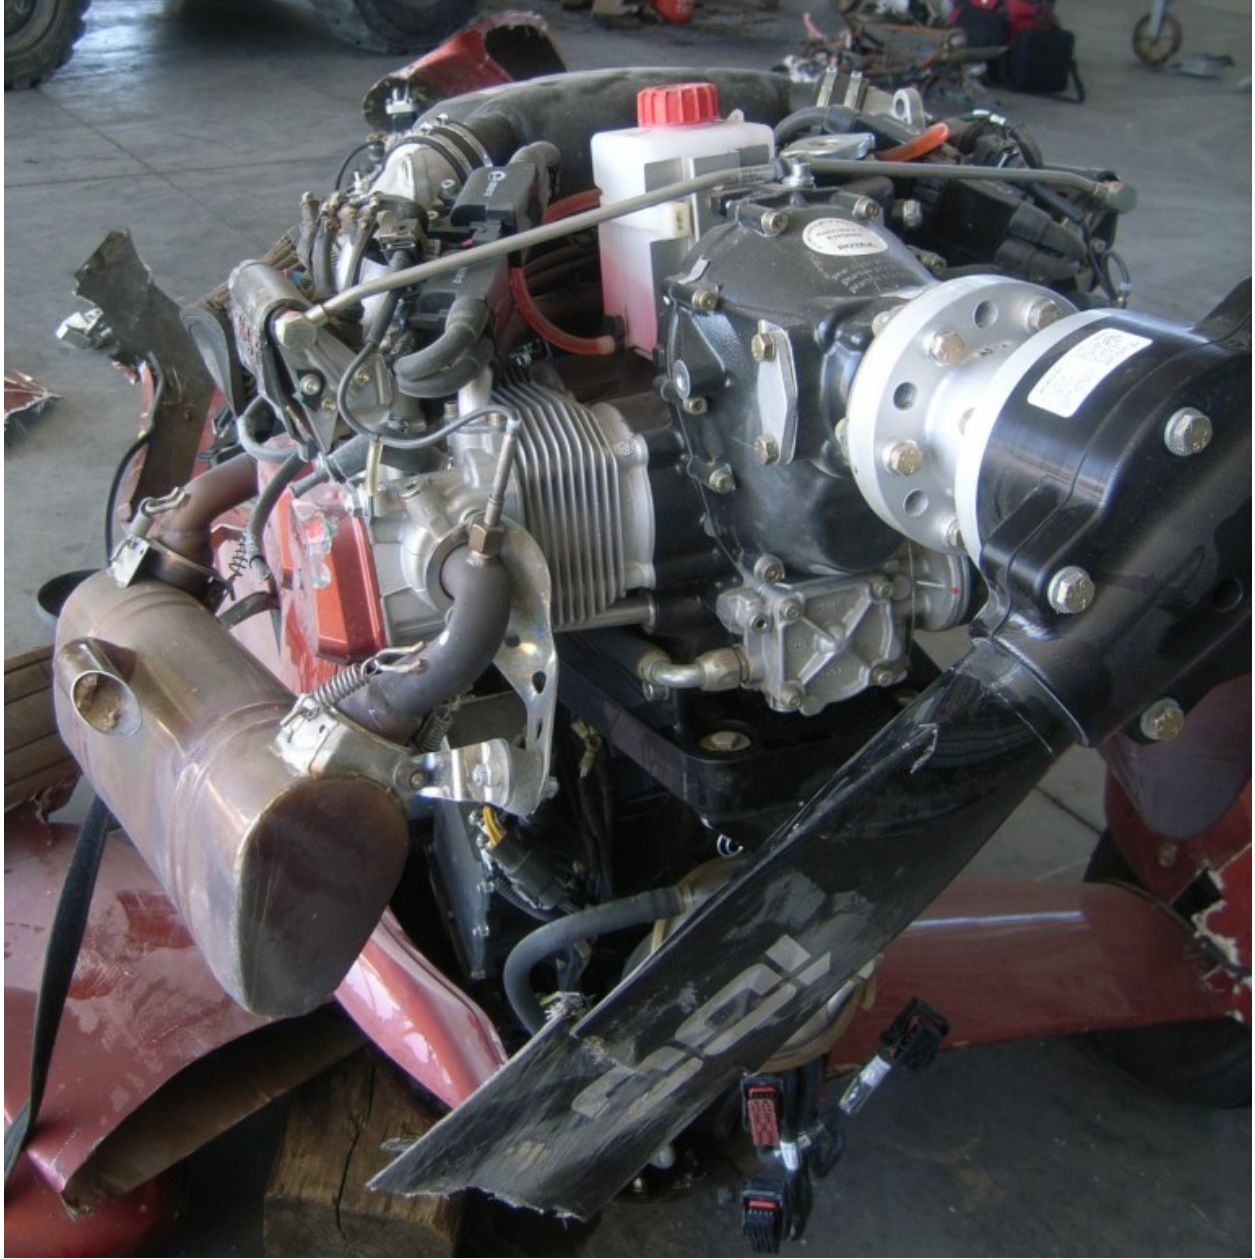
- The engine (Rotax 912 IS) did not exhibit any signs of any pre-impact failures
- Engine damage appeared to be limited to some minor muffler crush and displacement from impact
- The four top spark plugs were pulled and the engine rotated freely by hand; thumb compressions were observed on all four cylinders
- The bodies and electrodes of the four top spark plugs (NGK- DCPR8E) all were unremarkable
- The engine control unit (ECU) was removed and retained for data download
  - o ECU Rockwell Collins PN ECU-204-102 B SN 12.0412
  - o Rotax PN 665566 00 then (per software update) 665568
- Both composite propeller blades were fracture-separated at their approximate 18 inch span locations
- Propeller blade damage was consistent with power at impact

**Figure 9 - Propeller and Engine Aft left**

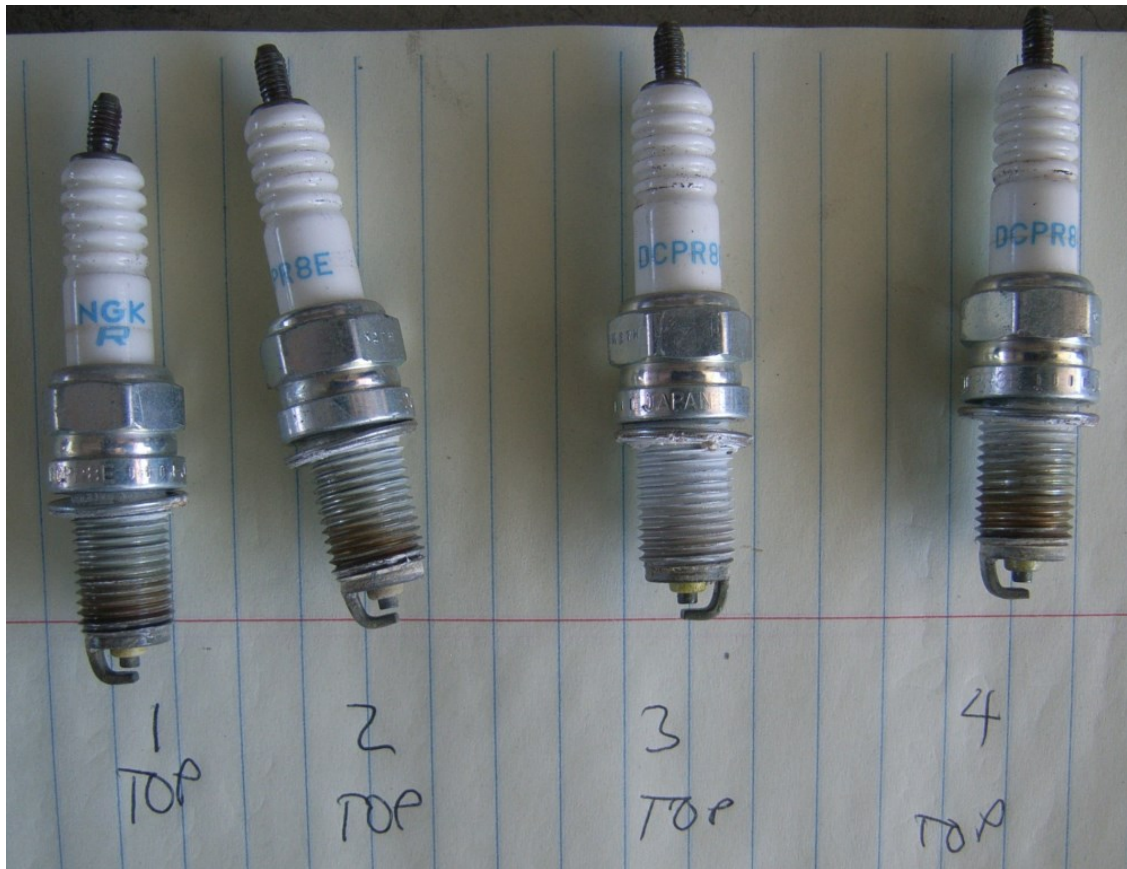
Figure 11 - Top Spark Plugs

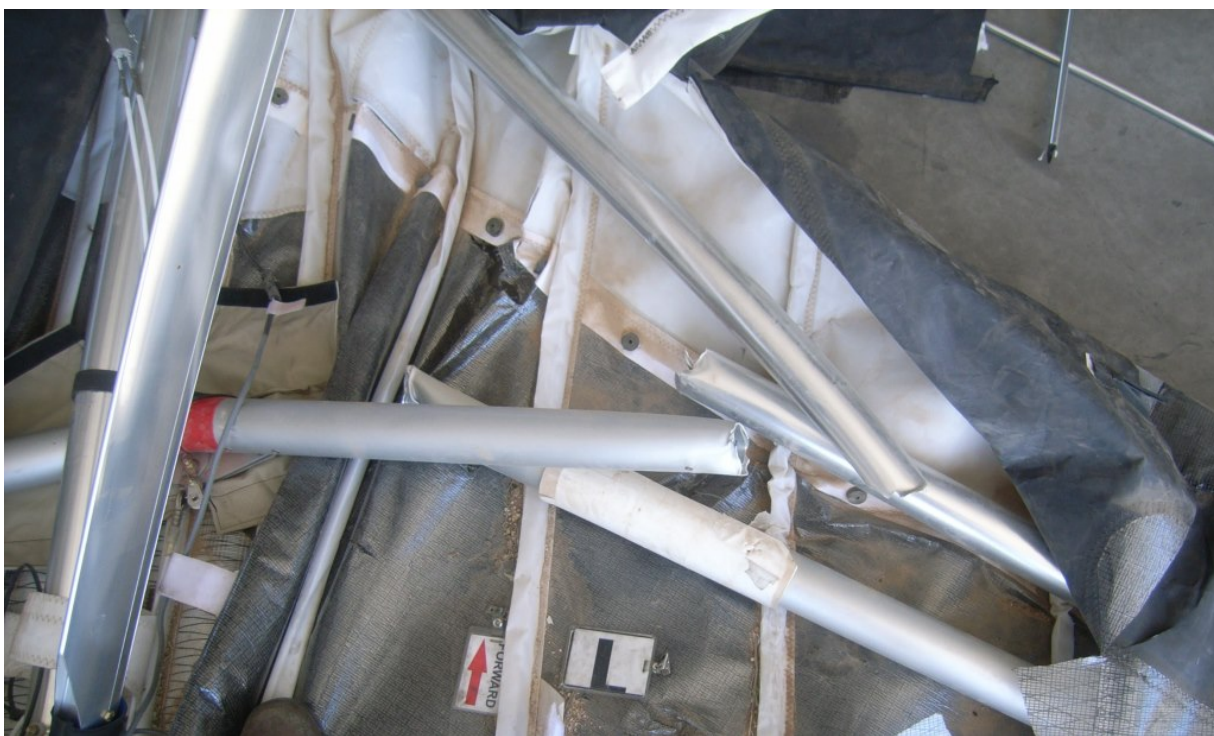
- o The left front spar was fracture-separated at about its 2 foot span location
  - o The right front spar was fracture-separated about 5 feet inboard of the tip

**Figure 14 - Fractured Left Spars**

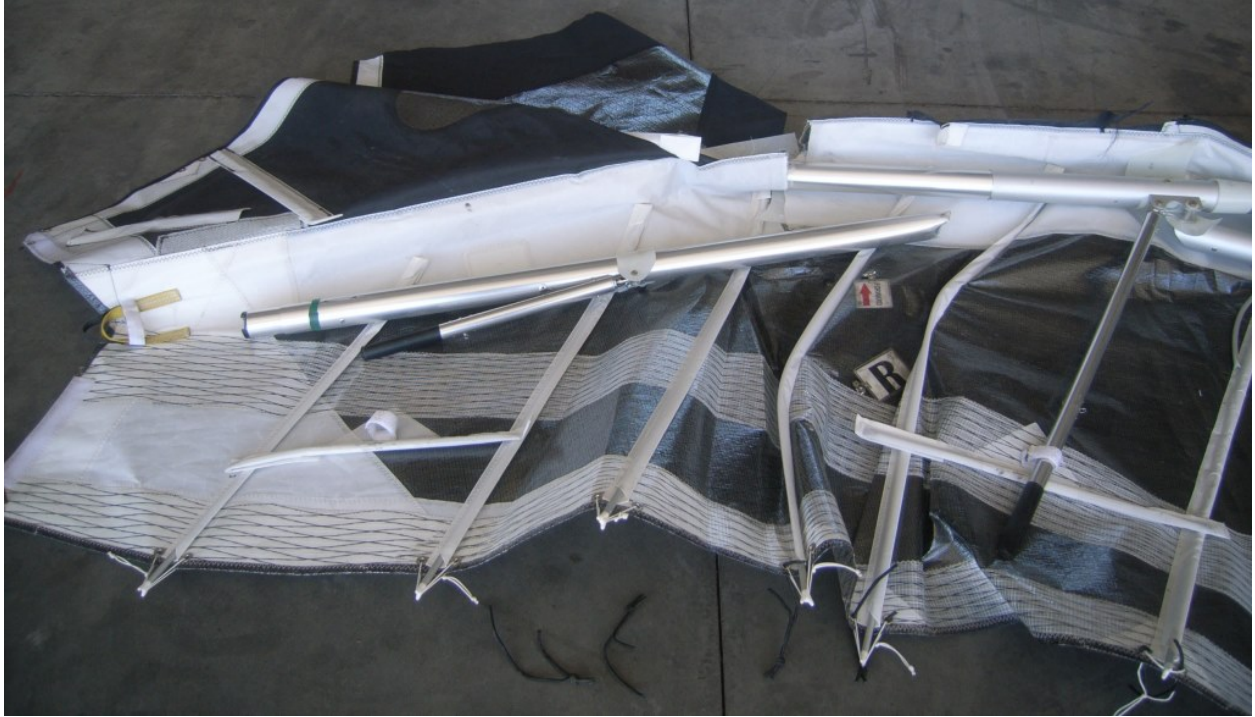
**Figure 15 - Fractured Right Spar**

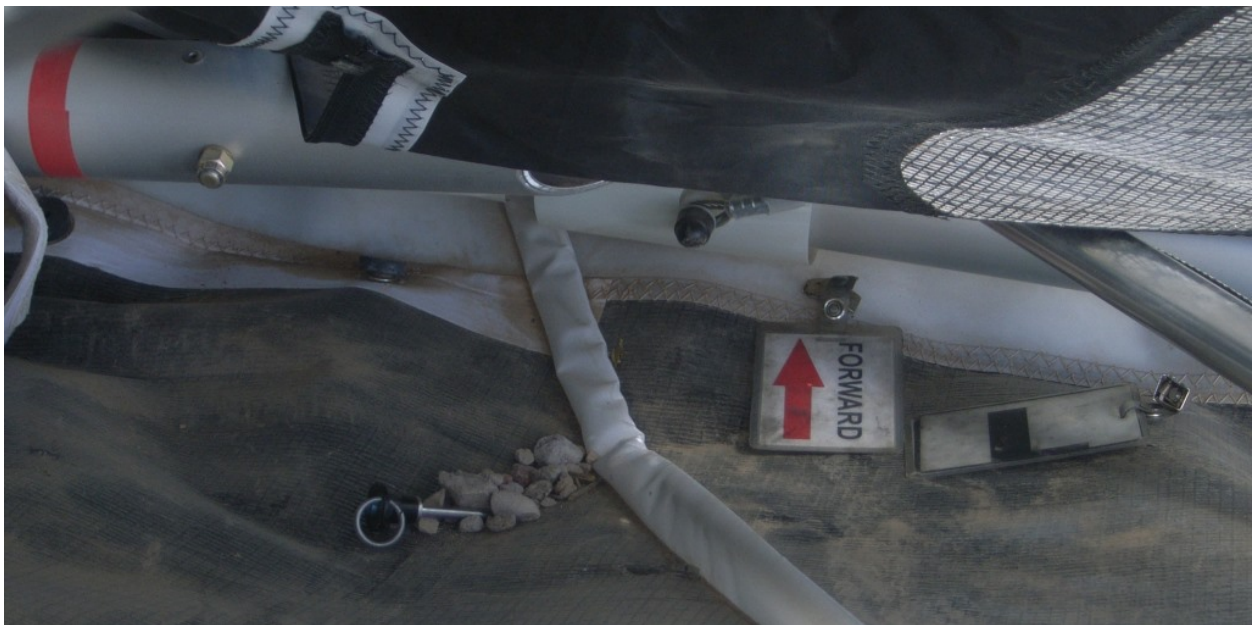
- The auxiliary/jury spar aft of the main spar was also fracture separated
- The wing cloth was intact excluding impact damage
- An unidentified/unassigned quick-release pin was found inside the left wing

**Figure 16 - Quick Release Pin in As-Found Location**

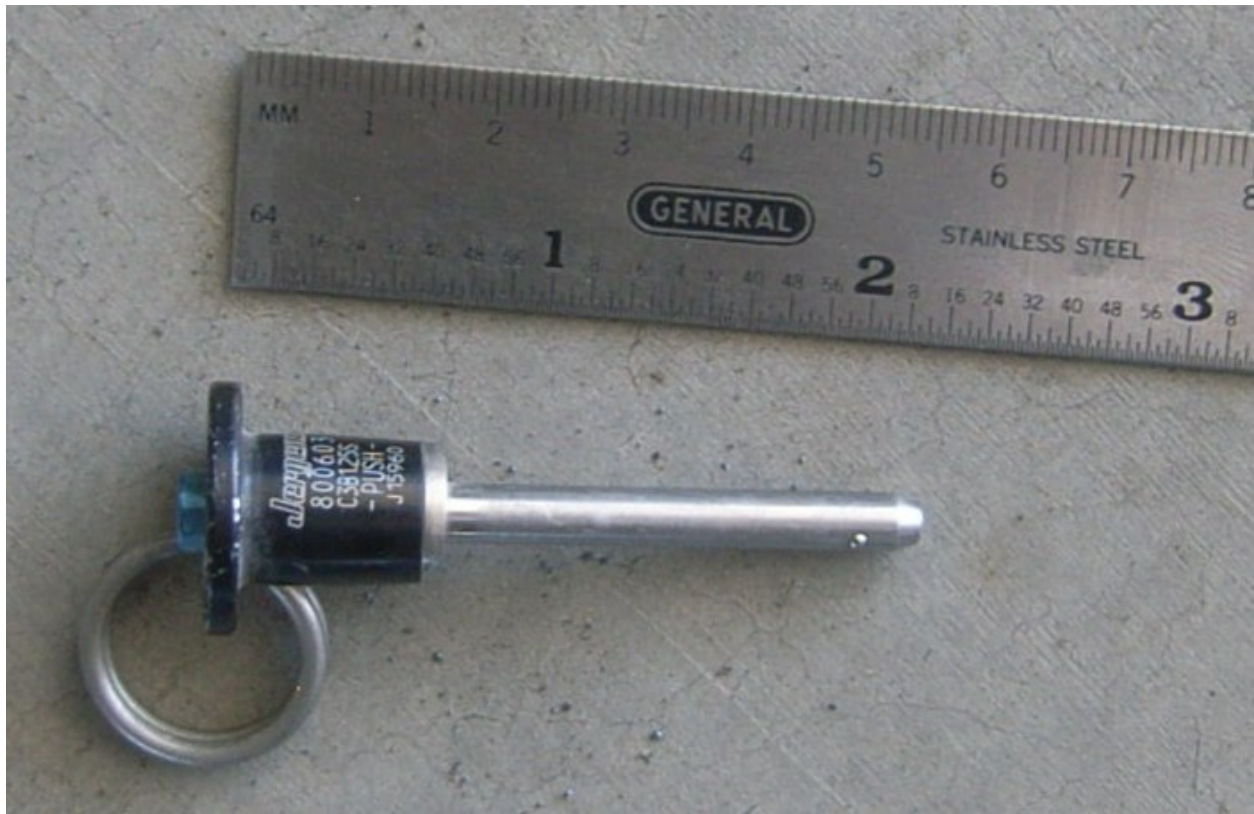
- o The pin bore the following markings  
Jergens  
800603  
C3B1.25S  
-PUSH-  
J 15960
  - o No vacant holes for the pin were located
  - o Discussions with the aircraft manufacturer did not enable determination of the pin's origin

**Figure 17 - Unassociated Quick Release Pin**

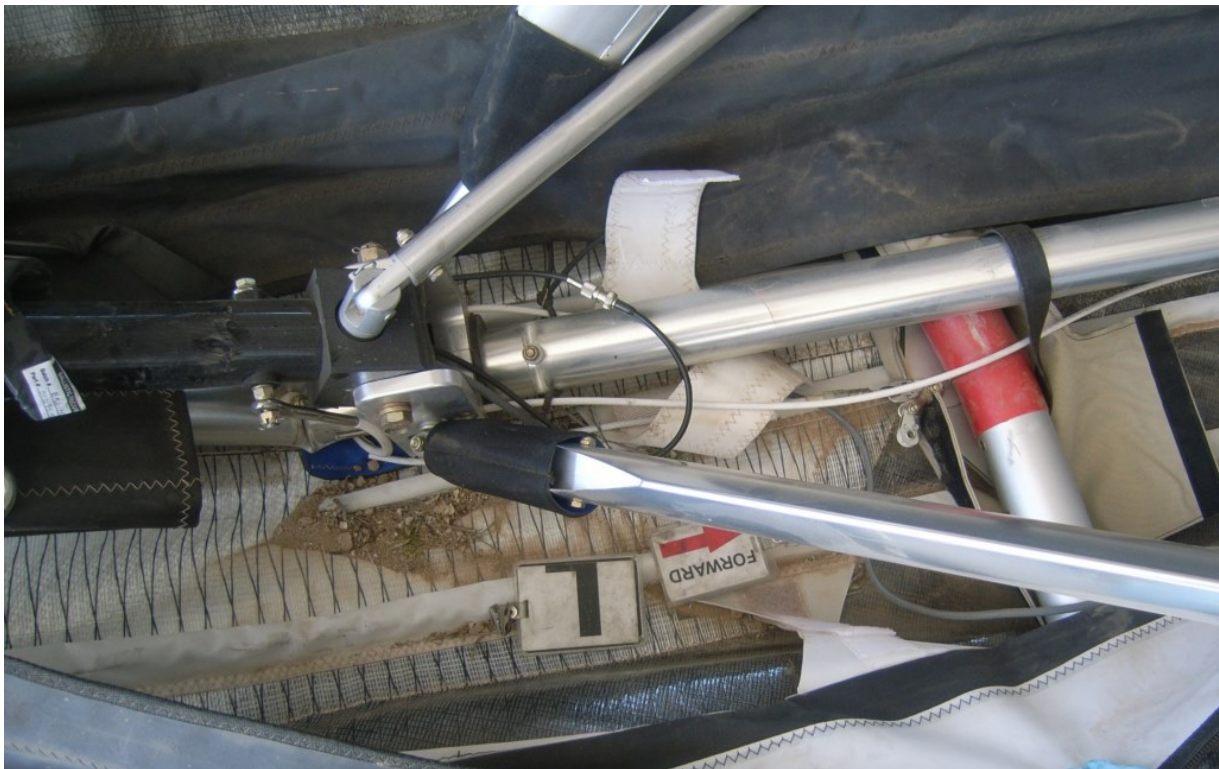
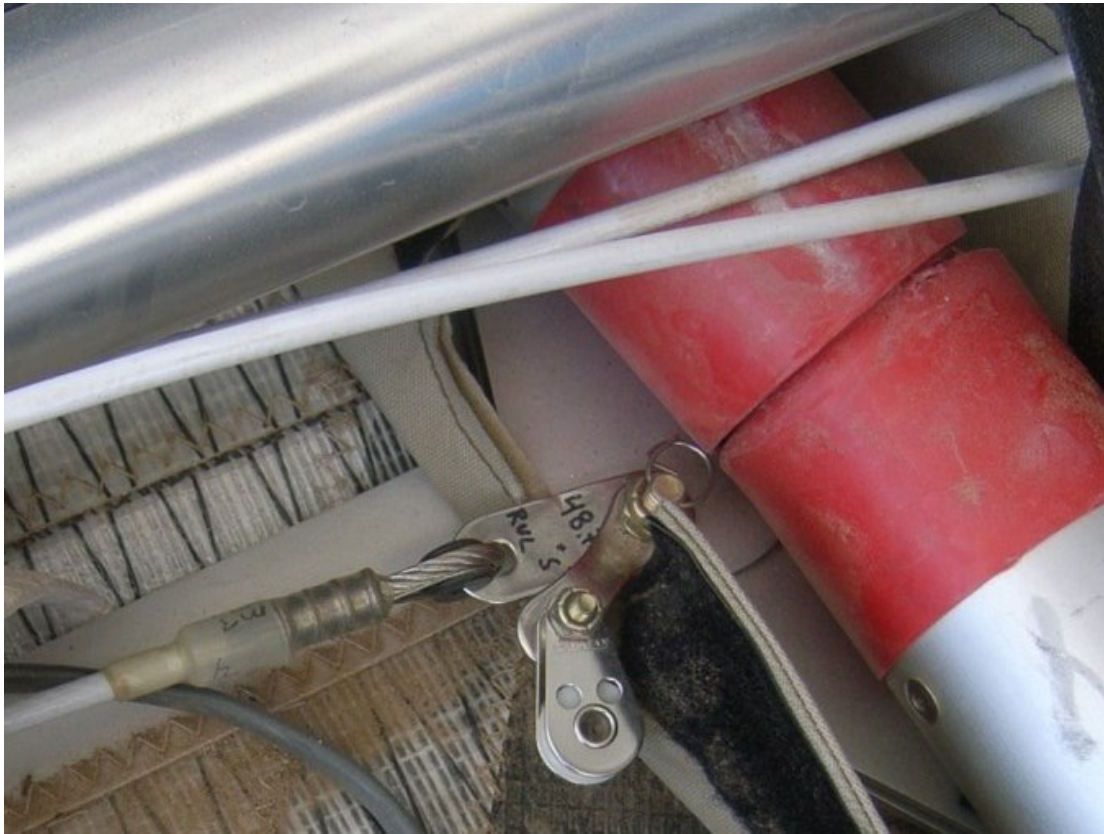
- A small attached but unused pulley was found inside the center wing
  - o The aircraft manufacturer advised that the pulley was used to provide mechanical advantage for initial wing setup, and that once the wing was set up, the pulley was no longer needed, but remained attached to the wing structure.

**Figure 18 - Unused Pulley**

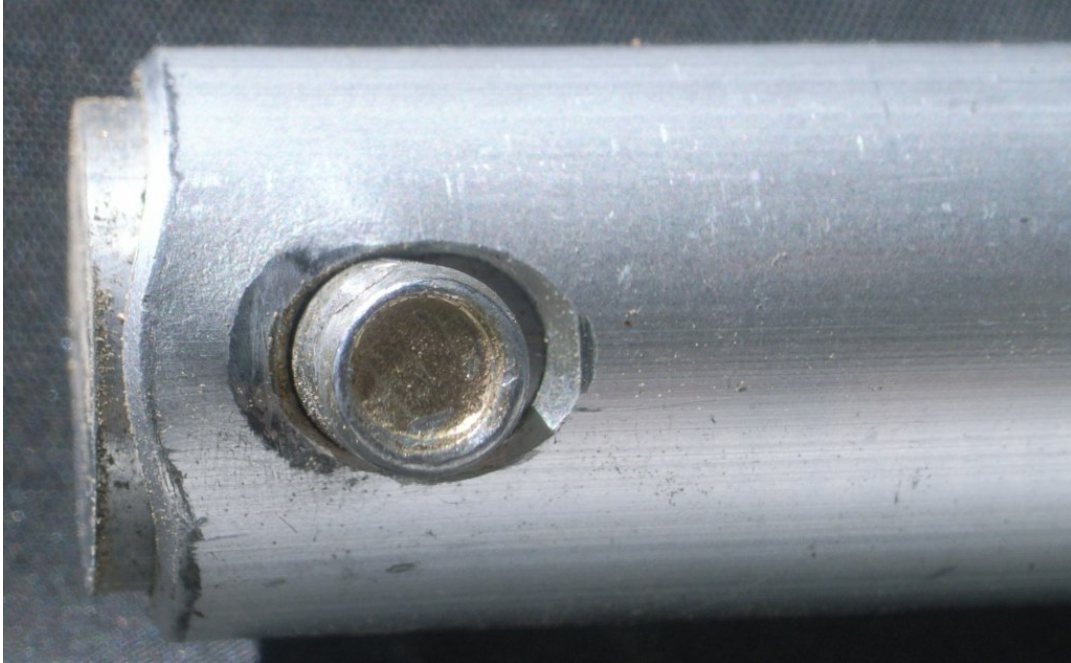
- o Fore-aft elongation of quick release pin hole in the aluminum tube was also consistent with a significant fore-aft separation load of the trim mechanism; this was not consistent with normal system capability, and was attributed to impact loads and structural deformation

**Figure 21 - Elongated Hole in Pitch Trim Actuator**

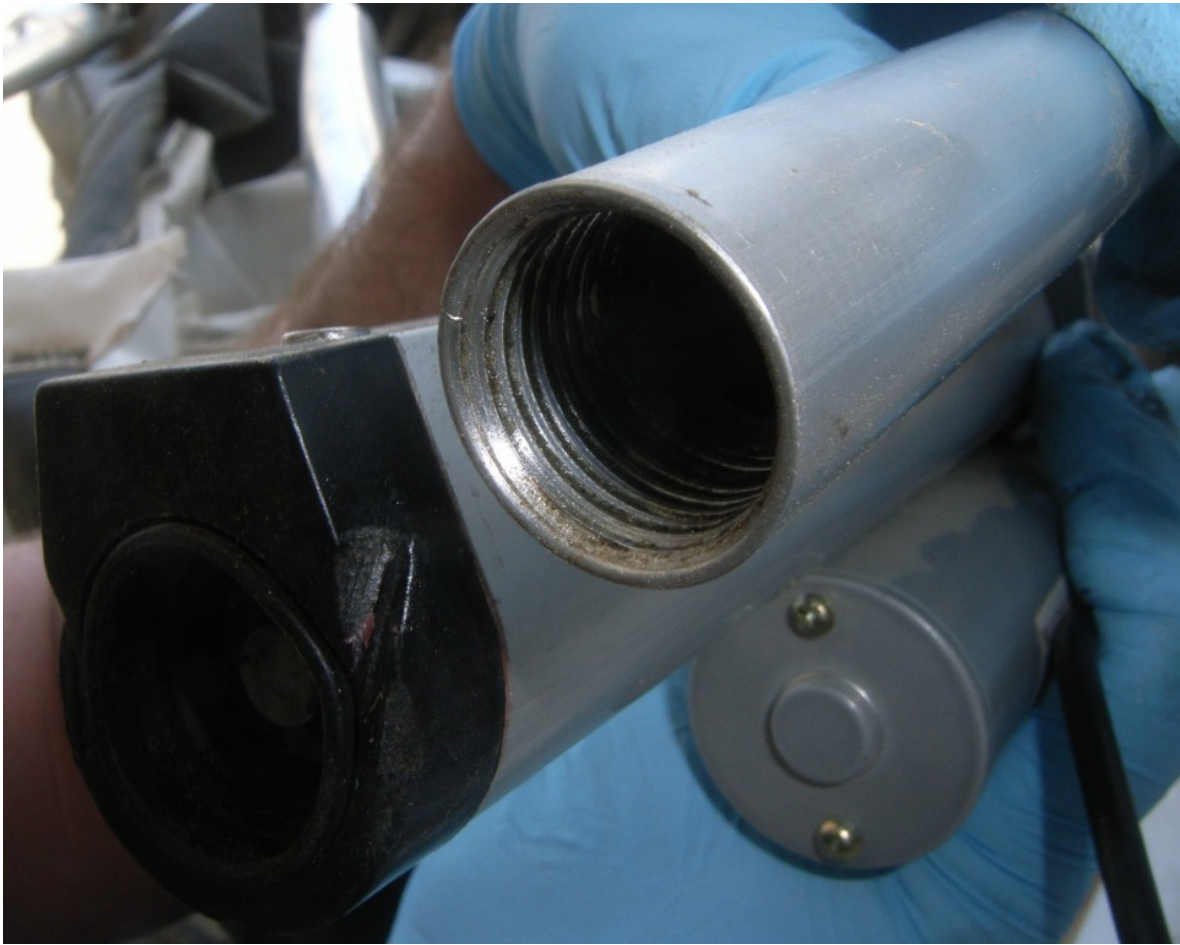
- The aft actuating tube assembly of the pitch trim mechanism was fracture-separated from the travel block of the main housing jackscrew
  - o On disassembly and inspection, it was revealed that the threads of the aluminum actuating tube had pulled aft over the jackscrew nylon travel block threads

Figure 23 - Separated Actuator Tube (pitch trim)

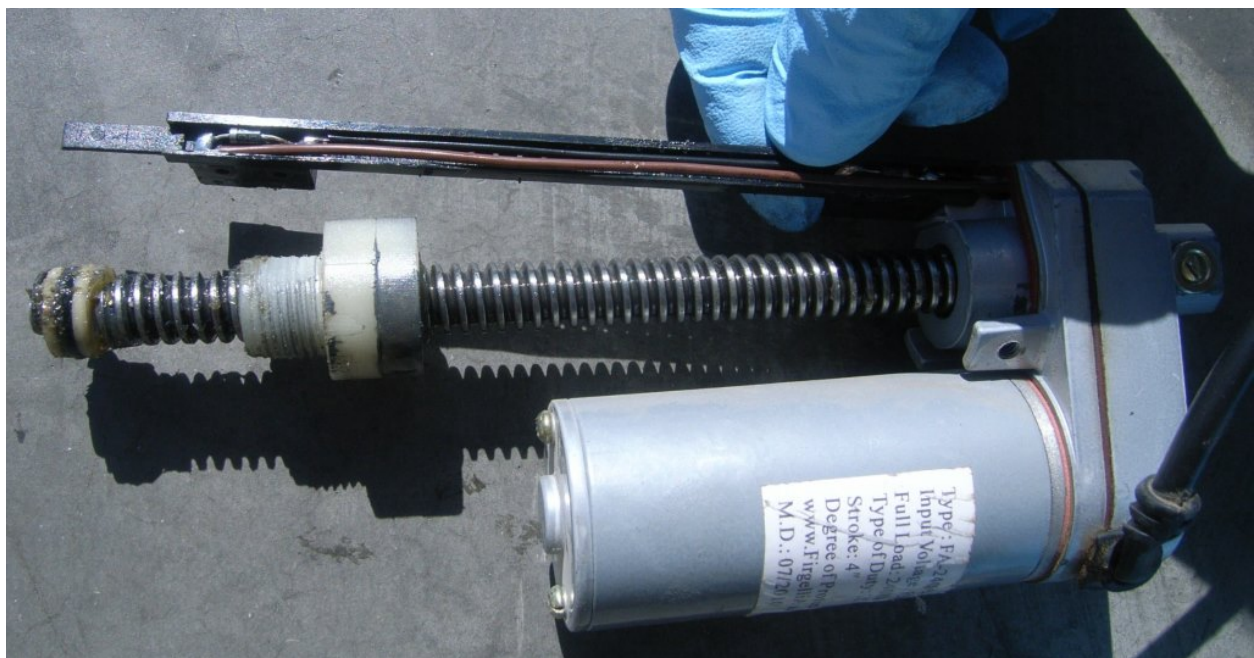
- The aircraft manufacturer stated that based on the position of the jackscrew travel block, the trim was set close to the slowest speed of the aircraft. He also stated that that trim setting was acceptable for takeoff.

Figure 24 - Pitch Trim Jackscrew Assembly

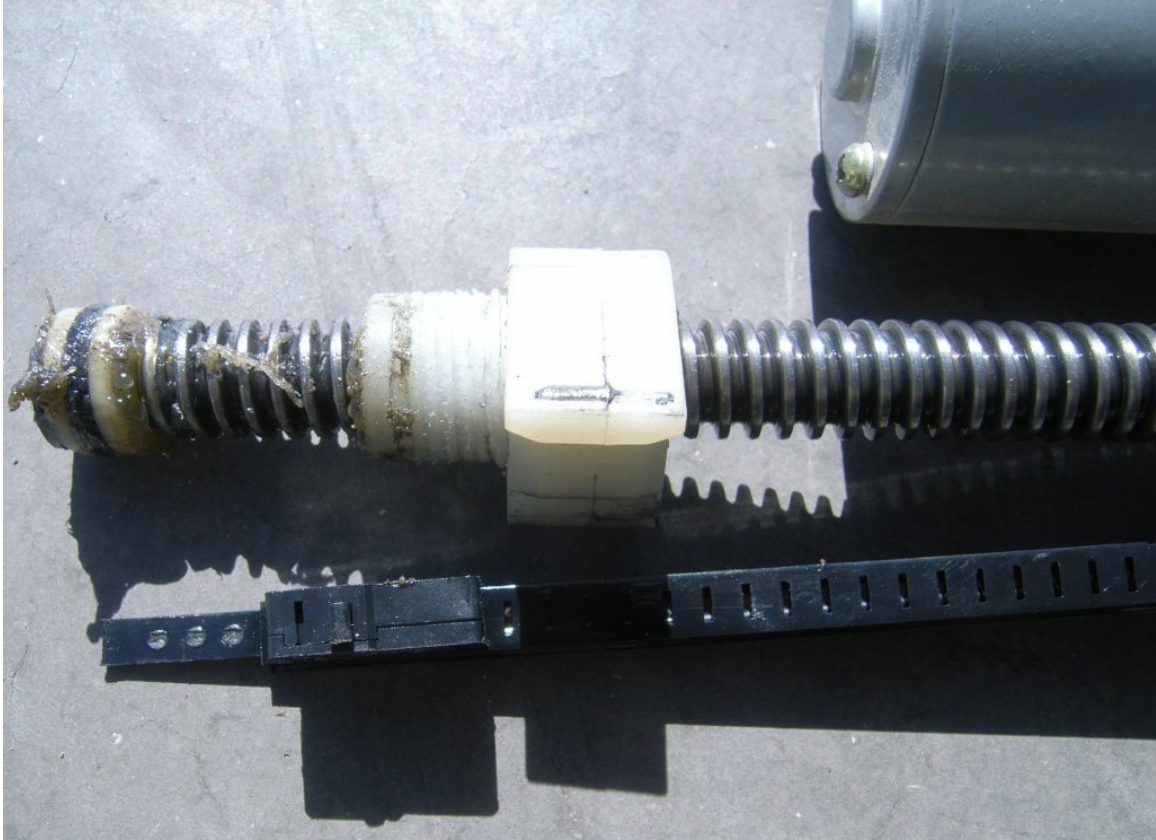
**Figure 25 - Nylon Travel Block of Pitch Trim (note stripped threads)**
