# **NATIONAL TRANSPORTATION SAFETY BOARD**

## **AIRFRAME AND ENGINE EXAMINATION**

**NTSB Accident: WPR16LA093  
Accident Date: April 17, 2016**

Location: Avalon, CA  
Date: April 17, 2016  
Aircraft: Cessna 172K, N7133G, Serial # 17258833  
NTSB IIC: Michael Huhn

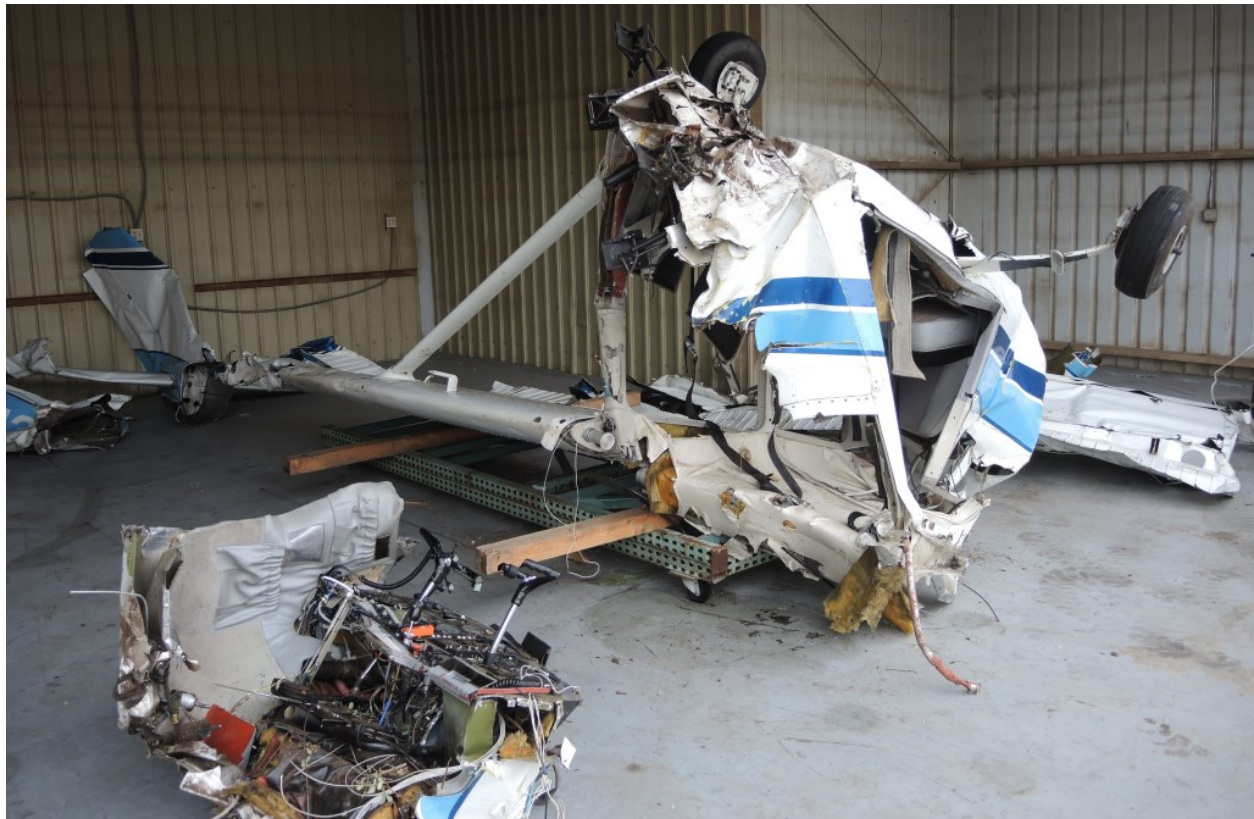
Figure 1 - Wreckage Overview

The right wing and the engine had almost completely fracture-separated from the airplane during the impact sequence. Those components were physically cut from the airplane by recovery personnel to enable recovery and transport.

The cabin structure retained most of its original occupiable volume, with the exception of the two footwells. The primary cabin impact damage and deformation was consistent with impact loads applied from the lower forward right side. Additional damage, particularly to the aft fuselage and empennage, was consistent with the airplane tumbling and/or sliding down the steep slope at the accident site. Recovery personnel and photographic evidence indicated that the airplane impacted steeply rising terrains, travelled forward/upward for about 30-50 feet, and then slid/tumbled downhill about 100 feet

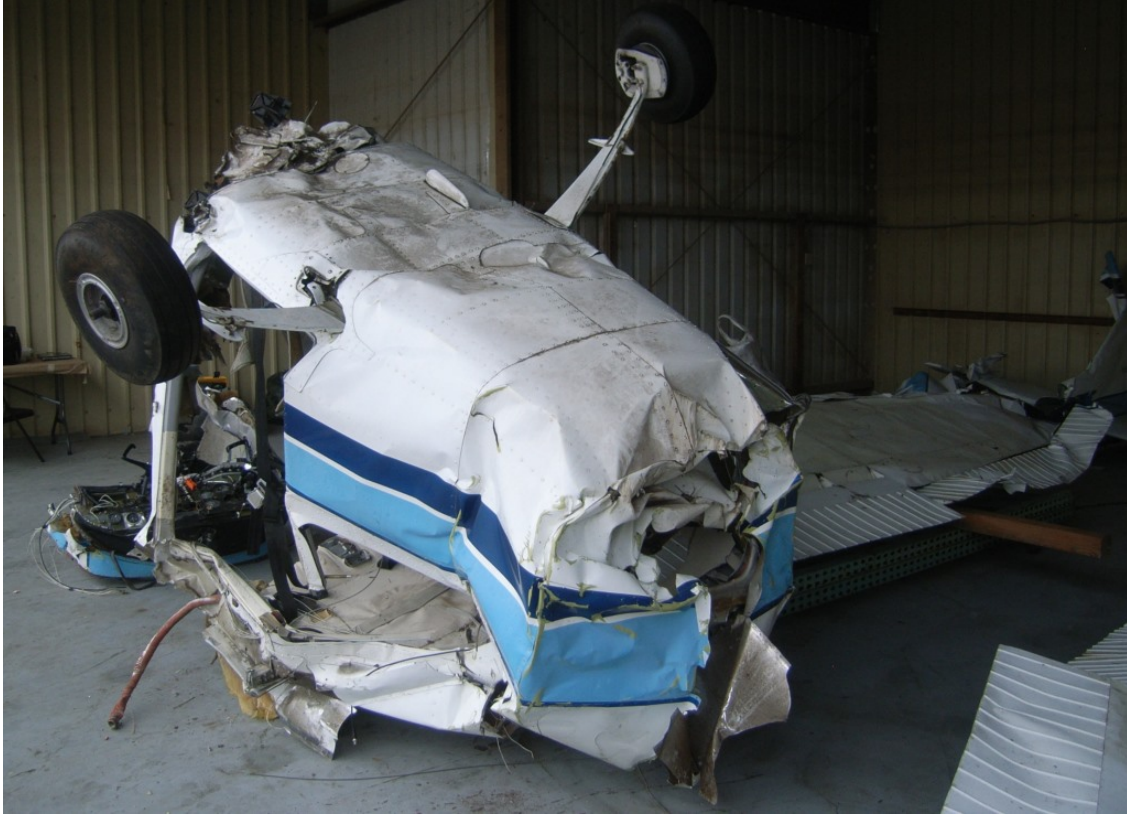
**Figure 3 - Aft Right (note forward crushing of fuselage)**

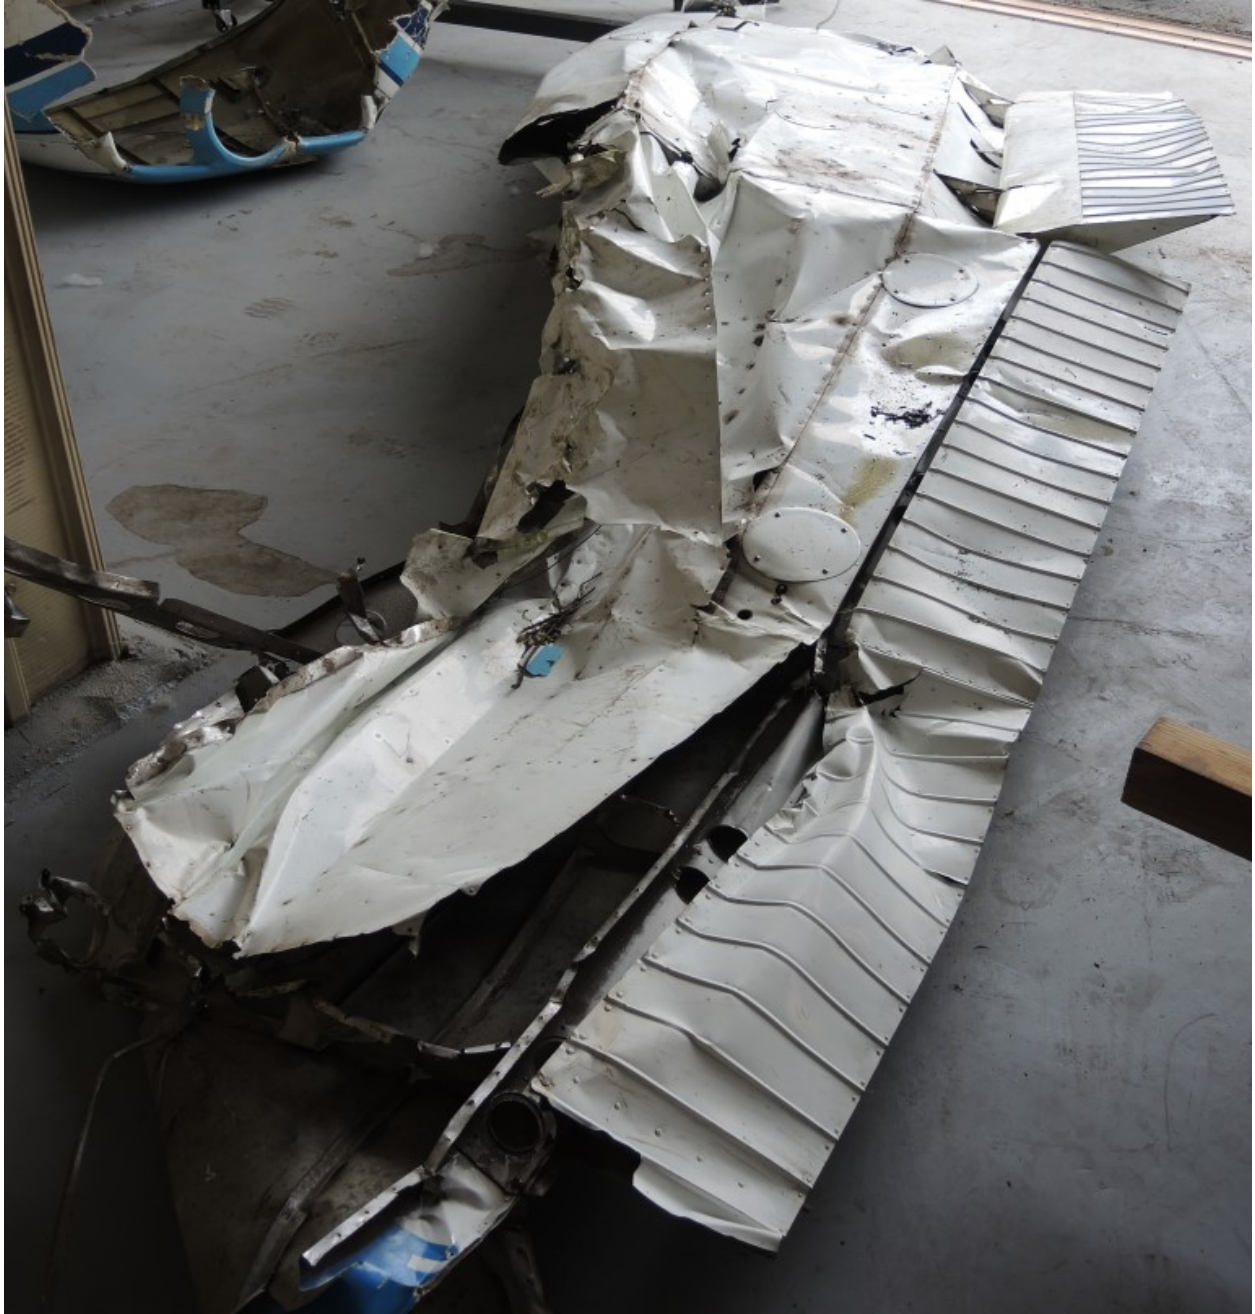
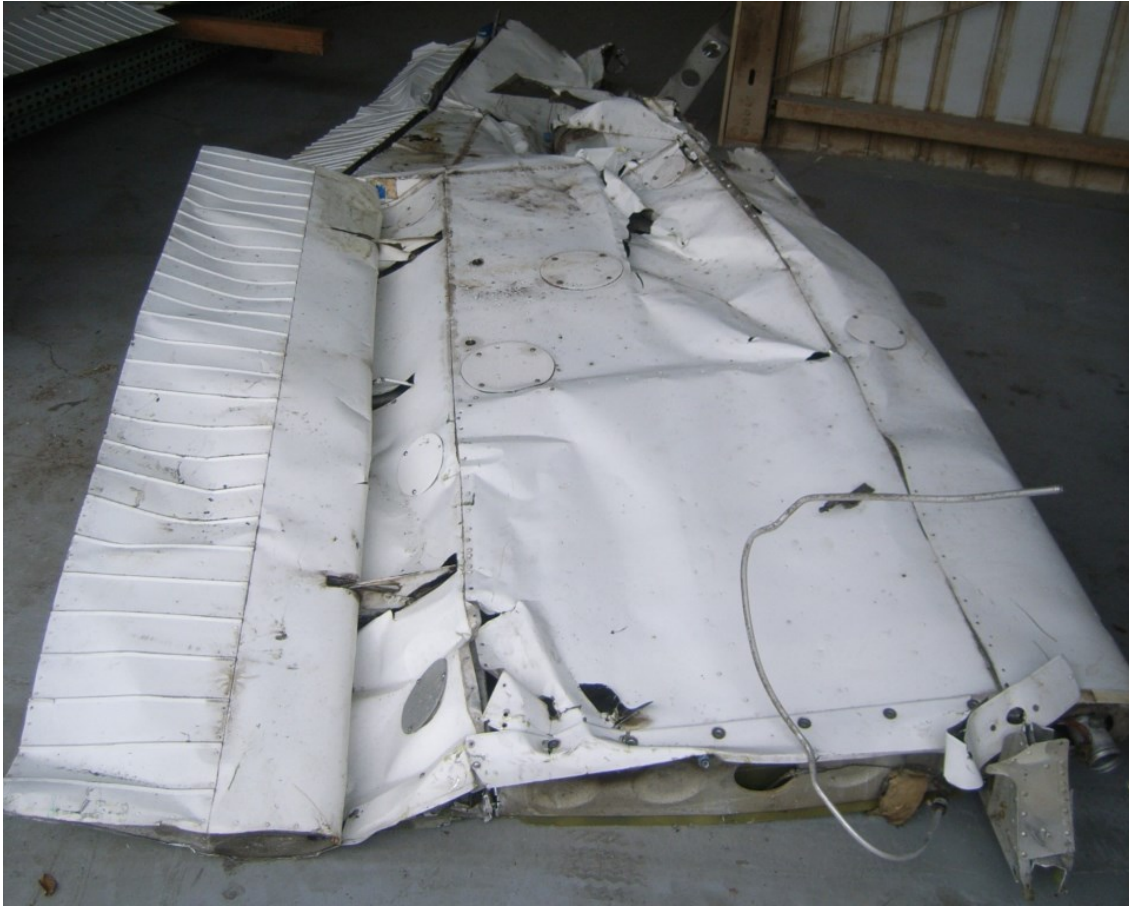
**Figure 7 - Right Wing**

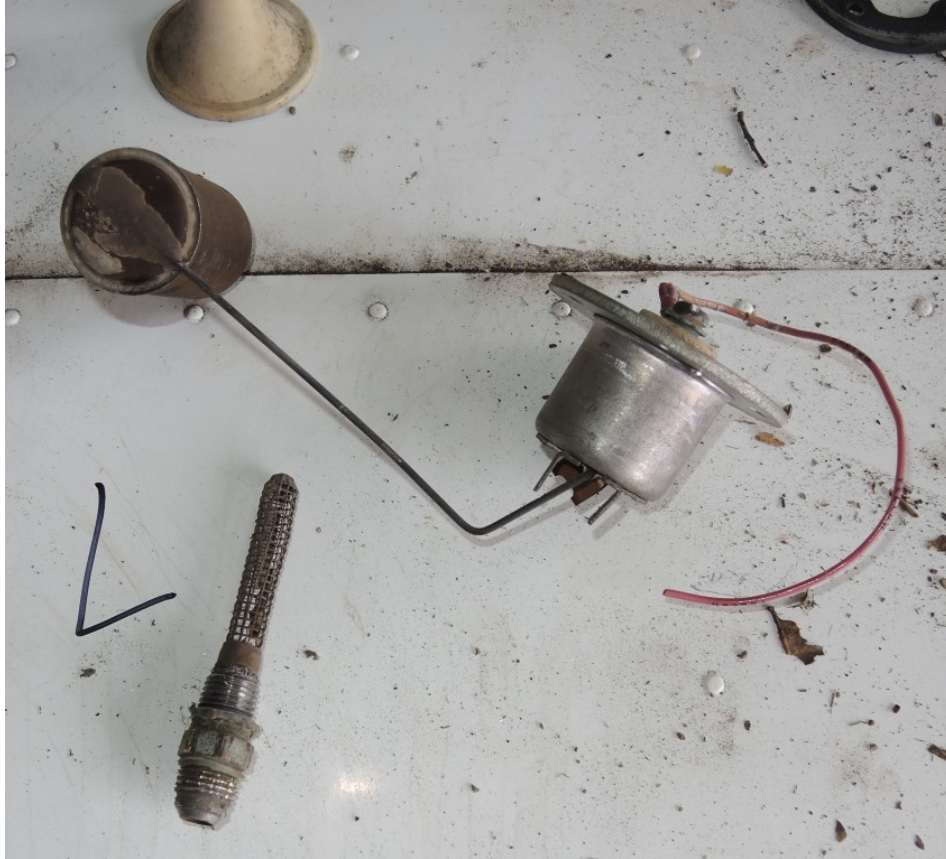
The airplane was equipped with two metal tanks, one per wing. At the time of this examination, both tanks were devoid of fuel. The left tank was intact, with no penetrations. The cap was securely installed. The single finger screen was removed, and found to be clear and unobstructed. The aft end of the right tank was crushed forward, with the possibility of a breached tank, but that was not definitively determined. There were no other penetrations or possible penetrations of the tank. The cap was securely installed. The single finger screen was removed, and found to be clear and unobstructed.

**Figure 9 - Left Fuel Tank Finger Screen and Float Assembly**

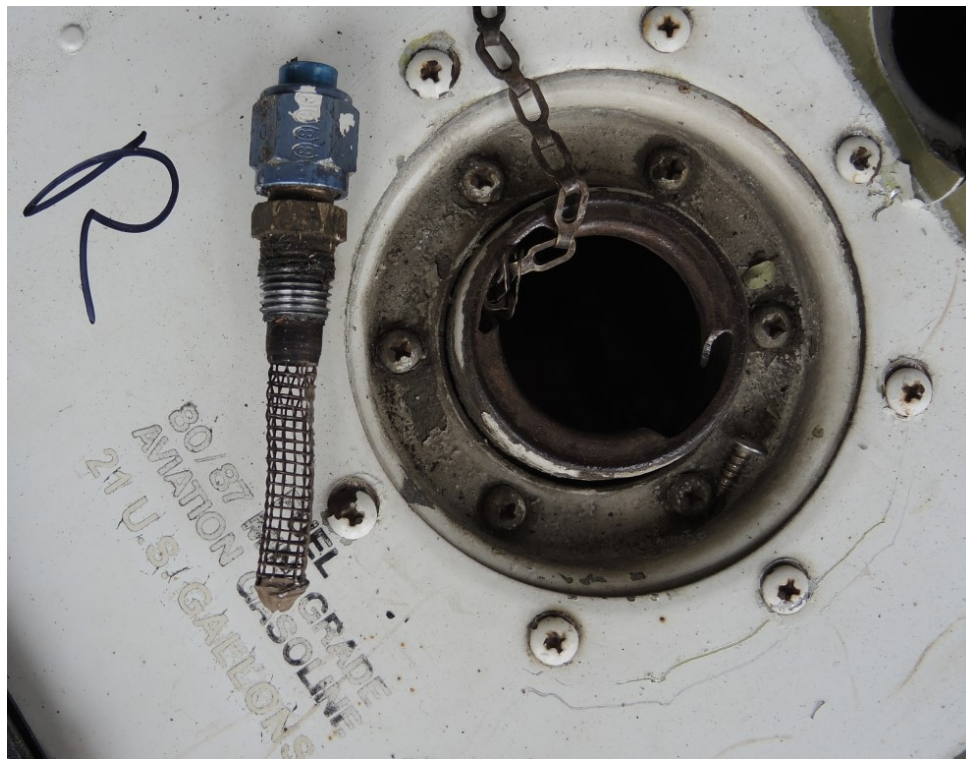
**Figure 10 - Right Fuel Tank Finger Screen and Cap**

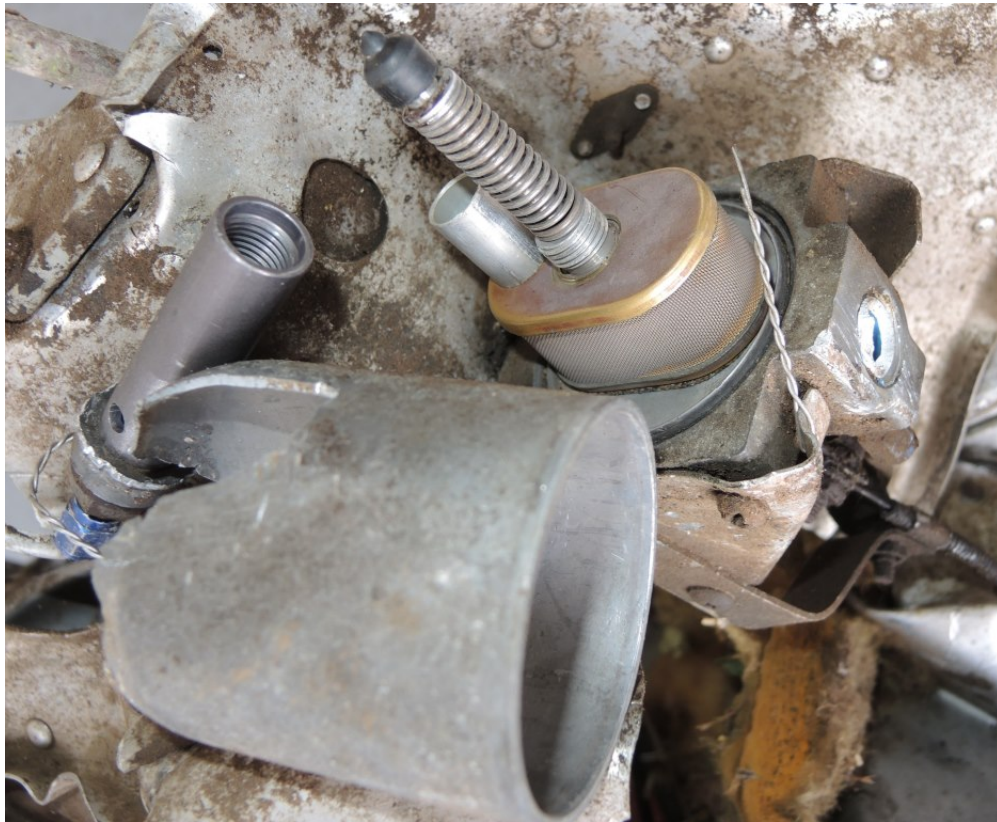
Fuel strainer screen: Clean

**Figure 11 - Fuel Strainer**

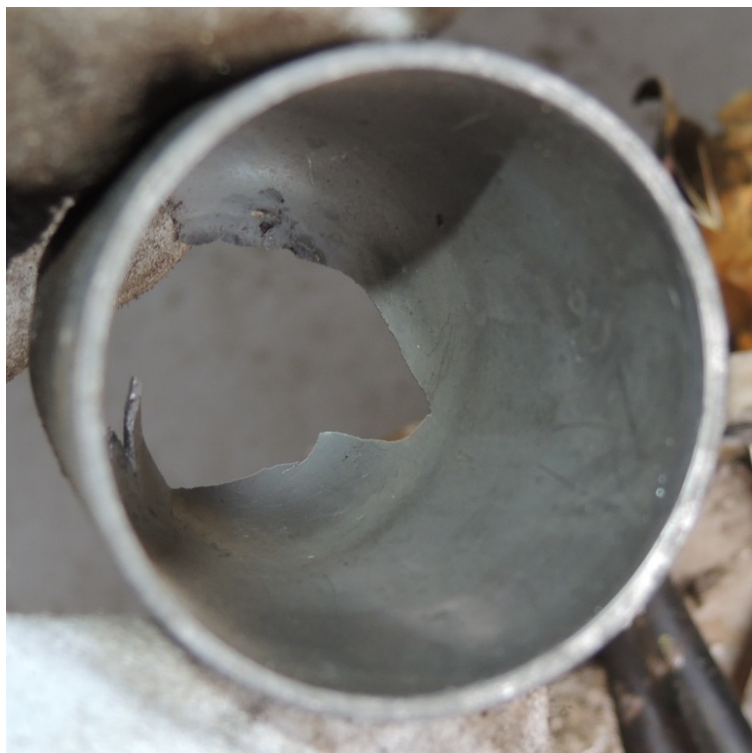
Fuel strainer bowl: Fractured with a small segment absent, devoid of fuel, but clean, with no debris or evidence of corrosion

**Figure 12 - Fuel Strainer Bowl**

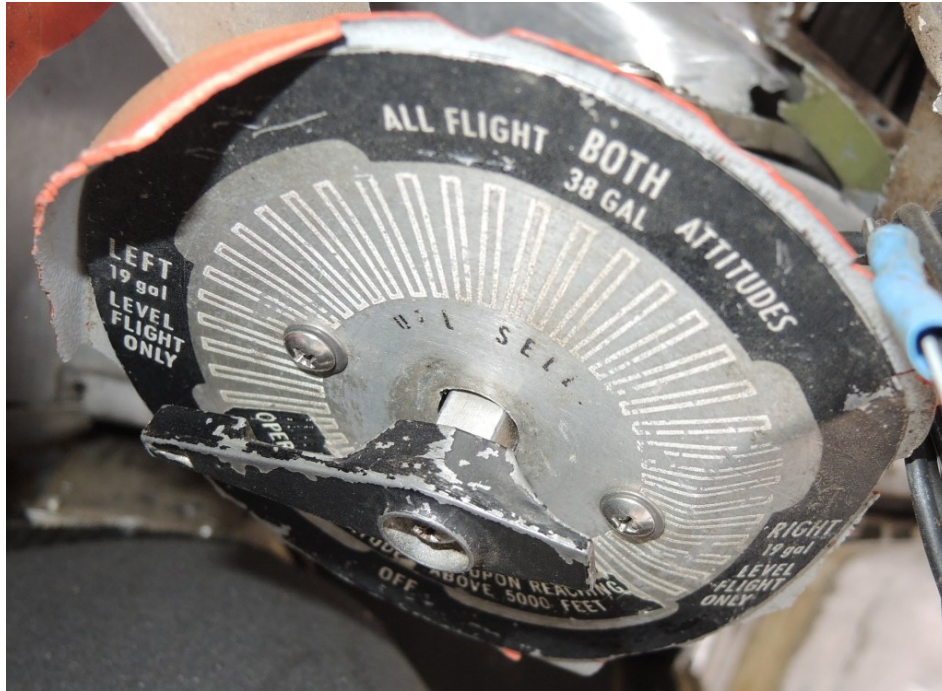
The fuel selector handle had four settings: Left, Right, Both, and Off. The fuel selector handle remained connected to the fuel selector valve. Both were found set to the Left fuel tank.

Figure 13 - Cockpit Fuel Selector

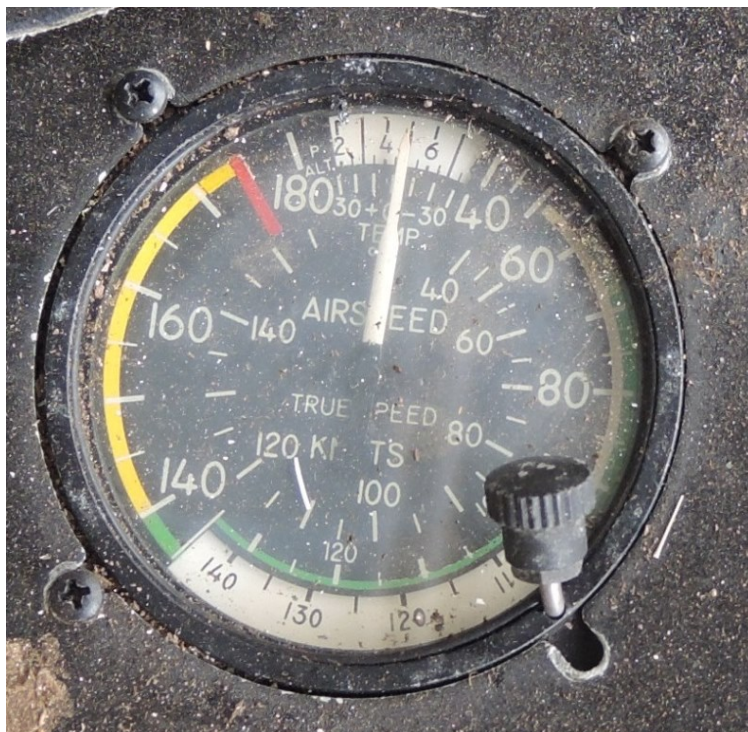
Airspeed: 0 mph (outer scale). NOTE: ASI speed arcs subsequently determined to properly depict ranges/limits.

**Figure 15 - Airspeed Indicator**

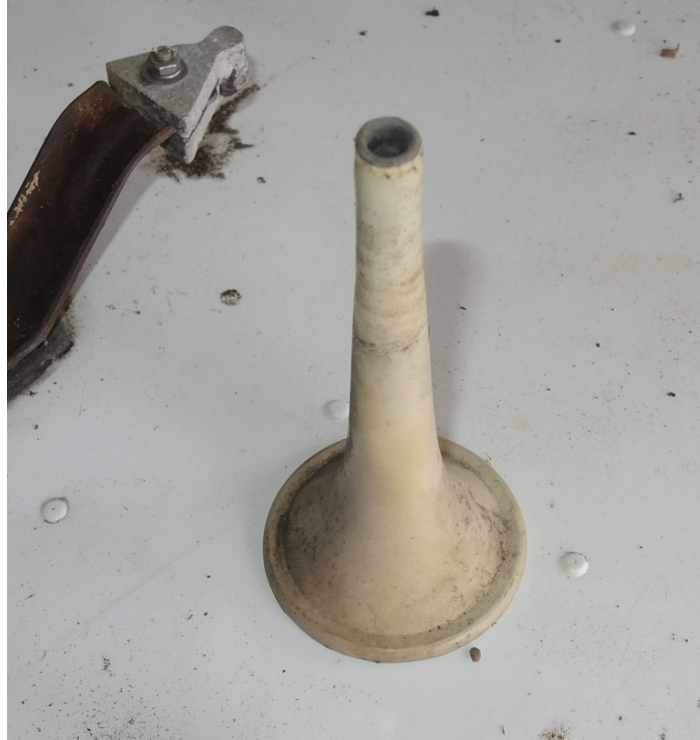
The airplane was equipped with a pneumatically-sensed/activated reed-horn stall warning system. The horn was removed from the airplane and application of low-pressure air resulted in the horn sounding properly.

**Figure 16 - Stall Warning Horn**

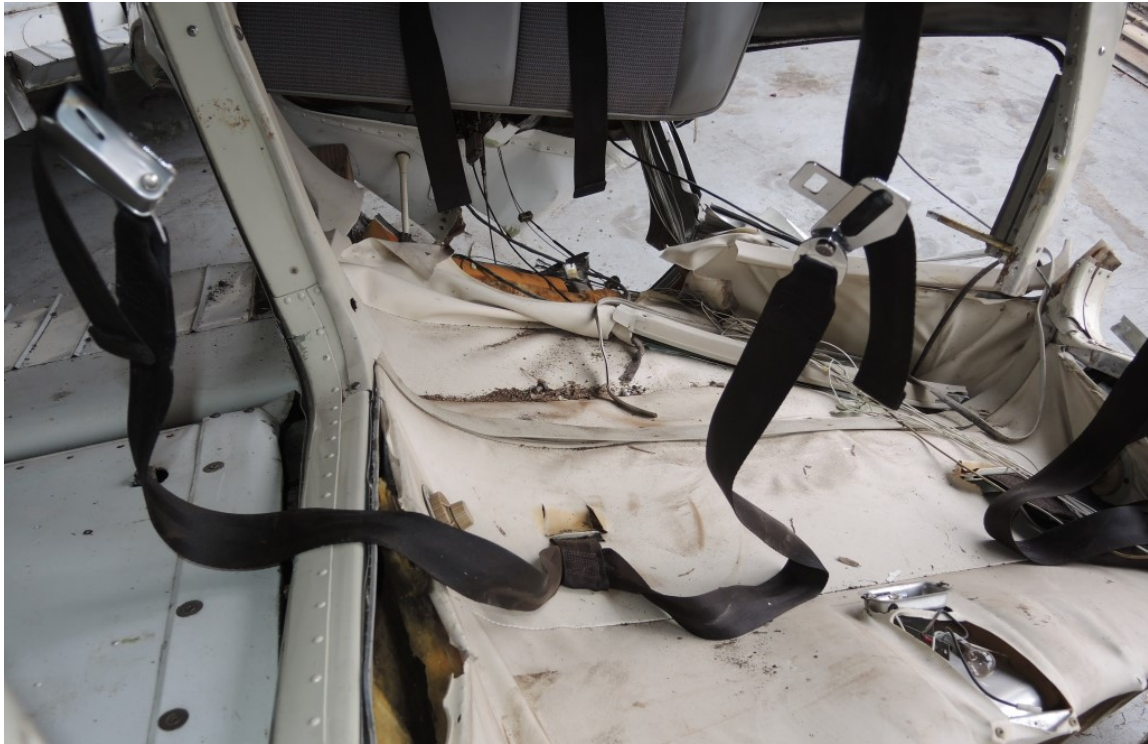
**Figure 19 - Left Front Seat Harness**

The front left seat was equipped with the Cessna reel-type secondary seat stop mechanism, and BAS brand aftermarket single point/dual strap shoulder harnesses. The left seat harness was unbuckled but intact. The right seat harness was buckled but cut, consistent with first responder passenger extraction efforts. The front lap belts were manufactured by AmSafe.

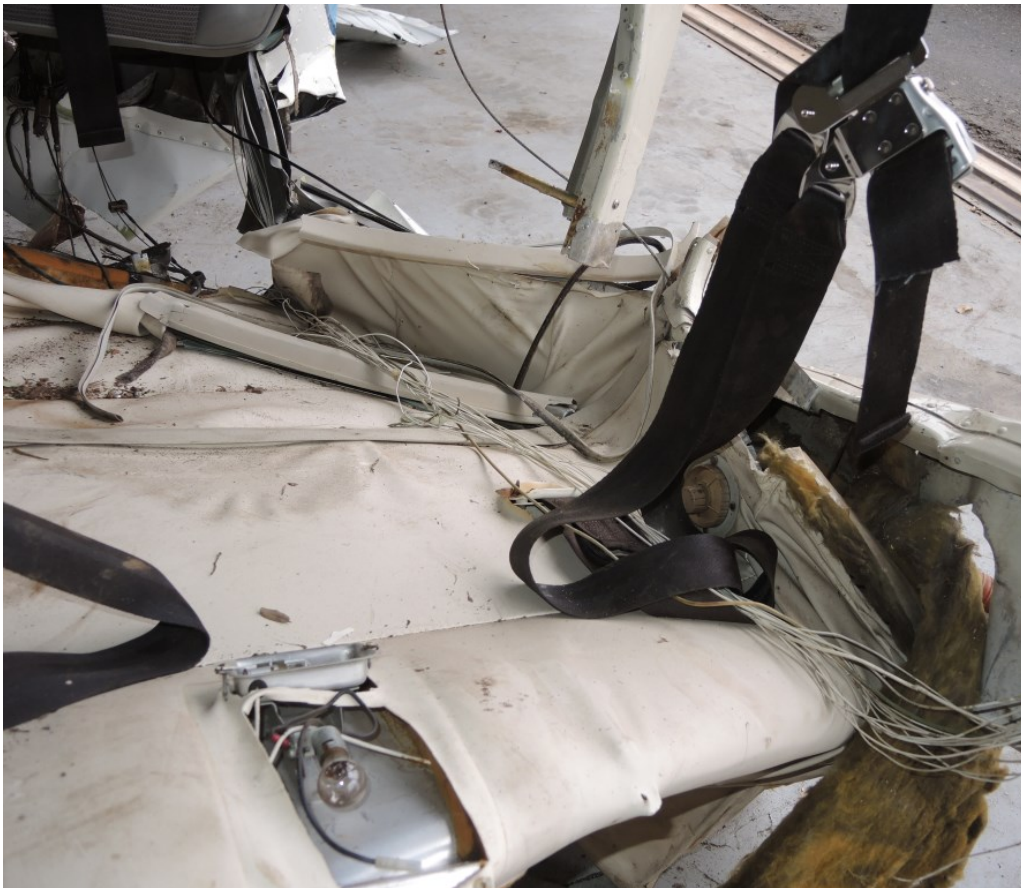
**Figure 20 - Right Front Seat Harness**

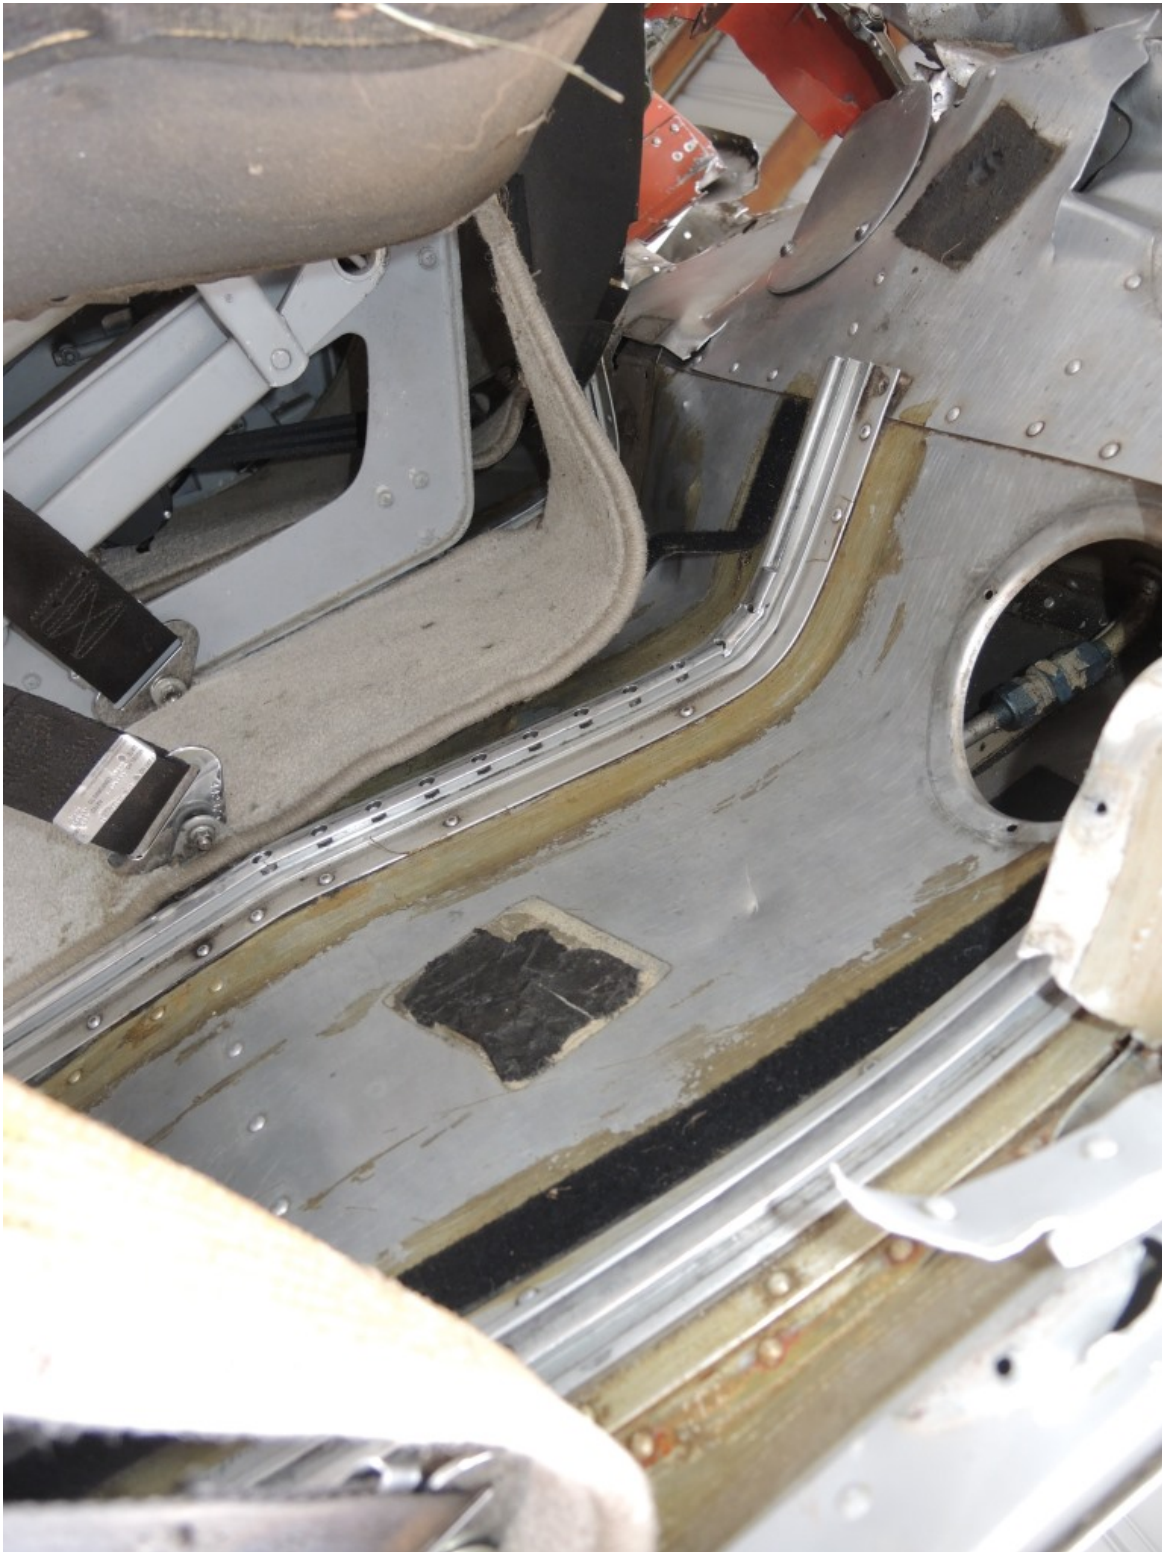
The forward portion of each of the four front seat rails was bent upward. The forward left seat locking pin was outside the rail, and bent forward. The inboard seat back bracket was separated at the hinge point. The outboard feet of the front right seat were partially deformed.

**Figure 22 - Front Seat Rails (Forward is frame right)**

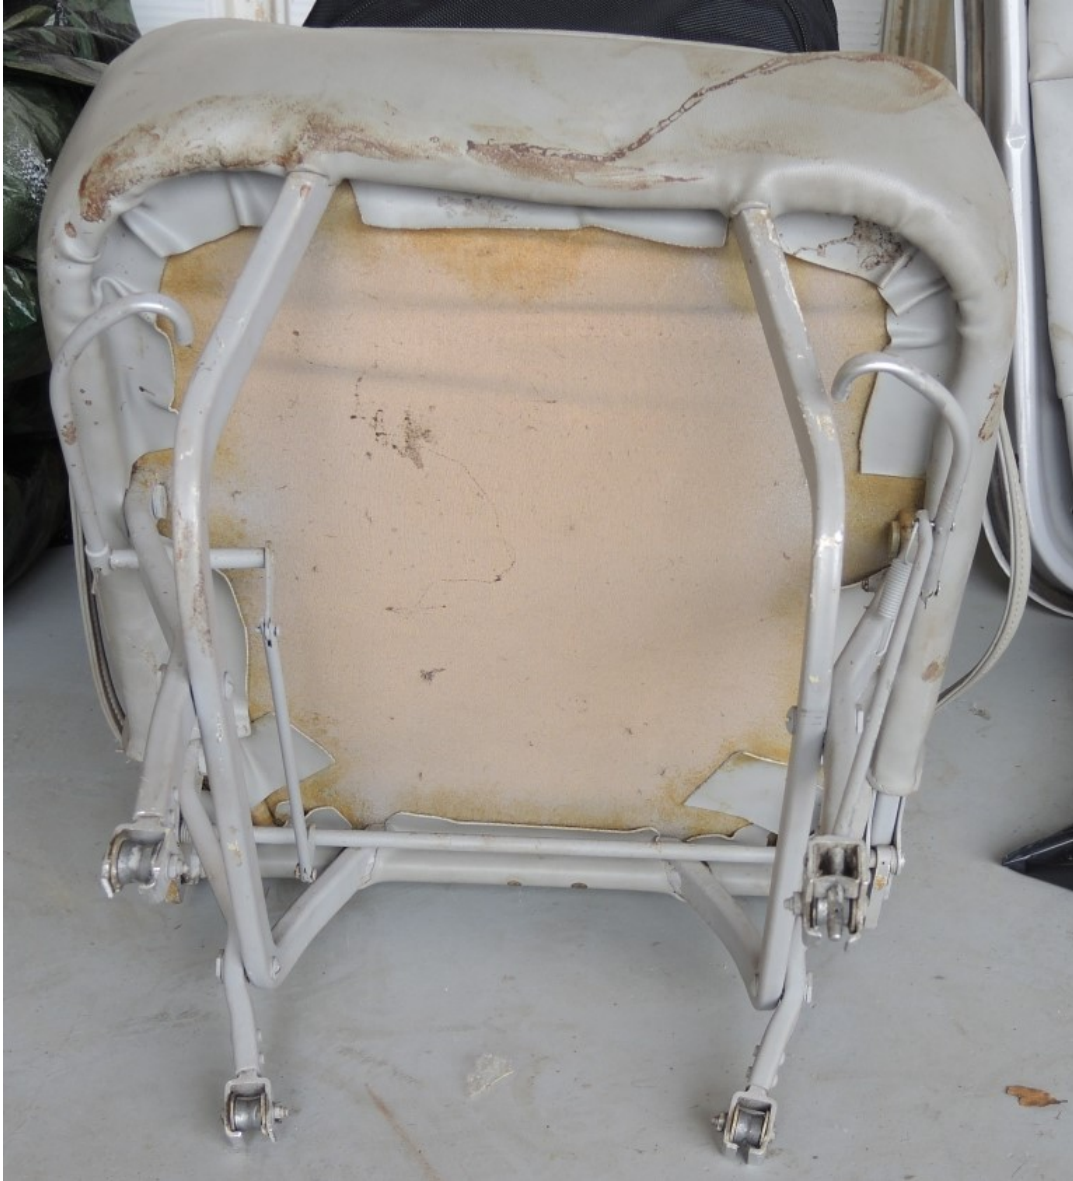
**Figure 23 - Front Right Seat**

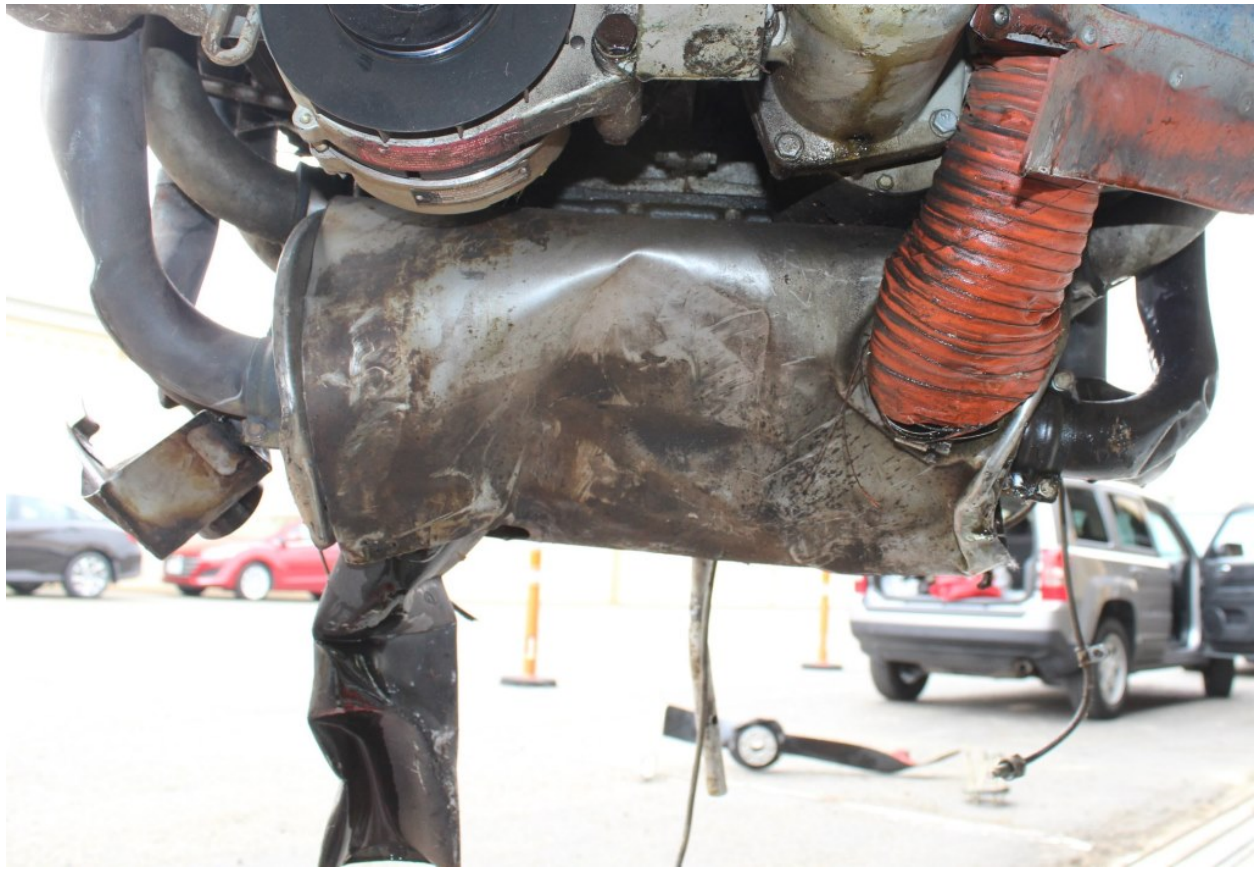
There was significant ductile bending of the exhaust system components. The exhaust system and muffler were found free of obstructions.

**Figure 32 -Exhaust Pipes and Muffler**

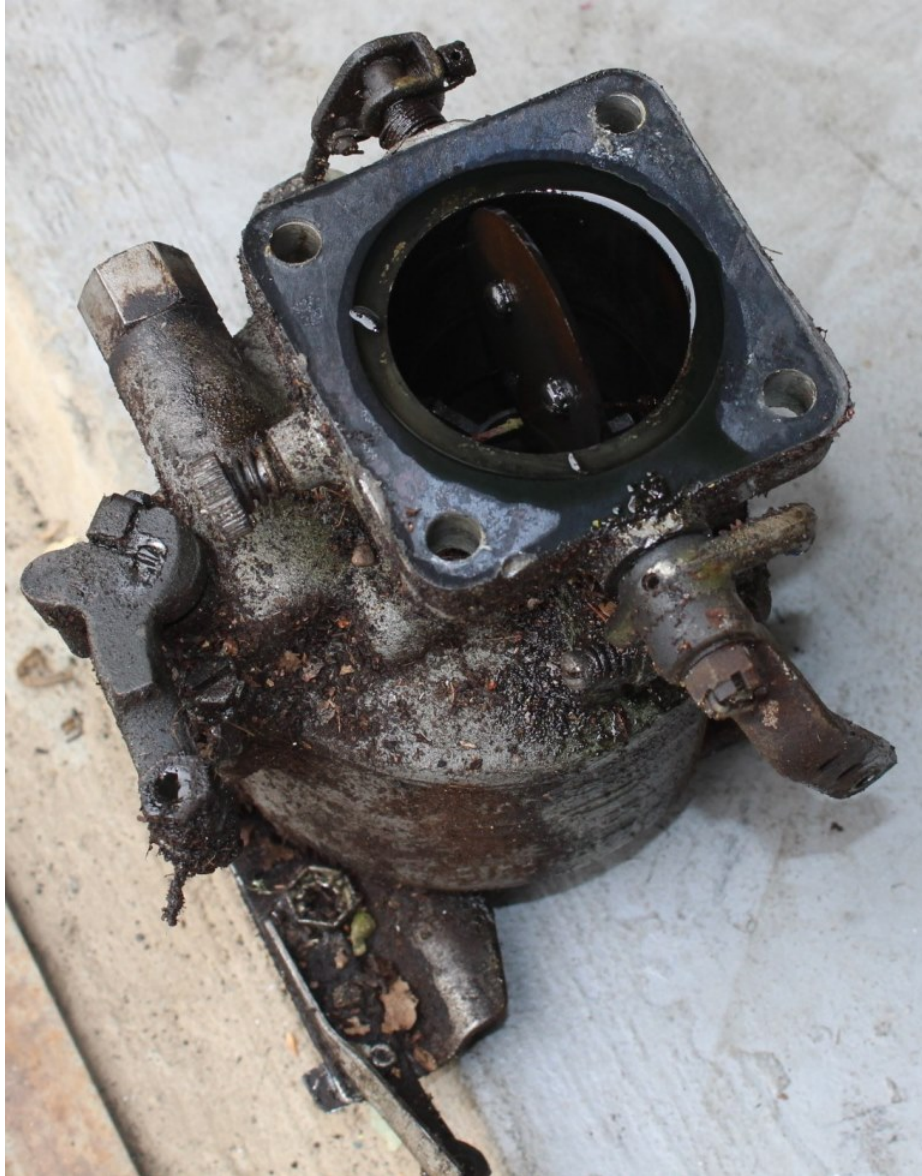
The carburetor was undamaged and remained securely attached at the mounting flange. The throttle and mixture control cables were found securely attached at their respective control arms of the carburetor. The throttle, mixture and carburetor heat cables had been cut by recovery personnel, but were otherwise intact.

**Figure 37 - Carburetor**

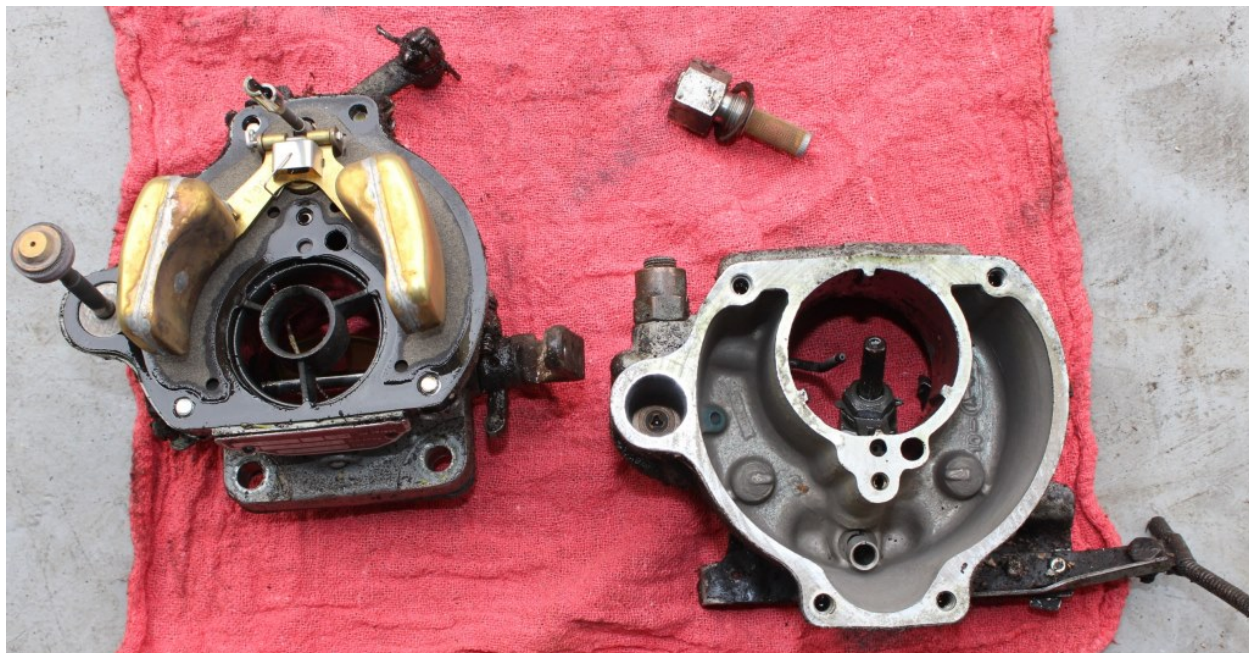
The carburetor was opened for examination. The fuel bowl was free of visible contaminants. The float assembly remained secure at its mount and was free of damage. Neither the bowl nor the float pontoons exhibited any evidence of rubbing against one another. All internal locking tabs and safety devices of the carburetor were in place and properly secured. The fuel inlet screen was found properly installed and free of contamination. No external fuel staining was observed.

**Figure 40 - Carburetor Bowl and Floats**

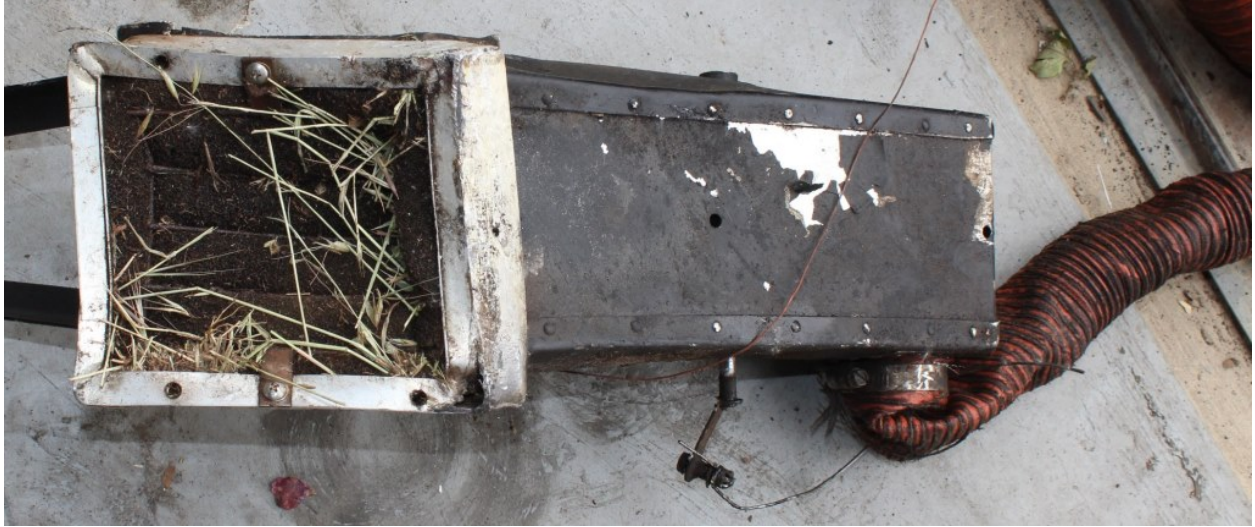
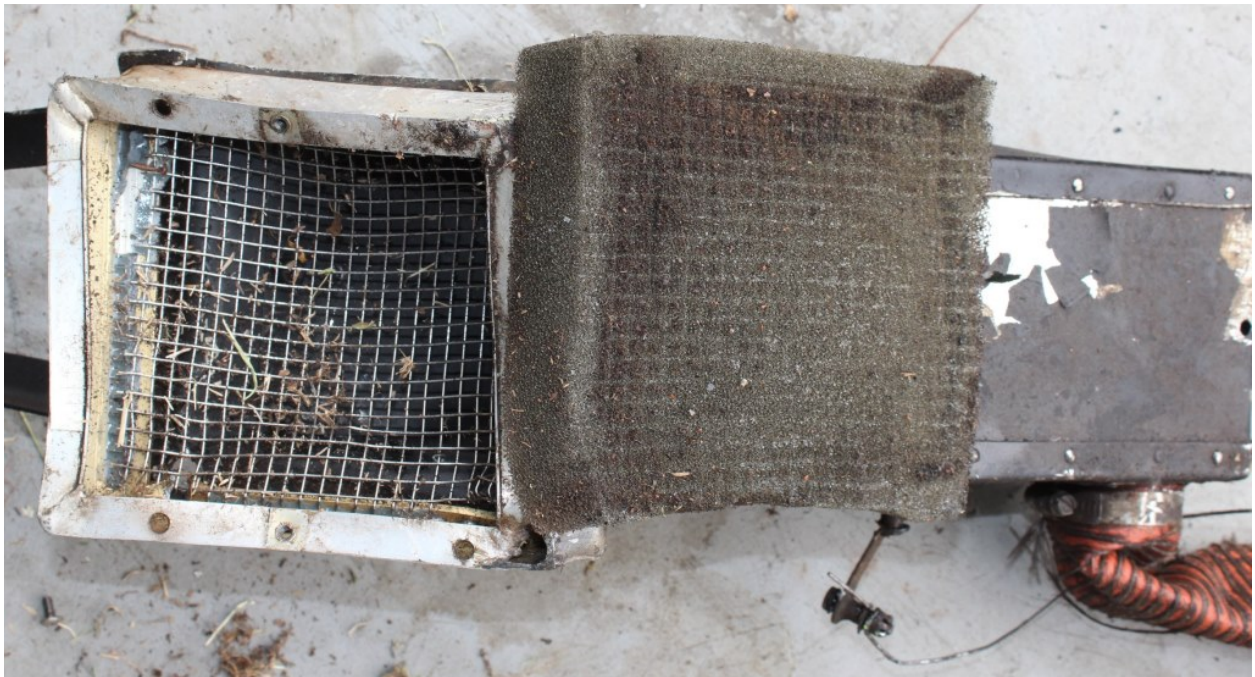
The carburetor and induction system were examined and observed to be free of obstruction. The airbox inlet and ducting were crushed and contaminated with vegetation & dirt debris consistent with impact. The foam filter element remained securely attached to the airbox bracket. The filter element remained intact and exhibited no evidence of pre-impact failure or obstruction to airflow.

**Figure 42 - Air Intake and Filter Assembly**

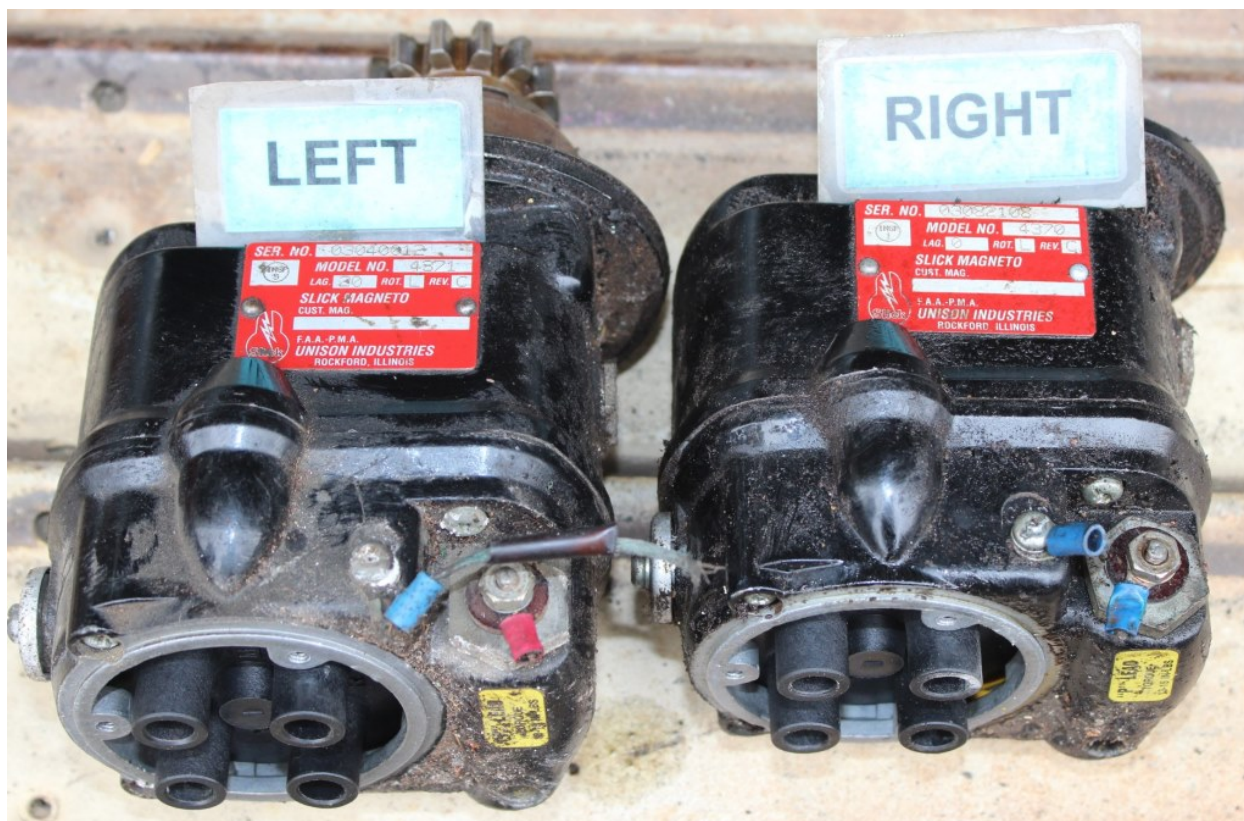
Figure 44 - Magnetos

| Damage: None | | | |

| Damage: None | | | |

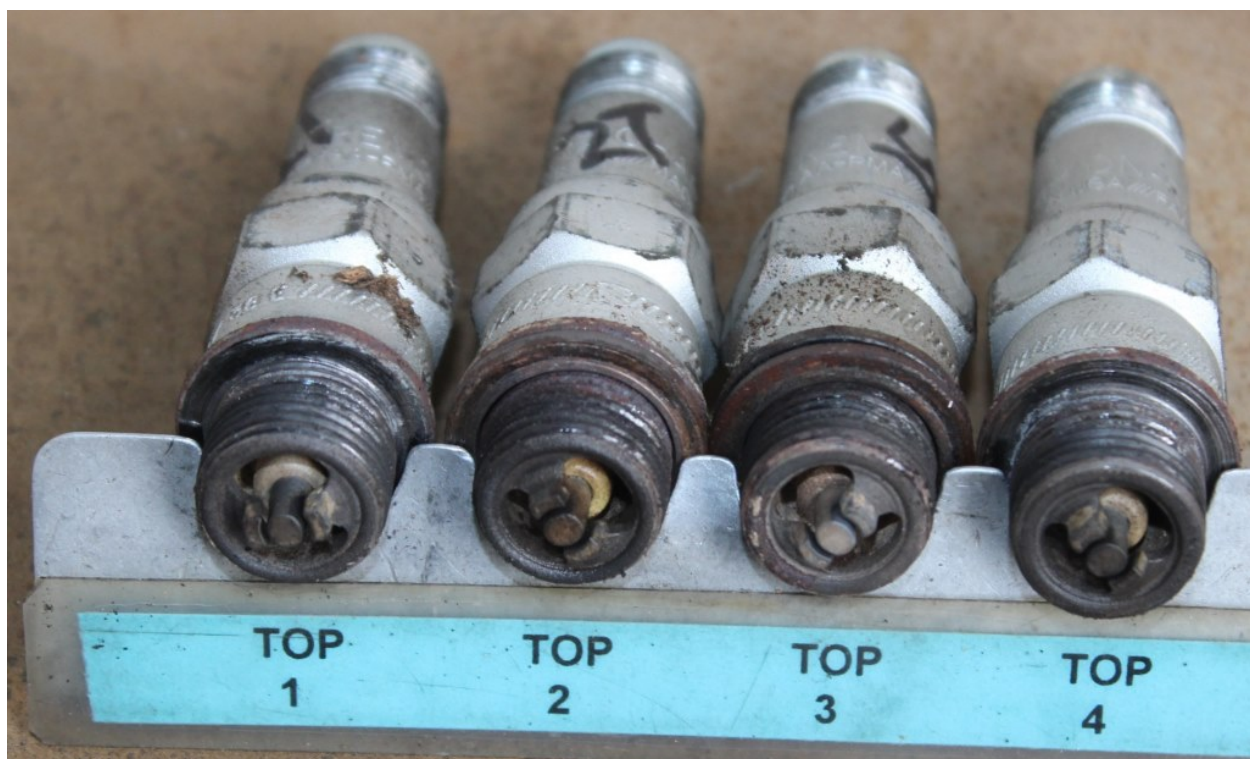
Figure 45 - Top Spark Plugs

All spark plugs were secure in their respective positions, each with its respective ignition lead attached. The spark plugs were removed, examined, and photographed. The spark plug electrodes were mechanically undamaged. According to the Champion Spark Plugs “Check-A-Plug” chart AV-27, the spark plug electrodes displayed coloration consistent with normal

operation with some shaping consistent with the normal/worn condition. The static oil soaking of some of the spark plugs was attributed to the engine post-accident and post-recovery orientation.
