# **NATIONAL TRANSPORTATION SAFETY BOARD**

## **AIRFRAME AND ENGINE EXAMINATION**

**NTSB Accident: WPR16LA093  
Accident Date: April 17, 2016**

Location: Avalon, CA  
Date: April 17, 2016  
Aircraft: Cessna 172K, N7133G, Serial # 17258833  
NTSB IIC: Michael Huhn

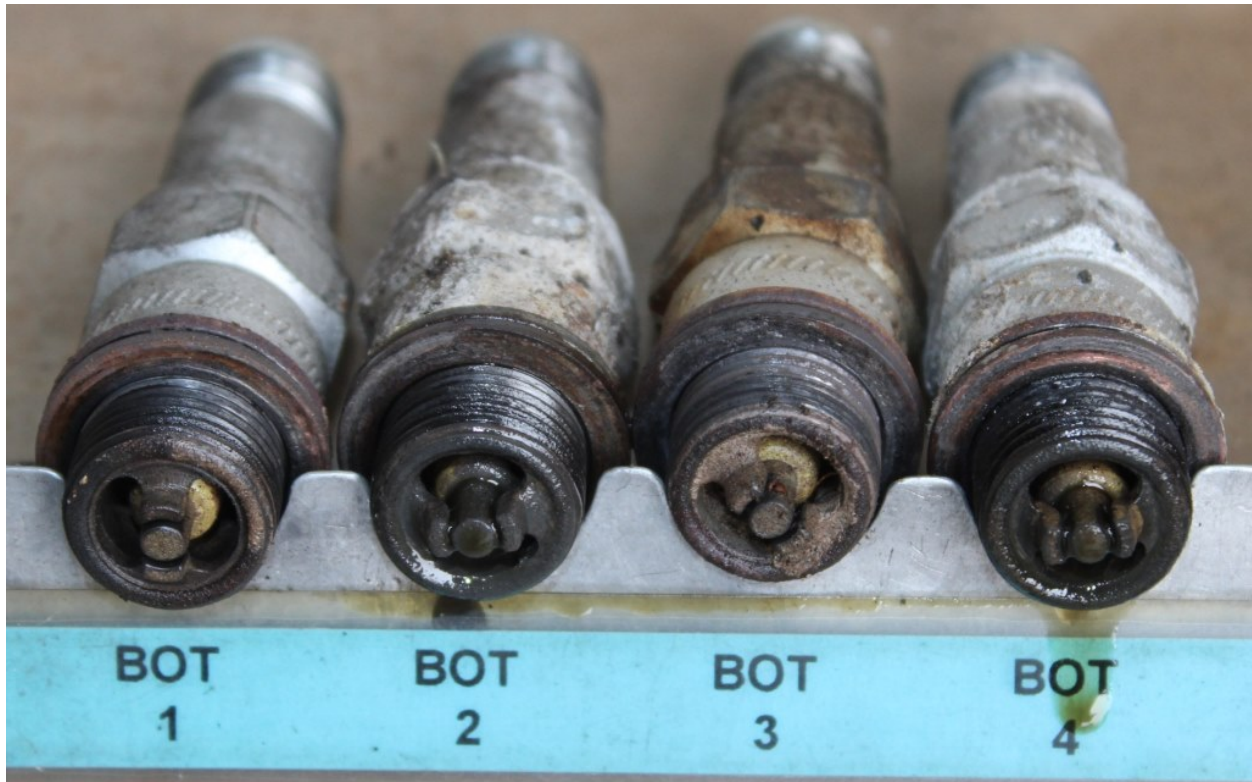
Figure 46 - Bottom Spark Plugs

All spark plugs were secure in their respective positions, each with its respective ignition lead attached. The spark plugs were removed, examined, and photographed. The spark plug electrodes were mechanically undamaged. According to the Champion Spark Plugs “Check-A-Plug” chart AV-27, the spark plug electrodes displayed coloration consistent with normal

operation with some shaping consistent with the normal/worn condition. The static oil soaking of some of the spark plugs was attributed to the engine post-accident and post-recovery orientation.

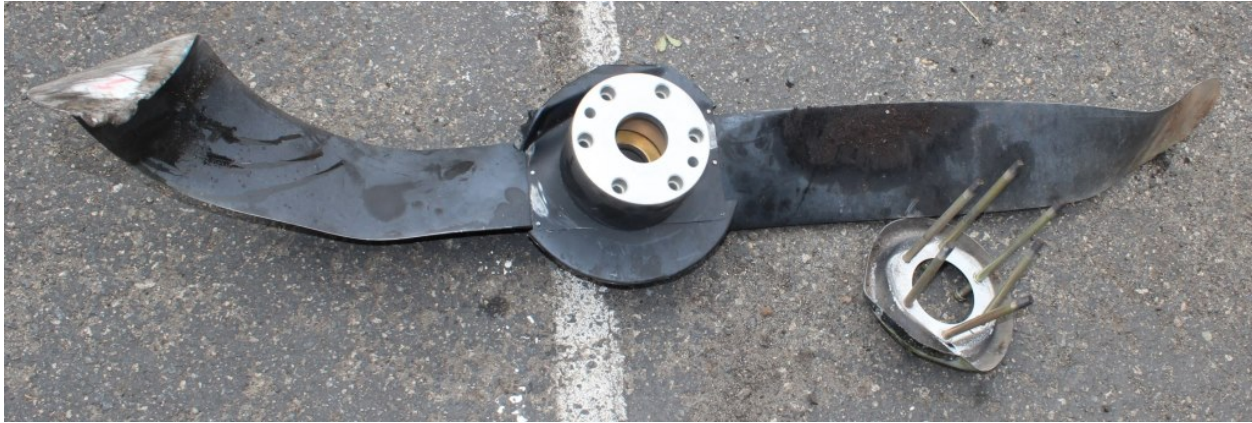
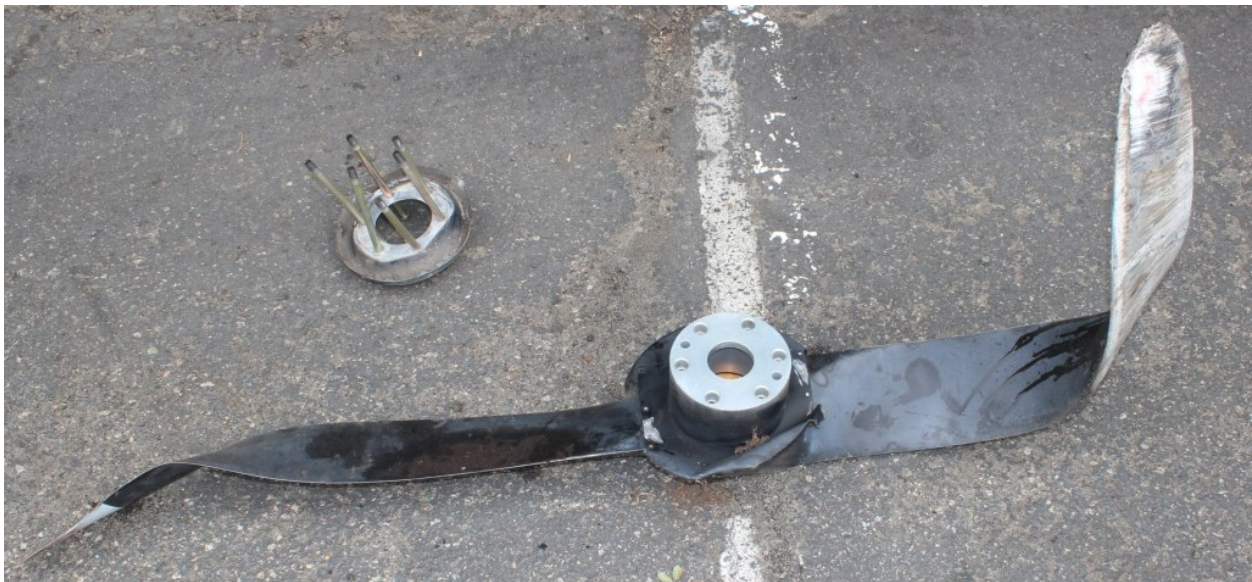
The two bladed fixed pitch propeller remained attached at the crankshaft flange. The spinner was attached to the propeller. The propeller blades remained attached to the propeller hub. The propeller blades displayed leading edge gouging, torsional twisting, chordwise striations across the cambered surface and trailing edge S- bending. The signatures were consistent with the propeller being driven by the engine at the time of impact.

**Figure 47 - Propeller After Removal**
