## Air Safety Investigations Aircraft Incident/Accident Technical Report

| <b>Aircraft Incident/<br/>Accident Information</b> | Year: 1957 | Make: Cessna | Model: 182A |
| Air Safety Investigator: Jonathon N. Hirsch | | Report #: ASI-16-BS-T | Report date: 10-10-16 |

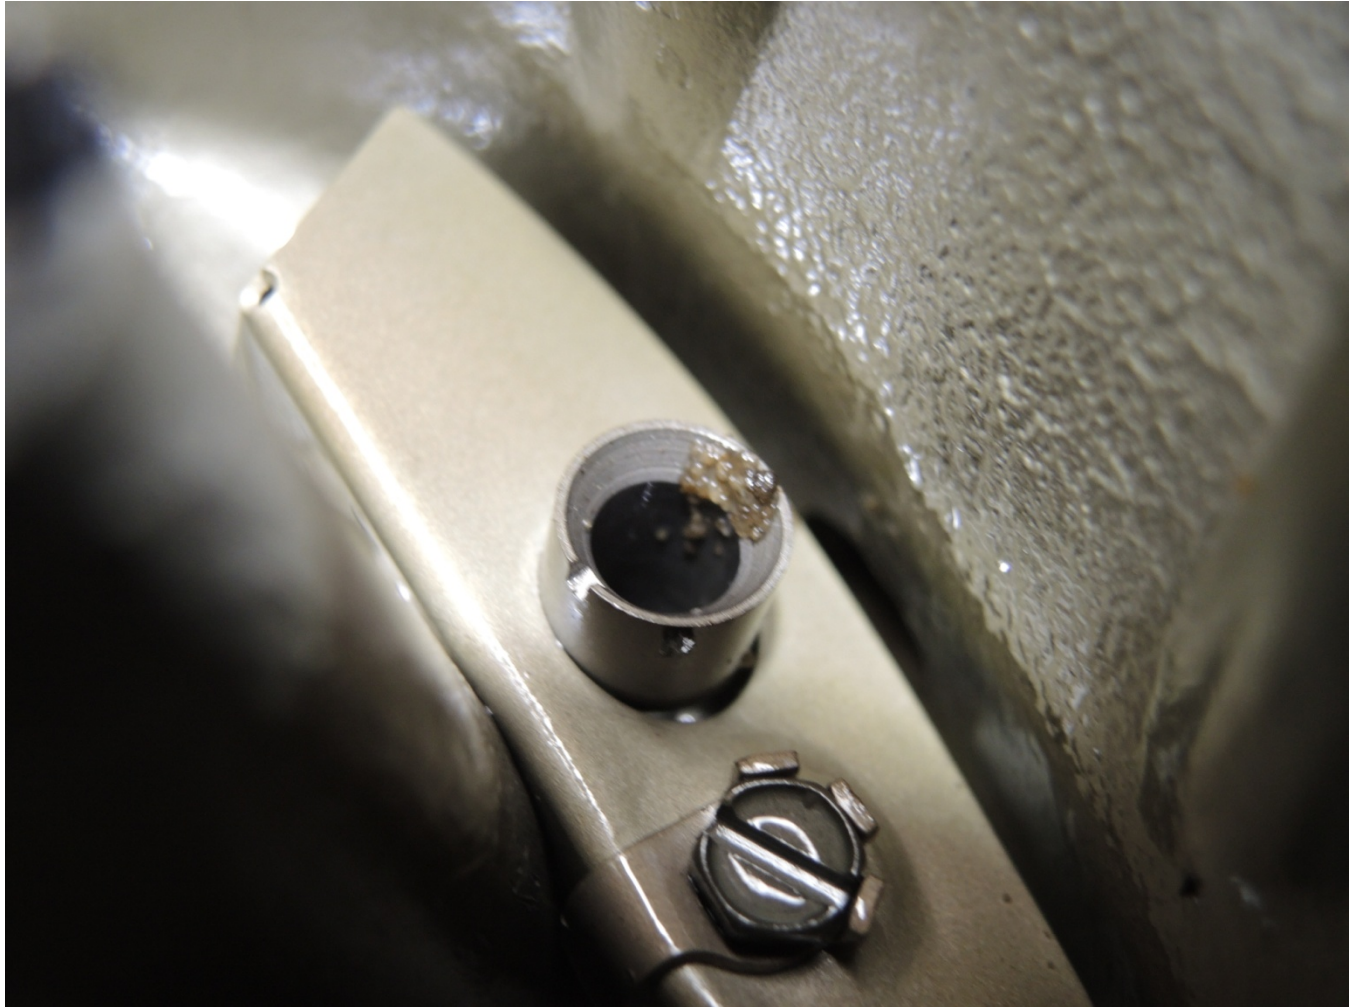
Undetermined debris which was dislodged from the Mixture Metering Sleeve.
