## **NATIONAL TRANSPORTATION SAFETY BOARD**

# **ENGINE EXAMINATION**

**WPR16LA096**

Location: Clements, CA  
Date: April 24, 2016  
Aircraft: DG Flugzeugbau GmbH DG-800B, N800YG, Serial #: 8-133B62  
NTSB IIC: Elliott Simpson

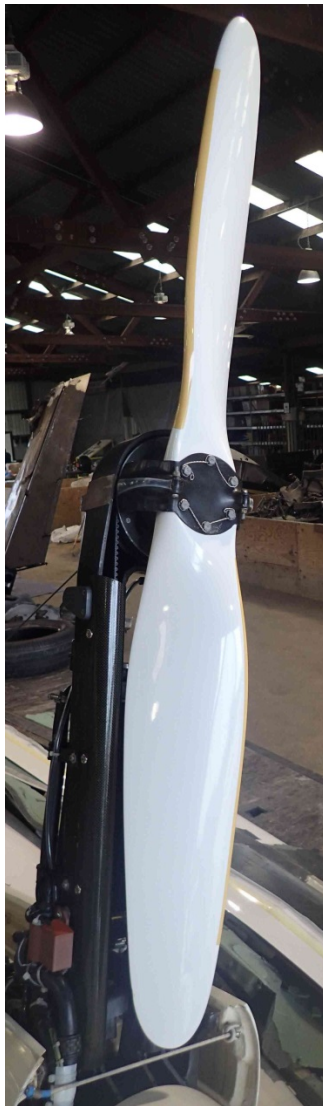
The engine and propeller assembly was then extended in accordance with the flight manual instructions (Photo 1, 2) and an engine start was attempted. The engine rotated, but would not start after two attempts. The fuel line to the carburetor was then removed and the fuel pump engaged; fuel flowed from the line, which was then reattached.

Photo 1 - Propeller Assembly Extended

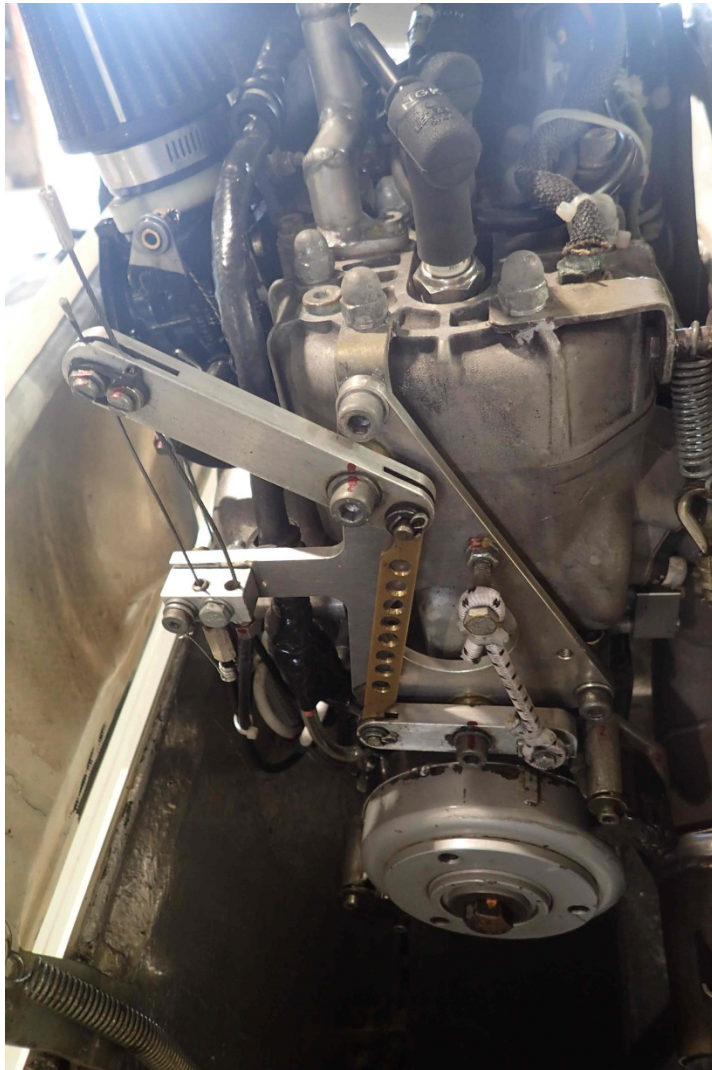
Photo 2 - Engine Extended

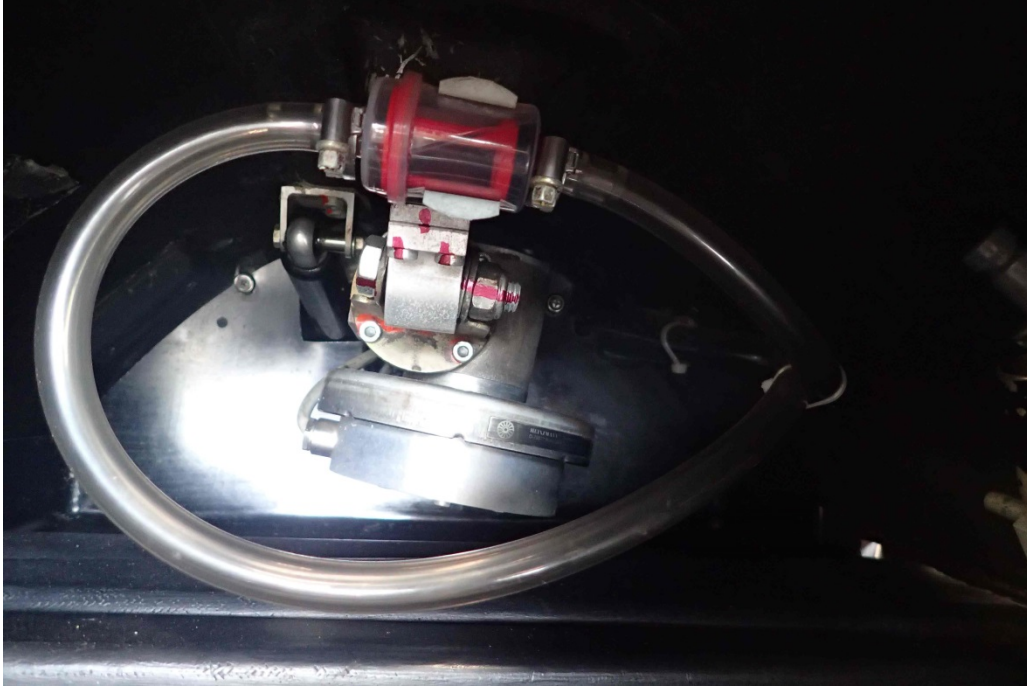
The clear plastic fuel filter appeared to be about 1/2 full with fuel, and no fuel was present on the engine side of the clear plastic fuel line (Photo 3). A dipstick was inserted into the fuel filler neck, and fuel was present. According to the fuel indicator/engine monitor, the tank contained 6 liters of fuel (22 liters maximum, 0.5 liters unusable).

Photo 3 - Fuel Filter and Line before Engine Start

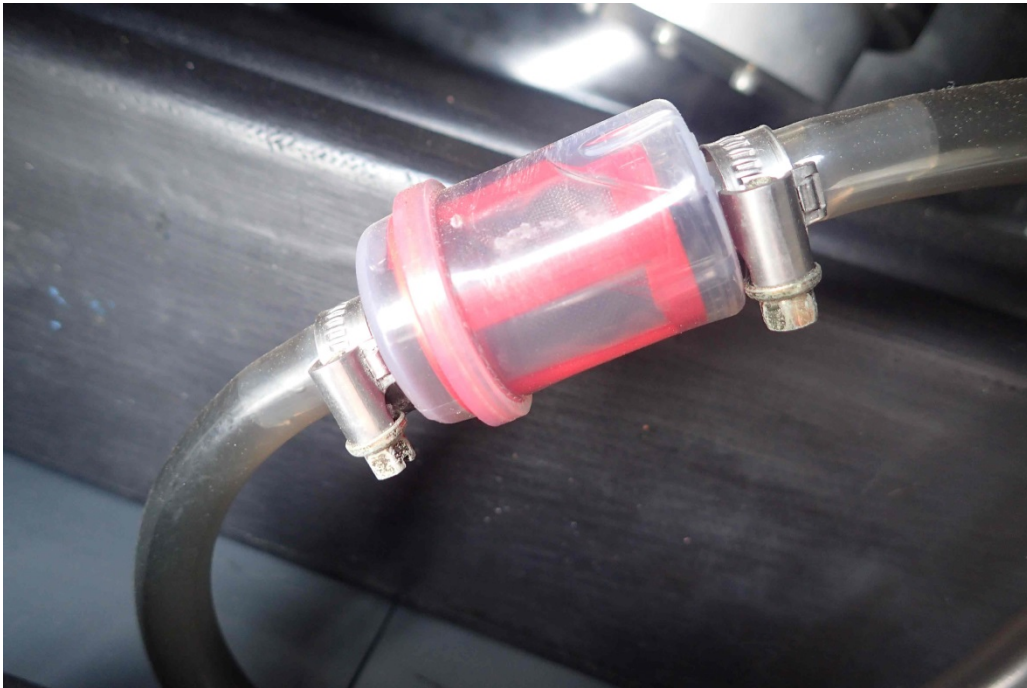
A third engine start was then attempted and the engine started immediately. A fourth start was then attempted, with the engine again starting immediately and ran smoothly at various speeds. Examination of the fuel filter revealed that it was now full of fuel (Photo 4).

Photo 4 - Fuel Filter and Line after Engine Start
