## **NATIONAL TRANSPORTATION SAFETY BOARD**

### **SITE and ON-SCENE INFORMATION (Rev B)**

**NTSB Accident: WPR16LA110  
Accident Date: May 13, 2016**

Location: Mohave, California  
Date: May 13, 2016  
Aircraft: Experimental, twin-turbine powered Quickie, N68TQ, Serial # 0001  
NTSB IIC: Michael Huhn

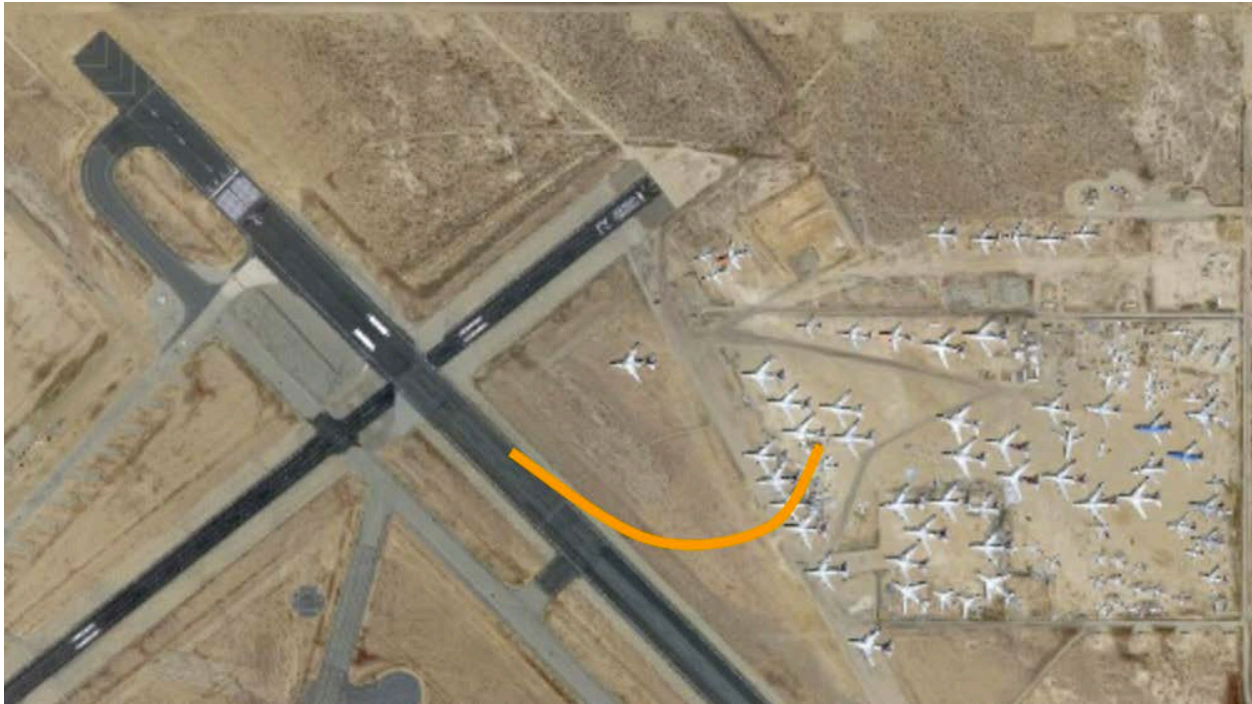
Figure 1 - Ground Track of Accident Airplane

The pilot provided the following depiction of his accident ground track on a Google Earth aerial image. (Note that the airliners depicted may not accurately reflect the actual status/arrangement at the time of the accident).

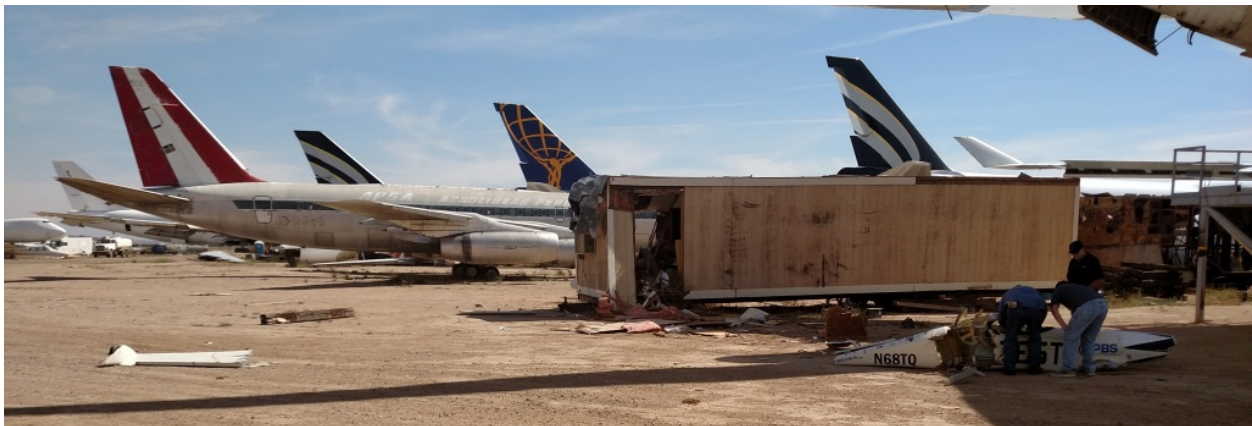
Figure 2 – Trailer and Wreckage (view southwest)

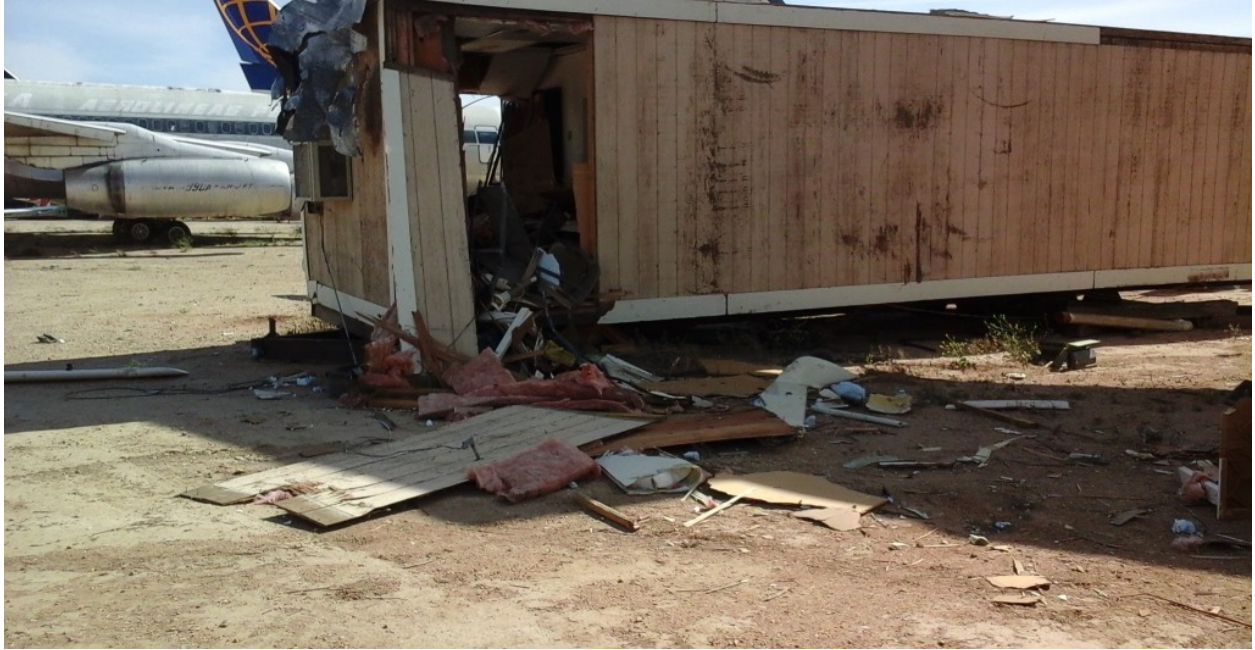
**Figure 3 - Trailer Close-Up (view southwest)**

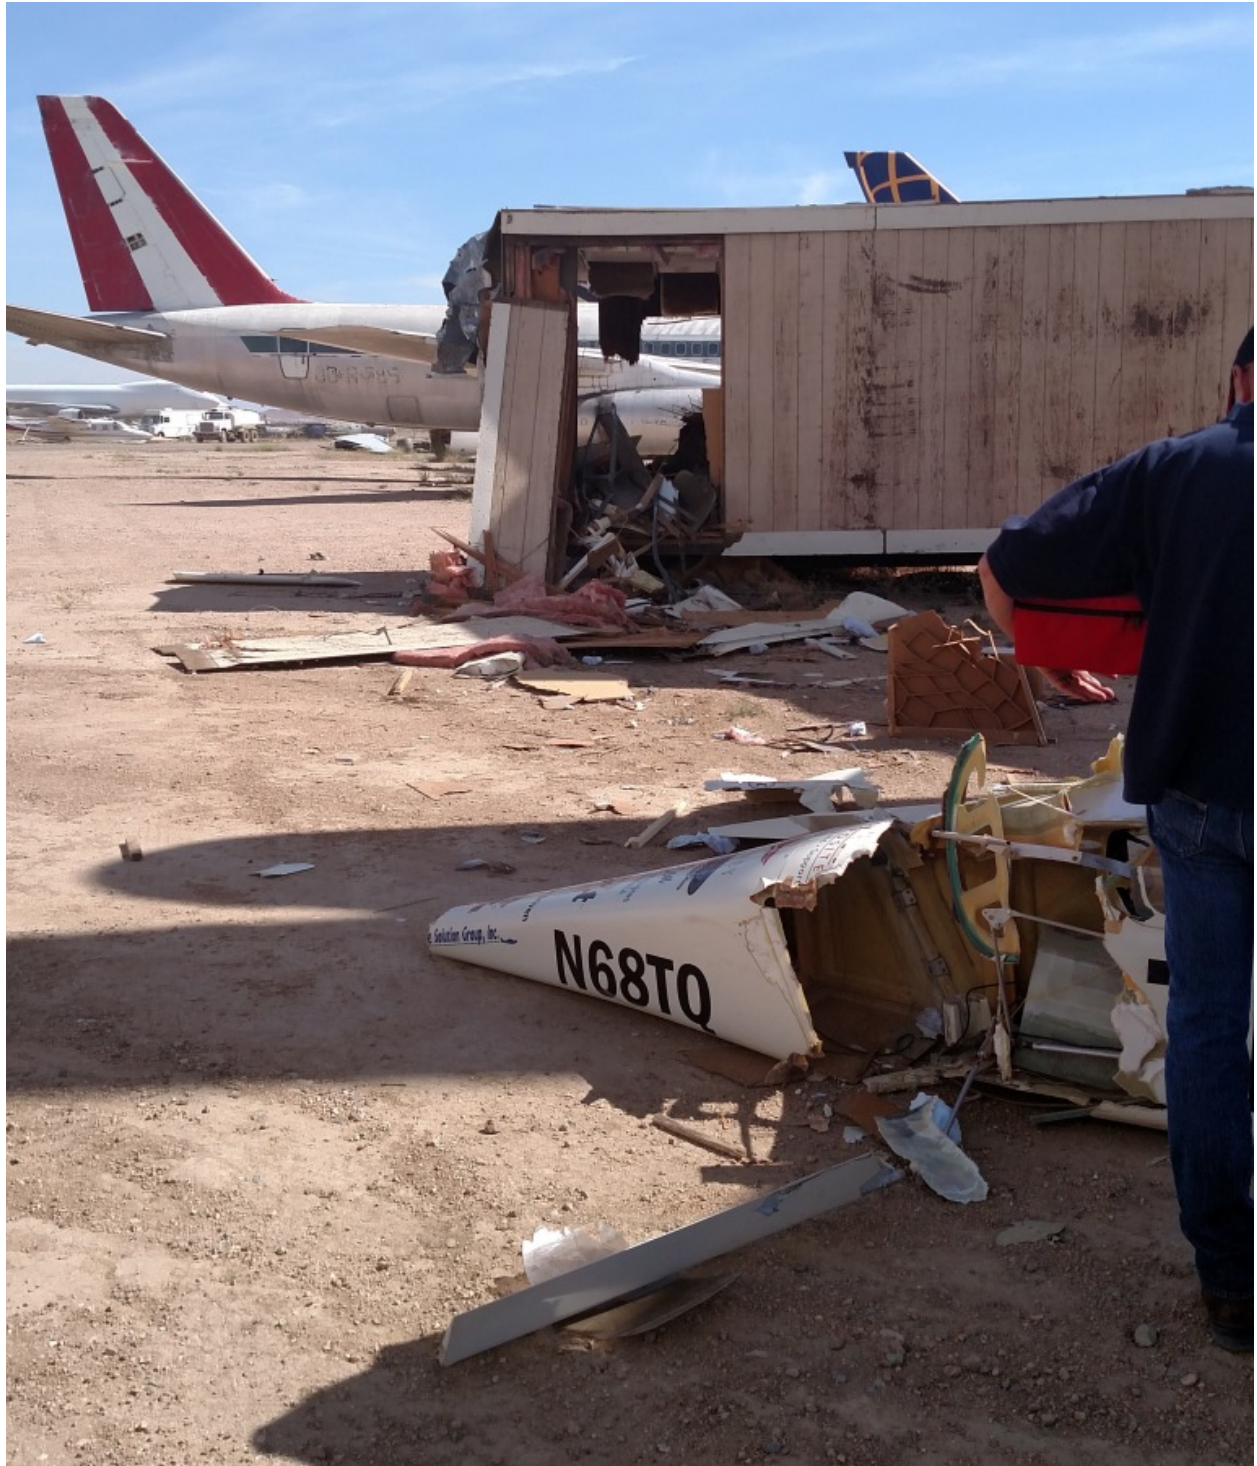
**Figure 4 - Trailer and Wreckage (view south)**

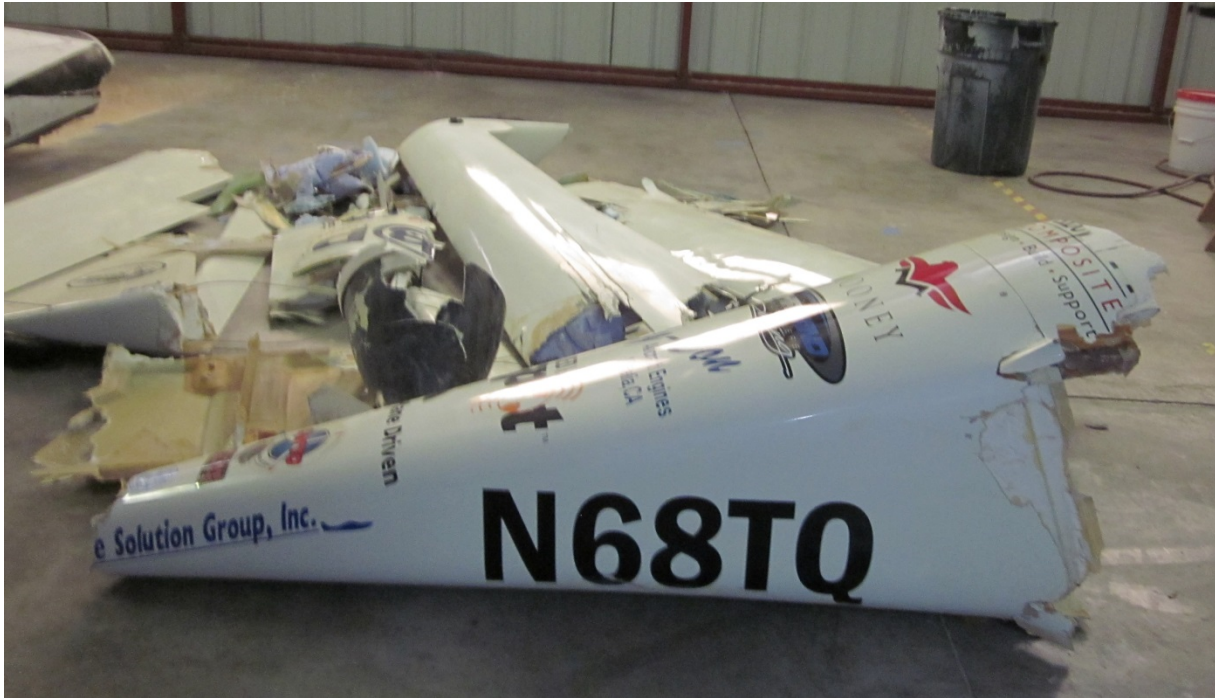
**Figure 7 - Collected Wreckage**

An FAA inspector examined the wreckage in the pilot's hangar at MHV on May 17, 2016. All components were accounted for. The inspector observed leaked fuel below the fuselage section where the fuel tank was mounted. He was unable to determine the remaining fuel quantity or whether the tank was breached. Neither engine displayed any evidence of an uncontained failure, or other evidence of any pre-impact mechanical failures.

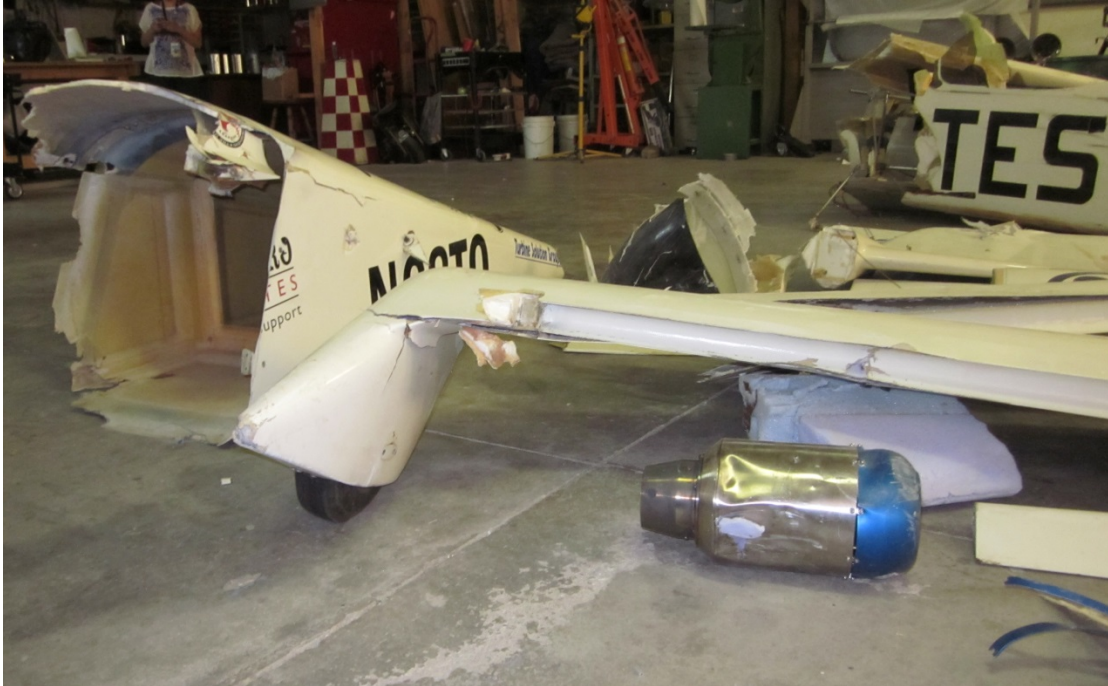
Figure 8 - Left Canard, Fuselage, and Liberated Engine

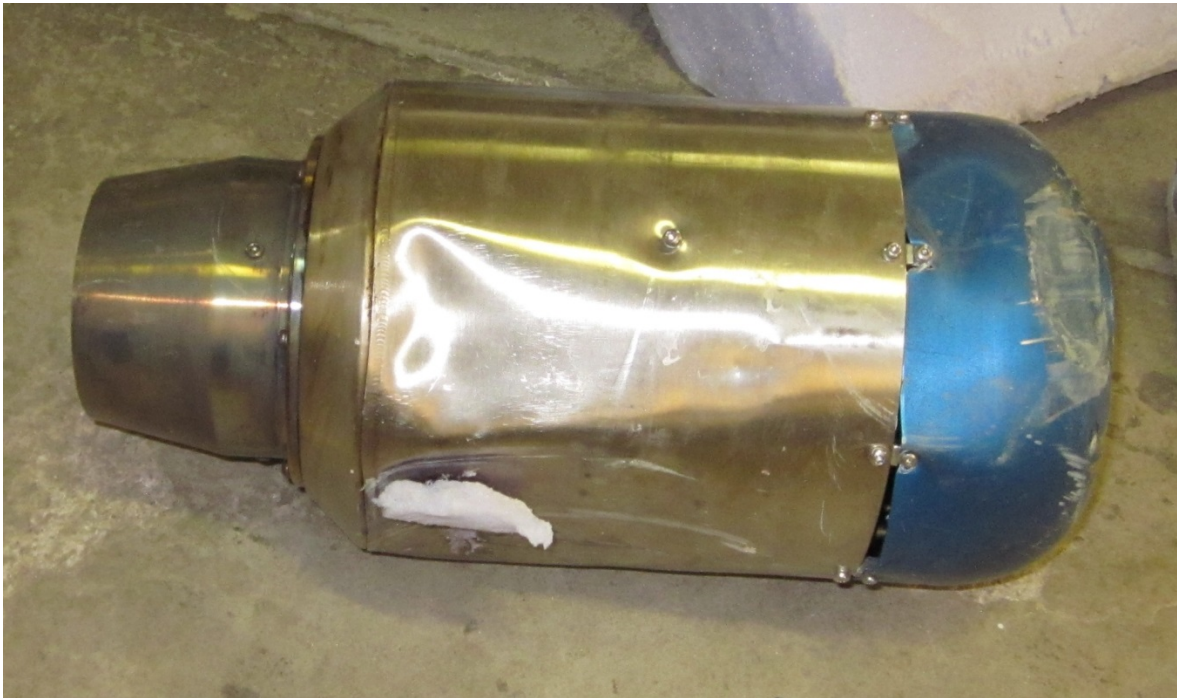
**Figure 19 - Liberated Engine**
