# **AIRFRAME AND ENGINE EXAMINATION SUMMARY**

**WPR16LA122**

| Location: | Lodi, California |
| Aircraft: | Rans S-5, N481TJ |

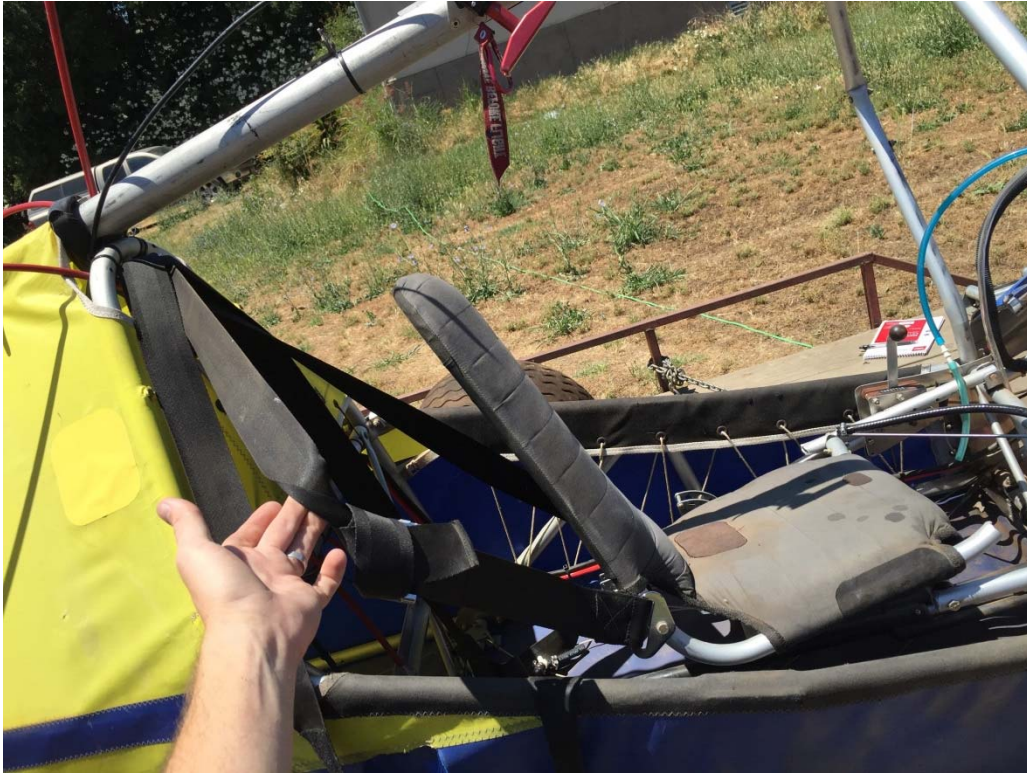
**Photo 1: Seat installation.**

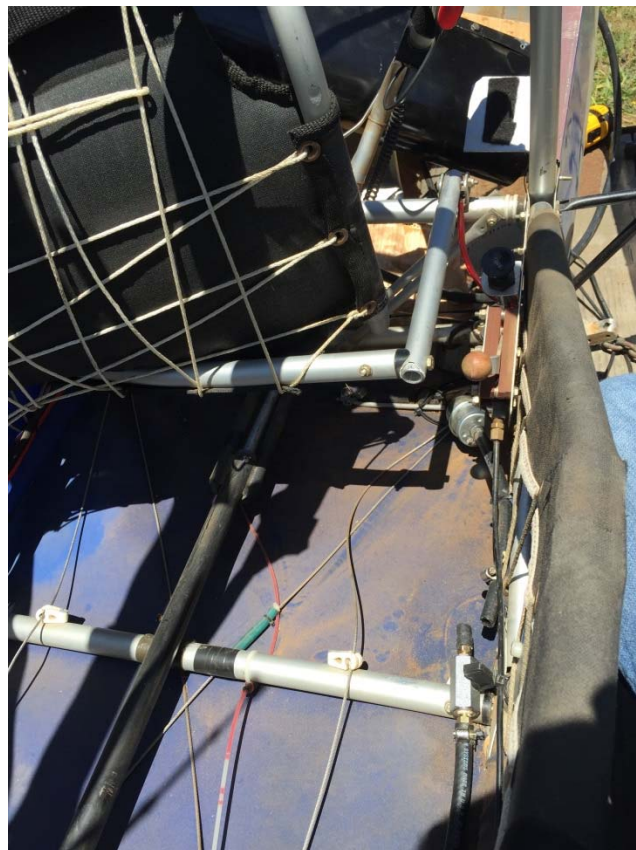
**Photo 2: Seat assembly and fuel line (side side).**

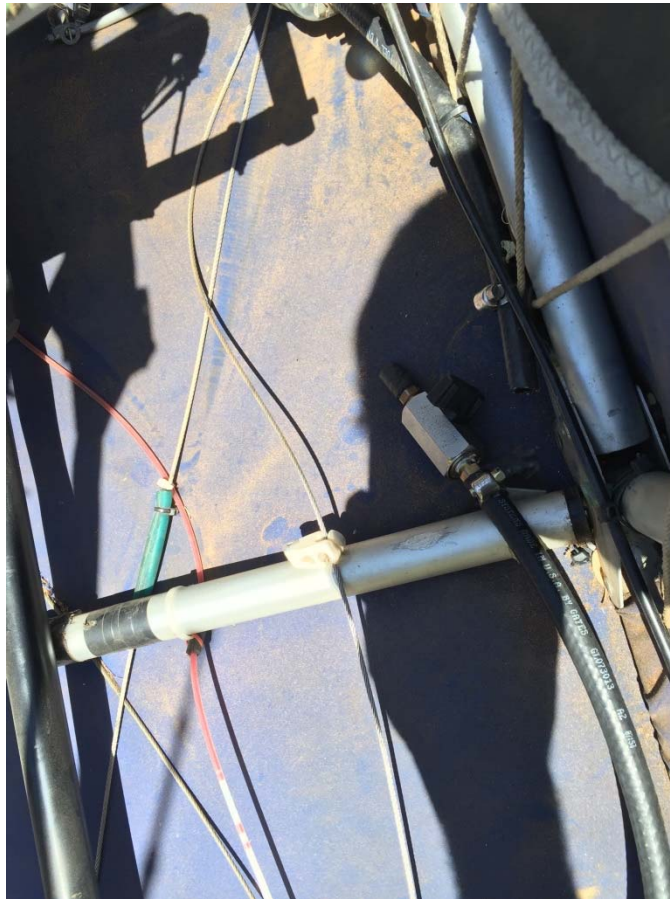
**Photo 3: Fuel line and shut off valve and wear mark on the airframe tube.**

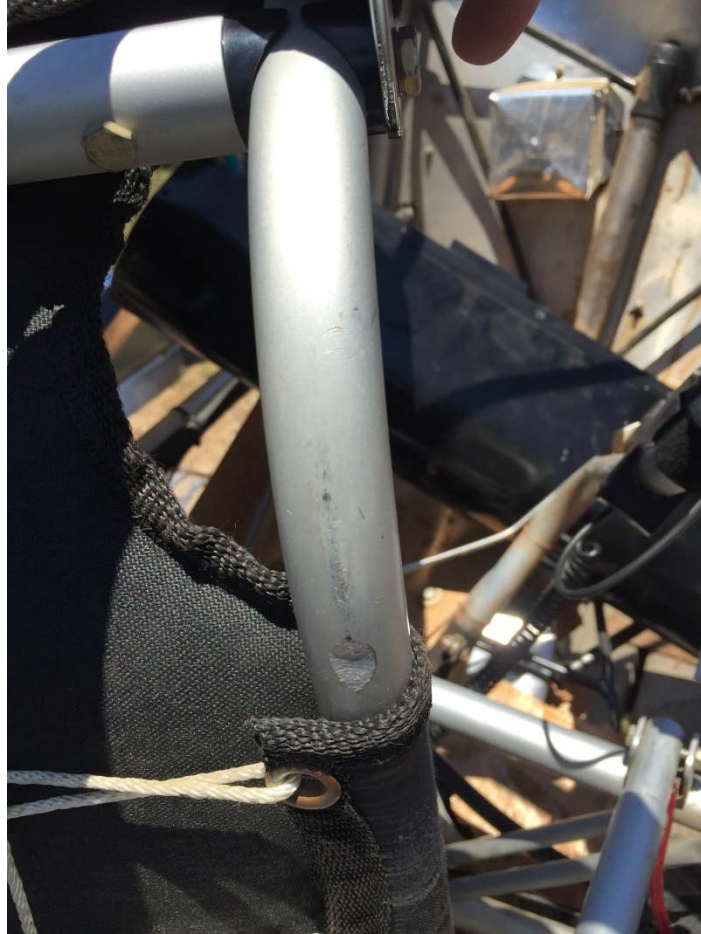
**Photo 4: Wear mark on the seat frame.**

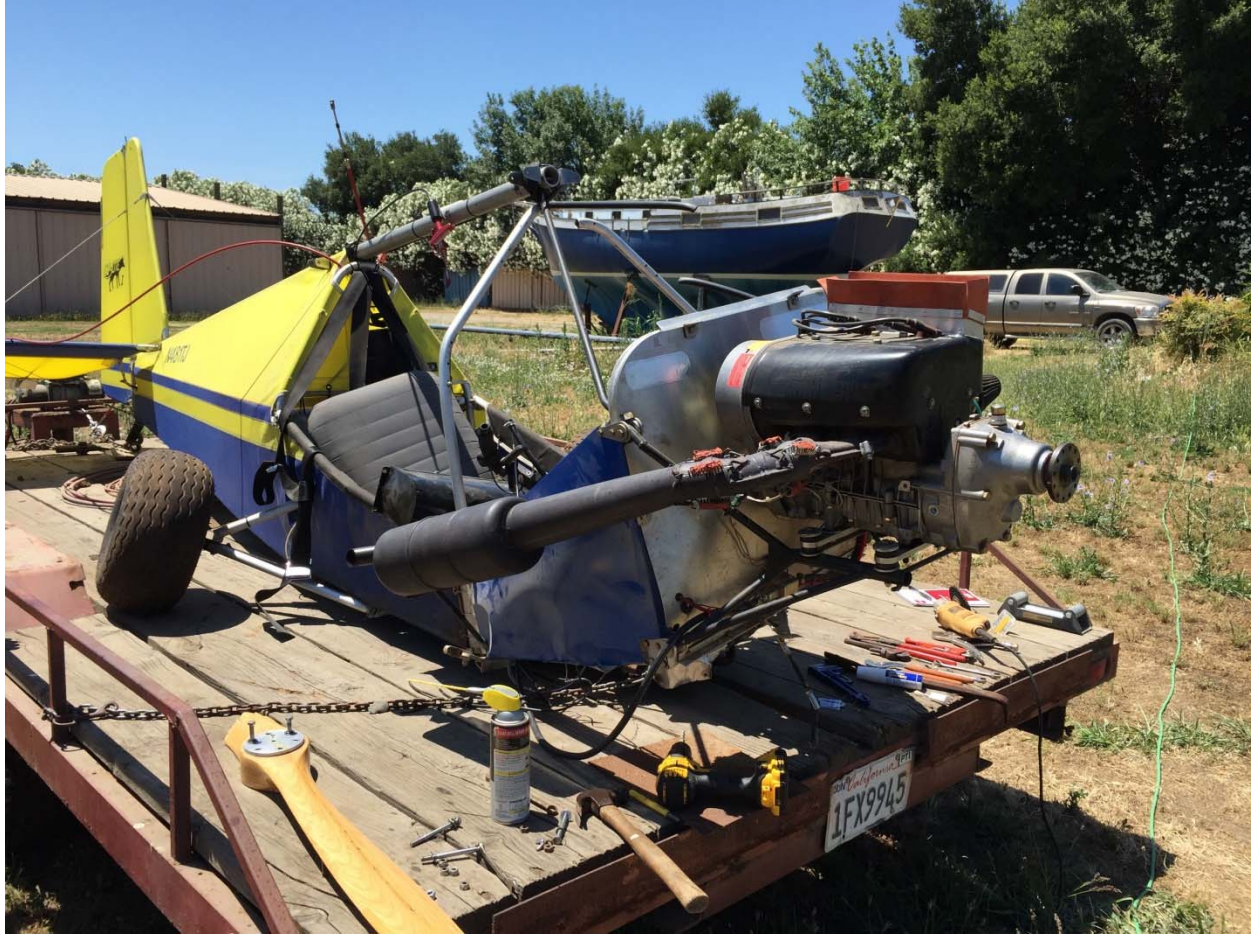
**Photo 5: Airframe and engine as found.**
