# Engine Investigation Report

**Rolls-Royce Corporation  
Model 250-C30P  
Engine CAE 890152**

**Bell 206L-1  
Registration: N1076Y**

**Accident date: 14 June 2016  
Investigation date: 1-2 August 2016  
Report date: 7 December 2016**

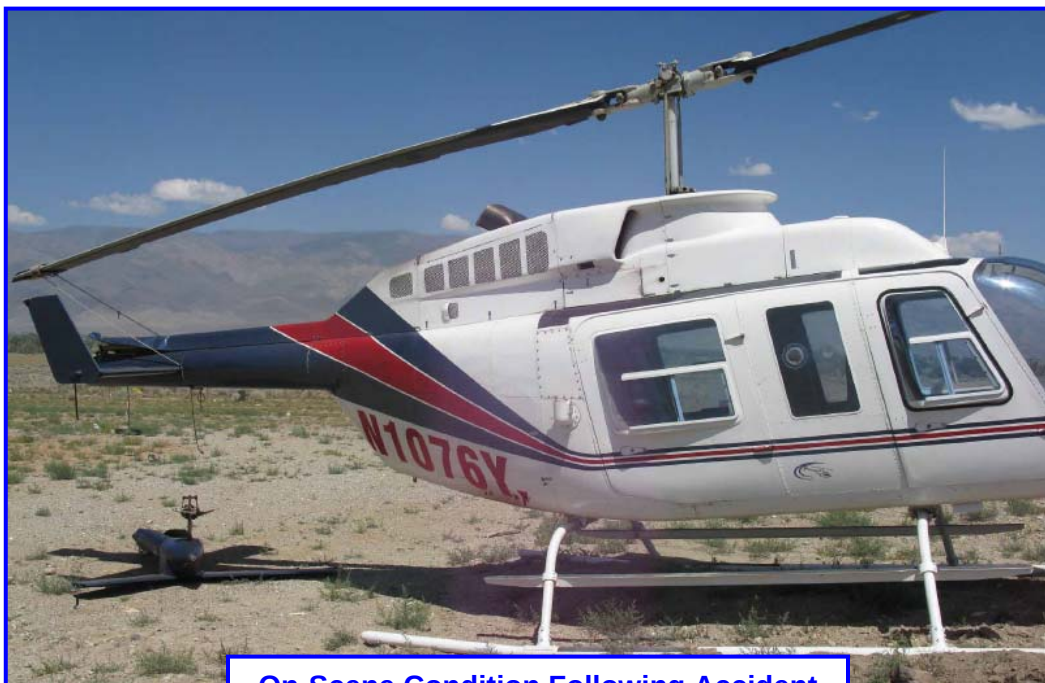
The helicopter impacted the ground hard resulting in substantial damage to the tail boom.

**On-Scene Condition Following Accident**

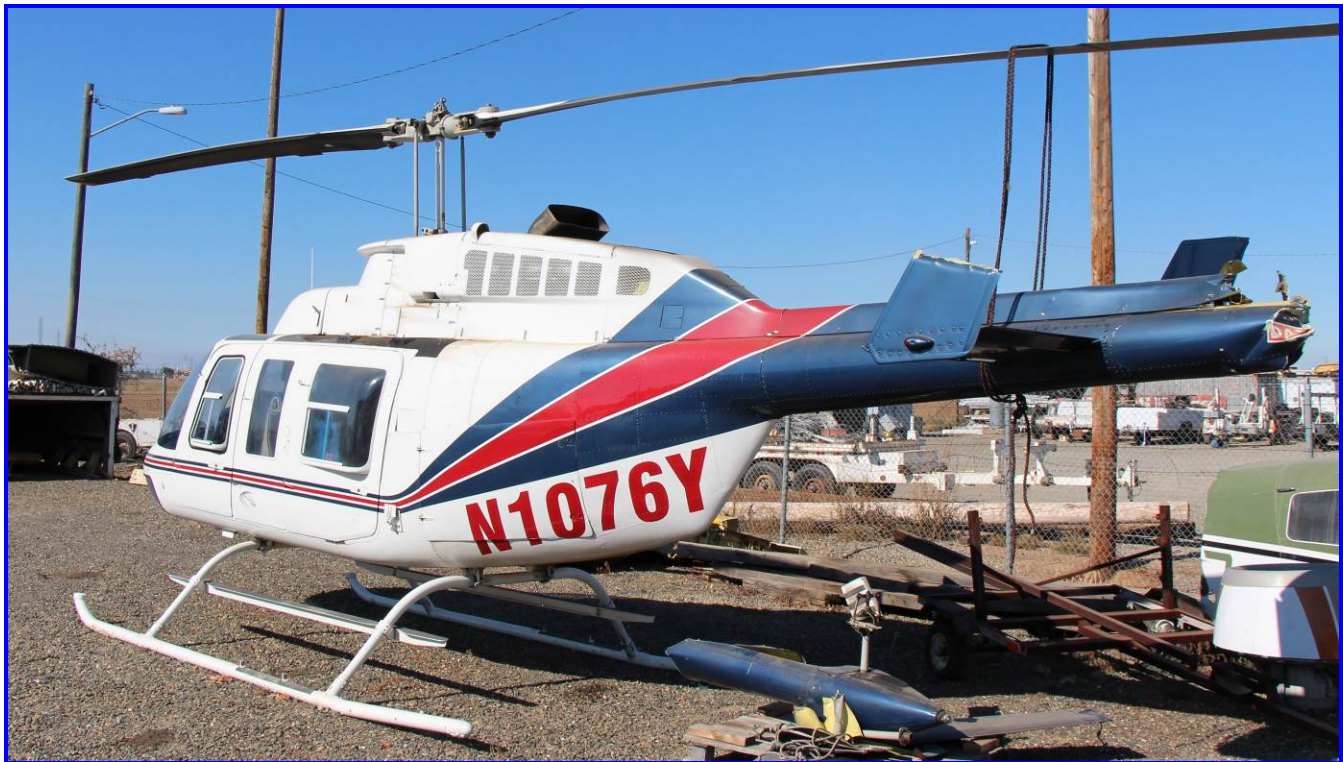
On-Scene Condition Following Accident

The aircraft exhibited damage consistent with landing on slightly inclined terrain. The tail boom completely severed aft of the horizontal stabilizer. Both main rotor blades exhibited leading edge damage and paint transfer due to contact with the tail boom. The skids did not show evidence of spreading nor was there any other notable damage to the fuselage cabin structure.

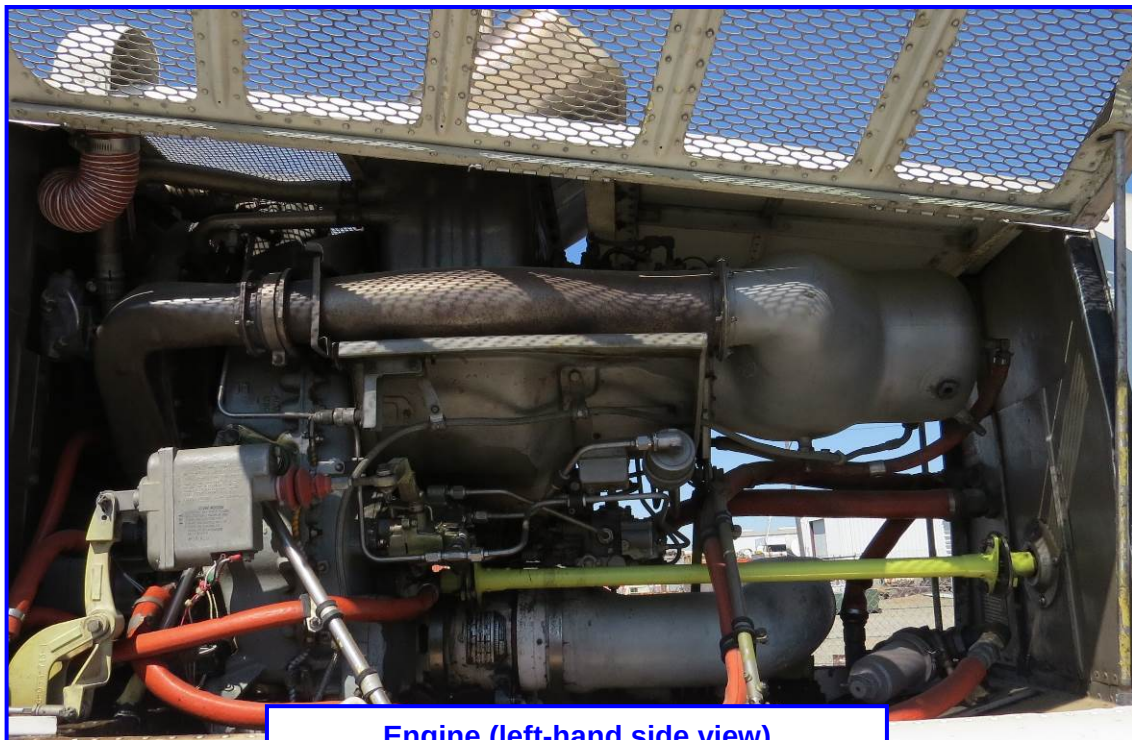
Engine (left-hand side view)

All engine B-nuts and fittings were checked by hand for proper torque. All were found to be at least hand tight and only a select few were marked with torque paint. Examination of the control air tubing did not reveal any evidence of pre-impact damage.

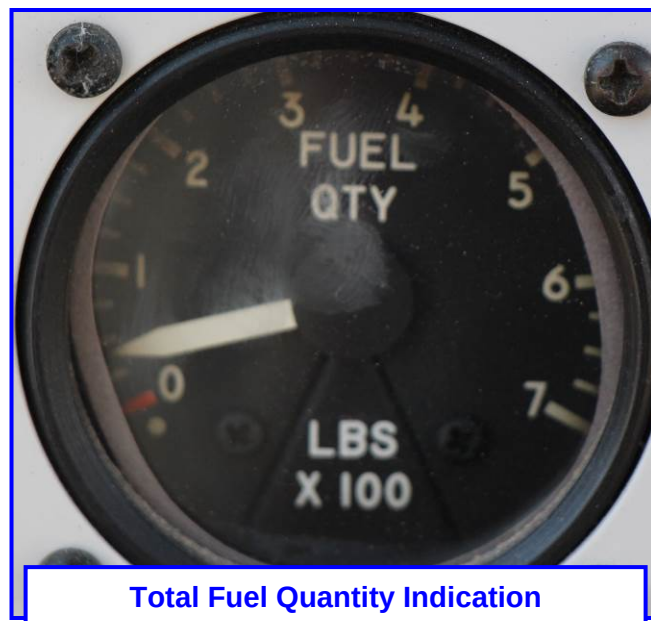
Total Fuel Quantity Indication

The fuel cut-off valve was found in the closed position. The fuel cut-off control in the cockpit was found in the OFF position. The cut-off valve was cycled and functioned normally as did both airframe fuel boost pumps. Cockpit fuel gauge indicated the total fuel load on board at the time of recovery was approximately 45 lbs (~6.5 gallons). However, a total of 18 gallons was drained from the helicopter during the recovery examination.

The forward fuel cell fuel quantity probe (located in the left hand forward tank) was removed to visually verify presence of fuel. Fuel was present and an attempt to measure the depth of the fuel a makeshift dipstick was inserted in the tank and confirmed approximately 3" height on the stick. The forward tanks are interconnected and each holds 11 gallons.

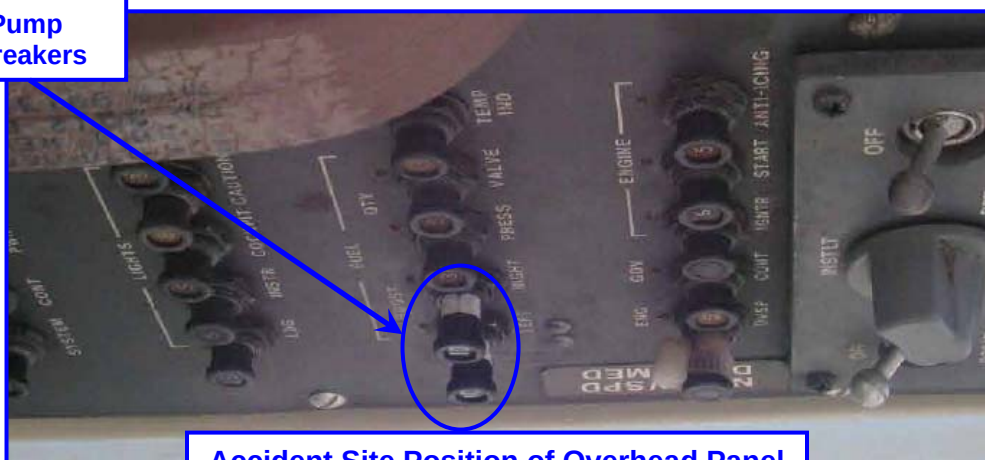
Accident Site Position of Overhead Panel  
Circuit Breakers

Initial reports stated that the left hand (LH) boost pump circuit breaker was pushed in (ON) and the right hand (RH) boost pump circuit breaker was pulled out (OFF). However, photographs taken at the accident site indicate that both LH & RH boost pump circuit breaker were pulled out. The exact position of the boost pump circuit breakers cannot be confirmed even with pilot statements. Operational functionality of both boost pumps using aircraft battery power was confirmed audibly (sound of boost pumps running), visually via sighting fuel movement in the main tank, and electronically in the cockpit on the fuel pressure gauge.

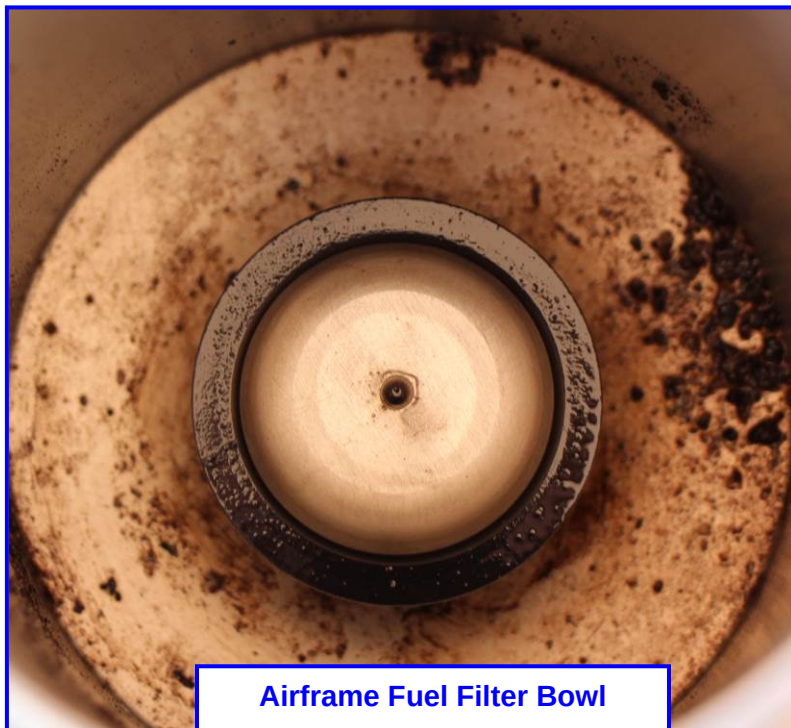
**Airframe Fuel Filter Bowl**

The airframe-mounted fuel filter was removed and the pleated filter unraveled. Both contained evidence of a brownish-black material.

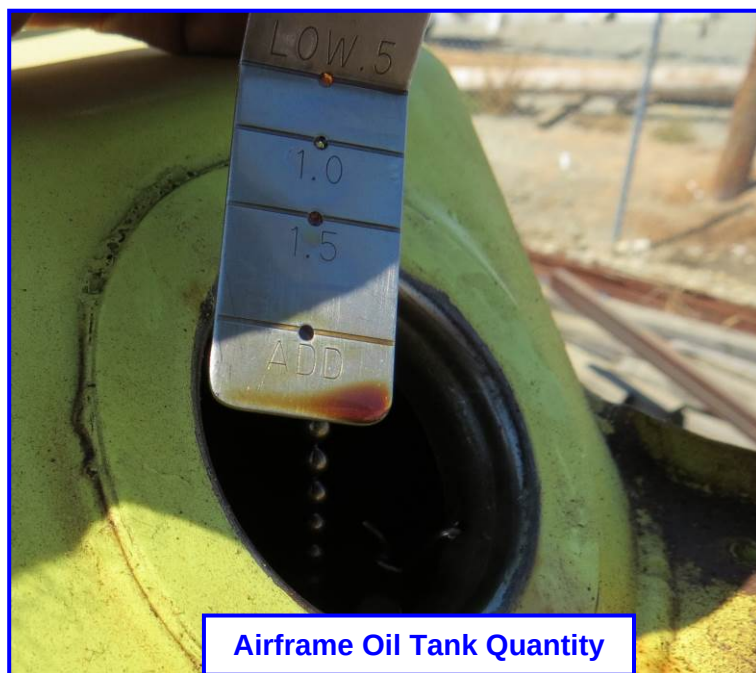
**Airframe Oil Tank Quantity**

The airframe oil tank filler cap was removed exposing the level of oil in the tank and on the integrated dipstick. The oil level barely registered on the dipstick, well below the ADD level. When removing the lower magnetic chip plug on the gearbox a considerable amount of oil poured out. The decision was made to quickly reinsert the chip plug in order to preserve the remainder of the oil thereby preventing an adequate assessment of the plug for ferrous metal.

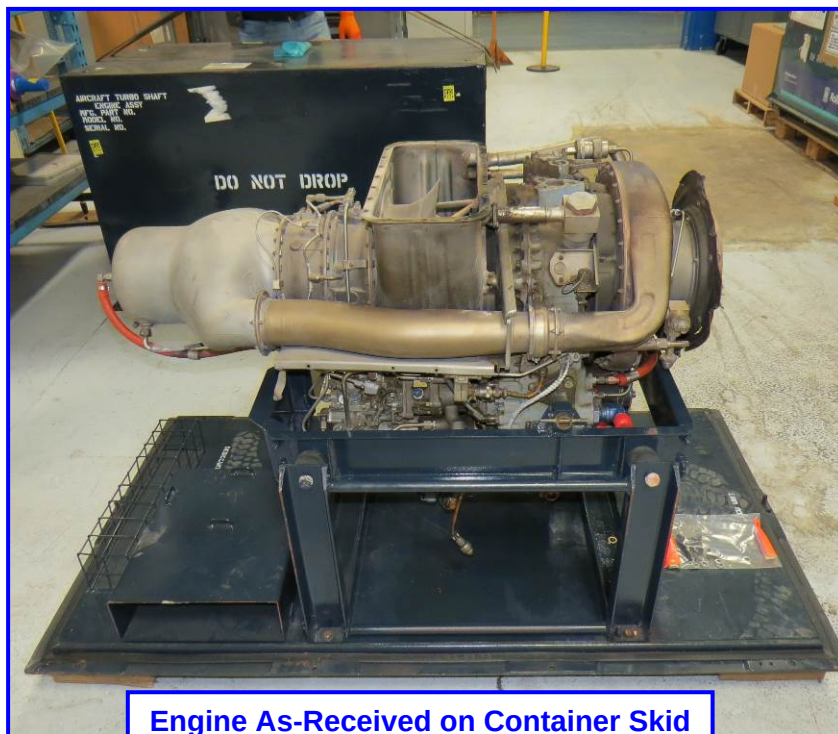
**Engine As-Received on Container Skid  
(with container top removed)**

On 19 October 2016, the subject engine was removed from the shipping container at Rolls-Royce's facility in Indianapolis, Indiana with NTSB-IIC oversight. The shipping container was opened and the engine appeared in the same general condition as when it was examined in Sacramento, CA.

There were no covers installed on compressor, open bleed port, or exhaust duct. No evidence of damage or abnormal conditions was noted during the un-crating process. The engine was hoisted by overhead crane and placed into a turnover stand for further examination and preparation for testing ahead.

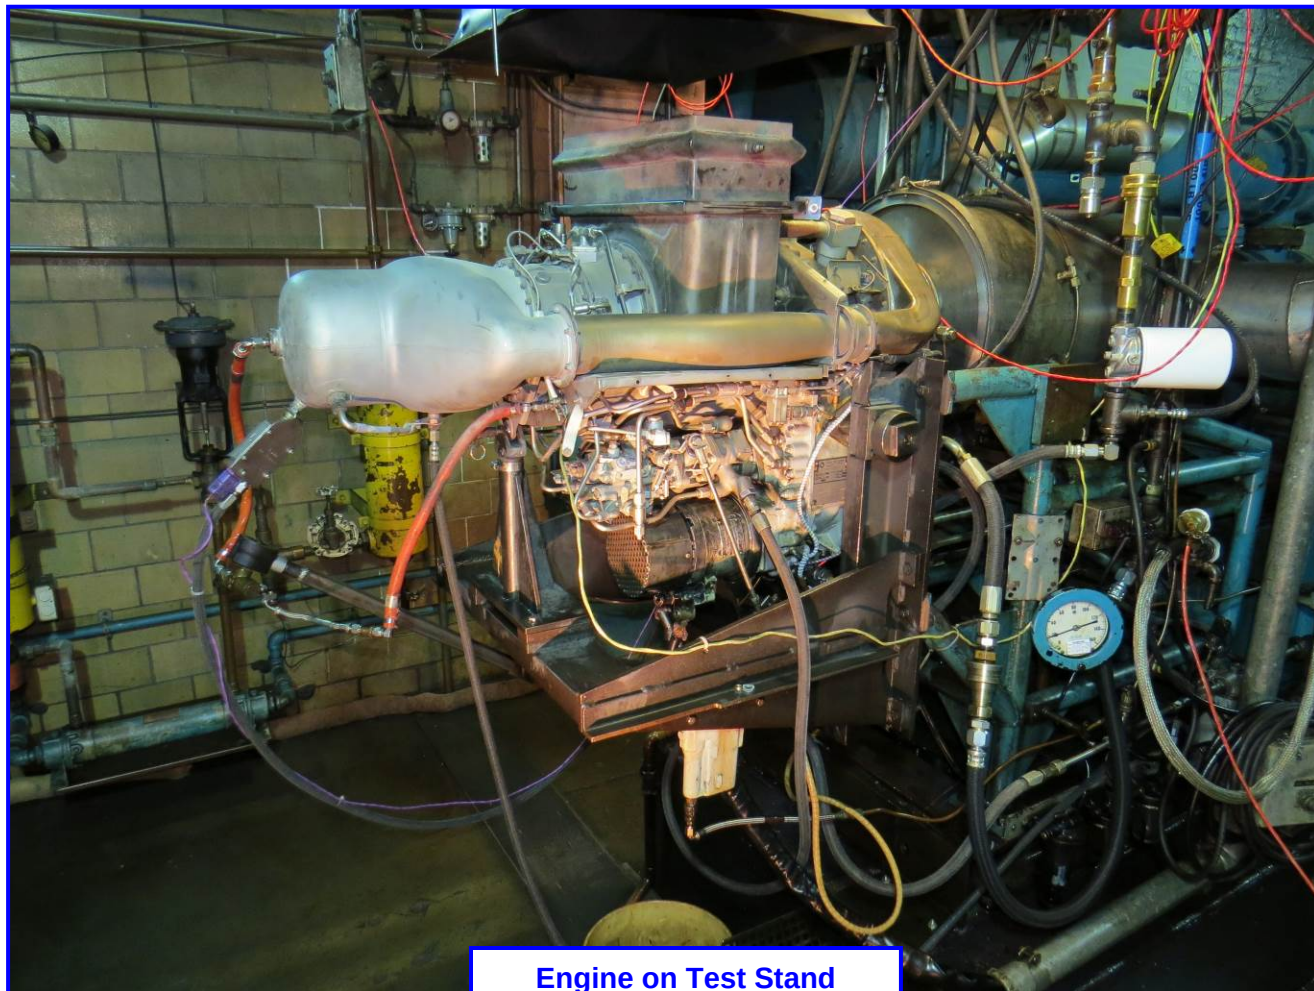
**Engine on Test Stand**

The engine successfully started, ran and shut down a total of 3 times. The engine successfully completed ground-idle, flight-idle, max-continuous-power and take-off power runs, in addition to “wave-off” max-power increases. Vibrations were well within limits.

It was noticed prior to the engine test that the max fuel flow stop was set to the low side on the Fuel Control Unit (FCU). This is a field adjustable setting that can be tweaked by mechanics for starting and related operational purposes. This may have been a contributor to the inability of the engine to achieve the max specification horsepower rating but was not considered as contributory to the accident sequence. Test cell technicians stated that it is very common for field return investigation engines to be set or rigged in this same manner.

Corrected for standard atmospheric conditions, the engine was 4.8% below new-production standards at maximum (take-off) power.<sup>1</sup> It was noticed during the engine test however, when checking the functionality of the anti-ice system that the anti-ice solenoid valve was inoperative and was failed in the open position (per design). This was confirmed during the test when the expected 12-15°F rise in MGT was not experienced when the anti-ice valve was switched to the ON position. The valve was also functionally tested after engine shutdown using test stand test power and confirmed to be inoperative. The as-received valve was temporarily replaced with a new anti-ice valve of equivalent standards and performed in accordance with PTS requirements.
