S.I.L. NO. 16-560-01

## SERVICE INFORMATION LETTER

SUBJECT: 90 Amp Generator Circuit Breaker Upgrade

TO: JetPROP Owners (JP 224 and earlier)

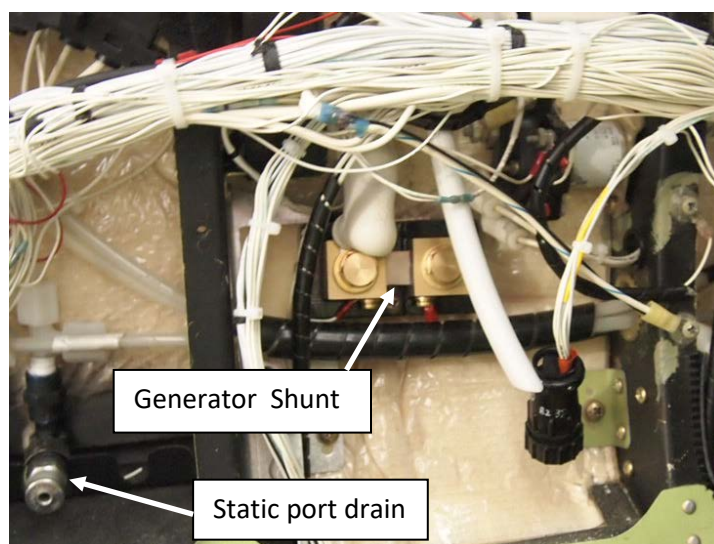
**Figure 1: Location of Generator Shunt**

1. Remove the single 2 gauge wire or two 4 gauge wires routed from the generator circuit breakers to the generator shunt. The shunt is located on the left side of the fuselage at immediately forward of the static port drain. See Figure 1.

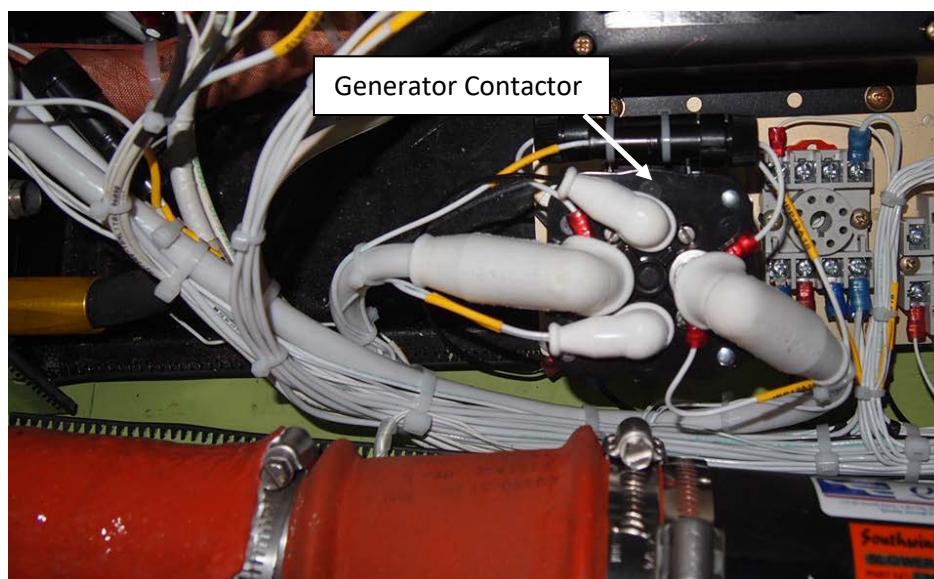
**Figure 2: Generator Contactor**

2. Run a length of M22759/16-1-9 wire from the generator circuit breakers buss down to the generator shunt.
3. Withdraw the original 2 gauge wire between the shunt to the generator contactor in the forward cargo compartment. See Figure 2.

4. Route a new length of M22759/16-1-9 wire from the shunt to the generator, utilizing the original bulkhead pass-through fitting.
5. Terminate that wire at the generator contactor. Replicate the original wiring route.
6. Remove the original 2 gauge wire from the generator contactor to the generator.
7. Run a length of M22759/16-1-9 wire from the contactor, through the firewall, to the generator. This wire must be in free air, not in contact with other wires, nor enclosed within spiral wrap.
8. Refer to JetPROP S.I.L. 09-560-01 for details on routing the new generator wire over the top of the engine.
9. Terminate the wire at the generator.
10. Reinstall circuit breakers in instrument panel.
11. Connect batteries.
