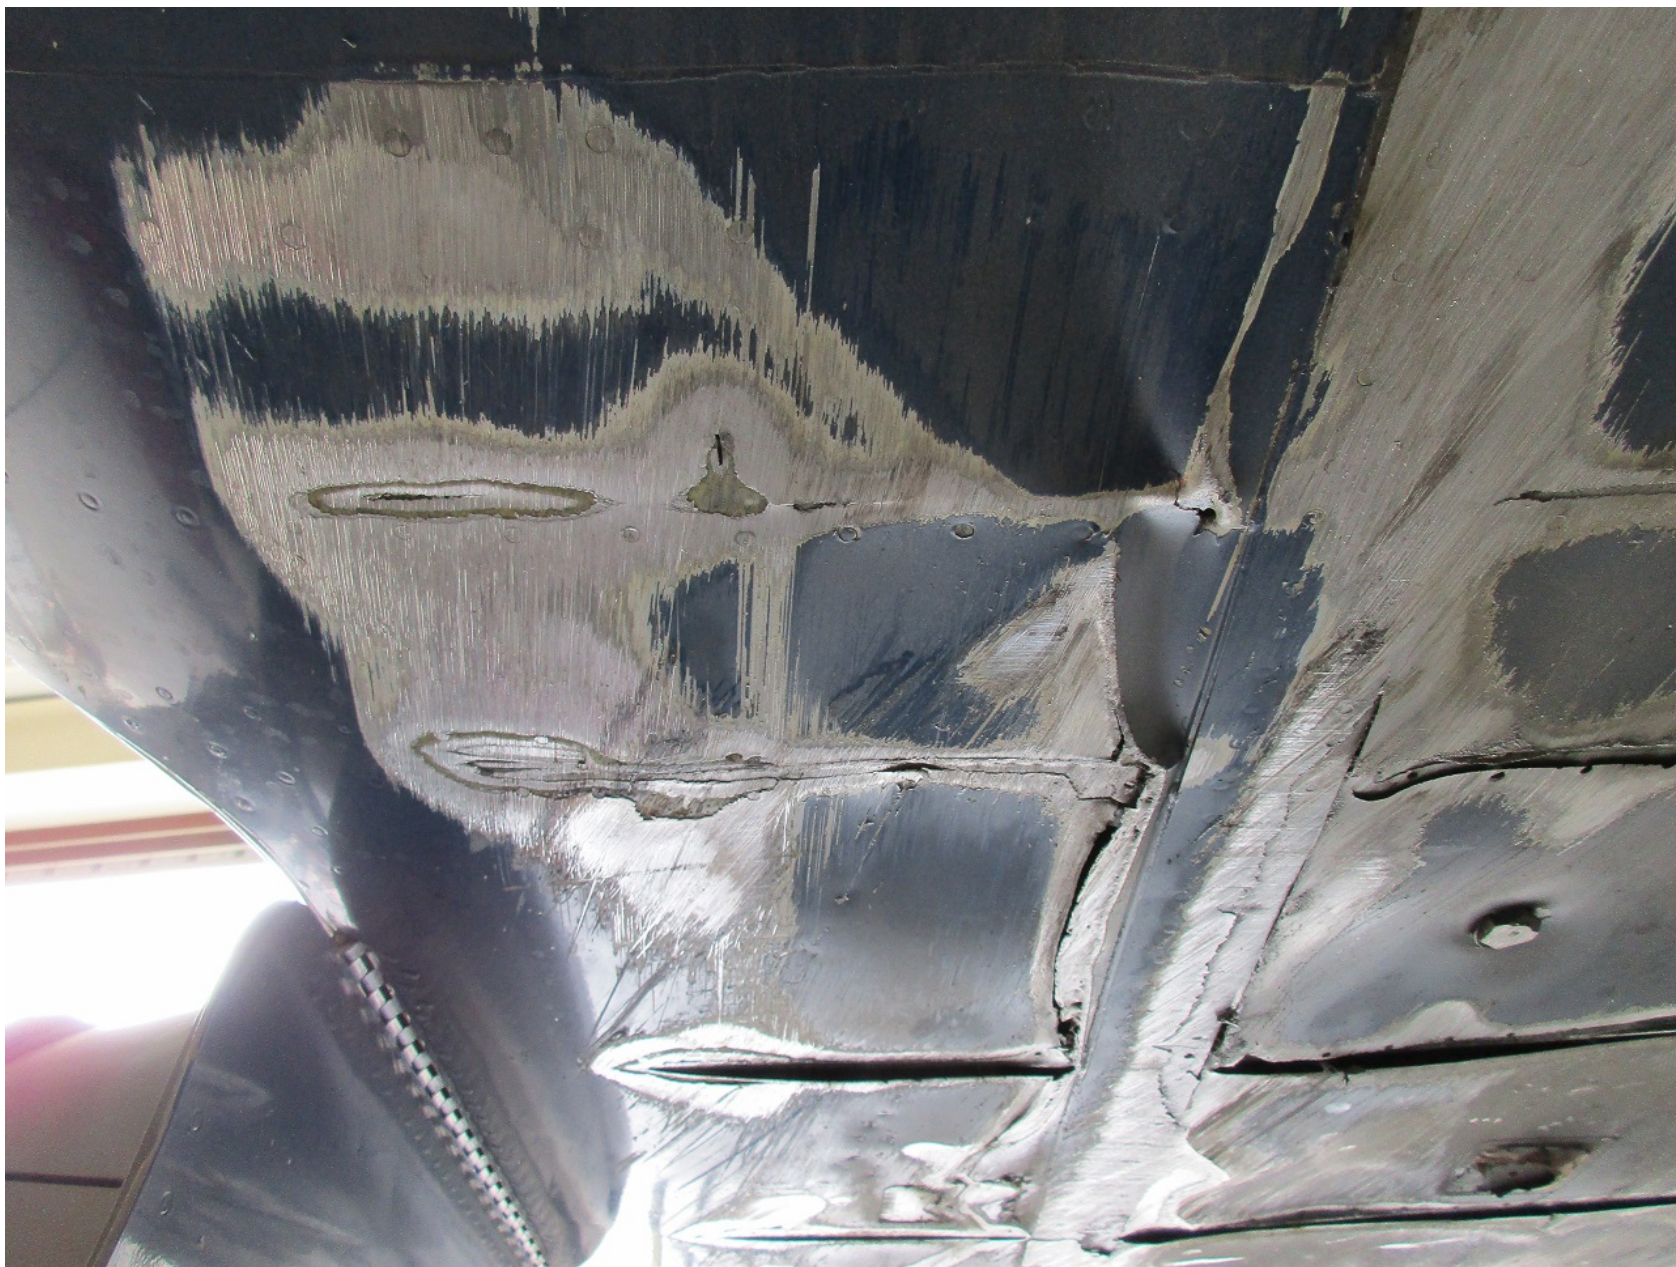
**Photo 1 – view one of undercarriage damage**

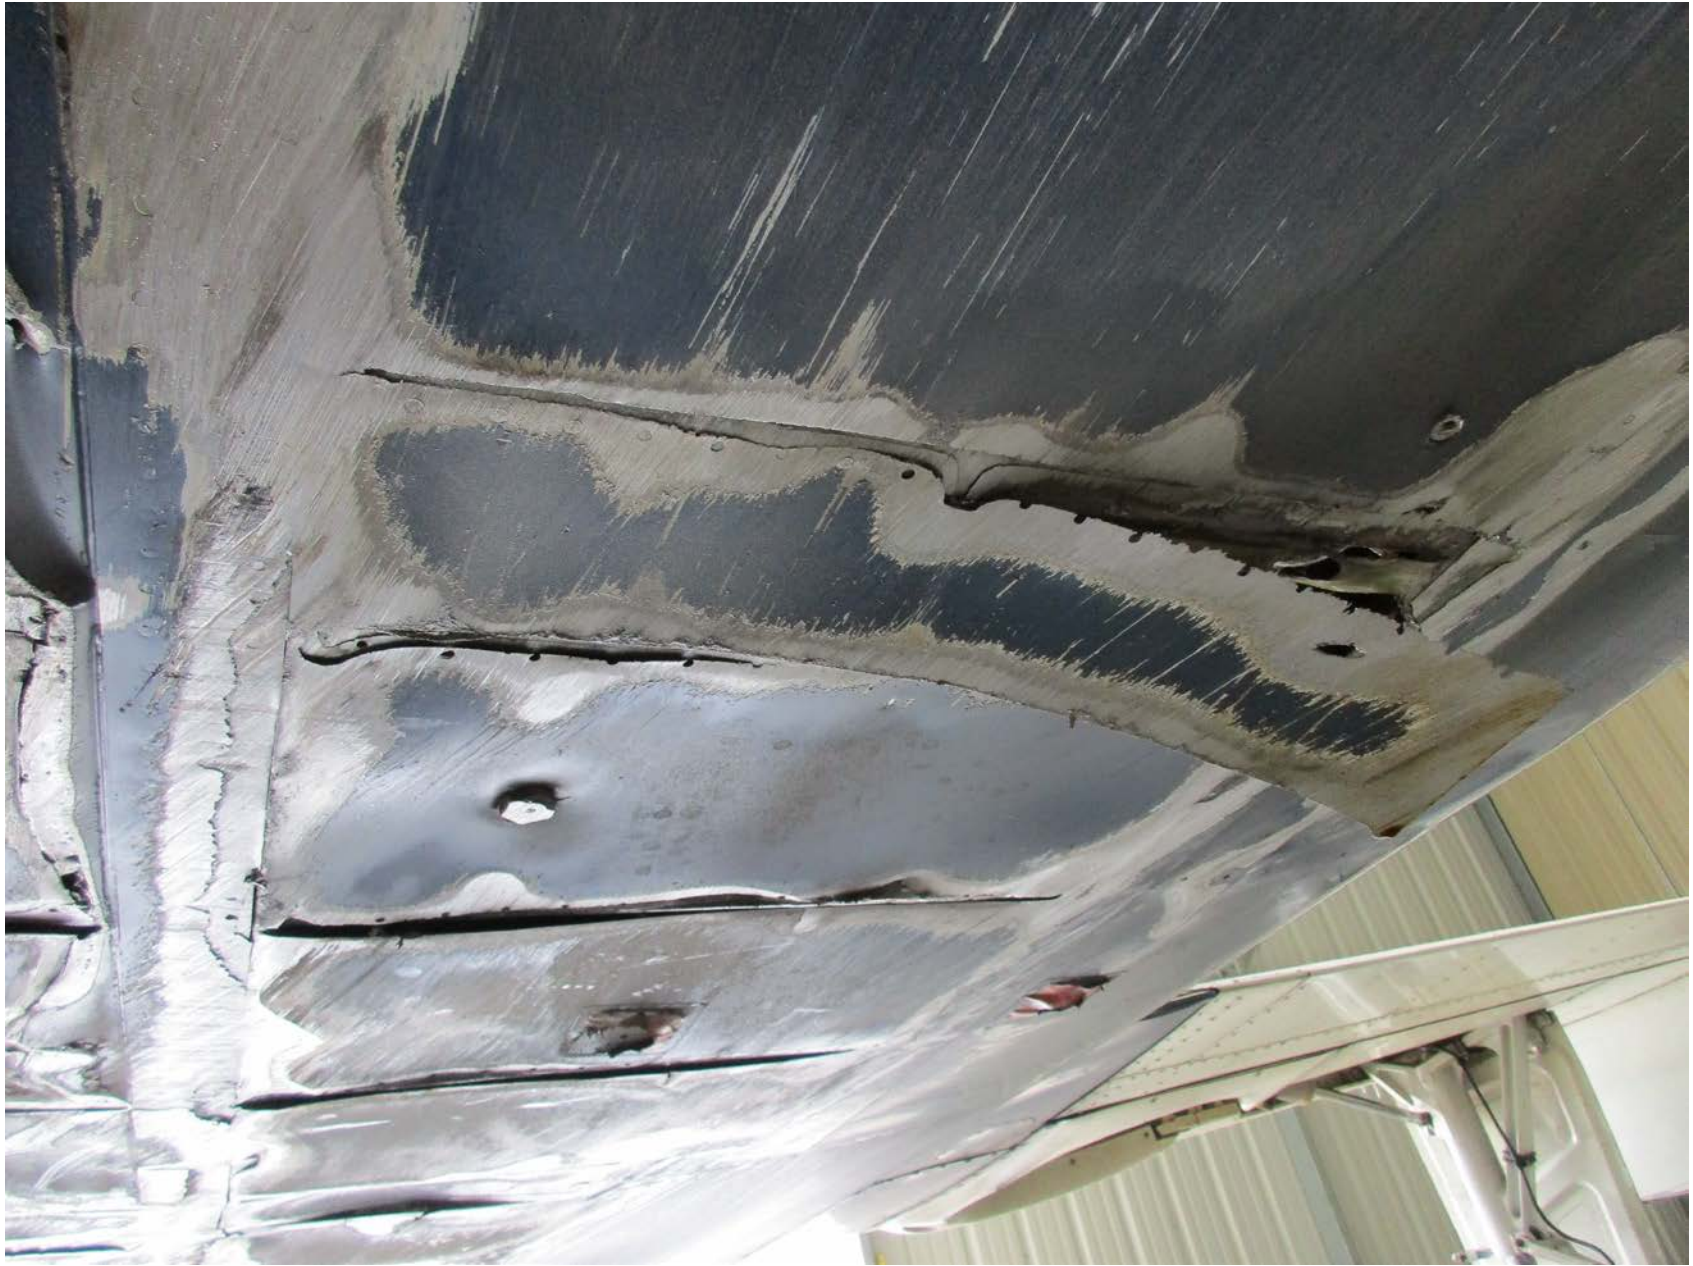
**Photo 2 – view 2 of undercarriage damage**
