## RECORD OF EMAIL

**Date: July 6, 2016**  
**Person Contacted: Mark Rushton (Federal Aviation Administration)**  
**NTSB Accident Number: WPR16LA129**

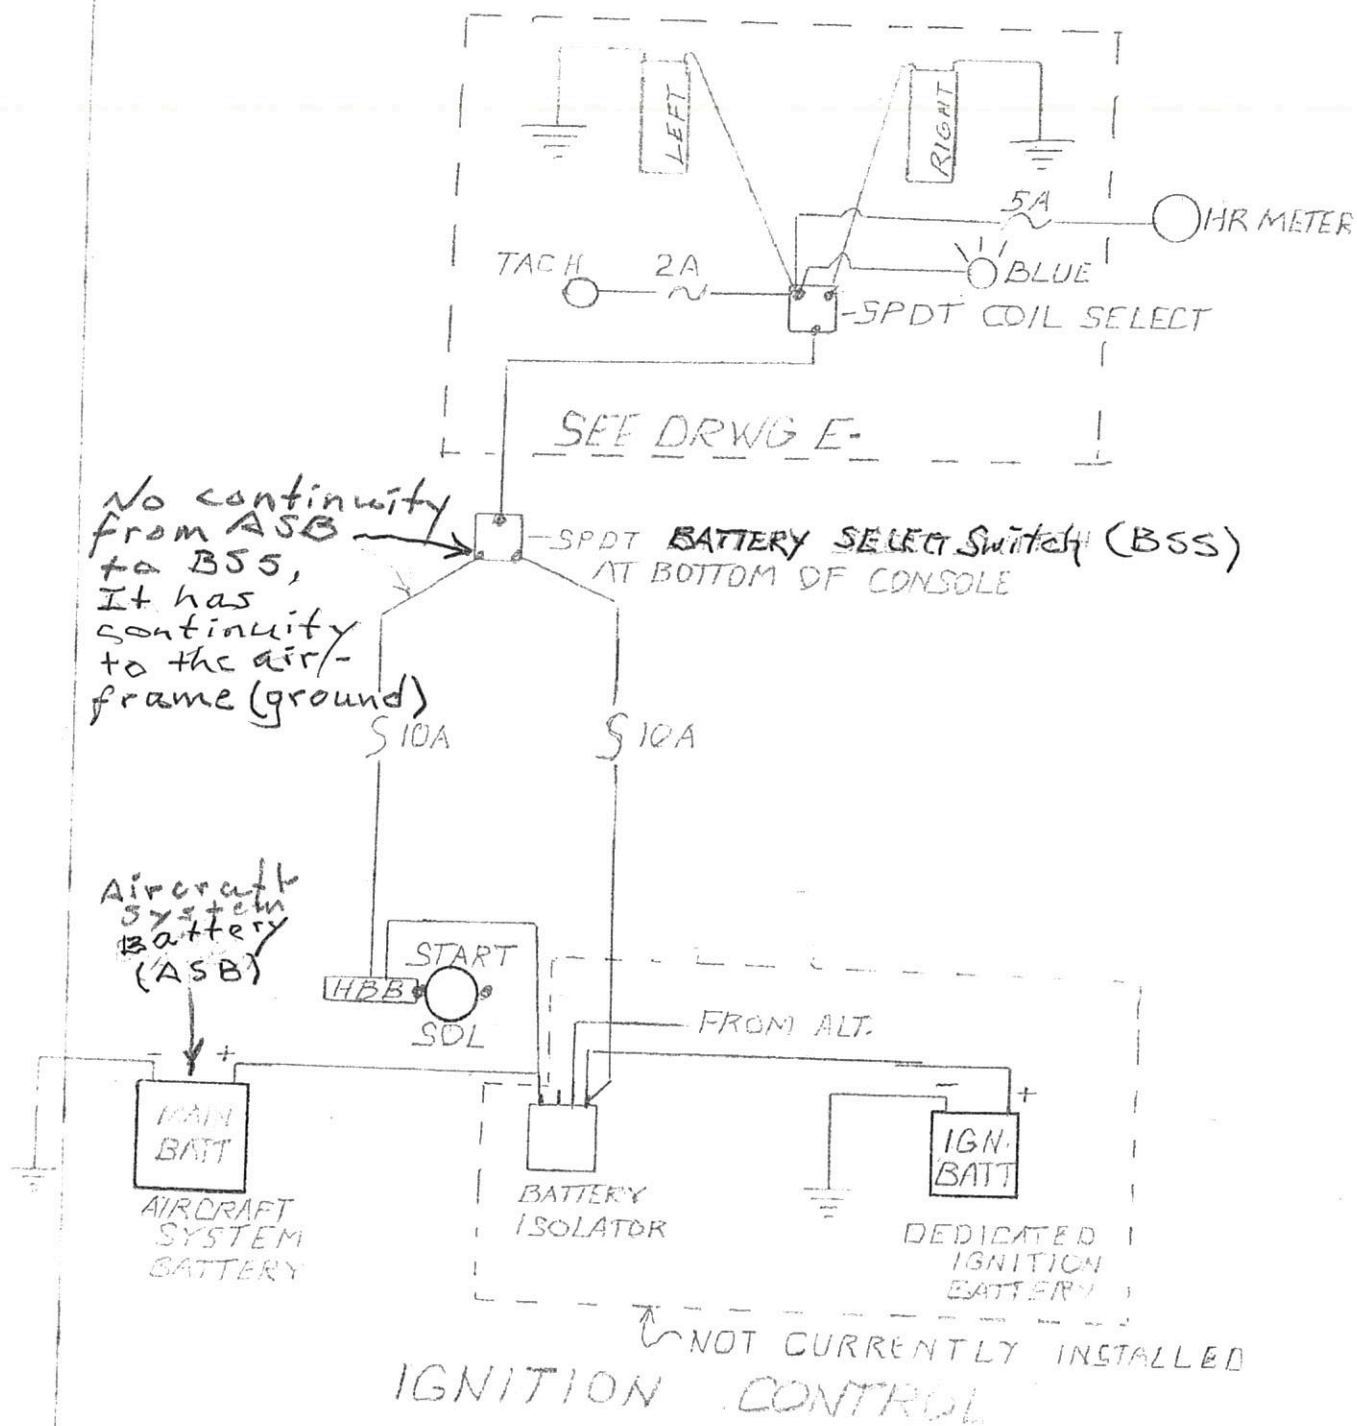
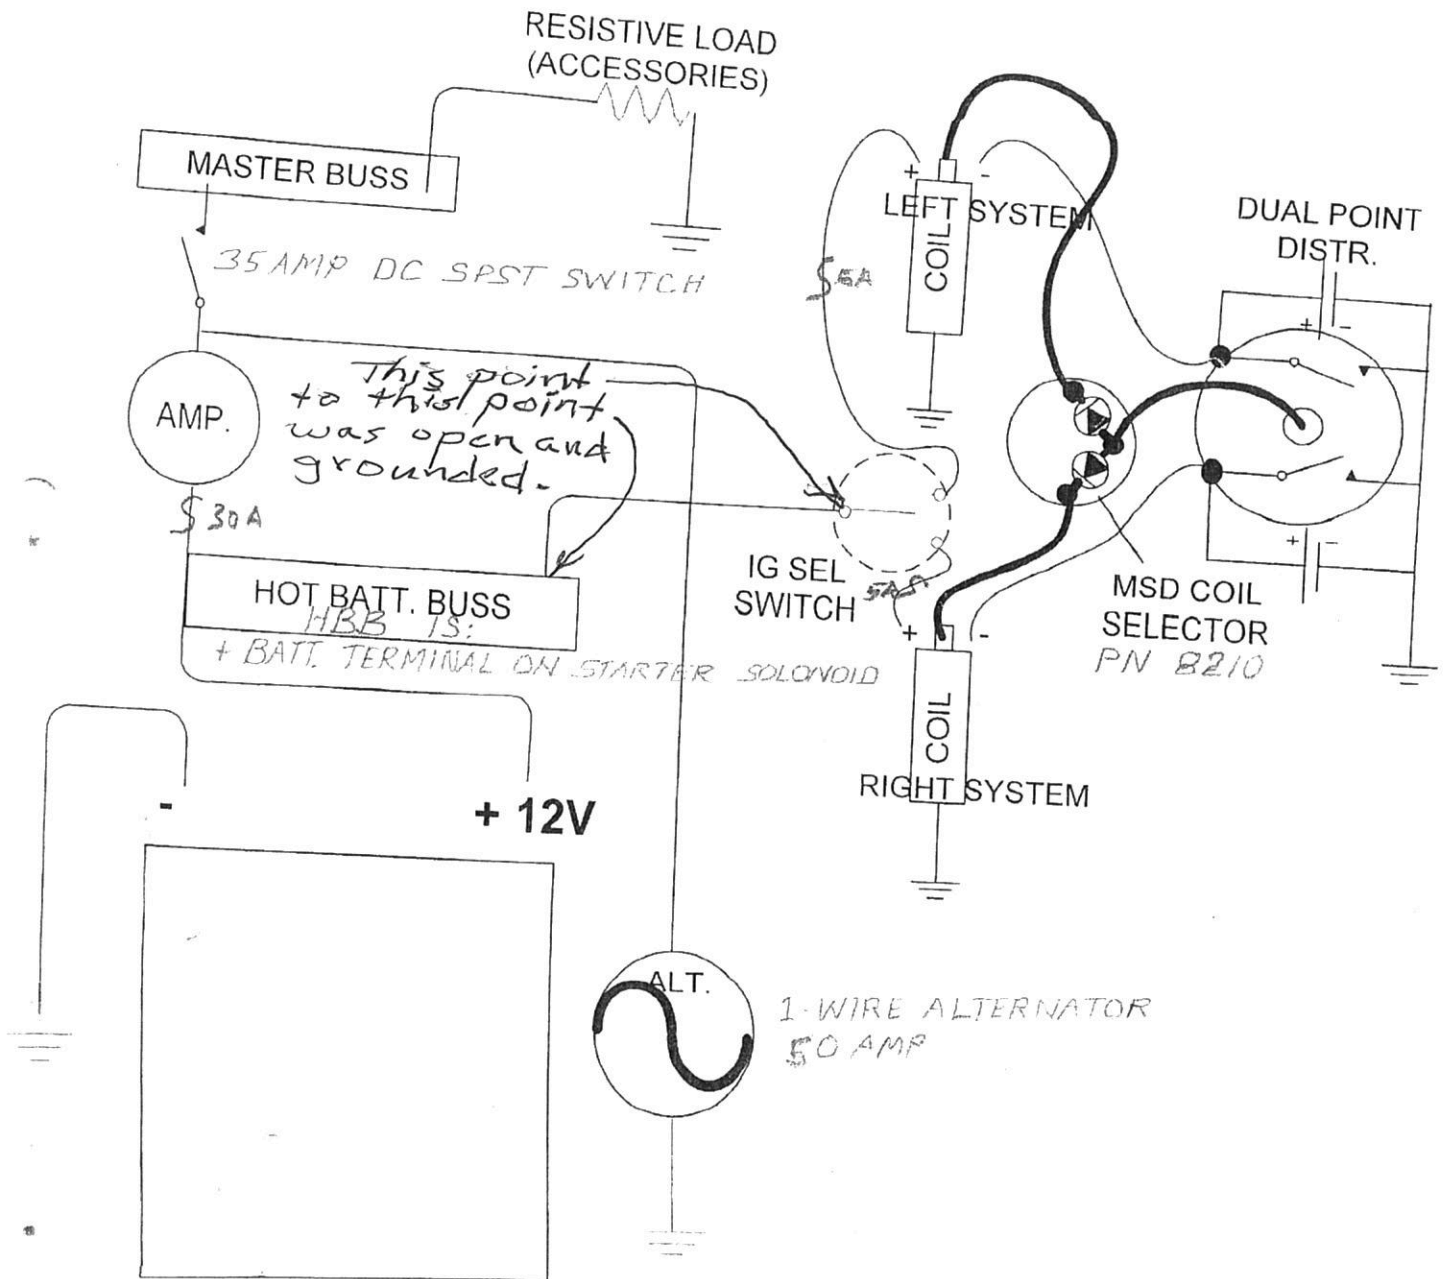
# IGNITION / MAIN BUSS

“The ignition system consists of a Mallory dual point auto racing distributor powered through dual redundant coils (see attached). Either coil can be powered by the aircraft system battery (ASB), or the secondary coil (only) can be powered by a stand-alone dedicated ignition battery (DIB). Following the engine quitting, Mr. Burkes first action, relative to ignition was to select the secondary coil, which produced no change, then to switch to the DIB, also with no change. Mr. Burkes surmises that the point he selected the DIB, the engine was grossly flood which prevented it from starting.

Our examination revealed that there was no continuity between the ASB and the battery select switch (BSS). Not only was the wiring open, but it was shorted to ground. This accounts for the initial engine failure. I have made copies of the two diagrams provided by Mr. Burkes, have added explanatory notes, and have added them to the attachments...”
