# NATIONAL TRANSPORTATION SAFETY BOARD

## MATERIALS LABORATORY FACTUAL REPORT

Report No. 17-004

Place : Spanish Fork, Utah  
Date : August 1, 2016  
Vehicle : Beech C99, N234AV  
NTSB No. : WPR16LA155  
Investigator : Chris Shaver, AS-WPR

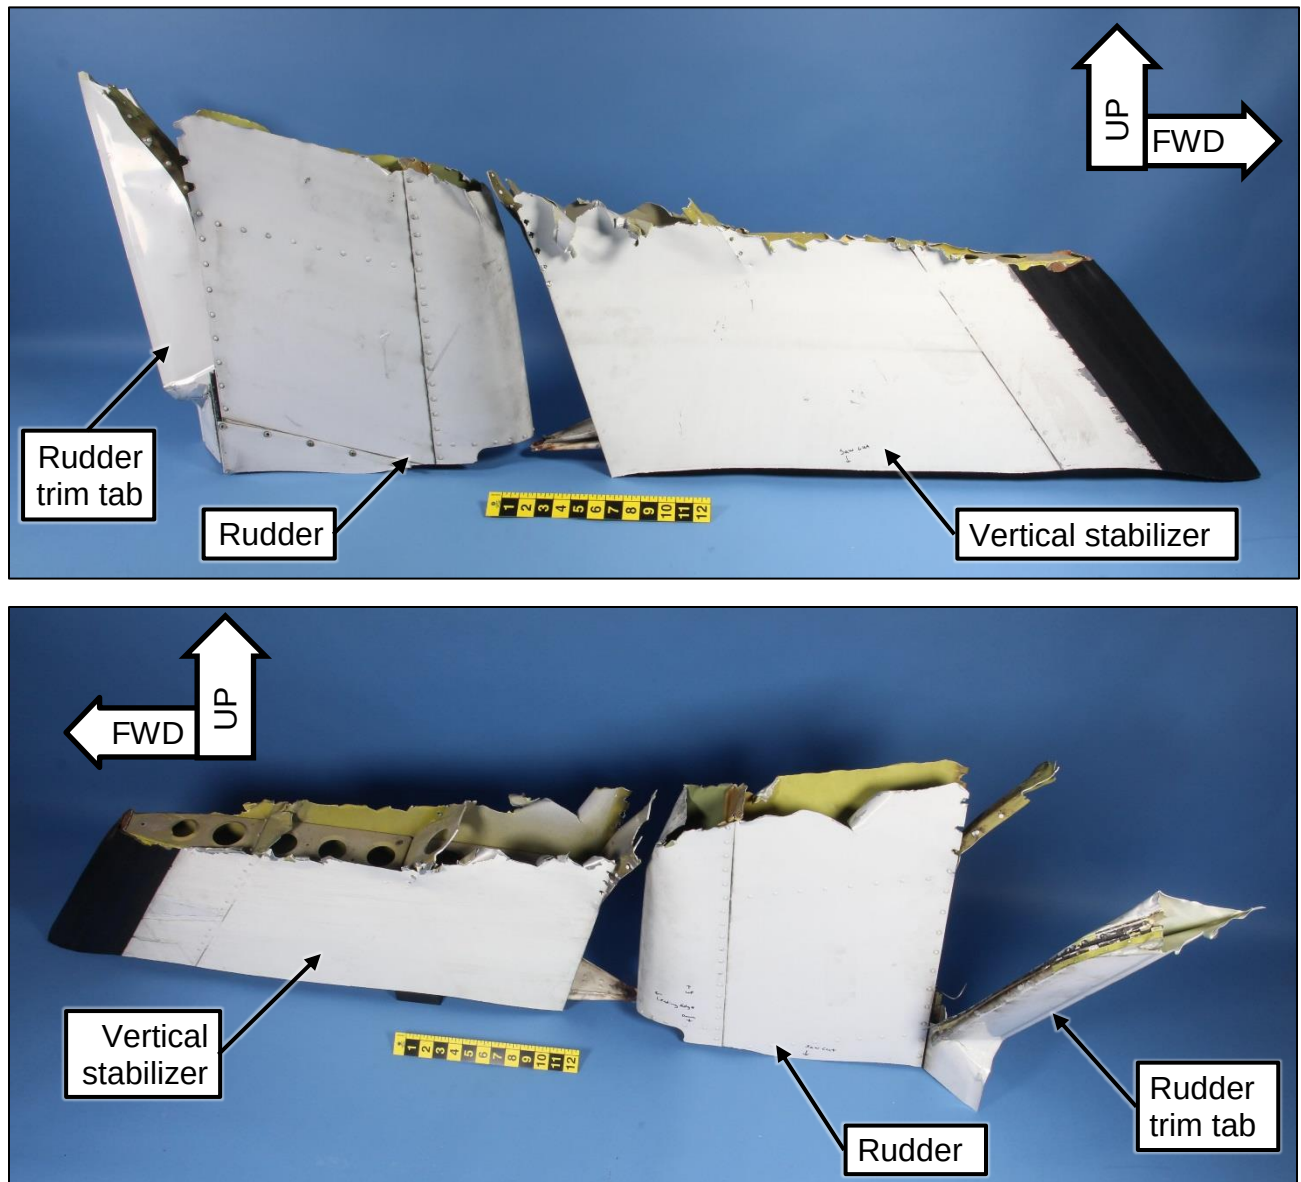
Overall views of the submitted vertical stabilizer, rudder, and rudder trim tab pieces are shown in figure 1. The pieces were fractured in a nearly horizontal plane at the upper ends of the submitted pieces and had been cut from the remainder of the structure at the lower ends to facilitate shipment to the NTSB Materials Laboratory. The piece of the rudder trim tab remained attached to the rudder. The mating upper pieces of the vertical stabilizer, rudder, and rudder trim tab were not recovered.

The leading edges of the vertical stabilizer, rudder, and rudder trim tab were all flattened adjacent to the fractures. Vertical spars in the vertical stabilizer and rudder were bent aft. Skin on the vertical stabilizer and rudder was deformed adjacent to the fracture into curled rolls turning downward and aft, and some areas were crushed consistent with the vertical stabilizer moving forward relative to another object. Sliding contact marks were observed at the leading edges, vertical spars, and deformed faces of the skin panels adjacent to the fractures. No evidence of any biological or manufactured foreign material transfer was observed associated with any of the fracture surfaces as observed visually and under optical magnification.

Figure 1. Overall views of the vertical stabilizer, rudder, and rudder trim tab as received.

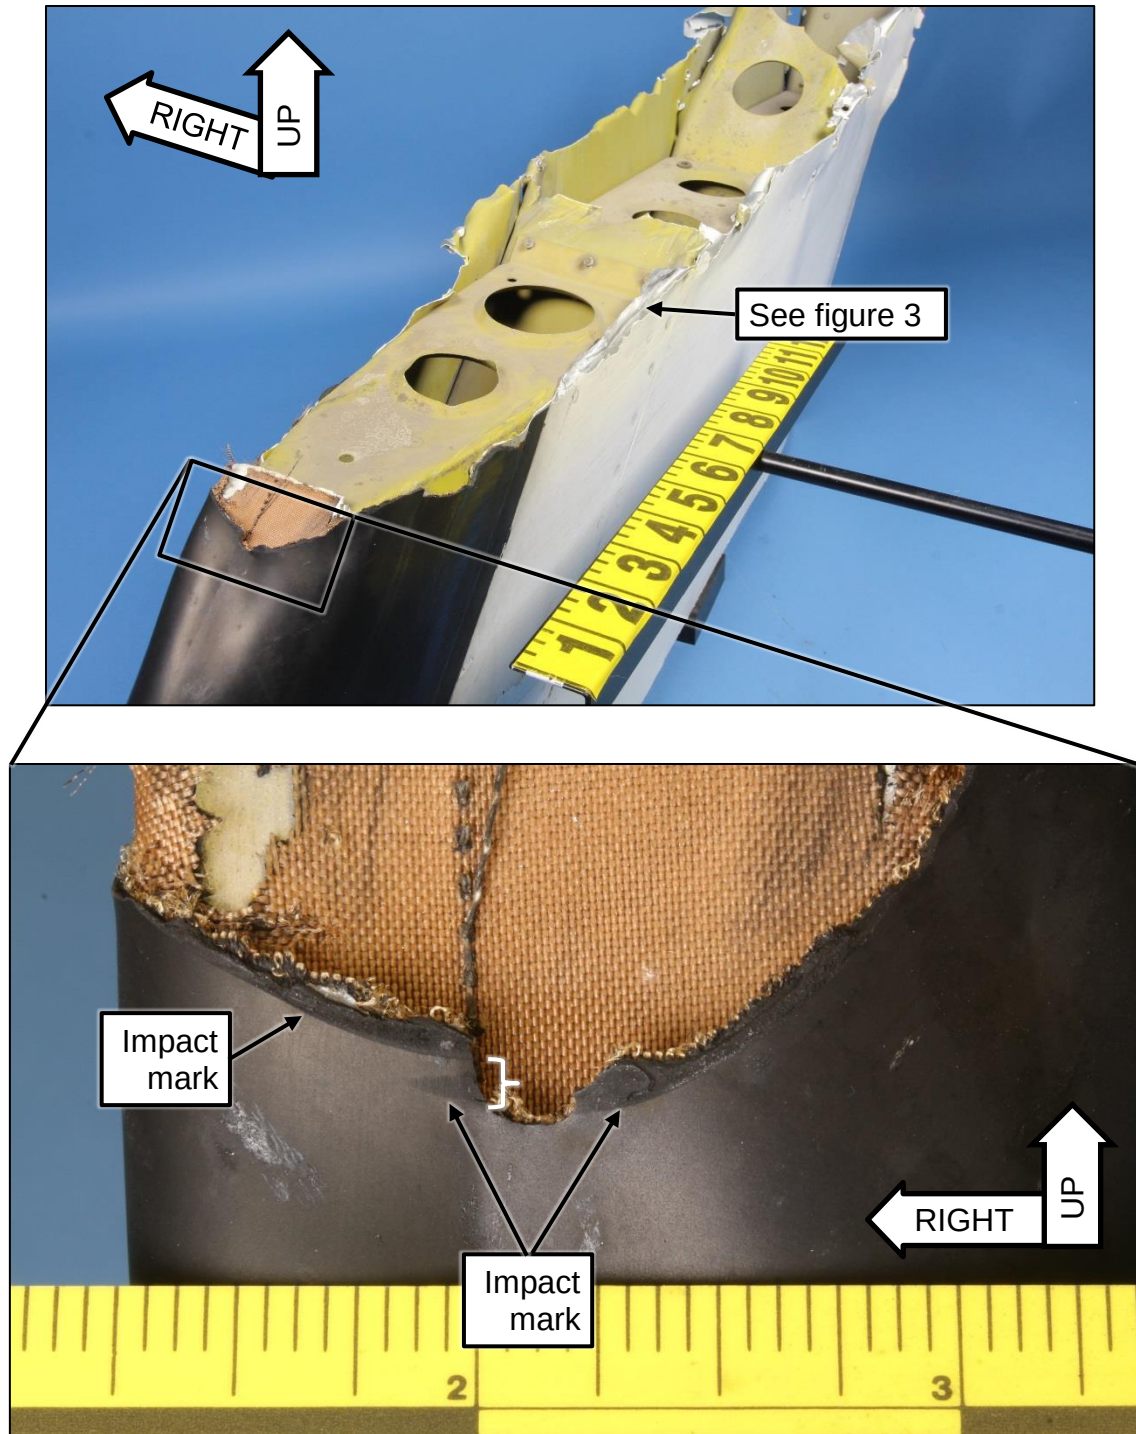
An oblique view of the vertical stabilizer is shown in figure 2. The leading edge of the vertical stabilizer was covered with a black elastomer. Impact marks were observed in the elastomer adjacent to the fracture as shown in the lower image in figure 2. One mark curved from the left side and ended in a point to the right of the aircraft centerline. A separate impact mark was observed above the other mark, and an unlabeled bracket in figure 2 indicates the spacing between the lower edges of the marks, which measured approximately 0.10 inch.

Figure 2. Oblique view of the vertical stabilizer fracture with a closer view of impact marks on the elastomer at the leading edge.

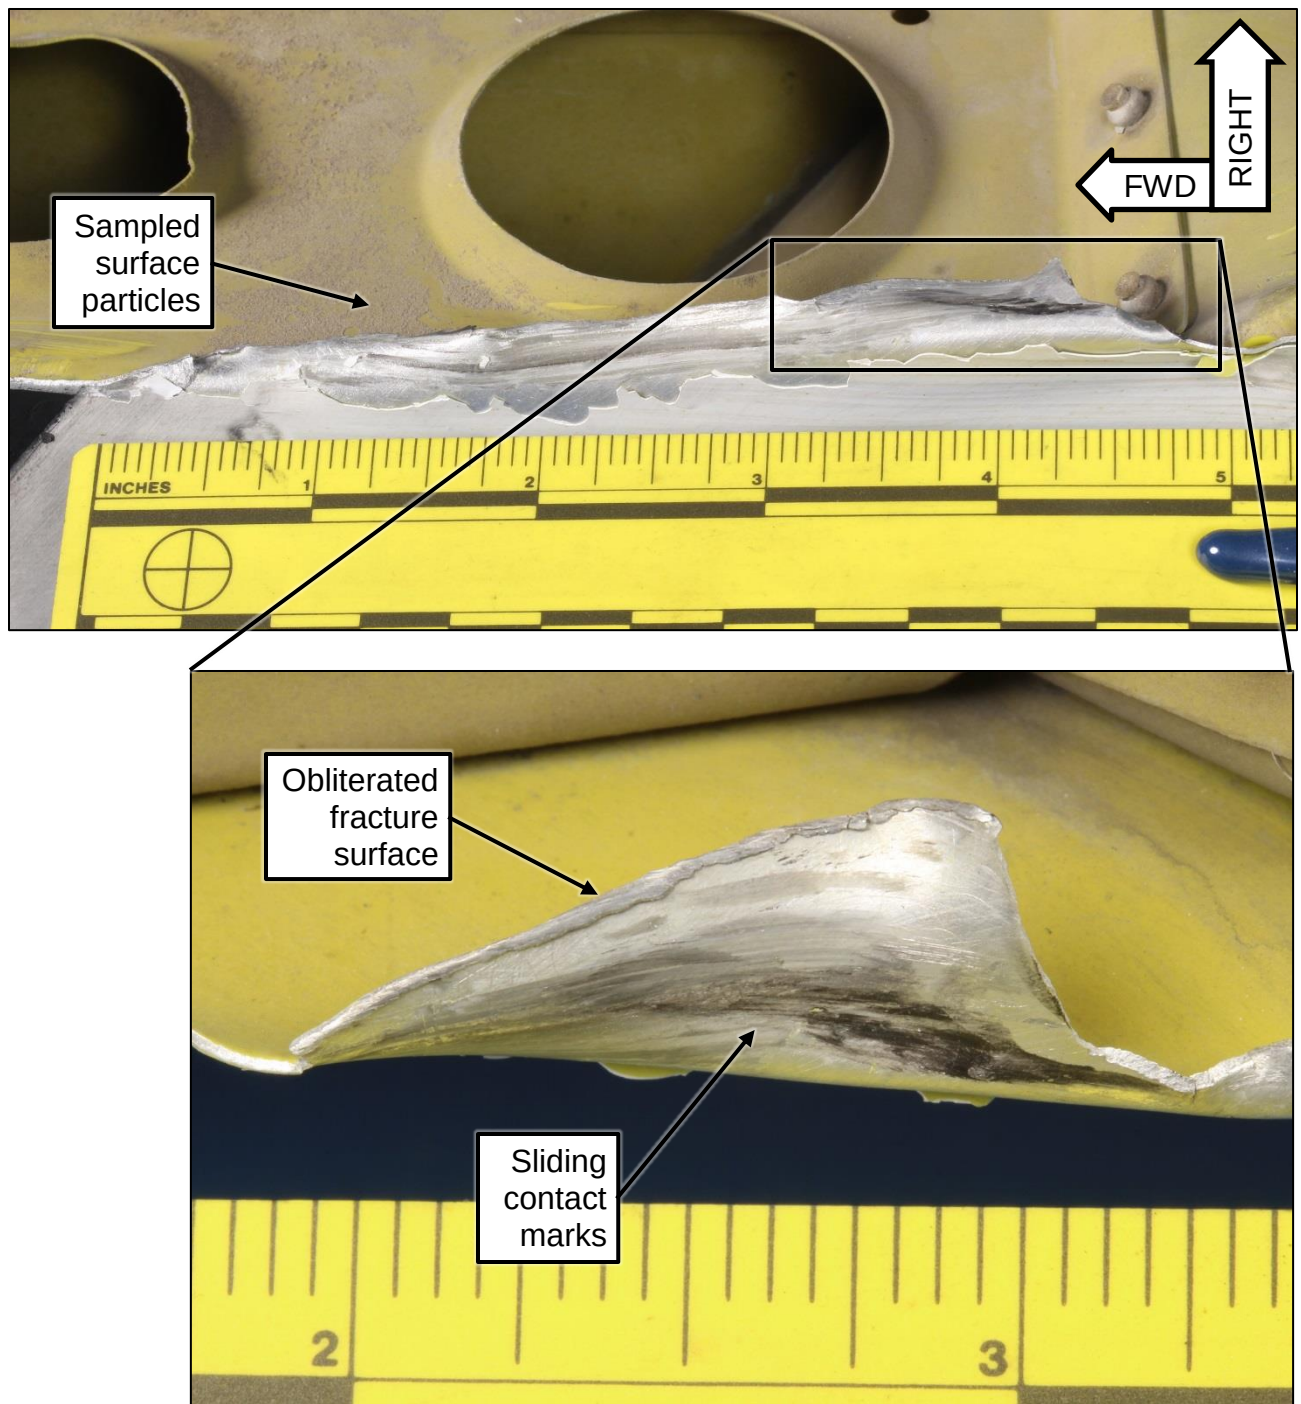
An area with heavy sliding contact was selected for closer examination using a scanning electron microscope (SEM) with energy dispersive x-ray spectroscopy (EDS). The area selected for further examination was from the left skin just forward of the forward vertical spar as noted in figure 2 and shown in closer views in figure 3. The skin adjacent to the fracture surface was deformed inward, and sliding contact marks were observed on the exterior surface of the skin. Paint and primer was missing from the areas with deformation and sliding contact. Fracture features on portions of the fracture surface in this area were obliterated by sliding contact, and the edge of the skin at the fracture face was flattened and rolled over onto the adjacent surfaces. The lower image in figure 3 shows rolled material associated with the obliterated fracture face and a closer view of sliding contact marks on the exterior surface of the skin.

Deposits of particles were observed on the interior surface mostly on the rib adjacent to the fracture as indicated in figure 3. The deposits were caked on and remained largely in place after being exposed to blasts of compressed air.

The area shown in figure 3 was sectioned from the remainder of the vertical stabilizer to facilitate an SEM examination. The surfaces were imaged using backscattered electrons<sup>1</sup> to help identify any potential foreign material on the surface for further compositional analysis using EDS. An area of sliding contact on the skin surface that appeared black in the optical image in figure 3 is shown in figure 4 as viewed in the SEM using backscattered electrons. The area of sliding contact appeared darker in the SEM image, consistent with lower atomic weight material. Many lighter gray particles were observed within the contact area, and an example of two of the particles are shown in figure 5. The particles generally appeared curved and deformed, and many appeared to have step features at the surface consistent with high strain deformation.

Figure 3. Close views of the deformed skin, sliding contact marks, and obliterated fracture surface on the left skin panel (see figure 2 for location).

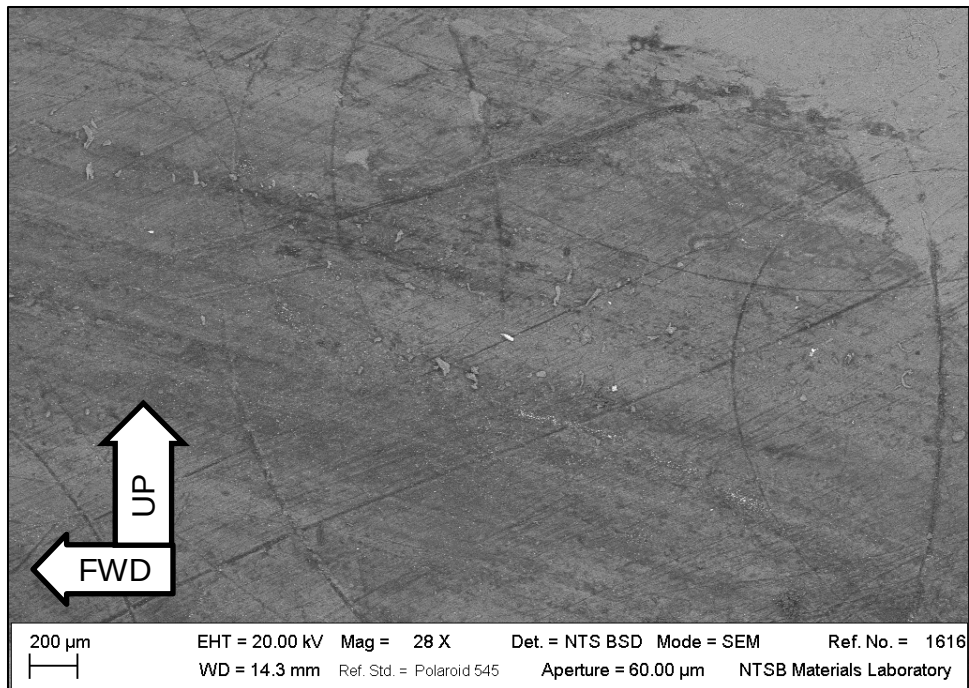
Figure 4. Area of sliding contact as viewed with an SEM using backscattered electrons.

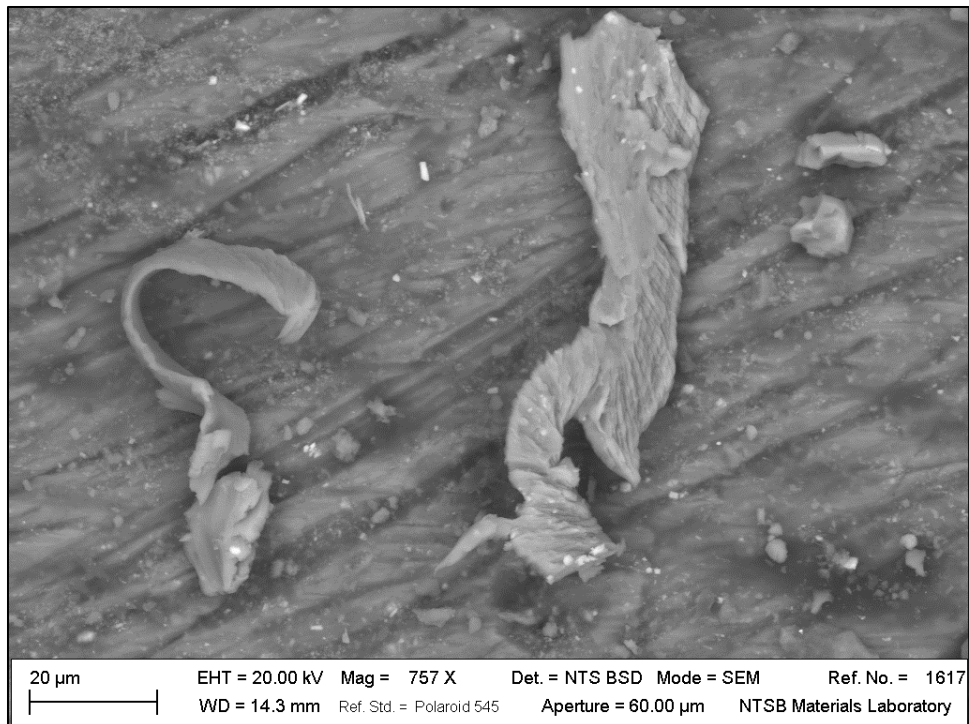
The gray particles shown in figure 5 had high peaks of aluminum with metallic element peaks of magnesium, copper, and manganese (see spectrum in figure 10). The spectrum was consistent with aluminum alloy 2024, and similar metallic element peaks were observed in EDS spectra of the skin surface as shown in figure 11.

Figure 5. SEM image of medium gray particles on the surface in the area of sliding contact as viewed using backscattered electrons.

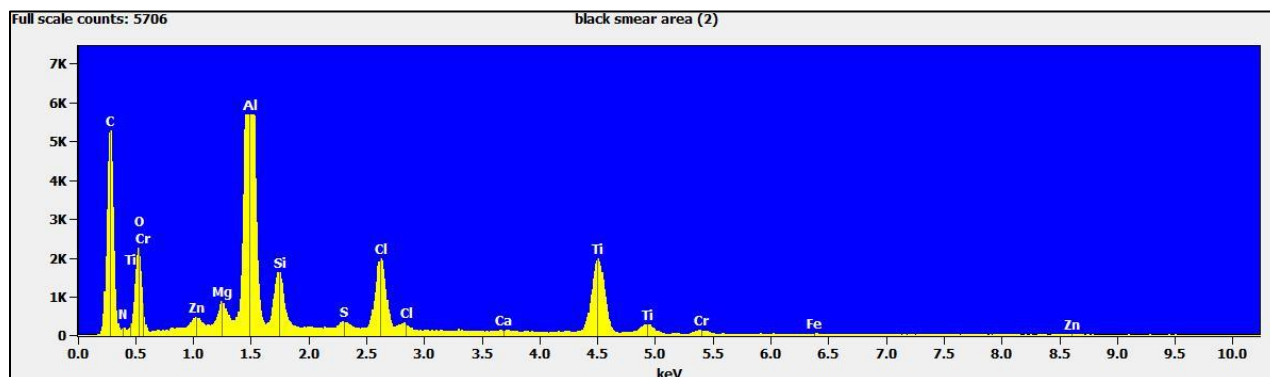
An EDS spectrum from the darker area in figure 4 (in the area of sliding contact) is shown in figure 6. The largest peaks were aluminum and carbon with additional peaks of oxygen, magnesium, silicon, sulfur, chlorine, calcium, titanium, chromium, iron, and zinc. EDS spectra of the paint and the primer layers were also taken as shown in figures 7, 8, and 9. The three highest peaks in the external paint layer were carbon, oxygen, and titanium. In the primer layer under the external paint layer, the three highest peaks were carbon, oxygen, and silicon. The internal surface of the skin had a primer layer with an EDS spectrum with high peaks of oxygen, carbon, chromium and zinc.

Figure 6. EDS of the surface in the darker area shown in figure 4 (area of sliding contact).

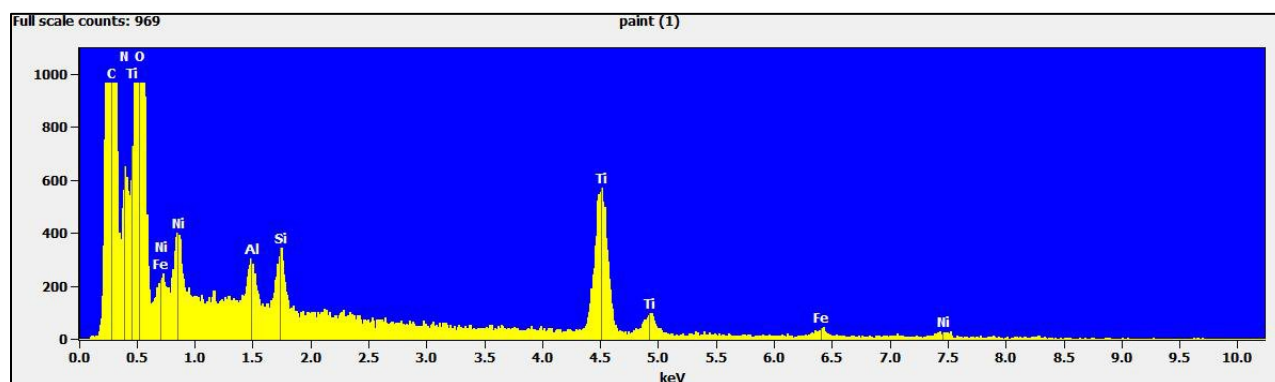
Figure 7. EDS spectrum of the exterior paint coating.

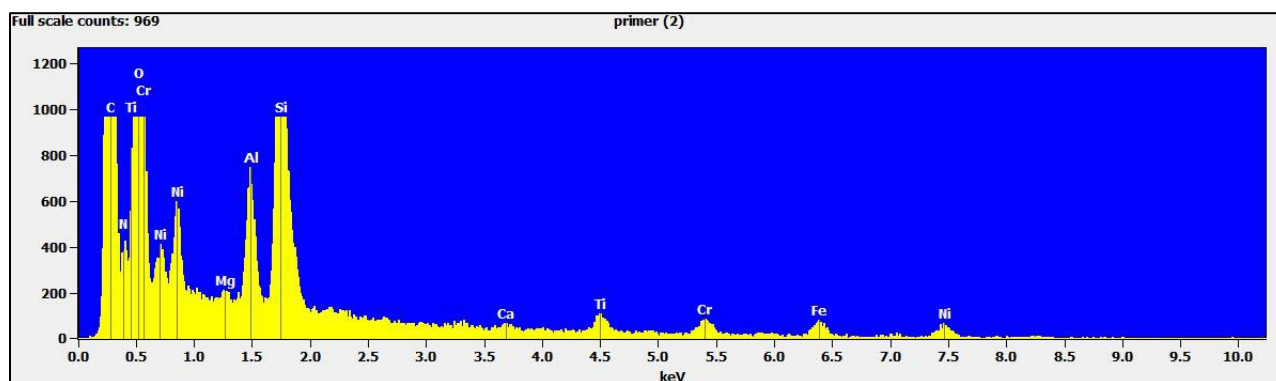
Figure 8. EDS spectrum of the primer coating under the exterior paint coating.

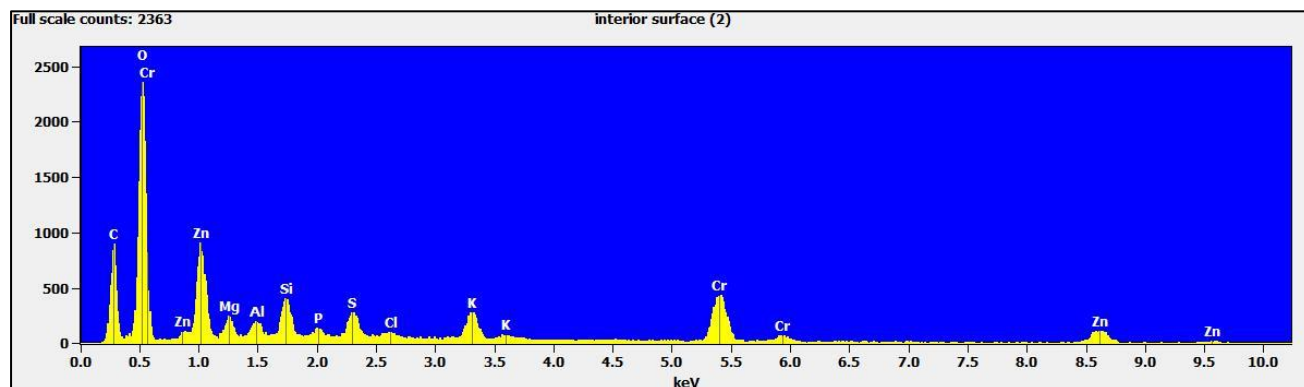
Figure 9. EDS spectrum of the primer on the interior surface of the skin.

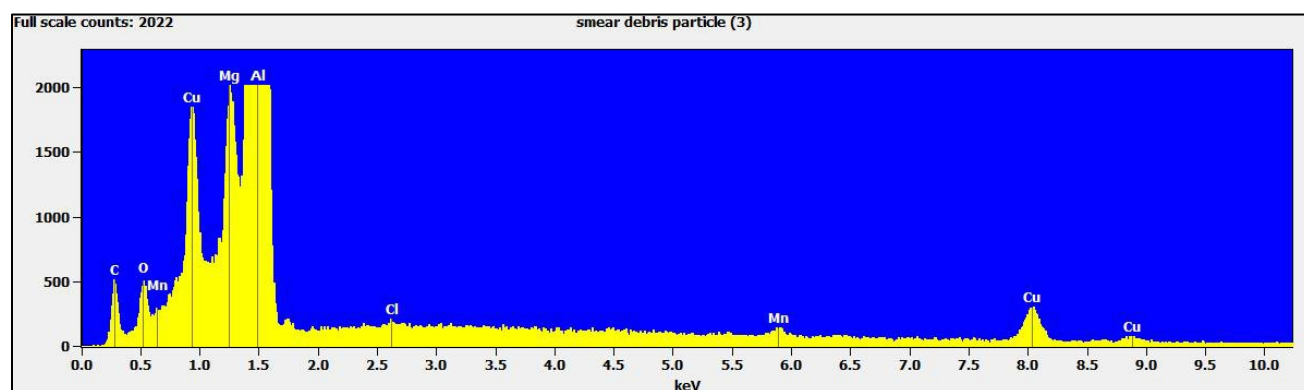
Figure 10. EDS spectrum of one of the medium gray particles such as those shown in figure 5.

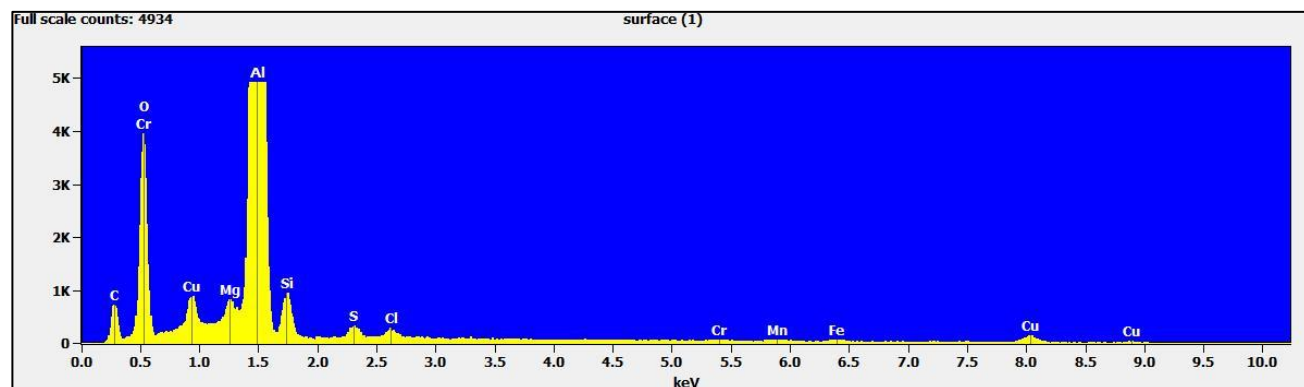
Figure 11. EDS spectrum of the surface of the vertical stabilizer skin.

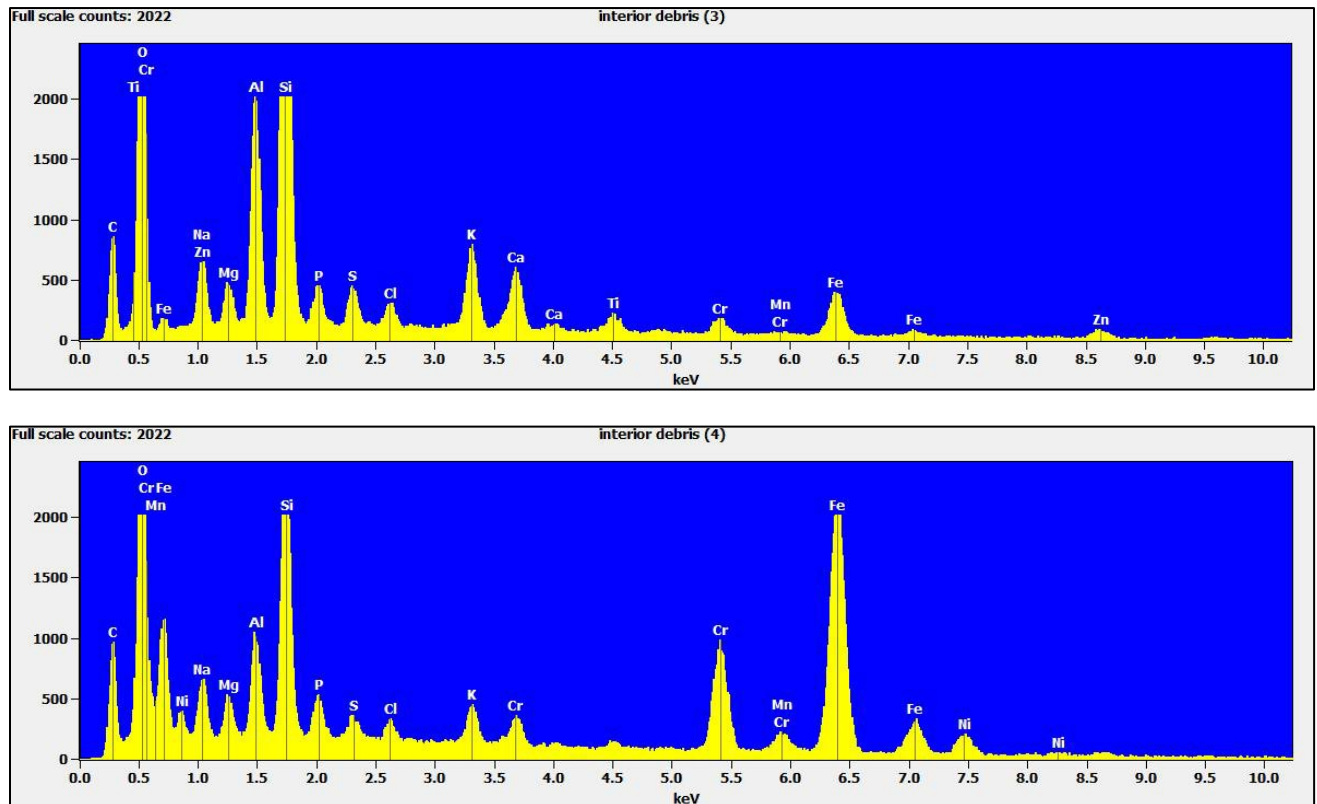
A sample of the particles remaining caked onto the rib adjacent to the fracture after being blast with compressed air (see indicated area in figure 3) was extracted from the surface by pressing an aluminum stub covered with carbon tape onto the surface and lifting several times. The extracted particles were then analyzed using EDS, and two of the resulting spectra are shown in figure 12. The EDS spectra for the particles showed many of the peaks observed for particles on the skin surfaces in the areas of sliding contact. Particles with a shape and EDS composition consistent with glass fiber fragments were also observed scattered within the extracted sample.

Figure 12. EDS spectra of debris sampled from the surface of the vertical stabilizer rib.
