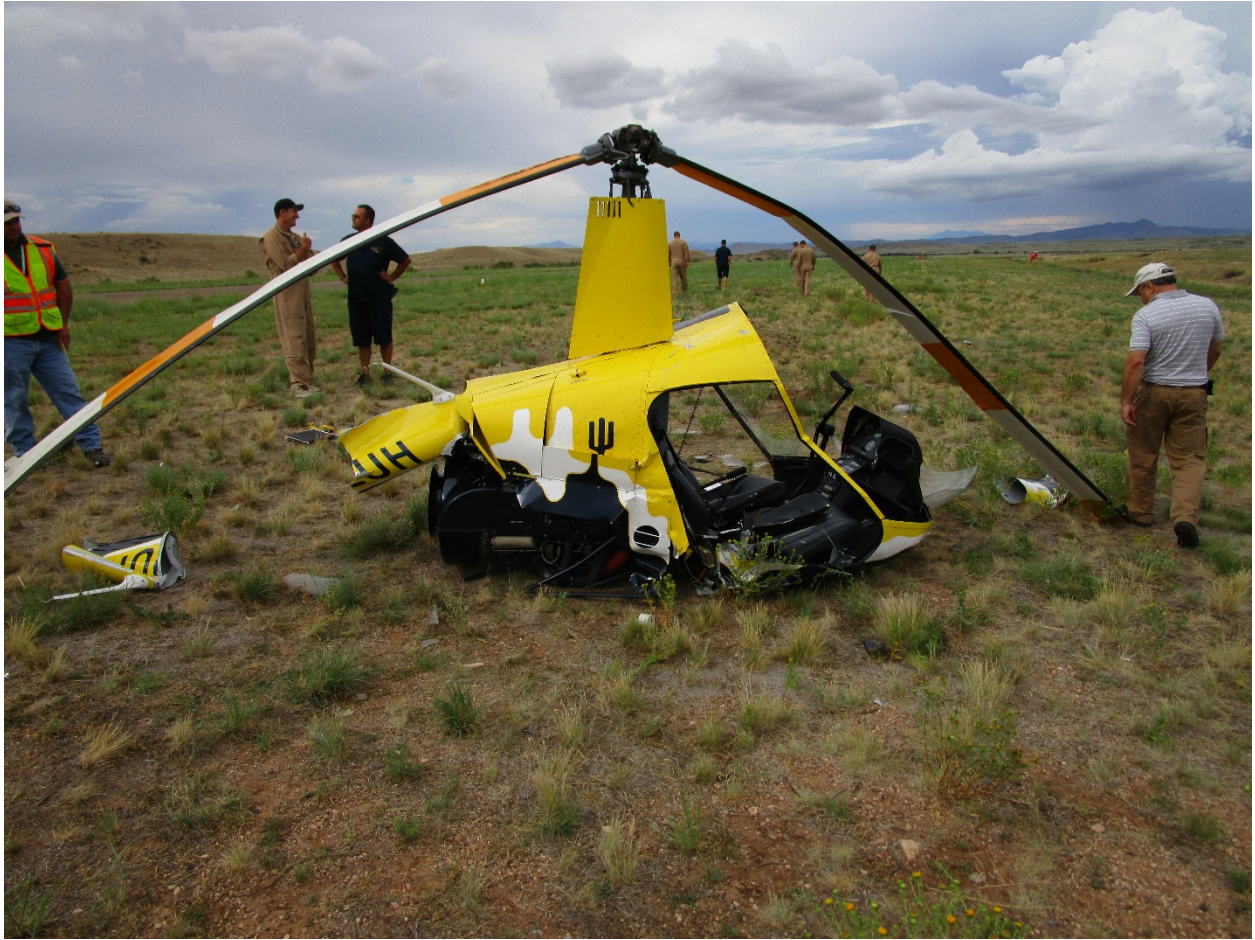
**Figure 1 Side view of structural frame damage to helicopter**

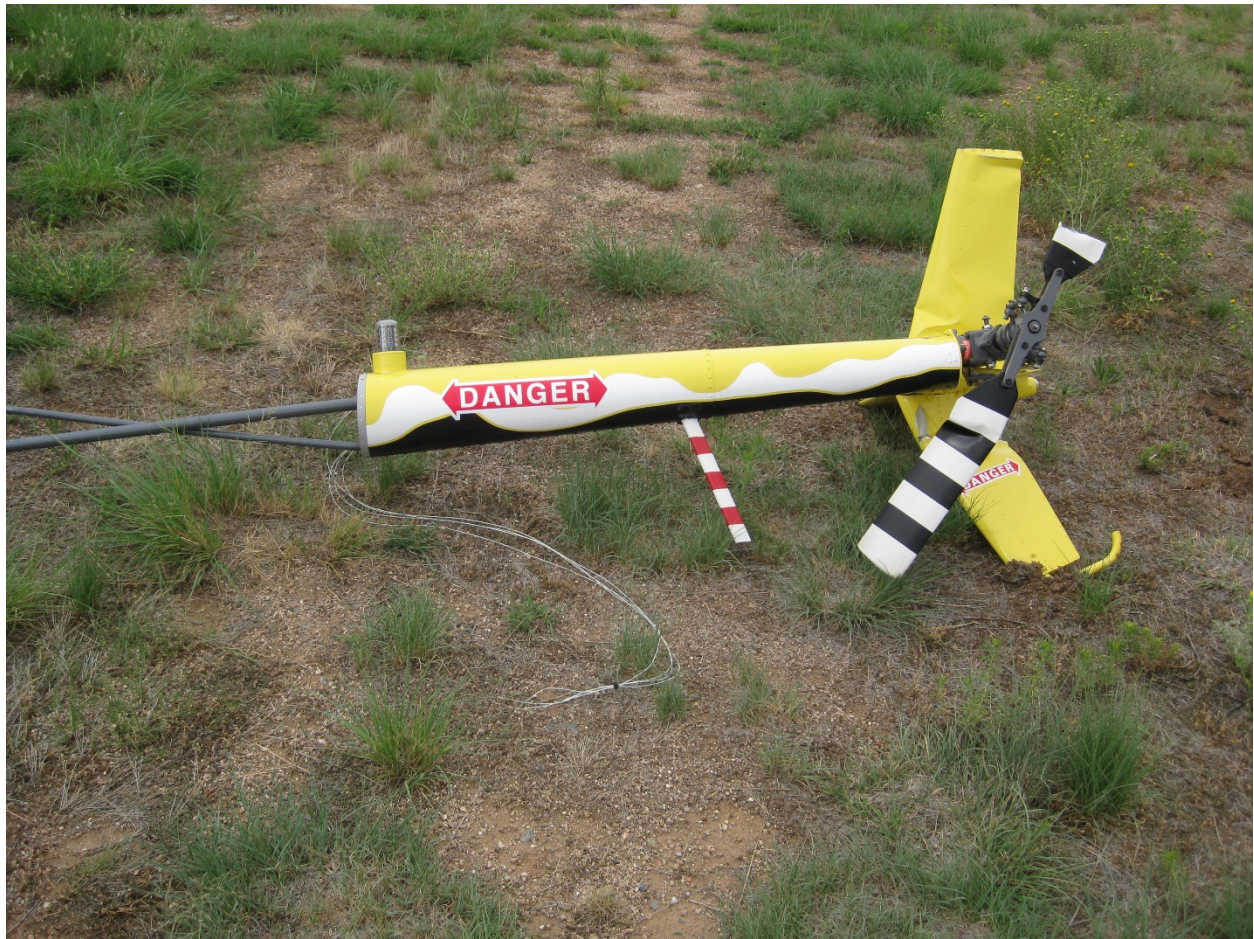
**Figure 2 Severed tail boom**

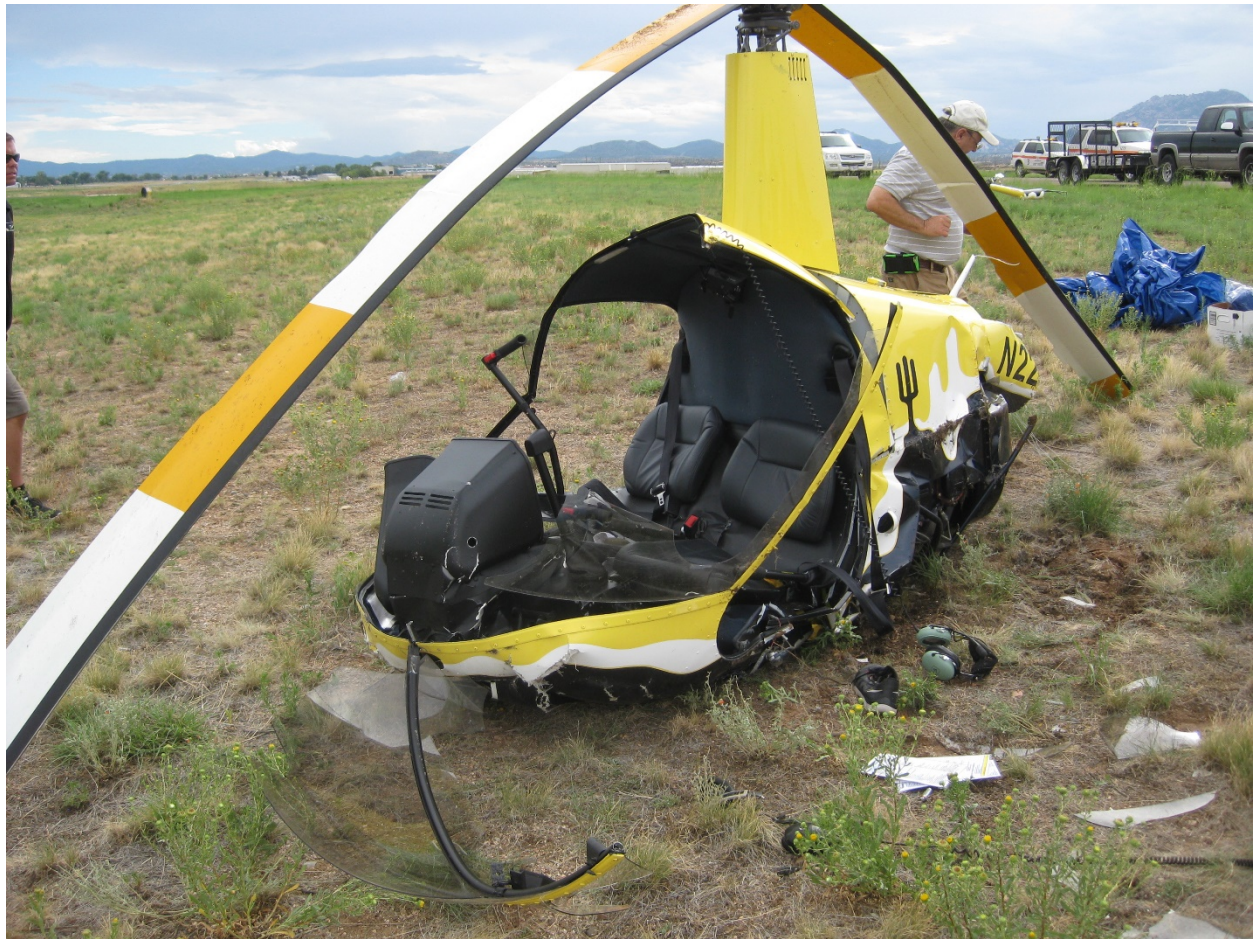
**Figure 3 Front view of helicopter with damaged main rotor blades**
