# NATIONAL TRANSPORTATION SAFETY BOARD

## MATERIALS LABORATORY FACTUAL REPORT

Report No. 17-027

Place : Gunnison, Utah  
Date : August 12, 2016  
Vehicle : Robinson R-44 II  
NTSB No. : WPR16LA165  
Investigator : Howard Plagens, AS-WPR

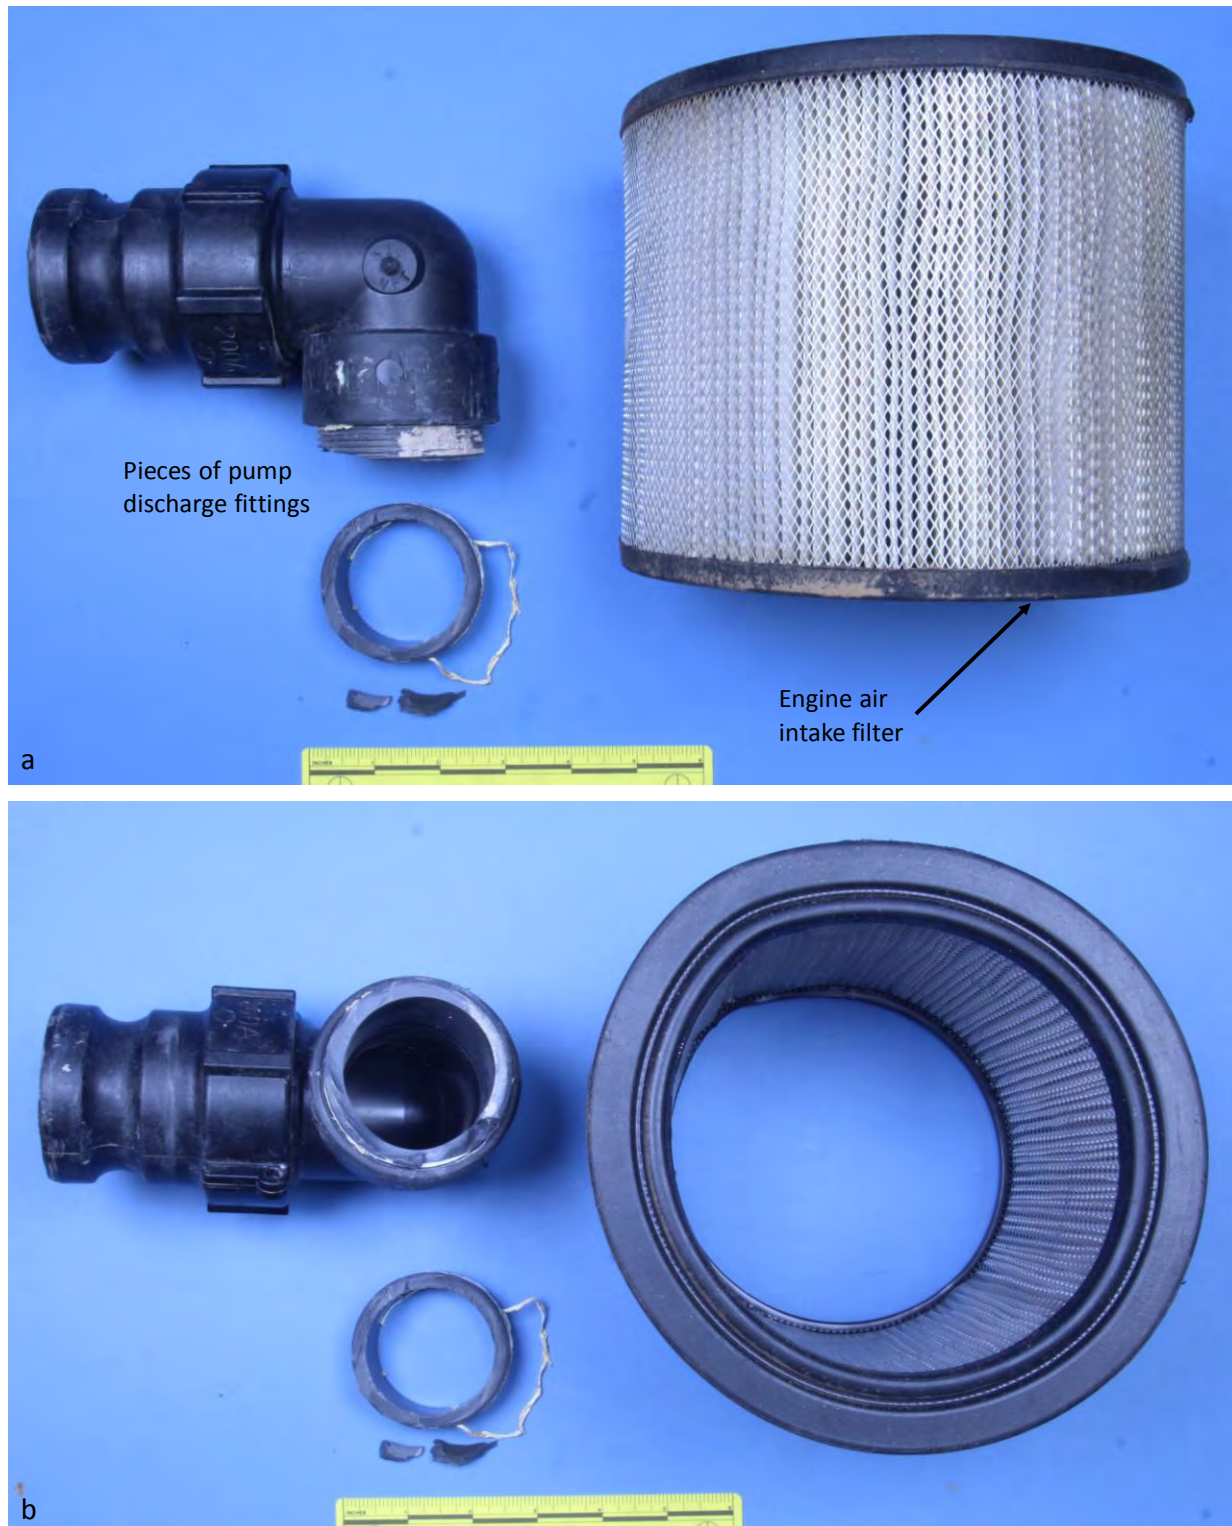
The as-received engine air intake filter and the pump discharge fitting pieces are shown in Figure 1. Further details of the pump discharge pieces are shown in Figure 5. The arrangement of the pump discharge fittings as installed on the Simplex R44III spray system are shown in Figures 2-4<sup>2</sup>. The purpose of this report is to determine the failure mode of the close nipple fractures and to inspect the engine air intake filter for cake deposits.

Figure 1 As-received pump discharge fitting pieces and engine air intake filter. View (a) is a profile image and view (b) is an axial image.

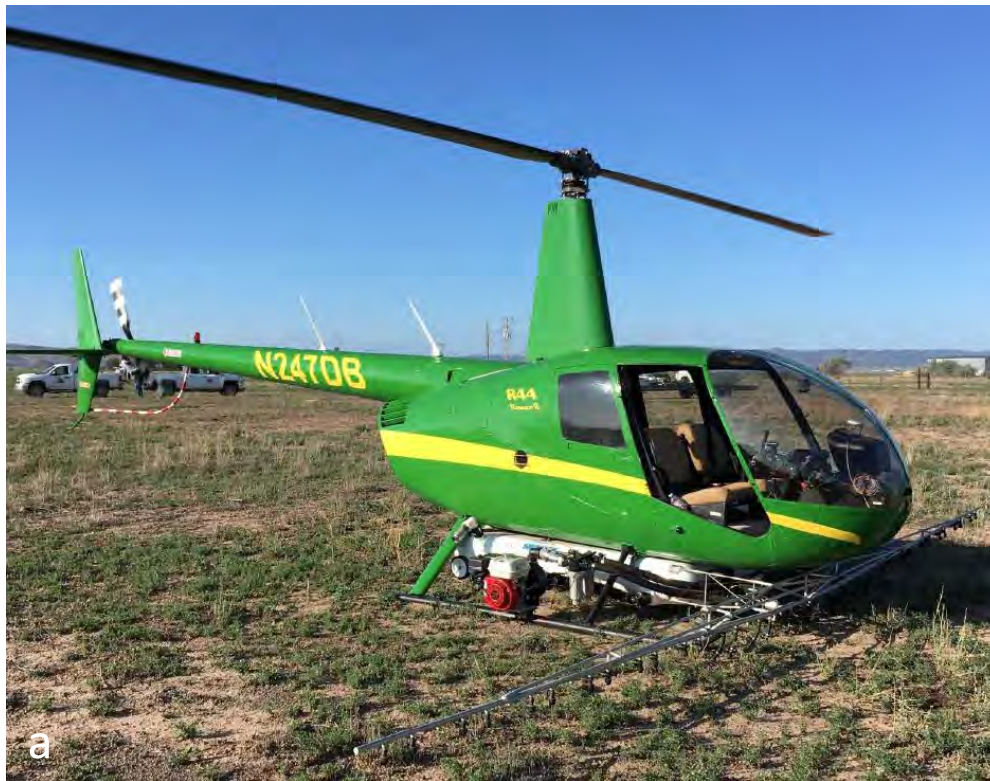
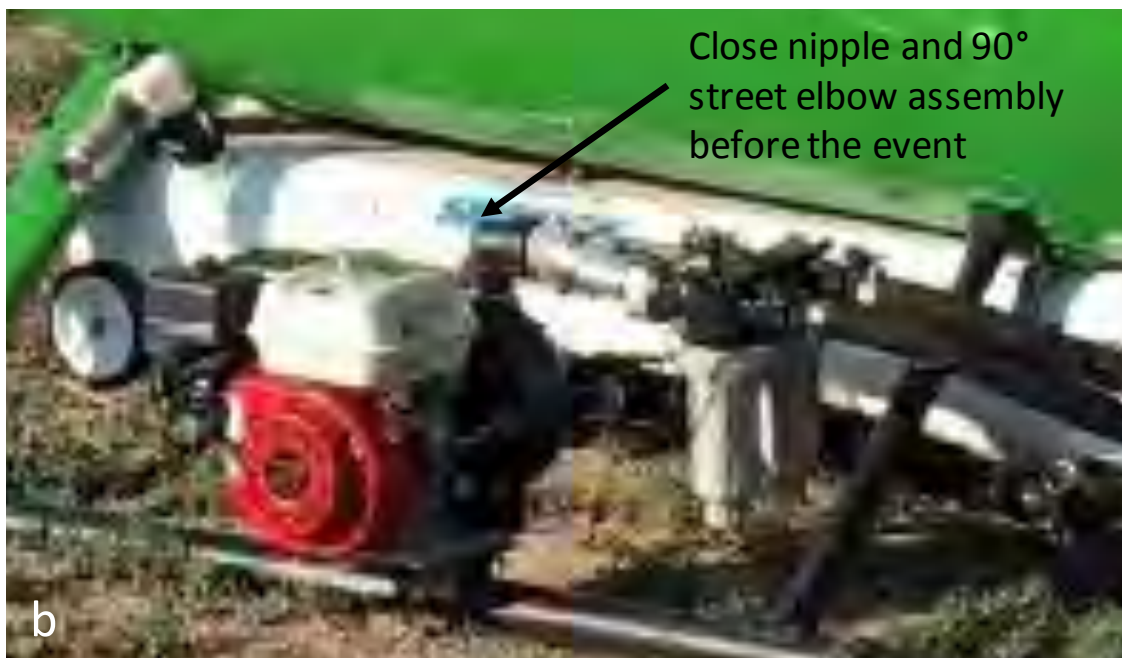
Figure 2 View of the close nipple and 90° street elbow as installed on the pump discharge portion of the Simplex R44III spray system (before the incident). Images provided by the operator.

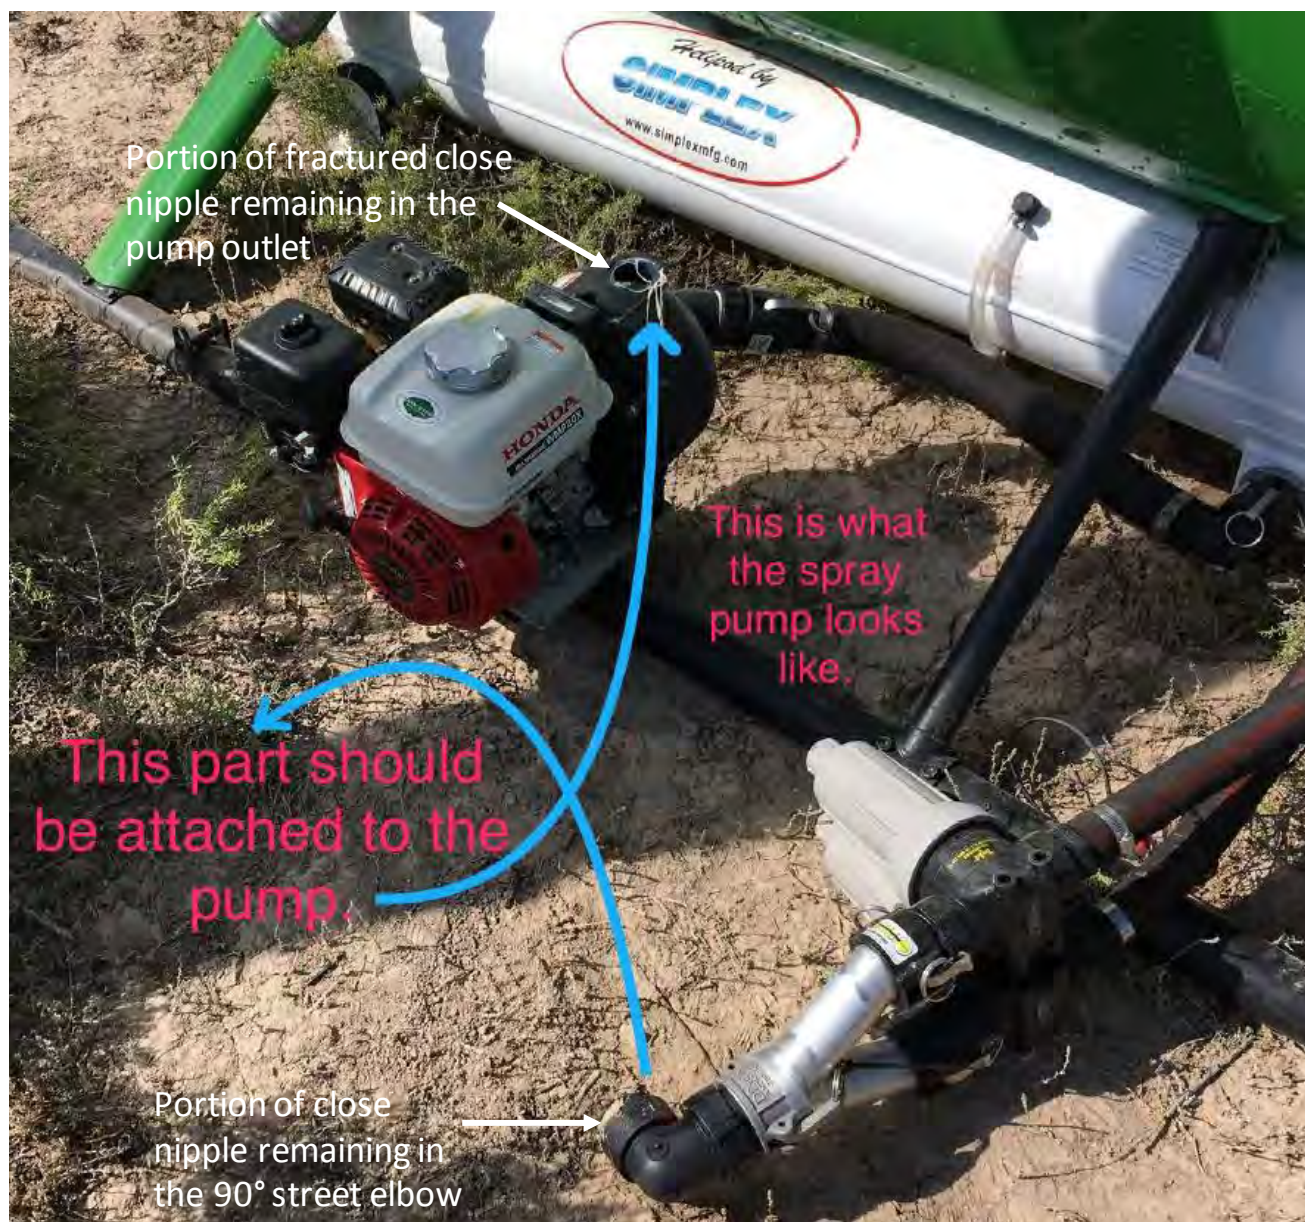
Figure 3 View of the close nipple pieces and the 90° street elbow on the Simplex R44III spray system (after the incident). Image provided by the operator.

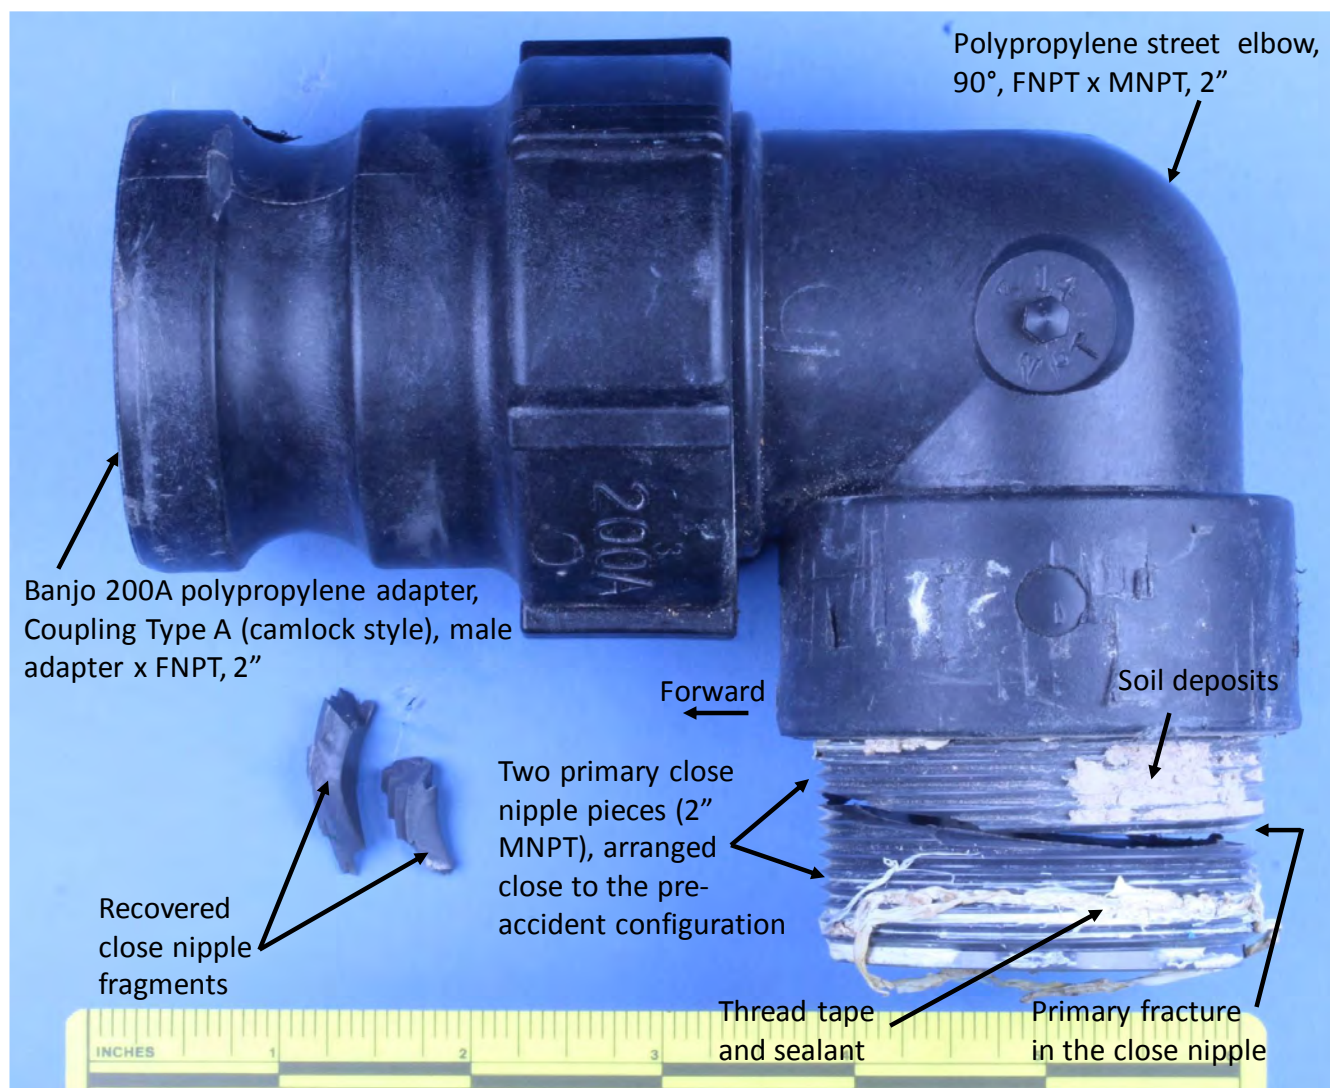
Specific details regarding the components and pieces in the submitted discharge fitting assembly are outlined in Figure 5. In the figure, the two primary close nipple pieces are arranged close to their pre-accident configuration (without fracture surface contact). The arrangement of the fitting components relative to the Honda illustrated parts diagram is shown in Figure 6. According to Figure 6 and a representative from Simplex, the close nipple was threaded directly to the pump housing discharge outlet. However, the parts diagram shows the male side of the elbow fitting to be threaded directly to the pump housing discharge outlet.

Figure 5 Close view of the 90° street elbow, the cam lock fitting and pieces of the close nipple removed from the discharge side of the spray system pump.

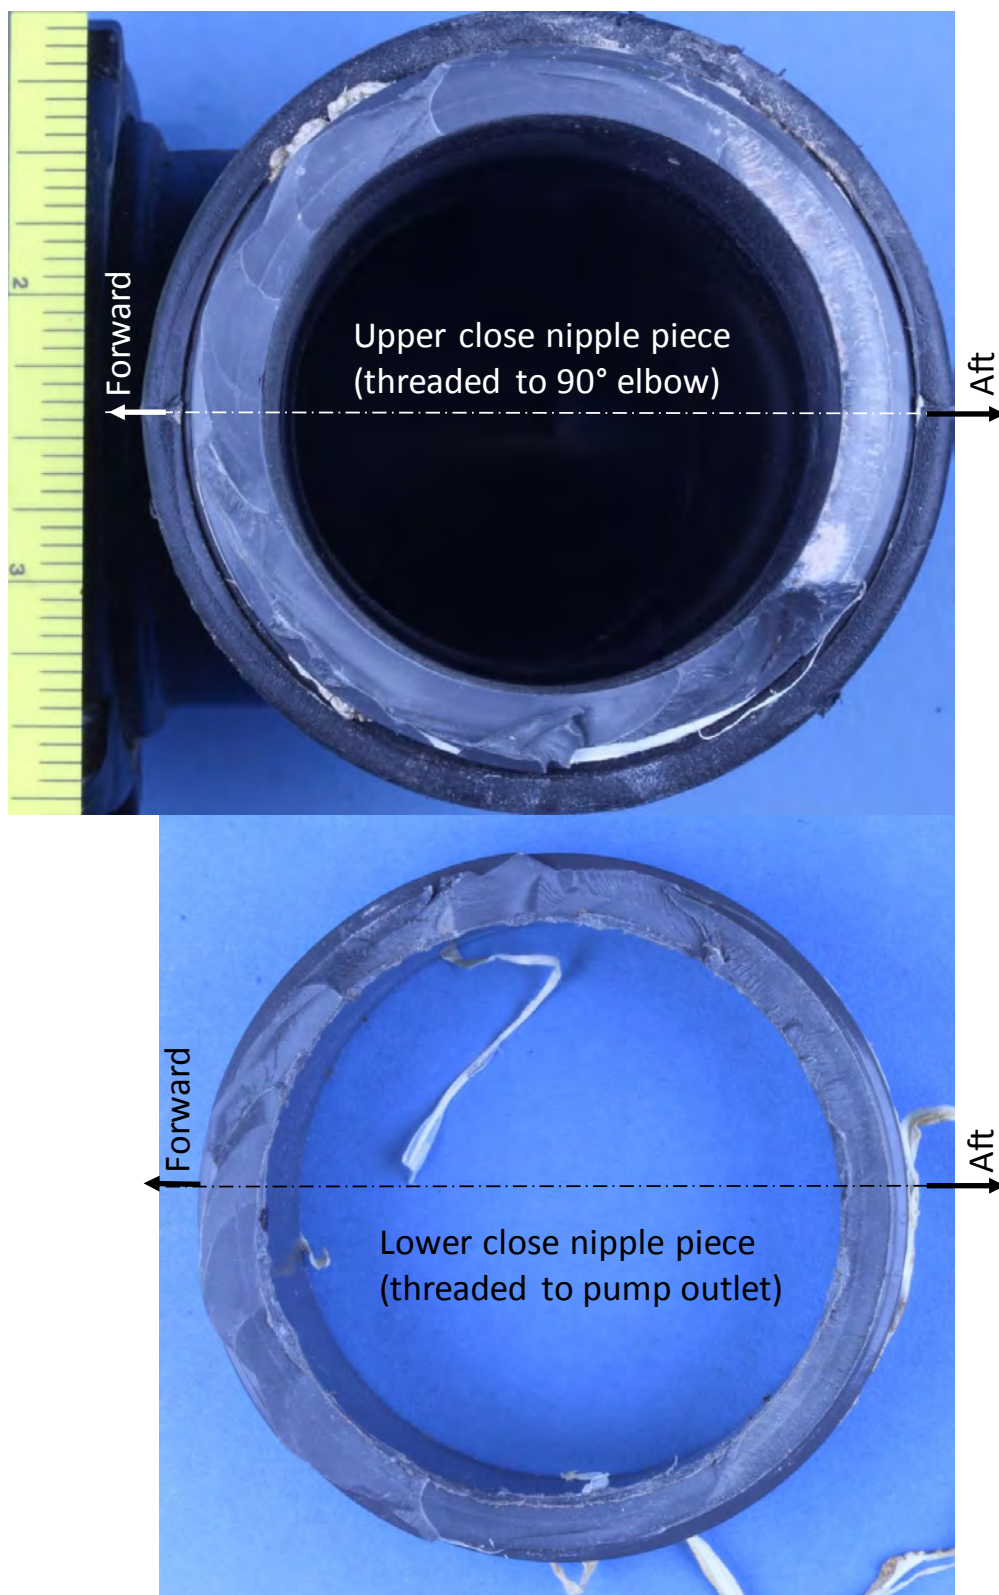
Images of the mating fracture surfaces of the close nipple pieces are shown in Figure 7. The forward and aft orientation of the fittings relative to the helicopter are annotated on the fracture surfaces. The portion of the close nipple threaded into the 90° elbow was removed by cutting the elbow fitting with an abrasive saw and extracting the piece. The two primary recovered close nipple pieces are shown in Figure 8 with the orientation relative to the pump housing and the 90° elbow indicated.

Figure 7 Top down views of both halves of the fracture surfaces from the primary close nipple pieces. The fracture features are oriented relative to the forward and aft directions of the helicopter.

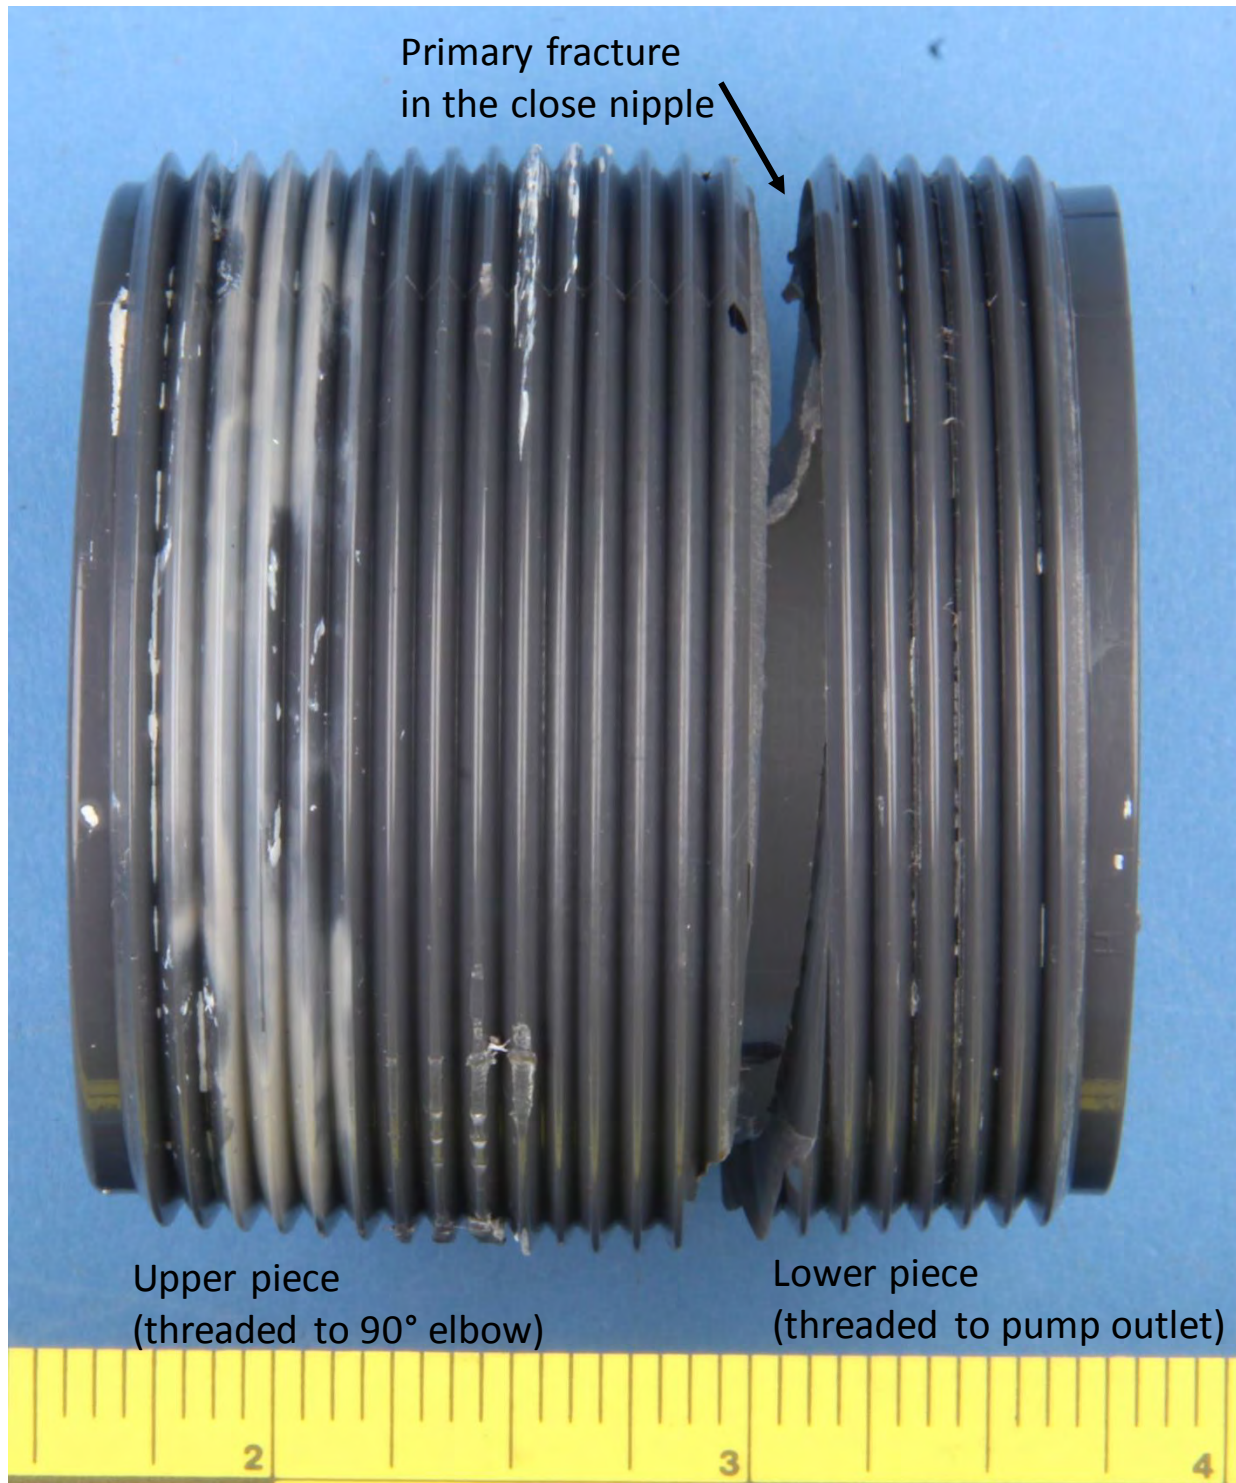
Figure 8 Image of the two primary close nipple pieces arranged close to their pre-accident configuration (without fracture surface contact).

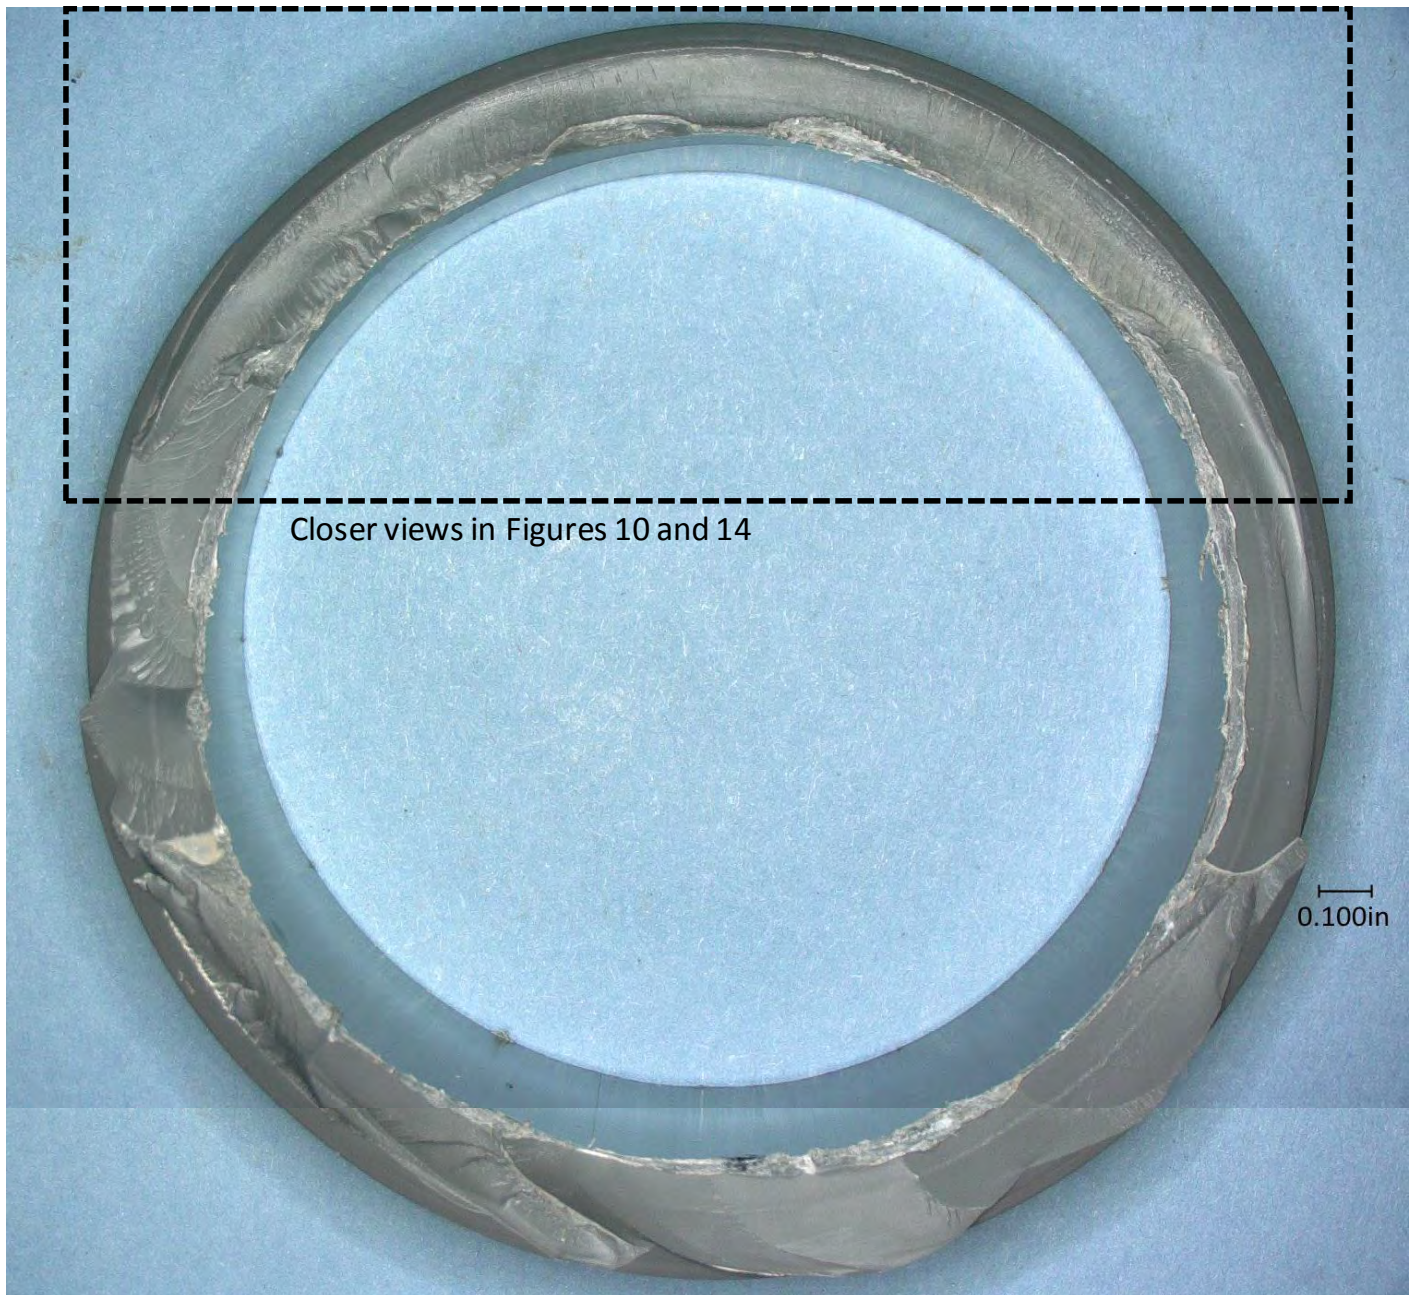
Close views of the lower close nipple piece fracture surface are shown in Figures 9–11. As indicated in the figures, the region along the aft side of the close nipple fracture surface revealed fractographic features consistent with slow crack growth, a progressive fracture mode in polymers. In Figure 11, the slow crack growth region is identified with tangerine shading. The balance of the fracture surface in Figure 11 exhibits fractographic features consistent with overstress fracture and a region of final fracture is identified in the figure. A higher magnification image of the initiation region within the slow crack growth region is shown in Figure 12. Just adjacent to the thread root, the initiation region exhibits mechanical damage. Several rib marks are revealed in this initiation region. Figure 13 shows another region with well-developed craze cracks consistent with slow crack growth.

Figure 9 Overall view of the lower close nipple piece fracture surface. An annotated version of this image is shown in Figure 11.

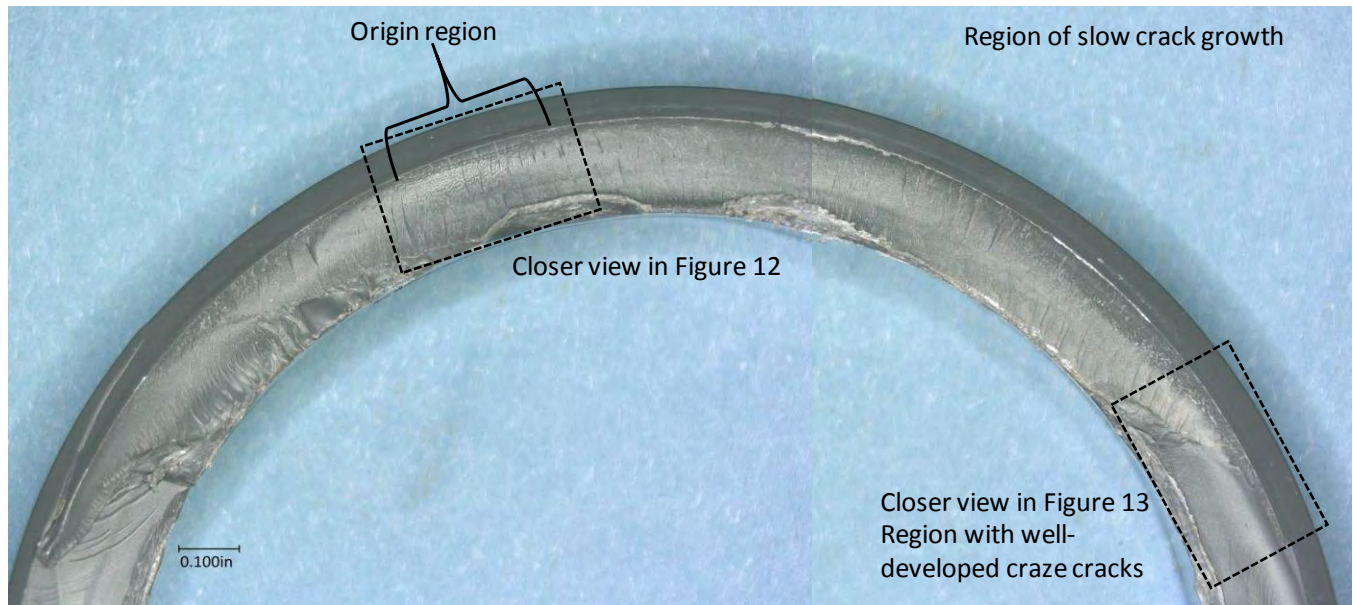
Figure 10 Close view of the lower close nipple piece fracture surface in a region dominated by fracture surface features. An origin region is identified.

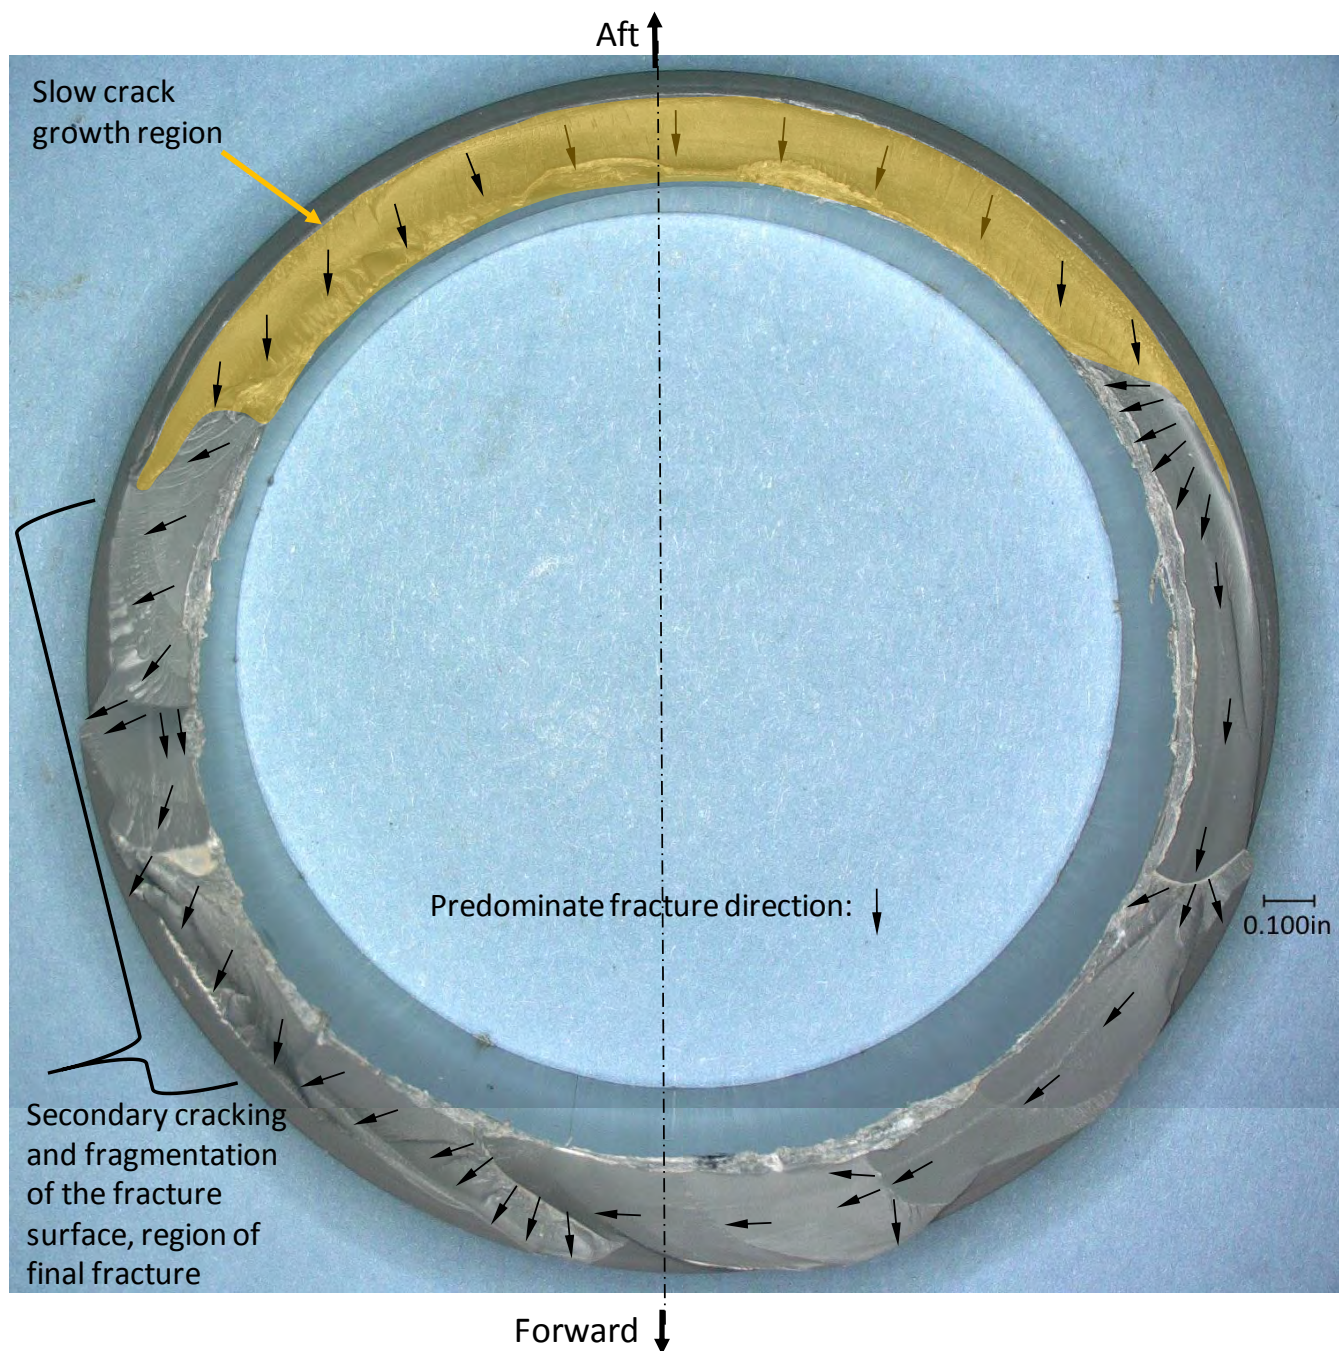
Figure 11 Same view as Figure 9 with the fracture surface annotated with arrows indicating the direction of predominate crack propagation.

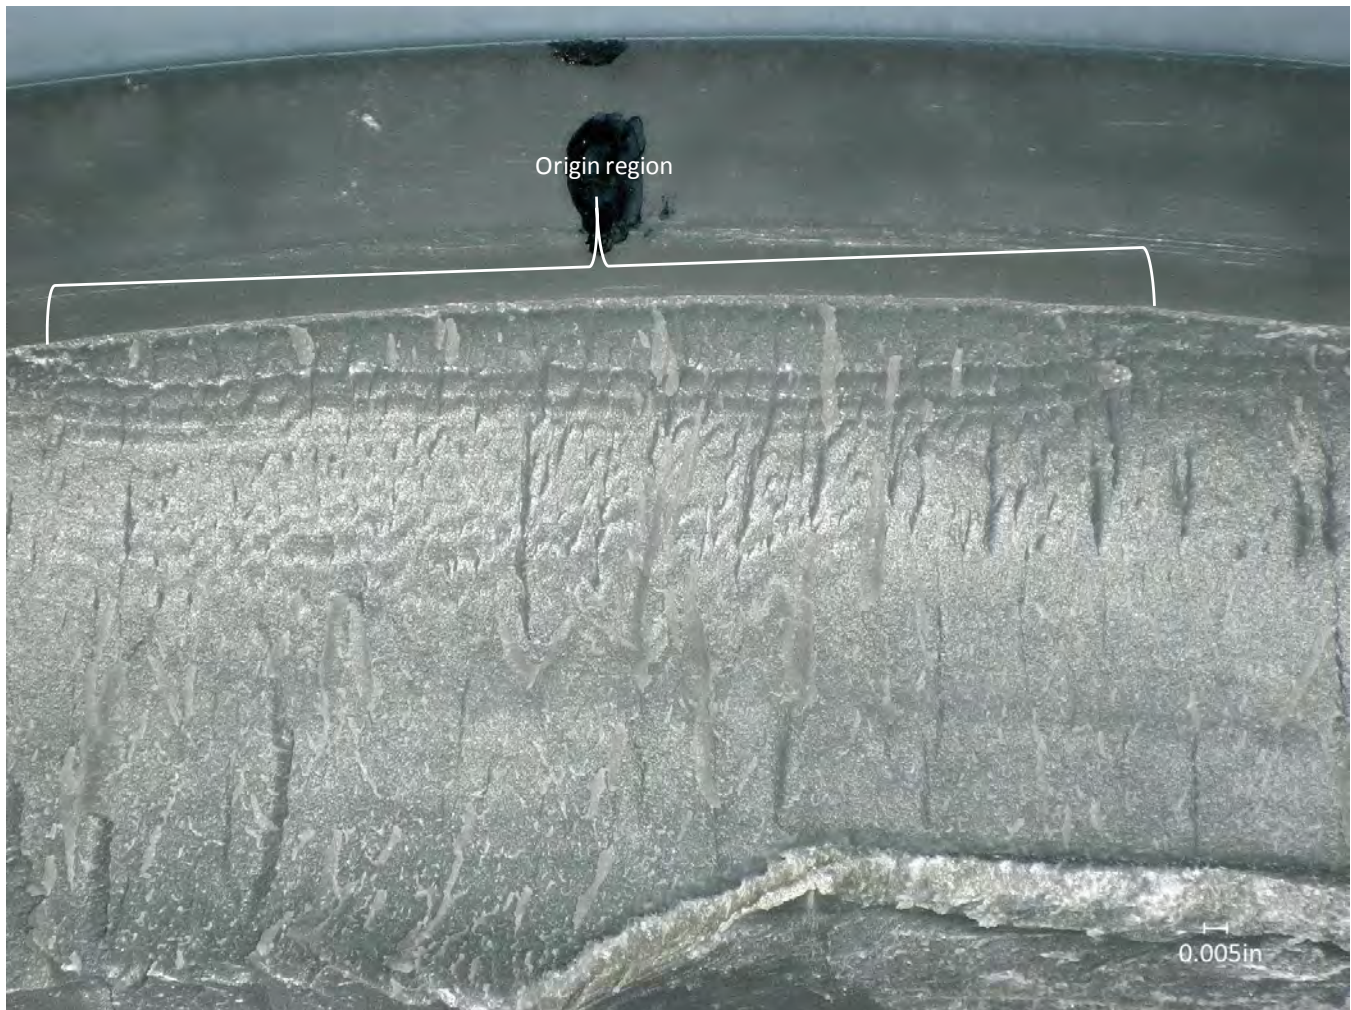
Figure 12 Digital microscope image of the origin region as identified in Figure 10.

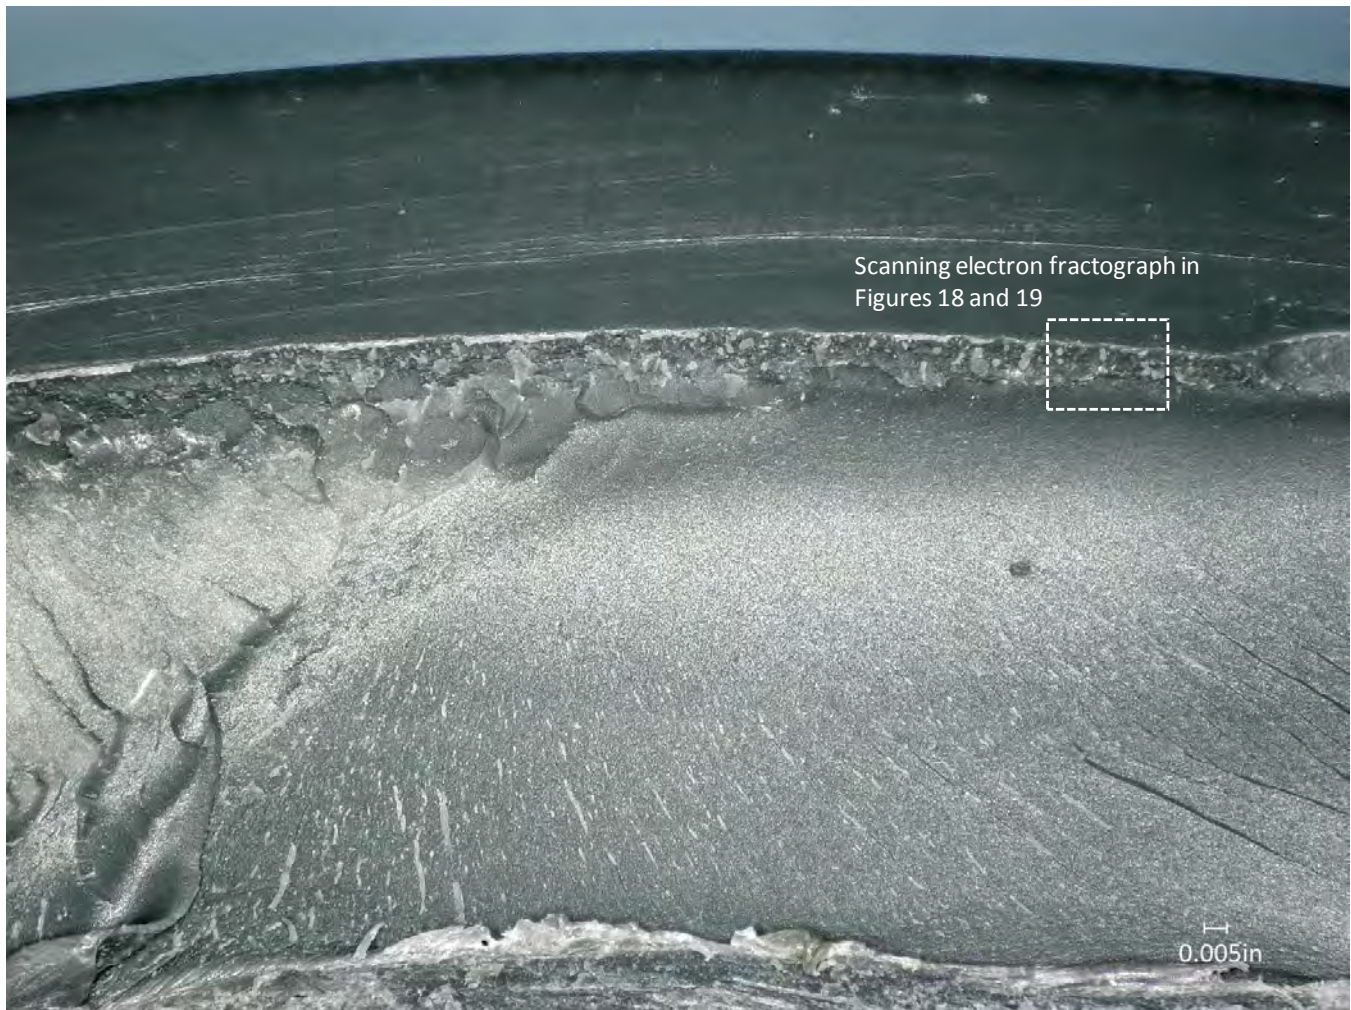
Figure 13 Digital microscope image of a region with incipient craze fracture features as identified in Figure 10

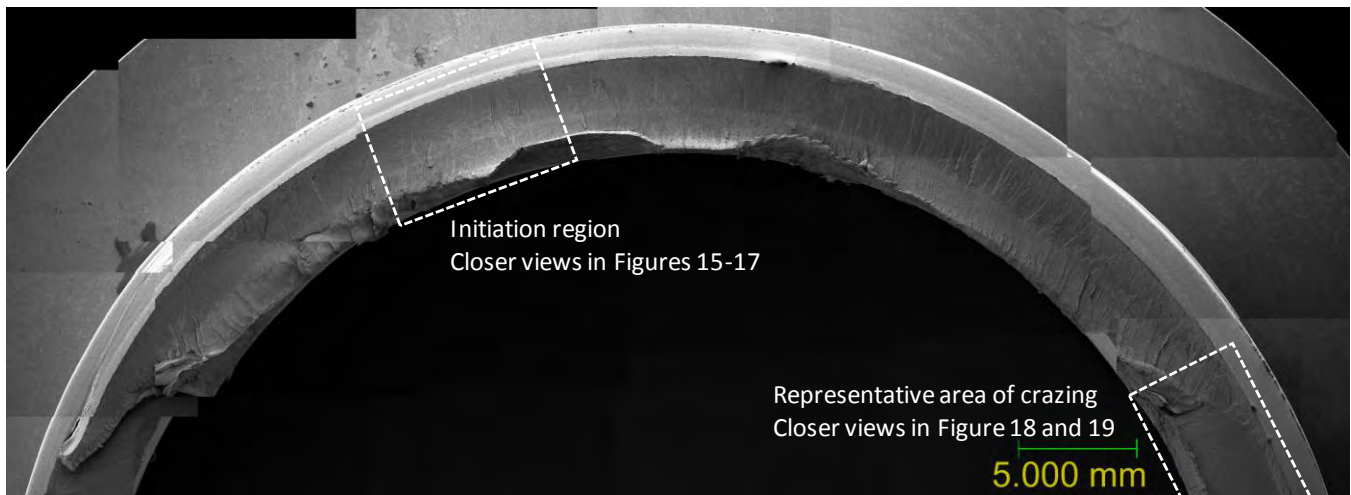
The fracture surface on the lower close nipple piece removed from the pump outlet (see Figures 5 and 8) was examined using a field emission scanning electron microscope (SEM). An overall SEM fractograph of the slow crack growth region is shown in Figure 14 with the initiation region and a representative area of crazing identified. Higher magnification fractographs of the initiation region are shown in Figures 15-17. The fractographs generally reveal mechanical damage in the fracture surface immediately adjacent to the thread root. Additionally, the thread root exhibits features (e.g. wavy, undulated melt front) consistent with mold under-fill. SEM fractographs of a representative area of crazing are shown in Figures 18 and 19. As observed in Figure 18, the thread root exhibits features (e.g. wavy, undulated melt front) consistent with mold under-fill. Also evident in Figure 18, are step features consistent with multiple crack initiation sites typically found in craze cracking in rigid thermoplastics. The SEM fractograph in Figure 19 reveals smooth fracture interfaces typical of craze cracks associated with slow crack growth.

Figure 14 Scanning electron fractograph of the fracture surface on the lower close nipple fracture surface in the slow crack growth region.

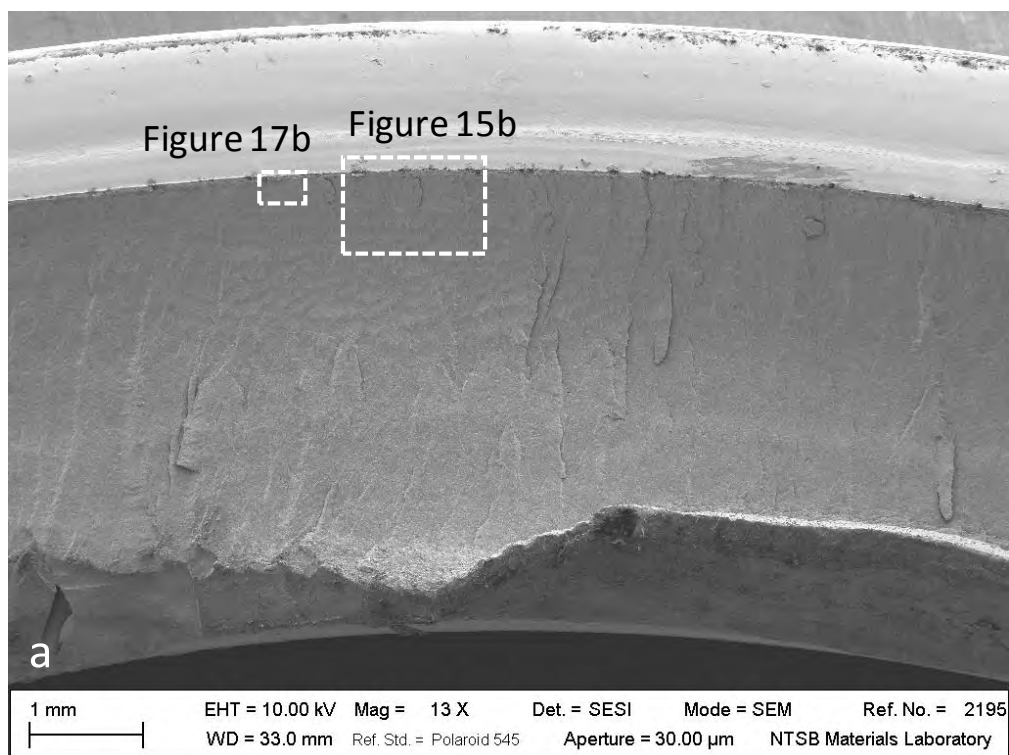
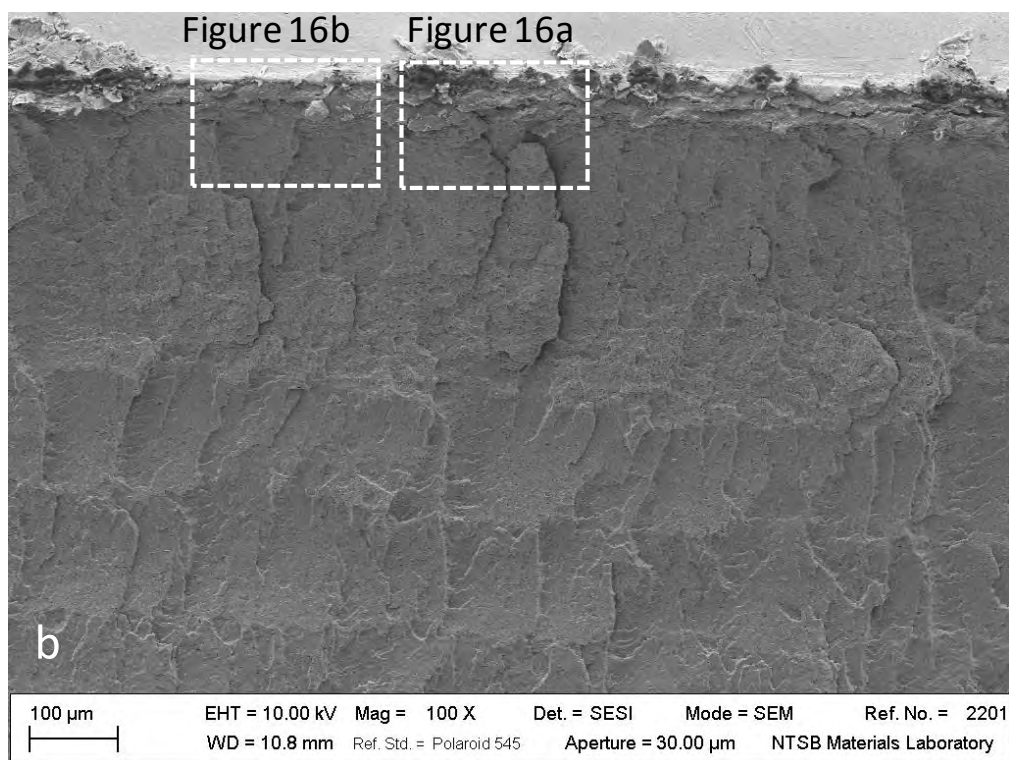
Figure 15 Scanning electron fractograph of the origin region shown in Figures 10 and 14. View (a) is an overall image and view (b) is a closer fractograph of the fracture surface just below the thread root.

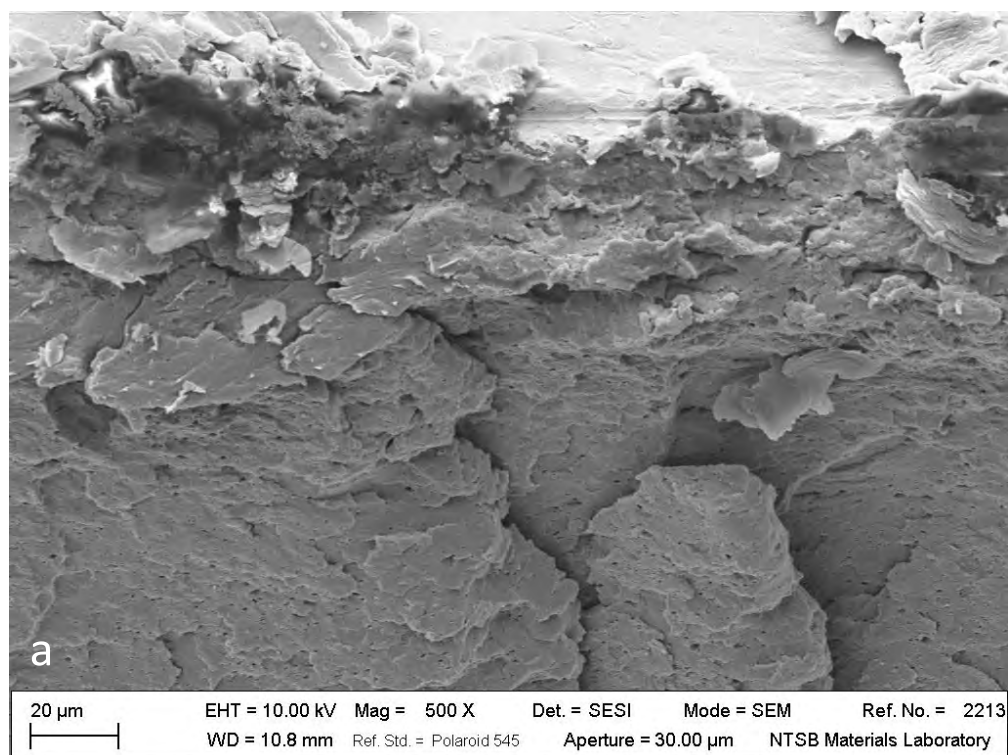
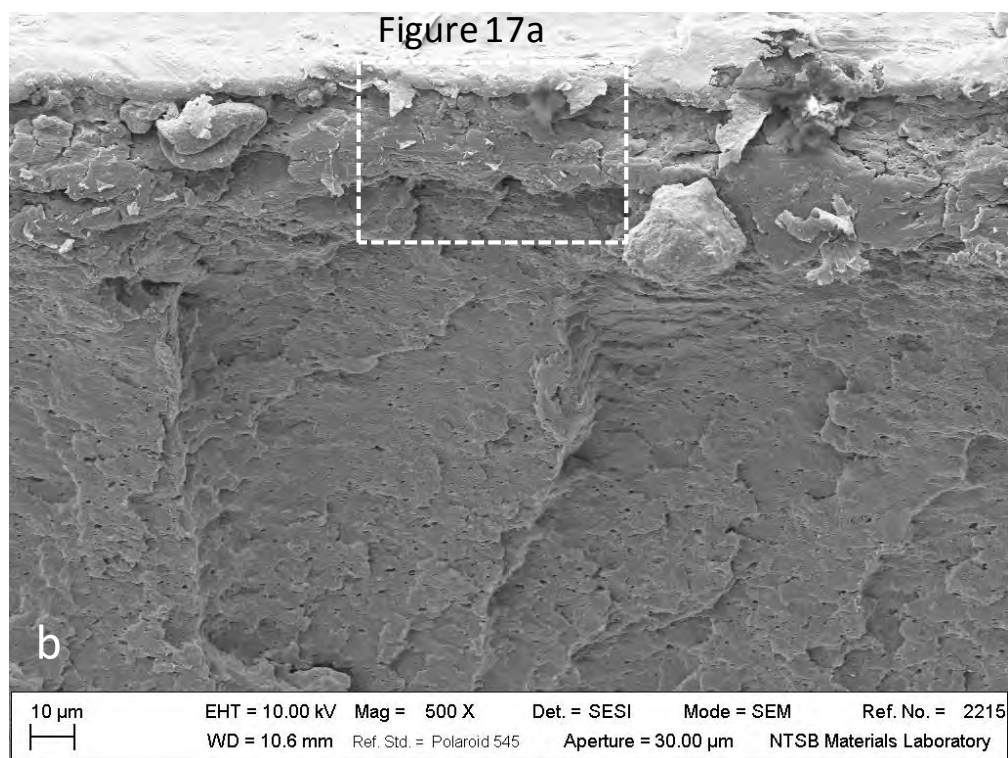
Figure 16 Scanning electron fractographs of the initiation region (just below the thread root) as identified in Figure 15b.
