# NATIONAL TRANSPORTATION SAFETY BOARD

## MATERIALS LABORATORY FACTUAL REPORT

Report No. 17-027

Place : Gunnison, Utah  
Date : August 12, 2016  
Vehicle : Robinson R-44 II  
NTSB No. : WPR16LA165  
Investigator : Howard Plagens, AS-WPR

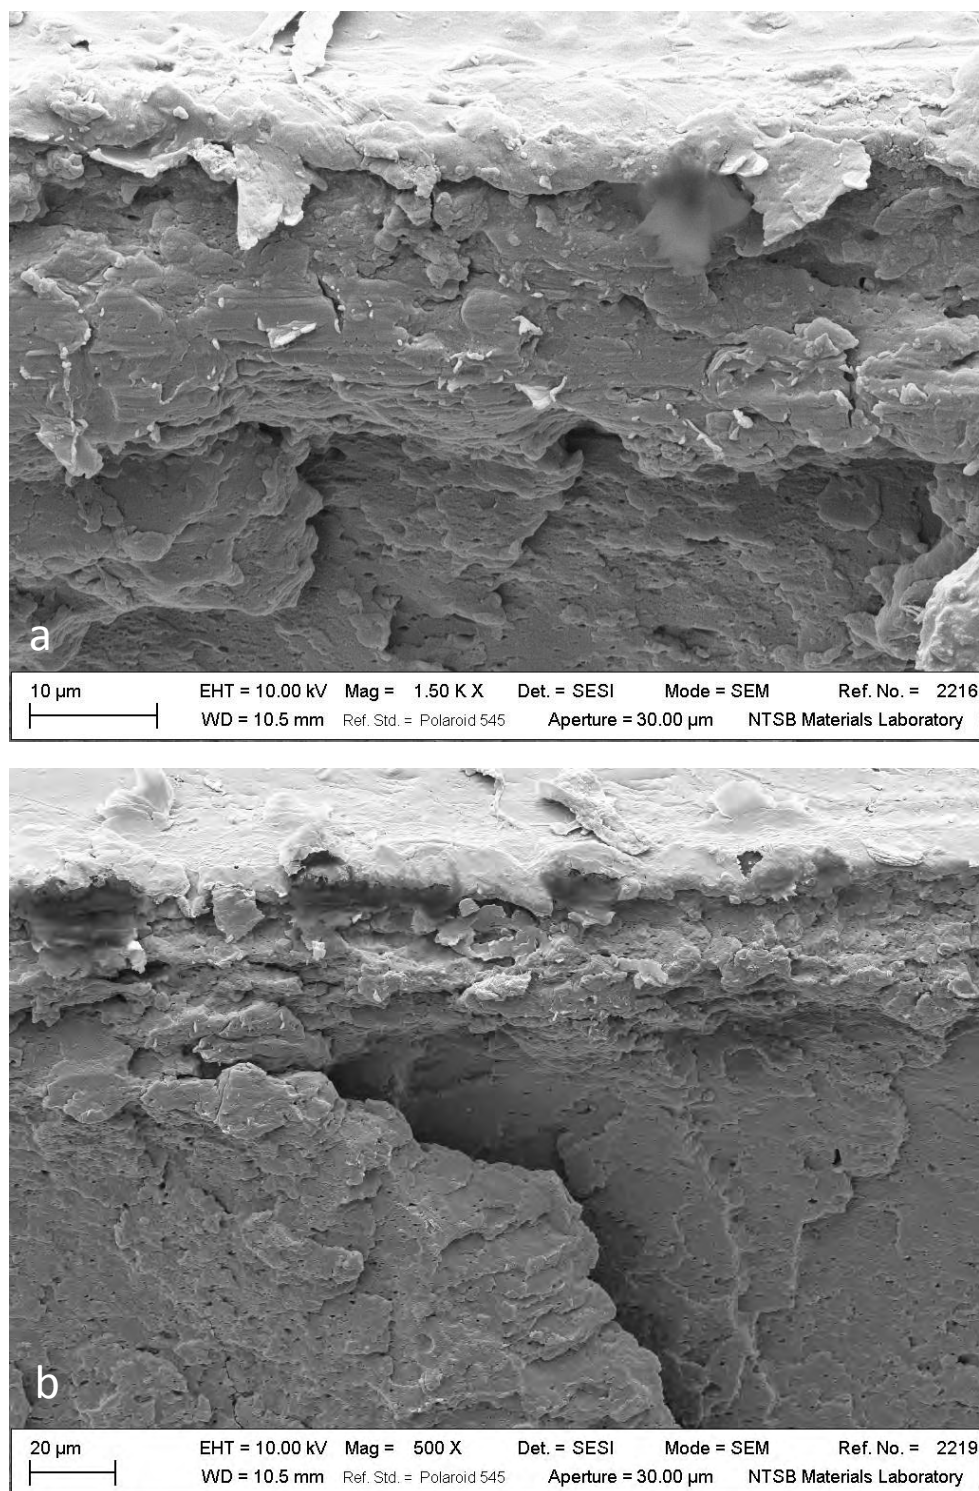
Figure 17 Scanning electron fractographs of the initiation region identified in Figures 15a and 16b. View (a) is a higher magnification fractograph revealing mechanical damage in the initiation region identified in Figure 16b. View (b) is a higher magnification fractograph of the initiation region identified in Figure 15a. This region, with less mechanical damage, shows incipient craze fracture features.

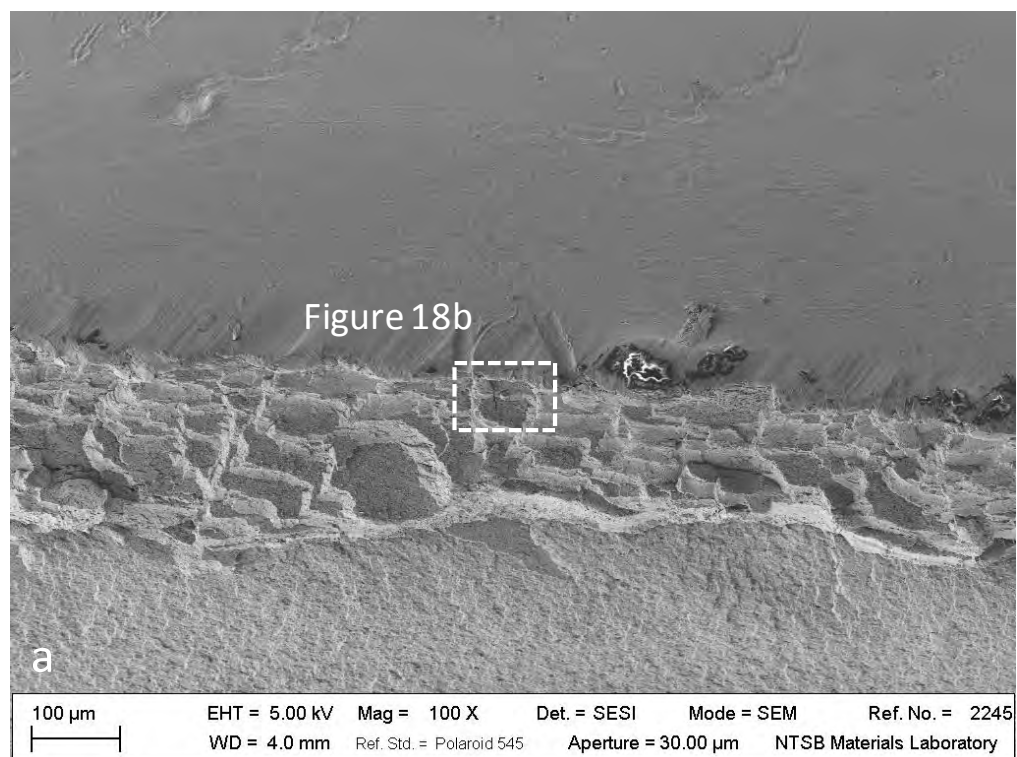
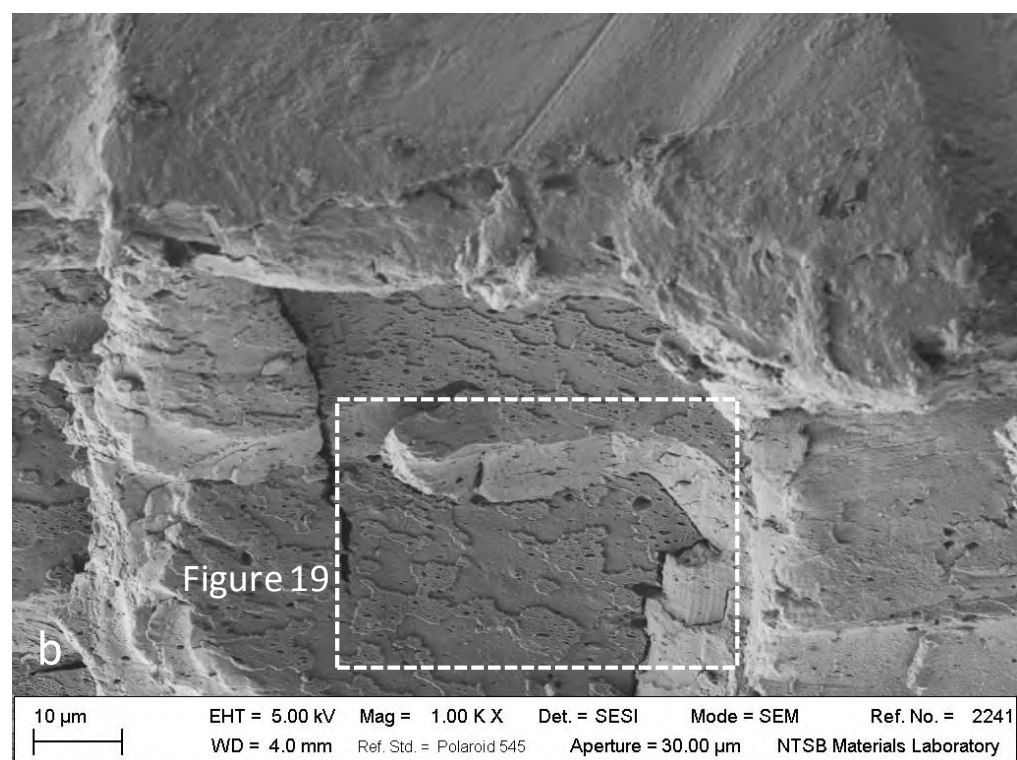
Figure 18 Scanning electron fractographs of a region identified in Figure 14. This region is largely free from mechanical damage and exhibits fracture features typical of craze crack formation.

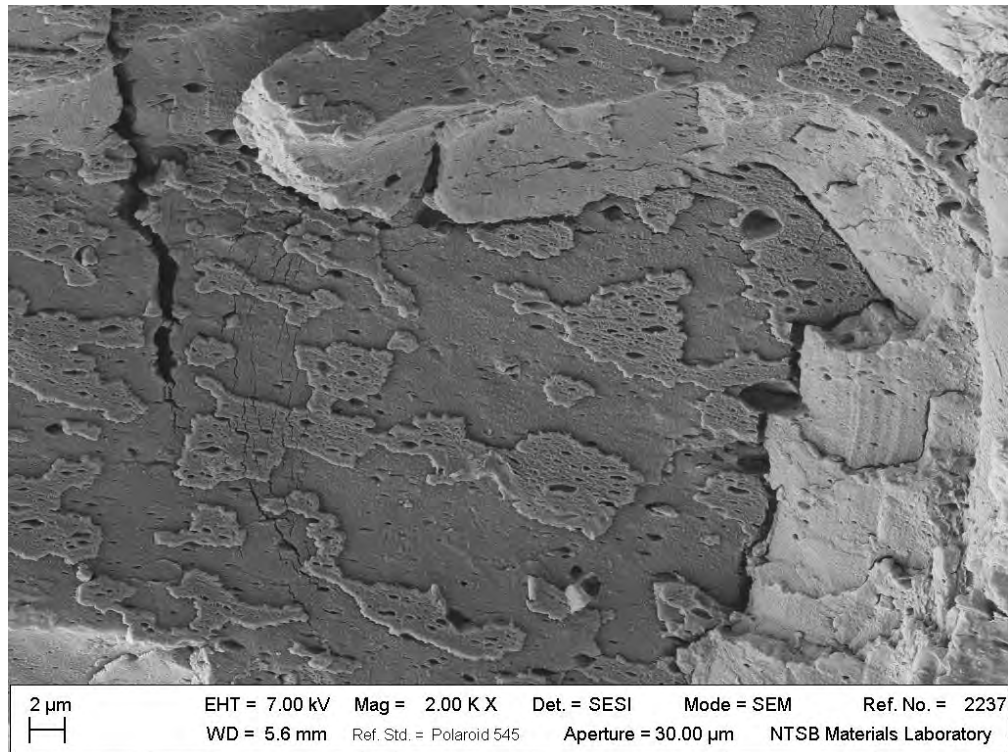
The fracture surface on the lower close nipple piece removed from the pump outlet (see Figures 5 and 8) was examined using a field emission scanning electron microscope (SEM). An overall SEM fractograph of the slow crack growth region is shown in Figure 14 with the initiation region and a representative area of crazing identified. Higher magnification fractographs of the initiation region are shown in Figures 15-17. The fractographs generally reveal mechanical damage in the fracture surface immediately adjacent to the thread root. Additionally, the thread root exhibits features (e.g. wavy, undulated melt front) consistent with mold under-fill. SEM fractographs of a representative area of crazing are shown in Figures 18 and 19. As observed in Figure 18, the thread root exhibits features (e.g. wavy, undulated melt front) consistent with mold under-fill. Also evident in Figure 18, are step features consistent with multiple crack initiation sites typically found in craze cracking in rigid thermoplastics. The SEM fractograph in Figure 19 reveals smooth fracture interfaces typical of craze cracks associated with slow crack growth.

Figure 19 Scanning electron fractograph of a region identified in Figure 18b. This fractograph reveals fracture features of a craze crack.

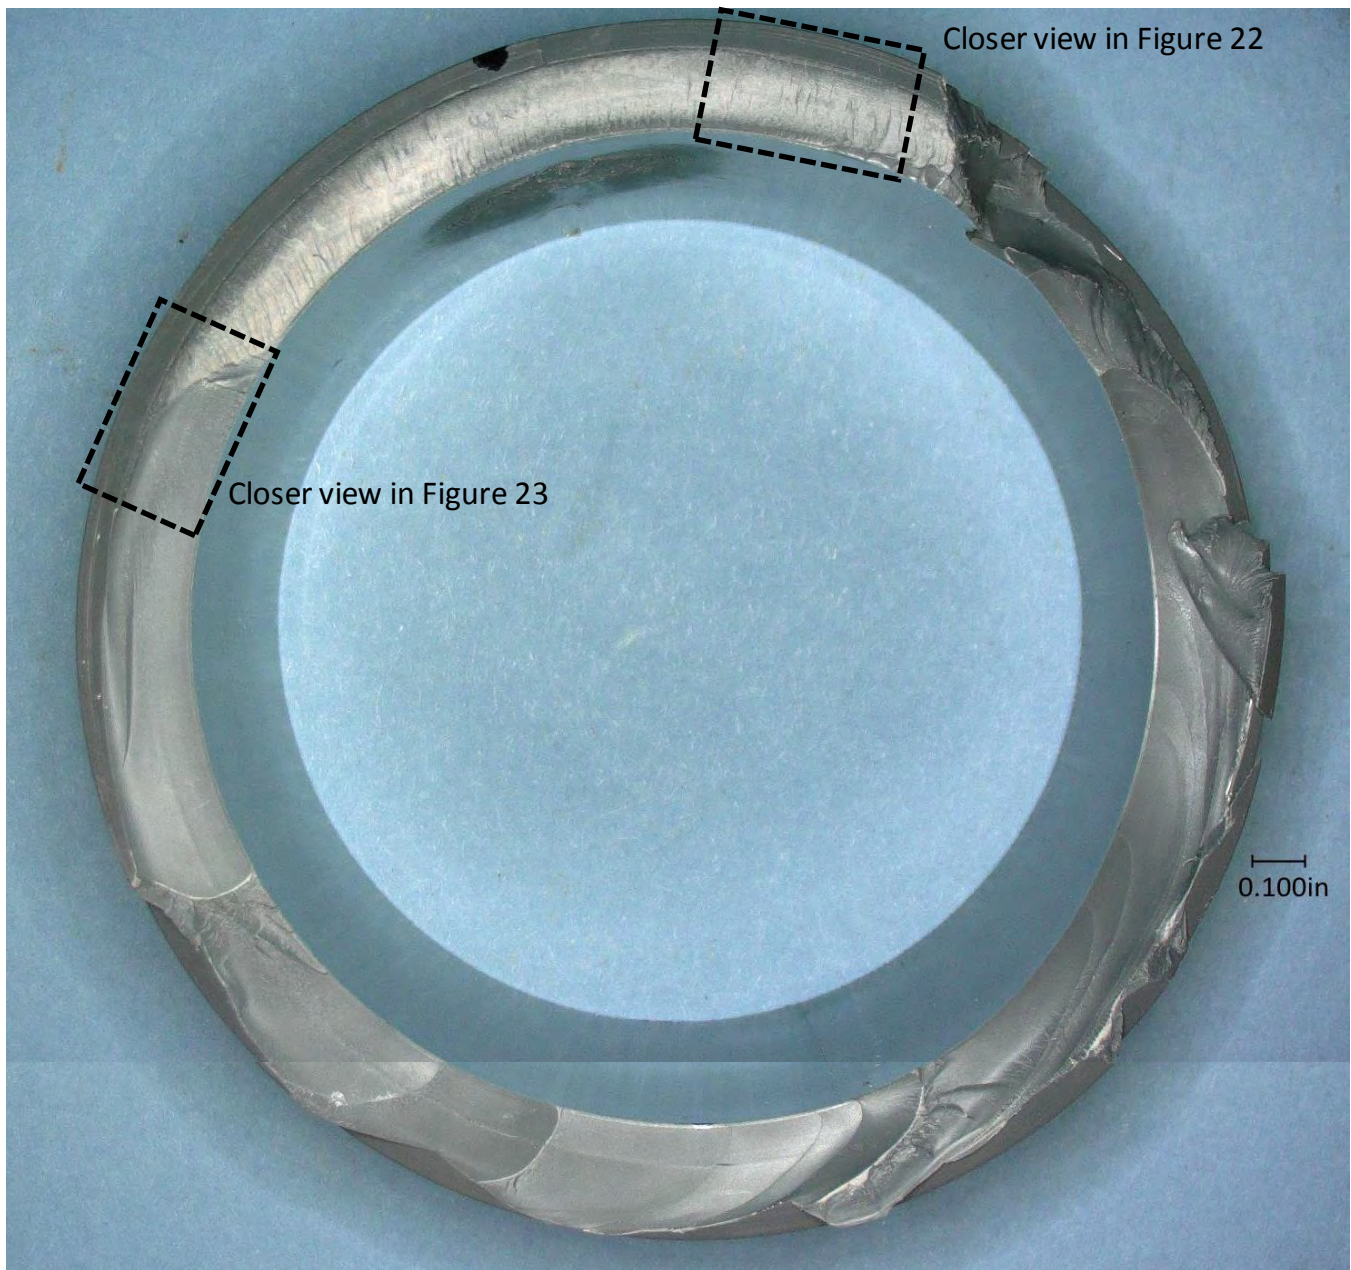
Figure 20 Overall view of the upper close nipple piece fracture surface. An annotated version of this image is shown in Figure 21.

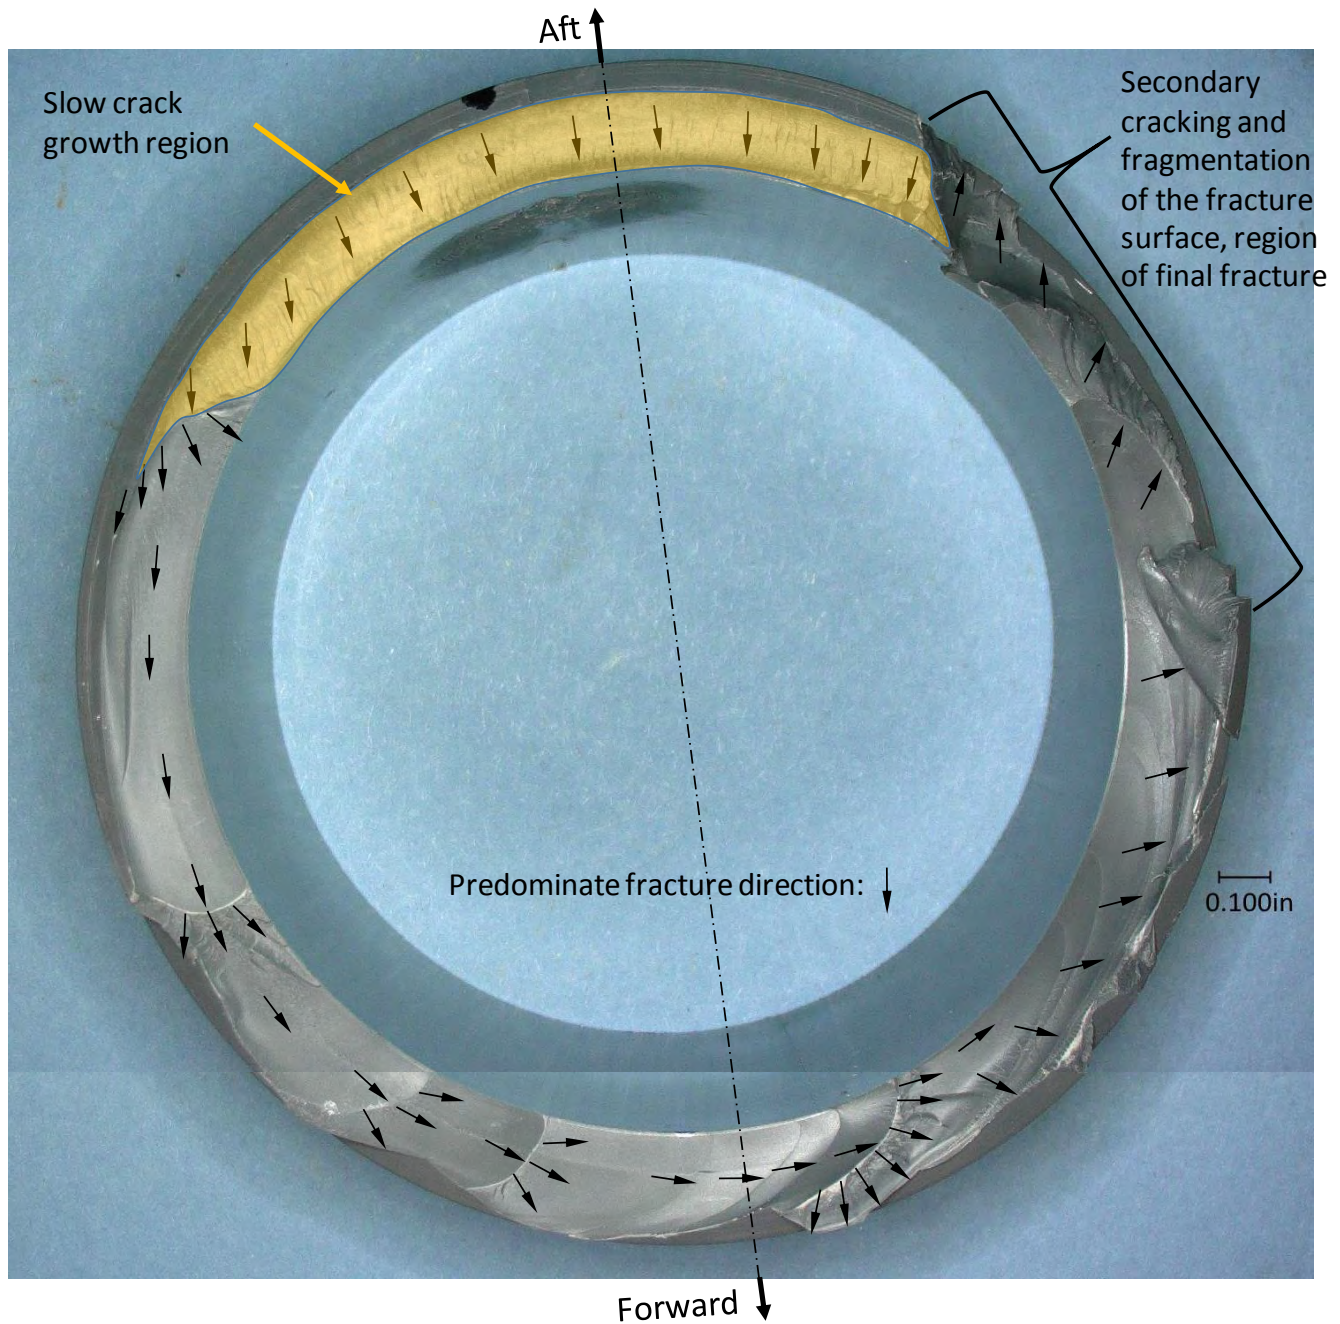
Figure 21 Same view as Figure 20 with the fracture surface annotated with arrows indicating the direction of predominate crack propagation.

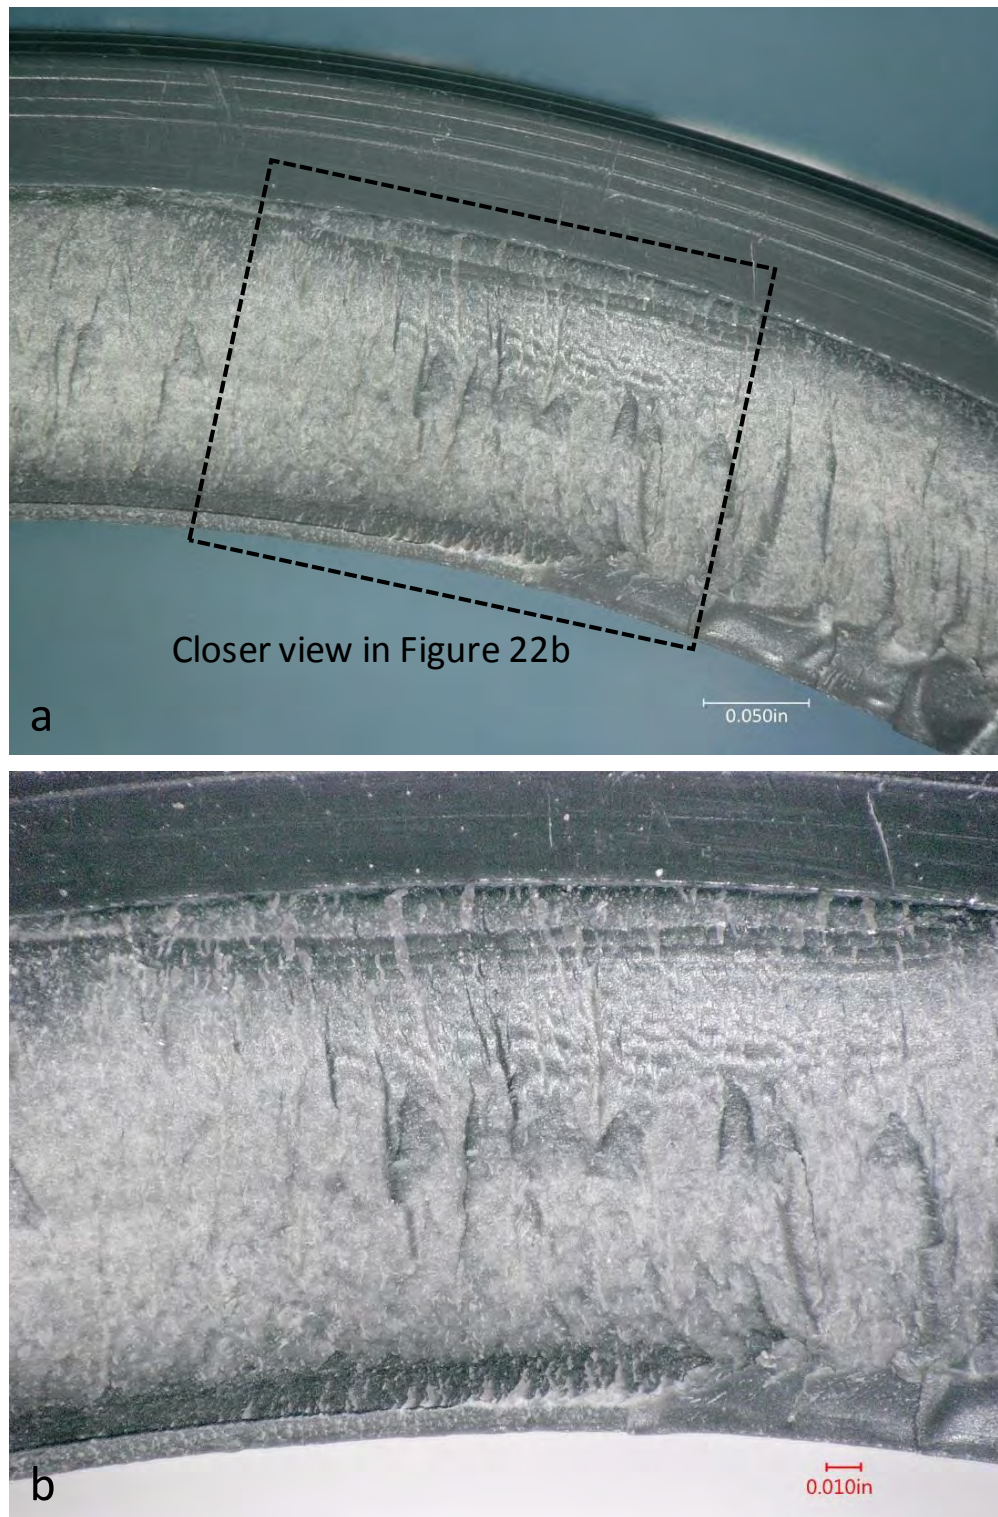
Upon receipt, the fracture surface of the upper close nipple piece connected to the 90° elbow was covered in soil deposits. The piece was removed from the 90° elbow by cutting the threaded region of the elbow with an abrasive saw, allowing the close nipple piece to be extracted. Before microscopic examination, the soil deposits were removed from the close nipple piece using Alconox nonionic detergent and a soft bristle brush. A digital microscope macrograph of the fracture surface on the close nipple piece removed from the 90° elbow (see Figures 5 and 8) is shown in Figure 20. In Figure 21, the slow crack growth region is identified with tangerine shading. The balance of the fracture surface in Figure 21 exhibits fractographic features consistent with overstress fracture and a region of final fracture is identified in the figure. A higher magnification image of the initiation region within the slow crack growth region is shown in Figure 22. Just adjacent to the thread root, the initiation region exhibits mechanical damage. Several rib

marks are present in this initiation region. Figure 23 shows a region with well-developed craze cracks consistent with slow crack growth.

Figure 22 Digital microscope macrographs of the origin region as identified in Figure 20.

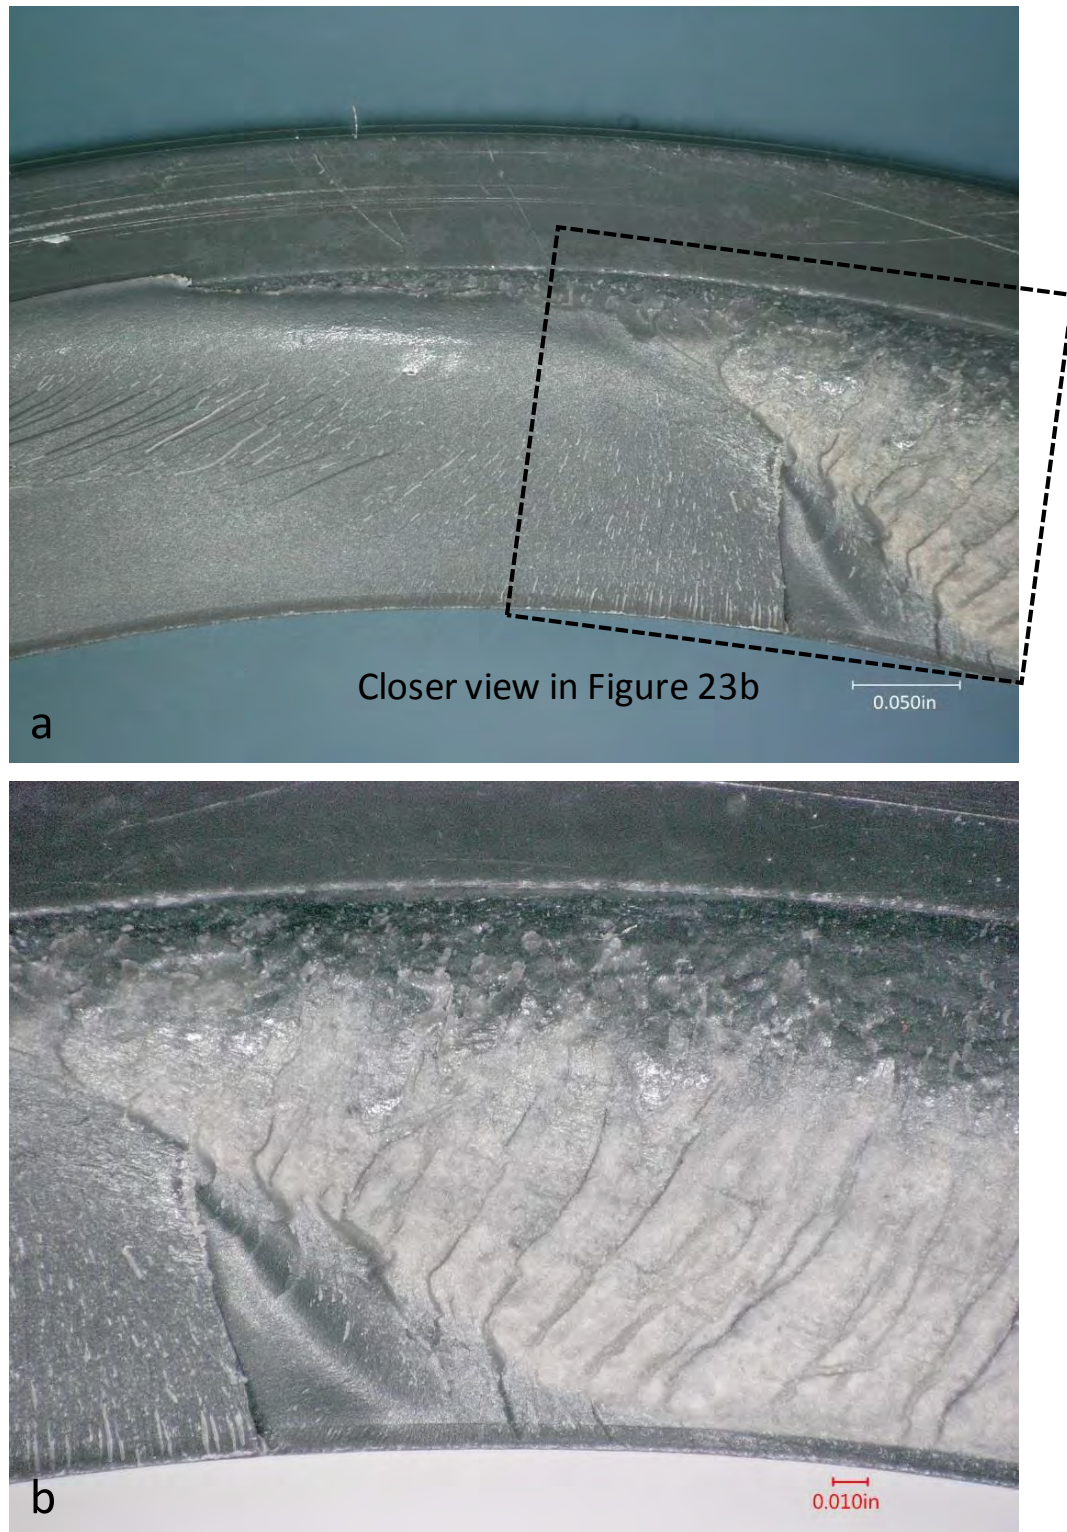
Figure 23 Digital microscope macrographs of a region with incipient craze fracture features as identified in Figure 20.

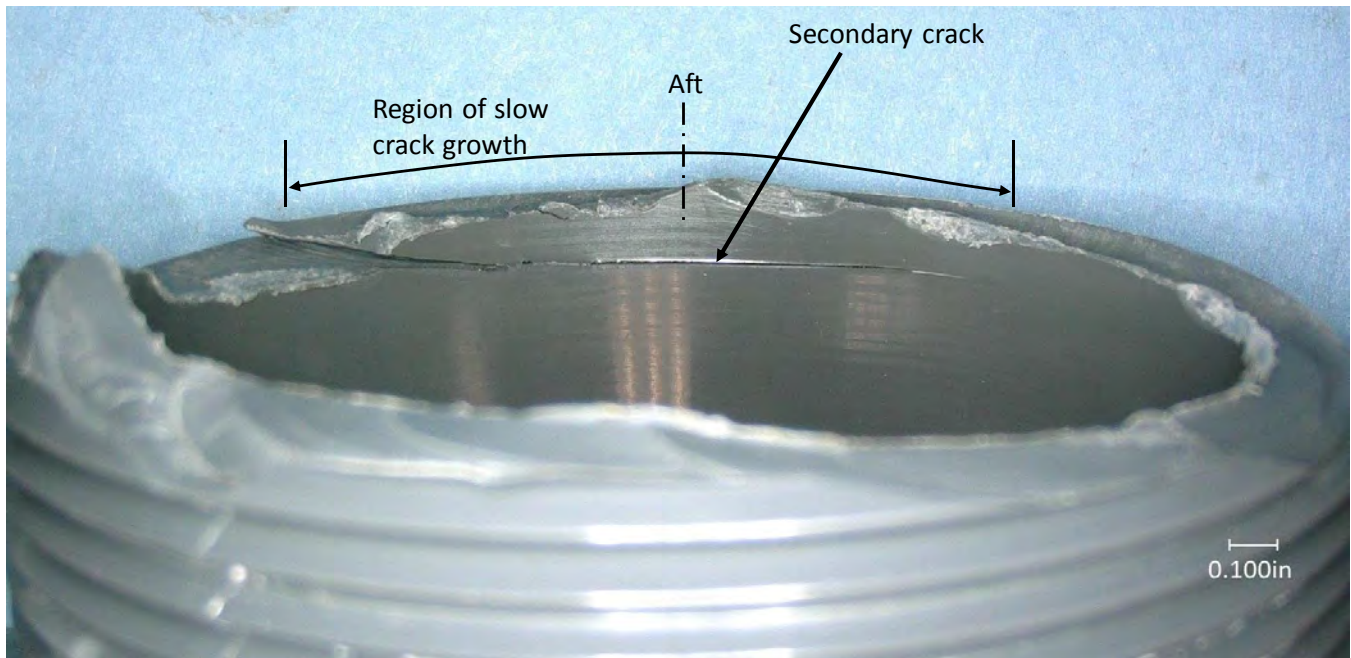
A digital microscope macrograph in Figure 24 shows the inside surface of the close nipple piece removed from the pump outlet revealing a secondary crack. Secondary cracks were also observed in the roots of the aft-facing thread roots. Digital microscope macrographs of example secondary thread-root cracks are shown in Figures 25 and 26. An SEM fractograph of the initiation region, as viewed from the direction of the thread root, reveals features (e.g. wavy, undulating melt front) consistent with mold under-fill. Higher magnification SEM micrographs of the thread roots shows evidence of under-fill and incipient secondary cracks (Figures 28 and 29). For comparative purposes, the thread roots on the forward side of the close nipple exhibited an under-fill condition but did not exhibit any incipient cracks as illustrated in Figure 30.

Figure 24 Digital microscope macrograph of a secondary through-crack.

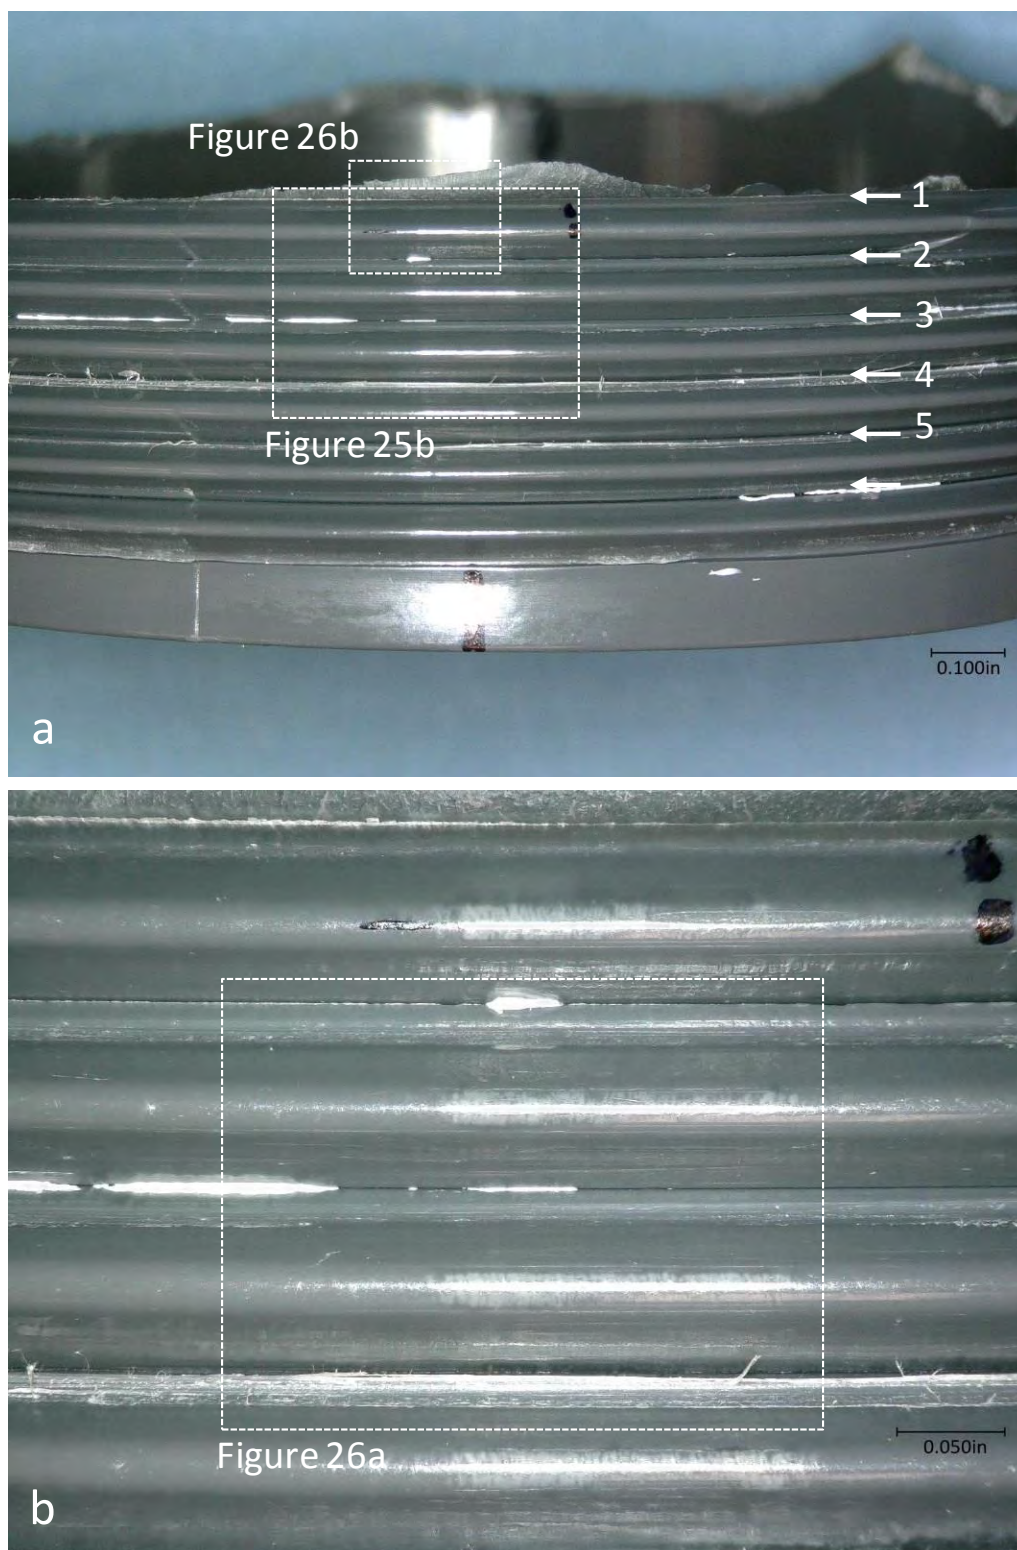
Figure 25 Digital microscope macrographs of the aft-facing threads on the lower close nipple piece threaded to the pump outlet.

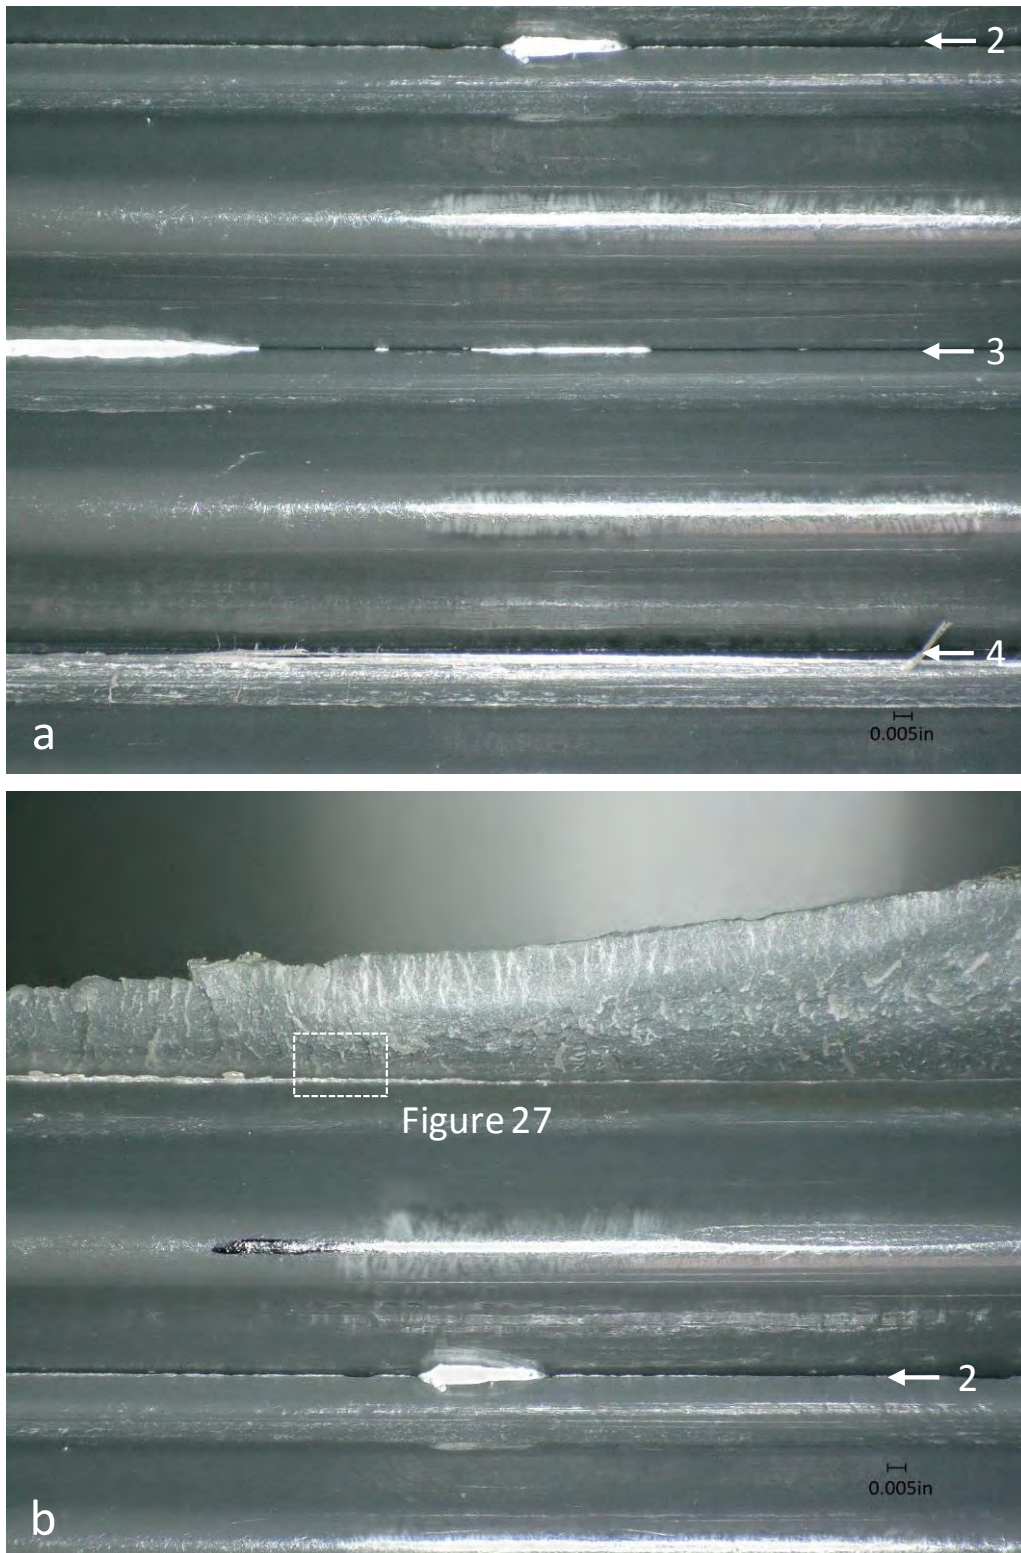
Figure 26 Higher magnification digital microscope macrographs of the aft-facing threads on the lower close nipple piece threaded to the pump outlet shown in Figure 25.

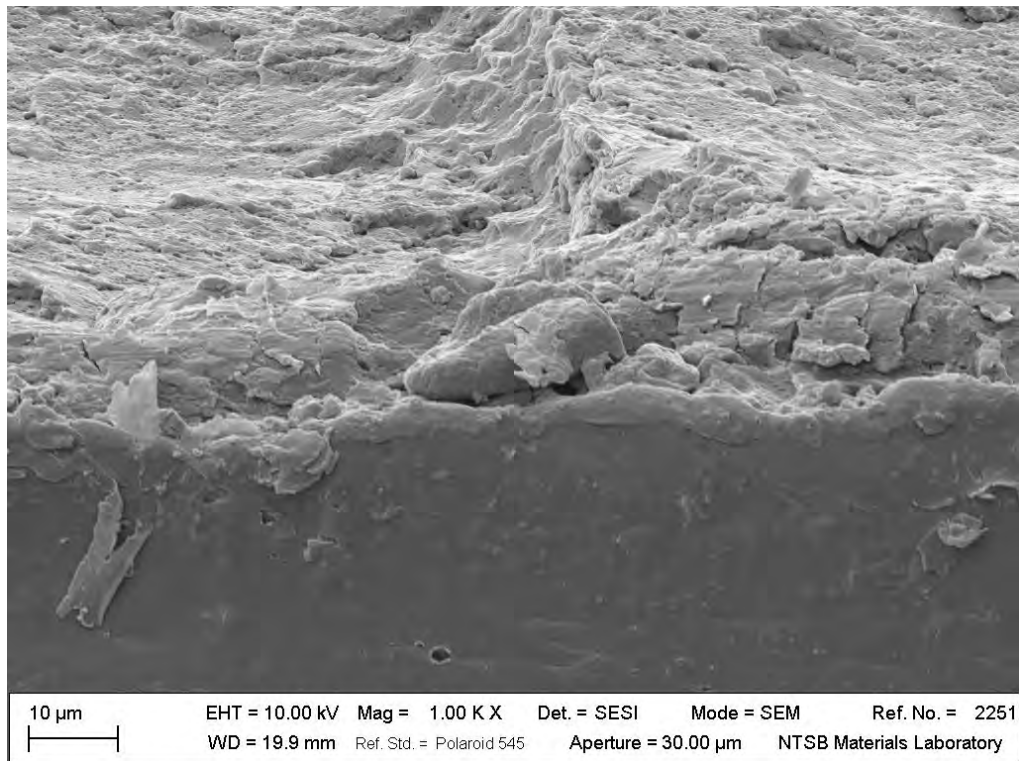
Figure 27 SEM fractograph of the slow crack growth initiation region looking from the thread root side (See Figure 26b for location).

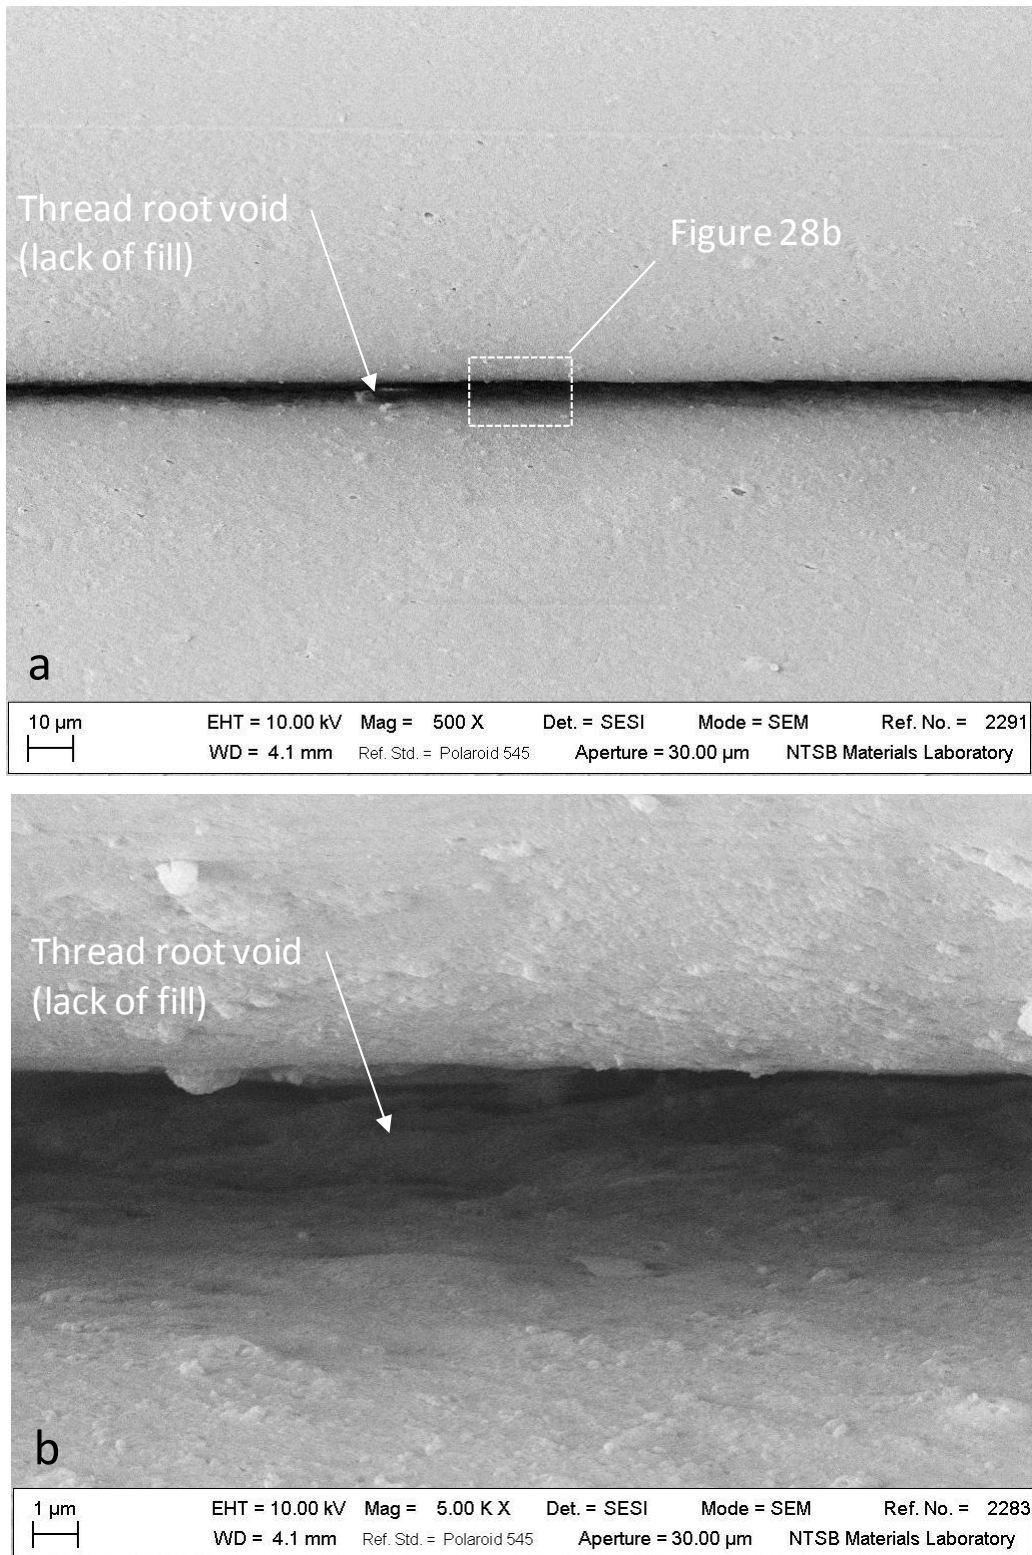
Figure 28 SEM micrographs of thread root 2 (see figures 25 and 26).

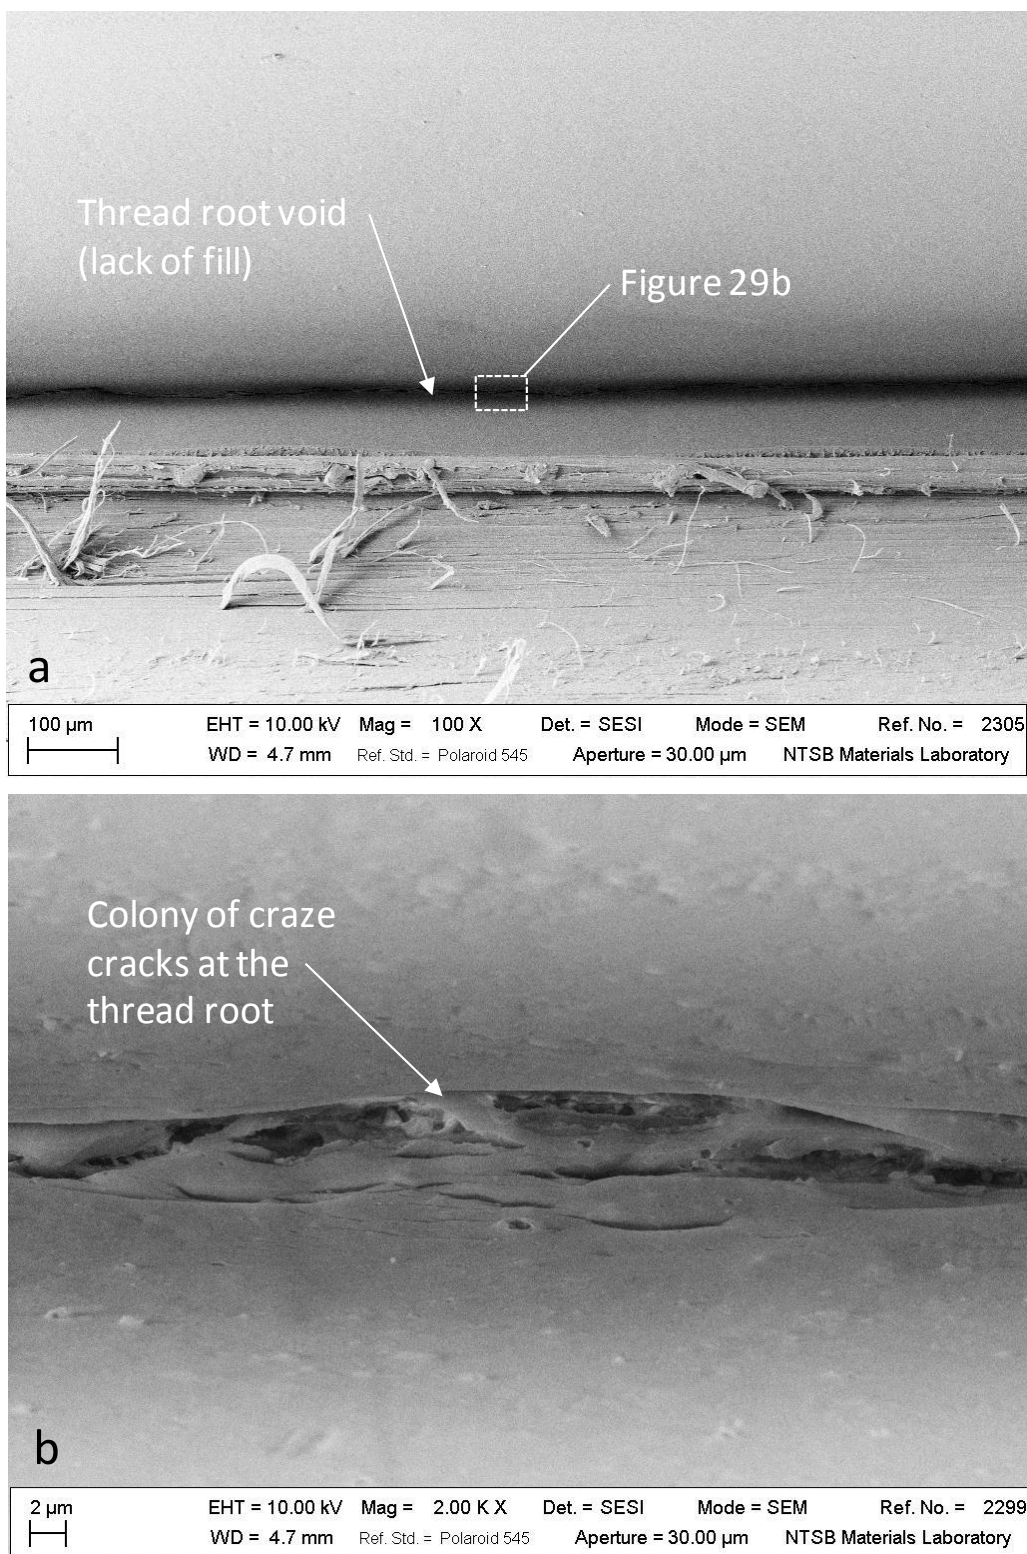
Figure 29 SEM micrographs of thread root 4 (see figures 25 and 26).

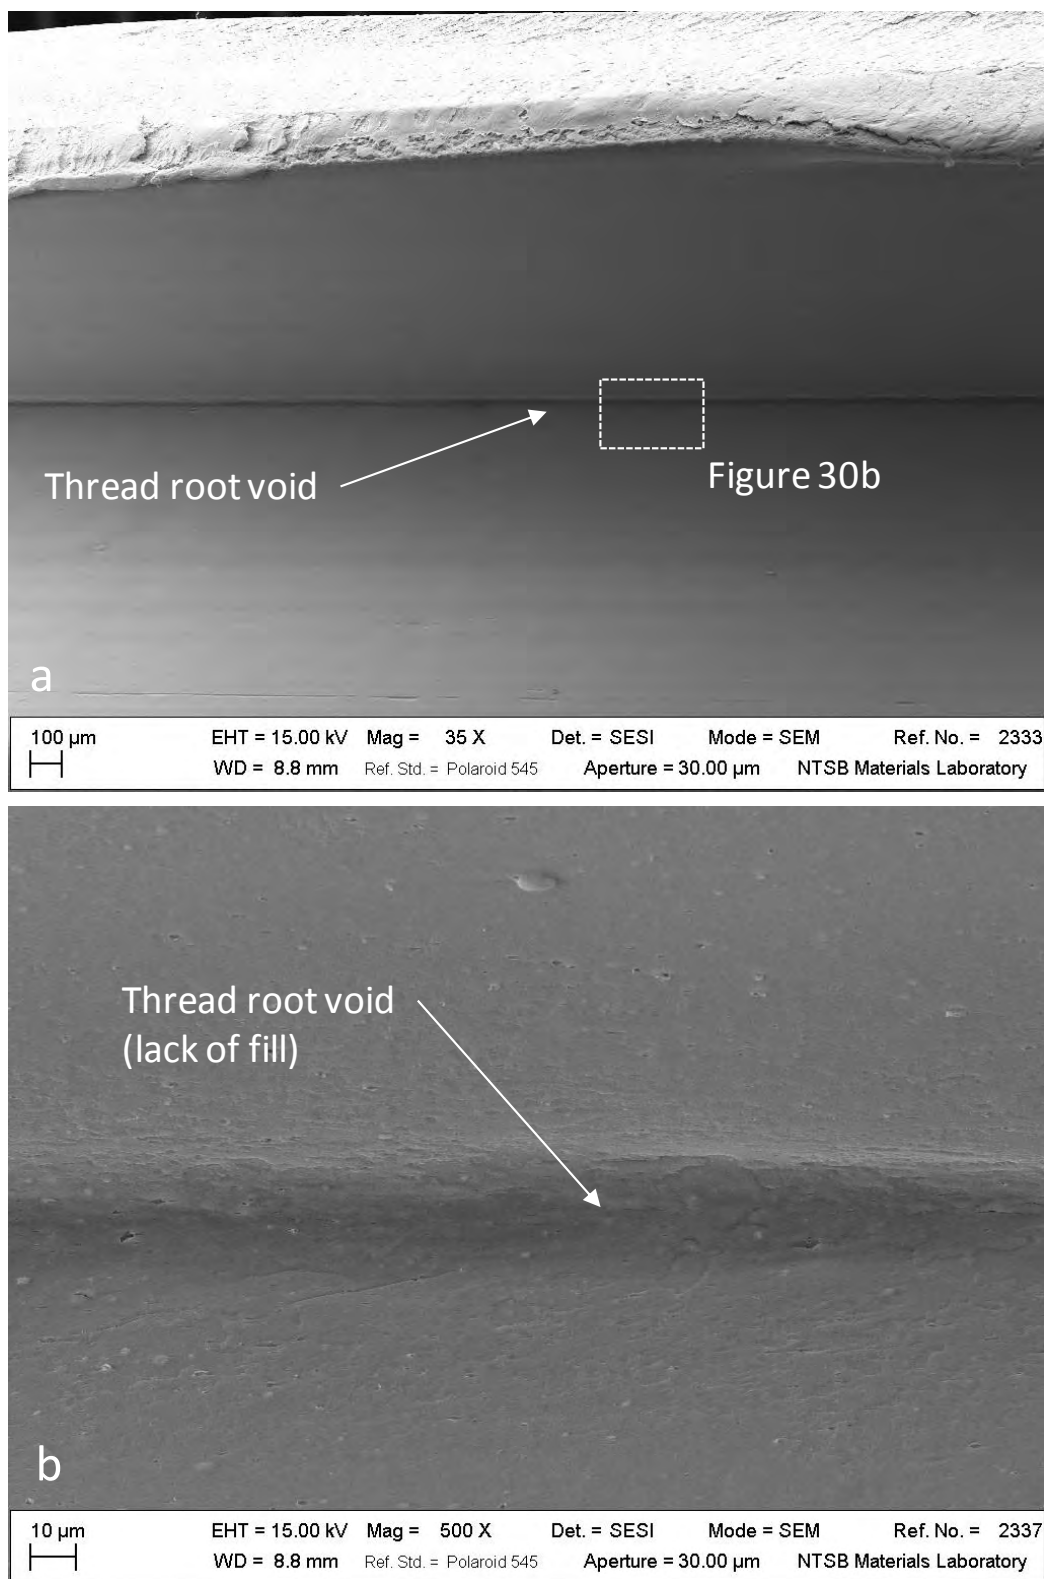
Figure 30 SEM micrographs of the thread root just below the fracture surface on the forward side of the lower close nipple piece.
