# NATIONAL TRANSPORTATION SAFETY BOARD

## MATERIALS LABORATORY FACTUAL REPORT

Report No. 17-027

Place : Gunnison, Utah  
Date : August 12, 2016  
Vehicle : Robinson R-44 II  
NTSB No. : WPR16LA165  
Investigator : Howard Plagens, AS-WPR

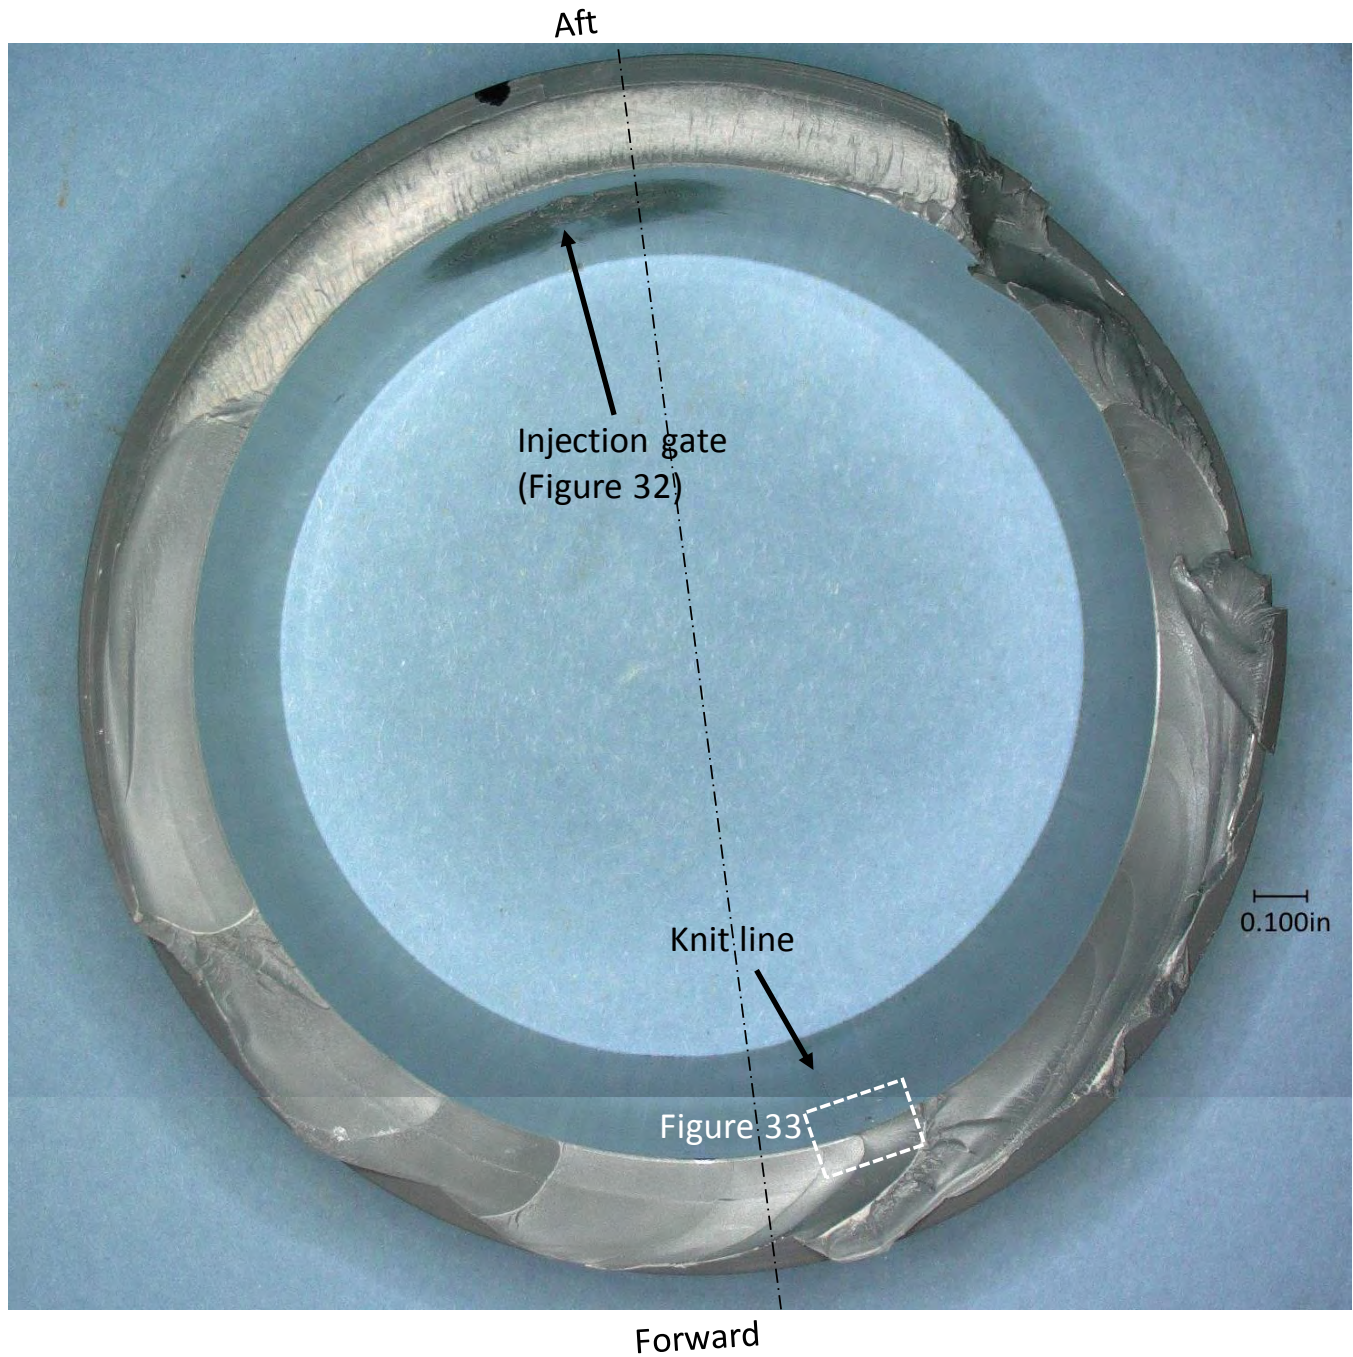
Other molding artifacts in the close nipple pieces such as the injection gate marks, wrinkles around the injection gate, and a knit line are identified in Figures 31-33. Although present and visible, none of these molding artifacts directly influenced the fracture of the close nipple.

Figure 31 Macrograph of the close nipple piece removed from the 90° elbow showing the location of the injection gate and the knit line.

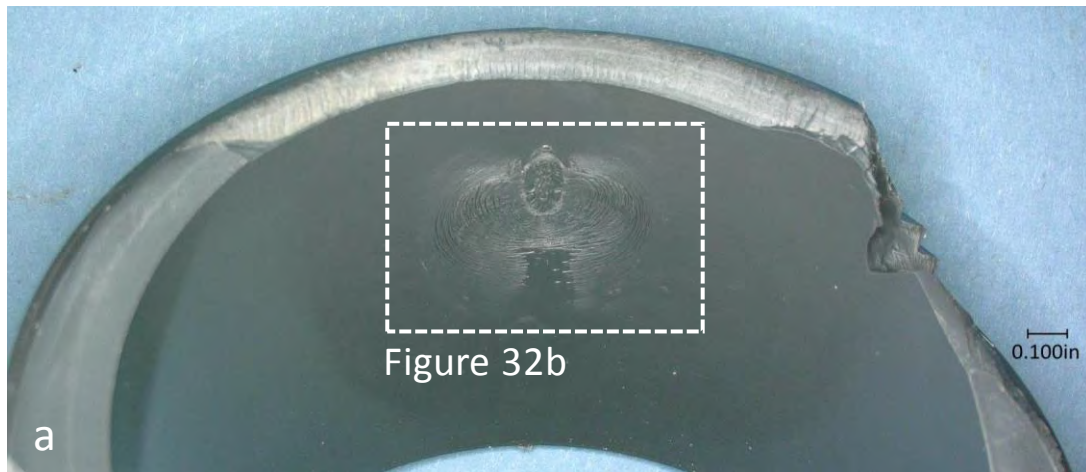
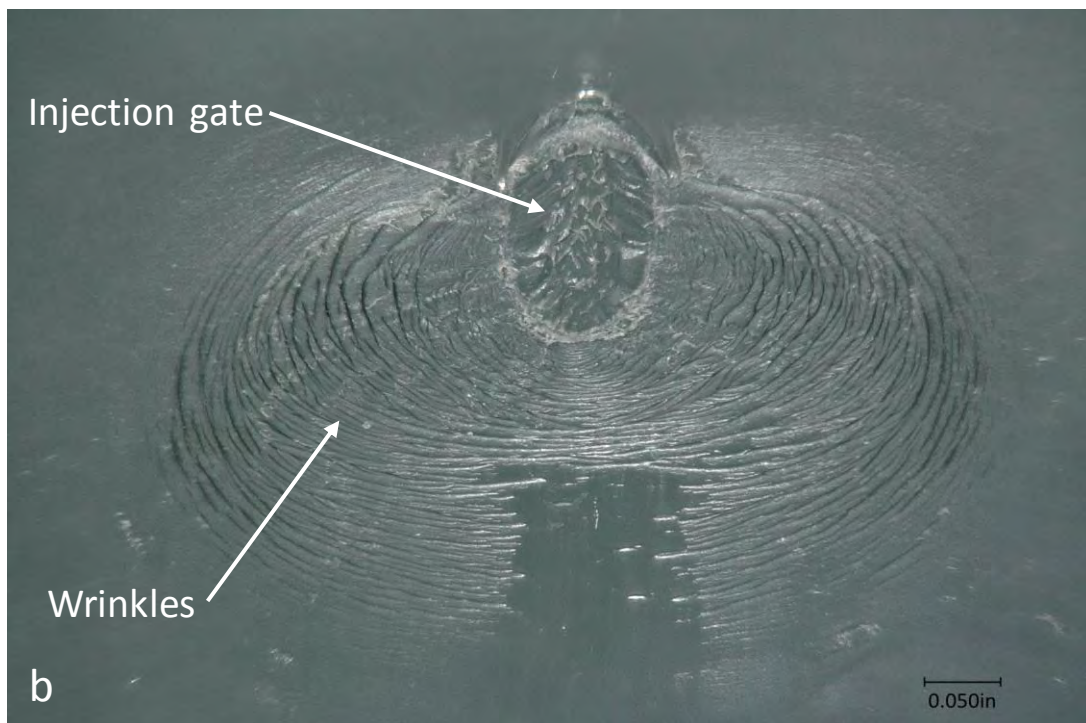
Figure 32 Digital macrographs of the inner bore of the close nipple piece removed from the 90° elbow.

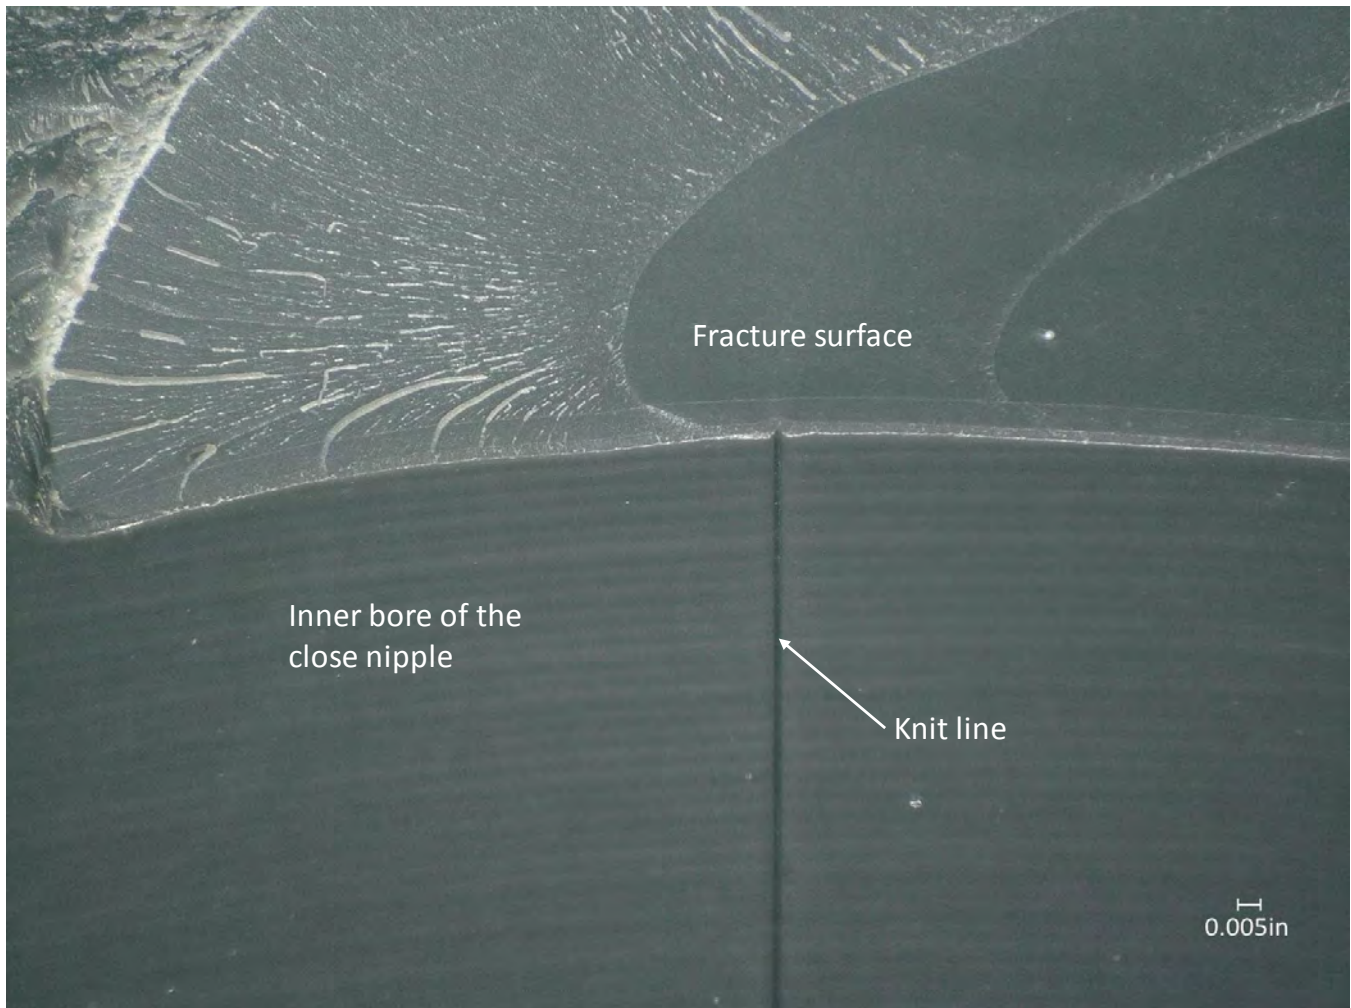
Figure 33 Higher magnification digital macrograph of the inner bore of the close nipple piece removed from the 90° elbow (see Figure 31 for location).

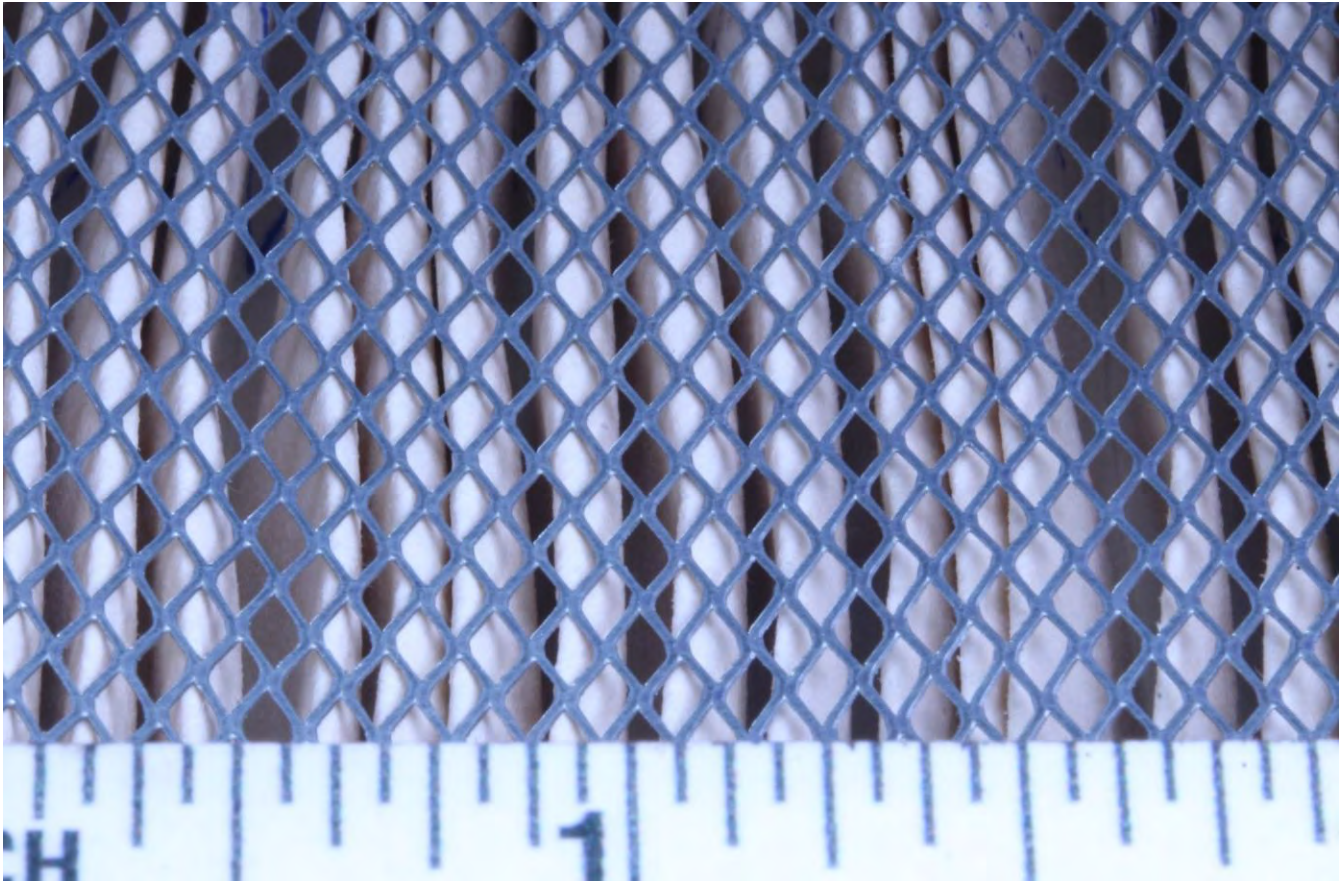
Inside surface of the filter

No cake deposits were noted on the internal and external surfaces of the engine air intake filter as documented in Figure 34.

Figure 34 Image of the intake side of the air intake filter.
