## **NATIONAL TRANSPORTATION SAFETY BOARD**

### **AIRFRAME AND ENGINE EXAM REPORT**

WPR16LA165

Location: Gunnison, UT  
Date: August 12, 2016  
Aircraft: Robinson R44, Registration Number: N247DB, Serial #: 10086  
NTSB IIC: Howard Plagens

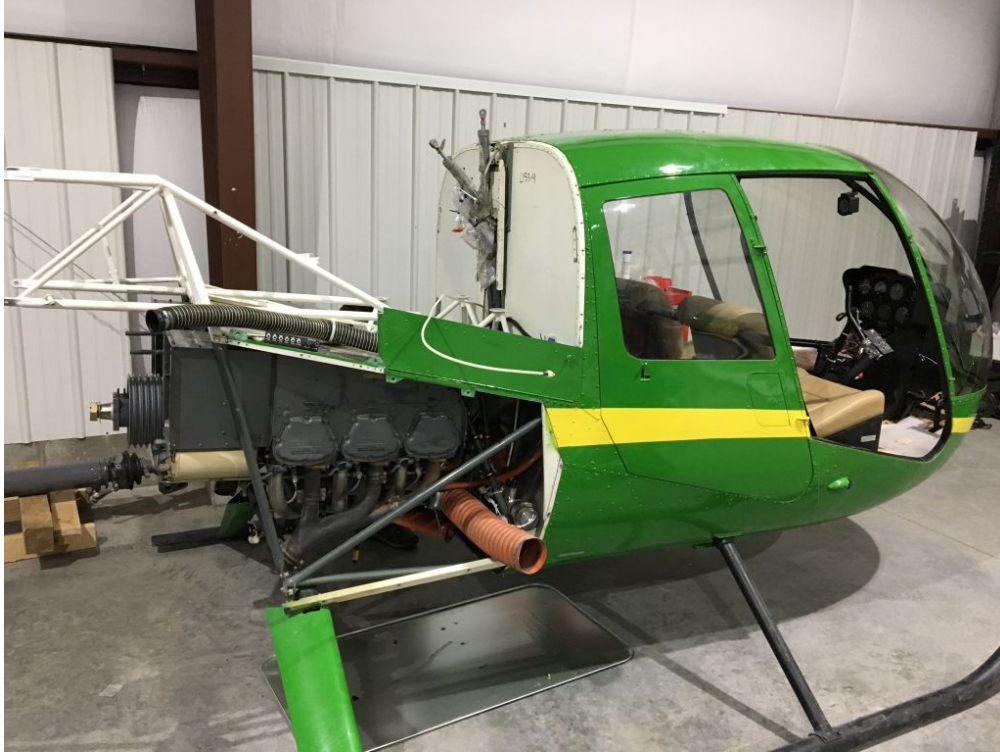
*Figure 1 Side View of Helicopter*

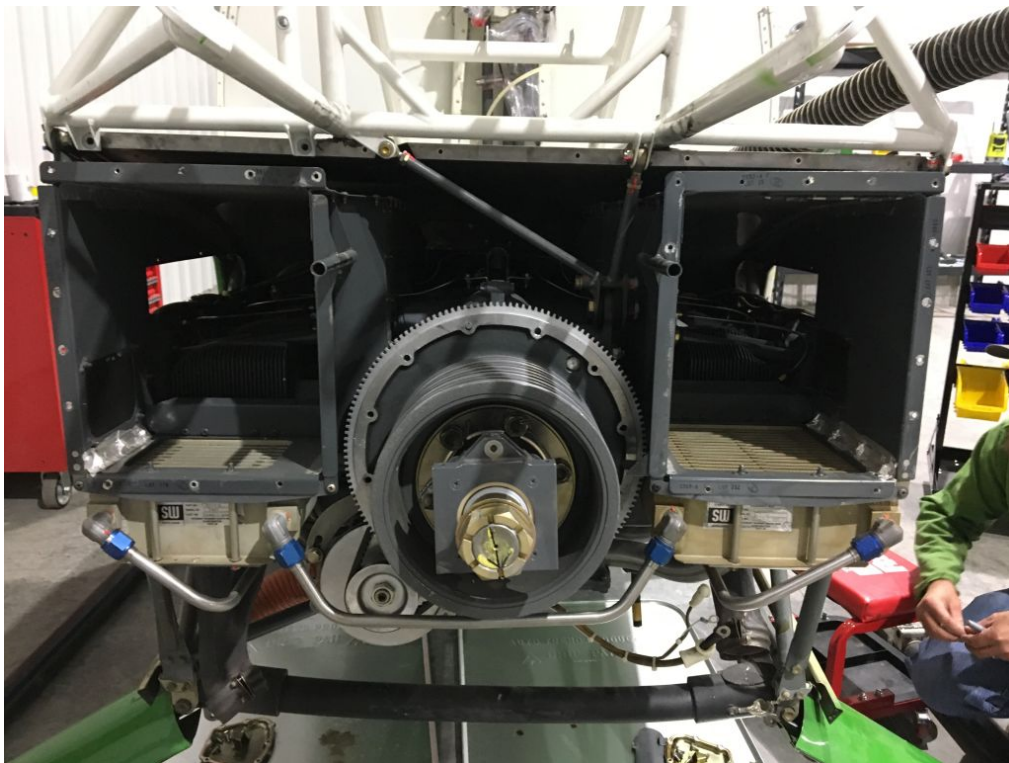
Investigators left the engine in place on the airframe. They removed the valve covers and the top spark plugs. They manually rotated the crankshaft with the belt drive. The crankshaft rotated freely, and the valves moved approximately the same amount of lift in firing order. Investigators obtained thumb compression on all cylinders in firing order.

*Figure 2 Rear View of Engine*

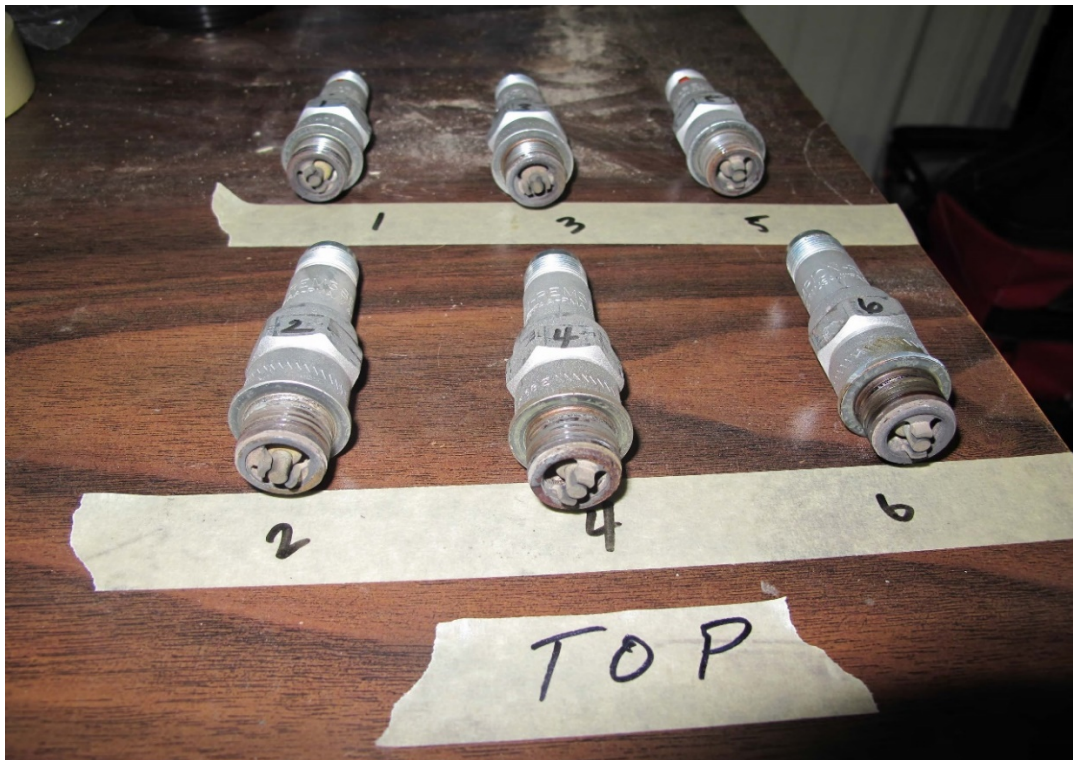
Investigators removed the spark plugs; all center electrodes were circular and clean with no mechanical deformation. The spark plug electrodes were gray, which corresponded to normal operation according to the Champion Aviation Check-A-Plug AV-27 Chart.

*Figure 3 Top Spark Plugs*

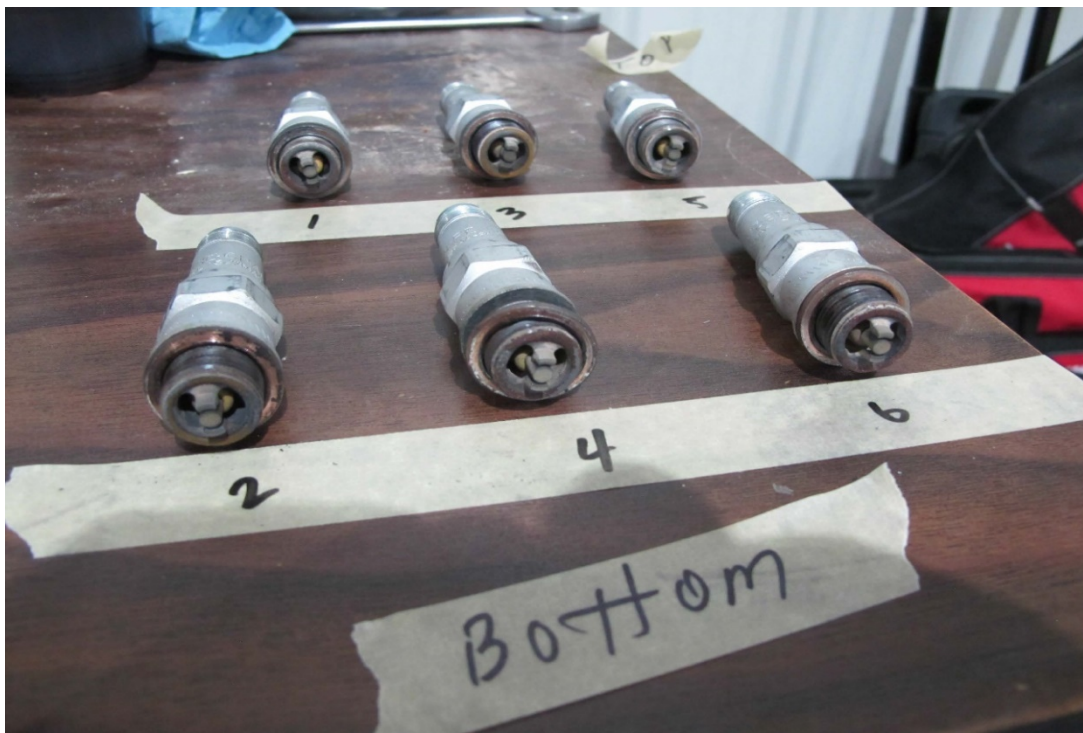
*Figure 4 Bottom Spark Plugs*

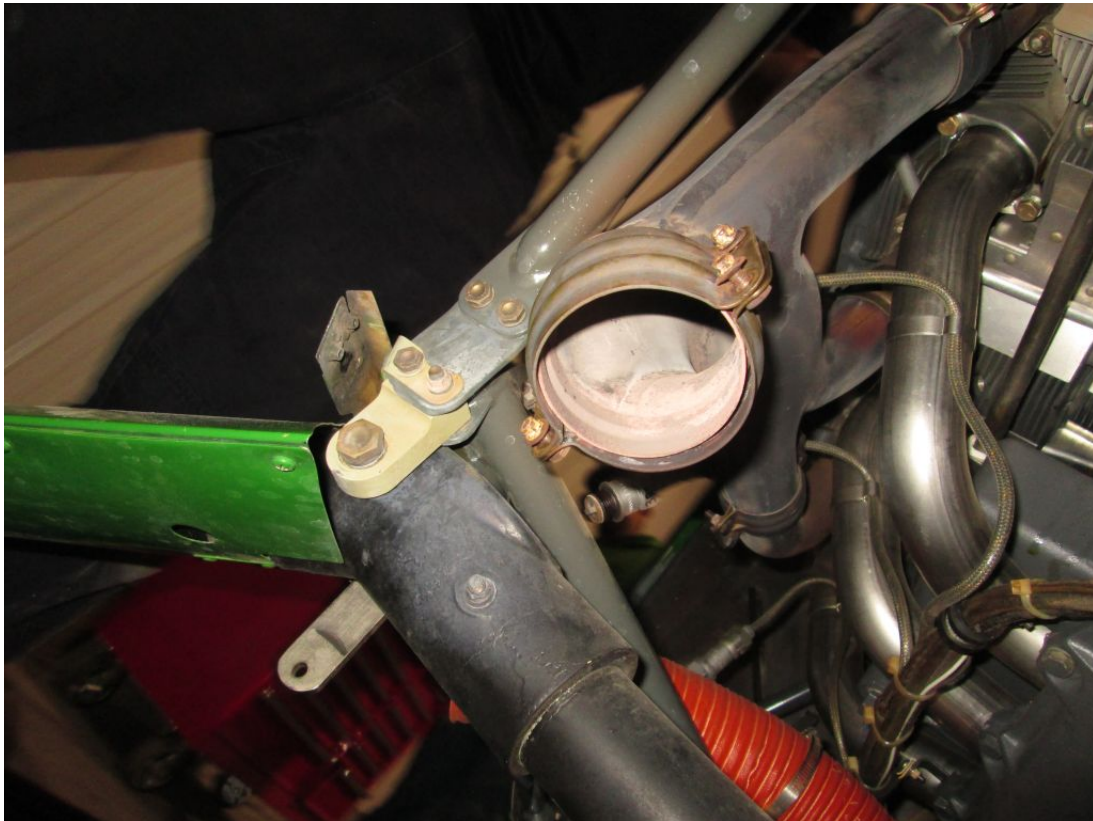
The exhaust path was light brown in color.

*Figure 5 Exhaust*
