## RECORD OF CONVERSATION

**Samantha Link**  
**Aviation Accident Investigator**  
**Western Pacific Region**

**Date: September 29, 2016**  
**Person Contacted: Mr. Anthony Jurcan (Pilot, Owner, Builder)**  
**NTSB Accident Number: WPR16LA187**

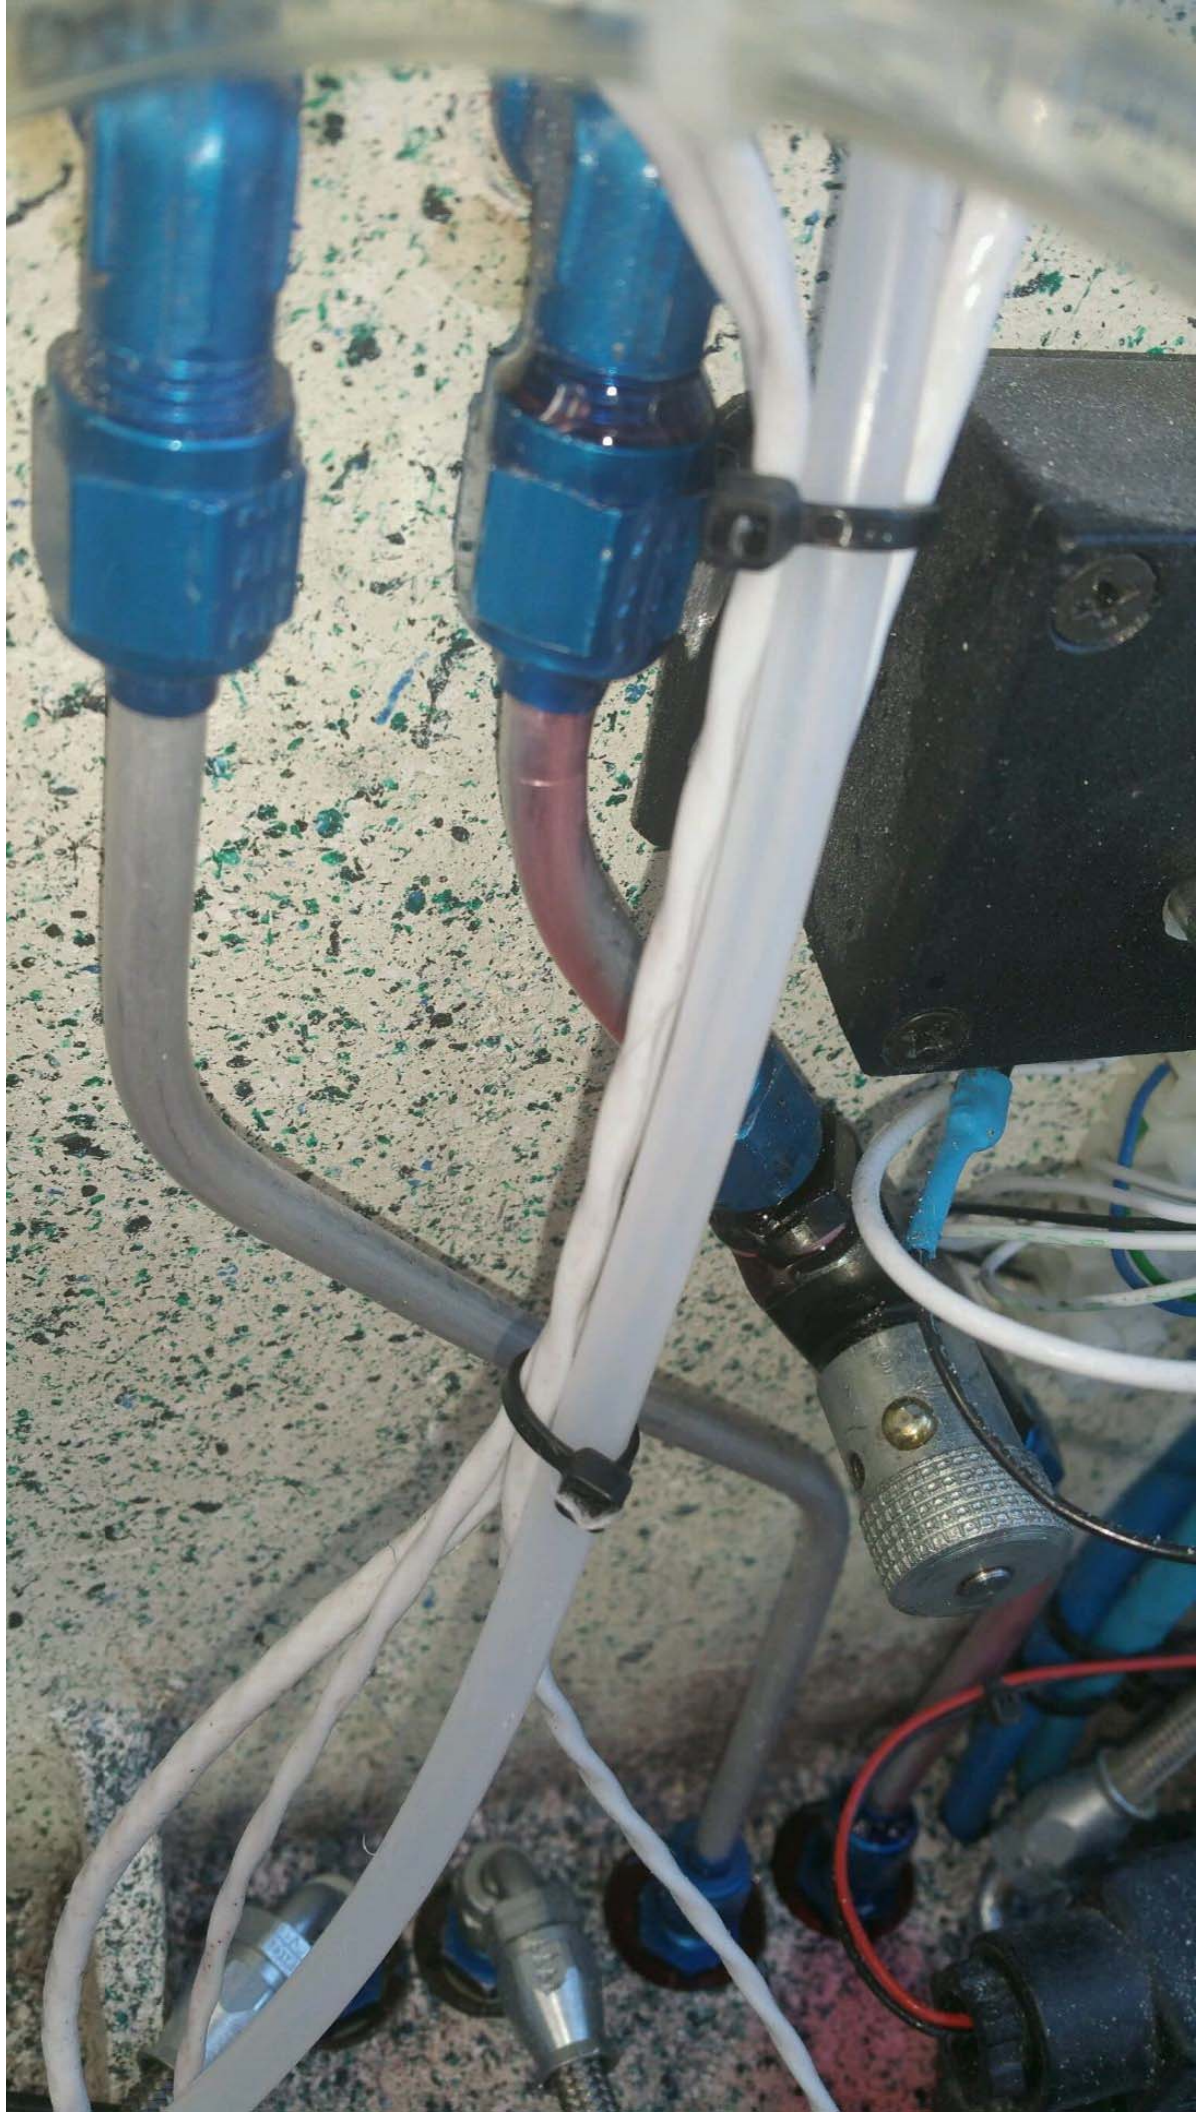
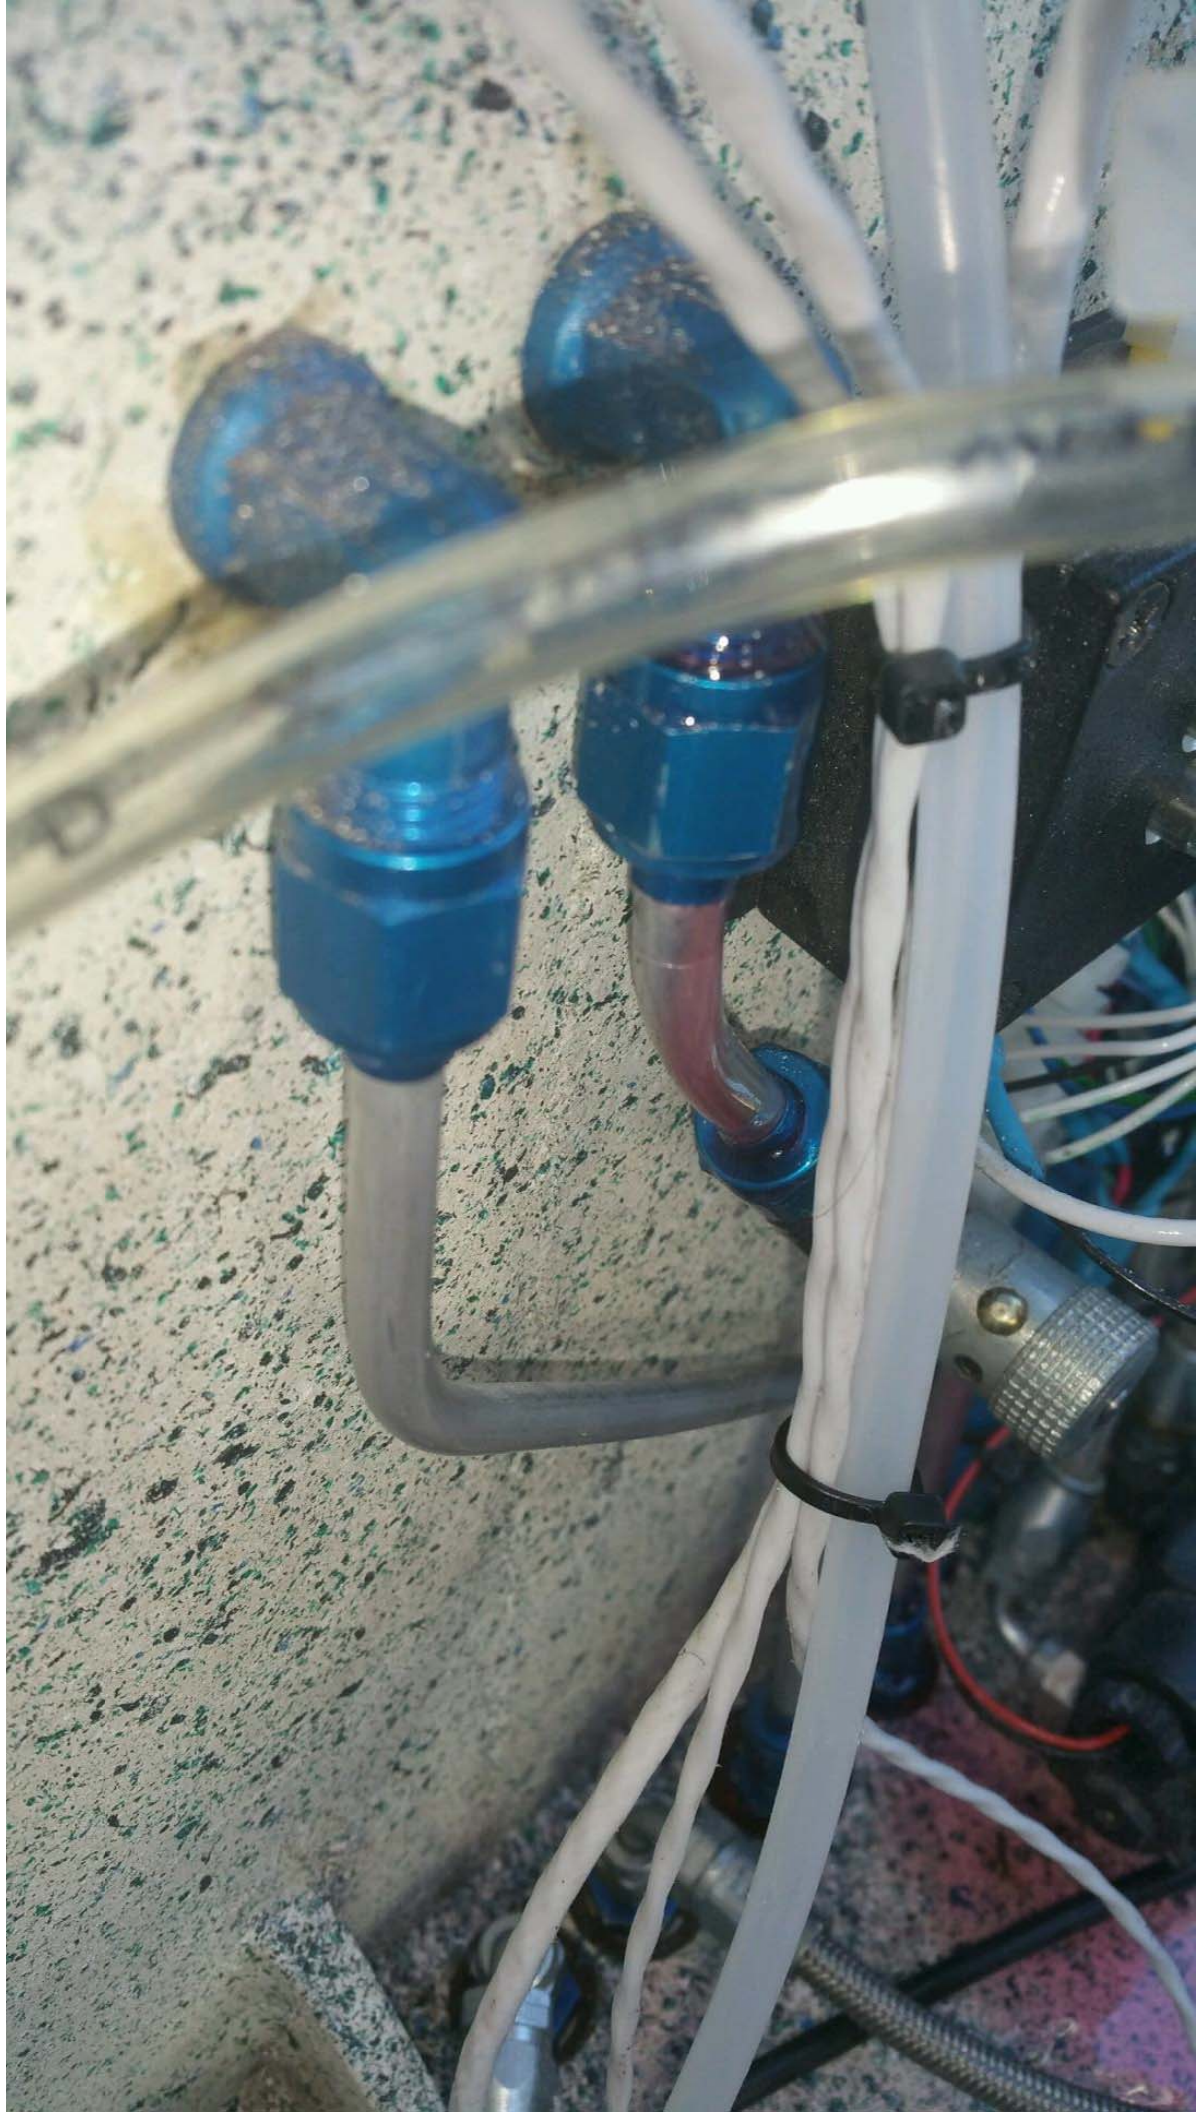
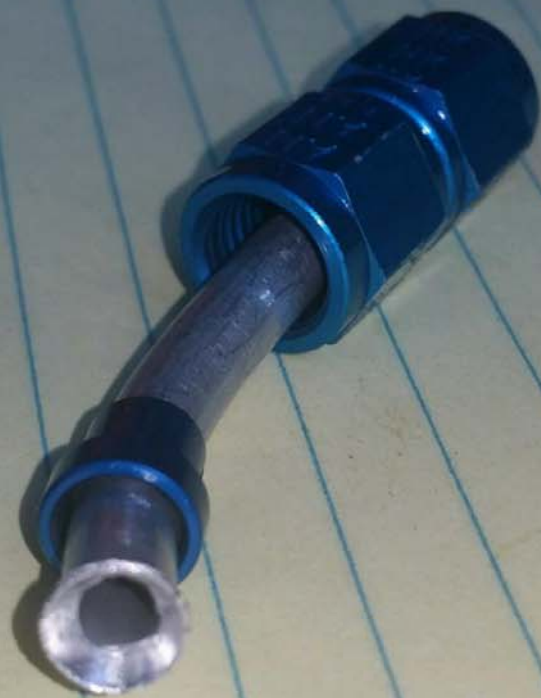
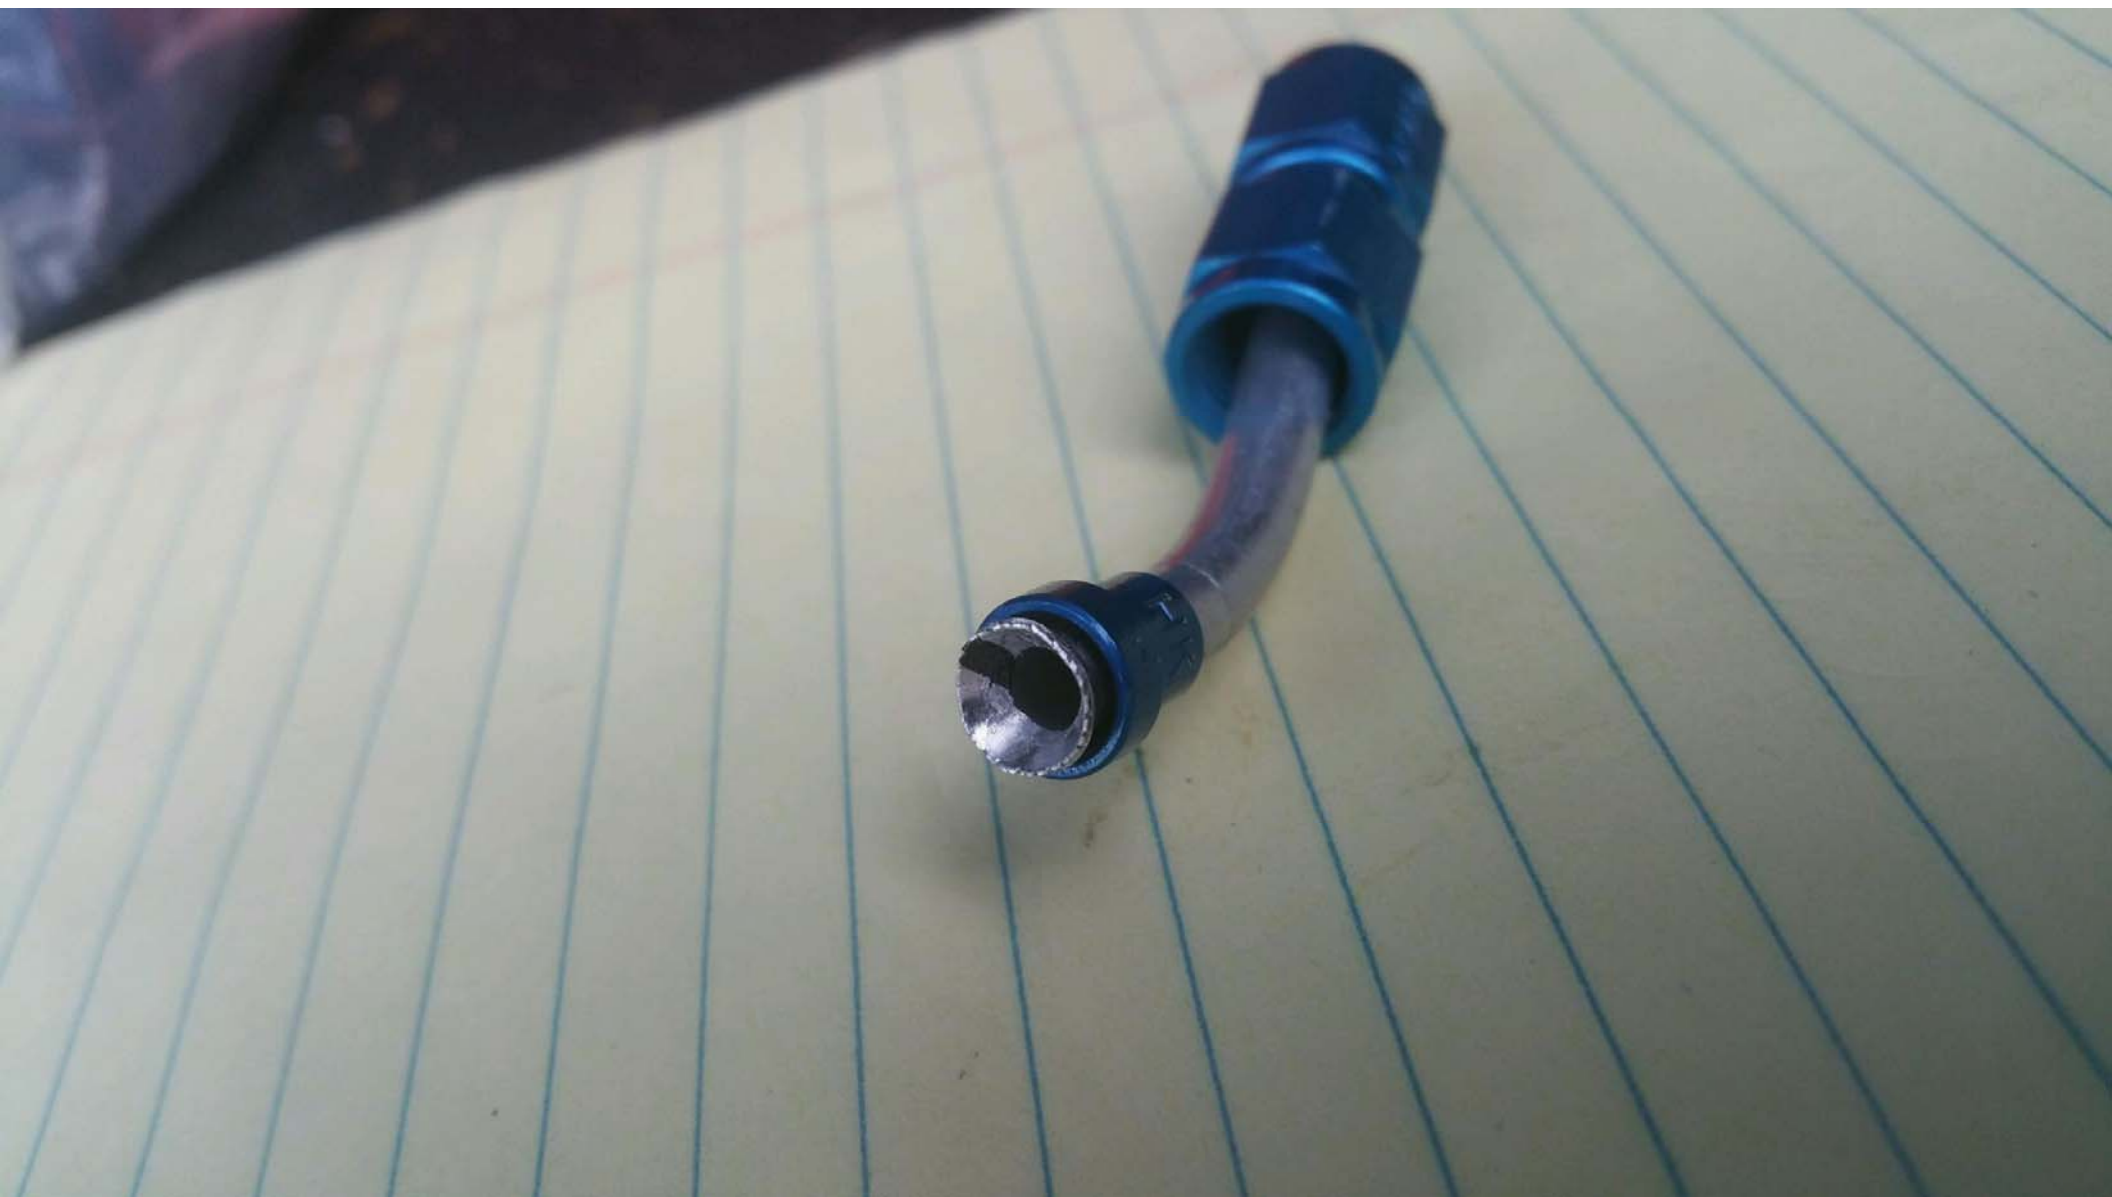
During a telephone text conversation with Mr. Jurcan, he reported that the hydraulic leak was caused by a cracked flare in a hydraulic line fitting. This fitting was located on the bulkhead between the cabin and nose compartment and it leads directly into the nose gear actuator. He believes the crack was caused by vibration. He included the attached photographs.

Mr. Jurcan further reported that he has purchased the components needed for a CO<sub>2</sub> emergency landing gear extension system. He is currently in the process of repairing the airplane and installing this system.
