Hillcrest Aircraft Company  
[REDACTED]  
Lewiston, Idaho  
FAA Repair Station GFLR237E

## **Pylon Whirl Inspect**

**BHT 206BIII S/N 4277 N6181A Date: 11-03-2016**

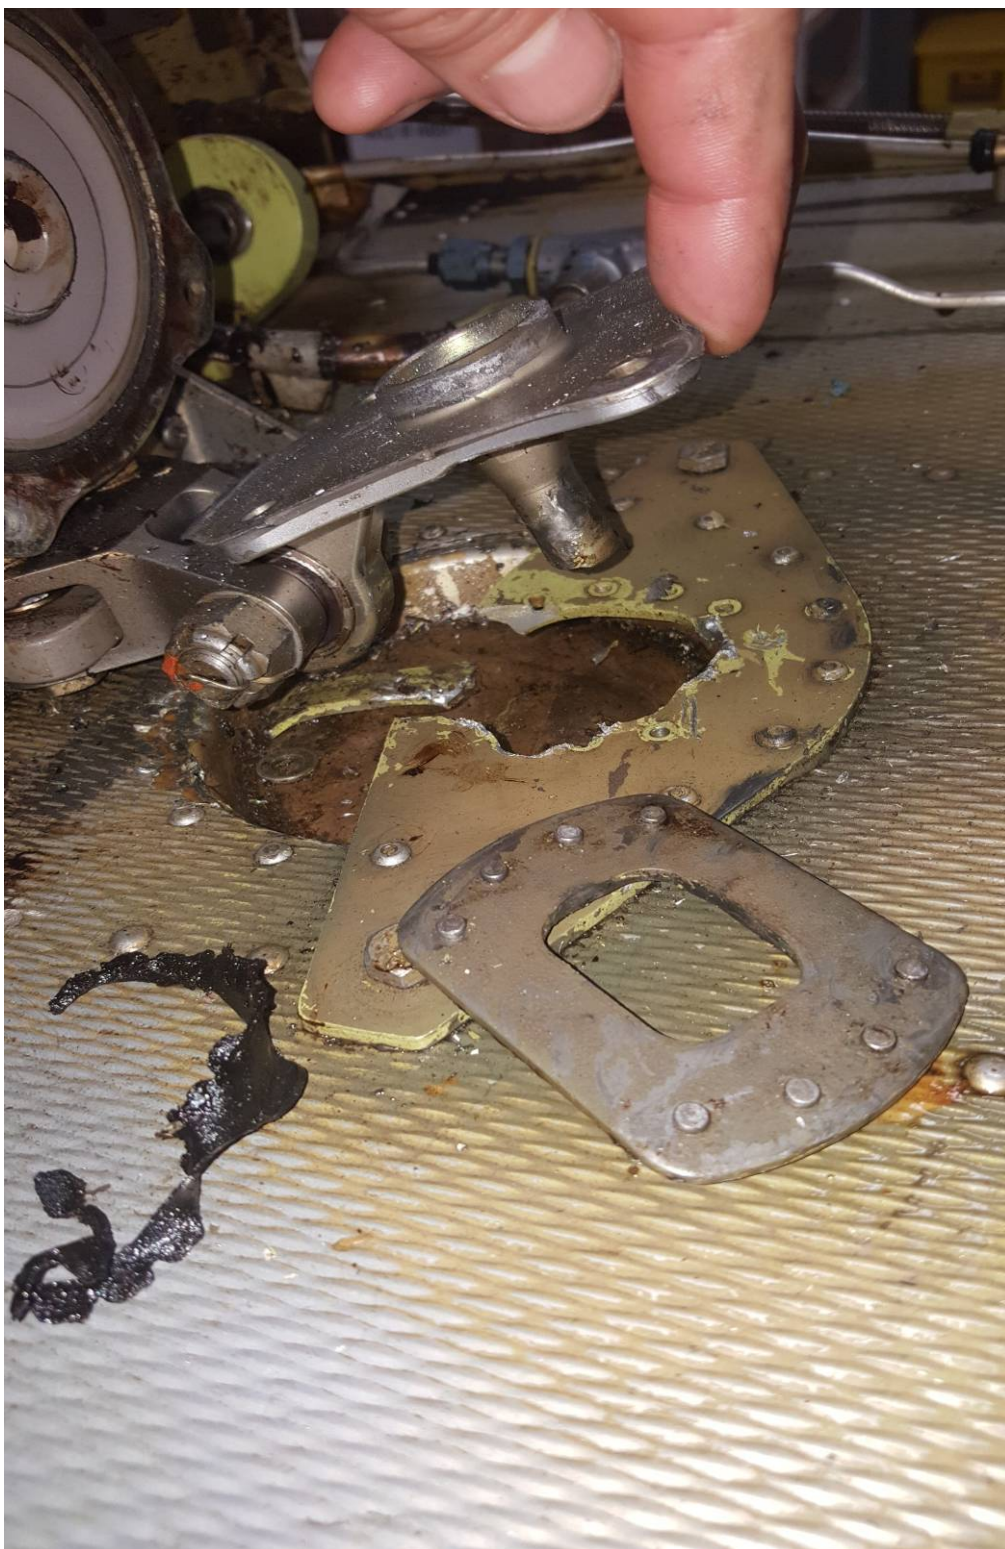
Pic #2

- Inspect support 206-031-510 for damage. (Pic #2)
  - o Support was found to be damaged beyond repair and requires replacement.
- Inspect Drag Pin for damage and security of attachment. (Pic #3-5)

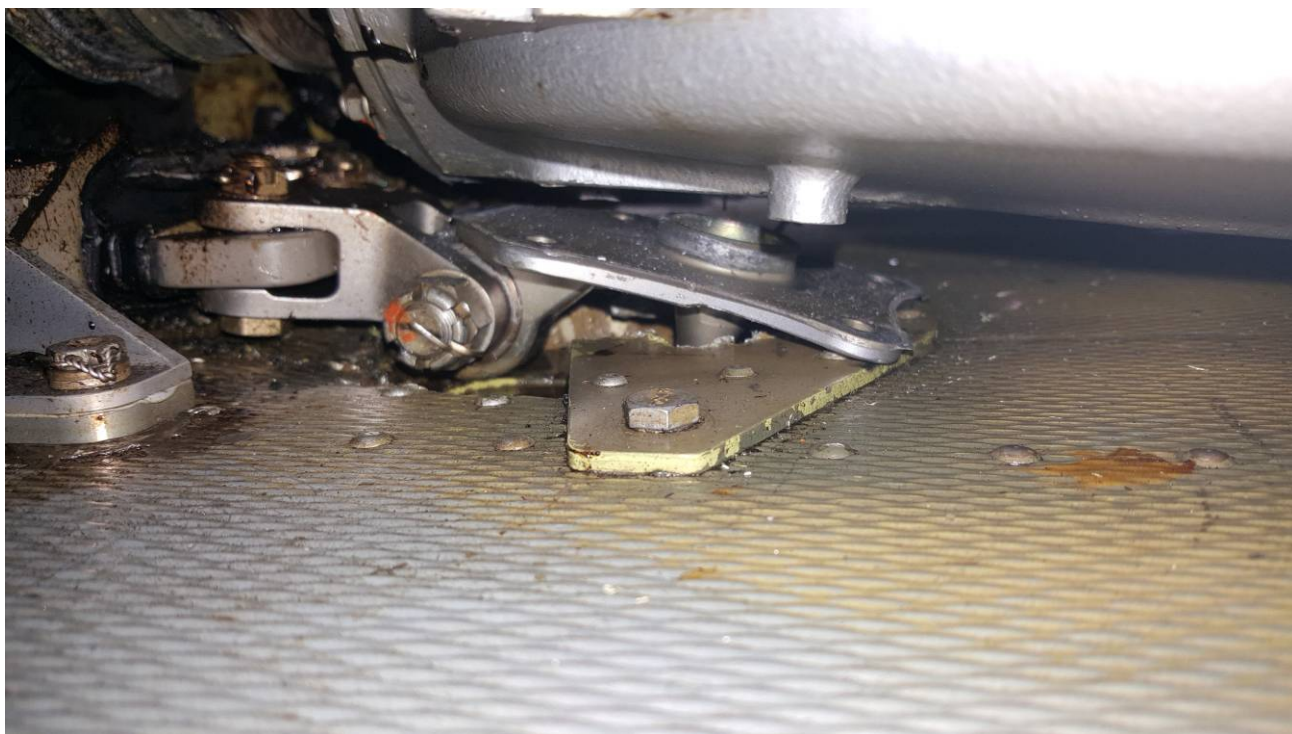
Pic #3

- o Drag Pin was found to be heavily damaged and attaching hardware sheared off from Main Rotor Gearbox. The Drag Pin requires Magnetic Particle Inspection to determine airworthiness and the Main Rotor Gearbox Drag Pin attachment point requires repair.

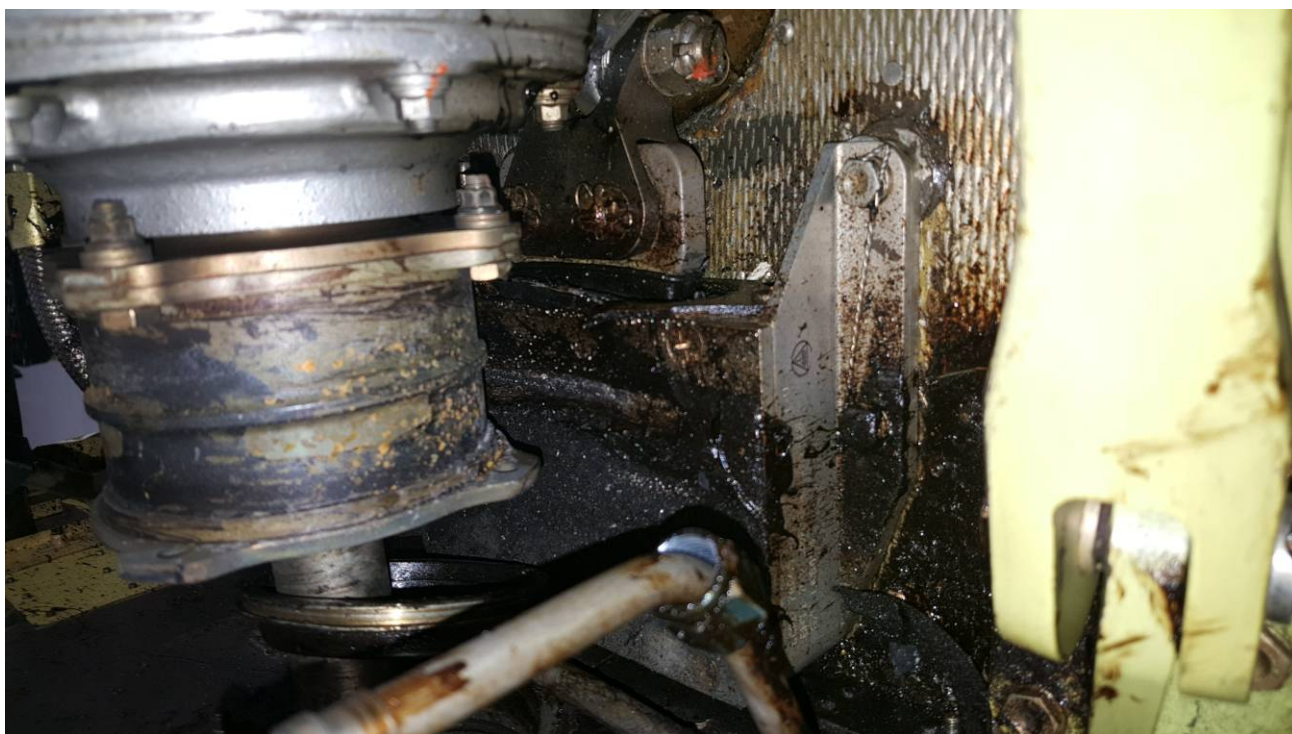
Pic #6

- Inspect Isolation Mount for damage caused by contact with the Main Rotor Driveshaft. (Pic #6-9)
  - o The Main Rotor Driveshaft made hard contact with the Isolation Mount and as a result the Isolation Mount and Main Rotor Driveshaft were damaged beyond repairable limits and will require replacement.

- o As a result of the damage to the Main Rotor Driveshaft the Freewheeling Assembly is required to be overhauled.
- Inspect Main Rotor Pitch Links for contact with the Cowling. (Pic #10-12)

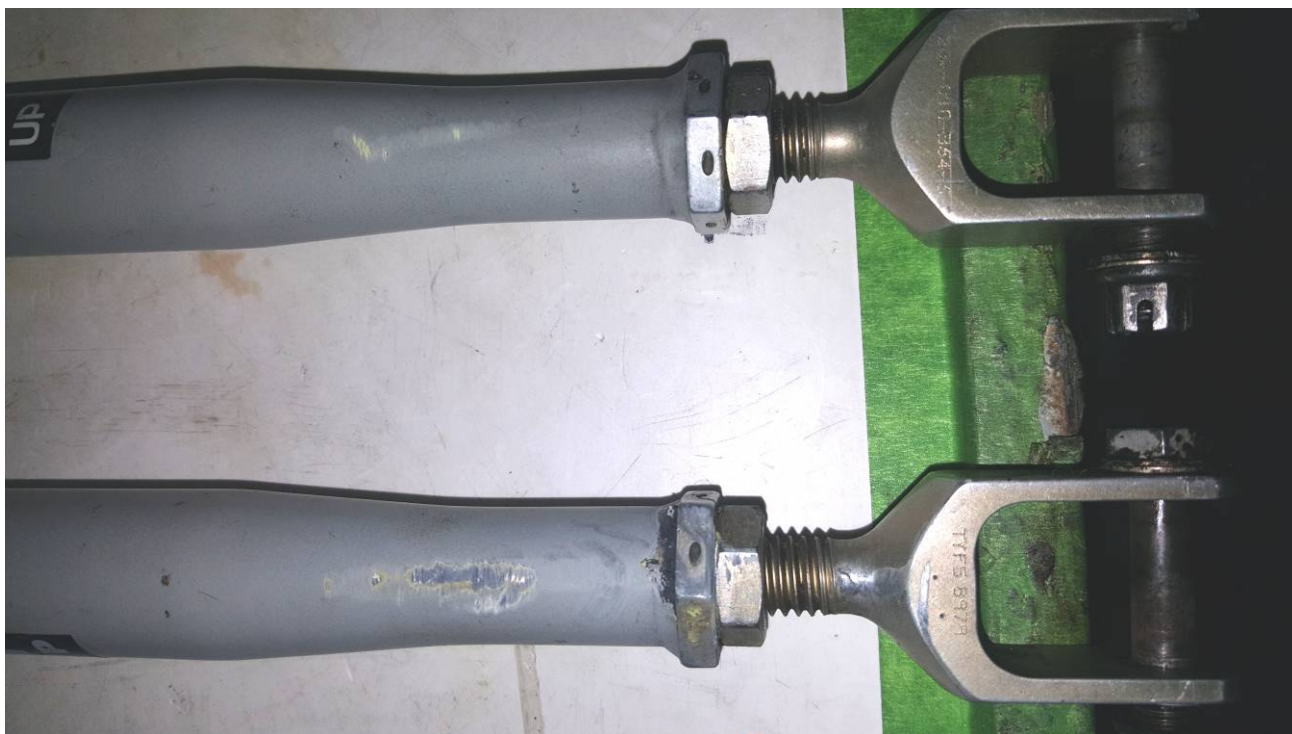
Pic #10

- o Both Main Rotor Pitch Links made contact with the cowling and as a result the Cowling will require repair, both Pitch Links require overhaul, the Swashplate Assembly requires overhaul and the Swashplate Drive Assembly requires overhaul.

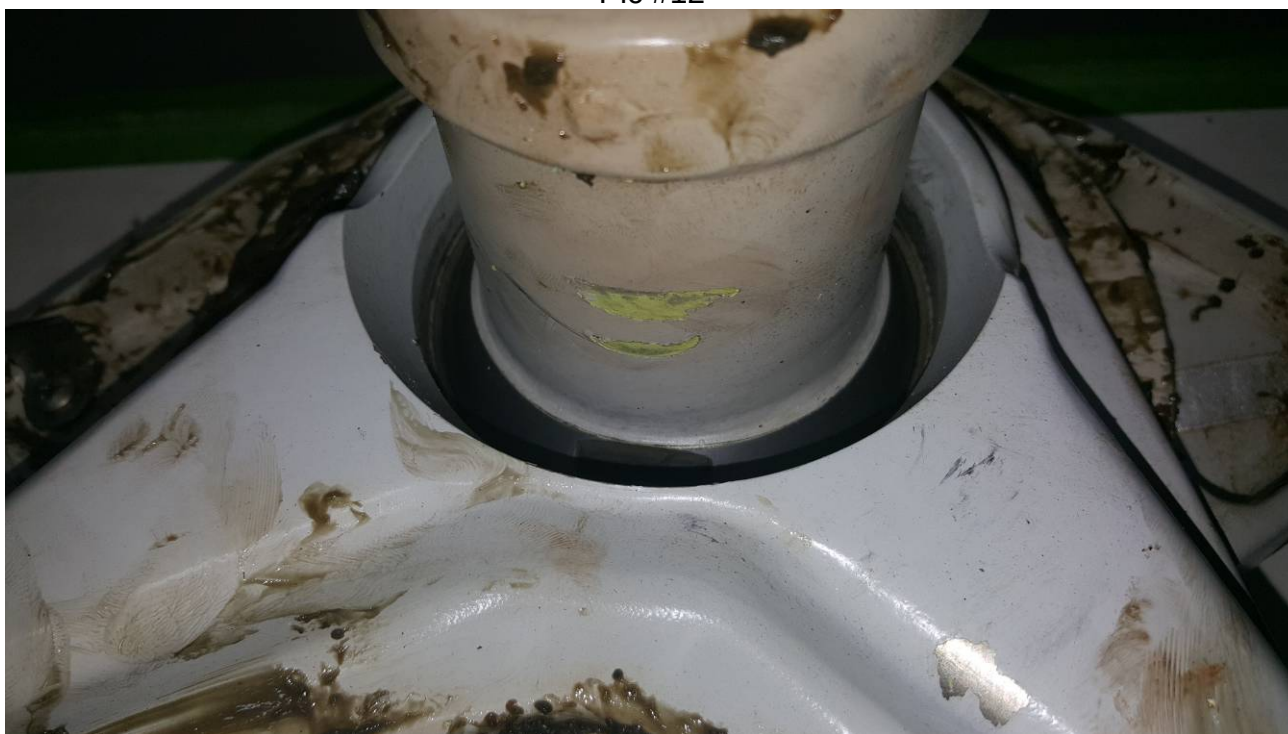
Pic #13

- Inspect Swashplate for contact of Inner Ring to the Sleeve. (Pic #13-14)
  - o The Inner ring made contact with the Sleeve and as a result the Sleeve is unserviceable and will require replacement; this finding also requires that the Swashplate be overhauled.

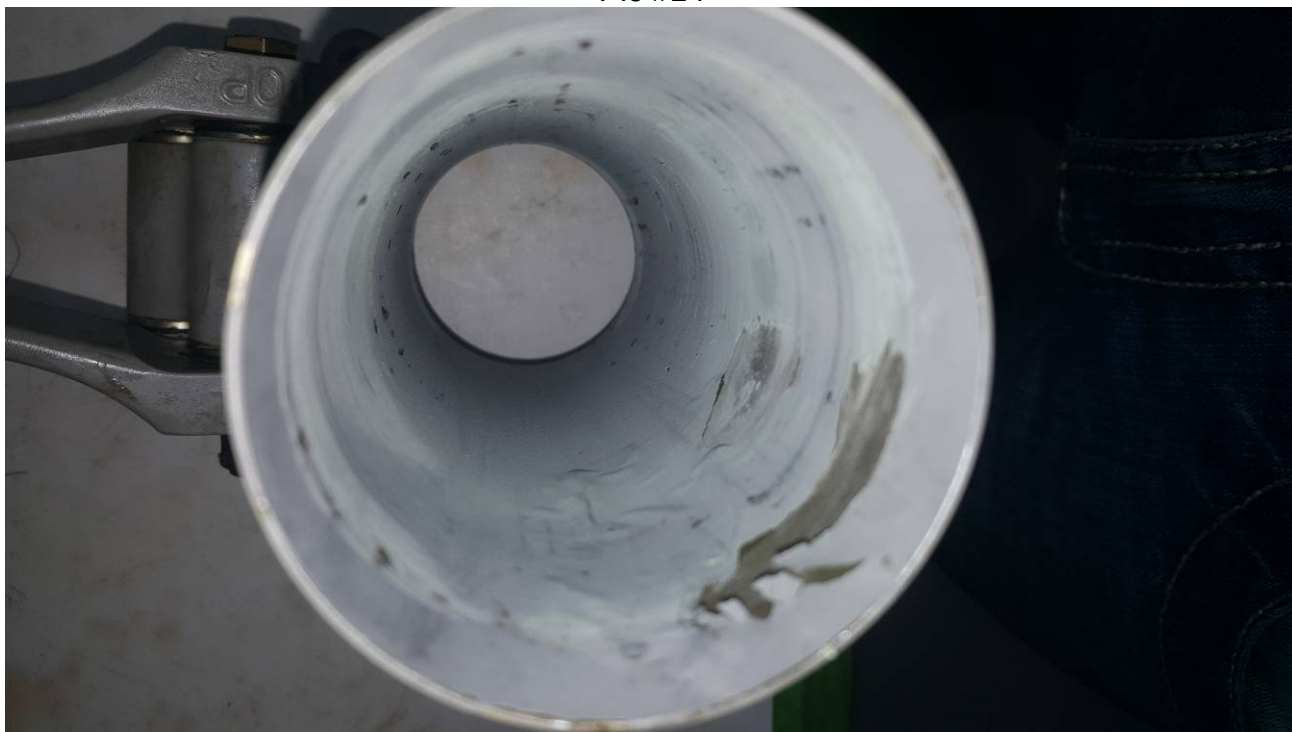
Pic #15

- Inspect the Mast for contact with the upper inside diameter of the Swashplate Support. (Pic #15-17)
  - o The Mast made hard contact with the Support; the Support is consider unserviceable and requires replacement. The Mast requires tear down and a complete visual inspect and a Total Indicated Run-Out performed.

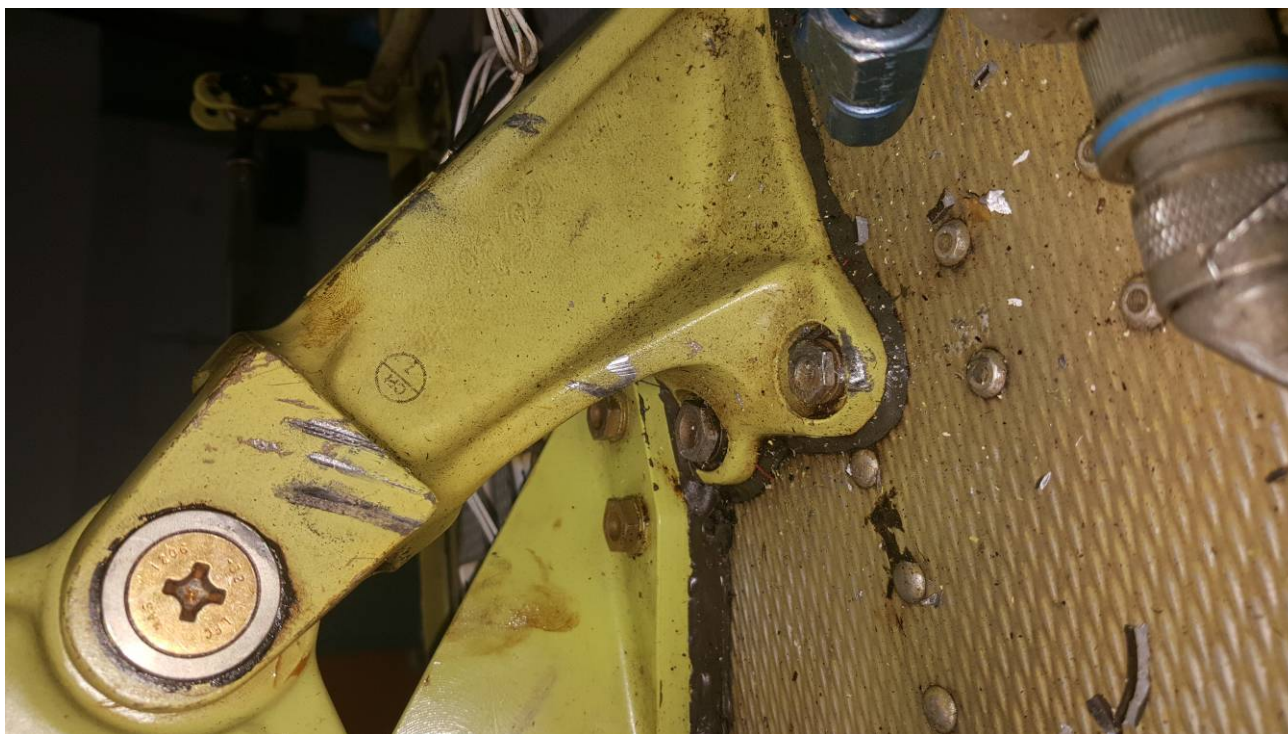
Pic #18

- Inspect Nr Tach Generator for contact with the Transmission Deck or the Left-Hand Cyclic Bellcrank Support. (Pic #18-20)
  - o No damage to the deck from contact with the Nr Tach noted. Left-Hand Cyclic Bellcrank Support has damage from contact with the Nr Tach Generator and requires Fluorescent Dye Penetrant Inspect.

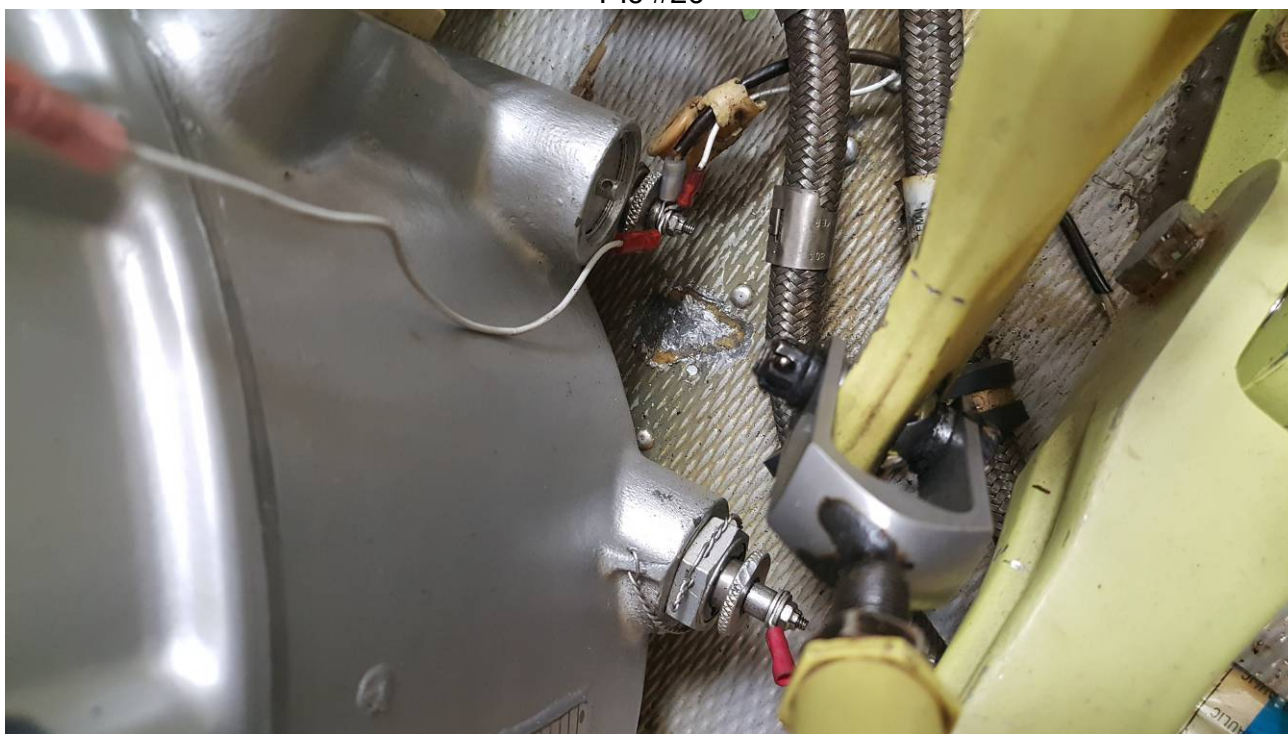
Pic #21

- o Tech Generator found to be damaged beyond repair and requires replacement.
  - o Hydraulic Pump requires further inspection for hidden damage.
  - o During the inspection of the Transmission Deck it was noted that there was damage to the deck from contact with the Main Rotor lower chip detector and will require repair. (Pic #21-22)

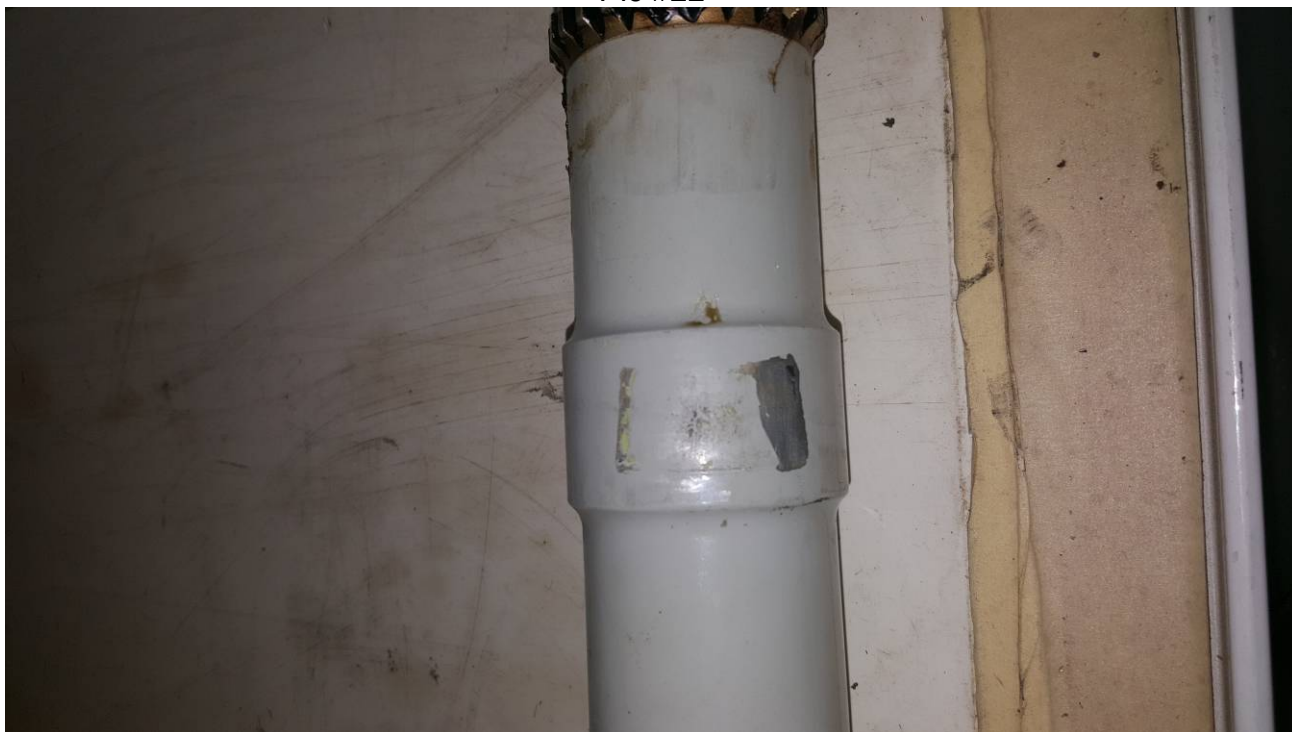
Pic #23

- Inspect Mast for severe contact with the Main Rotor Hub Static Stops. (Pic #23)
  - o Mast has signs of hard contact with the Main Rotor Hub Static Stops; the Mast requires tear down and a complete visual inspect and a Total Indicated Run-Out performed. The Mast assembly and Main Rotor Transmission assembly will also require Overhaul.
