## **NATIONAL TRANSPORTATION SAFETY BOARD**

# **AIRFRAME AND ENGINE EXAMINATION**

**WPR17FA008**

Location: Lake Tahoe, California  
Date: October 15, 2016  
Aircraft: Cessna 182D, N8718X, SN: 18253118  
NTSB IIC: Elliott Simpson

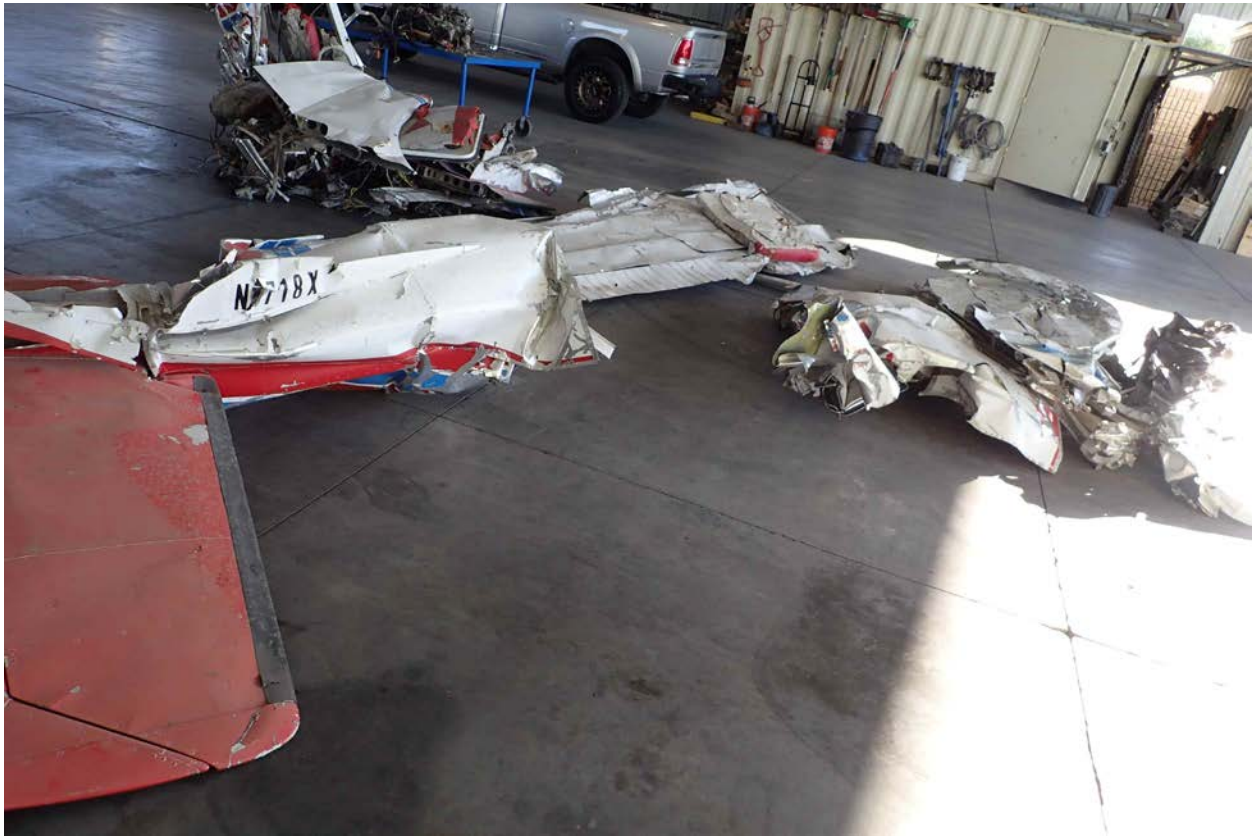
Photo 1 – Airframe Remnants

The fuselage sustained extensive crush damage, from the firewall through to the leading edge of the horizontal stabilizer (Photo 1). The top and bottom of the main cabin had detached, and the remaining structure had become fragmented into multiple pieces.

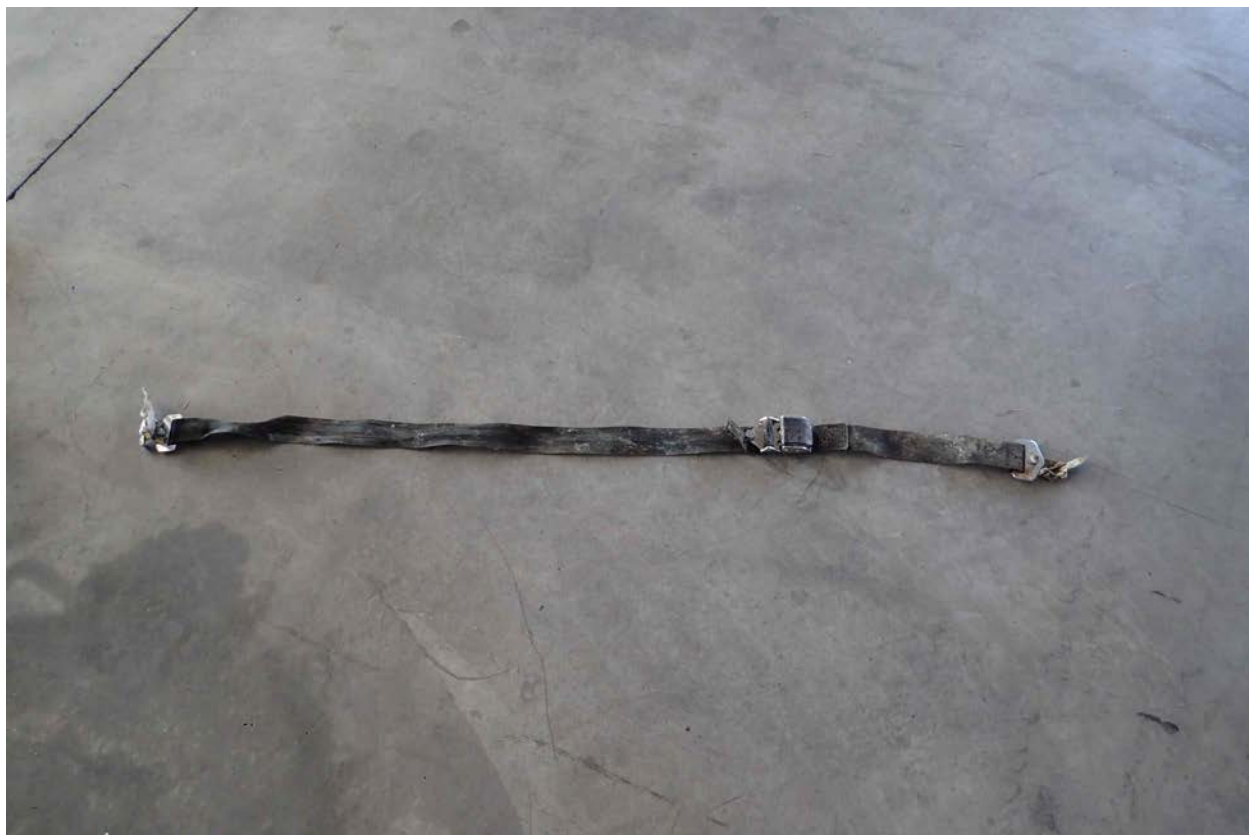
Photo 2 – Left Front Lap Belt

Both front seats had detached from the airframe. The right lap belt was not latched, and both ends of the belt remained coupled to the airframe. The right shoulder harness had been knotted up, and tied up against the airframe in what appeared to be an intentional manner. The left lap belt was latched about 2 inches short of its full range, and did not exhibit any indications of fraying or stretch (Photo 2, 3). Each end of the belt remained attached to its fitting hardware, which had been separated from the airframe. The shoulder harness nylon bushing at the belt buckle was intact and undamaged, and the shoulder harness had been tied and knotted up against the airframe in what appeared to be an intentional manner (Photo 4). The rear bench seat lower section remained attached to the airframe, and its back had detached. Both seat's buckles were unlatched. Cargo, including folding chairs, water canister cylinders, coolers, tools, and clothing was located unsecured, and no indication of webbing was found (Photo 5).

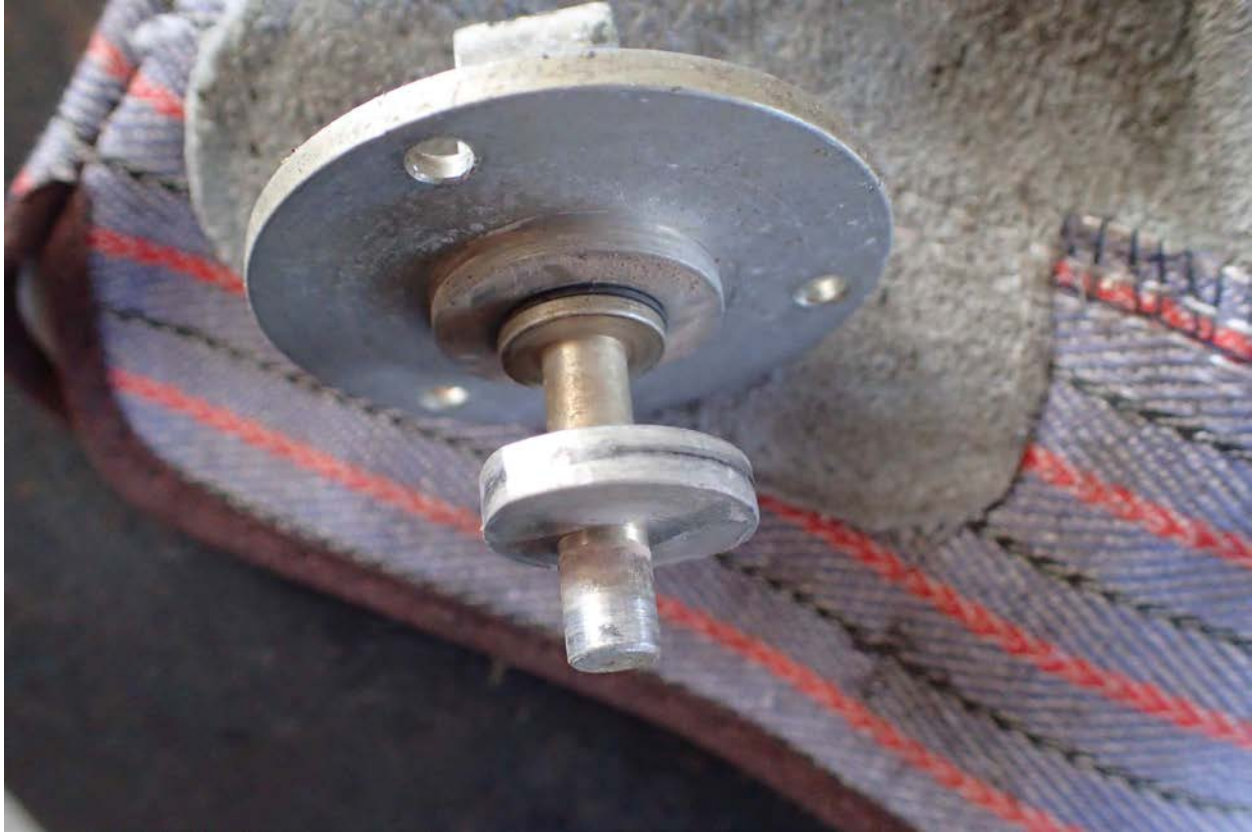
Photo 6 – Fuel Selector Valve Cam

The fuel selector valve was in the BOTH position, and when opened the valve balls were free and undamaged, and the valve cam was intact with minimal wear (Photo 6).

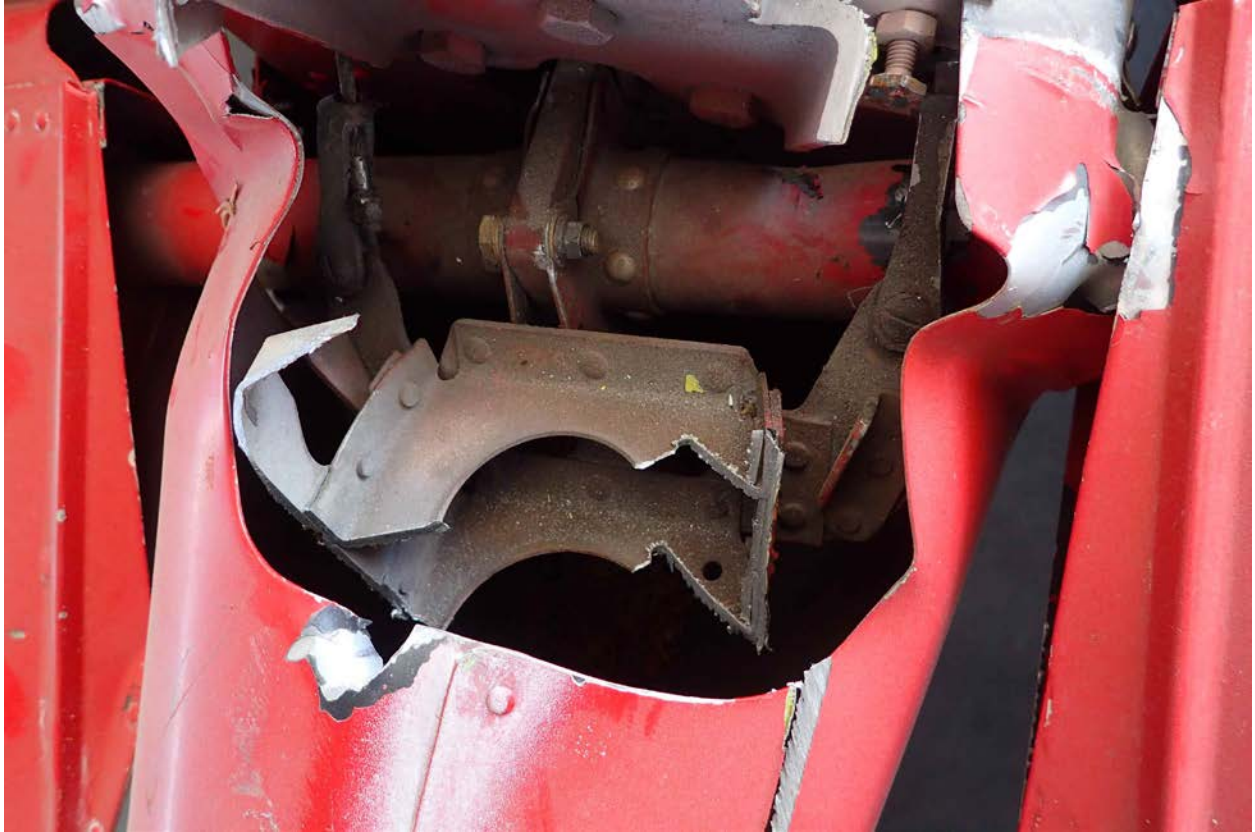
Photo 7 – Rudder Horn

recovery. The rudder cables were attached to the rudder horn assembly, which had been cut off during recovery (Photo 7). The rudder cables were continuous to the cabin, where they had been cut by the recovery crew just behind the rear seats. Forward of the seats, the cables were continuous to the rudder pedal torque tube assembly. The elevator remained attached to the horizontal stabilizer at its hinges. The elevator trim actuator was at a length, which when compared to Cessna documentation, was consistent with a 5 ° stabilizer down (nose up) position. The elevator push-pull control tube was continuous from the elevator pylon through to the cable bellcrank. The elevator cables remained attached to the bellcrank, and were continuous through to the recovery cut aft of the rear seats. Forward of the cut, the cables were continuous through to the lower control column bellcrank. The forward end of the column sustained crush damage and had bent away from the control column.

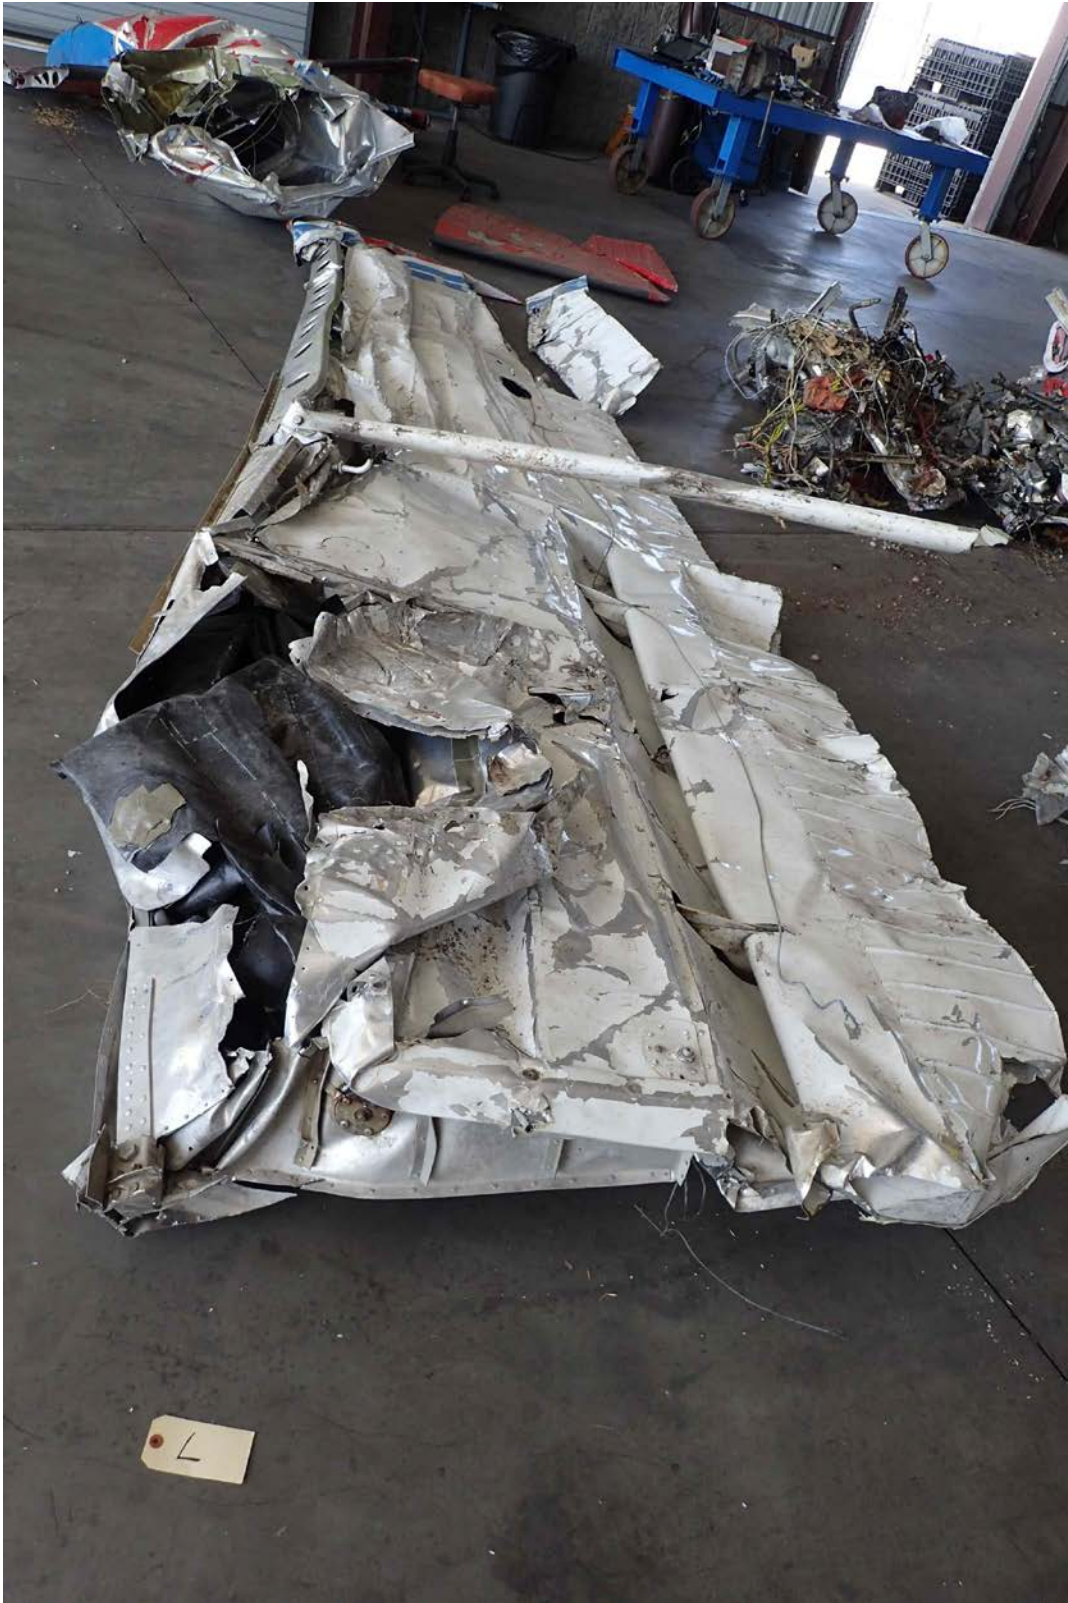
Photo 8 – Left Wing

The left wing sustained accordion-like crush damage along its entire length, separating the leading edge skins (Photo 8). The fuel tank bladder was exposed and had shredded. The fuel cap was in place at the filler neck. The flaps remained attached at the rails, and the lift strut had separated mid-span, but remained attached to its mount points on the main spar and the fuselage belly structure. The aileron, outboard of the push-pull control rod, had separated; inboard of the rod, the aileron remained attached by its hinges. The control rod and bellcrank were intact, and the control cables were continuous to the wing root, where the drive cable appeared to have been cut during recovery, and the carry-through cable had separated with broom straw-like signatures consistent with overload.

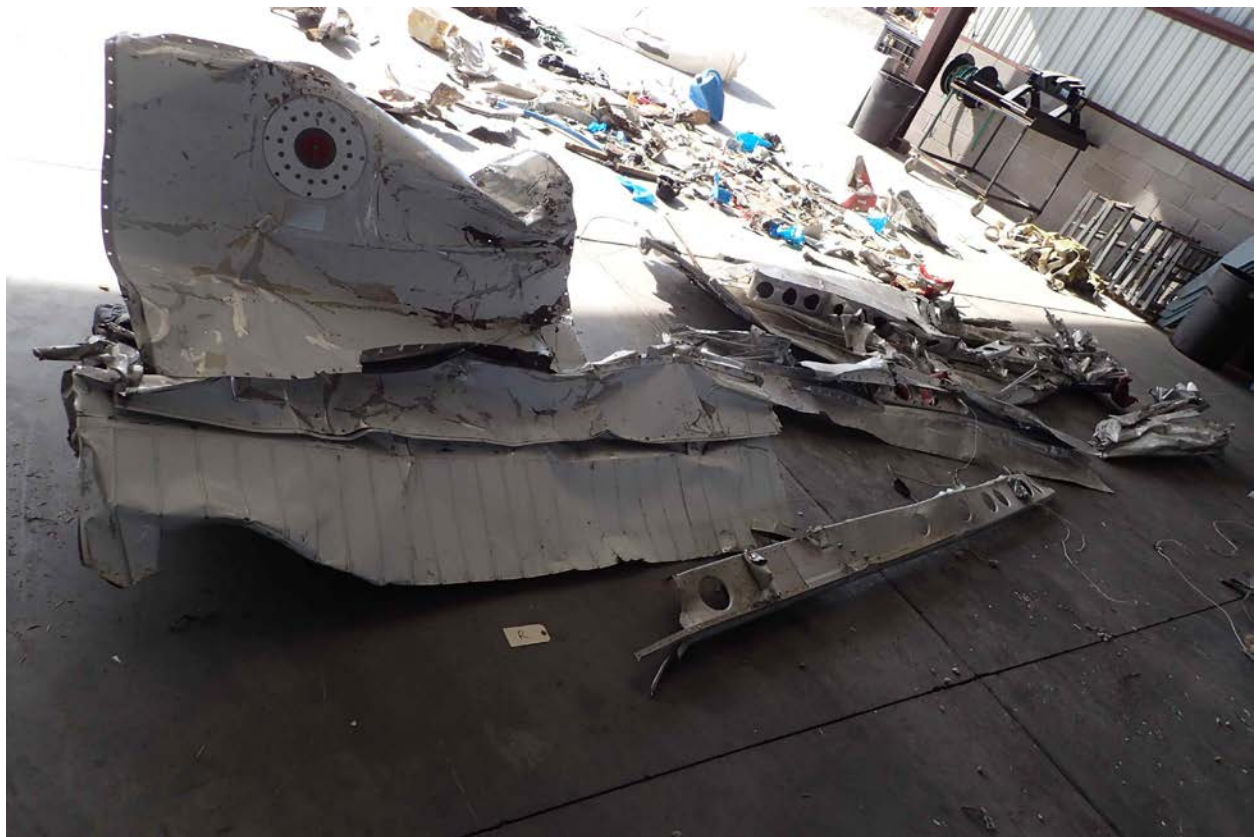
Photo 9 – Right Wing

The right wing had fragmented into multiple pieces (Photo 9). A 10-ft-long section of the spar along with leading edge skins had detached, outboard of the flap. The fuel tank bladder was exposed, and had shredded. The fuel cap was in place at the filler neck. The flap remained attached to its rails, and the aileron remained attached by its hinges. The control rod and bellcrank were intact, and the cables were continuous to the wing root, where the drive cable appeared to have been cut during recovery and the carry-through cable had separated with broom straw-like signatures consistent with overload. The lift strut was not located, however, its fittings at the wing spar and fuselage belly structure were in place.

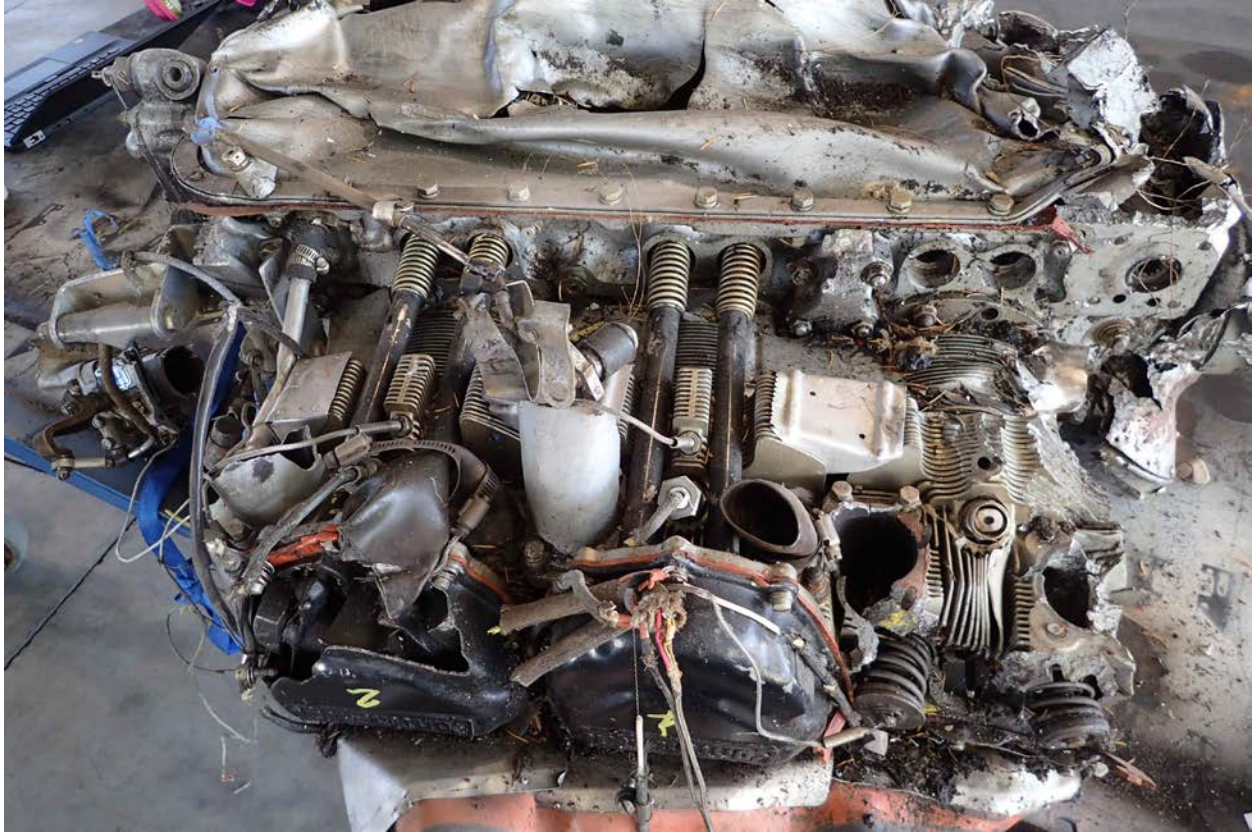
Photo 10 - Engine

The engine had detached from its mount, and had sustained extensive damage, with most of the ancillary components liberated, and the induction manifold and exhaust system shattered and crushed (Photo 10). The magnetos were not located, however fragments of their attachment lugs remained in place at the mounting bolts on the engine. The accessory case was fractured, and the magneto gears were missing and not located. The carburetor body remained bolted to a

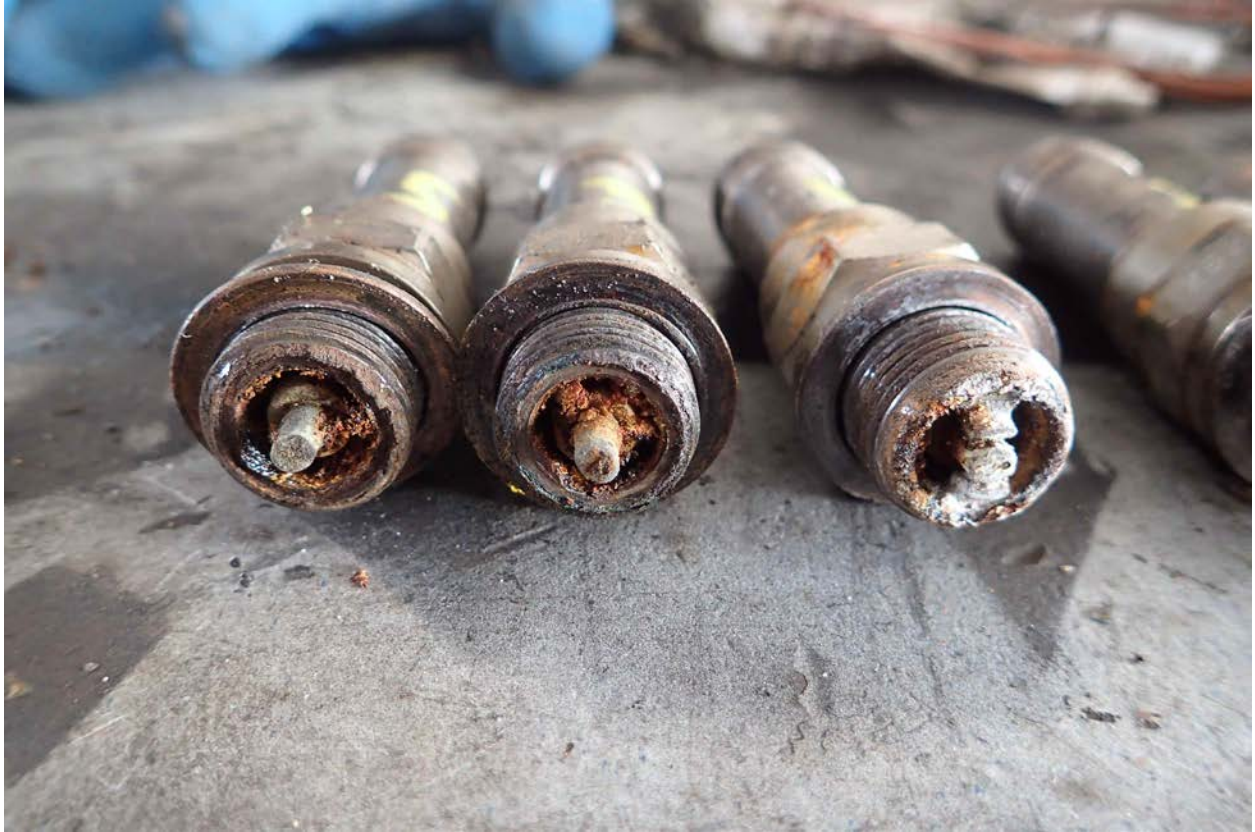
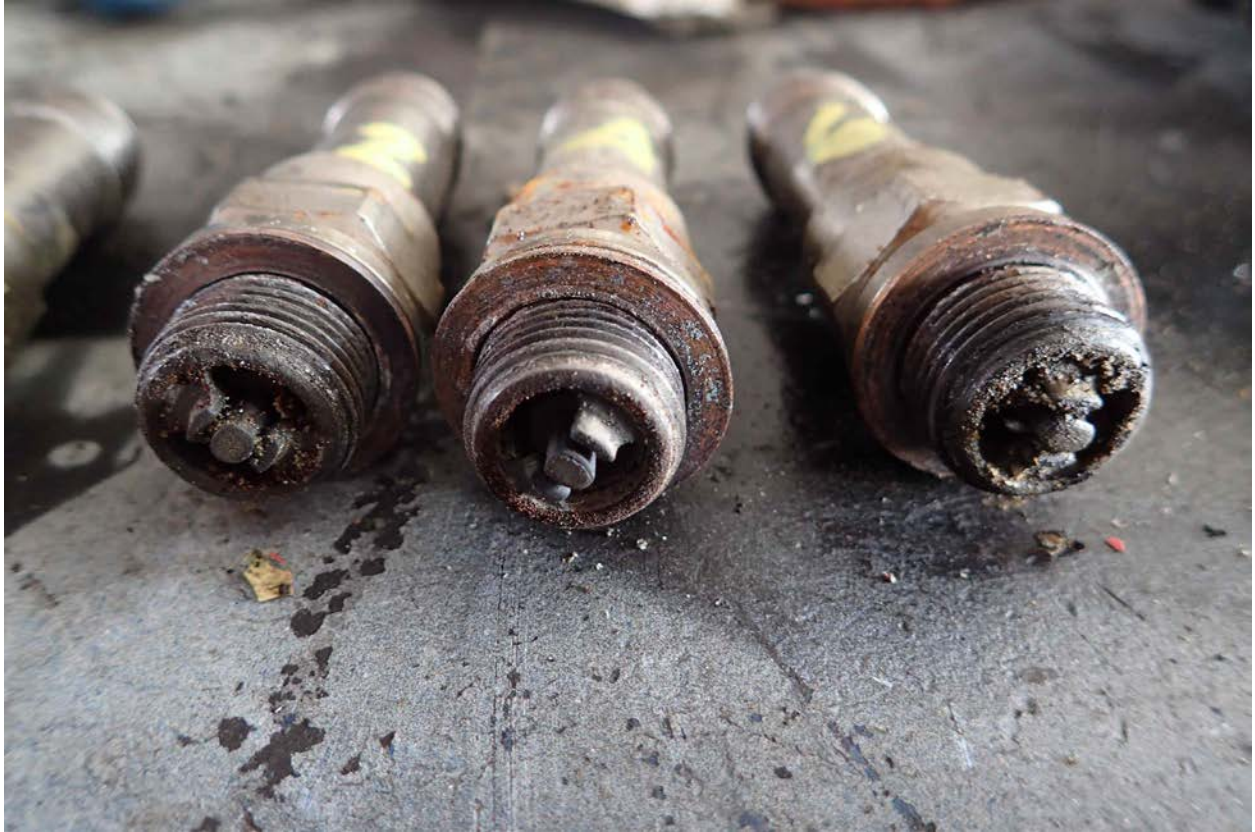
The top spark plugs were removed; all electrodes exhibited varying degrees of corrosion, particularly evident on the plugs for cylinders 1, 3, and 5 (Photo 11, 12). The ground electrodes for plugs 3, and 5 had detached, most likely during plug removal. All plug electrodes exhibited worn out-normal operational and wear signatures when compared with the Champion Aviation Check-A-Plug AV-27 Chart. Visual inspection of the combustion chambers was accomplished through the spark plug bores utilizing a borescope; there was no evidence of foreign object ingestion or valve damage and all combustion surfaces exhibited white, grey, and rust-colored corrosion-like deposits, again particularly sever for cylinders 1, 3, and 5.

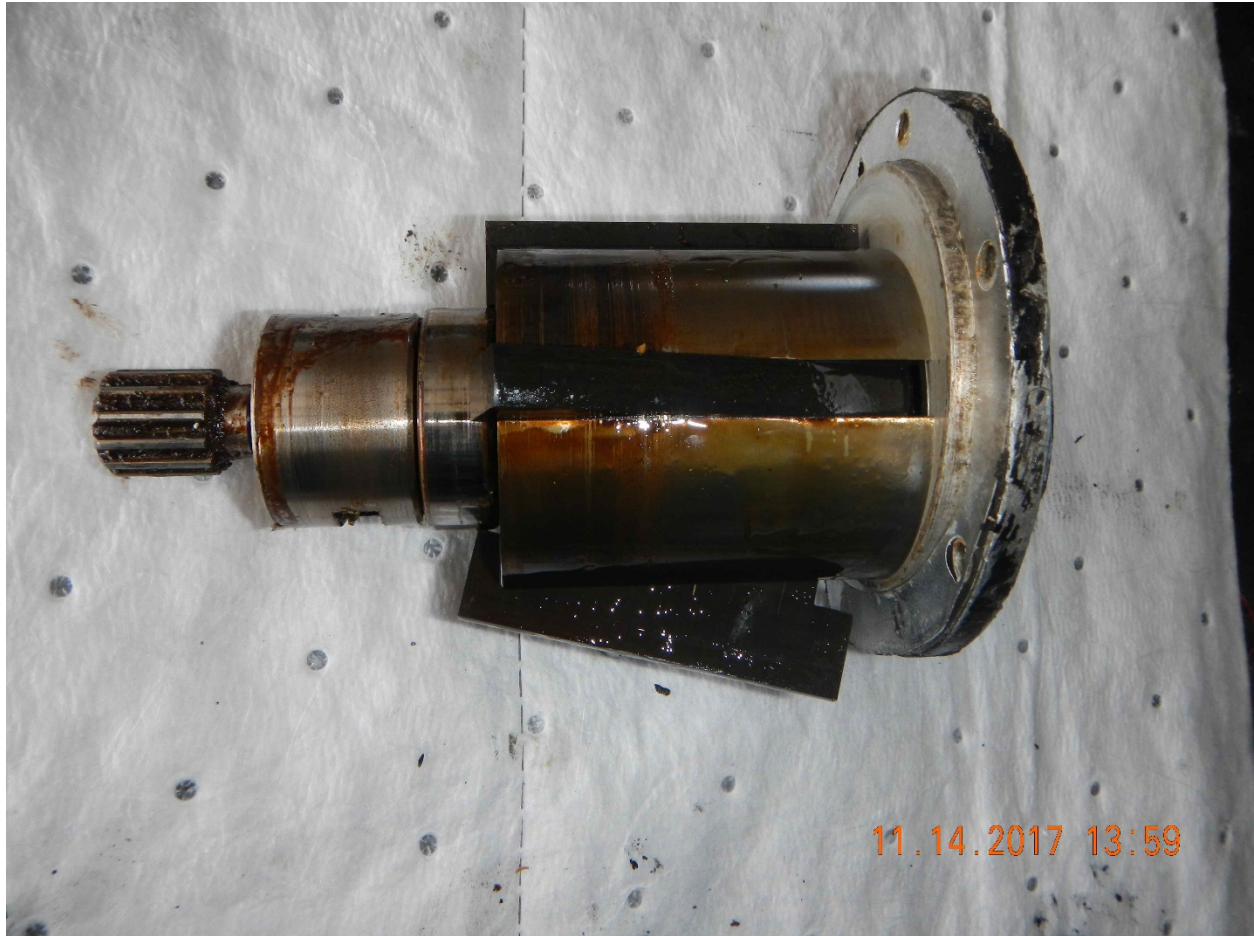
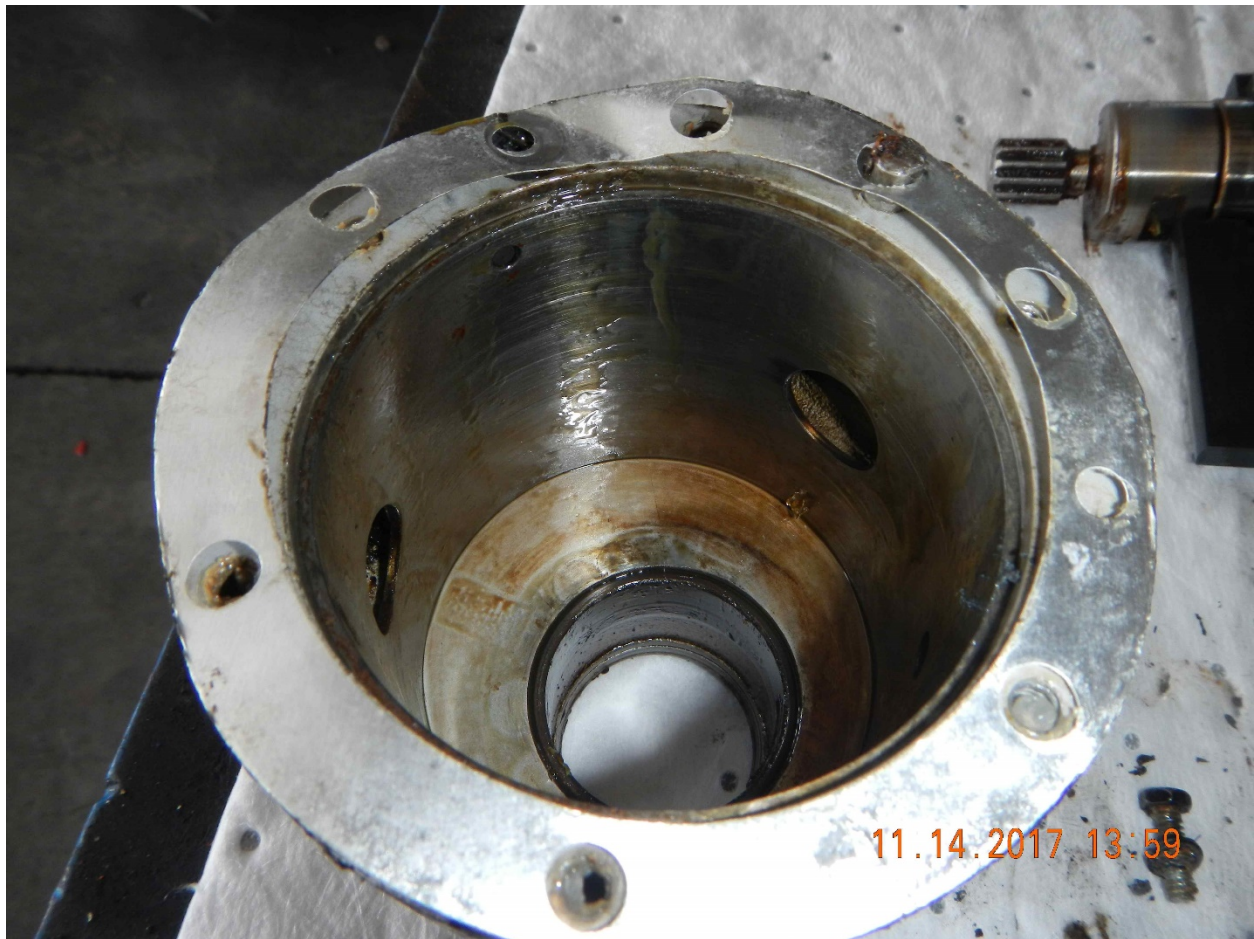
The vacuum pump was the wet type, and was disassembled and examined. All vanes were intact, wet with oil, and the inner pump cavity was free of damage (Photo 13,14). The input drive gear was undamaged and remained attached via it's coupling.

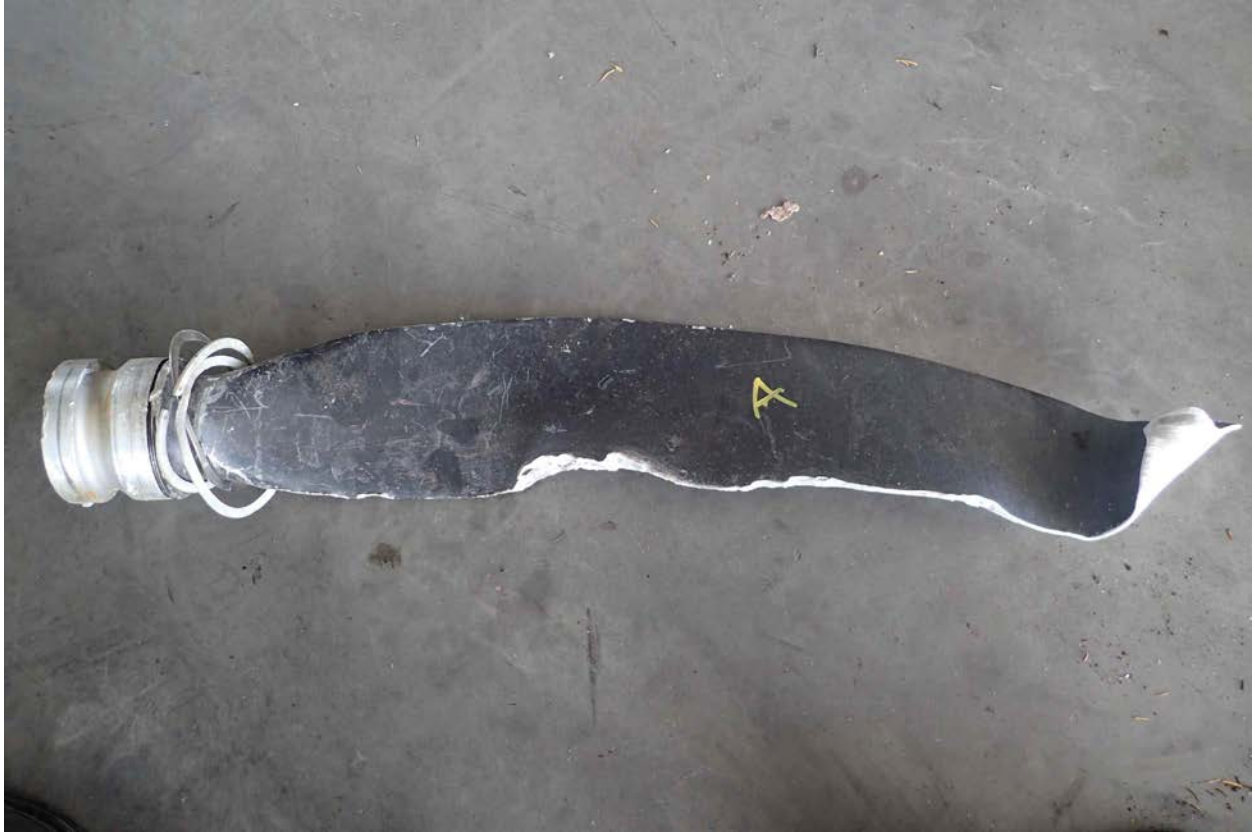
Photo 15 – Propeller Blade A

Both propeller blades had separated from the hub, and the partial remains of the propeller hub, remained attached to the crankshaft flange. One blade exhibited 1- to 2-inch-deep gouges along

its entire leading edge, with aft curling and chordwise scratches at the tip (Photo 15). The second blade exhibited diagonal gouges to its front side, with 2-inch-deep leading edge gouges emanating outwards from midspan. The tip had separated into a 9-inch-long section, and had curled aft, leaving a serrated tear (Photo 16). The hub had fragmented, exposing the piston and spring. The governor was not located.
