# NATIONAL TRANSPORTATION SAFETY BOARD

## MATERIALS LABORATORY FACTUAL REPORT

Report No. 17-082

Place : Pukoo, HI  
Date : 11/15/2016  
Vehicle : Hughes 369D (500D)  
NTSB No. : WPR17FA021  
Investigator : Noreen Price

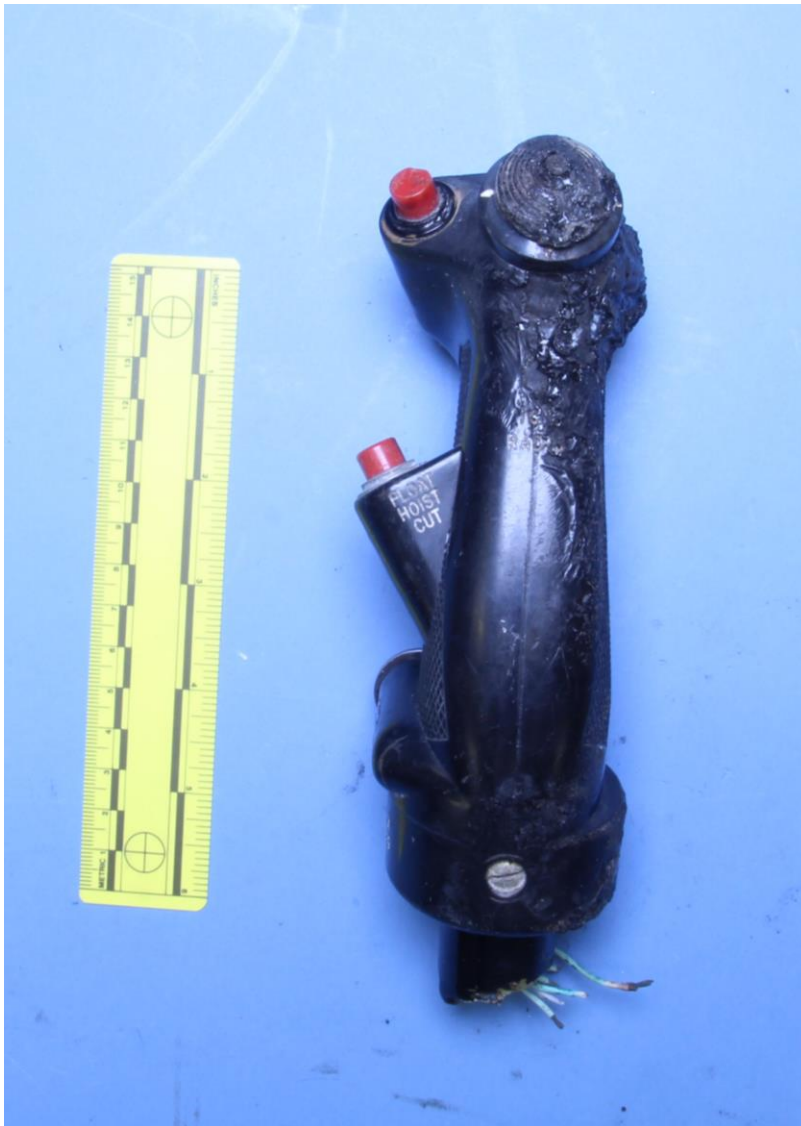
The cyclic grip had separated from the control stick. A portion of the control stick remained attached at the base of the cyclic grip. The separated end of the attached portion of the control stick exhibited slant fractures consistent with an overstress fracture. The signal wires from the grip's switches were protruding from the area of the separation. A portion of the cyclic grip's surface on the right-side in the area of the 4-position trim switch exhibited melting.

Figure 1: Cyclic grip as received.

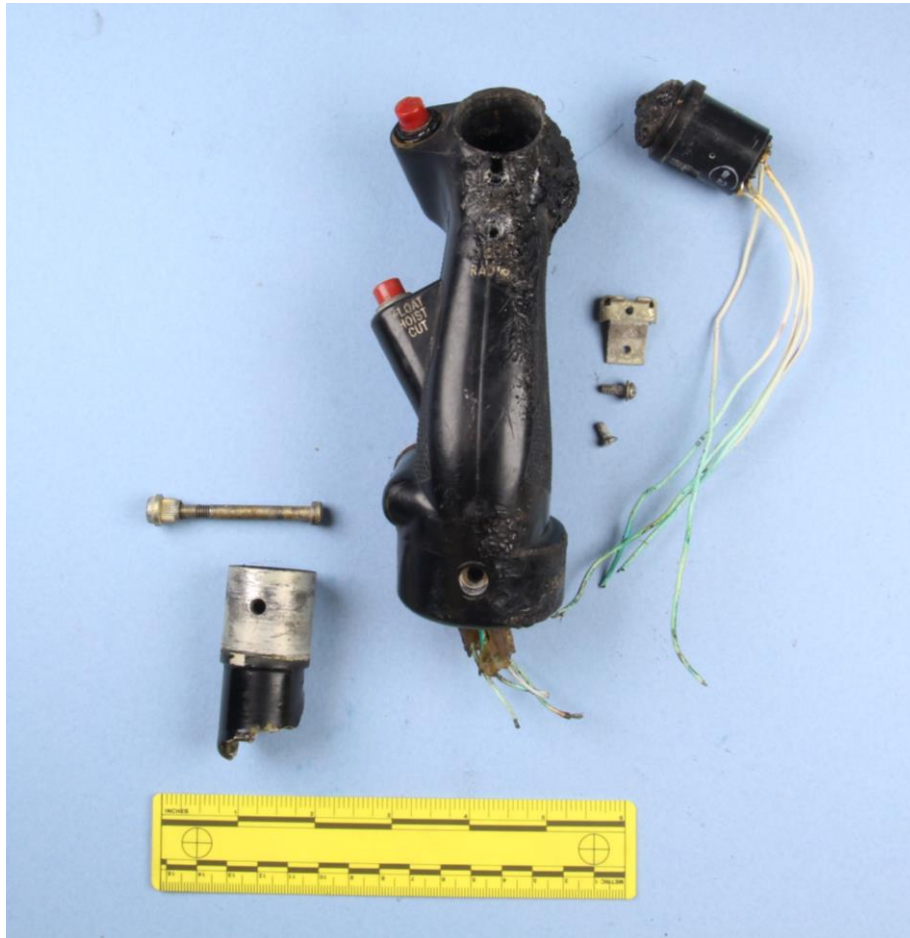
Figure 2: Cyclic grip after partial disassembly to remove the trim switch.

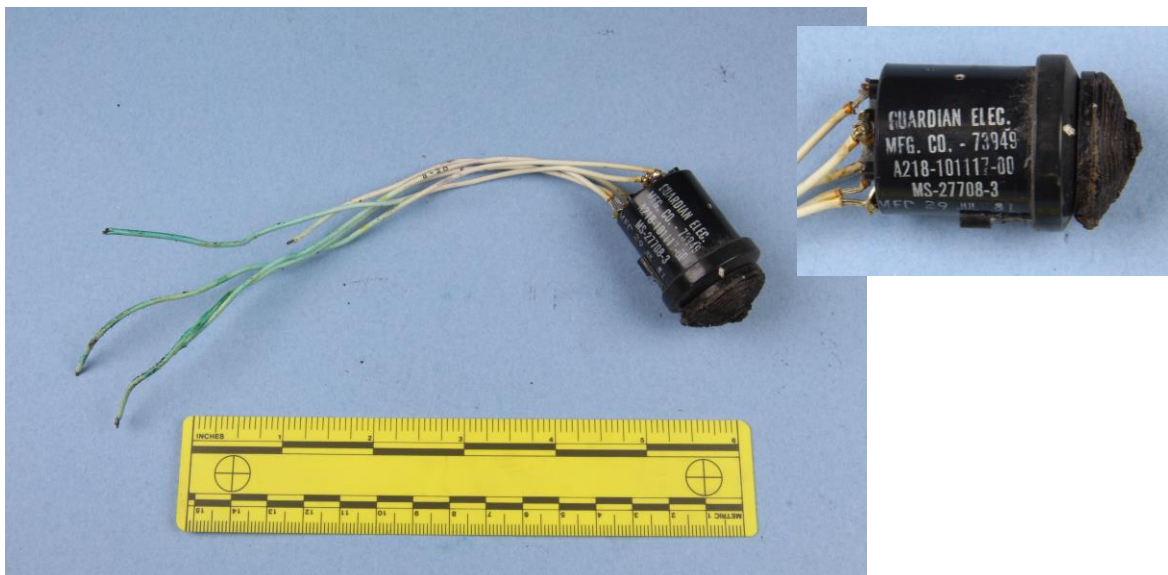
The 4-position trim switch was tested using a digital multi meter. The operation of the switch in all four positions was verified by measuring the resistance between the common terminal and the terminal for each of the four trim positions when activating the switch. Initial measurements gave varying (orders of magnitude) and inconsistent resistance values depending on the finger pressure applied to the switch. After about a dozen repetitions of pressing the switch the measured resistance between the common and each of the four trim positions was less than 1Ω. The continuity of the signal wires

Figure 3: Trim switch after removal from the grip assembly.

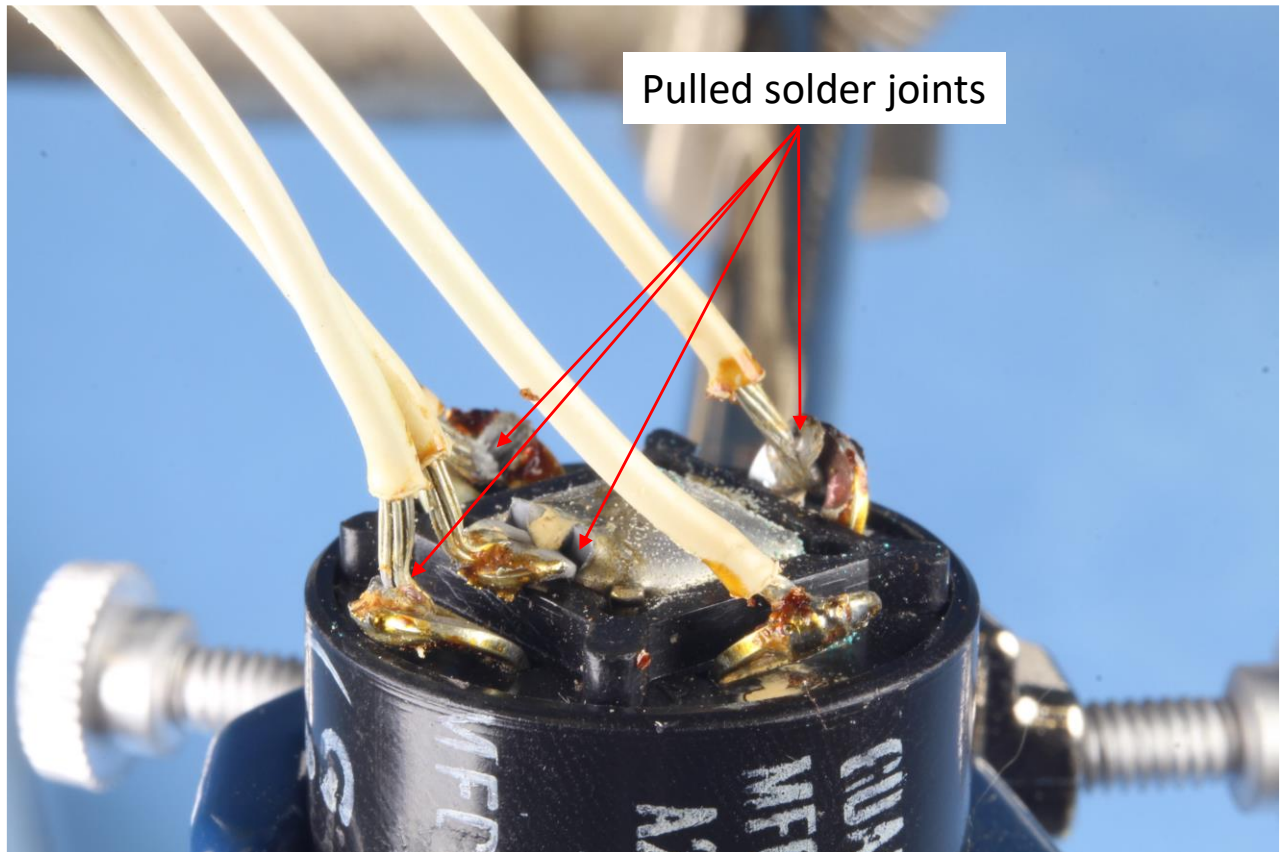
Figure 4: Close-up view of the solder joints for the contacts of the trim switch.

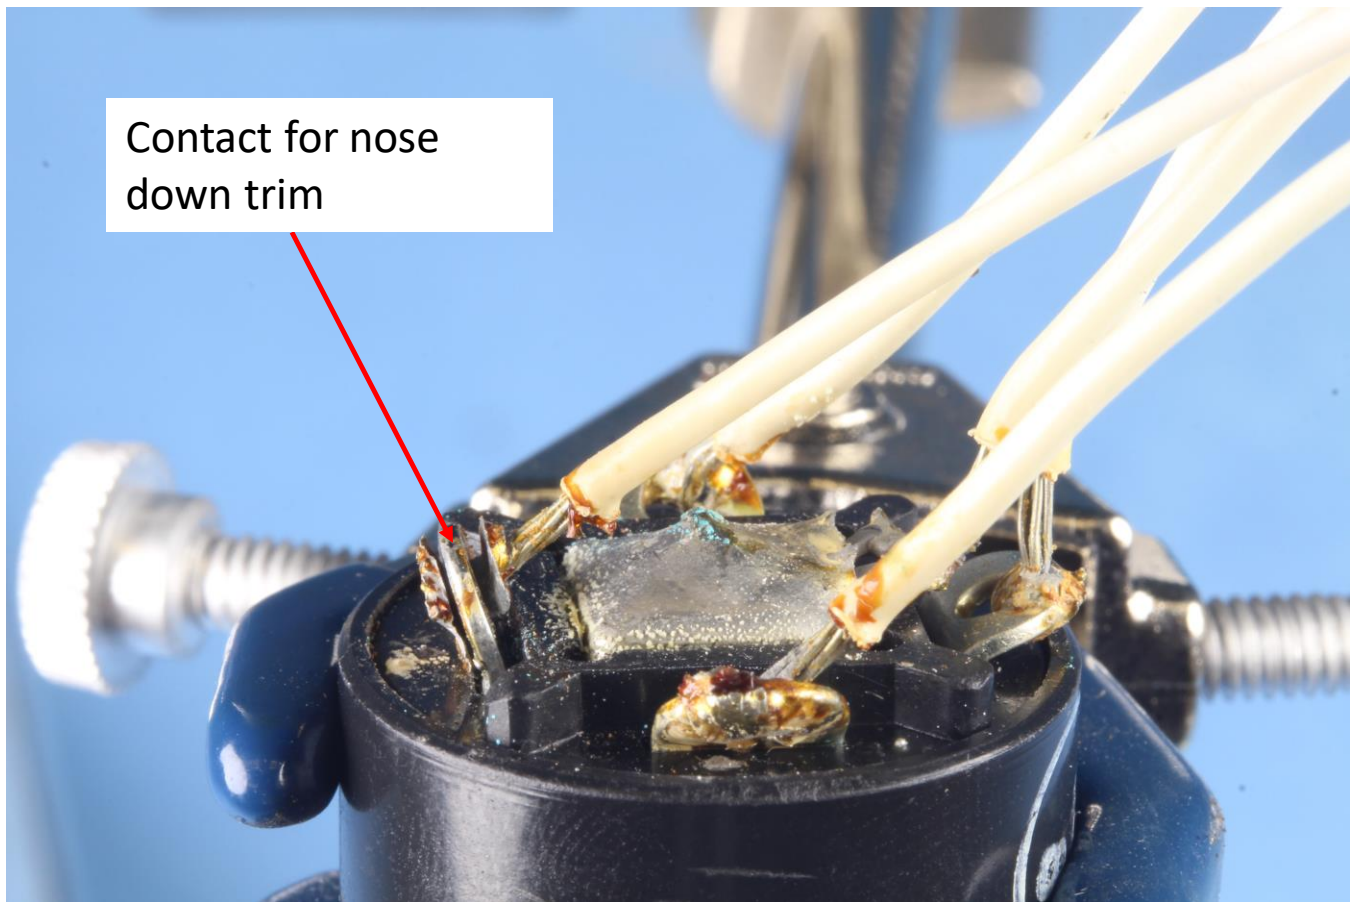
Partial disassembly of the cyclic grip was performed to carefully remove the 4-position trim switch from the top of the grip (figure 2). The top cap of the trim switch exhibited thermal damage. The trim switch and the attached wires (figure 3) were examined visually using a stereo microscope. The switch had five contacts on the bottom for connection to the signal wires. The signal wires were soldered to the switch contacts. Examination of the soldered connections revealed that four of the five soldered connections exhibited varying levels of disbonding consistent with the wires having been pulled (figure 4). The soldered connection between the signal wire and the switch contact for the nose down trim had completely disbonded and remained attached due to mechanical interference (figure 5).

Figure 5: Close-up of nose down trim contact.
