**NATIONAL TRANSPORTATION SAFETY BOARD**

**Computed Tomography Specialist's Factual Report**

WPR-17-FA-021

Location: about 1-mile north of Pukoo, Hawaii  
Date: November 15, 2016  
Time: 1841 Hawaii standard time  
Airplane: Hughes 369D (500D) helicopter, N81GG

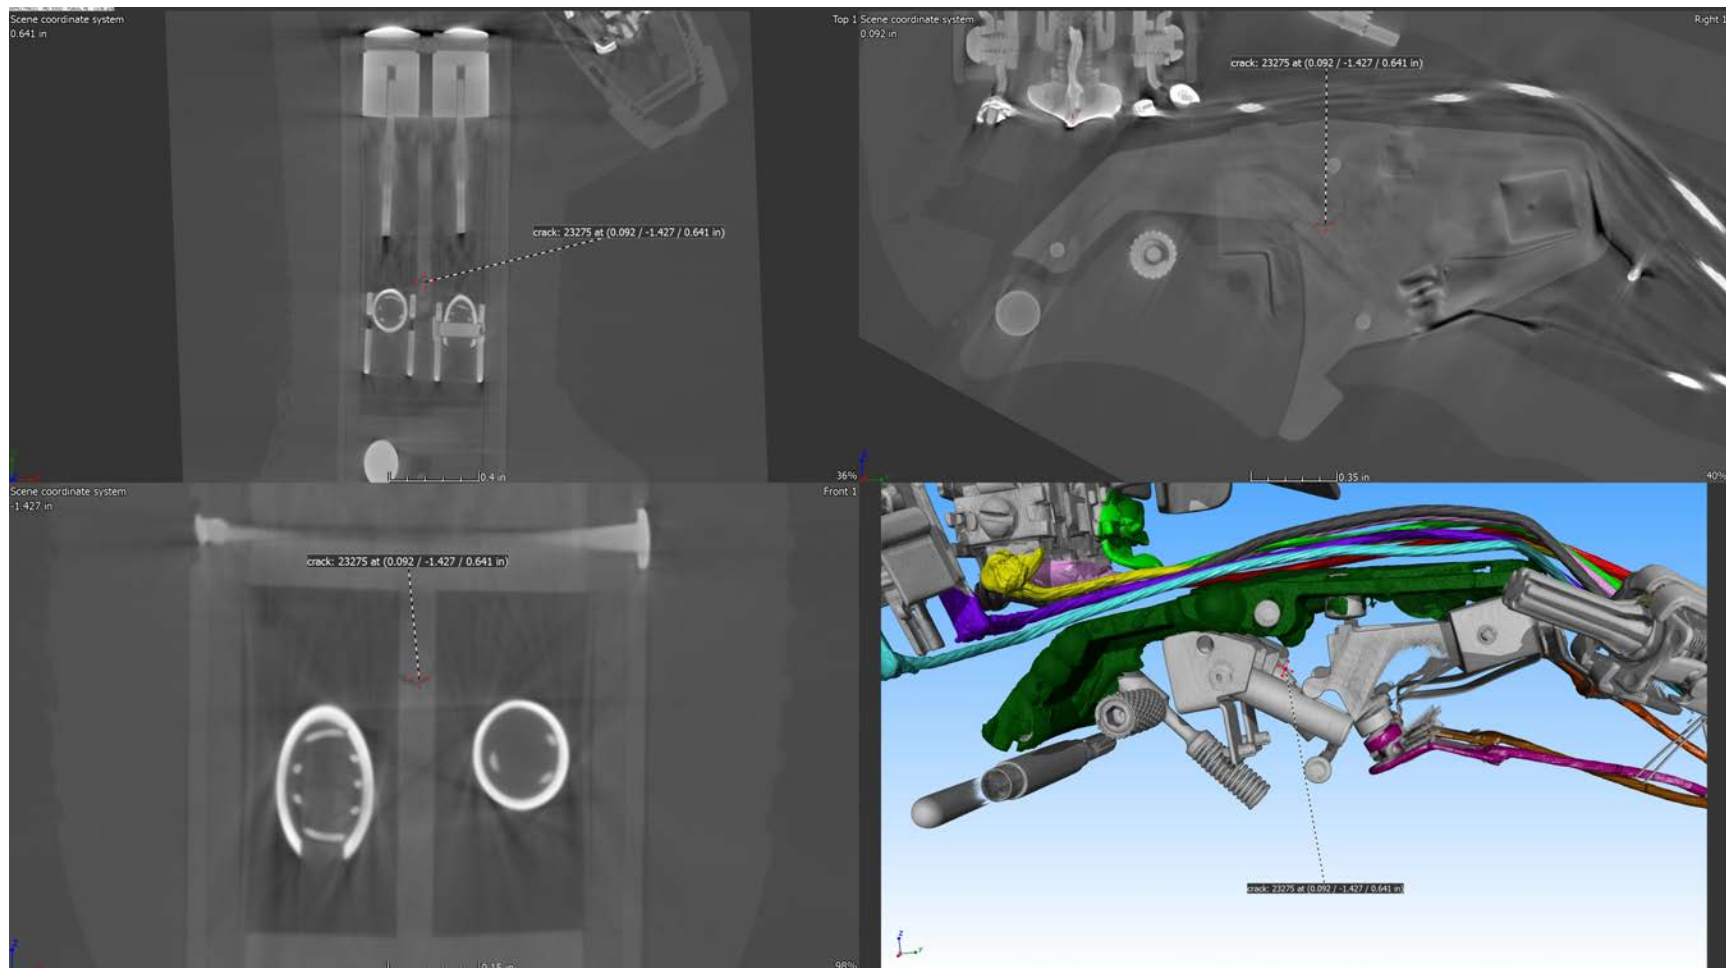
Figure 13  
Cyclic grip – crack 1 in trigger switch structure

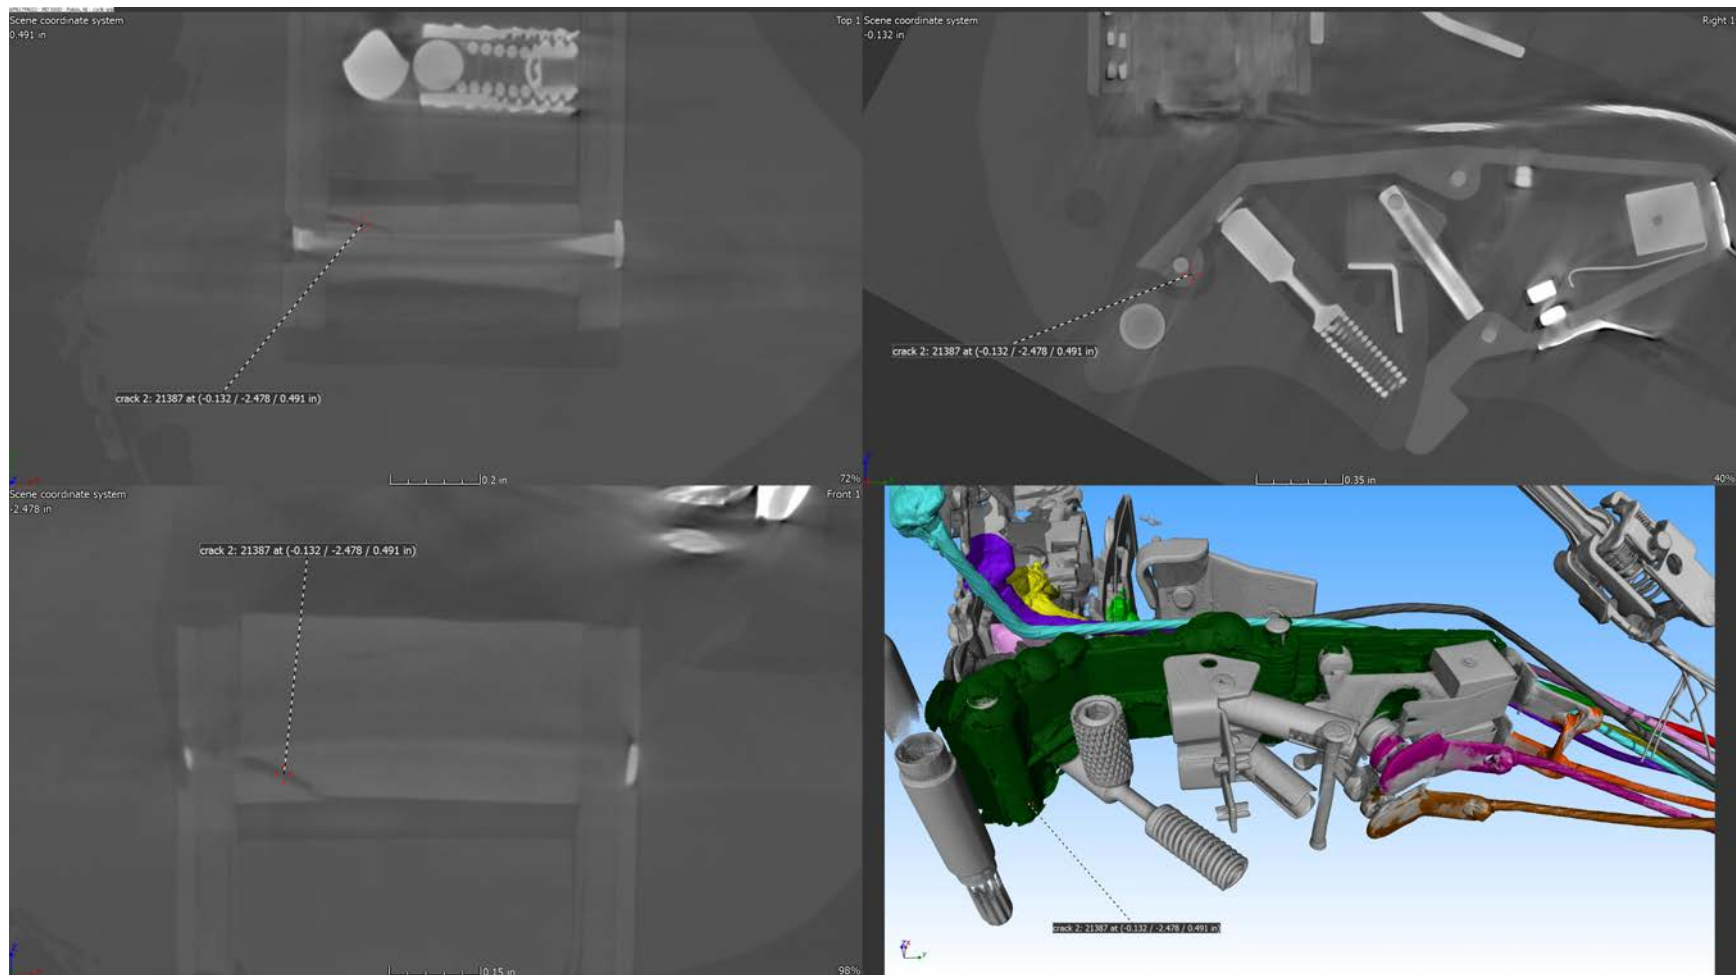
Figure 14  
Cyclic grip – crack 2 in trigger switch structure

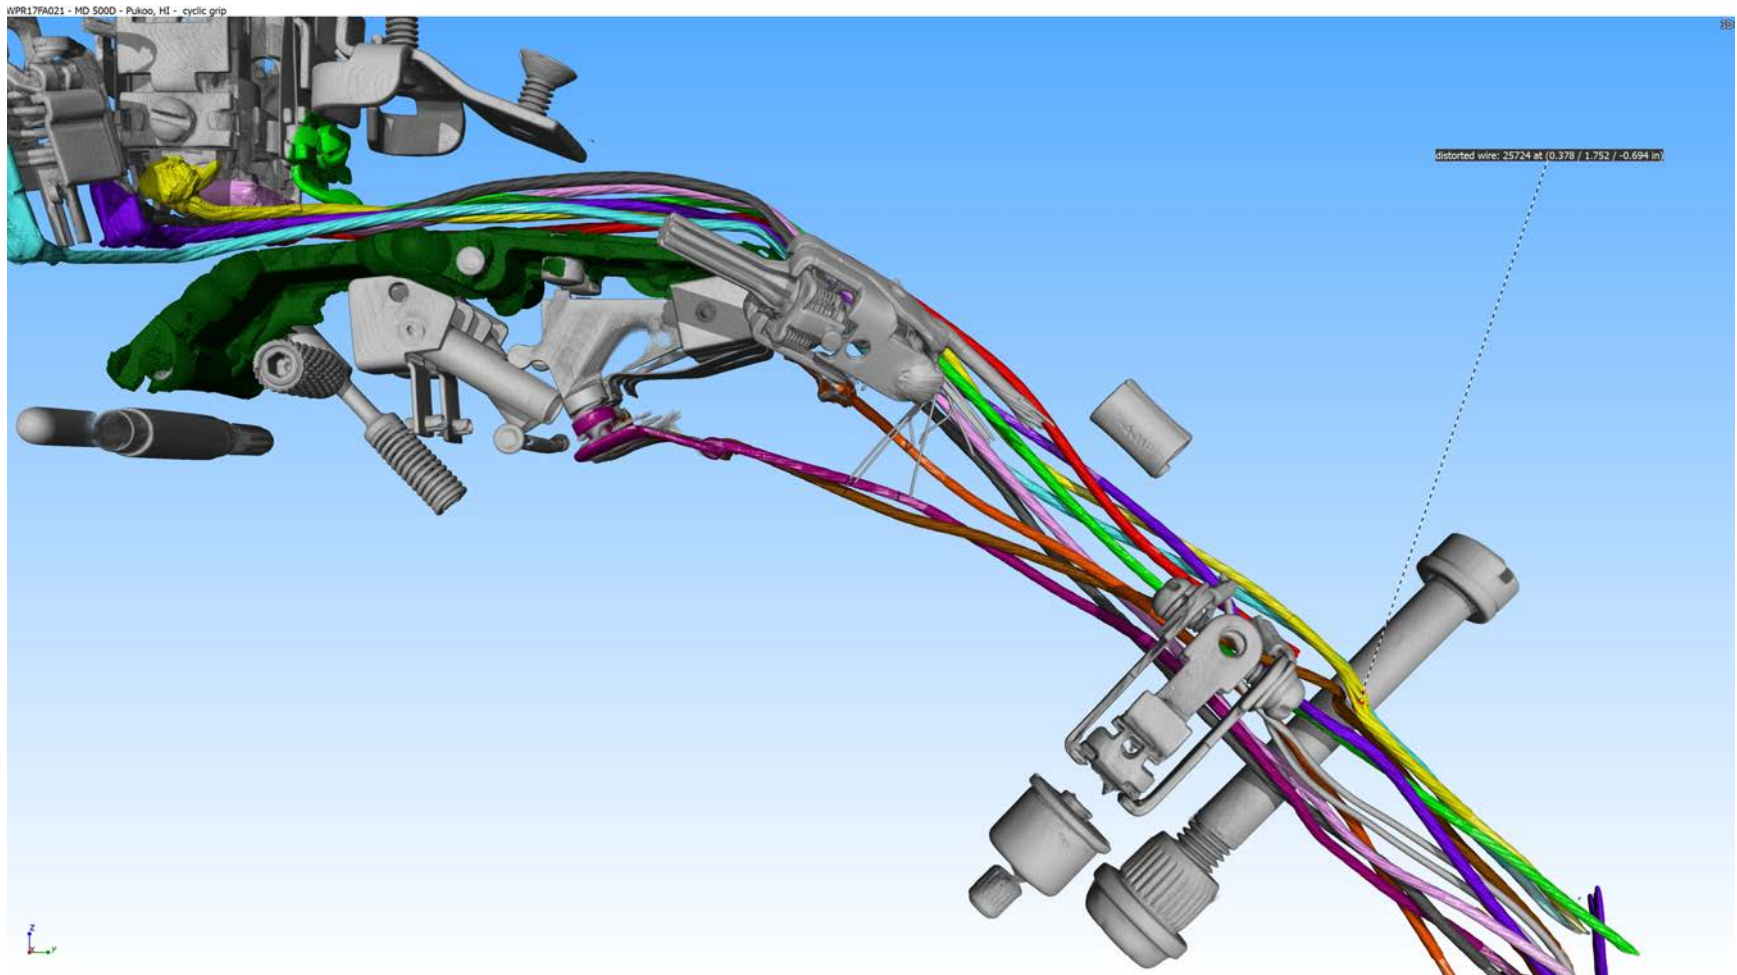
Figure 15  
Cyclic grip – distorted wire core strands

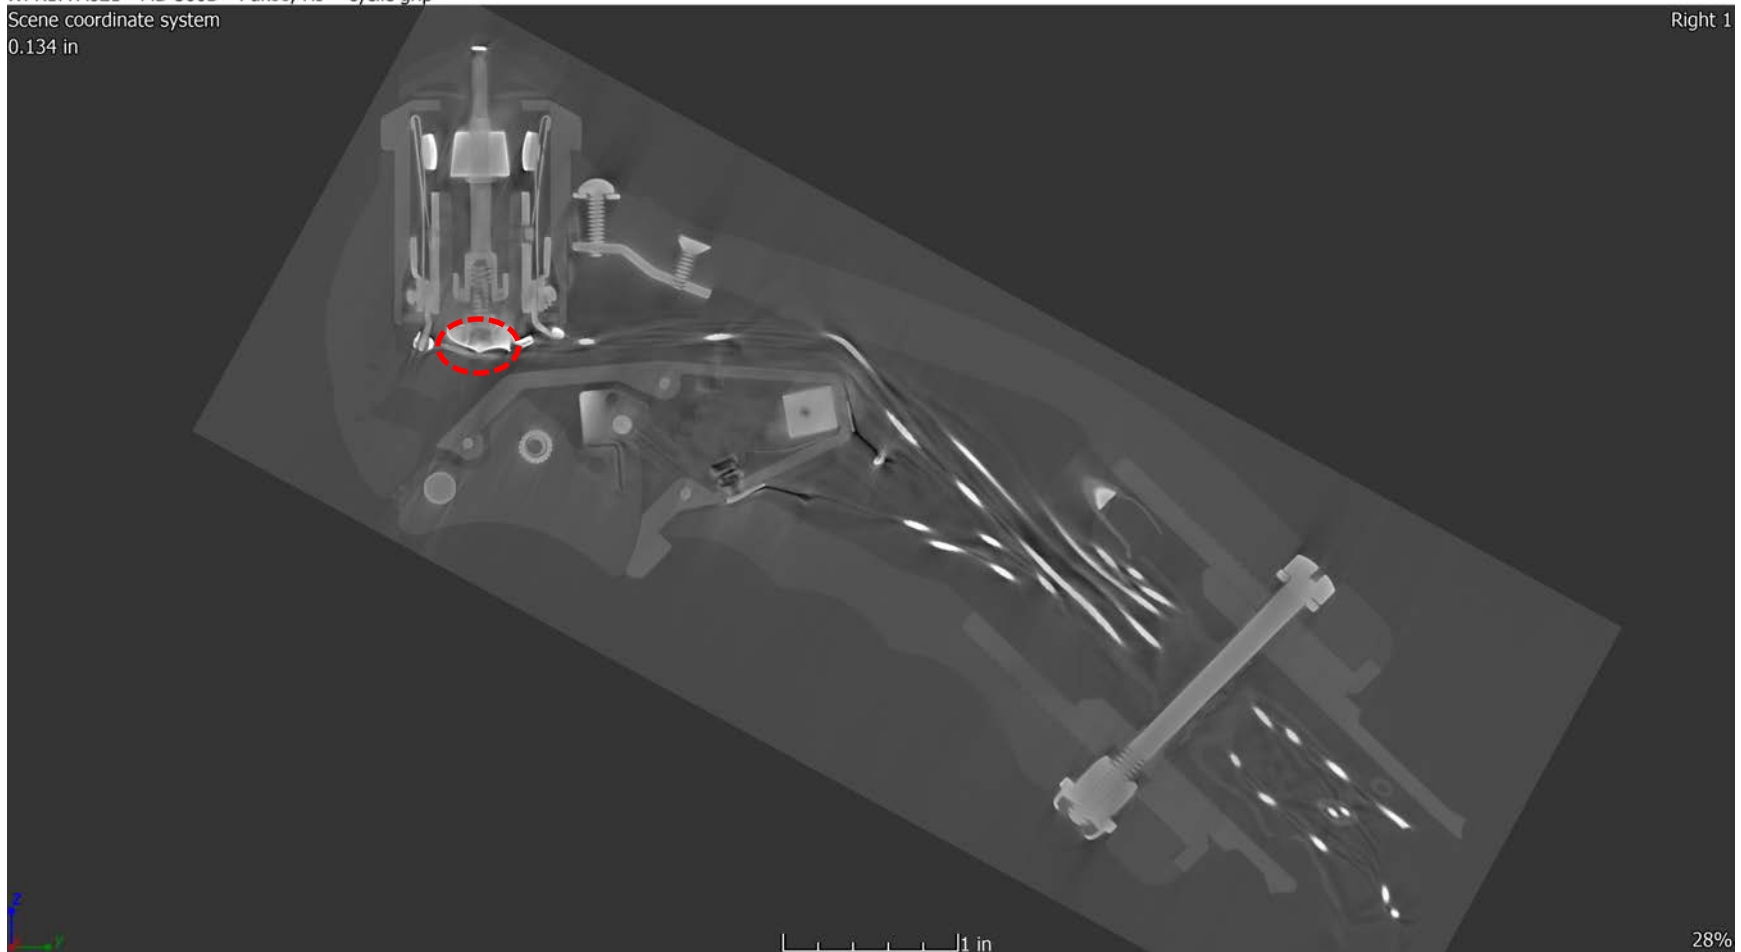
Figure 17  
Cyclic grip – possible wire to solder contact point

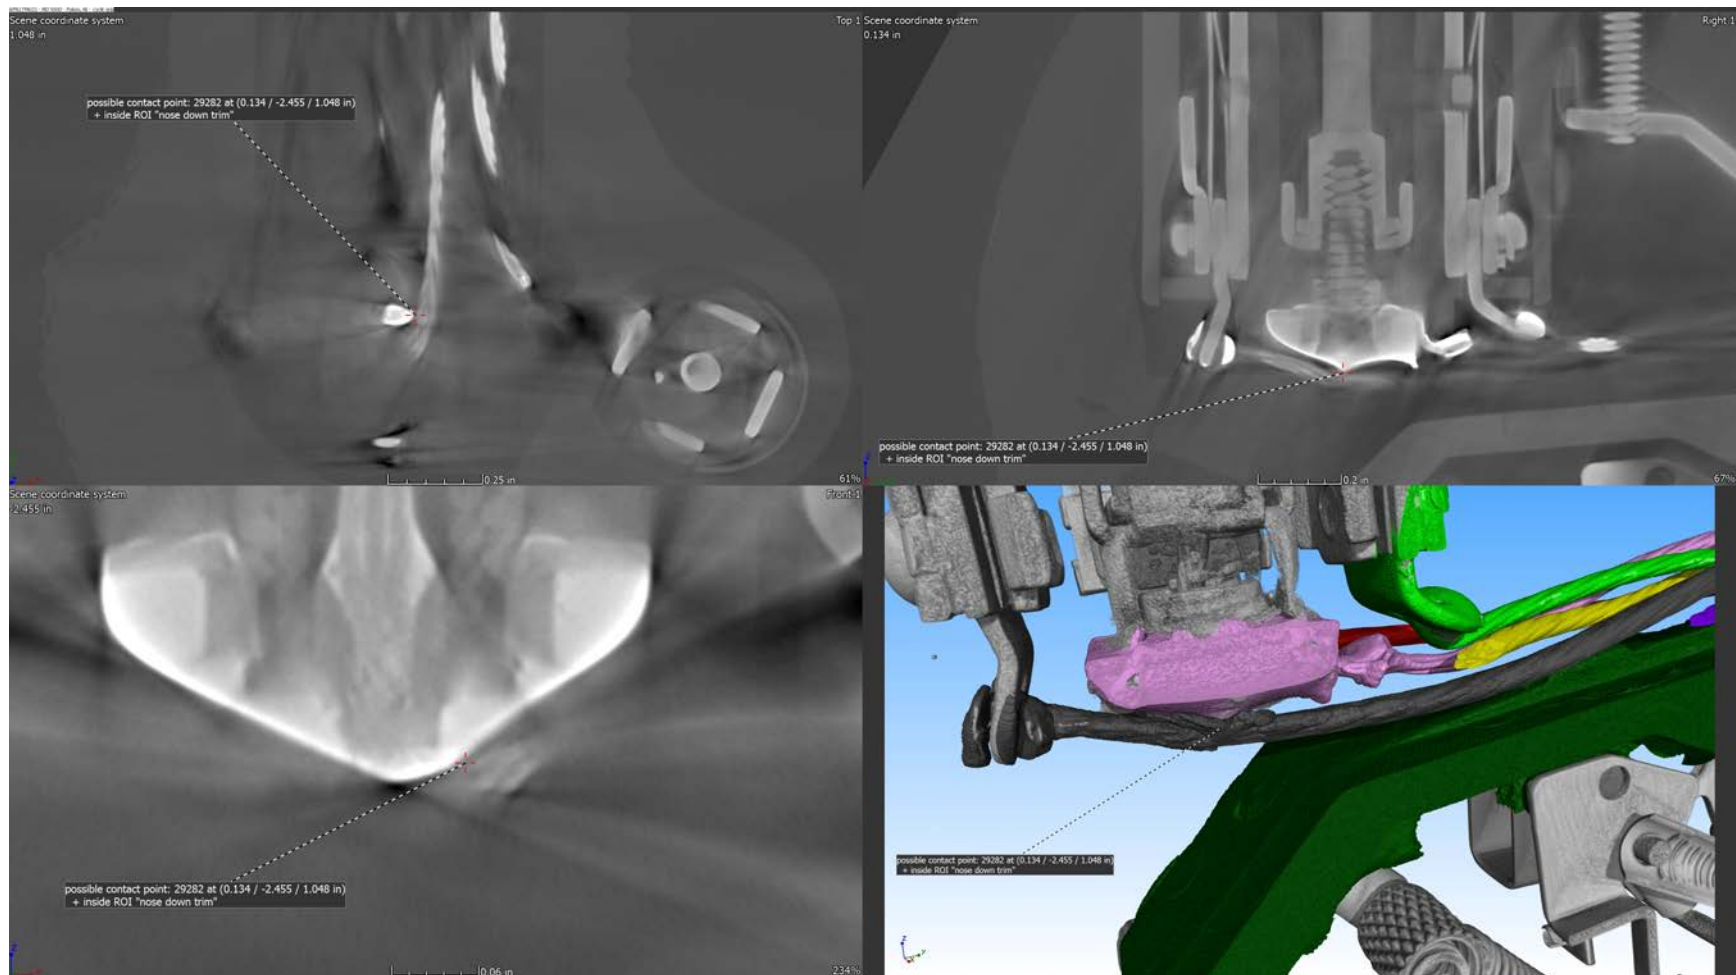
Figure 18  
Cyclic grip – possible wire to solder contact point – multiple views

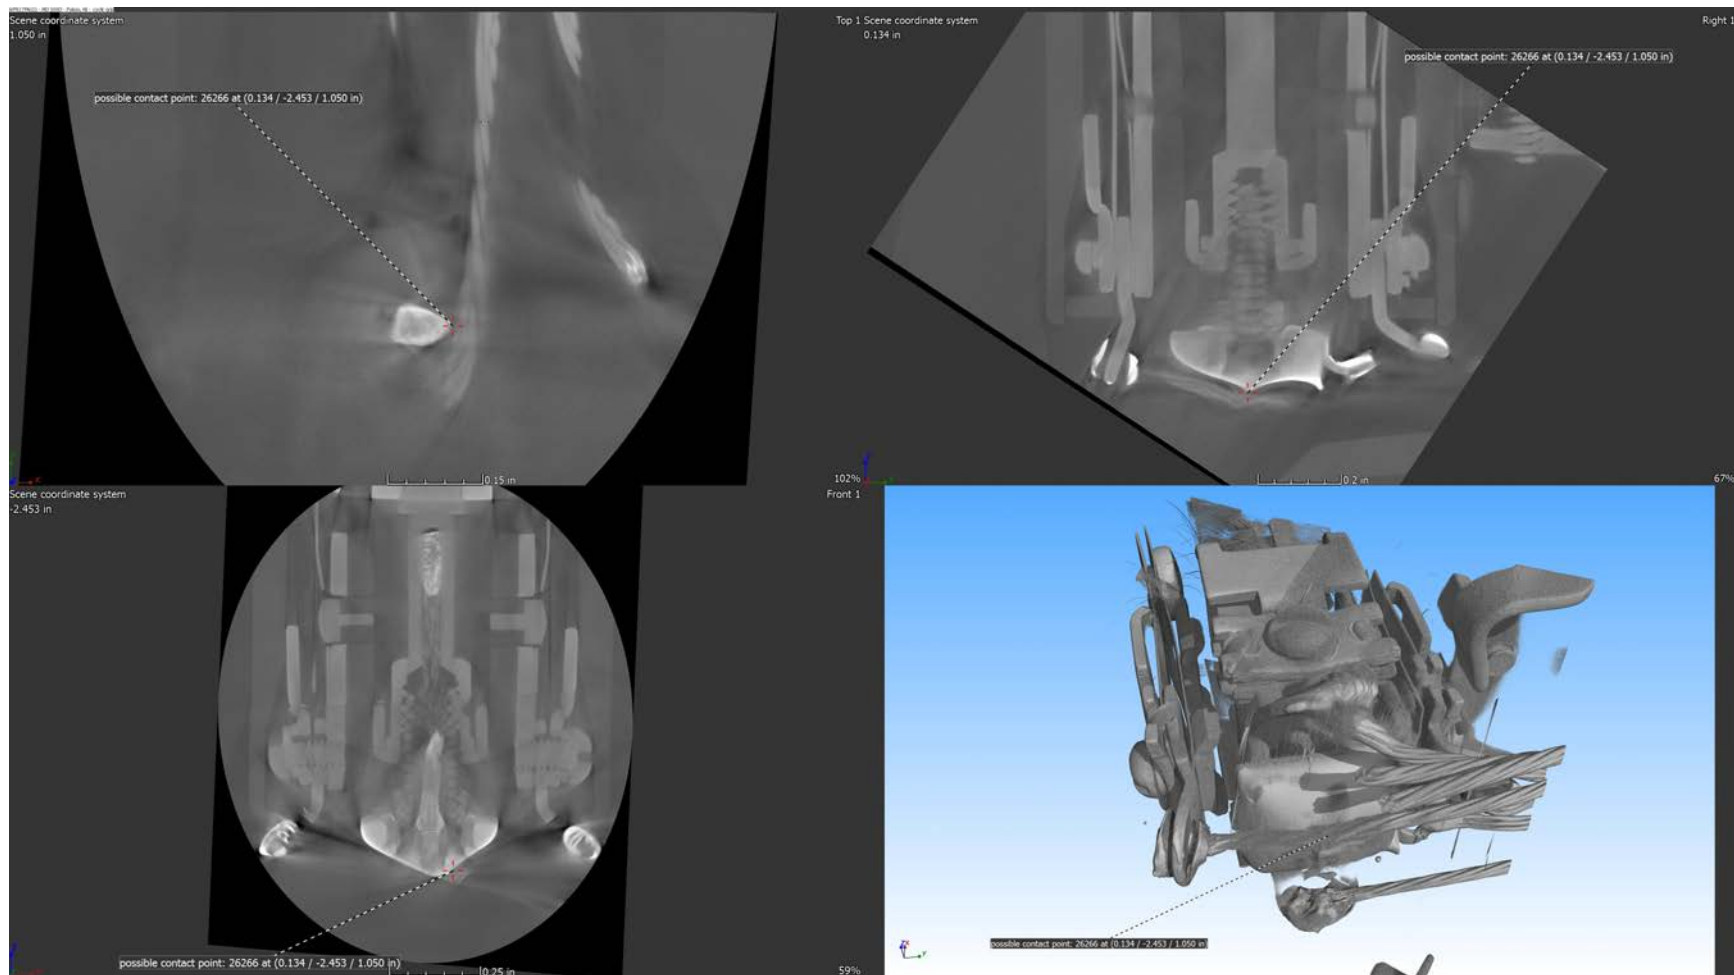
Figure 19  
Cyclic grip – target CT - possible wire to solder contact point

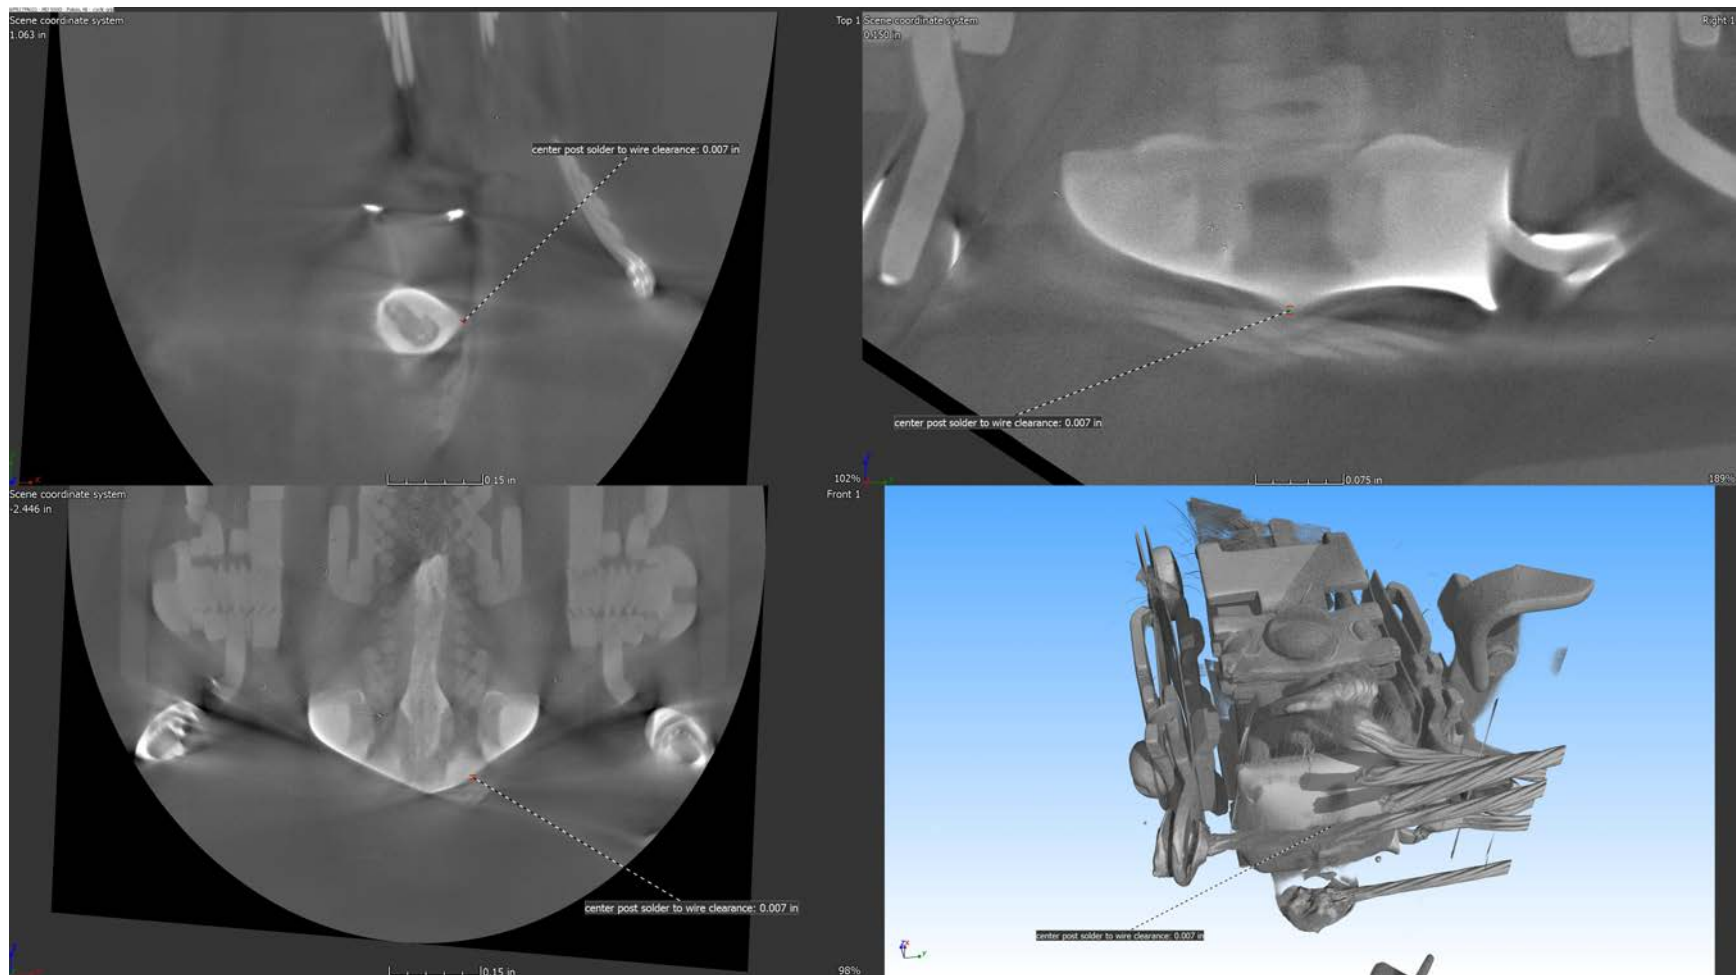
Figure 21  
Cyclic grip – target CT – solder to wire core clearance measurement

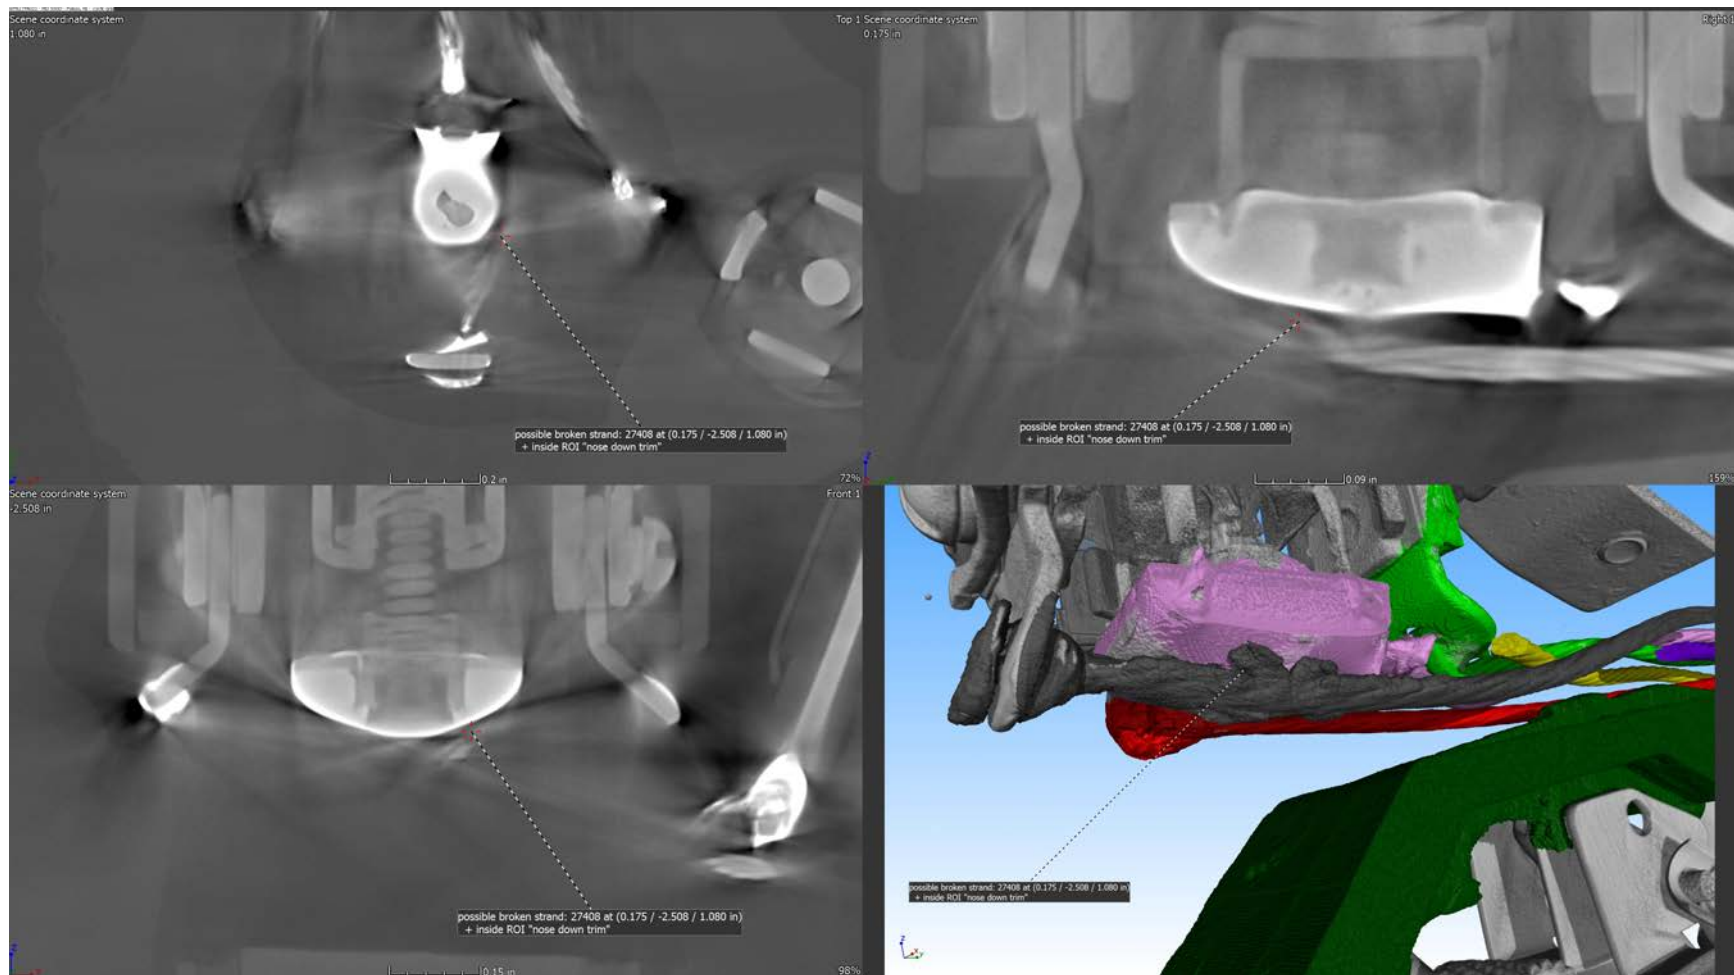
Figure 22  
Cyclic grip – possible broken wire strand
