**Photo 1 – N81GG Hughes 369D (MD 369D) wreckage site (compliments of Maui Police Department)**

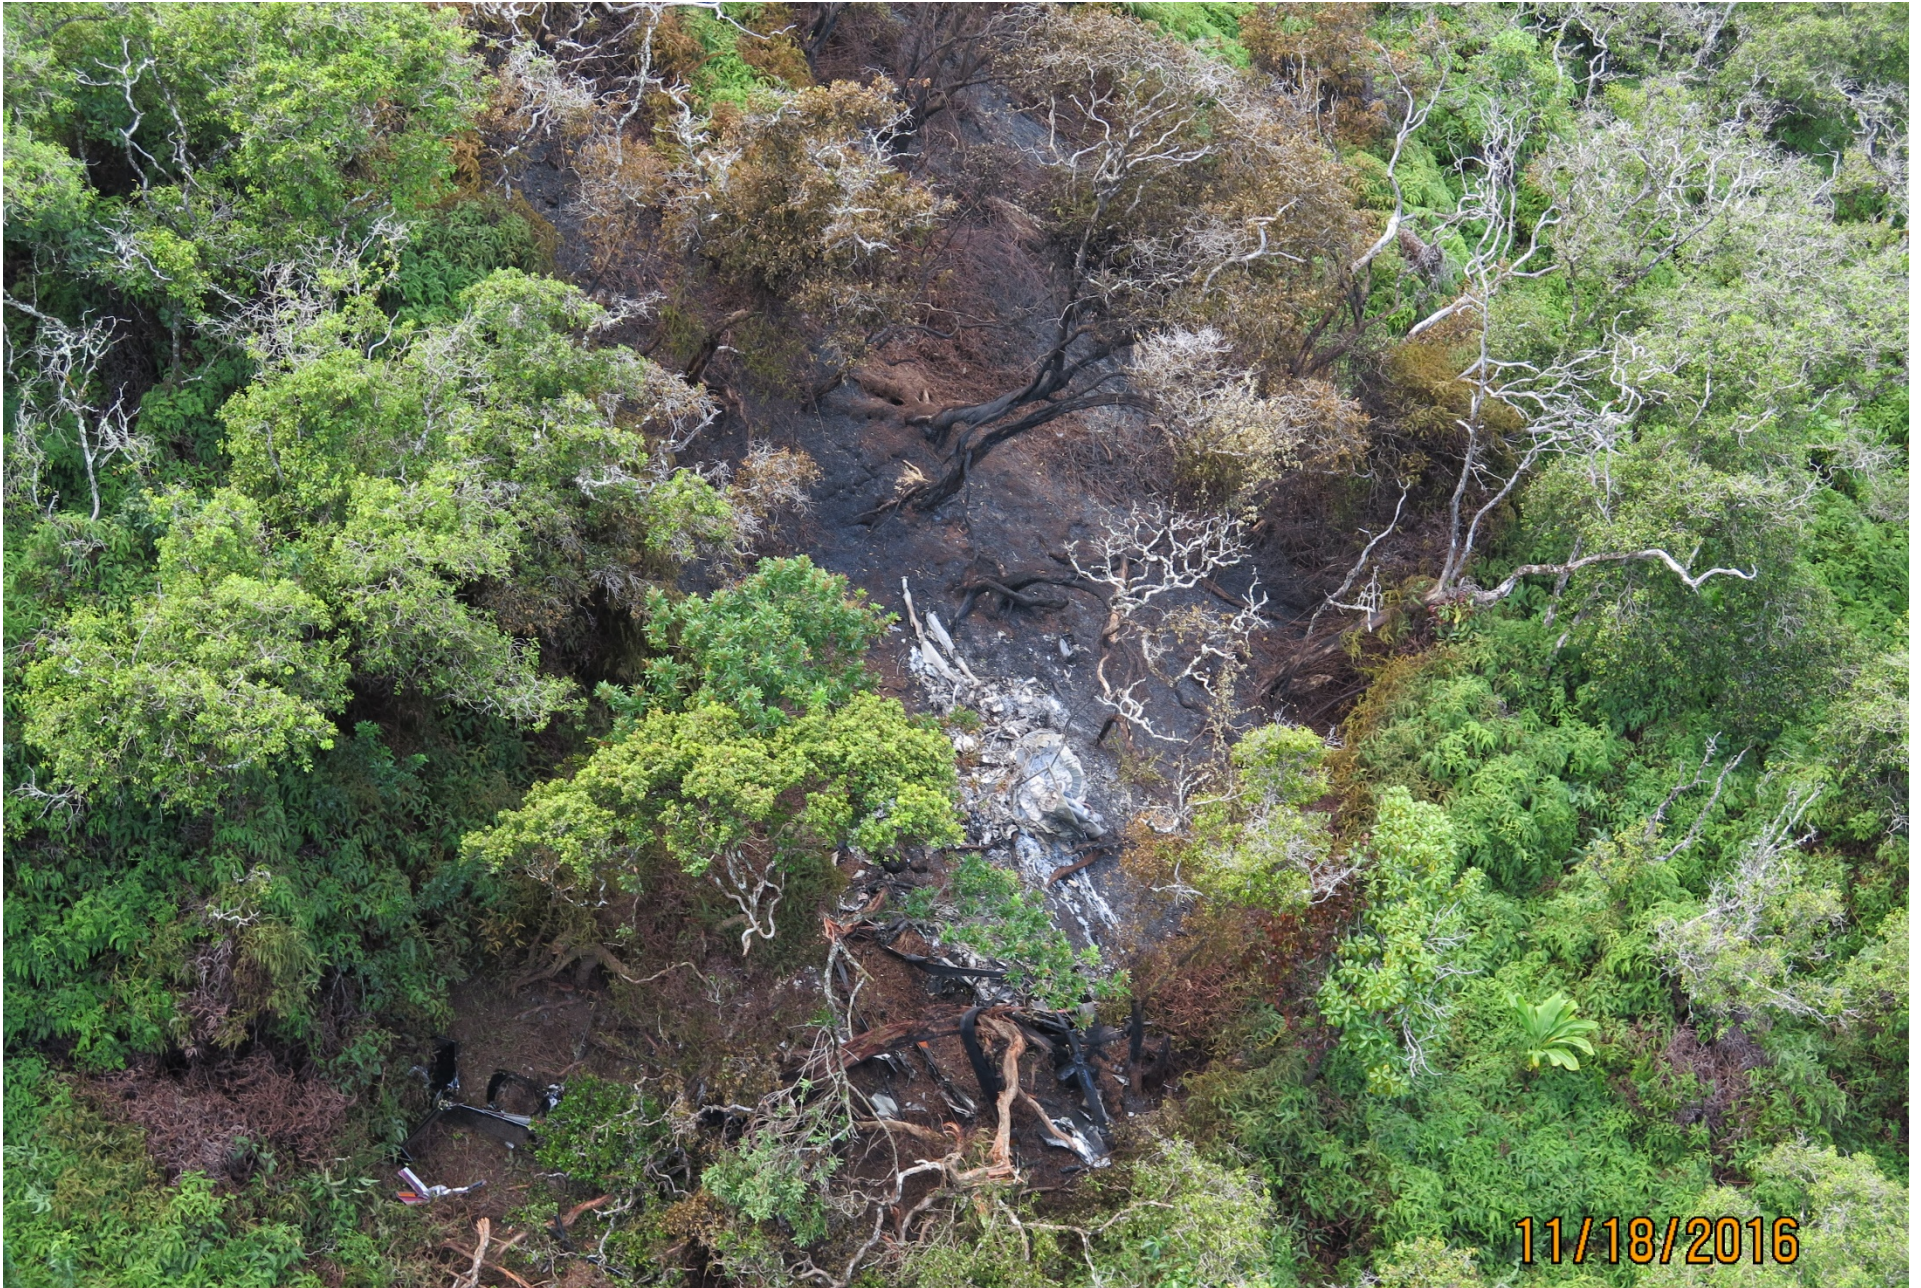
**Photo 2 - Aerial view of wreckage site**

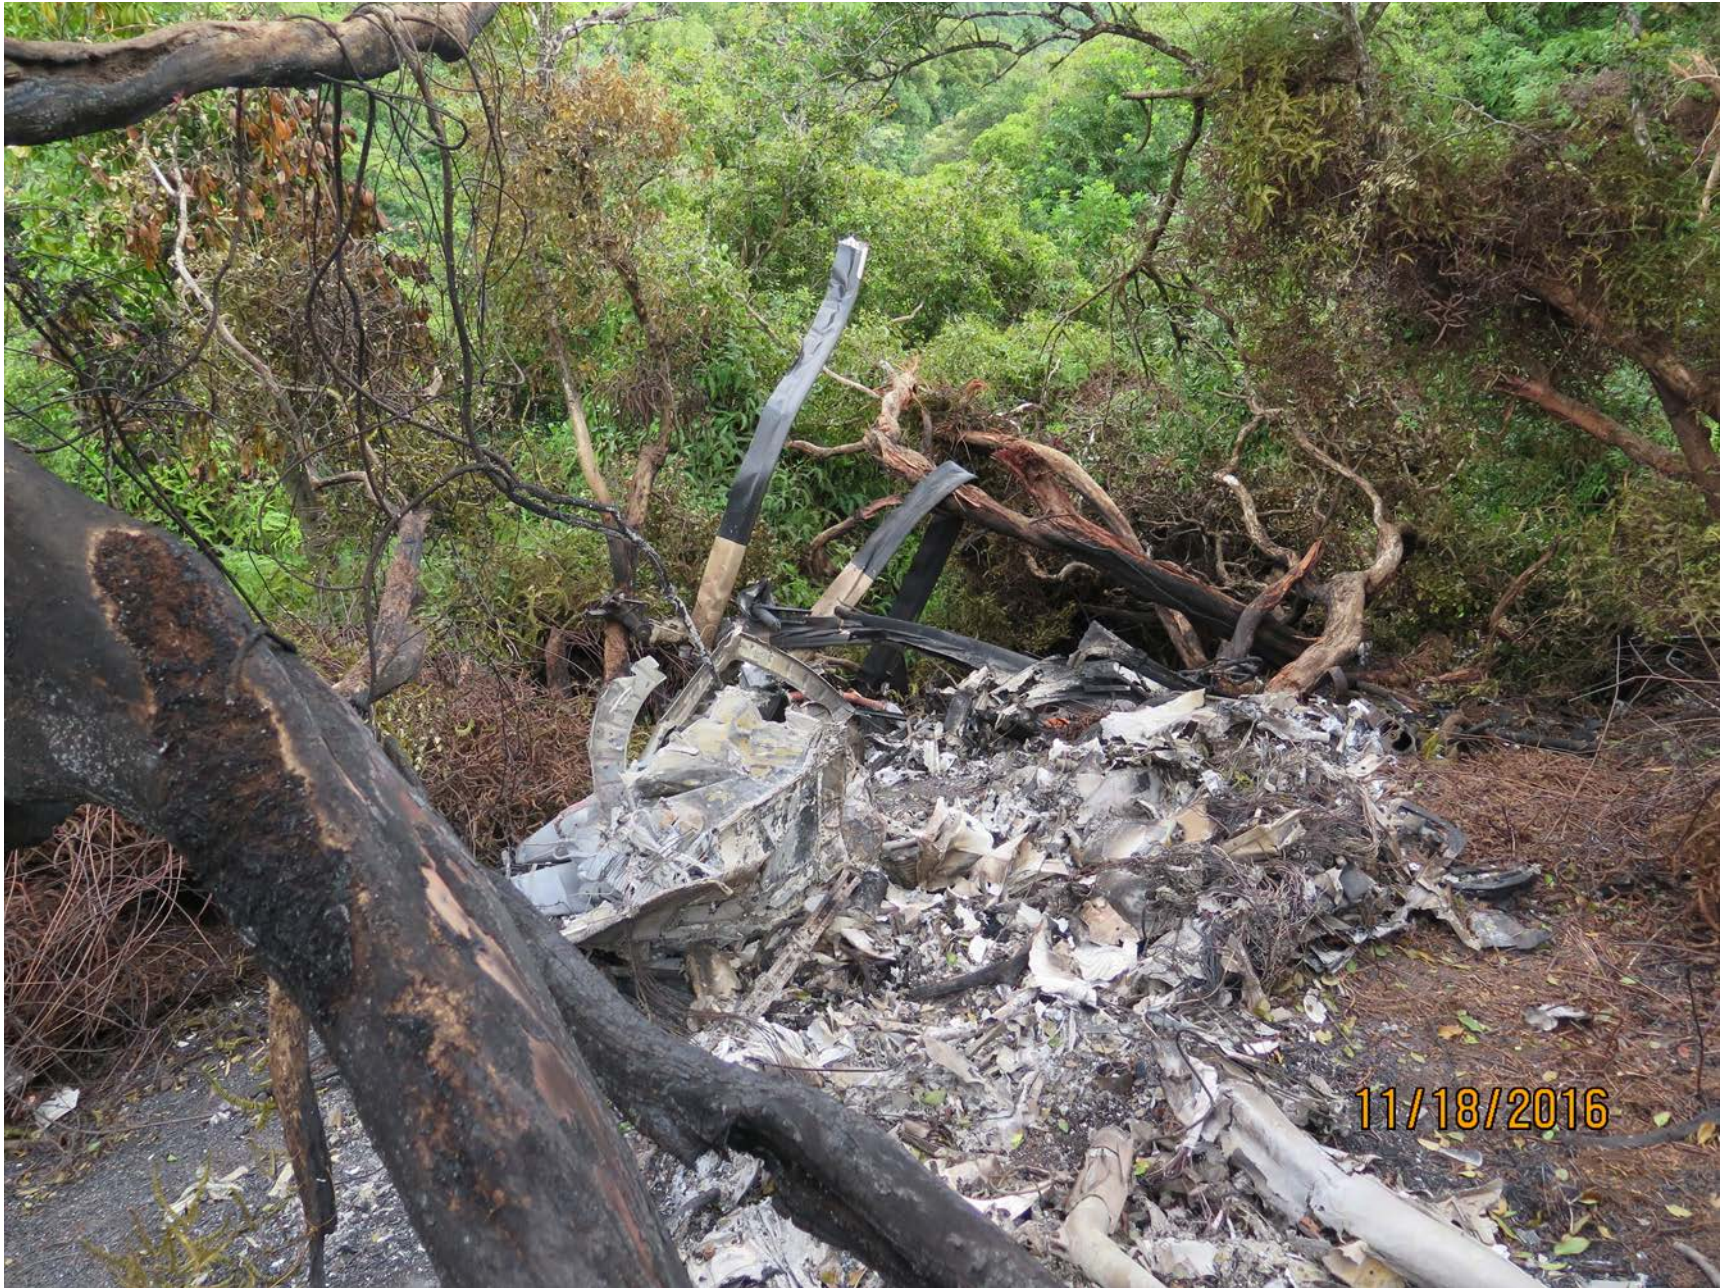
**Photo 3 - Main rotor and transmission assembly**

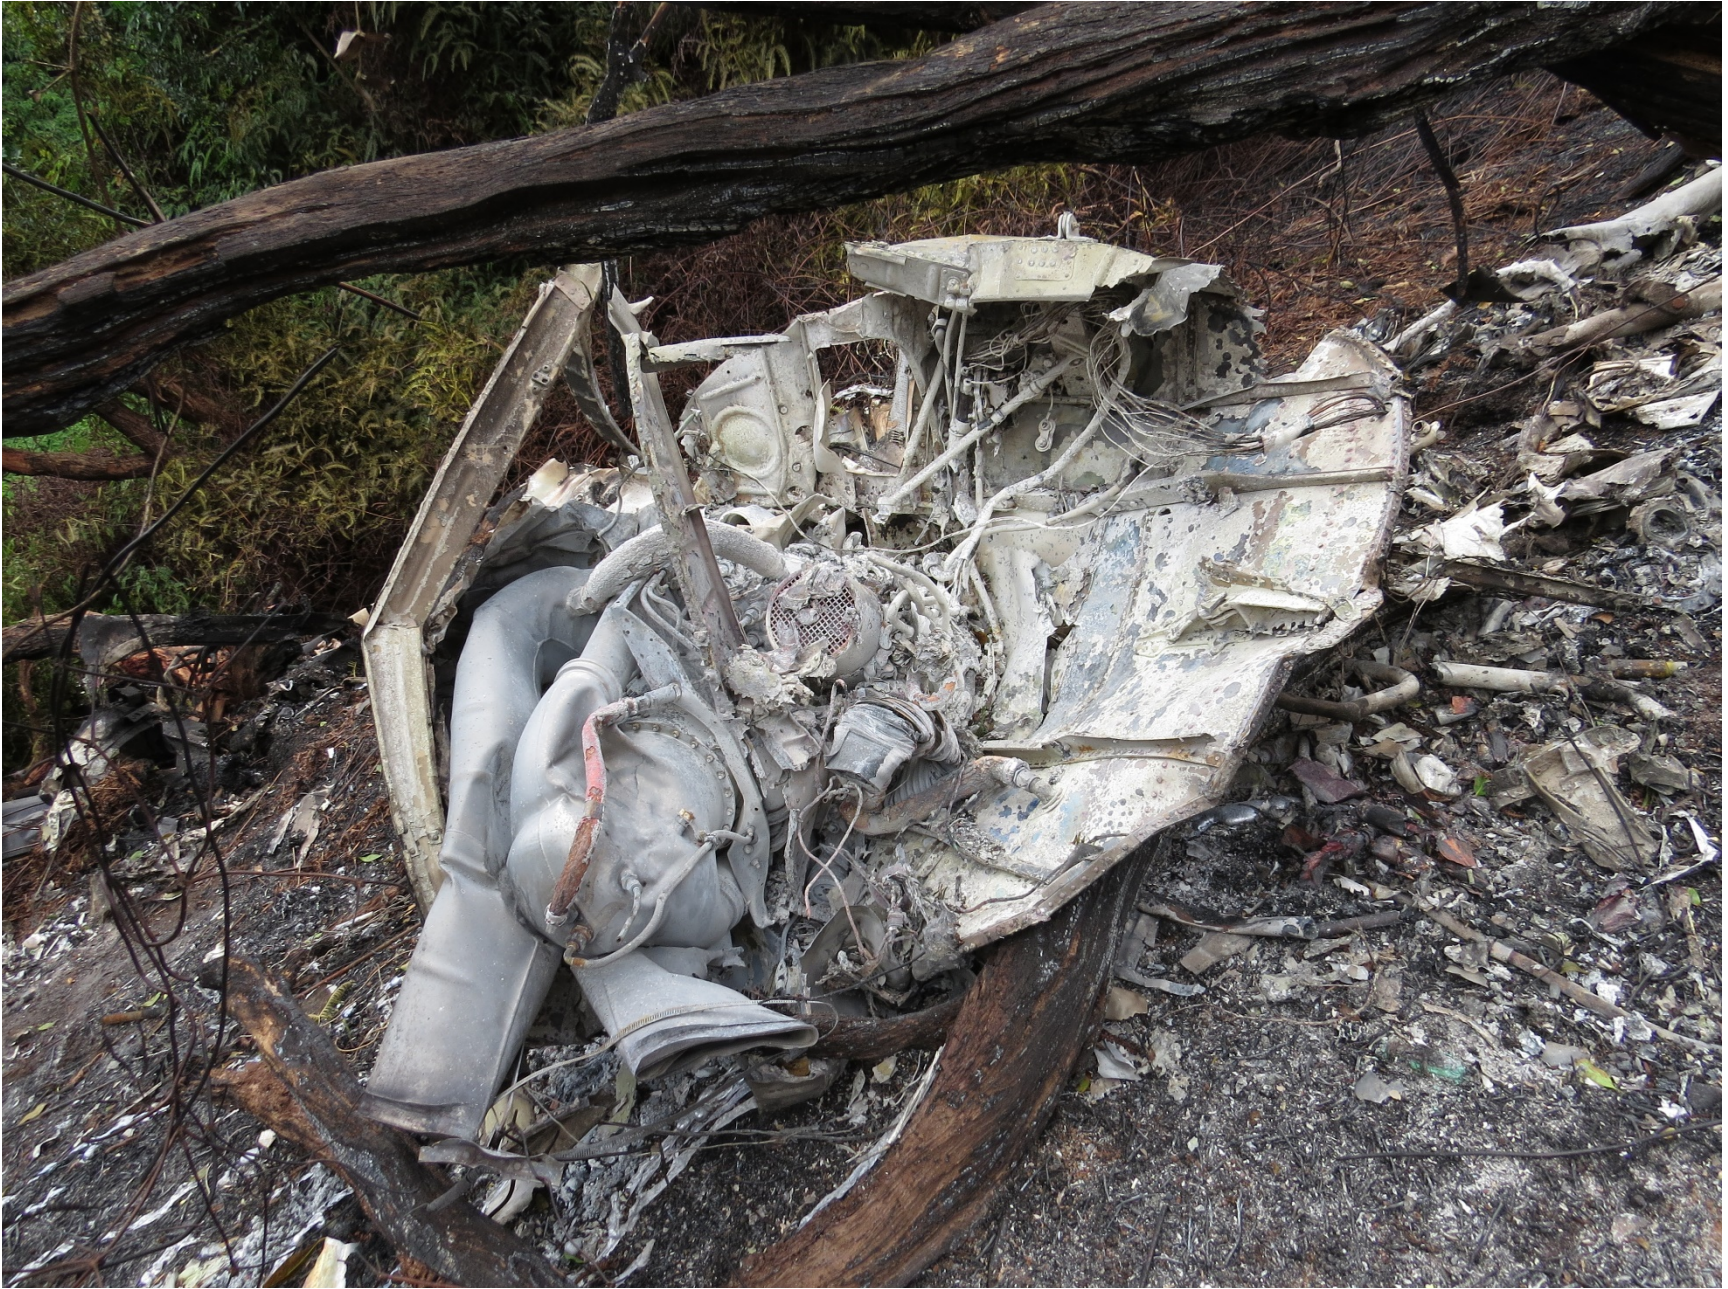
**Photo 4 - Rolls Royce (Allison) 250-C20B engine at accident site**

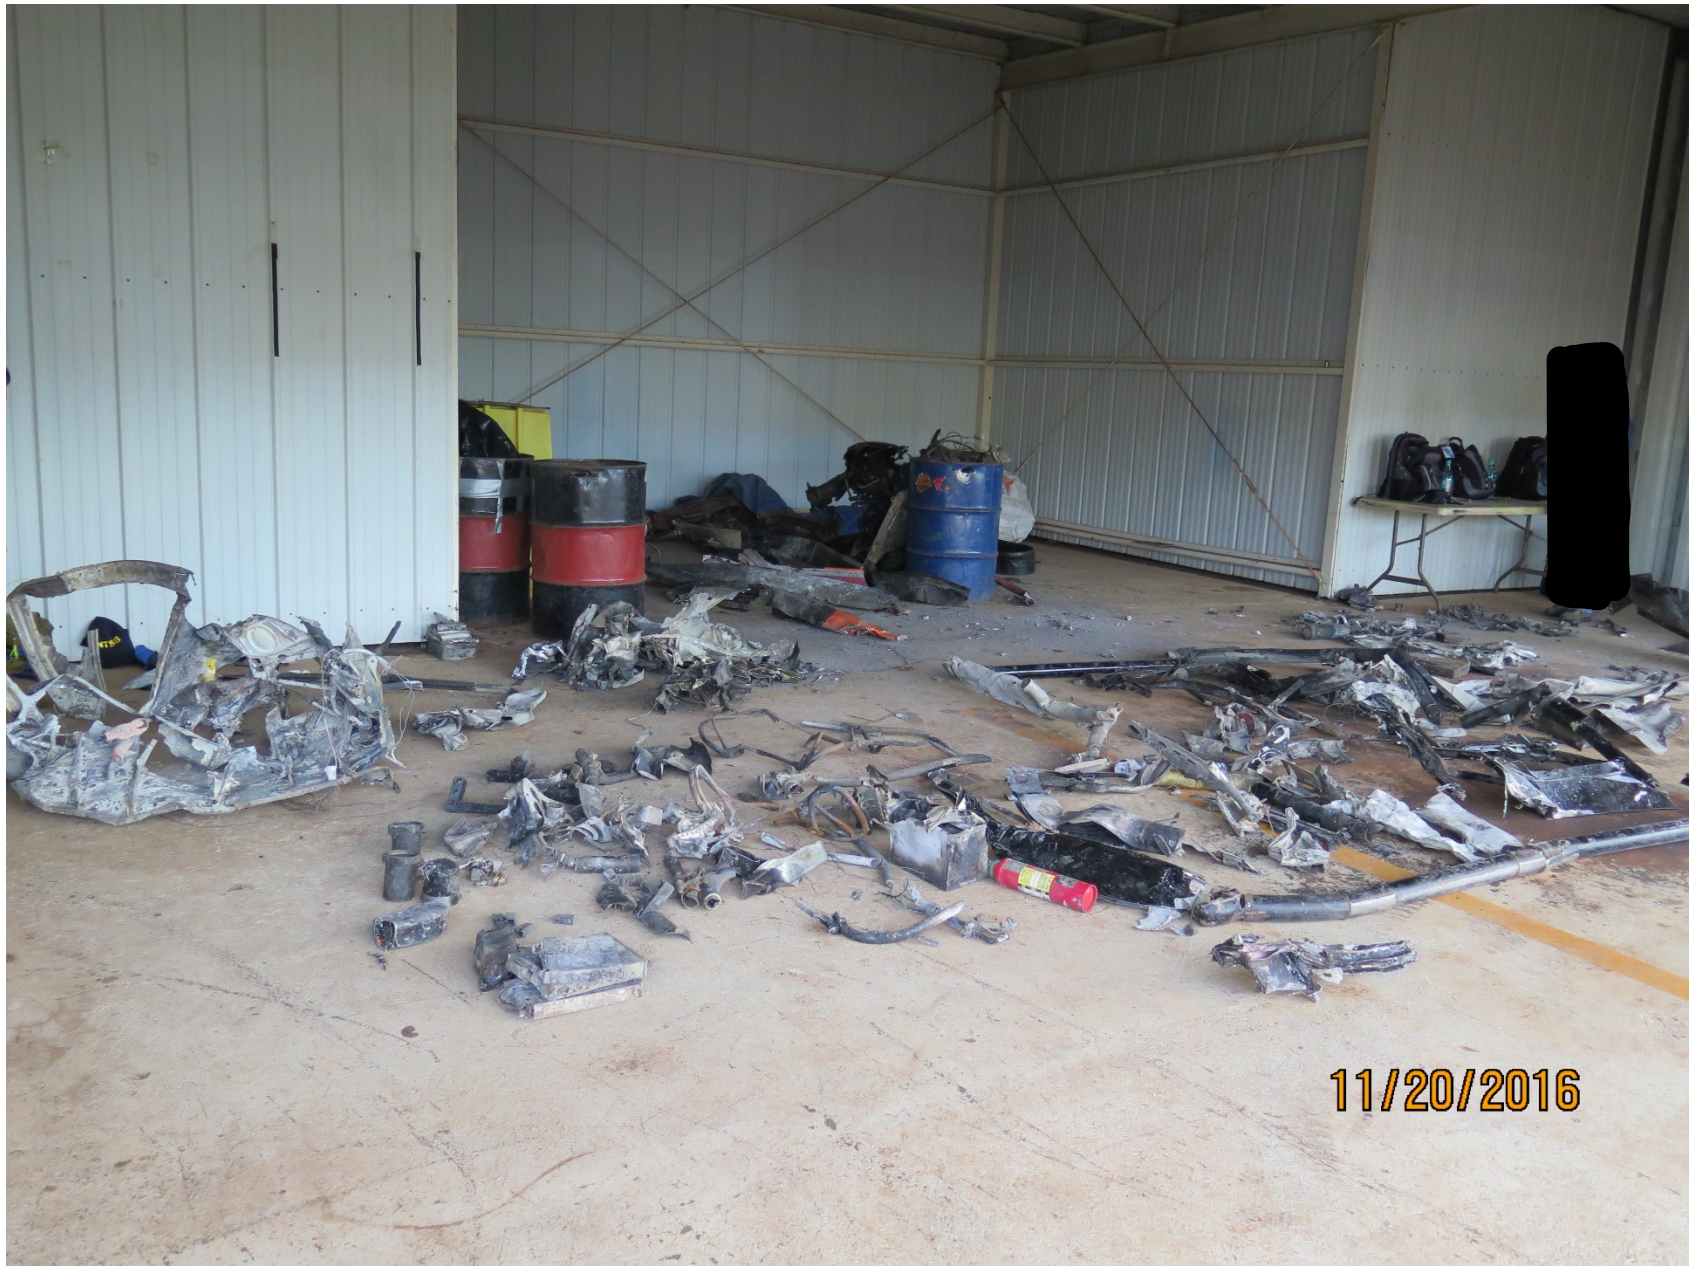
**Photo 5 - Wreckage fragments at examination hangar**

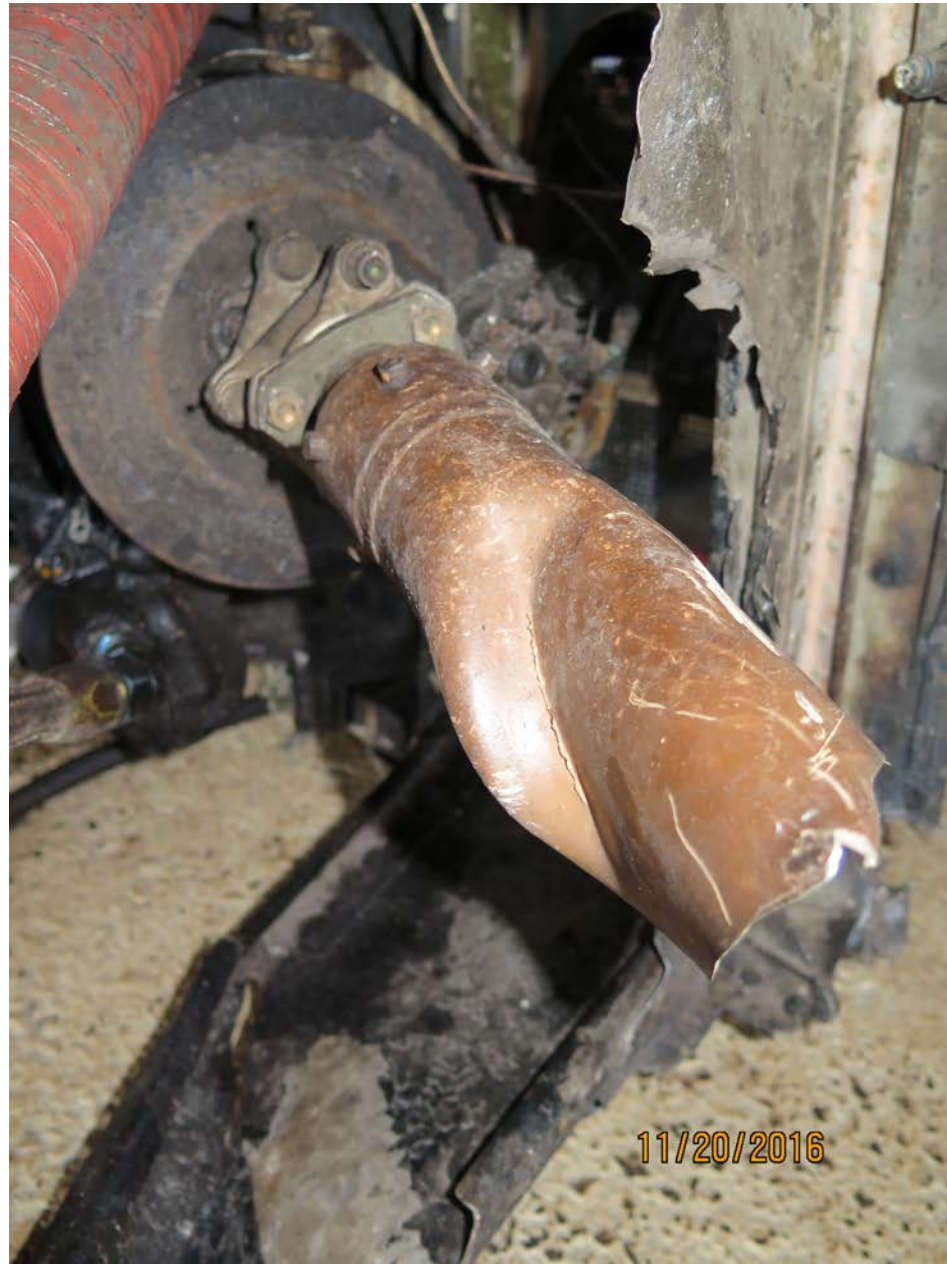
**Photo 6 - Tail rotor drive shaft with fracture and torsional deformation**

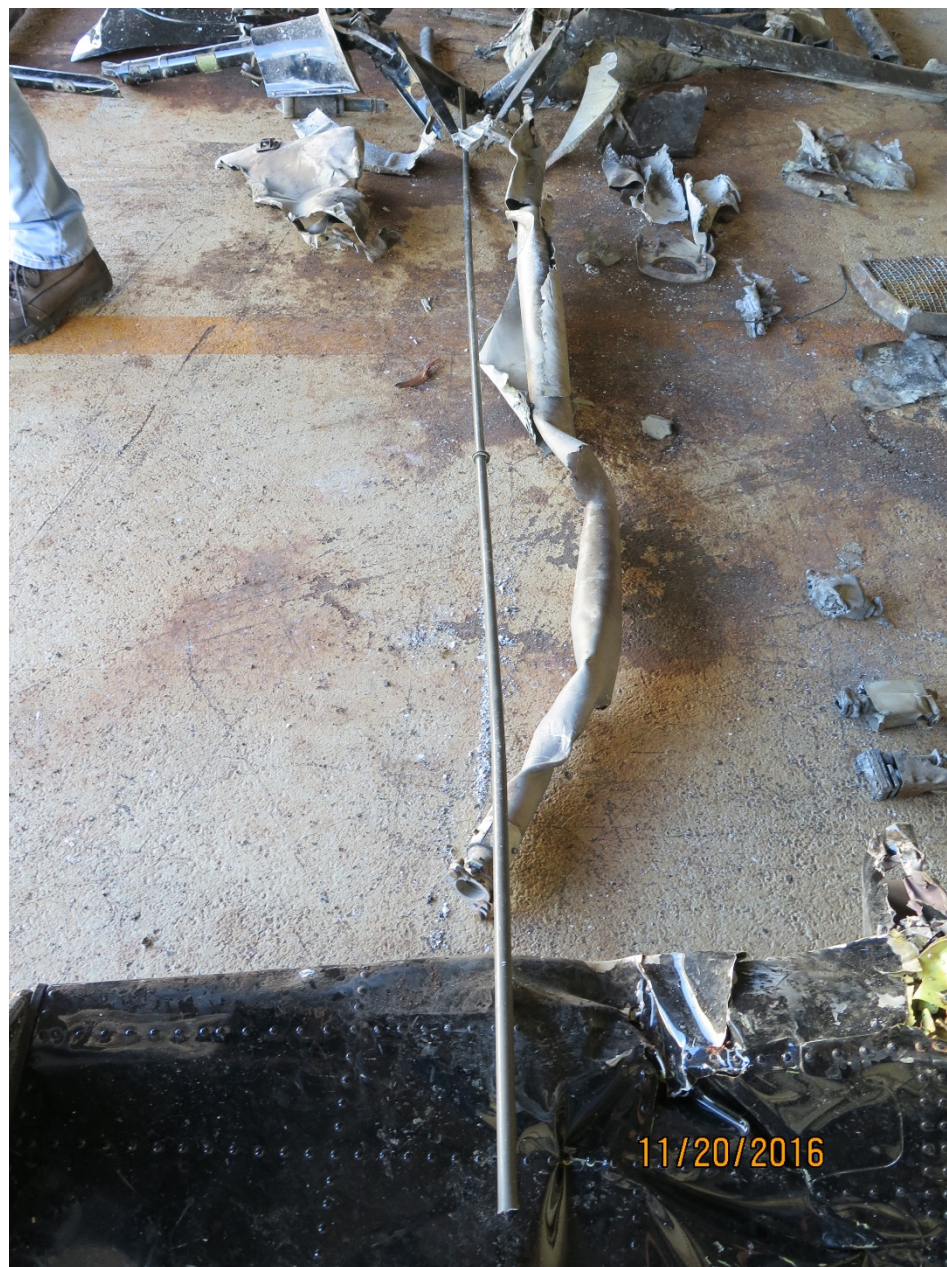
**Photo 7 - Fractured and twisted tail rotor drive shaft**

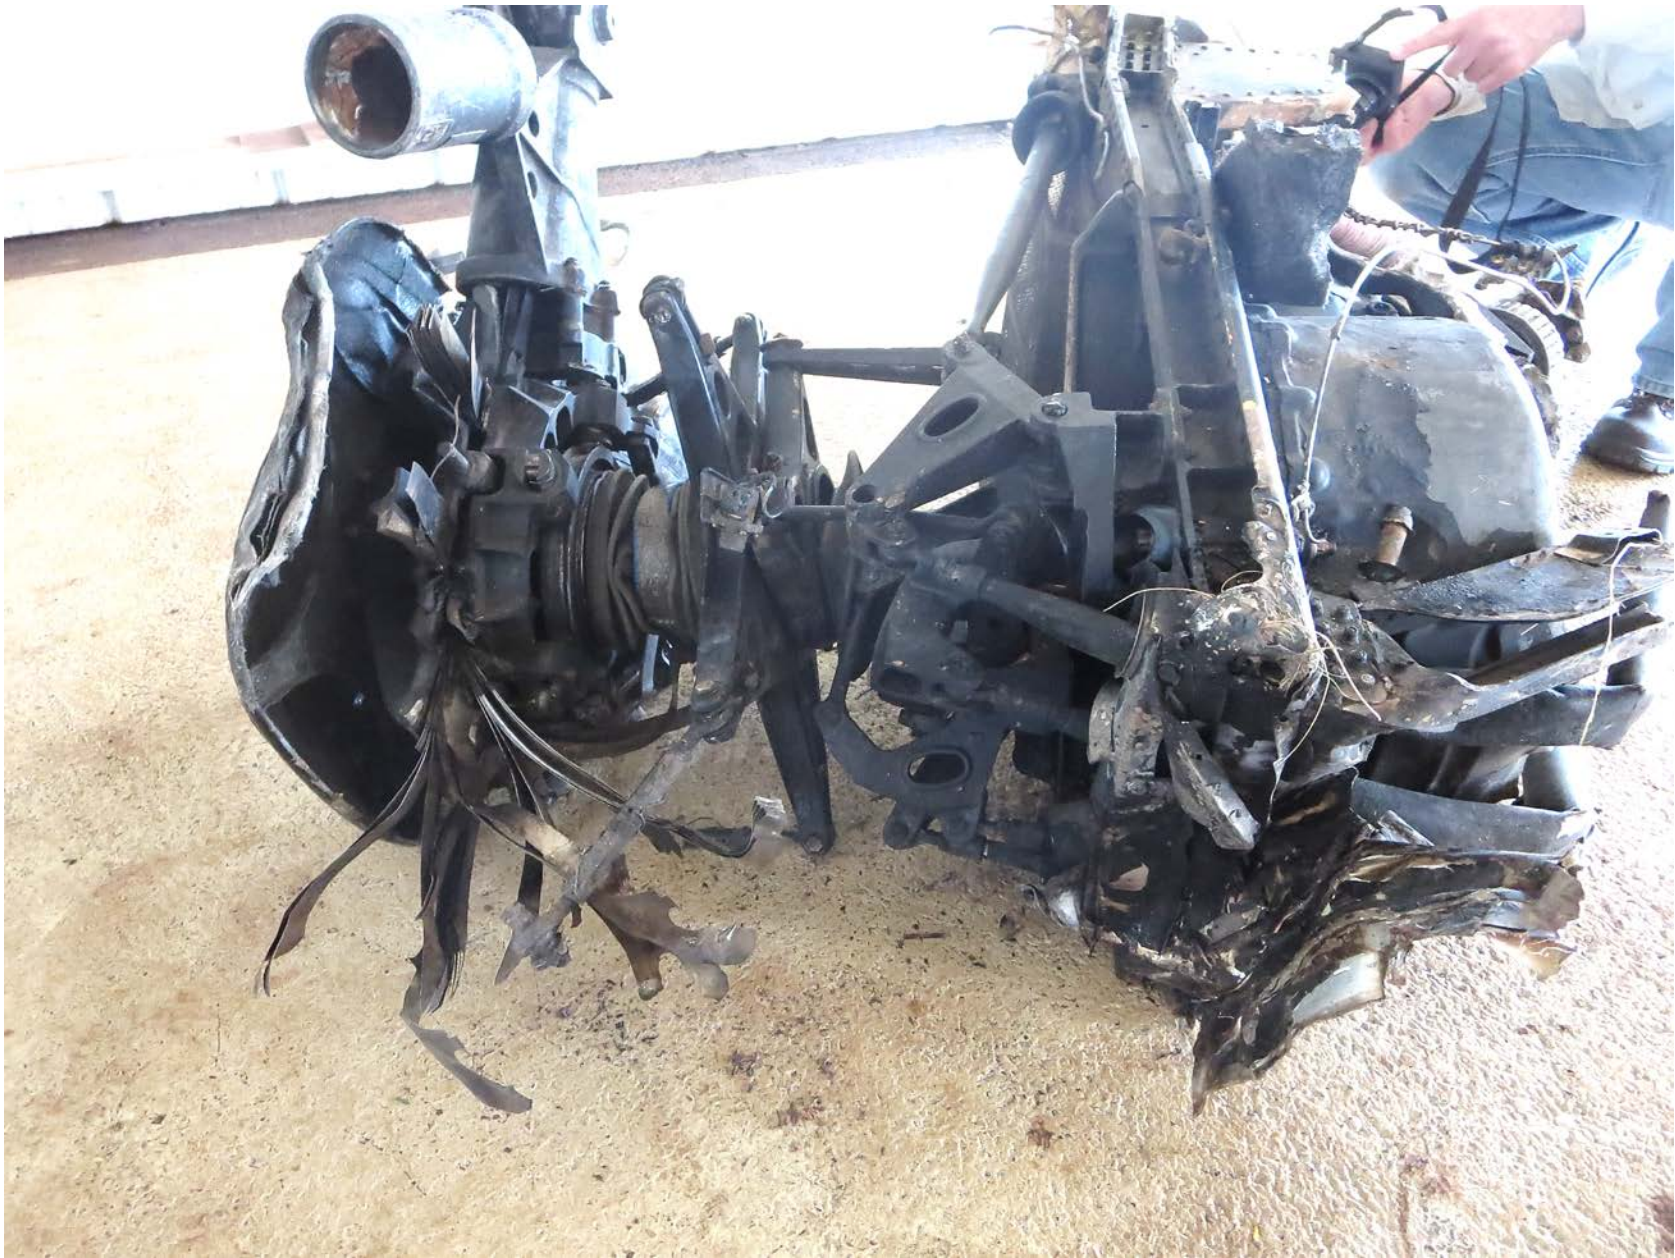
**Photo 8 - Main rotor head and transmission**

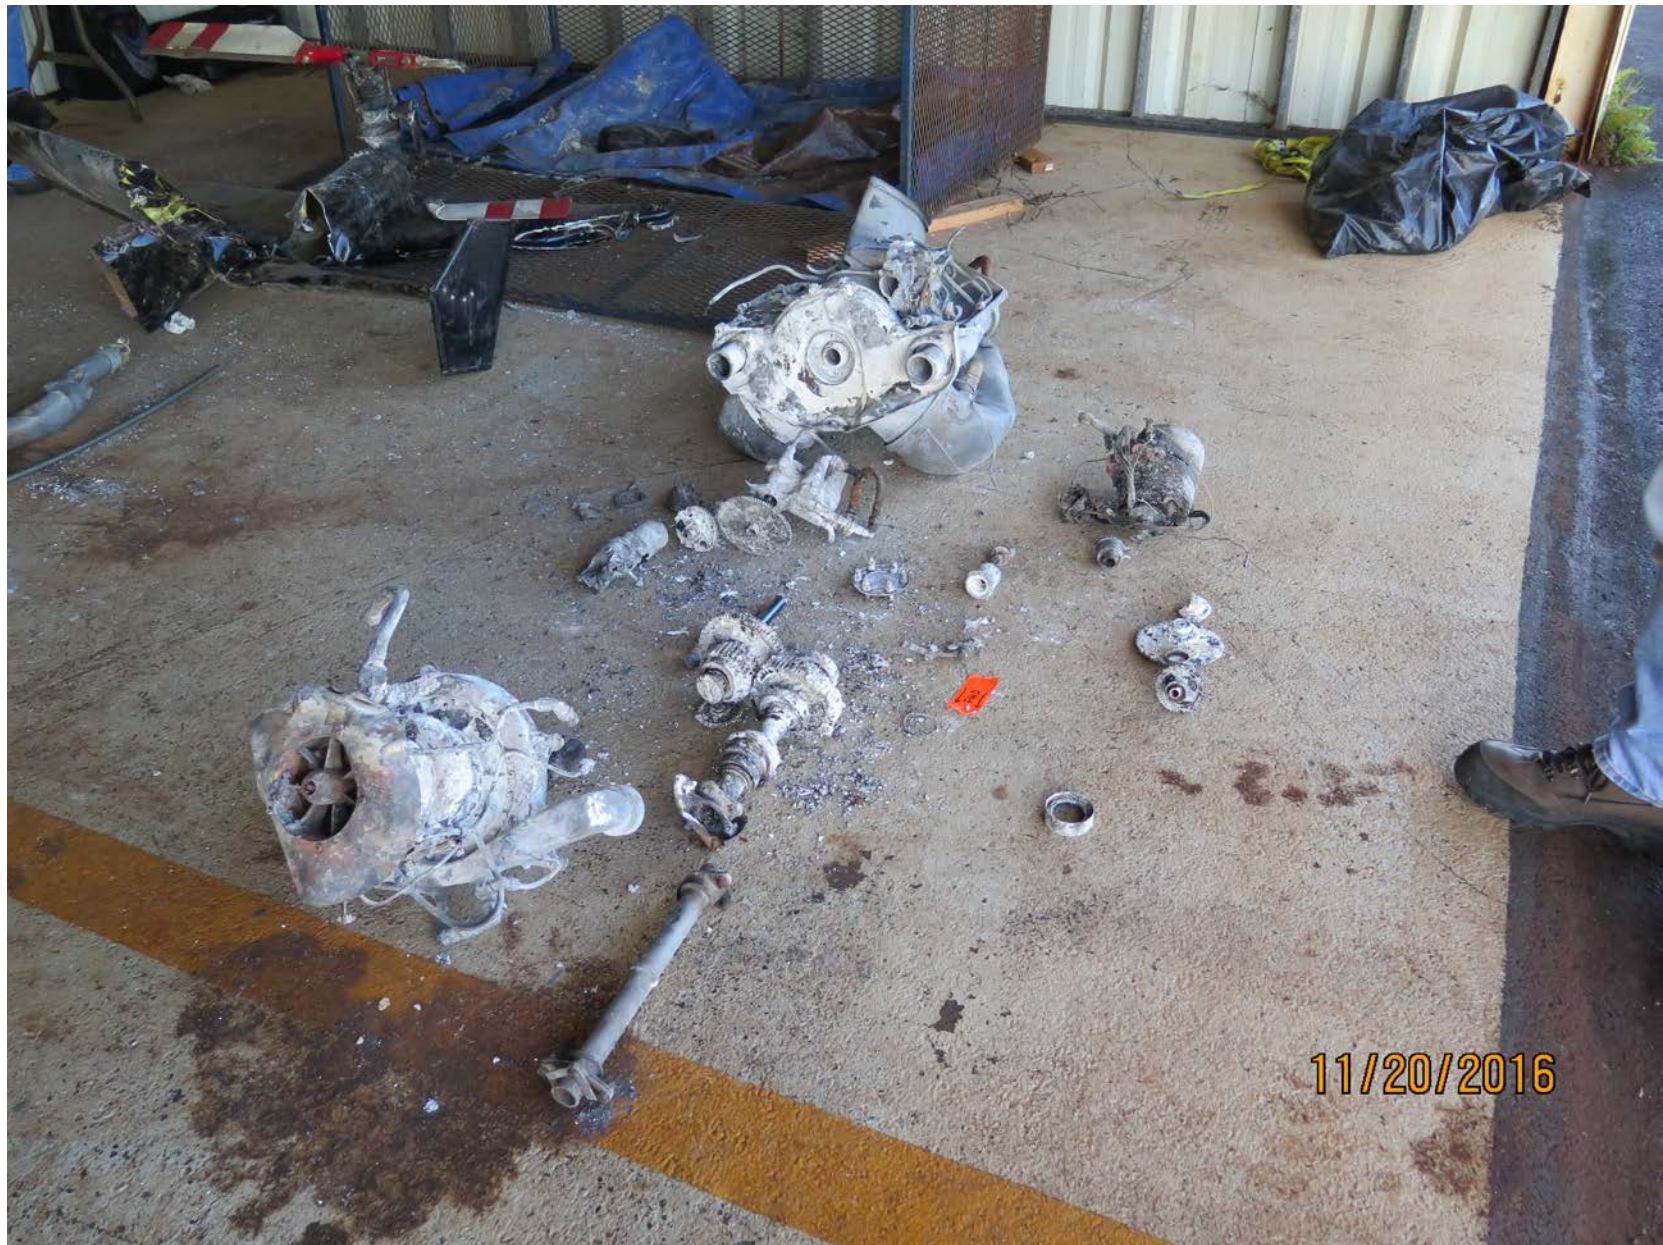
**Photo 9 - Rolls Royce 250-C20B engine with drive shafts, pinion gear and couplings**

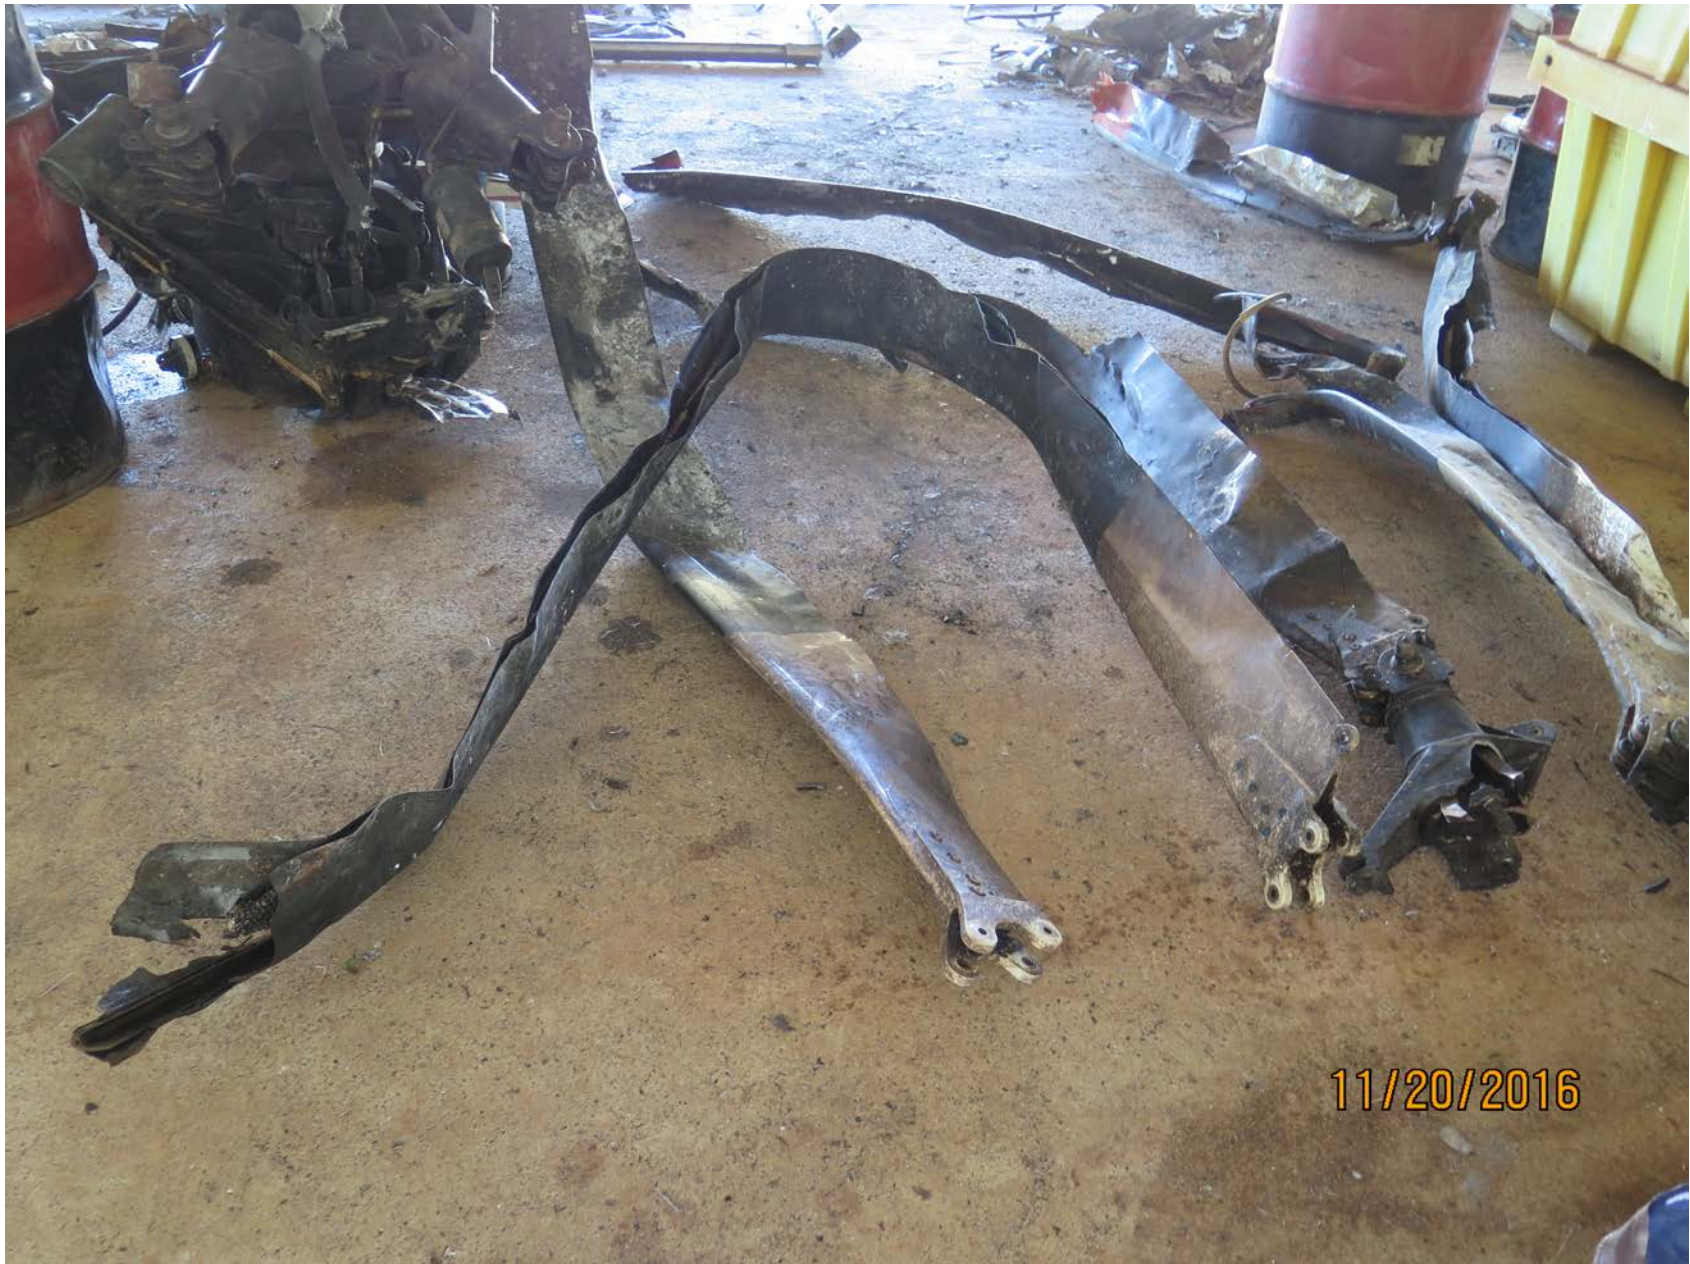
**Photo 10 - Five recovered main rotor blades**

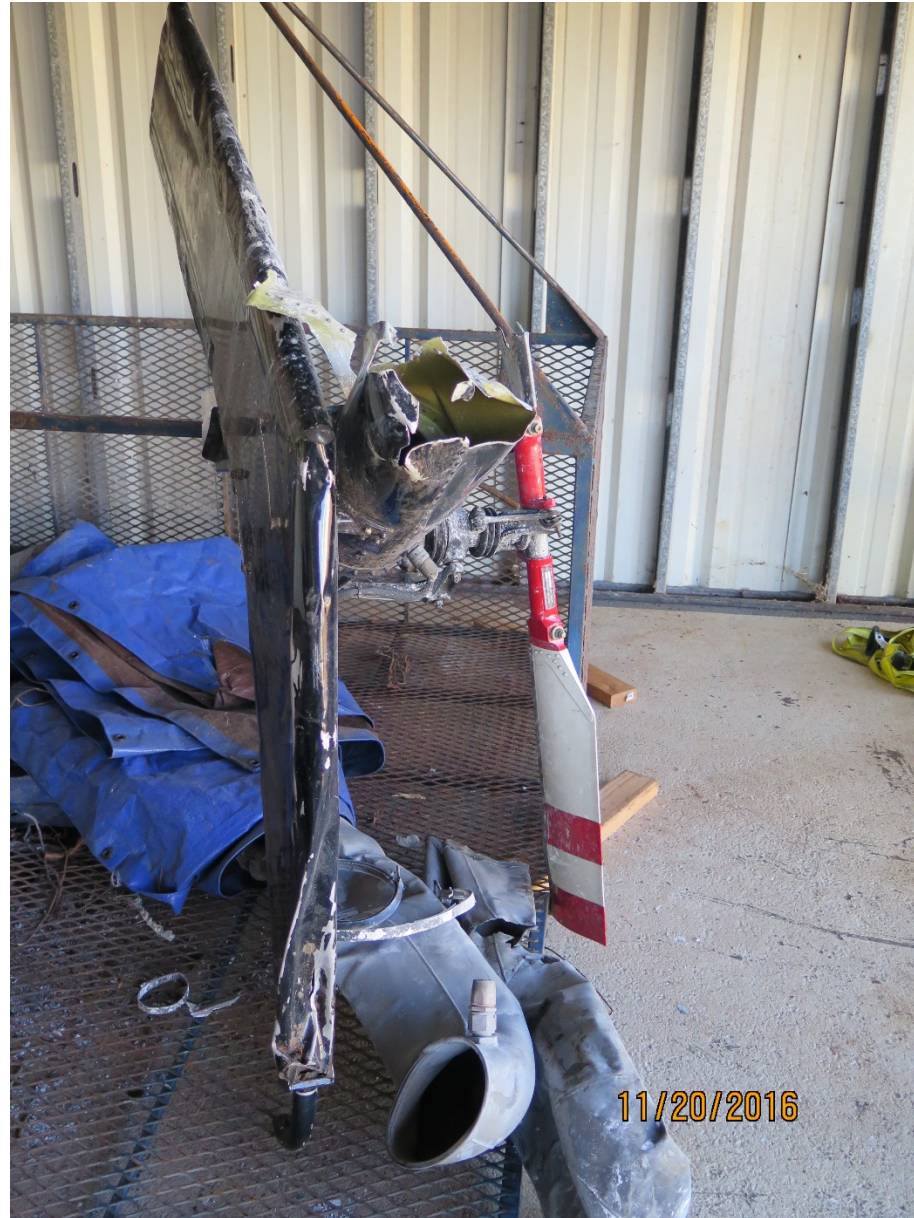
**Photo 11-Tail rotor and vertical stabilizer assembly**

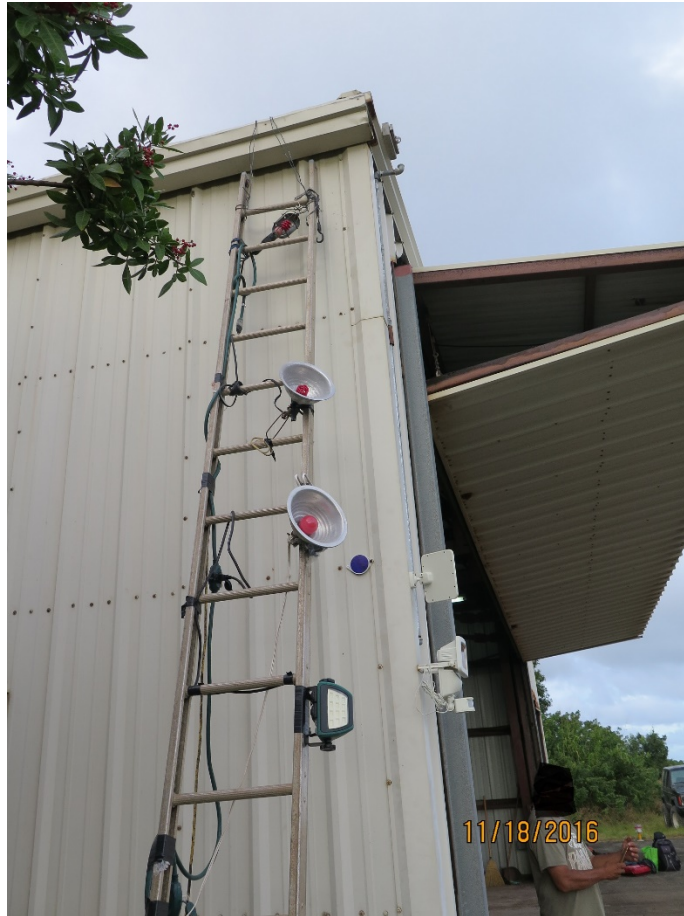
**Photo 12-Hangar vertical light array**

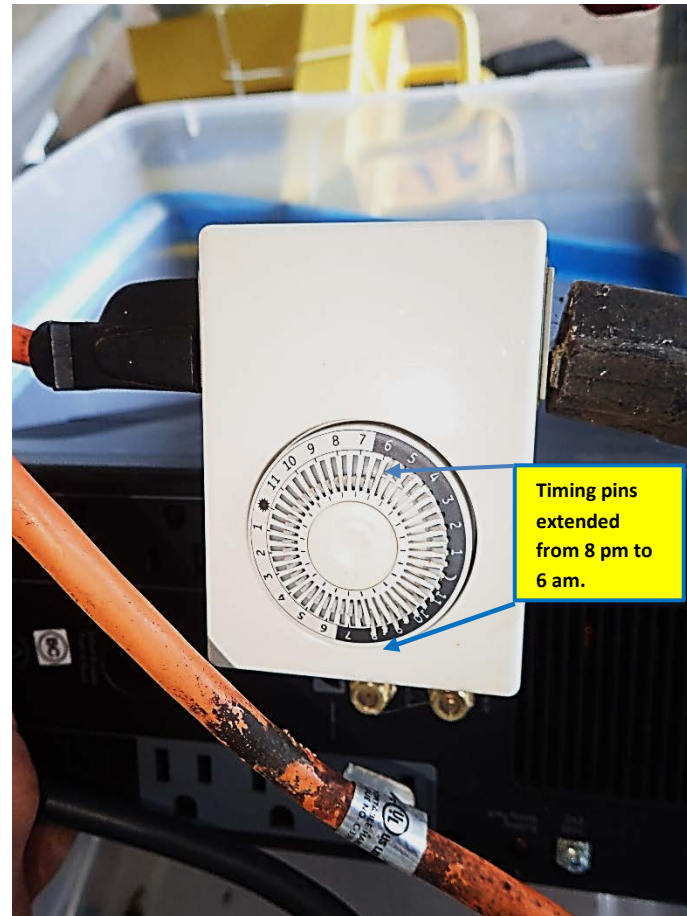
**Photo 13-Mechanical pin timer for vertical hangar lights**
