**National Transportation Safety Board**  
Office of Research and Engineering  
Washington, D.C. 20594

## Airplane Performance Study

| Airplane: | Cessna C-172N, Registration N6610D |
| NTSB Number: | WPR17FA023 |

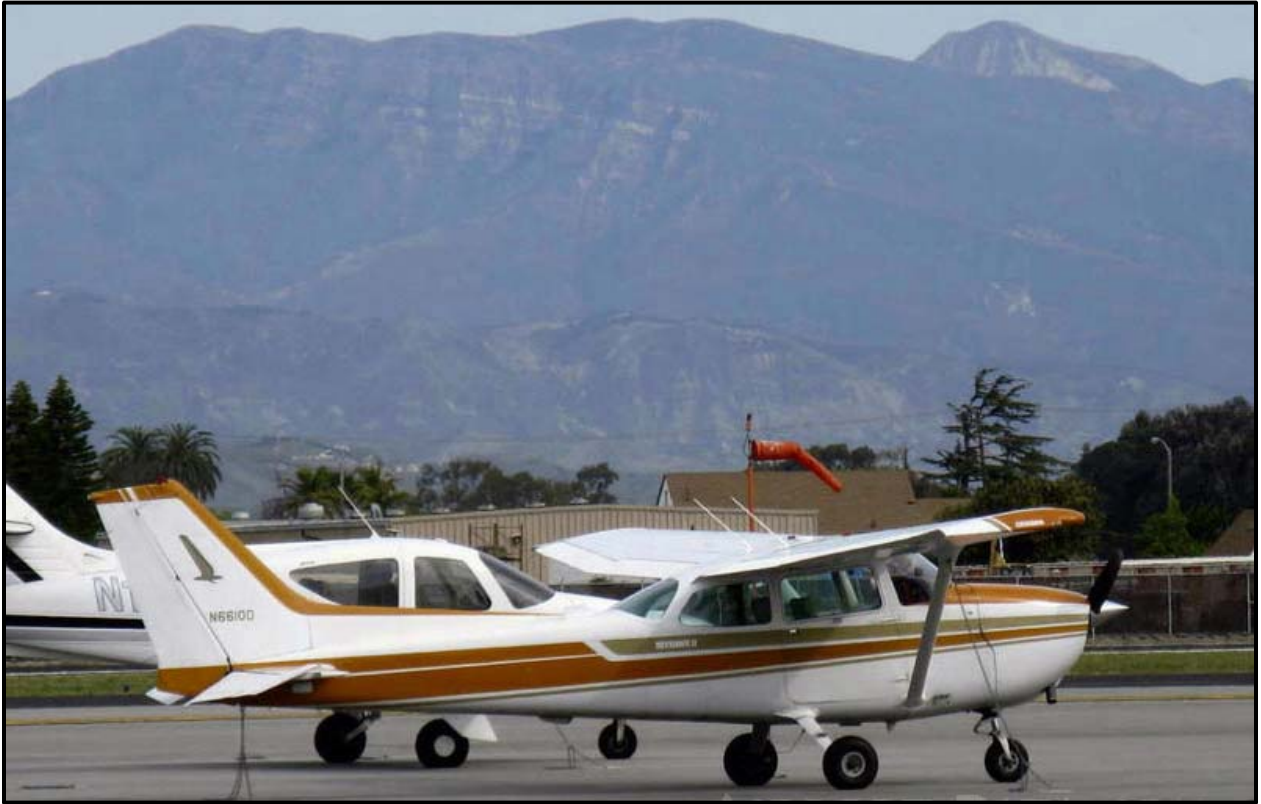
**Figure 1: Accident Airplane N6610D, a 1980 Cessna C-172N “Skyhawk”**

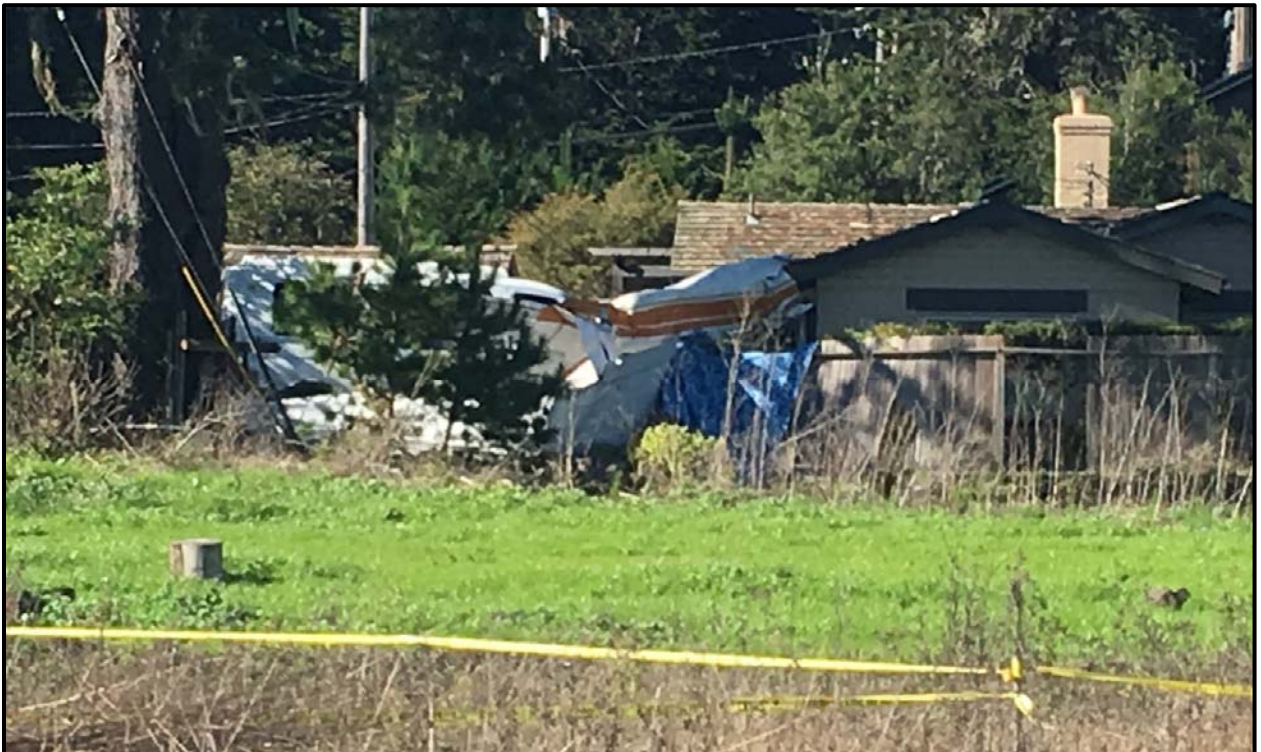
On November 18, 2016, about 1118 Pacific standard time (PST), a Cessna 172N, N6610D, sustained substantial damage after impacting terrain and objects in a residential area near Moss Beach, California, following a loss of control while on final approach to Half Moon Bay Airport (HAF), Half Moon Bay, California. The private pilot sustained serious injuries, and the passenger was fatally injured. The personal cross-country flight was being operated in accordance with 14 *Code of Federal Regulation* Part 91, and a flight plan had not been filed. Visual meteorological conditions prevailed for the flight which originated from the Sacramento Executive Airport (SAC), Sacramento, California, at about 1015. HAF was the intended destination.

**Figure 2: Accident Site**

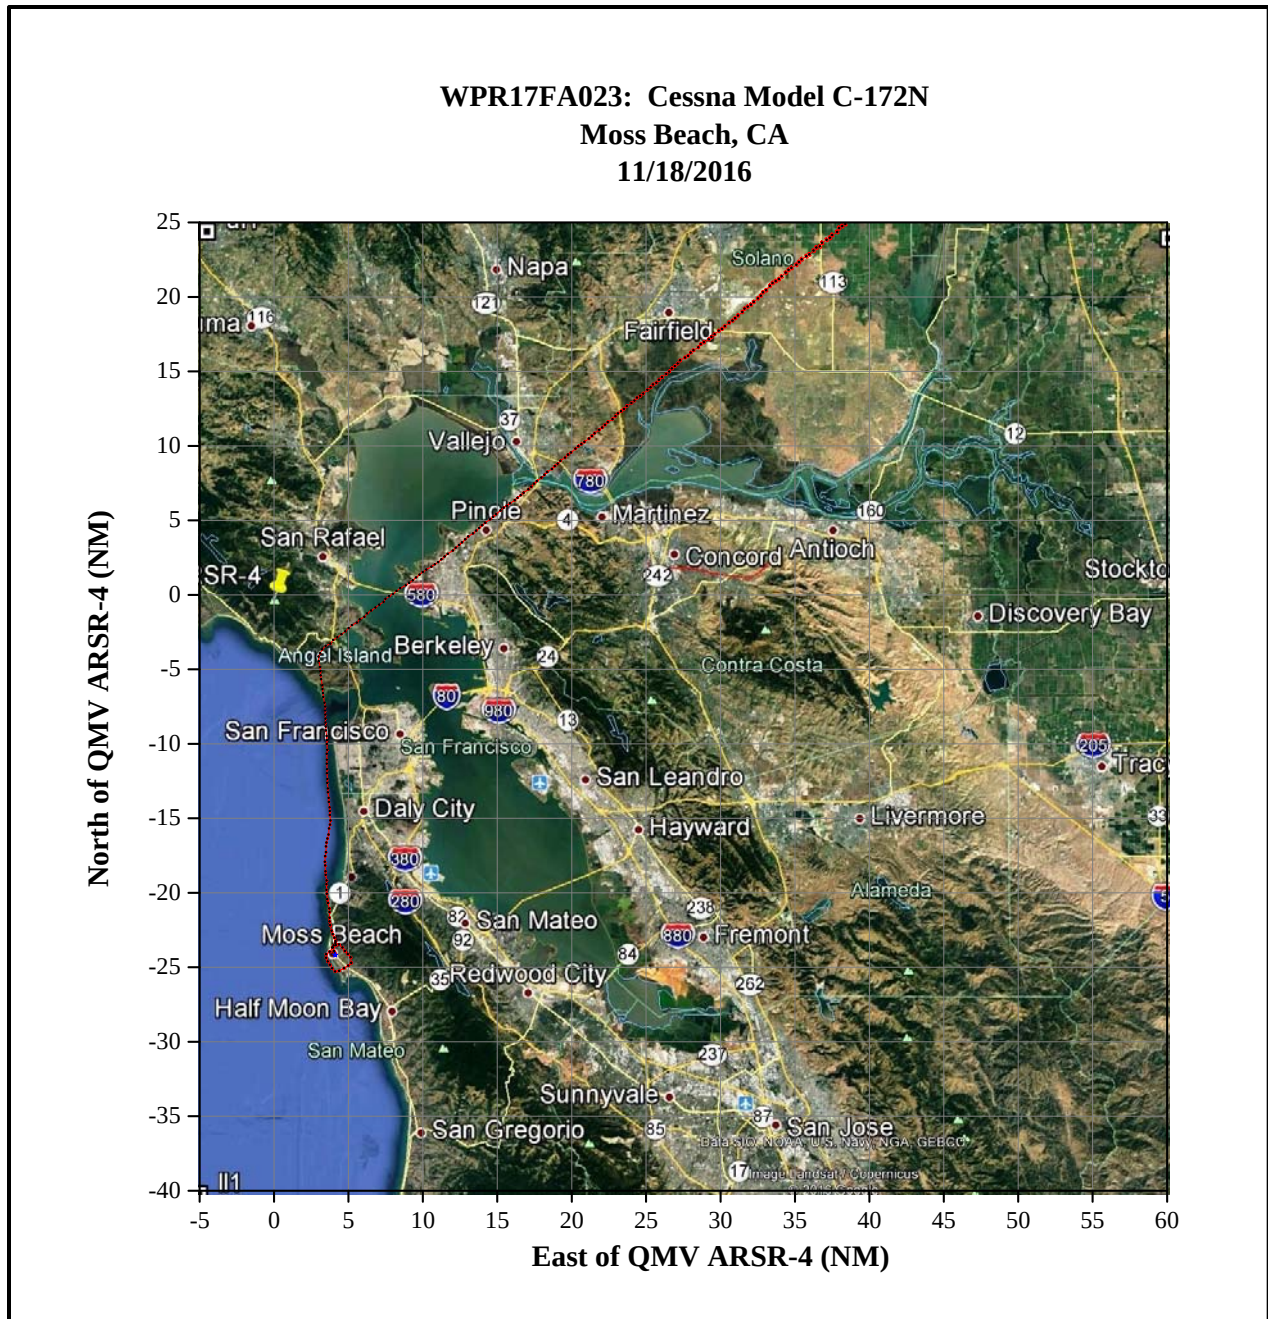
N6610D approached HAF from the north and entered a 45° leg to the left upwind for runway 12. (See Figure 3 for an overview of the radar ground track.) The airplane was at about 86 kt calibrated airspeed (KCAS) and 1,000 ft mean sea level (msl) when the pilot completed the turn for a left downwind to runway 12. (These are typical numbers for a C-172 in the airport traffic pattern.)

Figure 3: Radar Ground Track for Flight from SAC

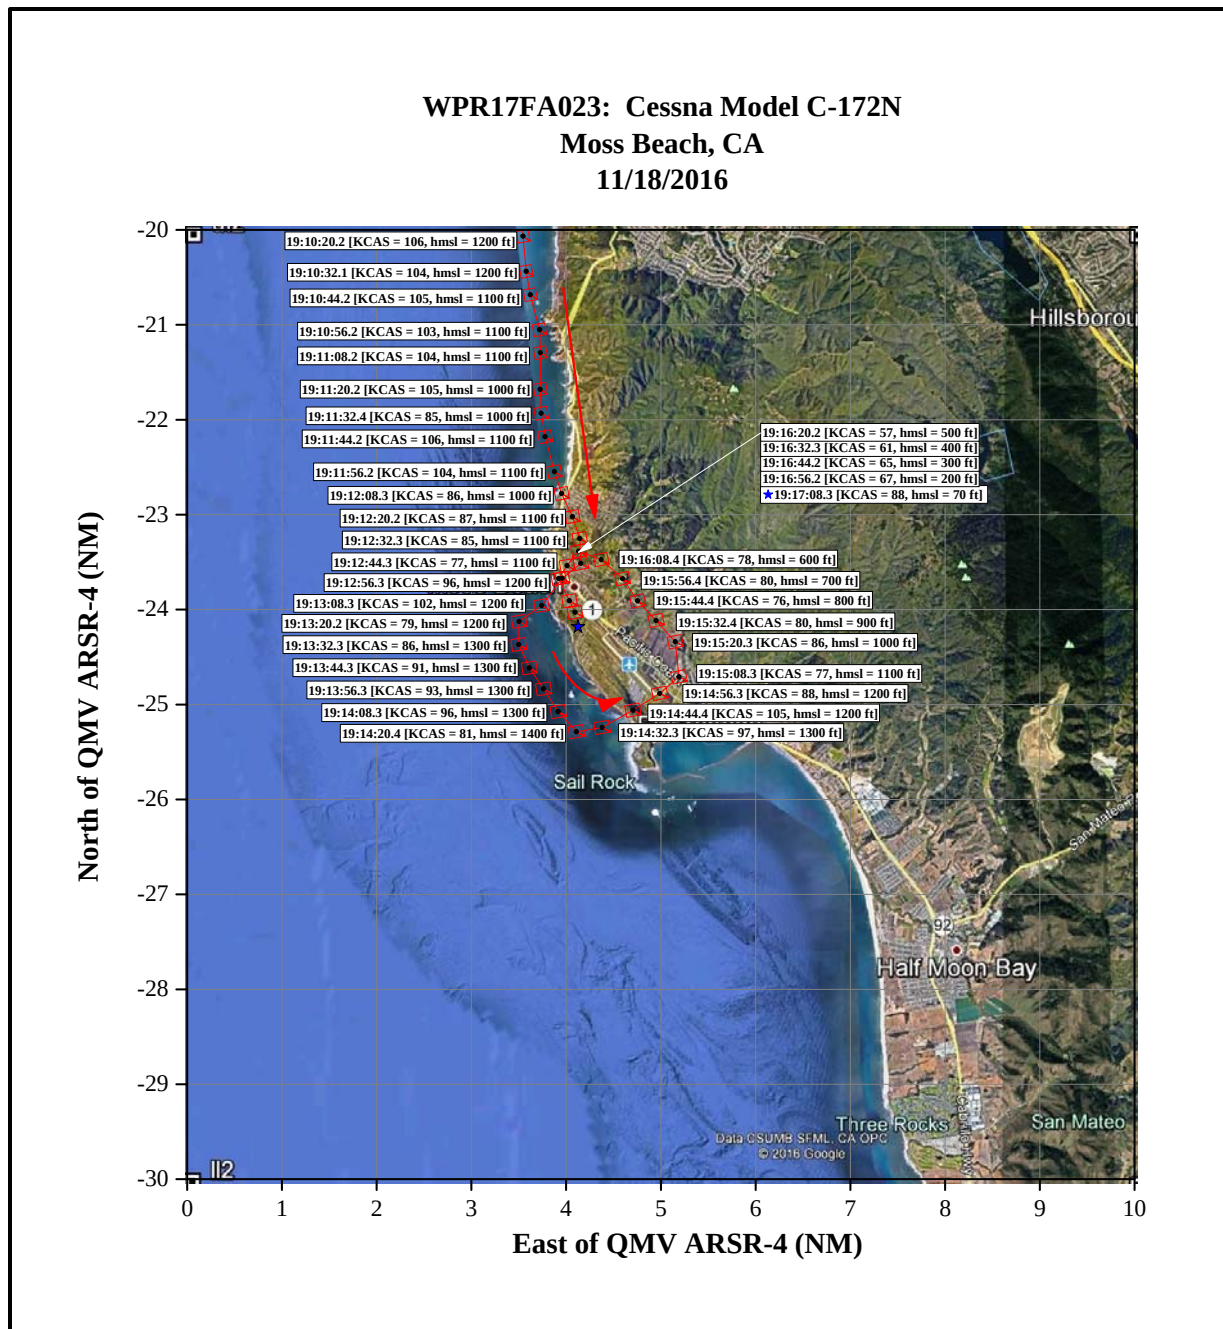
Radar show that the airplane slowed to about 80 KCAS and descended to about 700 ft msl on the downwind leg. See Figure 4. The airplane then entered a continuous 180° left turn from downwind to final<sup>1</sup>. Radar data indicate that, at 1116:20 PST, the airspeed was about 57

Figure 4: Radar Ground Track Near HAF with Estimated Airspeed and Altitude

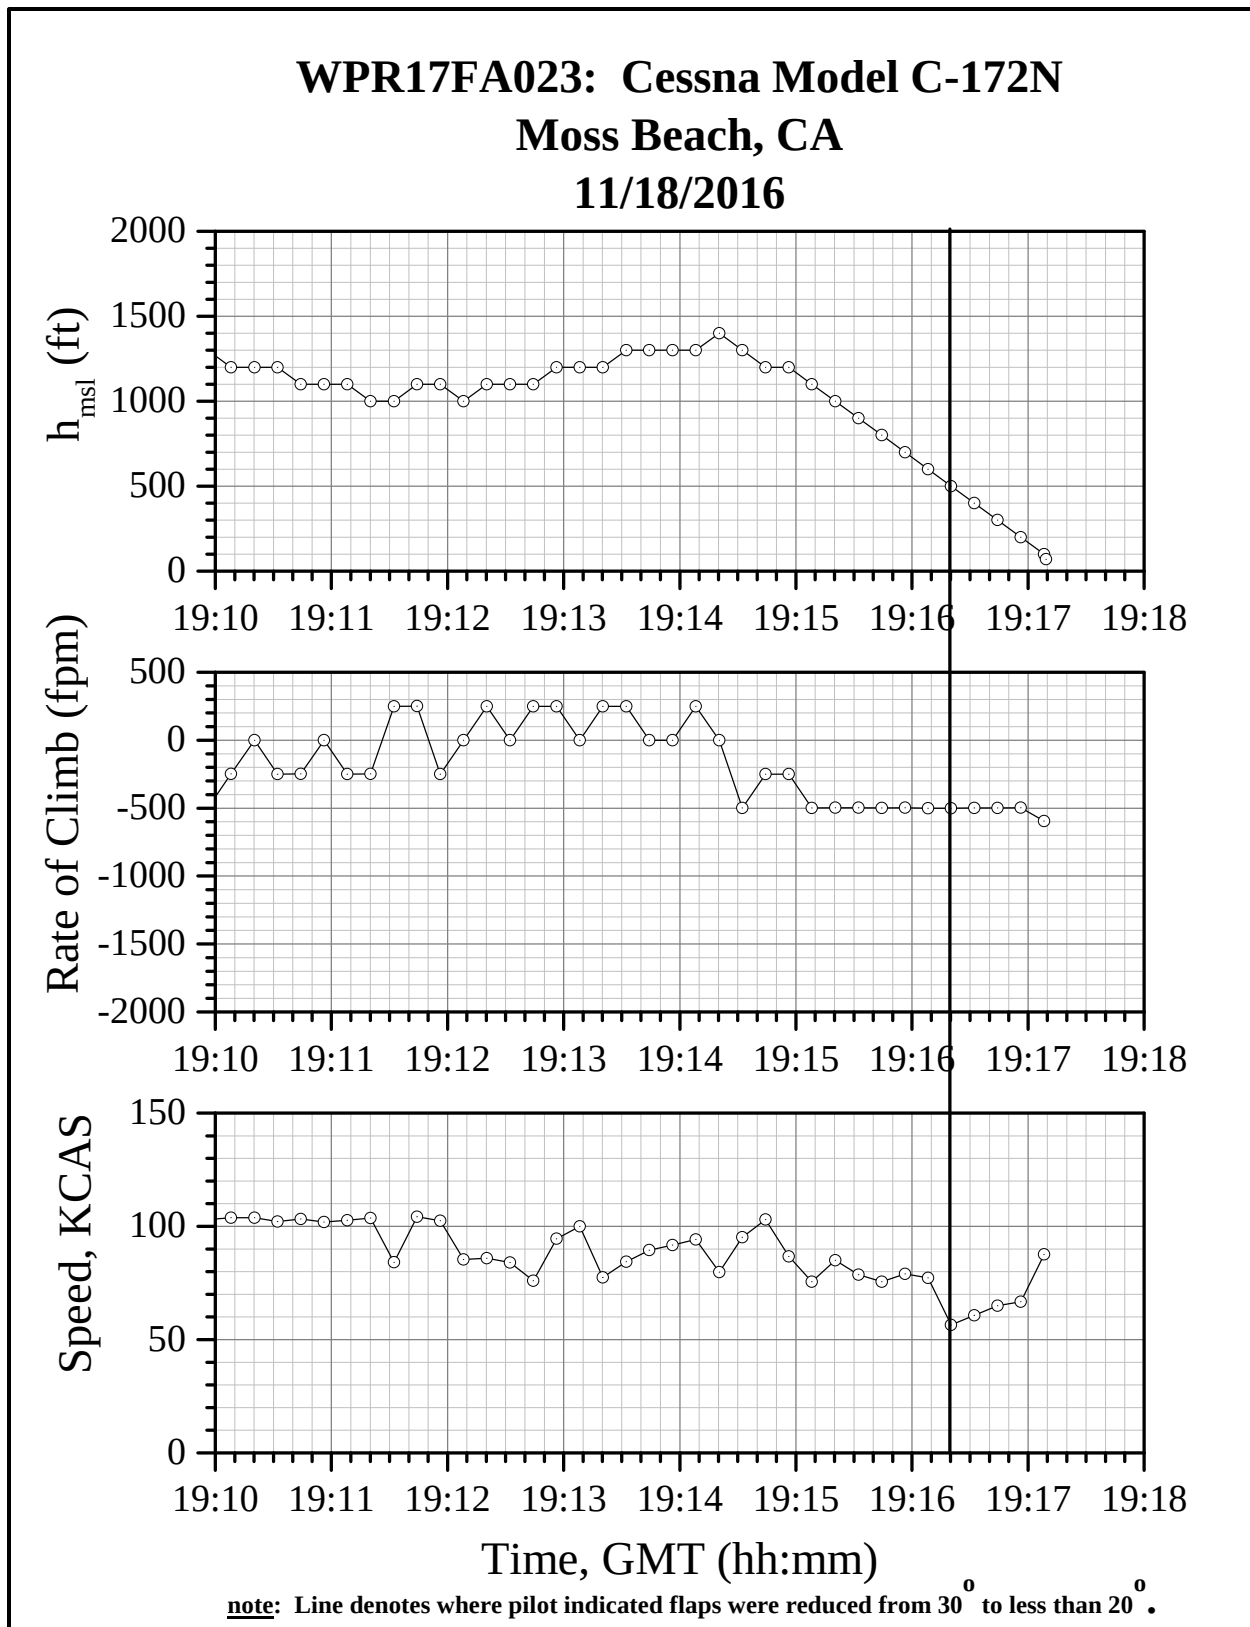
KCAS, the altitude was 500 ft msl, and the airplane was at the apex of a 10° left turn to final. At this point the airplane pitched down (from 5° nose up to about -3° nose down) and accelerated as it descended until impact at about 1117:10 PST. Figures 5, 6, and 7 include time histories of the airplane's altitude, speed, and attitude as estimated from radar.

**Figure 5: Altitude and Calibrated Airspeed Based on Radar**

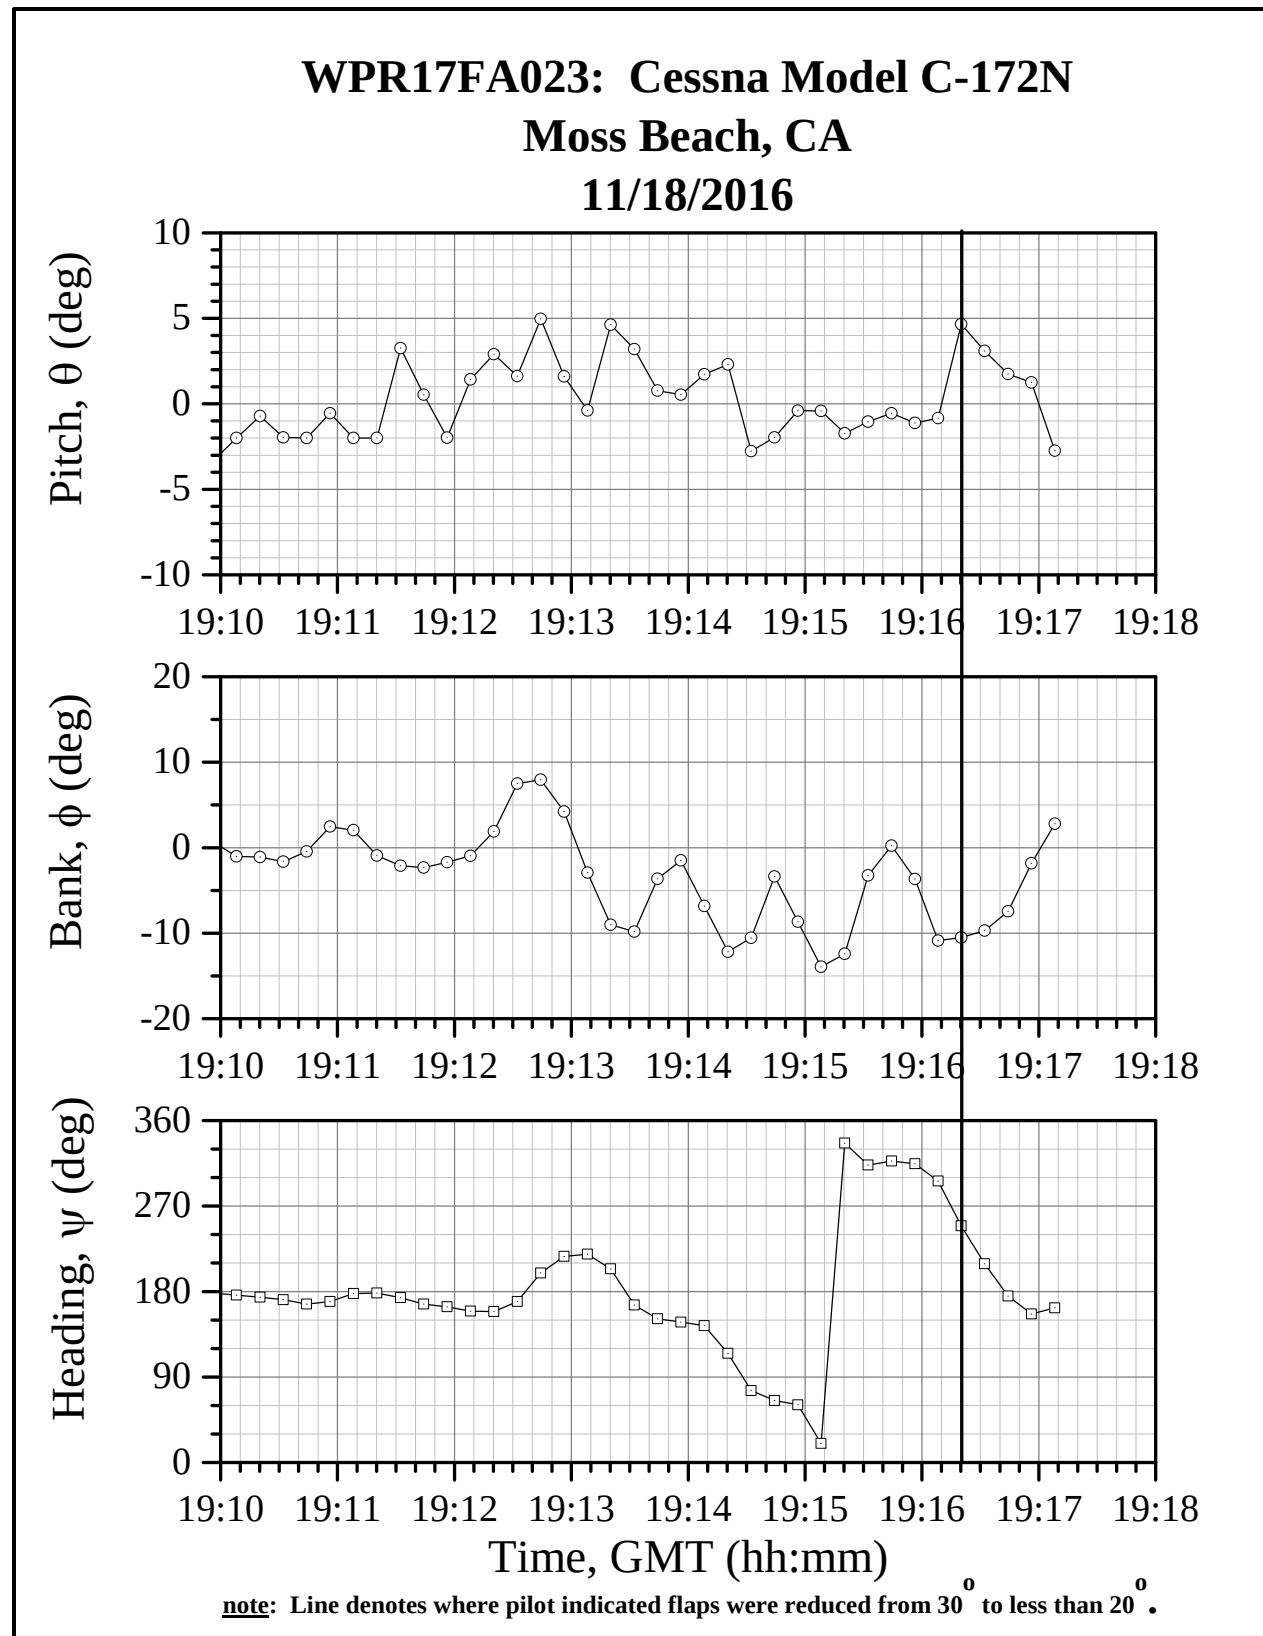
Figure 6: Pitch, Bank, and Heading Based on Radar

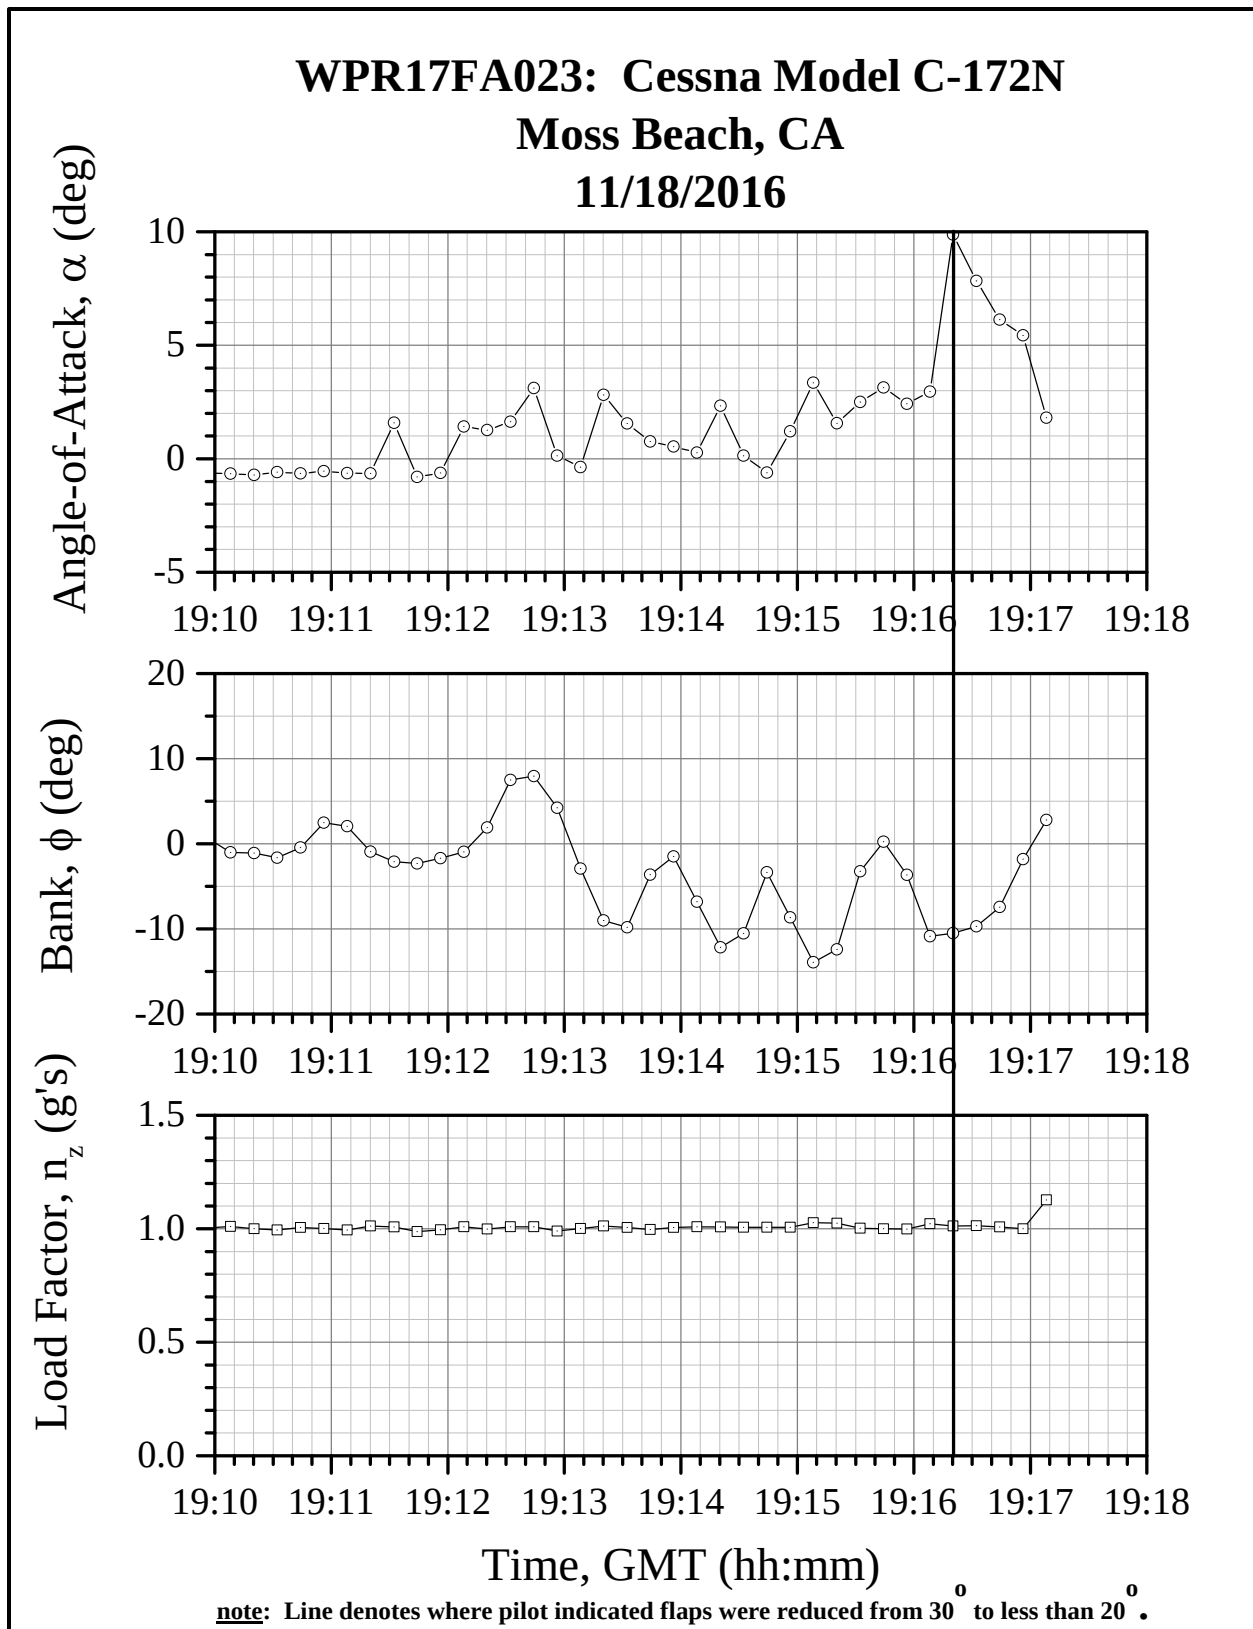
**Figure 7: Estimated Angle-of-Attack, Bank Angle, and Normal Load Factor Based on Radar**
