## **NATIONAL TRANSPORTATION SAFETY BOARD**

### **AIRFRAME AND ENGINE EXAMINATION**

**WPR17FA025**

Location: Upland, California  
Date: November 22, 2016  
Aircraft: Piper PA28-181, N6912C, Serial #: 28-8590051  
NTSB IIC: Patrick H. Jones

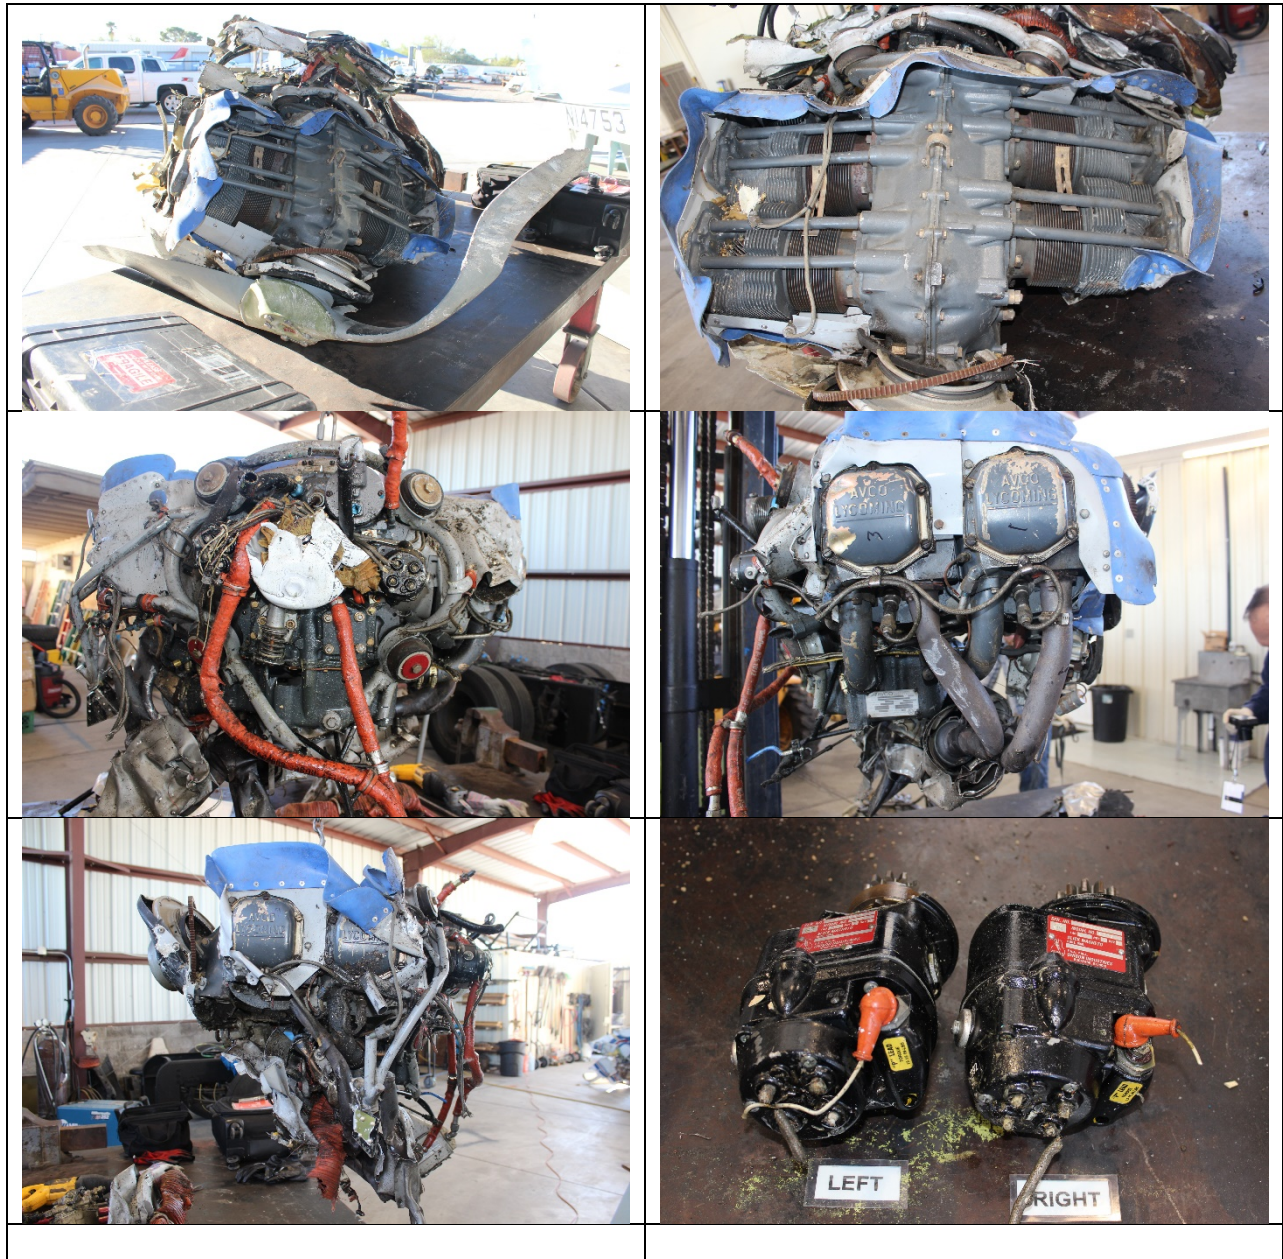
## 2.1 Engine Exam Photos

The engine remained attached to the airframe by the engine mount. The engine had sustained significant impact energy damage at the left lower area, which displaced the starter and portions of the exhaust system. Visual examination of the engine revealed no evidence of pre-impact catastrophic mechanical malfunction or fire.

Rotation of the crankshaft was precluded due to impact damage to the crankshaft flange at the nose of the engine. The propeller flange was cut off to facilitate the examination. The top spark plugs were removed, examined and photographed. The vacuum pump was removed, and the crankshaft was rotated by hand through the drive pad utilizing a drive tool. The crankshaft was free and easy to rotate in both directions. "Thumb" compression was observed in proper order on all four cylinders. The complete valve train was observed to operate in proper order, and appeared to be free of any pre-mishap mechanical malfunction. Normal "lift action" was observed at each rocker assembly. Clean, uncontaminated oil was observed at all four rockerbox areas. Mechanical continuity was established throughout the rotating group, valve train and accessory section during hand rotation of the crankshaft. The bottom spark plugs were not removed. The combustion chamber of each cylinder was examined through the spark plug holes utilizing a lighted borescope. The combustion chambers remained mechanically undamaged, and there was no evidence of foreign object ingestion or detonation. The valves were intact and undamaged. There was no evidence of valve to piston face contact observed. The gas path and combustion signatures observed at the spark plugs, combustion chambers and exhaust system components displayed coloration consistent with normal operation. There was no oil residue observed in the exhaust system gas path. There was significant ductile bending of the exhaust system components. The exhaust system was found free of obstructions.

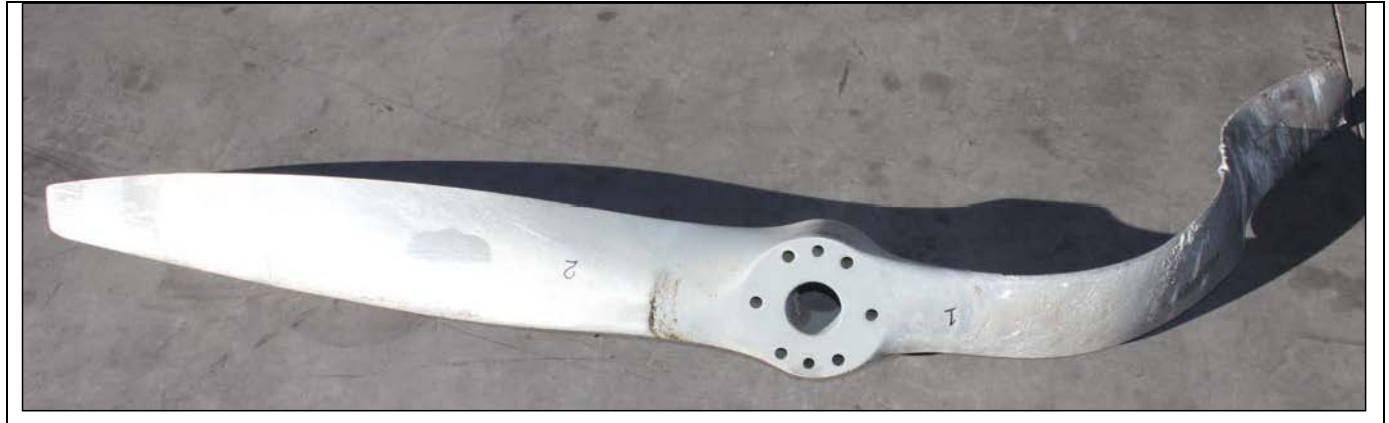
The two-bladed fixed pitch propeller remained attached at the crankshaft flange. The spinner was attached to the propeller. The propeller blades remained attached to the propeller hub.

The propeller blade marked as “1” displayed leading edge gouging, torsional twisting, chordwise striations across the cambered surface and trailing edge “S” bending. An approximate 2 inch section of blade tip had been torn away. The signatures were consistent with the absorption of rotational forces applied at the crankshaft at the time of impact.

The propeller blade marked as “2” remained intact and sustained minor damage.

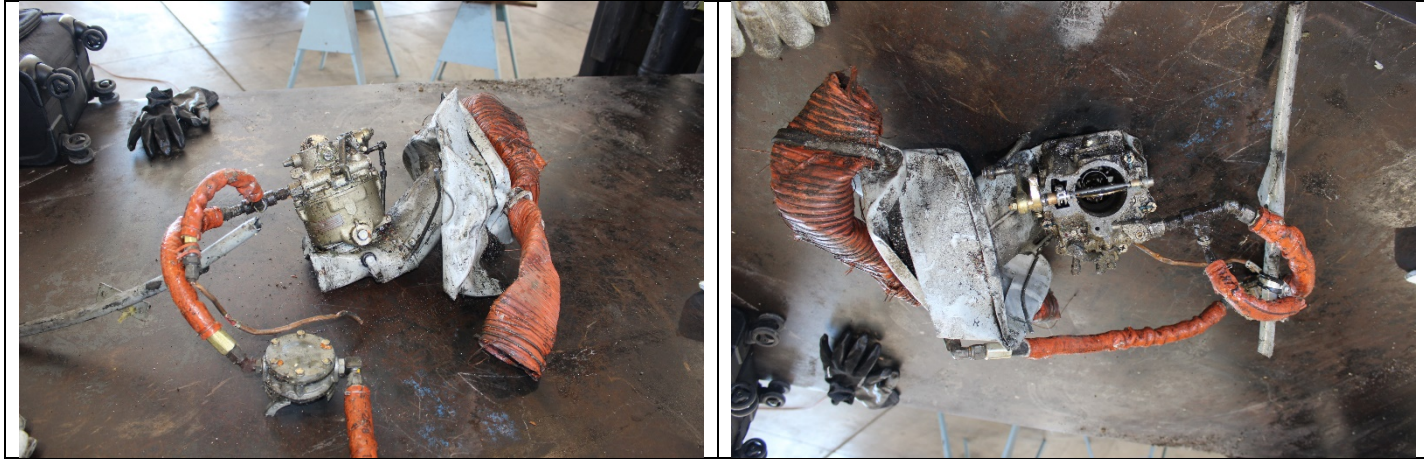
The carburetor was displaced from the engine due to the forces of impact. The portion that remained attached at the mounting pad was secure. The fracture surface signatures were consistent with overload. The throttle/mixture controls were found securely attached at their respective control arms of the carburetor.

The carburetor was opened for examination. The fuel bowl remained free of visible contaminants. The float assembly remained secure at the mounting and free of damage. The float pontoons exhibited no evidence of rubbing against the wall of the bowl. All internal locking tabs and safety devices of the carburetor were in place and properly secured. The fuel inlet screen was found properly installed and free of contamination. No external fuel staining was observed. Fluid consistent with the appearance and odor of aviation fuel was observed within the carburetor bowl and accelerator pump well.

The carburetor and induction system were examined and observed to be free of obstruction. The foam filter element exhibited crush damage. The filter element remained intact and exhibited no evidence of pre-impact obstruction to airflow.

The fuel pump was displaced from the engine. The portion of mounting flange remained secure at the mounting pad. The fracture surfaces exhibited signatures consistent with overload. The fuel pump was opened for examination. The fuel pump remained free of internal mechanical malfunction and obstruction to flow. The diaphragm was torn during the displacement of the pump from the mounting flange.

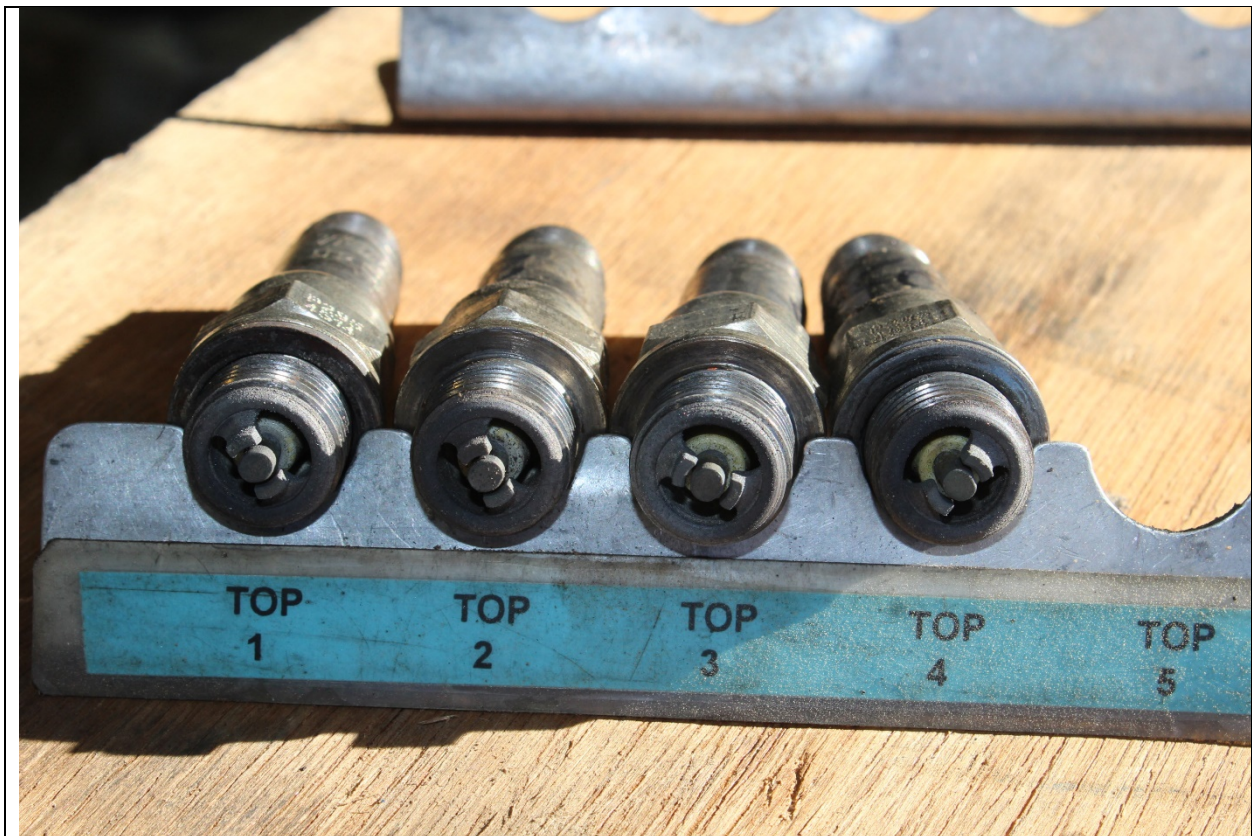
### SPARK PLUGS

The spark plugs were secure at each position with their respective spark plug lead attached. The spark plugs (as noted) were removed, examined and photographed. The spark plug electrodes remained mechanically undamaged, and according to the Champion Spark Plugs Check-A-Plug chart AV-27, the spark plug electrodes displayed coloration consistent with normal operation.
