## **NATIONAL TRANSPORTATION SAFETY BOARD**

### **ACCIDENT SITE / AIRFRAME / ENGINE EXAMINATION SUMMARY**

**WPR17FA029**

Location: Glamis, California  
Date: November 25, 2016  
Aircraft: Bellanca 7GCAA, N88373  
NTSB Investigator-in-Charge: Joshua Cawthra

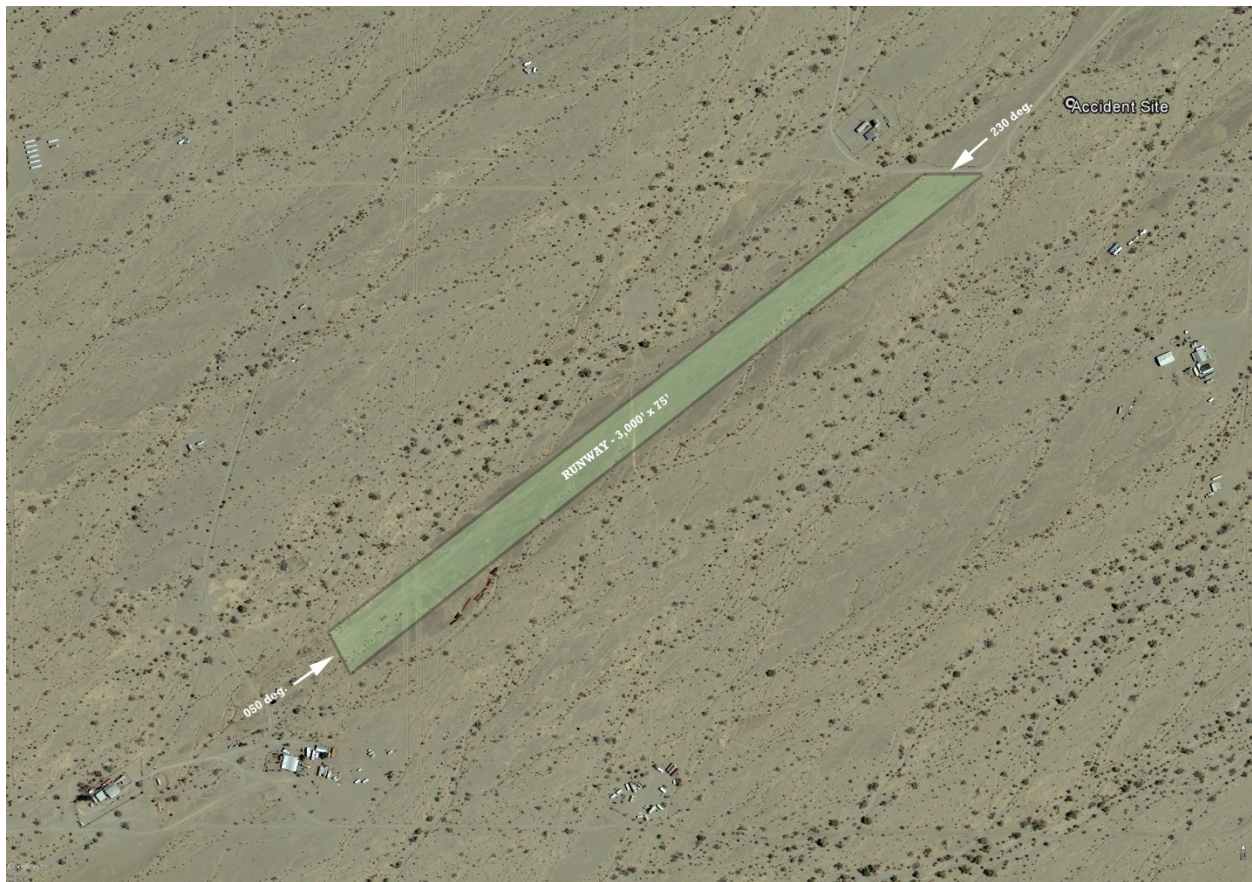
Figure 1: Google Earth Airport Overview with Markings

The private airstrip was part of a private residence and business located in an area of open desert terrain. The reported field elevation 440 feet mean sea level. The dirt runway was oriented on a heading of about 230 and 050 degrees respectively and was about 3,000 feet in length. No flags or windsocks were located near the runway or structures nor was there any weather reporting equipment.
