# NATIONAL TRANSPORTATION SAFETY BOARD

## MATERIALS LABORATORY FACTUAL REPORT

Report No. 17-059

Place : Fresno, California  
Date : December 26, 2016  
Vehicle : Petrus Express S90, N176PA  
NTSB No. : WPR17FA041  
Investigator : Michael Huhn, AS-ERA

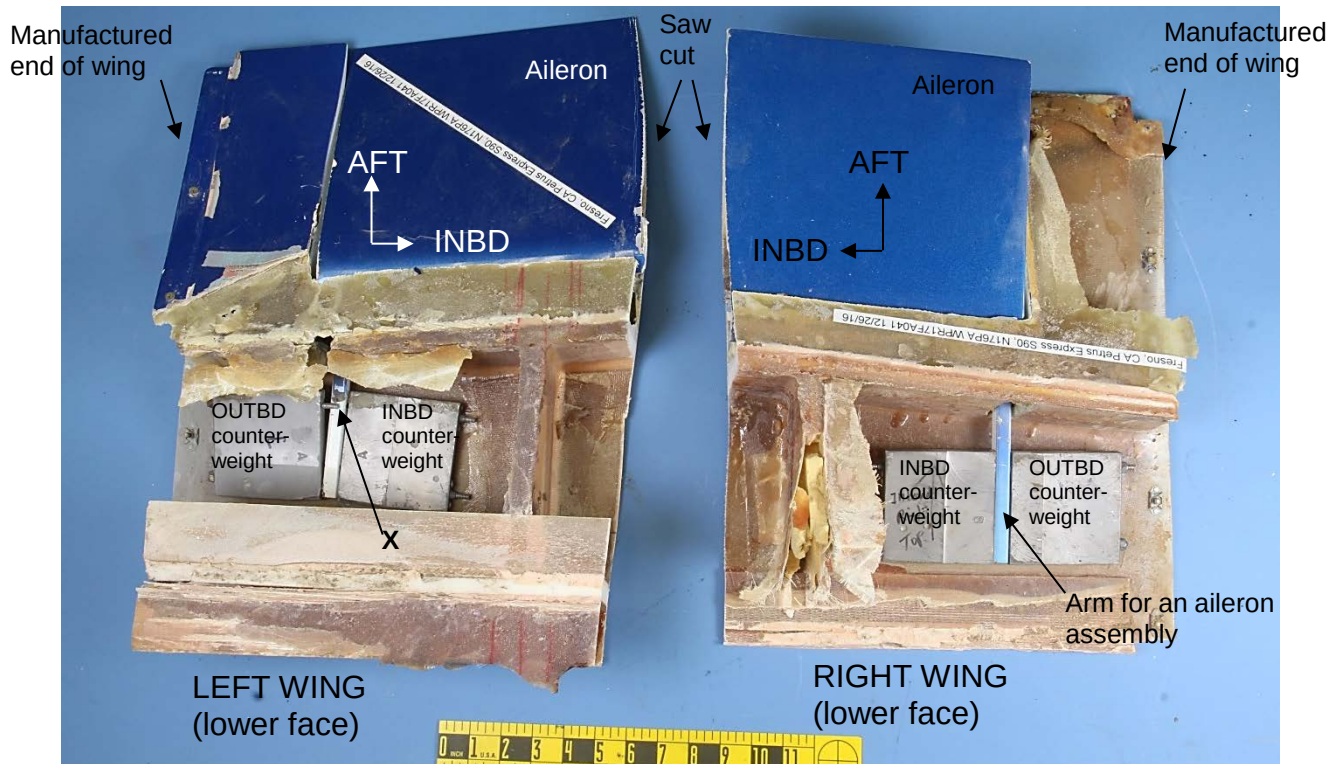
Visual examination of the counterweight assemblies for the left wing revealed the aft through-rod fractured at the outboard end of the inboard counterweight, in the area indicated by arrow "X" in figures 1, 2, and 5. The attachment nut was disassembled from the outboard end of each through rod. Figures 6 and 7 show a photographs of the disassembled through-rods. The bore for each threaded through-rod contained a sleeve (see figure 8). The entire length of each through-rod was threaded.

Figure 1. Overall view of the as-received portions of the left and right wings showing the lower faces of the ailerons and exposed counterweights assemblies. The aft through-bolt for the counterweight assembly on the left wing fractured in the area indicated by arrow "X". The lower face of the inboard counterweight assembly for the right wing was incorrectly labeled as "Top".

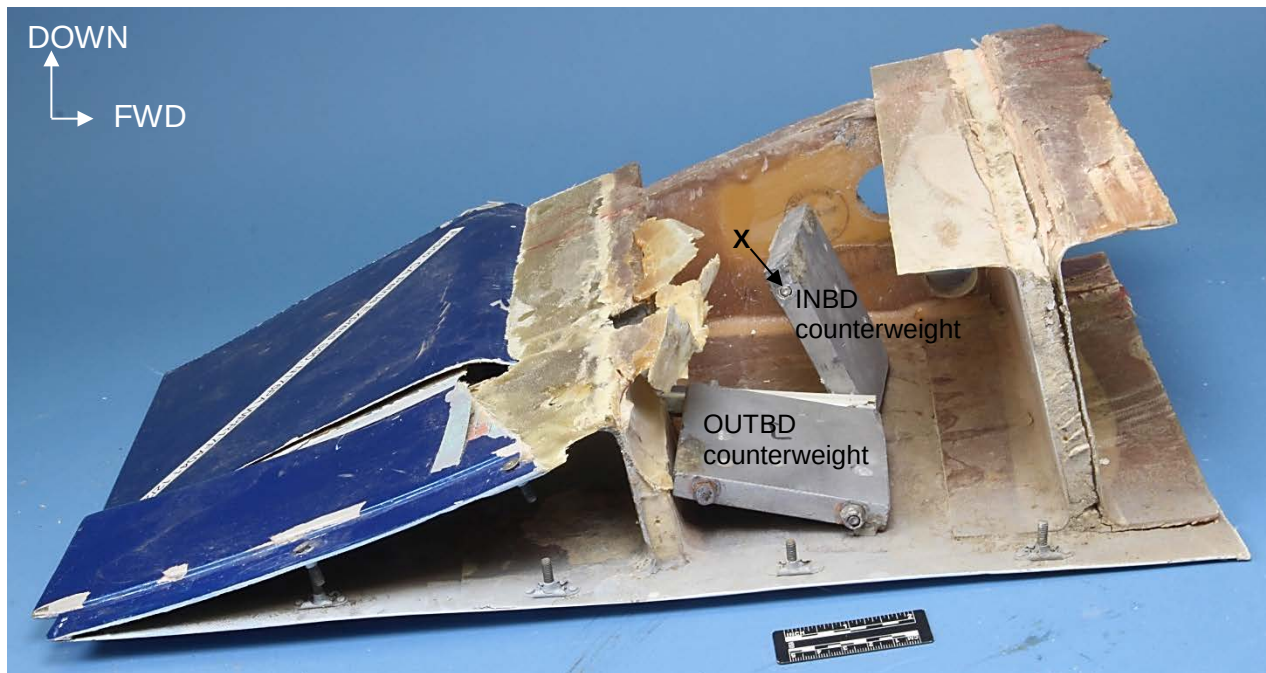
Figure 2. View of the outboard end of the left wing portion showing the exposed counterweight assemblies. The aft through-bolt for the counterweight assembly on the left wing fractured in the area indicated by arrow "X".

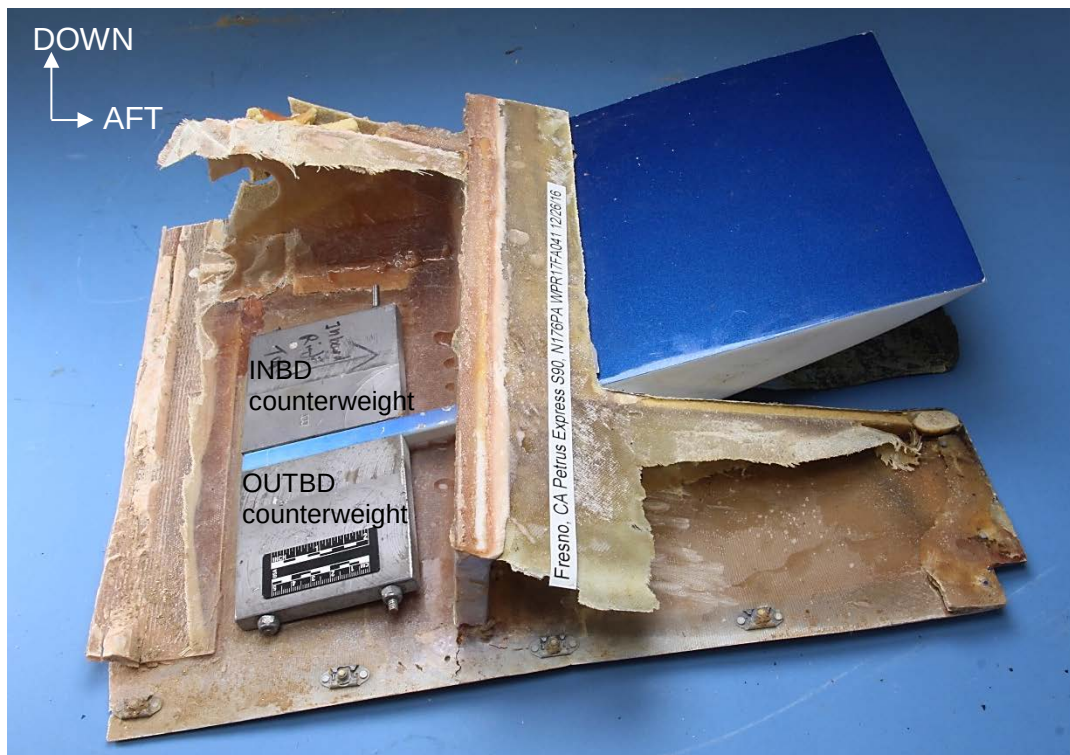
Figure 3. View of the outboard end of the right wing portion showing the exposed counterweight assemblies.

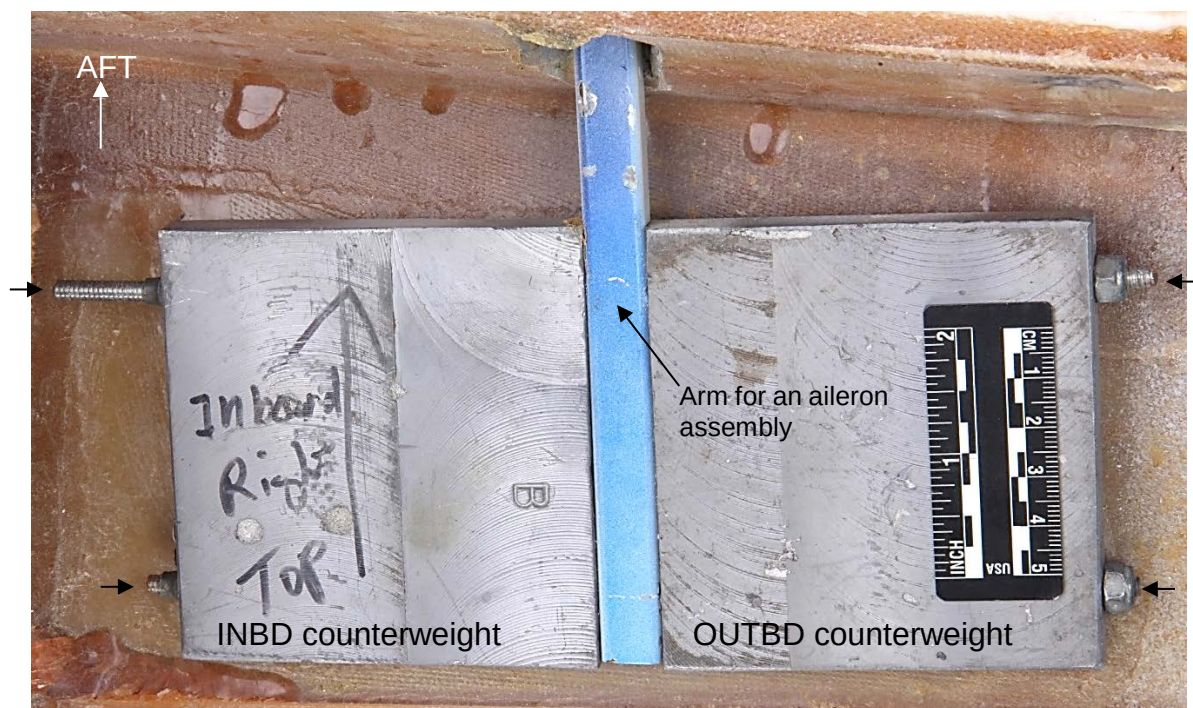
Figure 4. Close-up view of the counterweights from the right wing showing the lower faces. The ends of the two through-bolts are indicated by arrows. The lower face of the inboard counterweight assembly was incorrectly ink marked as “Top”.

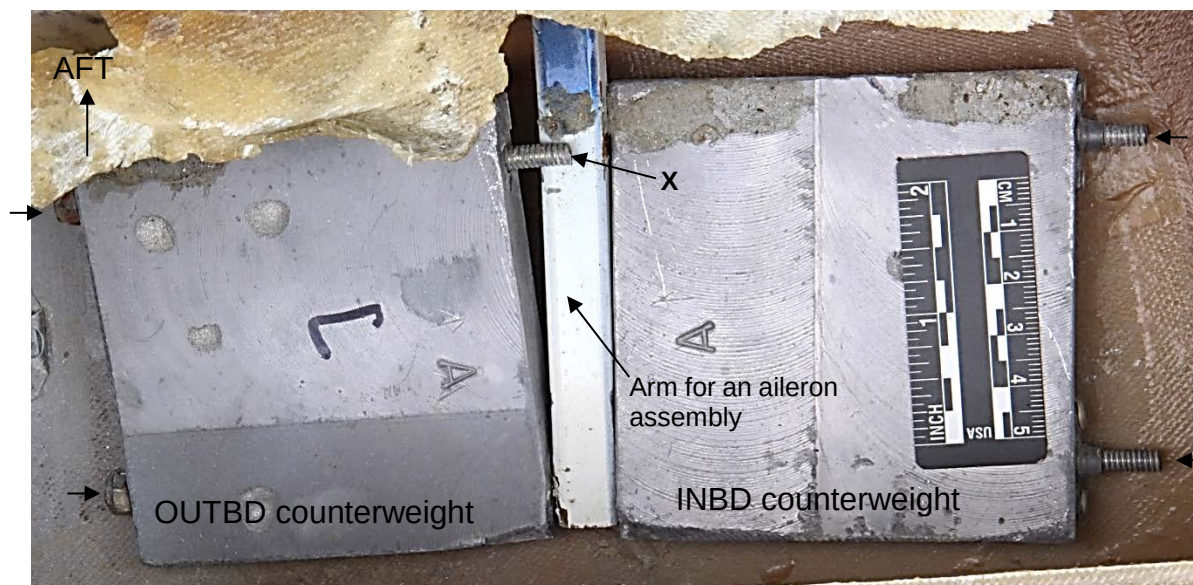
Figure 5. Close-up view of the counterweights from the left wing showing the lower faces. The ends of the two through-bolts are indicated by arrows. The aft through-bolt fractured at the outboard end of the inboard counterweight.

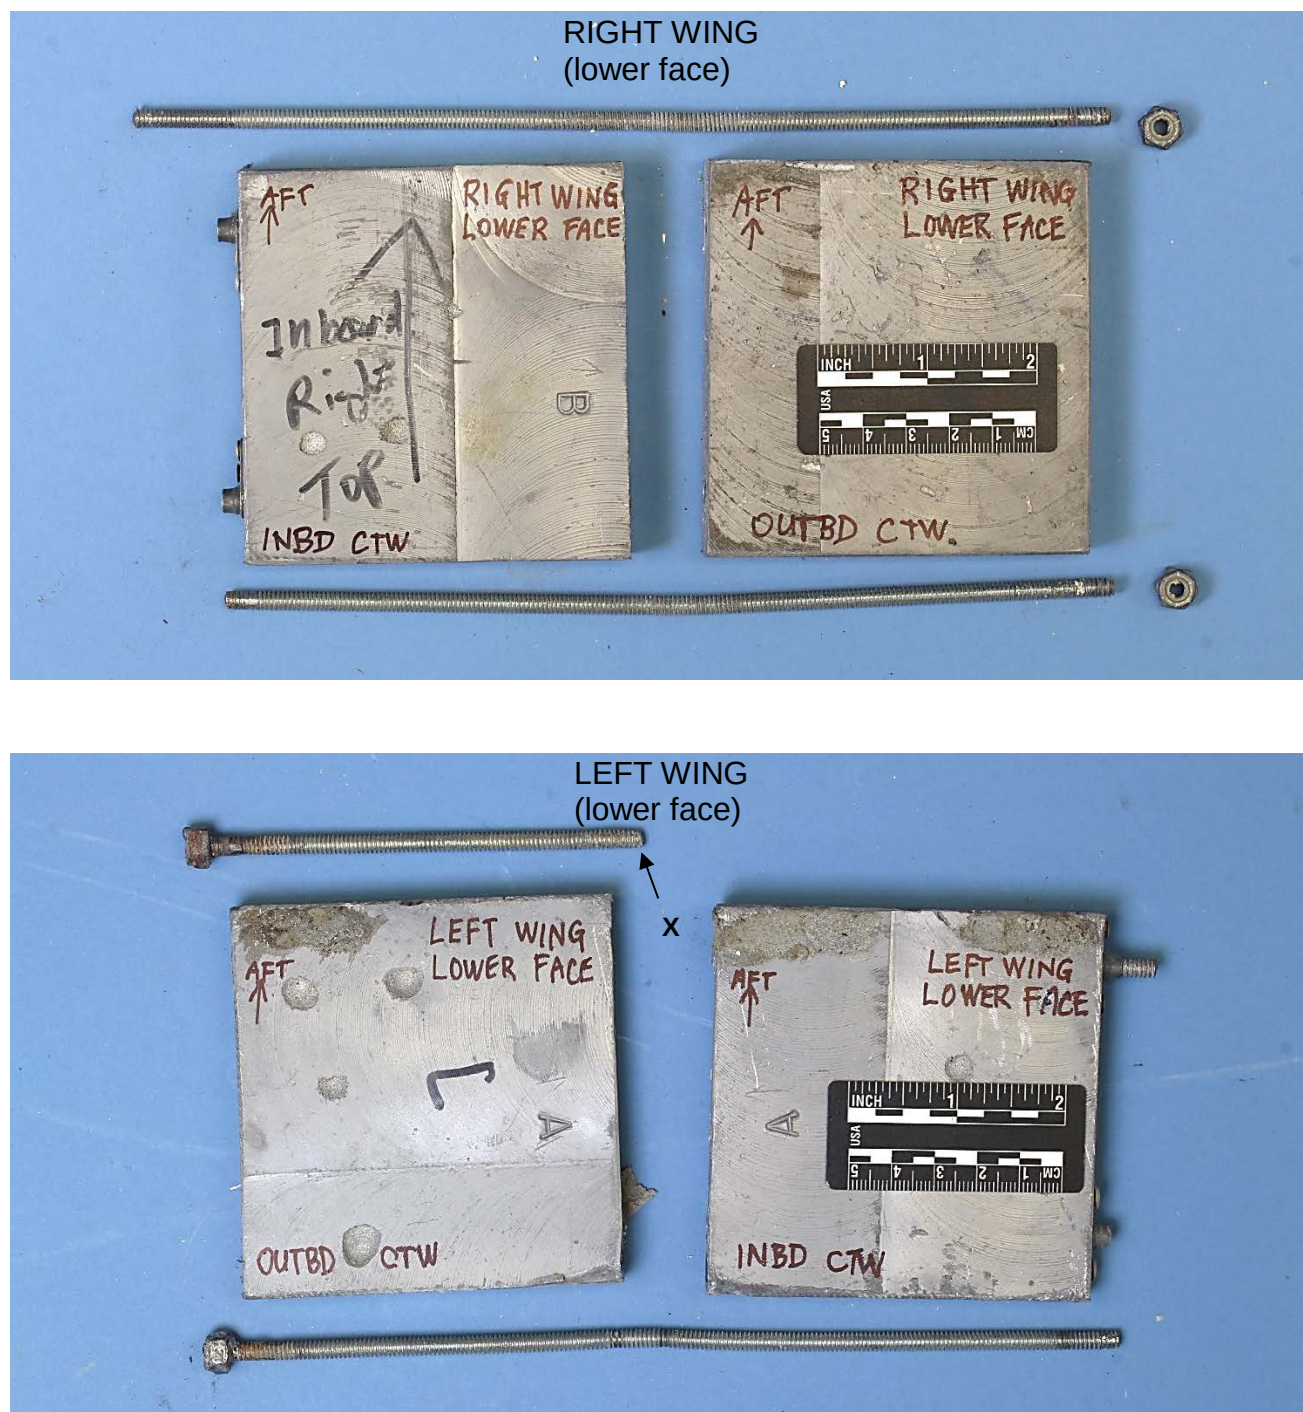
Figure 6. Photographs of the disassembled counterweights from the right and left wings showing the lower faces. The aft through-bolt for the right wing fractured at the outboard end of the inboard counterweight, indicated by arrow "X".

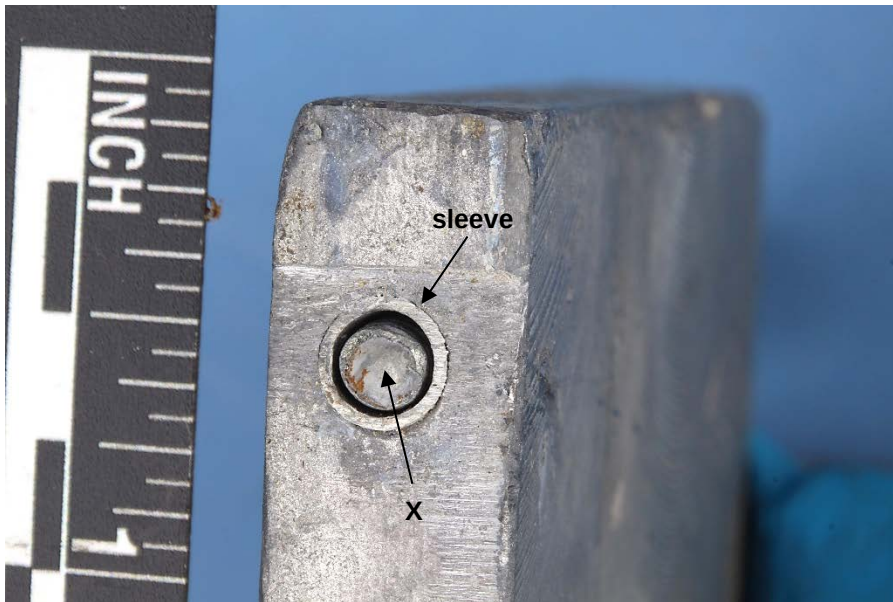
through-rod fracture face revealed micro-void coalescence features typical of ductile overstress separation in steel alloys with no evidence of fatigue cracking.

Figure 7. View of a portion of a counterweight showing one of the through-holes and the exposed end of the fractured through-bolt, indicated by arrow "X". The through-hole contained a sleeve.
