## **NATIONAL TRANSPORTATION SAFETY BOARD**

### **SITE, ON-SCENE, & EXAMINATION INFORMATION Rev A**

**NTSB Accident: WPR17FA041  
Accident Date: December 26, 2016  
Examination Dates: 12/27 & 12/29 2016**

Location: Fresno, California  
Date: December 26, 2016  
Aircraft: Petrus Express S90, N176PA, Serial # 80842  
NTSB IIC: Michael Huhn

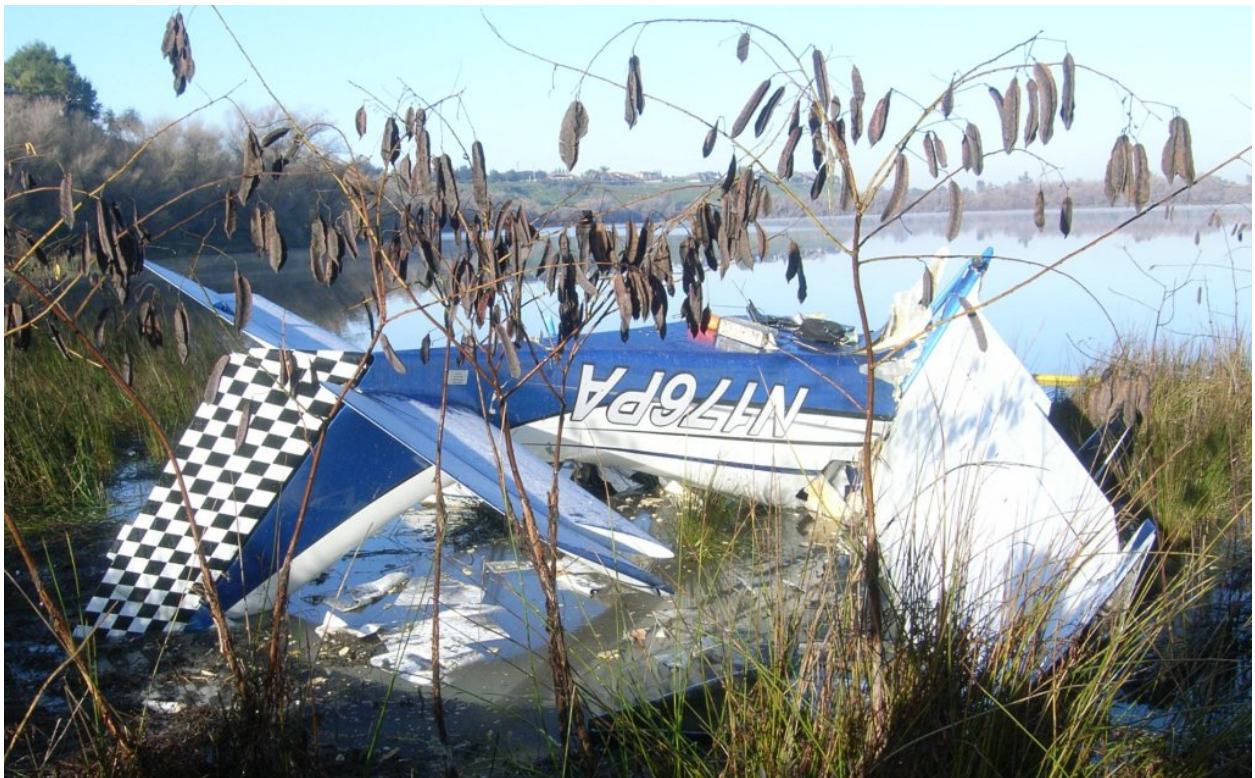
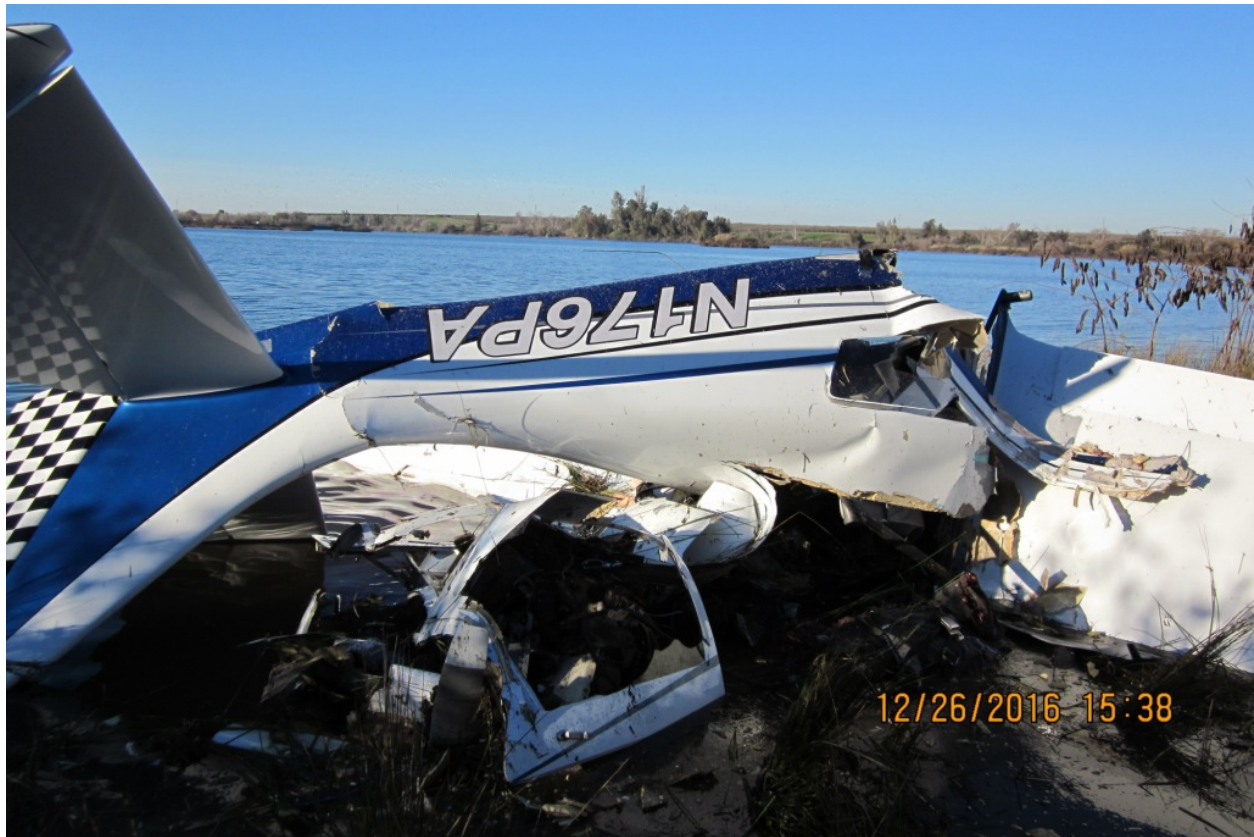
**Figure 3 - Main Wreckage**

- The main wreckage of the composite airplane came to rest in three major pieces, which remained partially attached to one another;
  - These 3 pieces were the wings, the engine and cockpit, and the aft fuselage.

- The two wings remained attached to one another, and came to rest approximately perpendicular to the ground, leading edge down.
- The engine and attached propeller were fully immersed in the water and underlying mud/silt, with the significantly deformed and fractured cockpit remnants mostly above the waterline.

- The aft fuselage came to rest inverted over the top of the cockpit
- The USAF Rescue Coordination Center reported that shortly after the accident, they began receiving an ELT signal from the accident airplane

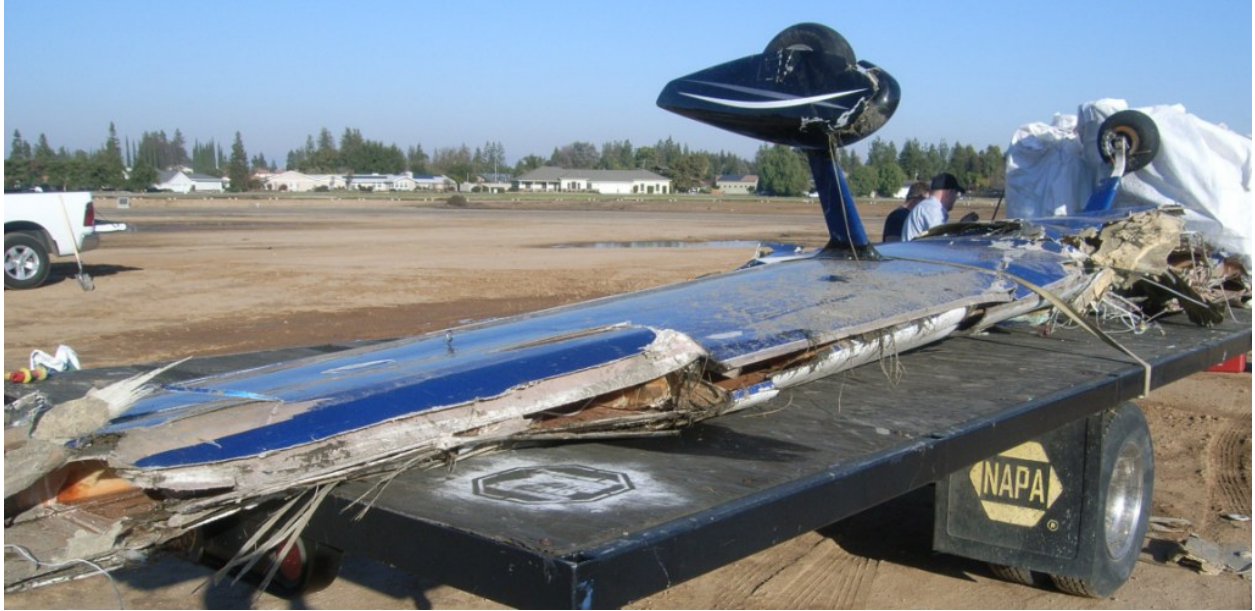
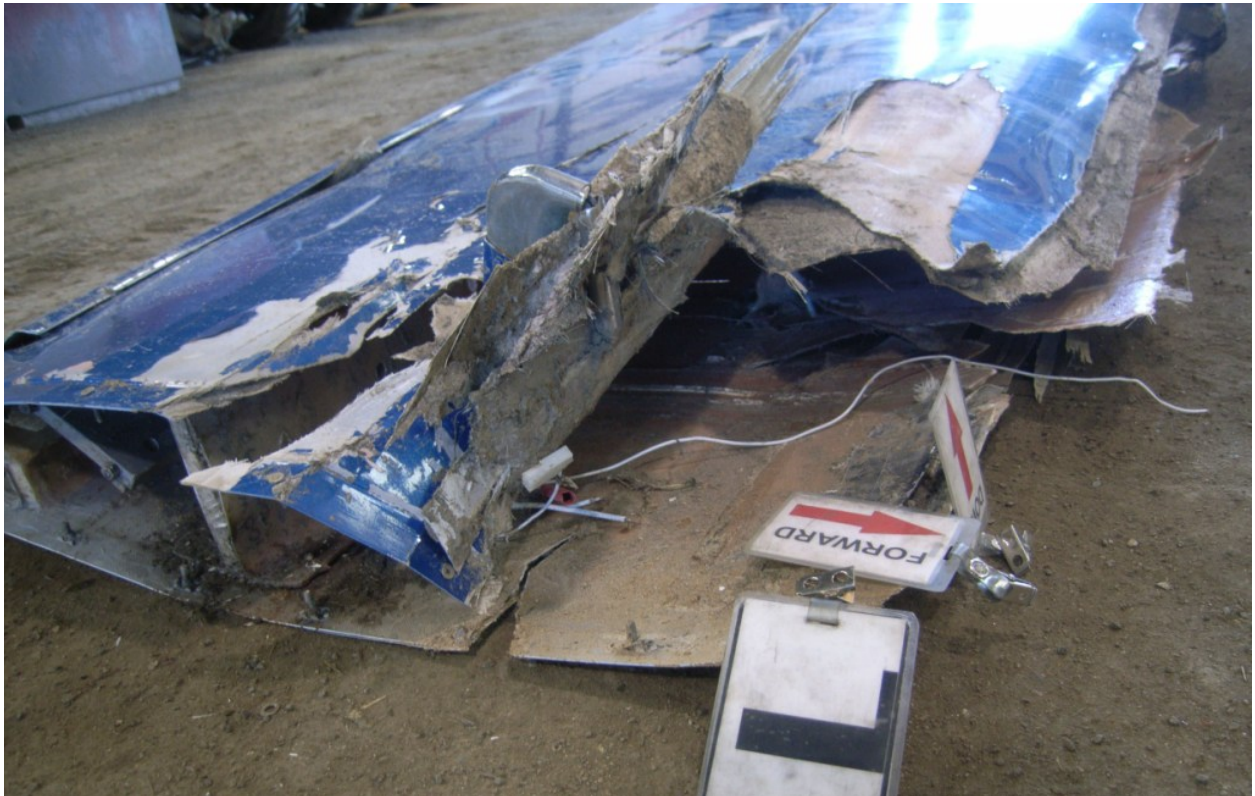
**Figure 7 - Left Wing**

- The wing assembly (both wings and connecting structure) was standing in about 12 inches of water, and slightly embedded in the underlying silt
- Leading edge crush and fracture damage was continuous along the entire span

- Wing damage/disruption was generally absent aft of the main/forward spar
- Both removable (via multiple screws) wingtips were fracture-separated from their respective wings, and both wing-ends exhibited LE crush and fracture damage

- The wingtip damage appeared consistent with the wing damage, and both were consistent with a laterally symmetric wing leading edge impact, in the aft (chordwise) direction, across the entire span

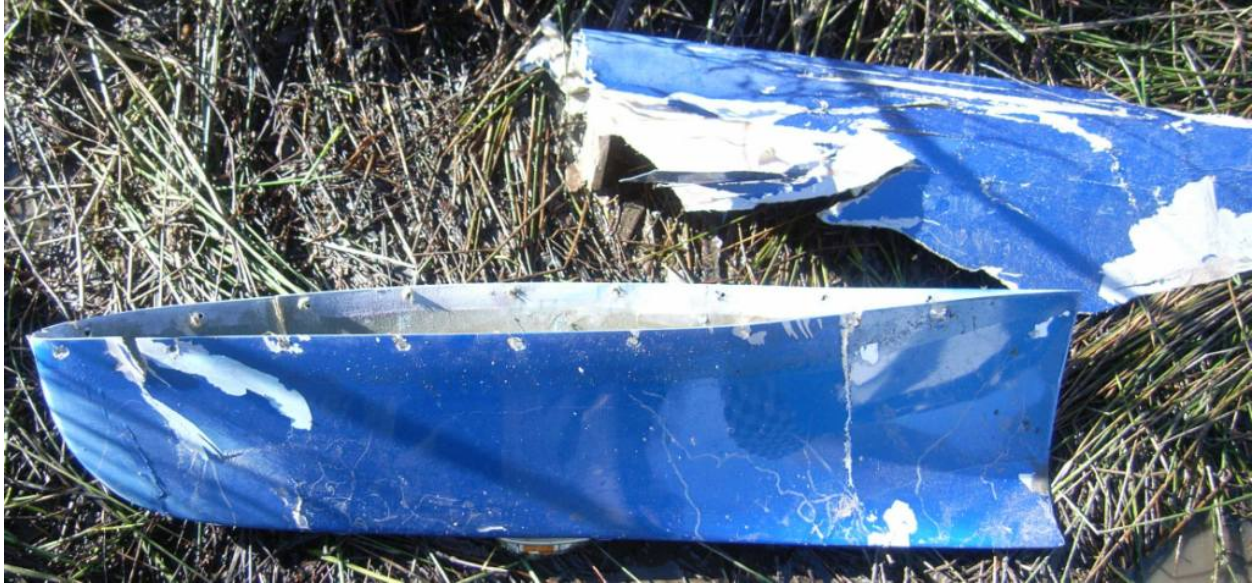
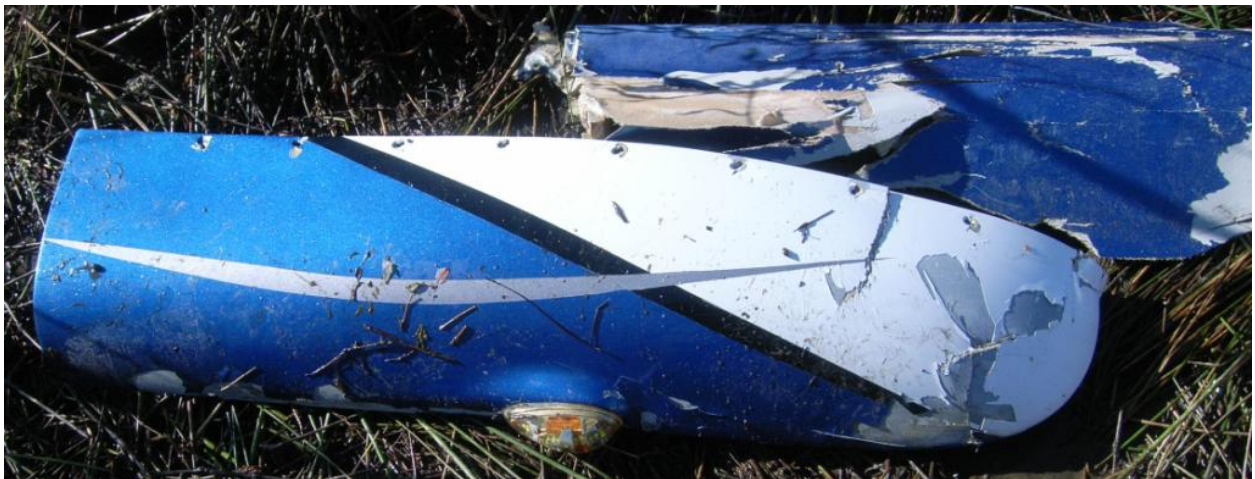
Figure 9 - Wingtips (Undersides)

- The left wingtip was complete, but with multiple partial fractures
  - The right wingtip was missing its forward 25% (which was not located), and the remainder of the wingtip contained multiple partial fractures

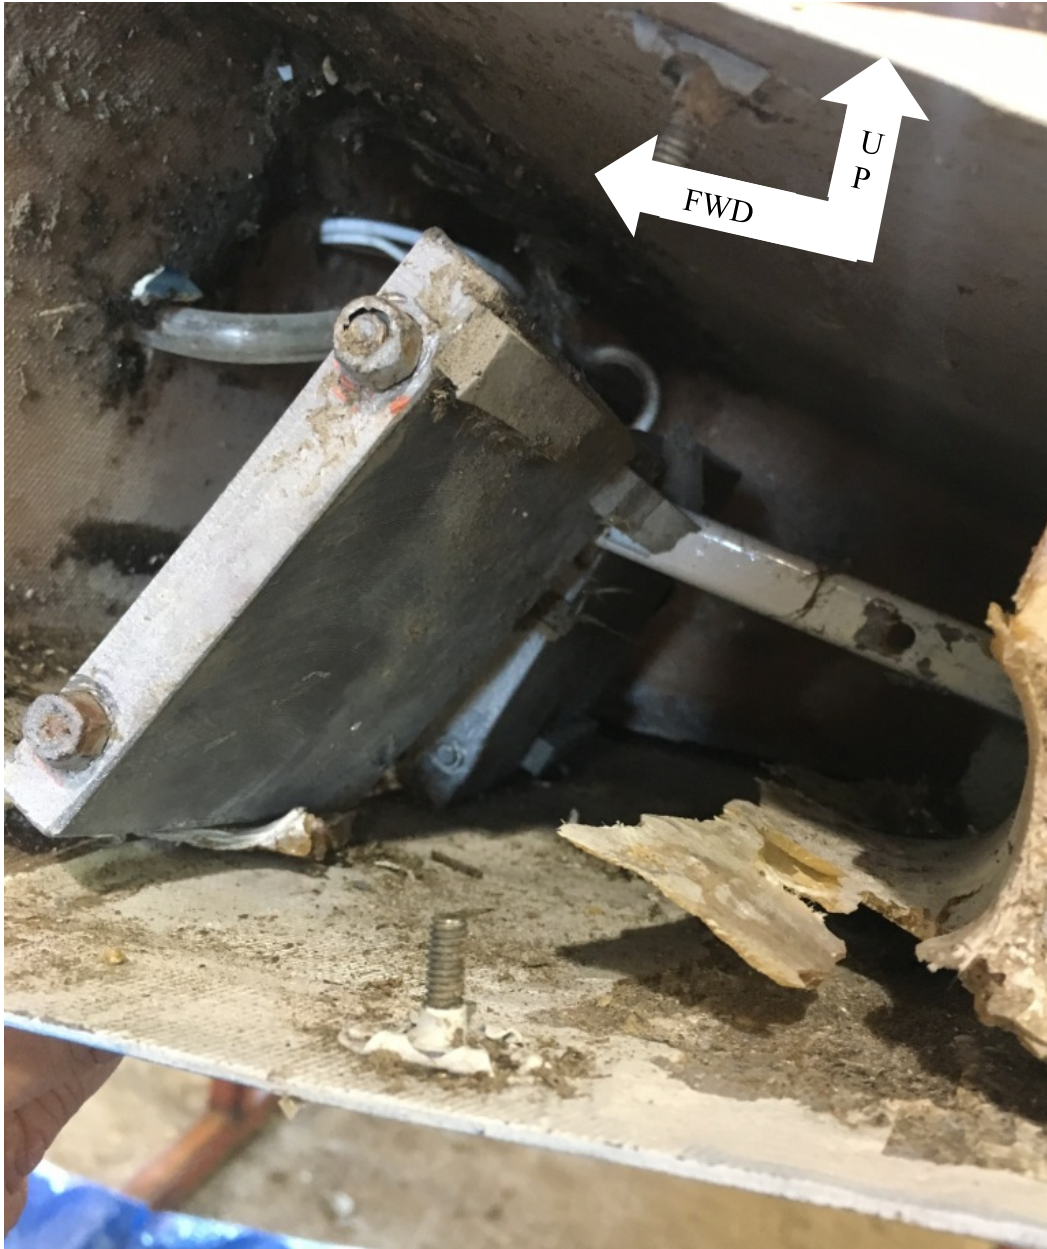
- Nuts on each threaded portion of each rod (2 per rod, 4 total per side) secured the weights to the rods
  - During the post recovery examination, the left weights were found partially displaced from their normal orientation

- The aft threaded rod of the left weight assembly were failed at the junctures of the weights and arm
    - The timing and cause of this failure were not immediately apparent

- The rod failure allowed the weights to pivot around their forward attach rod, resulting in the aft edges of the weights being re-oriented to become the lower edges

- With the aileron faired, these 'new' lower edges of the weights contact the interior surface of the lower wing skin, which prevents any left aileron trailing edge up travel

- The timing and cause of this weight rotation could not be determined
  - The right aileron weights remained securely attached to their arm

**Figure 11 - Displaced Left Aileron Weights (looking inbd)**

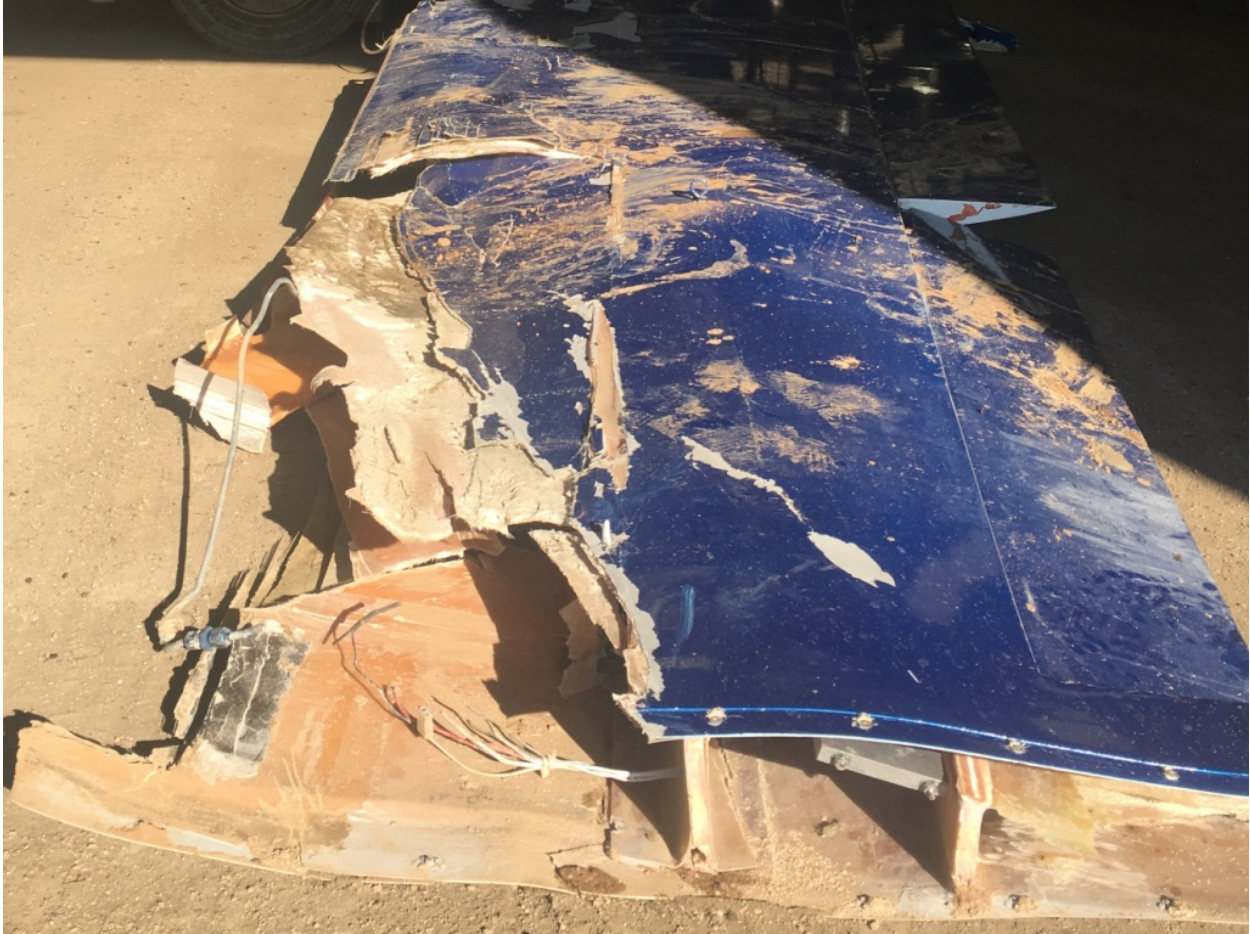
**Figure 12 - Non-Displaced Right Aileron Weights (wing inverted)**

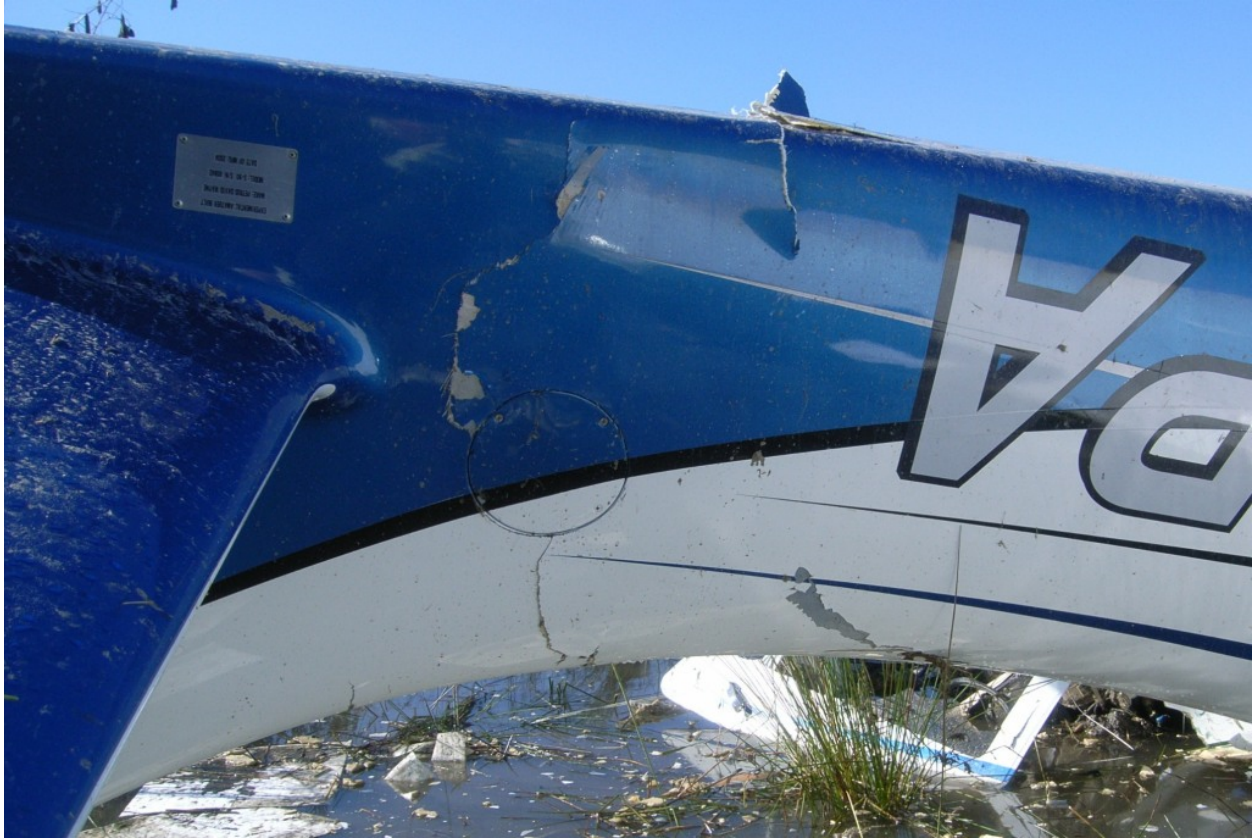
- The aft fuselage was almost completely fracture-separated from the cabin, at approximately the station of the aft end of the rear windows
  - The aft fuselage was nearly intact, except as follows:
  - A circumferential crack, of unknown depth, and located about 18 inches aft of where the vertical stabilizer faired into the aft fuselage, fully ringed the aft fuselage
  - Portions of this crack possibly fully penetrated the structure

**Figure 13 - Circumferential Crack on Aft Fuselage**

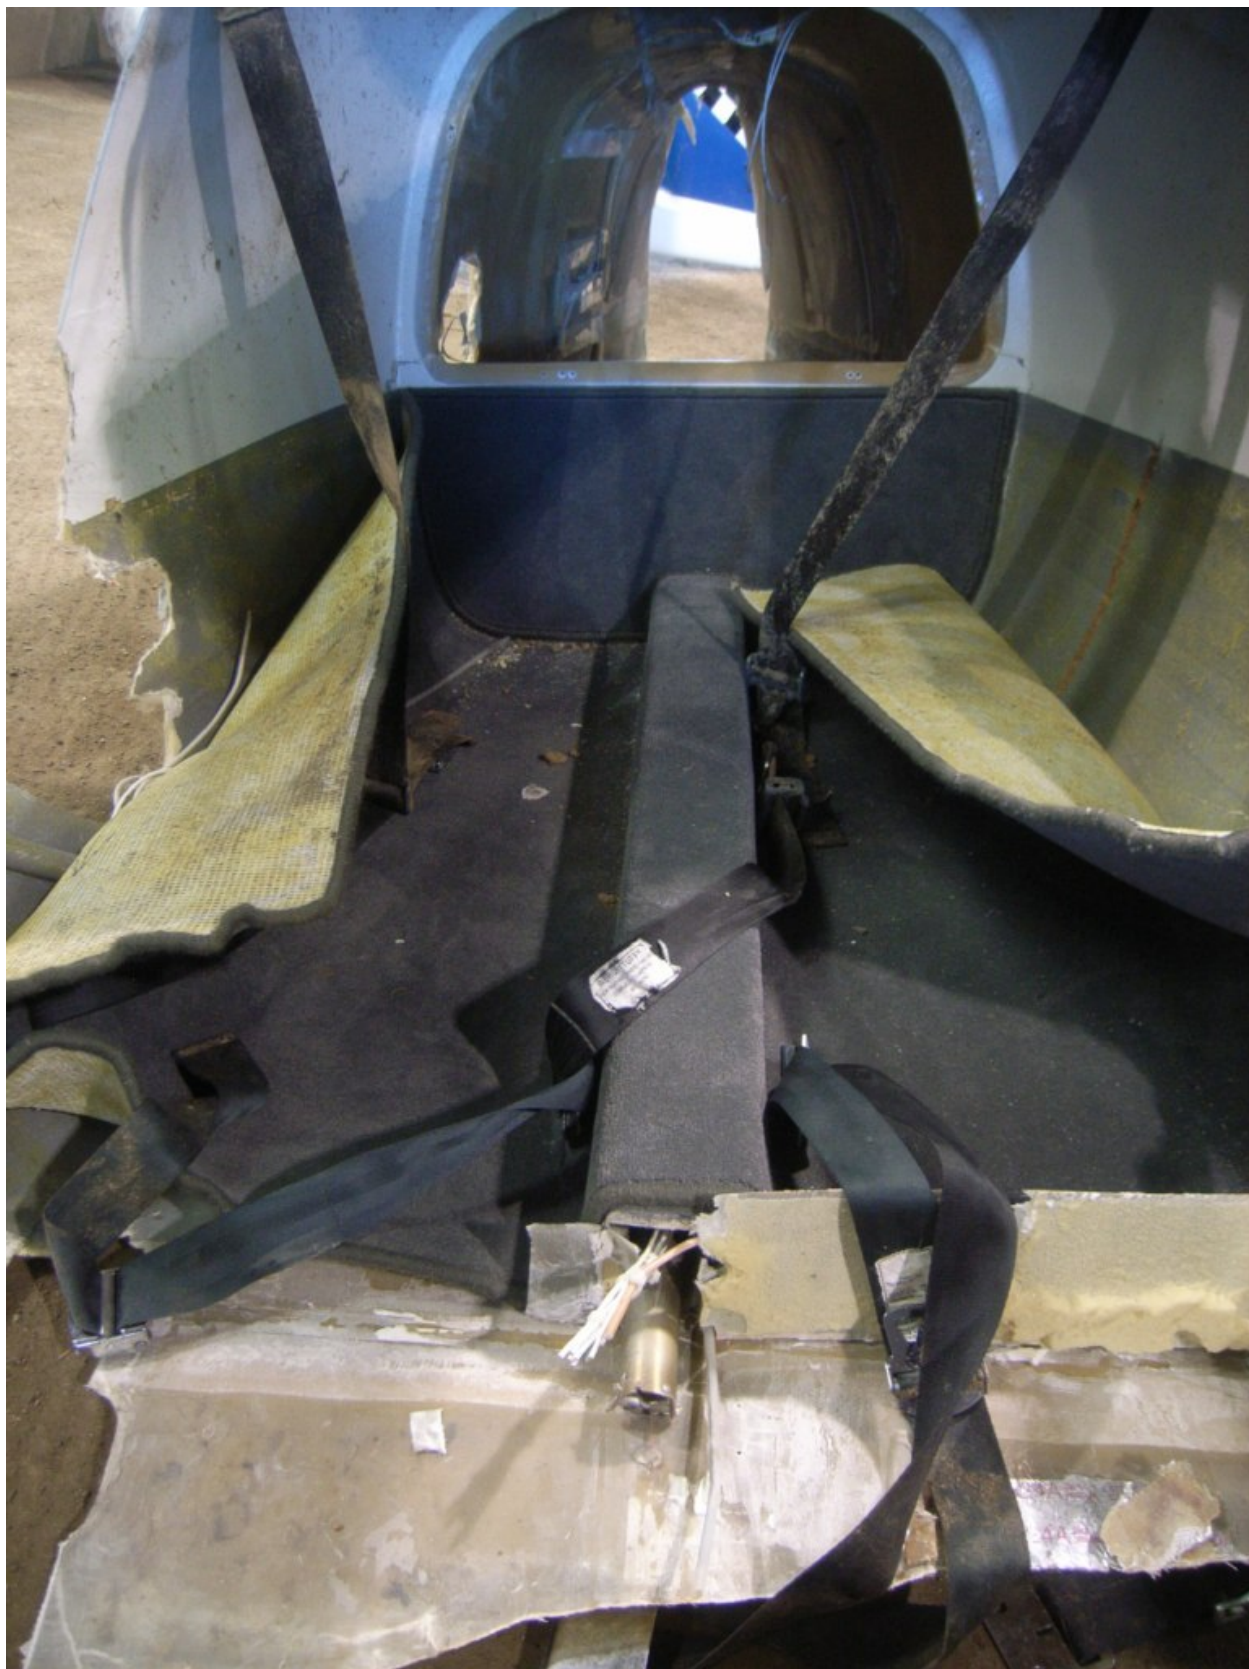
- The control rod from the aft fuselage bellcrank to the elevators remained connected to the elevators, but was fracture separated at the rod end at the aft bellcrank

**Figure 16 - Aft Fuselage with Elevator Control Rod**

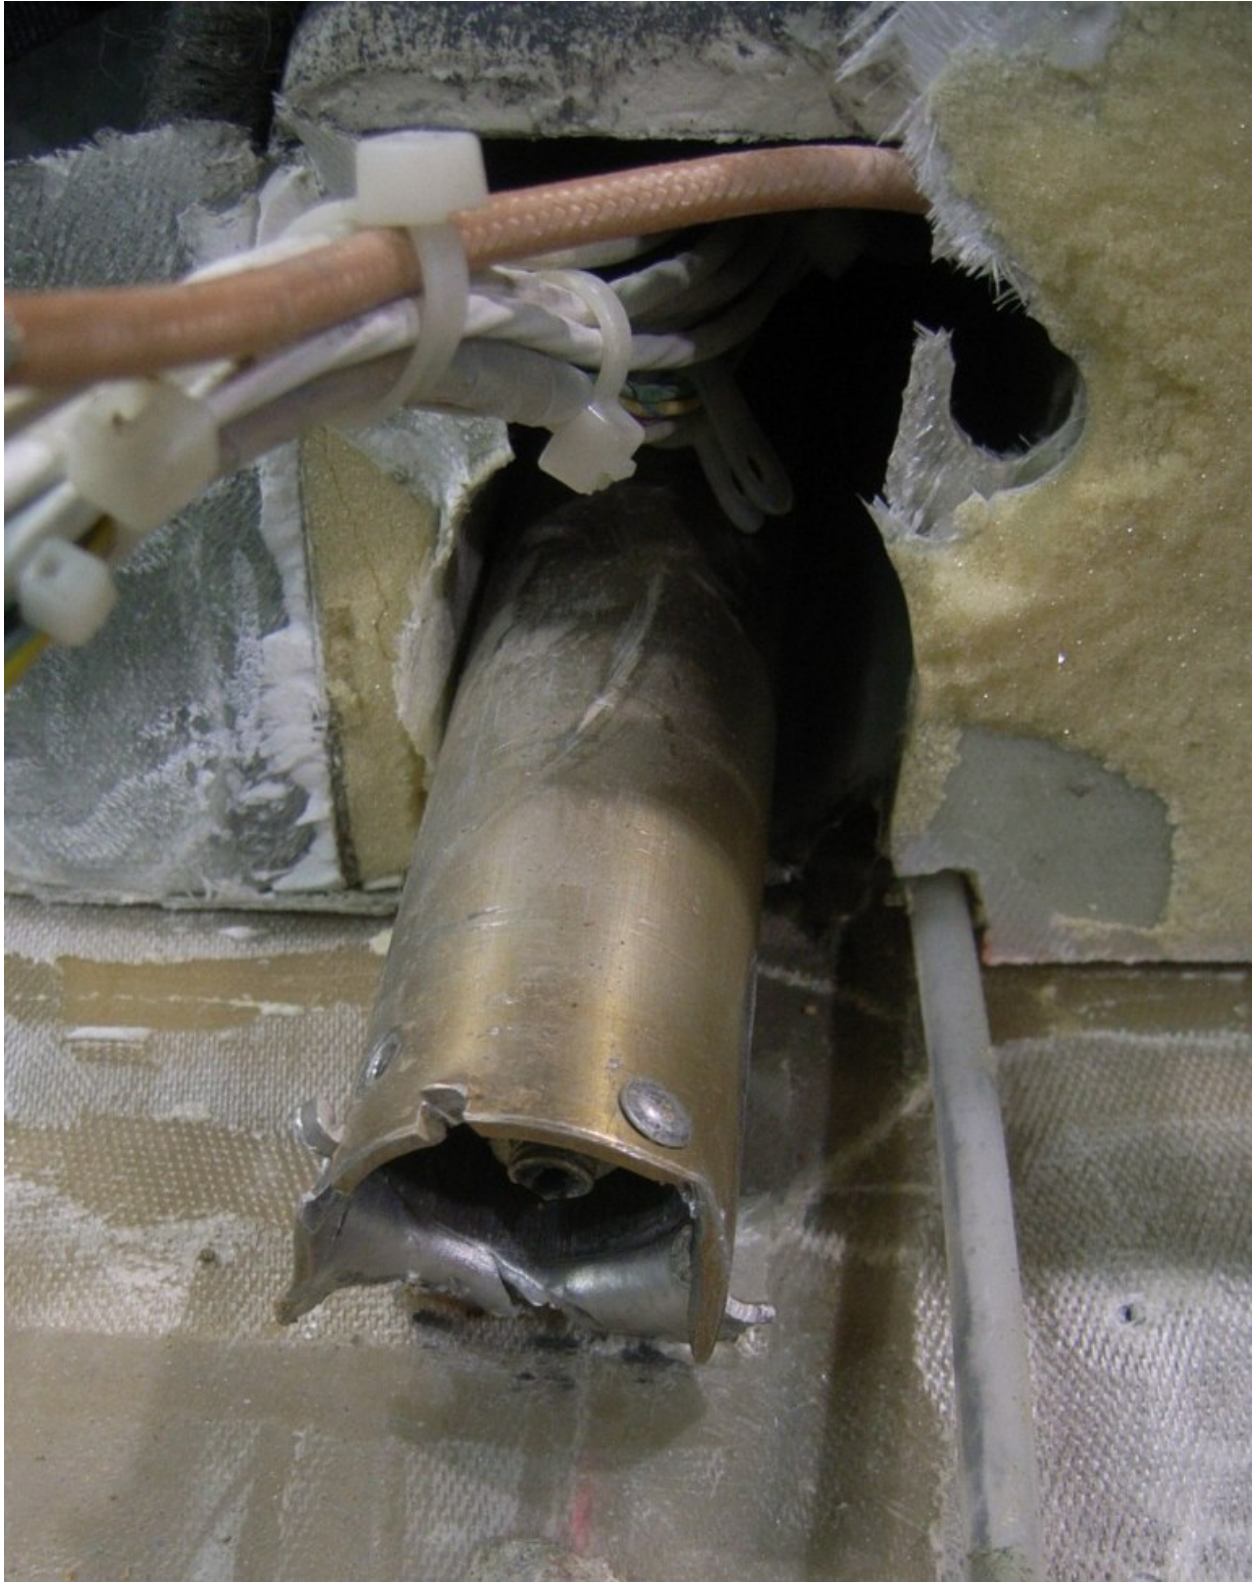
- The control rod from the mid-fuselage bellcrank forward remained attached to the that bellcrank, but terminated in a fracture/tear at the same approximate station as the aft fuselage fracture

- All fracture faces were consistent with one-time overload fractures, with no evidence of pre-existing failures

**Figure 17 - Fractured Elevator Control Rod**

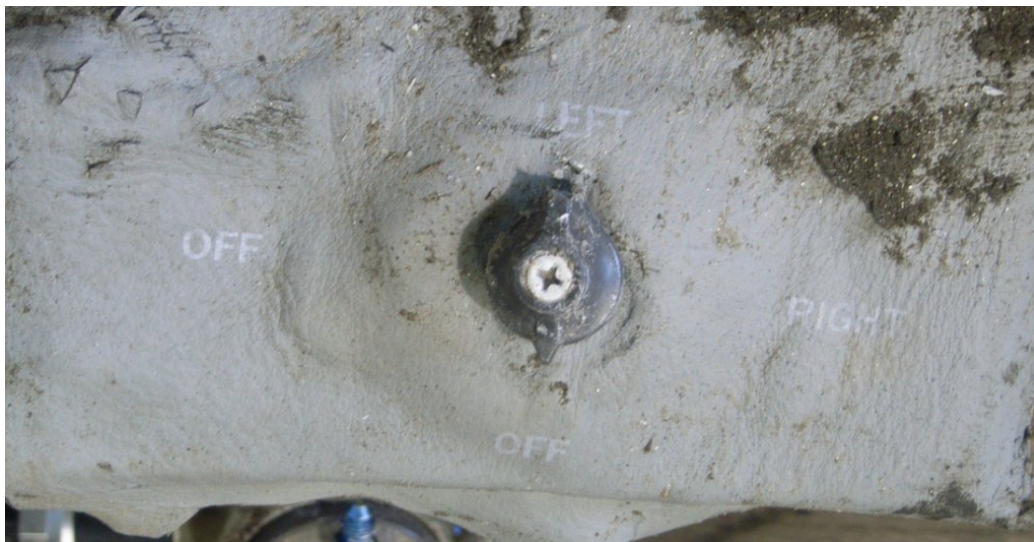
**Figure 30 - Cockpit Fuel Selector Panel with Fractured Handle**

- The fuel selector valve was found fully fracture-separated from the airplane, but captive by the console facing which bore the selector setting positions
  - This precluded ready determination of the as-found setting of the selector valve
  - Most of the selector valve handle was fracture-separated from the valve

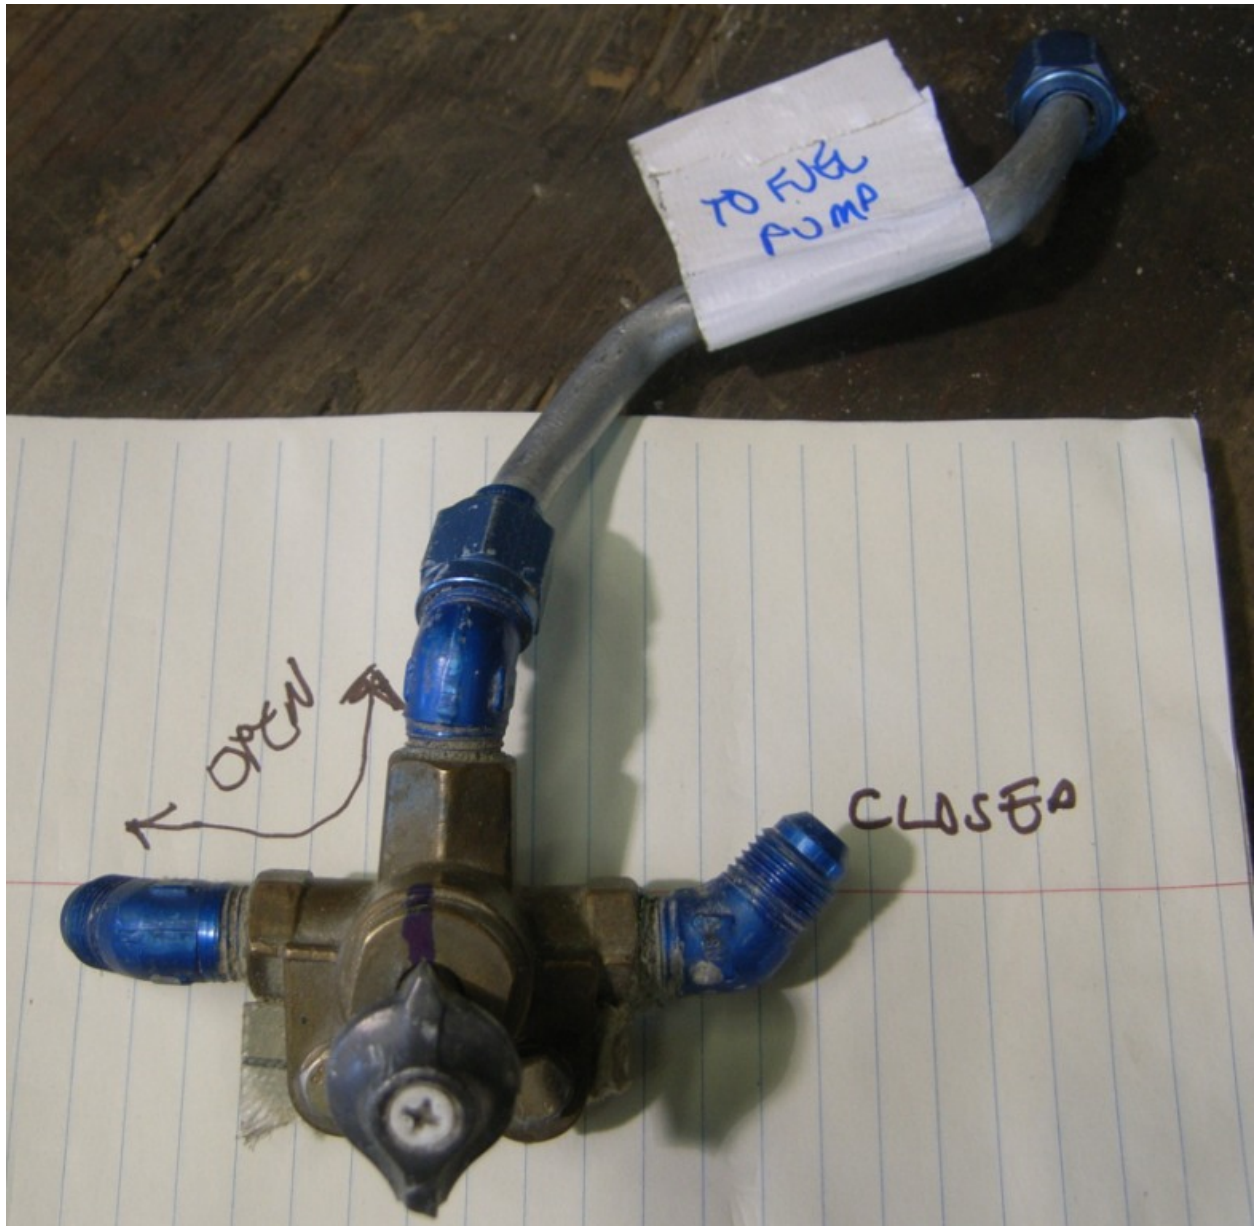
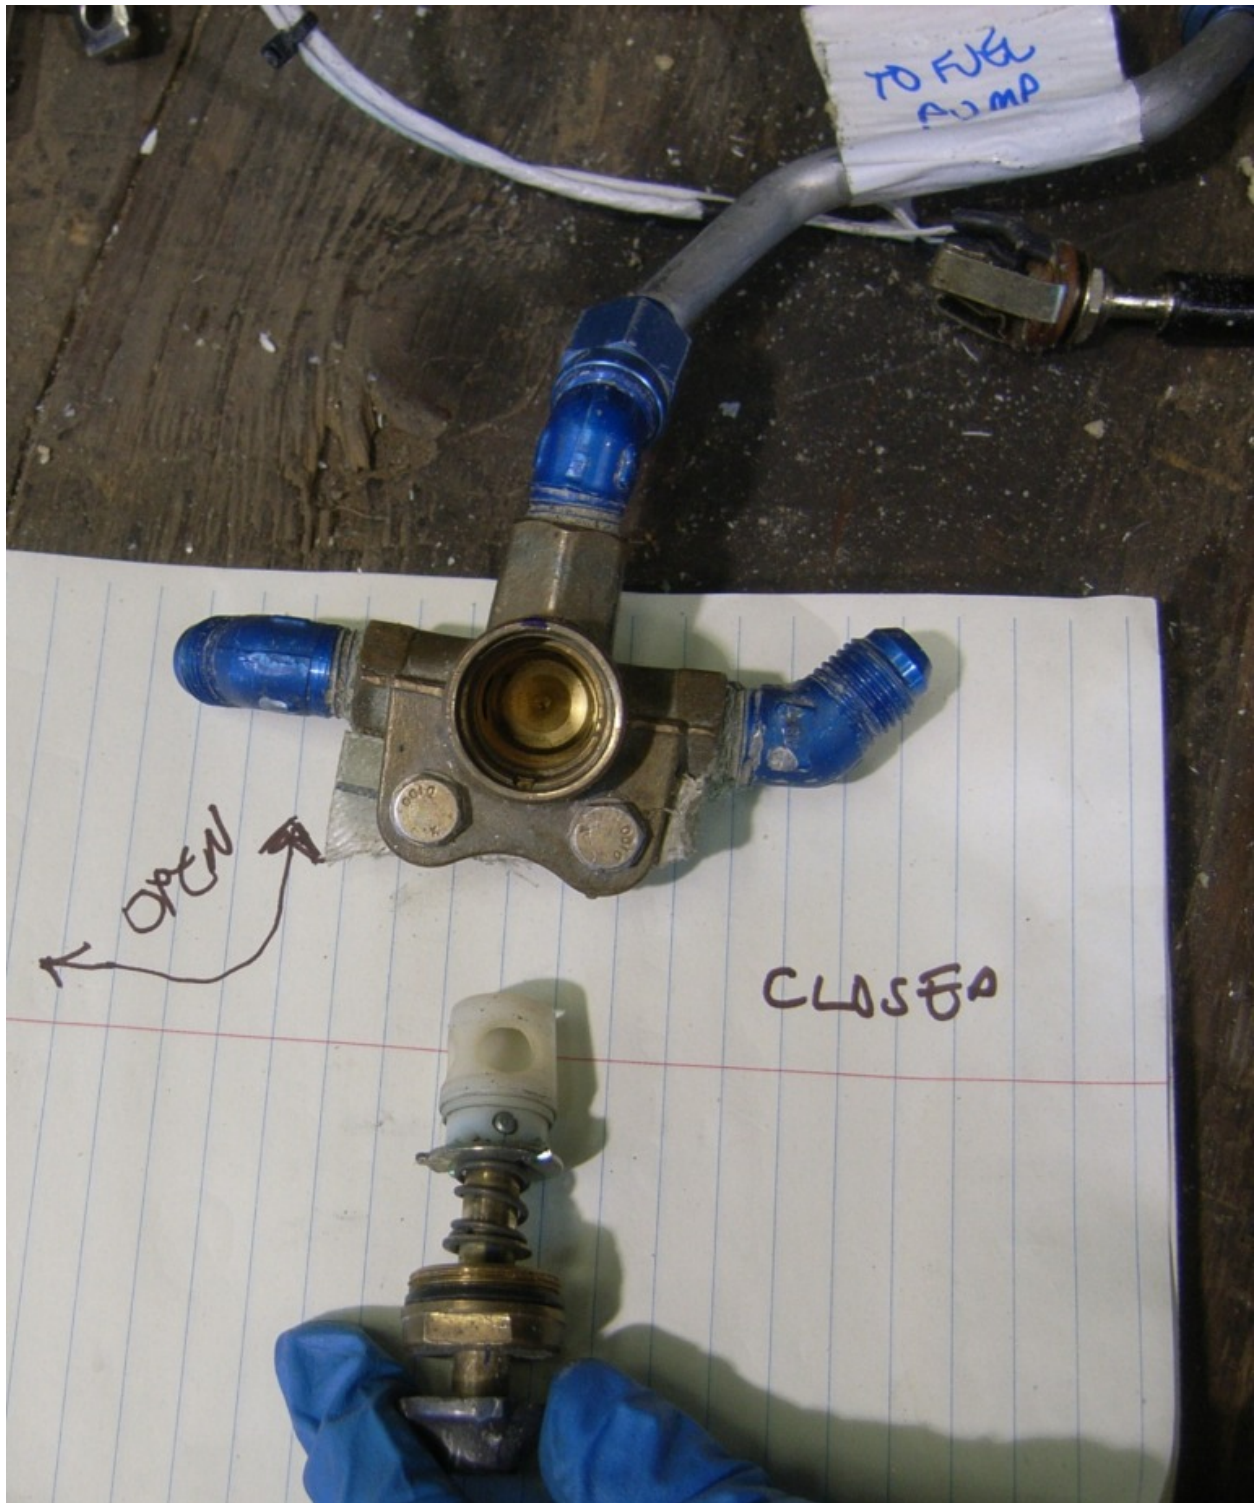
Figure 32 - Excised Fuel Selector Valve

- Comparison with pre-accident photos of the airplane, combined with damage and fracture information, indicated that the fuel selector valve was found in a position that likely corresponded to the left tank setting
- The valve passage from the (presumed) left tank line to the engine line allowed unobstructed passage of low pressure air
- The valve was unable to be rotated/actuated
- Upon disassembly, the rotatable internal valving/routing mechanism was found to be plastic/nylon, while the valve body appeared to be brass
  - No internal debris was observed in the valve body or passages

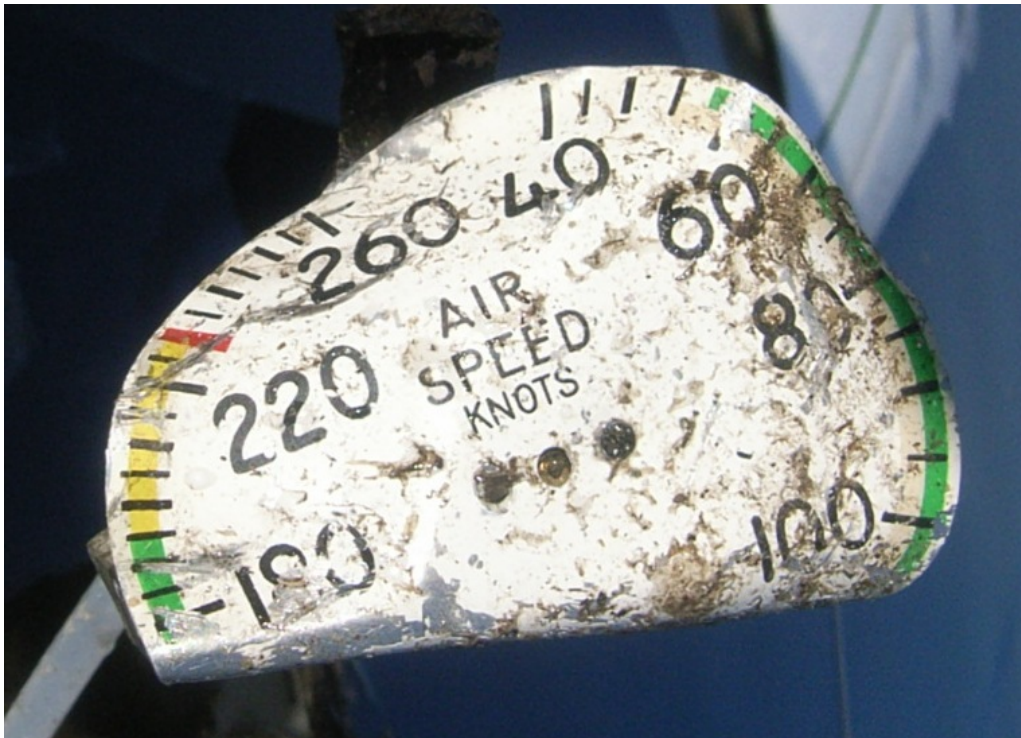
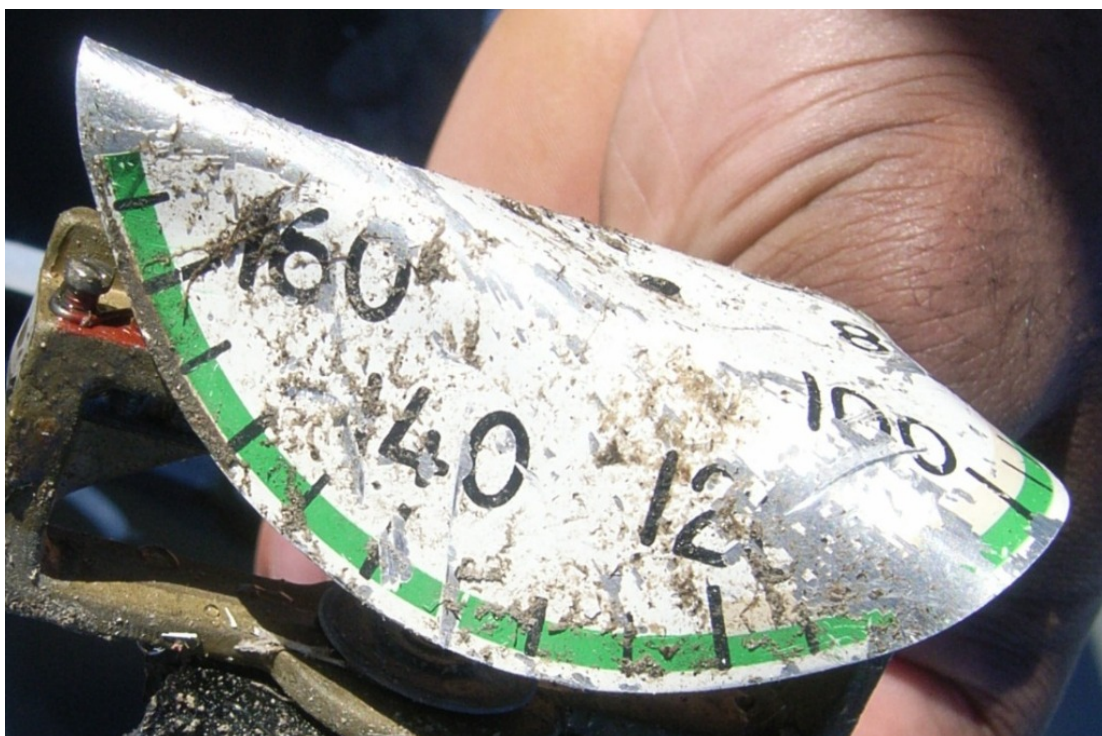
Figure 34 - Upper Face of Airspeed Indicator

- The airspeed indicator (ASI) face was recovered damaged and fracture-separated from the rest of the unit.
  - The lower quarter of the face was bent about 90° away from its display side

- No needle or 'needle slap marks' were observed
- The ASI face was labeled and graduated in "knots"
- The ASI was manufactured with a white face. A marginally-visible (non-prominent) yellowish arc, presumed to be the normal white (flap operating range) arc, appeared to extend from 55 knots to 120 knots

- Comparison of those checklist speeds with what was found in the POH and on the ASI revealed several discrepancies or conflicting values.

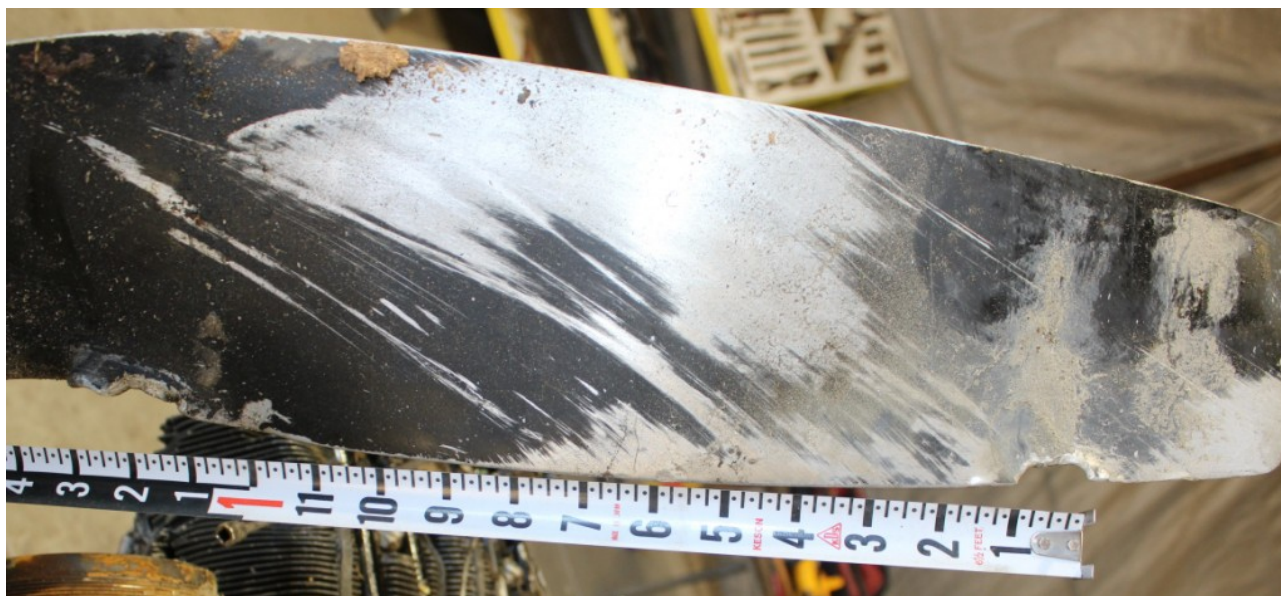
- These gouges and indentations aligned precisely with similar features on the engine
    - That blade was bent aft, near its root, approximately 45 degrees

**Figure 49 - Propeller Blade with Engine-Congruent Gouges**

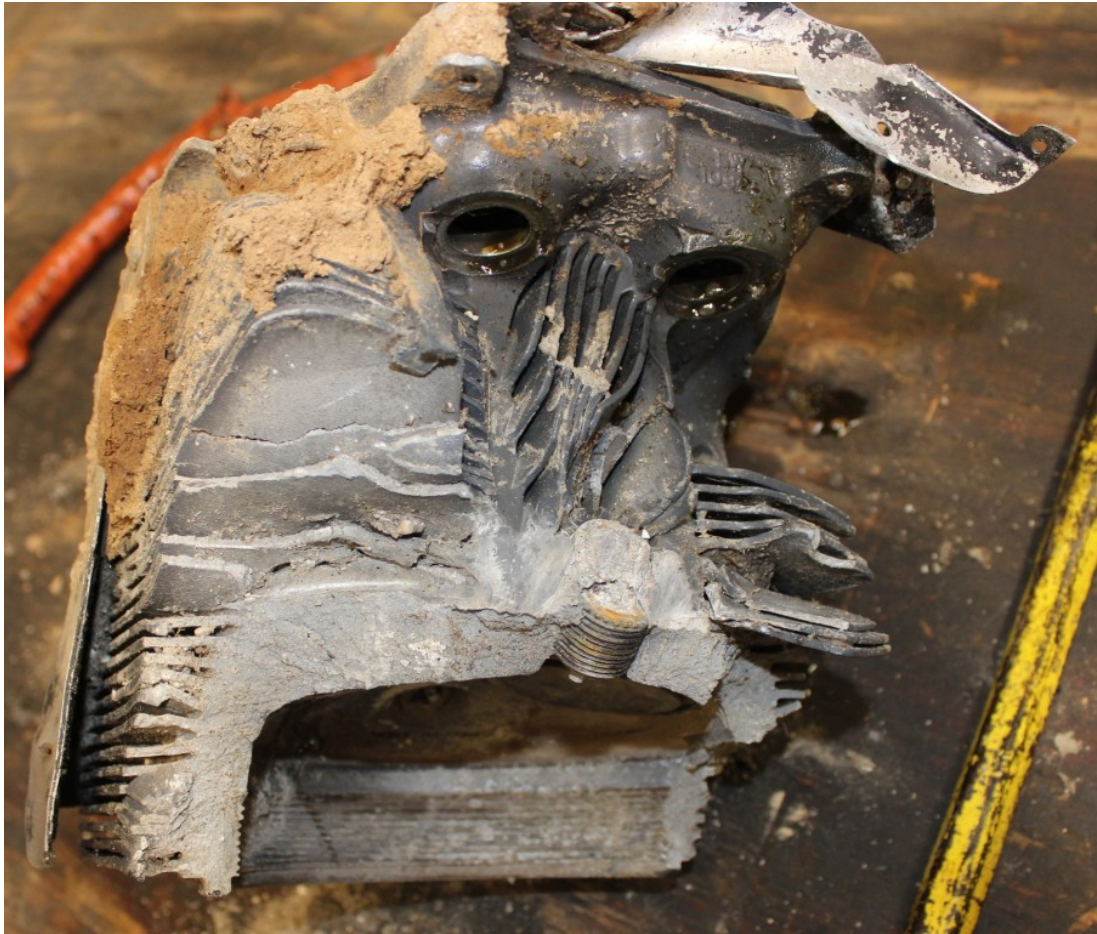
- The head, valves, rocker assembly, and rocker cover were fracture-separated from the No.1 cylinder, but partially retained by the baffling and other components

- Some fragments of those components were identified on scene, consistent with their separation at the accident site
  - The No. 1 cylinder bore shear/smear damage consistent with being cut/sheared by a metal object

**Figure 50 - Propeller-Separated Portion of No 1 Cylinder**

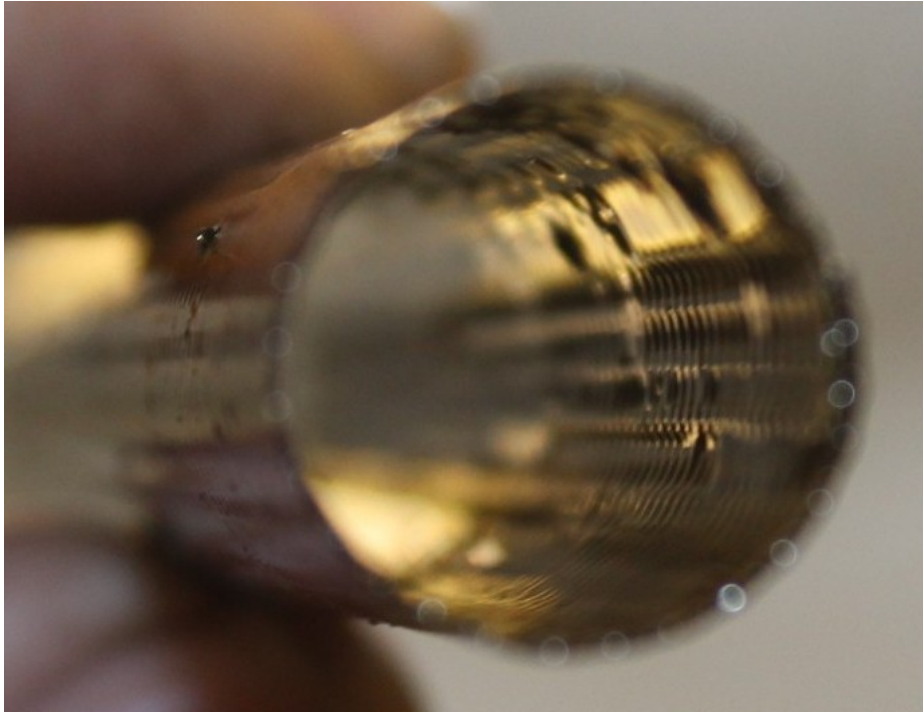
- The oil filler cap remained securely installed in its crankcase mount
- The engine internal oil screen was found to be clean/unobstructed
- The filter element of the externally mounted, spin-on oil filter was free of debris or contamination

**Figure 54 - Internal Engine Oil Screen**
