## **NATIONAL TRANSPORTATION SAFETY BOARD**

### **SITE, ON-SCENE, & EXAMINATION INFORMATION Rev A**

**NTSB Accident: WPR17FA041  
Accident Date: December 26, 2016  
Examination Dates: 12/27 & 12/29 2016**

Location: Fresno, California  
Date: December 26, 2016  
Aircraft: Petrus Express S90, N176PA, Serial # 80842  
NTSB IIC: Michael Huhn

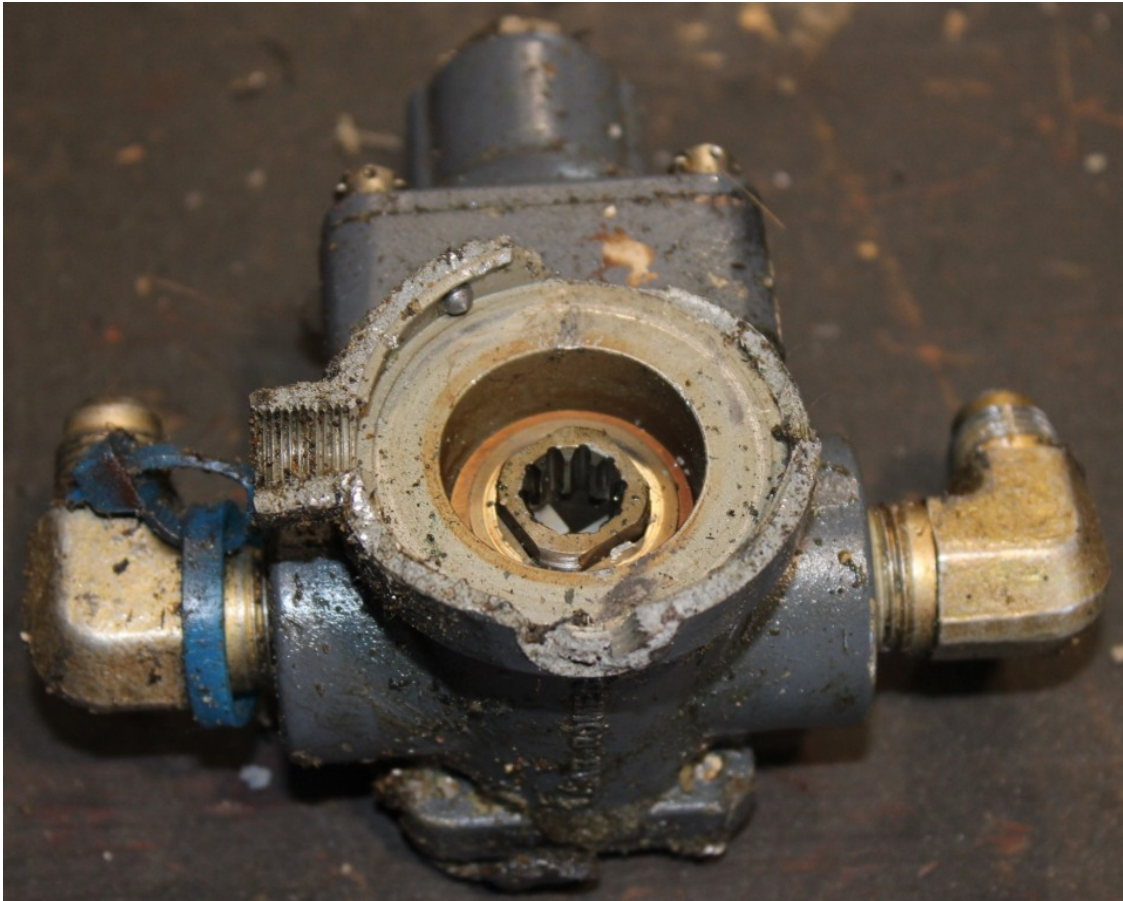
- The rotary-type engine-driven fuel pump (EDP) was fracture-separated from the engine but was recovered
  - The drive gear was manually rotated and turned freely
  - ROMEC PN RG9080J4A SN D-7796

**Figure 56 - Engine-Driven Fuel Pump**

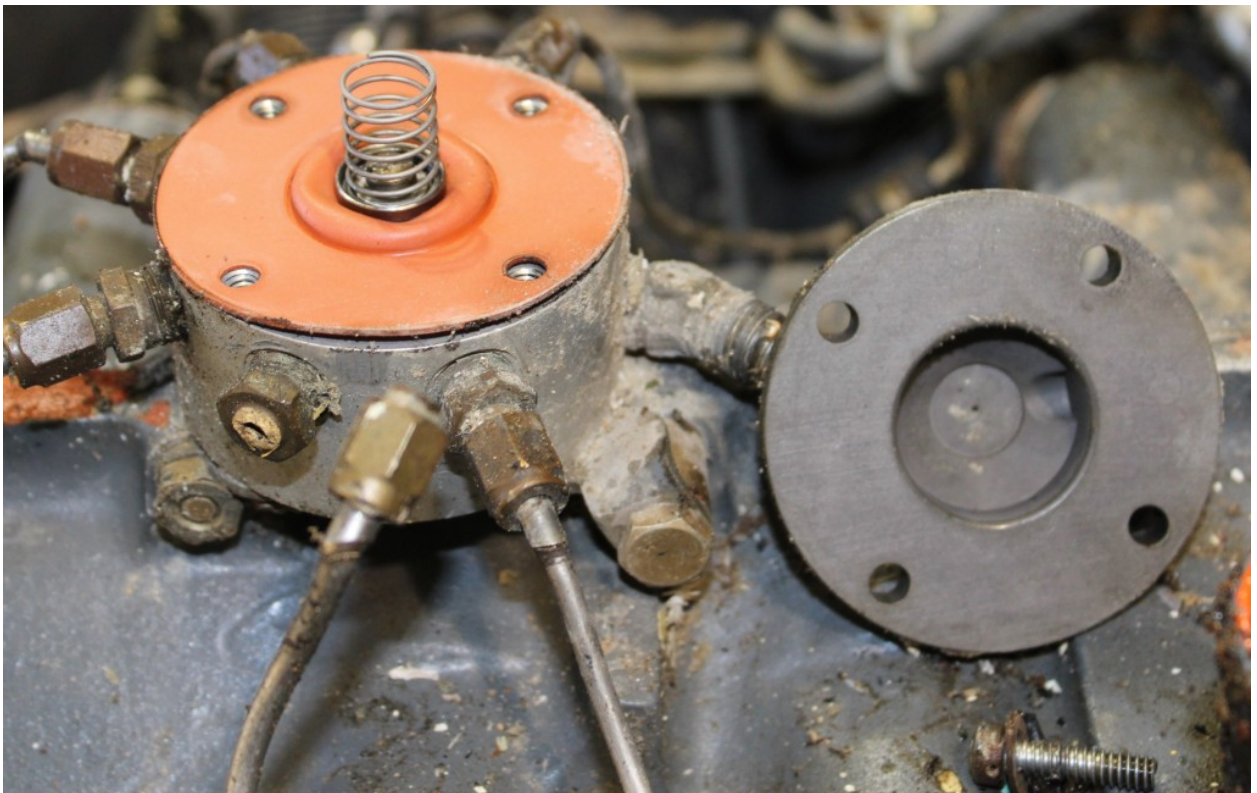
- The flow divider (fuel manifold distribution valve) remained intact and securely attached to the engine in its normal location
  - With one exception, all fuel line fittings and at least portions of their fuel lines were securely attached to the valve body
  - One was fracture-separated at the body/fitting interface; the fracture was consistent with one time overload
  - All lines were deformed down (towards the engine crankcase) by impact
  - When opened, the internal components of the valve were all clean and intact (including the diaphragm), and no foreign material or corrosion was observed

**Figure 58 - Partially Disassembled Flow Divider**

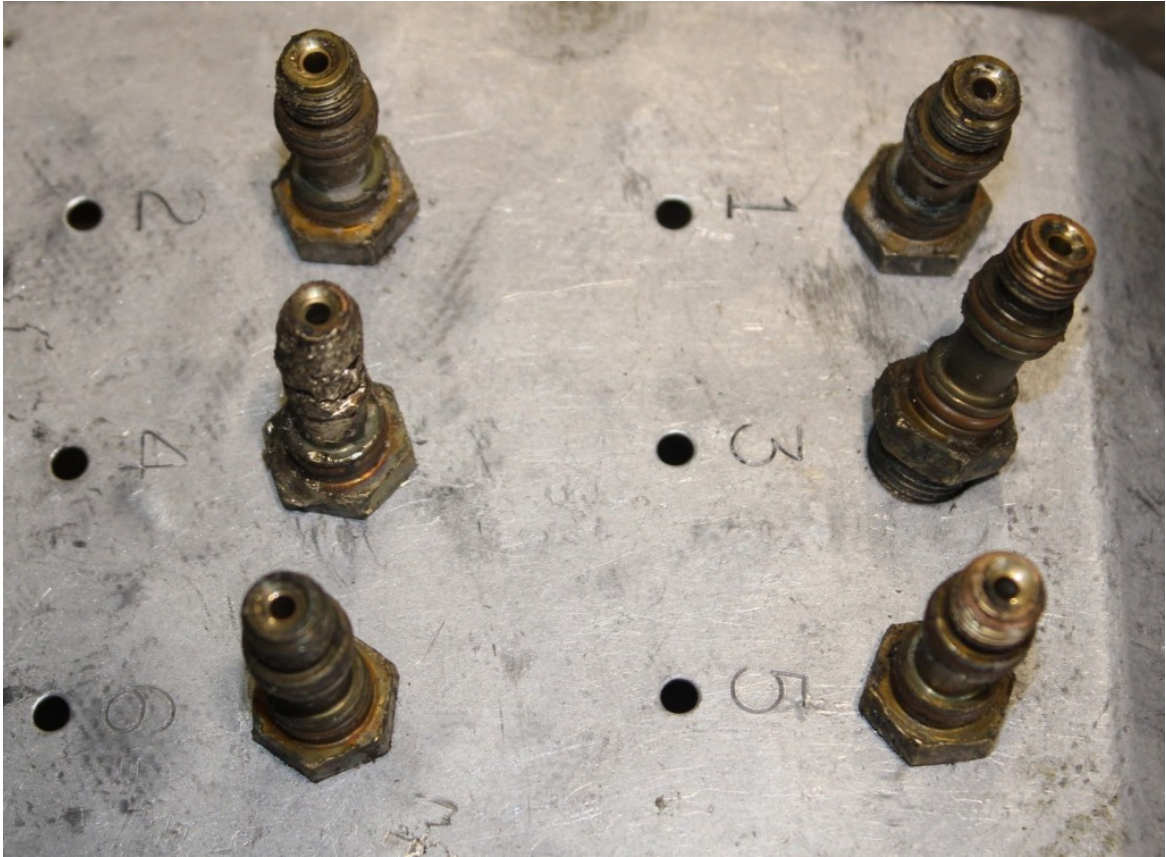
- Fuel Injection Nozzles
  - o All 6 were found securely installed
  - o All 6 had clear passageways
  - o The #4 injector was slightly damaged during the removal process

**Figure 59 - Fuel Injection Nozzles**

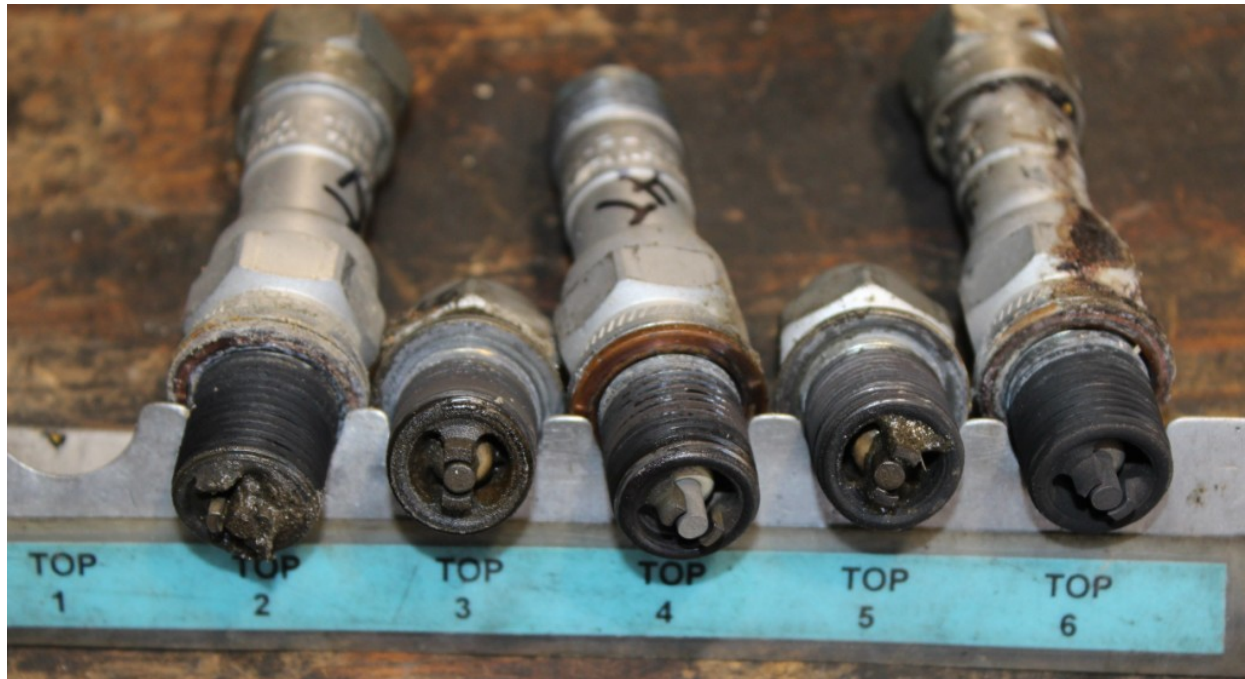
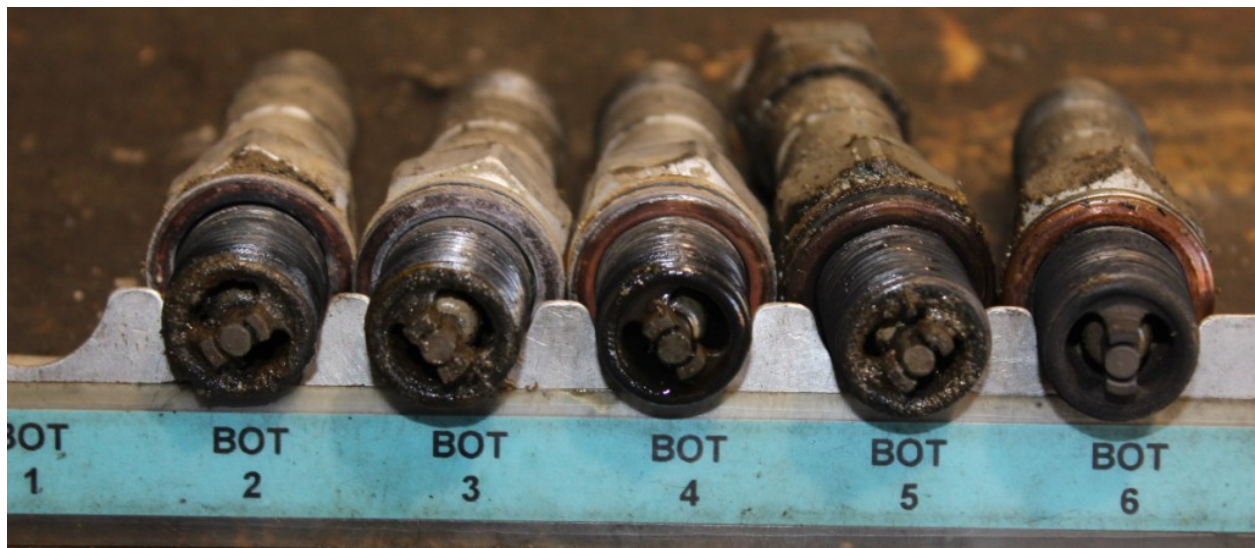
Figure 63 - Top Spark Plugs

- All spark plugs remained installed
  - No electrodes on any spark plugs exhibited mechanical damage from objects in the cylinders
  - None exhibited any signs of significant fouling
  - Their combustion signatures appeared to be generally normal, although some were contaminated with mud/silt and other lake-water exposure effects

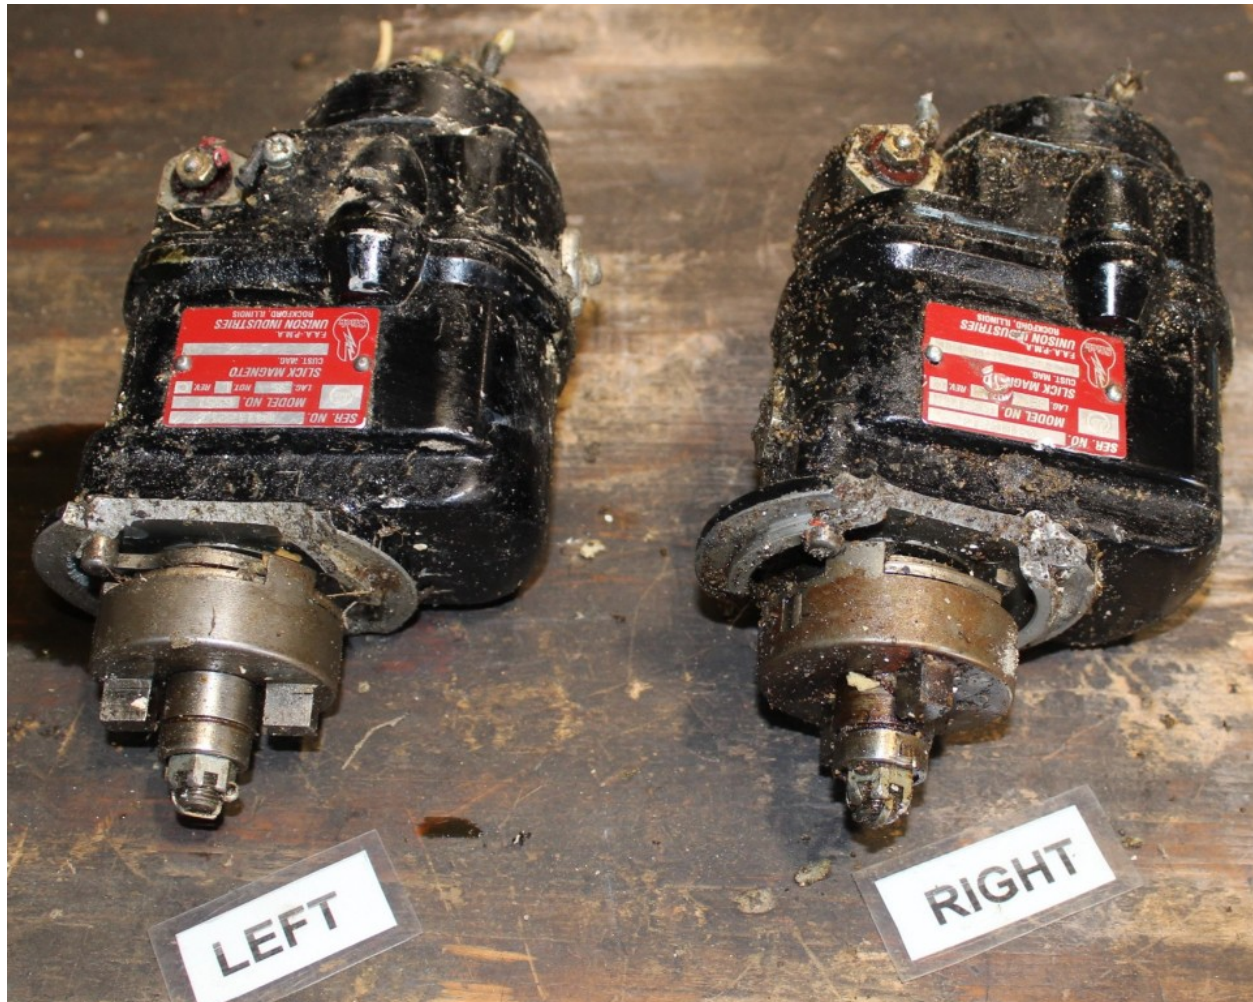
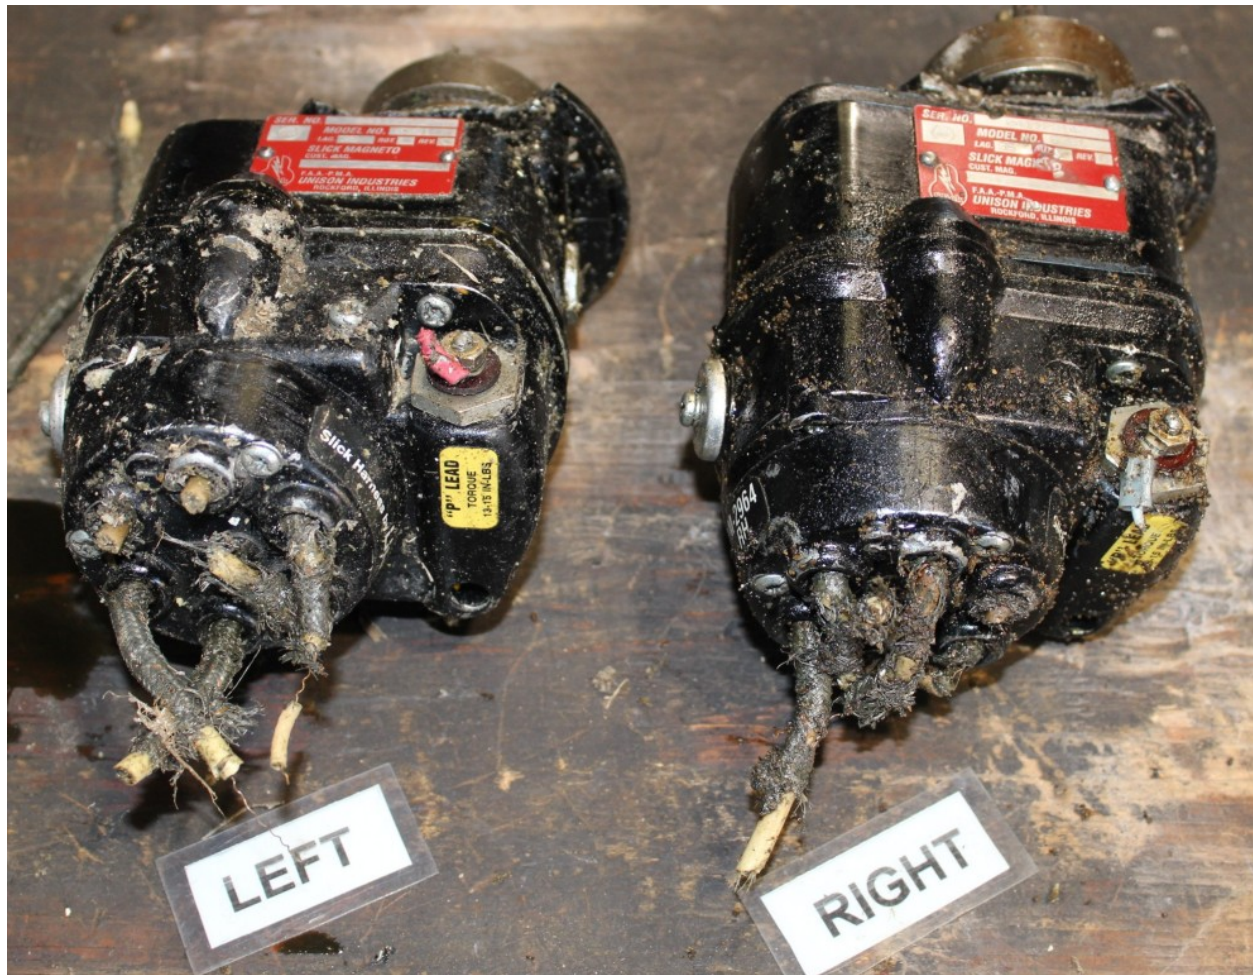
Figure 65 - Magnetos

- The two magnetos were fracture-separated from the engine but were recovered
  - o Both were equipped with impulse couplings, which could be heard on manual rotation
  - o Both produced sparks at all towers when manually rotated
  - o Left: Slick Model 6351 SN 04112213 lag 35 Rotation L Rev C
  - o Right: Slick Model 6351 SN 04112214 lag 35 Rotation L Rev C

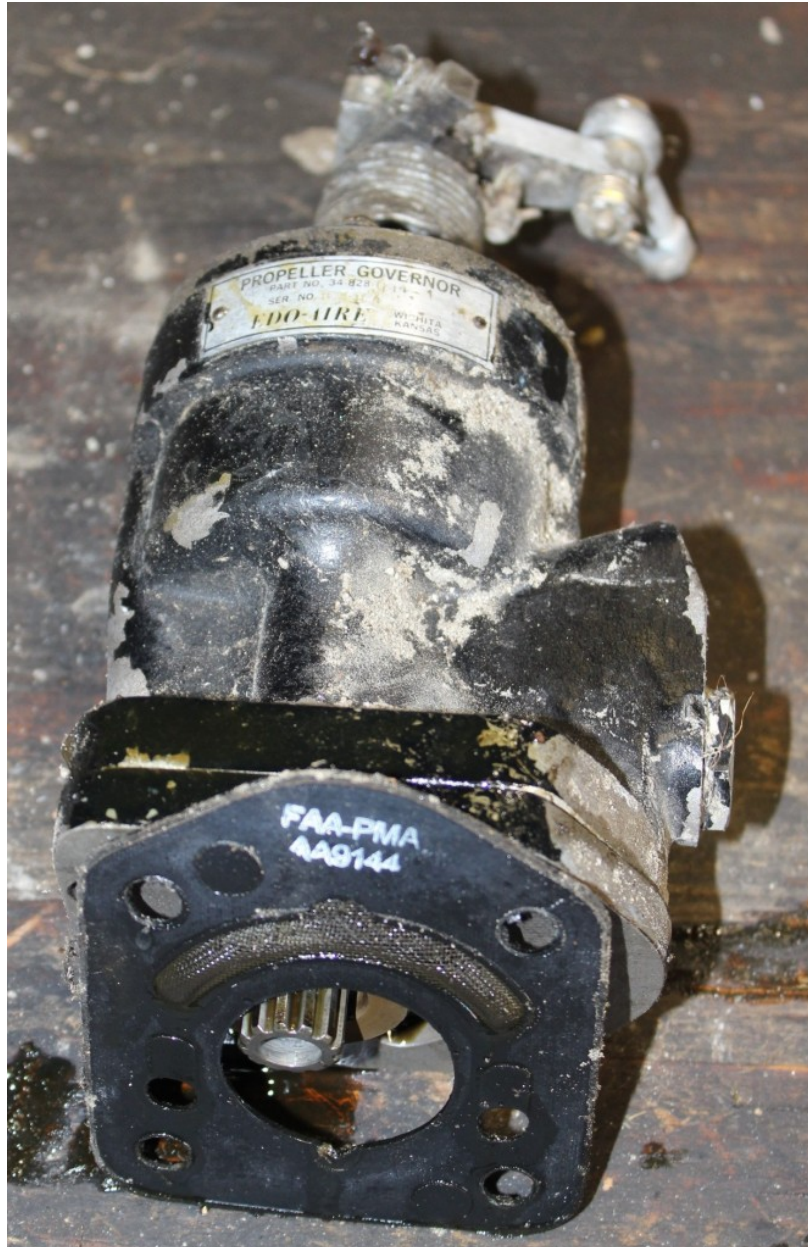
**Figure 67 - Removed Propeller Governor**

- The propeller governor remained securely attached to the engine in its normal position and orientation
  - o EDO-Aire PN 34-828-014-1 SN 8384
  - o The oil screen was clean & unobstructed
  - o The control rod was fracture-separated at the governor rod-end
  - o The fracture face was consistent with one-time overload
