# Continental Motors

## ENGINE FIELD INSPECTION REPORT

| ENGINE MODEL | O470R (25A) |
| FILE NUMBER | 16-333 |

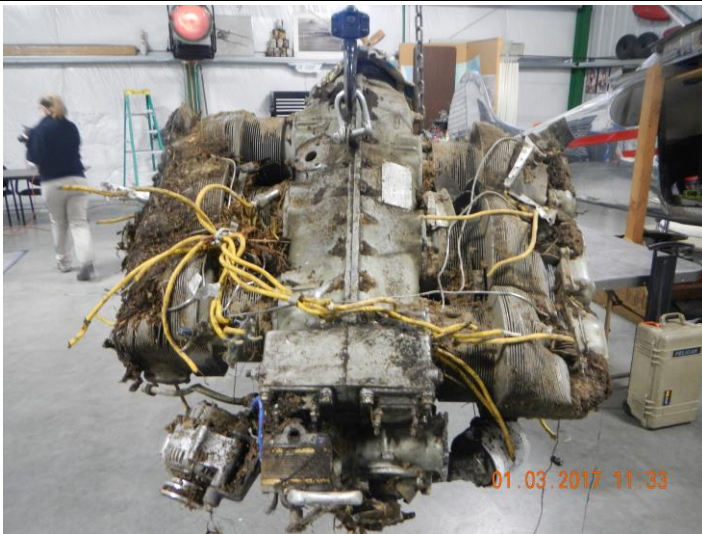
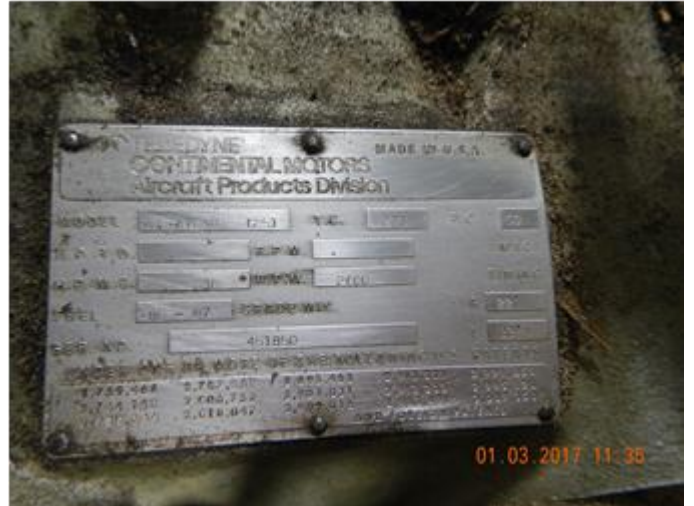
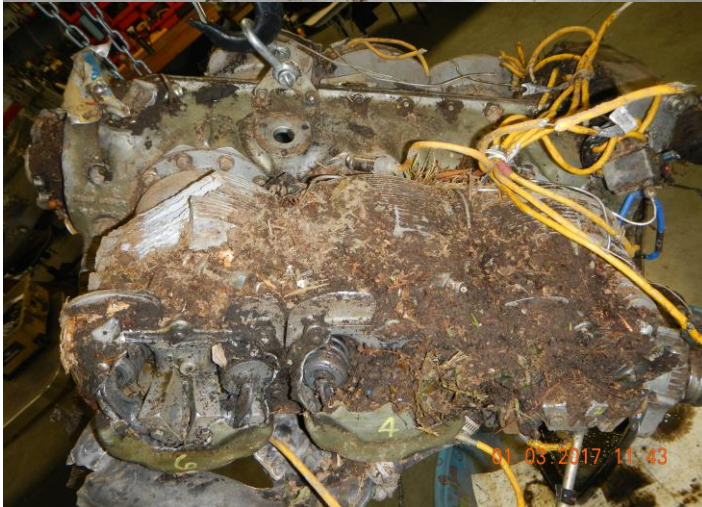
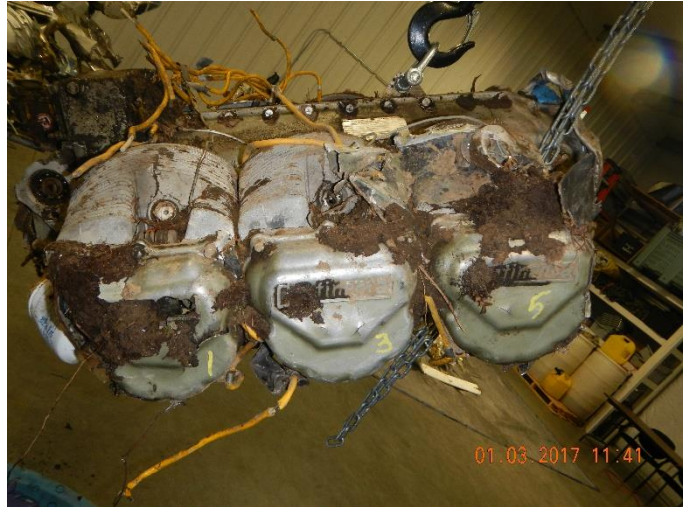
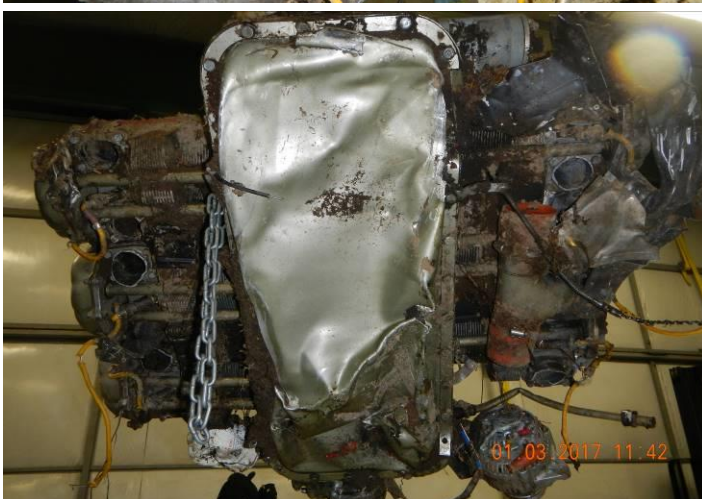
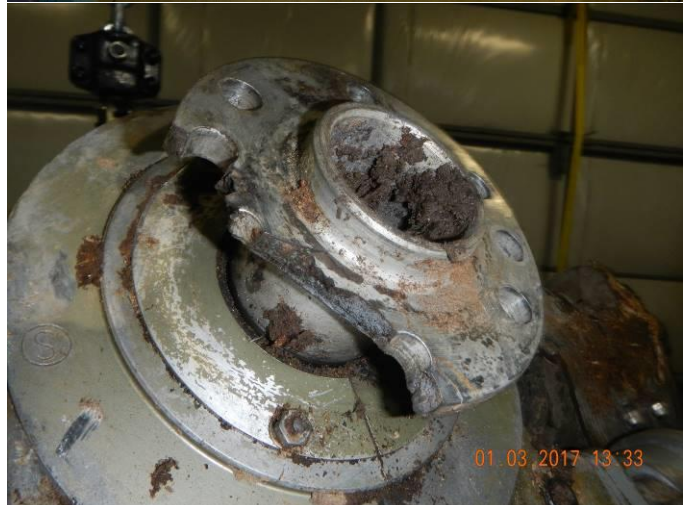
The propeller separated from the engine crankshaft flange. A portion of the crankshaft flange separated and all six propeller mounting bolts sheared. The damaged propeller spinner backing plate remained attached.

The crankcase remained intact but a crack was visible in the forward right crankcase half beginning at cylinder # 5 mounting base (stud number 4) continuing upward to the top parting line.

The fuel priming system was impact damaged but remained attached to each cylinder head. The primer leads were damaged and the primer manifold remained partially attached.

All induction system components separated with the exception of the number 4-cylinder induction elbow which remained attached. The damaged carburetor was recovered and examined.

The right side (cylinders 1, 3, and 5) exhaust components separated. Left side (cylinders 2, 4, and 6) exhaust collector and risers were impact damaged but remained attached.

The right and left magnetos separated. One magneto was recovered which was nearly intact but with impact damage to the case. This magneto could not be rotated due to mechanical damage to the case. The impulse coupler remained attached but could not release since the magneto could not be rotated manually. Parts of another heavily damaged magneto was recovered. Only the impulse coupler, shaft, gear and a portion of the magneto mount remained.

The ignition harness was heavily damaged. Only cut and pinched leads remained attached. A portion of the left ignition harness attach plate remained with the damaged harness leads.

The crankcase filler neck, breather tube and oil rod separated. The oil rod was recovered and inspected. The engine oil sump remained attached but was heavily impact damaged. The oil sump drain plug remained attached with security wire in place. The spin-on type oil filter remained attached to the oil filter adapter. Security wire for the oil filter and oil filter adapter remained attached. The oil filter exhibited crushing damage.

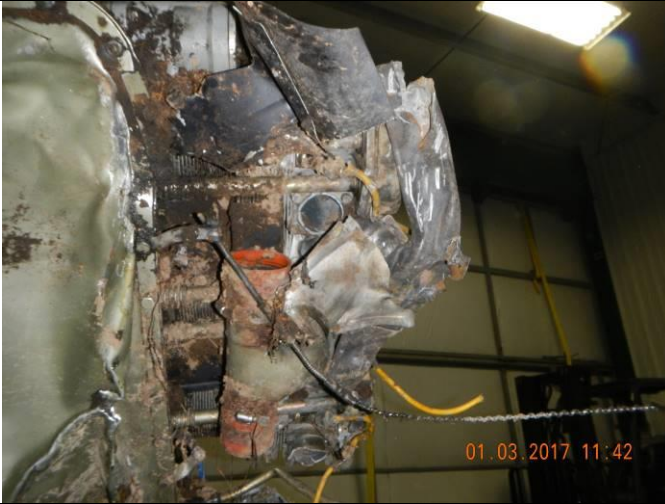
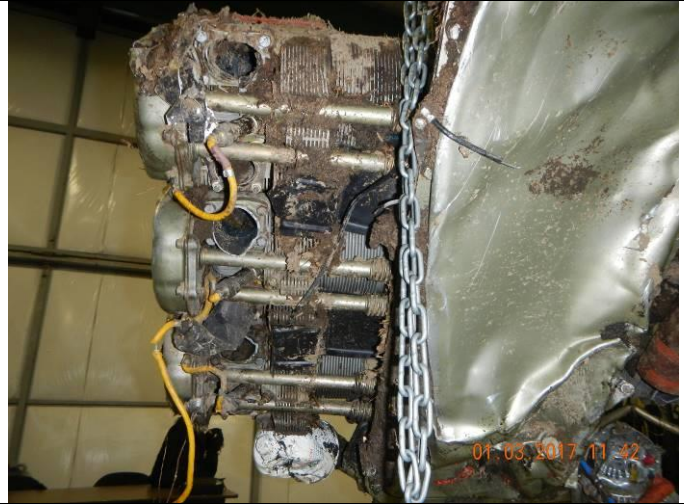
Condition: The right side (cylinders 1, 3, and 5) exhaust components separated. Left side (cylinders 2, 4, and 6) exhaust collector and risers were impact damaged but remained attached.

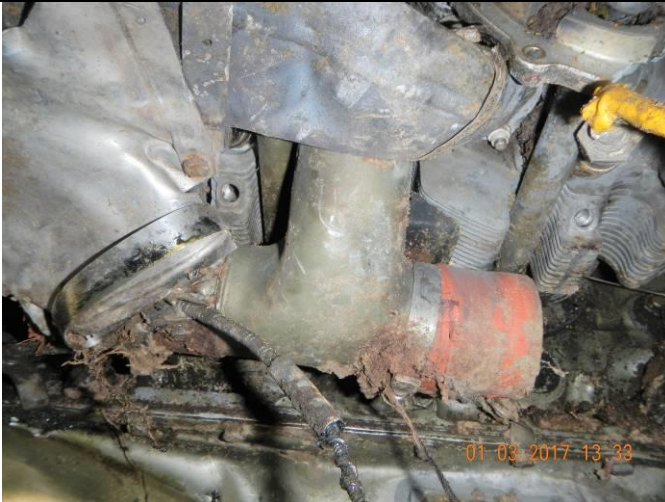
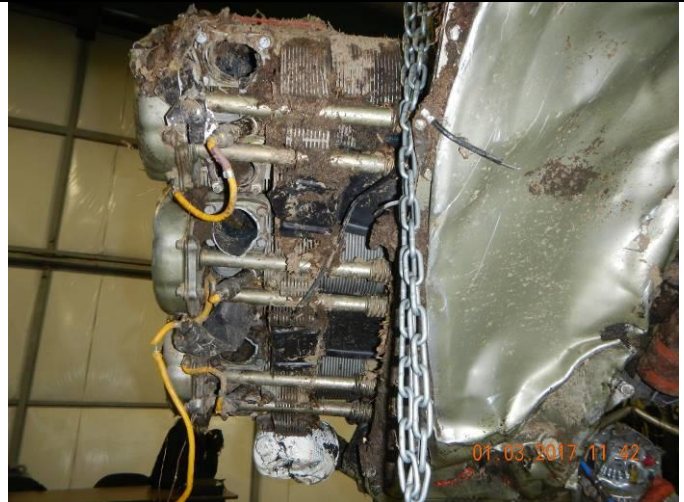
Condition: All induction system components separated with the exception of the number 4-cylinder induction elbow which remained attached.

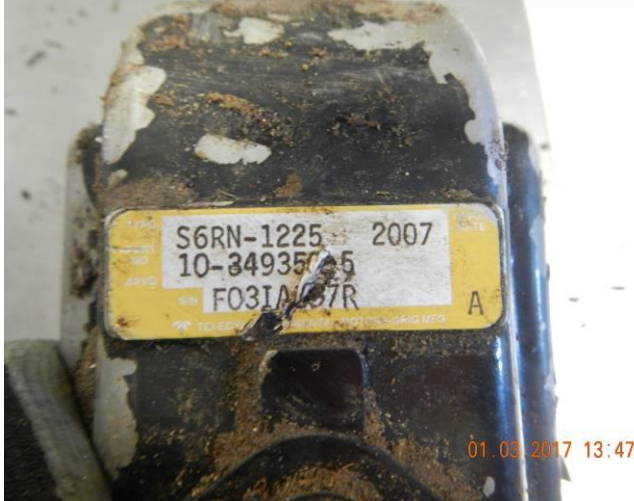
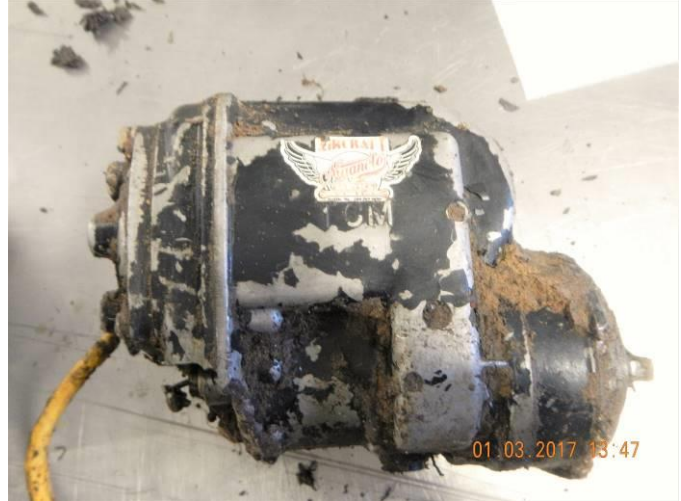
The magneto separated from the engine and the case was impact damaged. The impulse coupler was contaminated with dirt and could not be rotated manually.

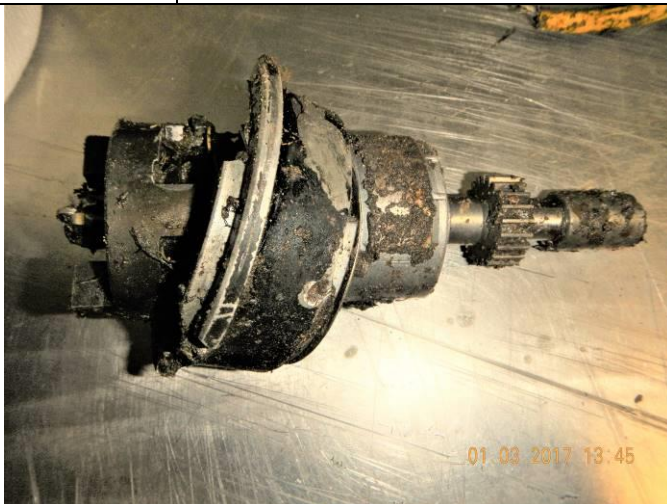
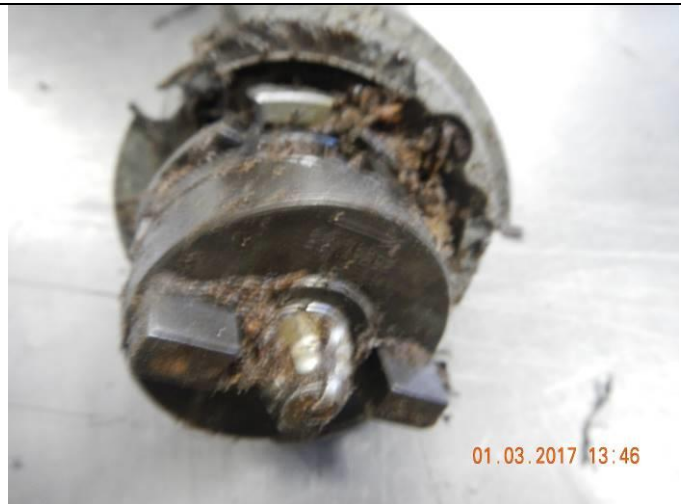
Only a portion of this magneto was recovered.

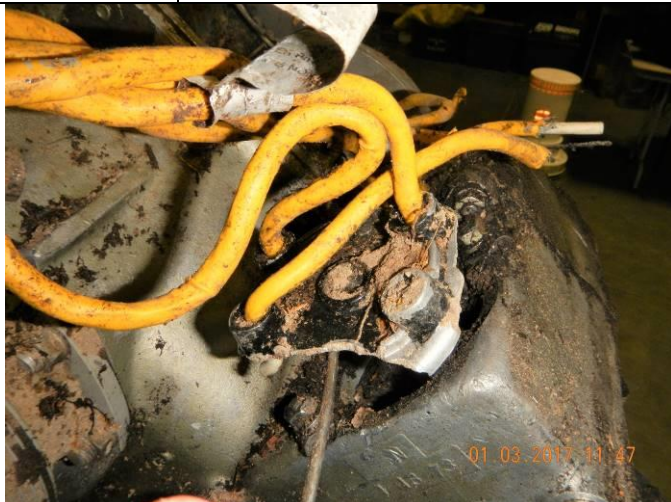
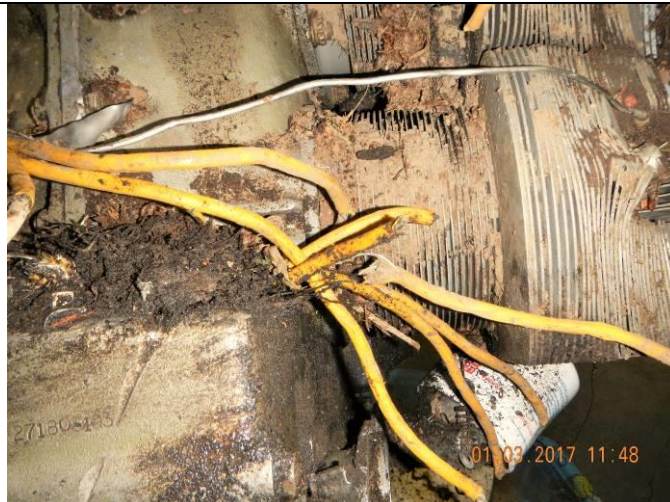
The ignition harness was cut and pinched during the impact sequence.

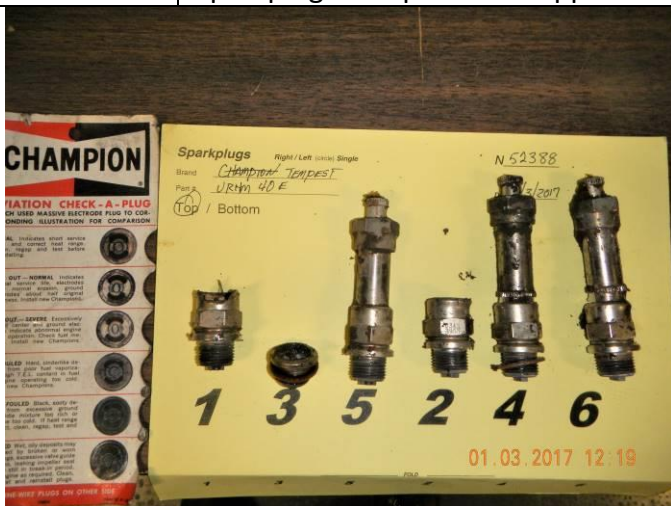
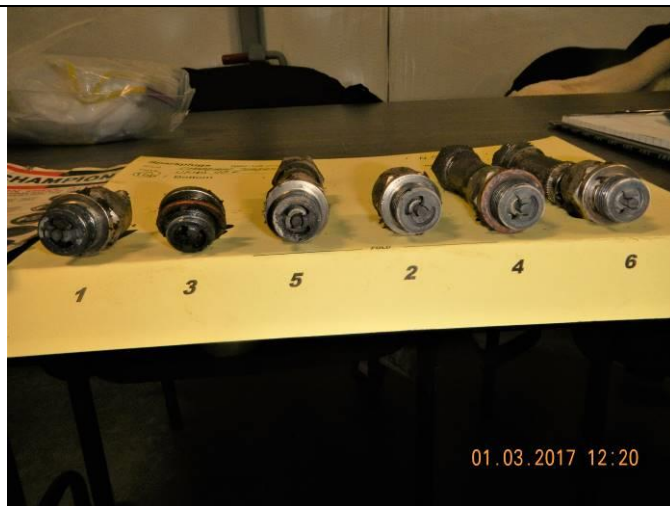
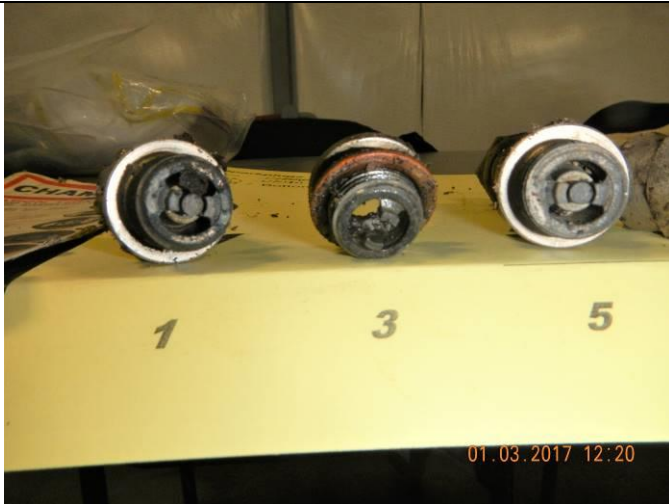
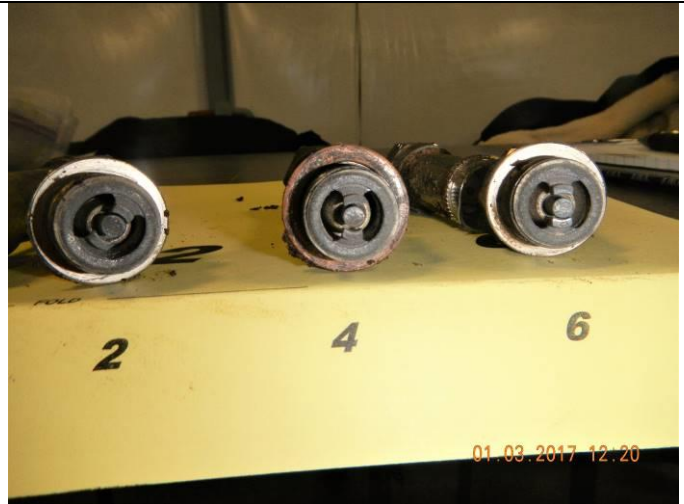
Top sparkplugs from cylinders one, two, three and four were impact damaged. Top sparkplug three separated and only the threaded shell remained. Top sparkplug four was impact damaged with the upper body bent and the internal insulator broken. All top sparkplugs except # three appeared to be normal in wear and coloration.

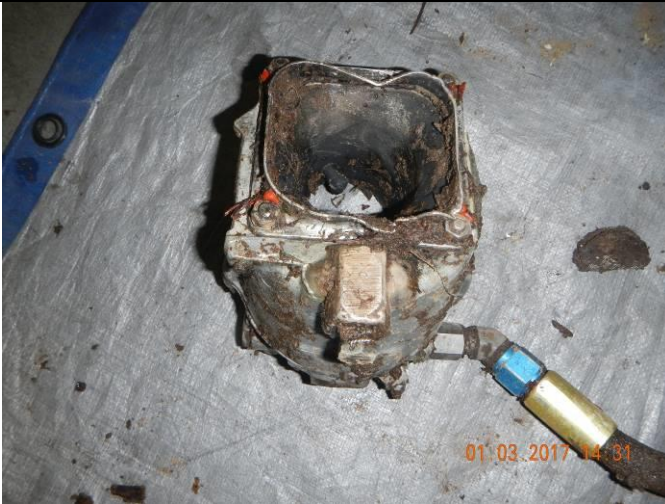
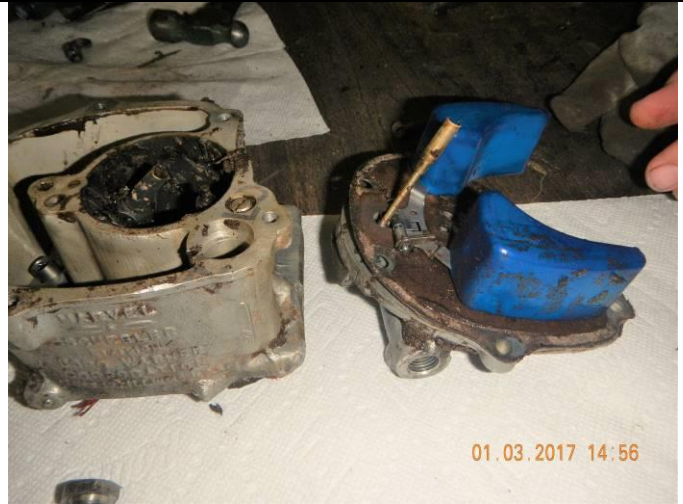
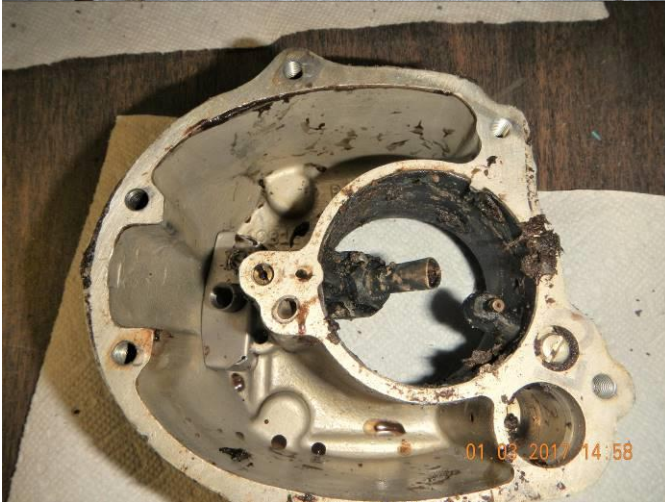
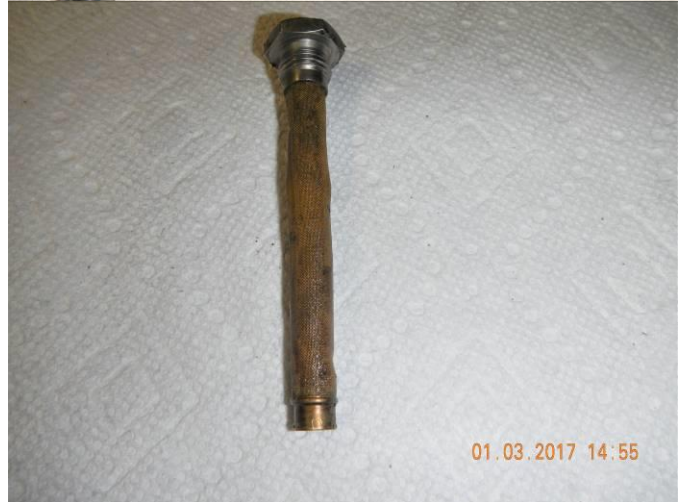
The attachment flange and a section of the upper carburetor housing including the valve, linkage and accelerator pump was missing. The inlet line separated from the carburetor. The inlet screen was removed and was free of debris.

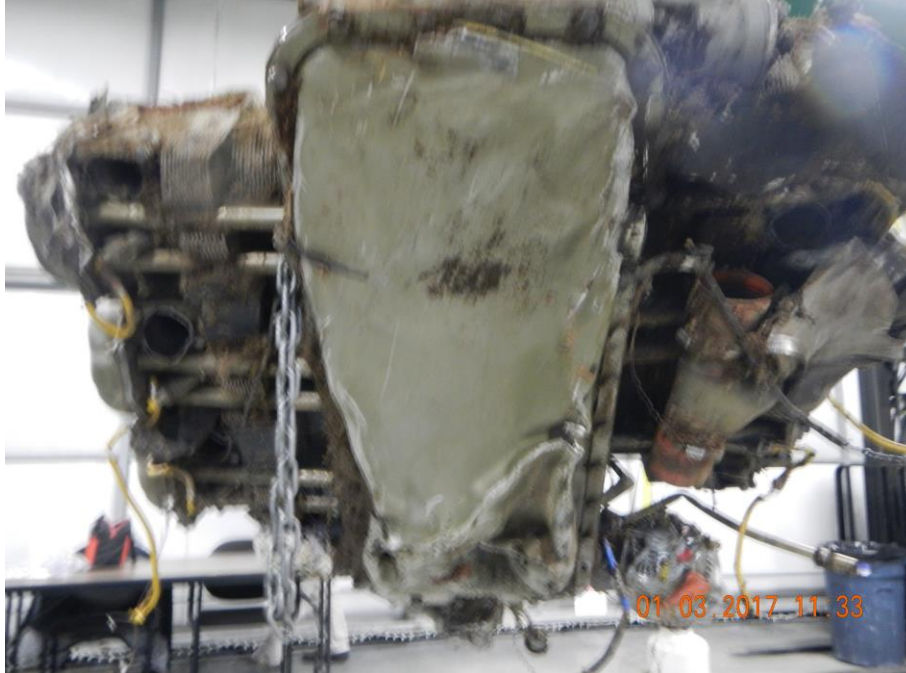
The oil sump received impact damage. The drain plugs remained in place with safety wire secured.

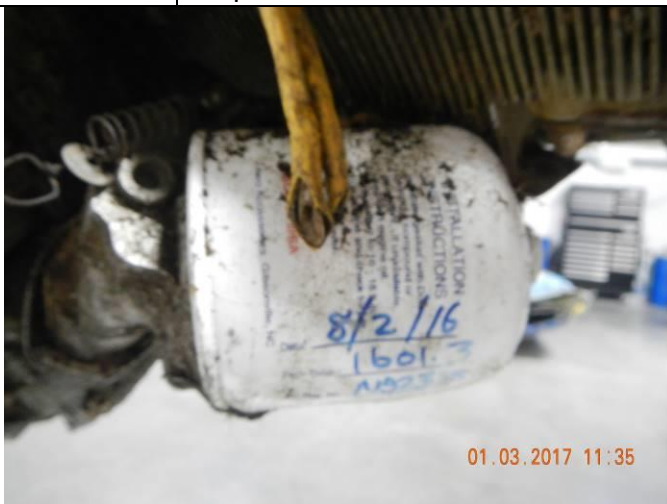
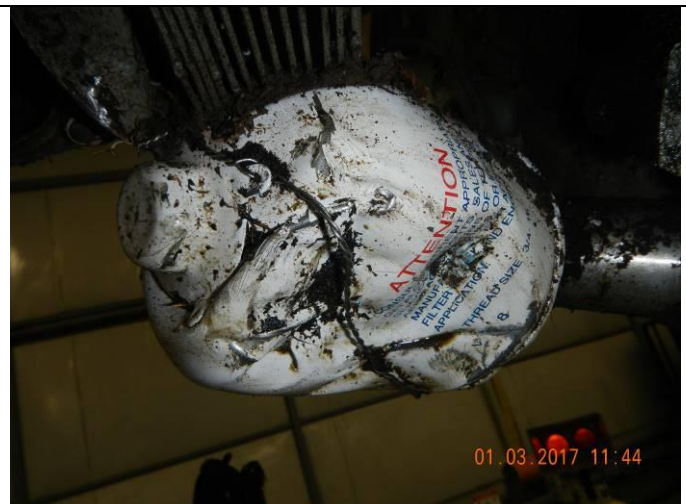
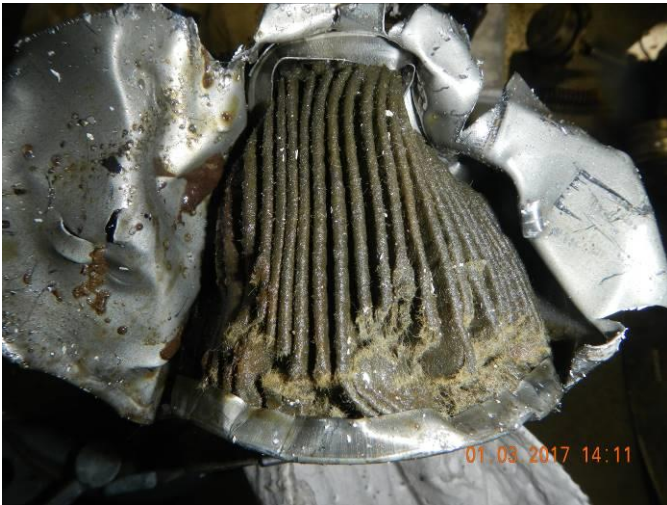
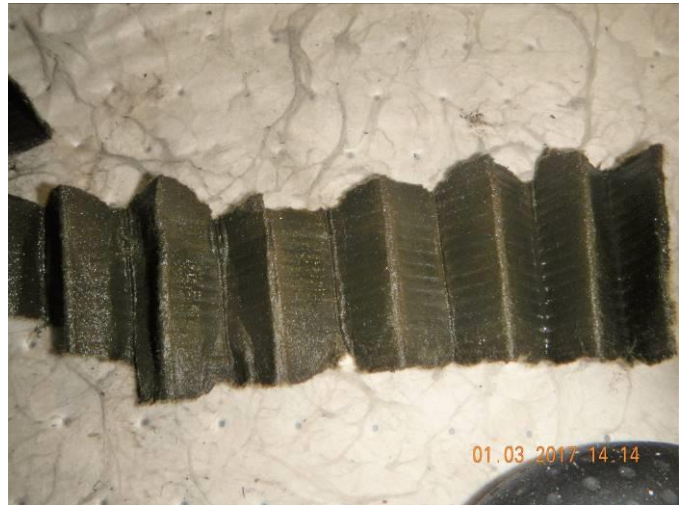
The oil filter received impact damage. A note on the oil filter outer case indicated that the oil filter was installed 8/2/2016 at tach time 1601.3 hours. The filter was opened and inspected. No metal contamination was noted.

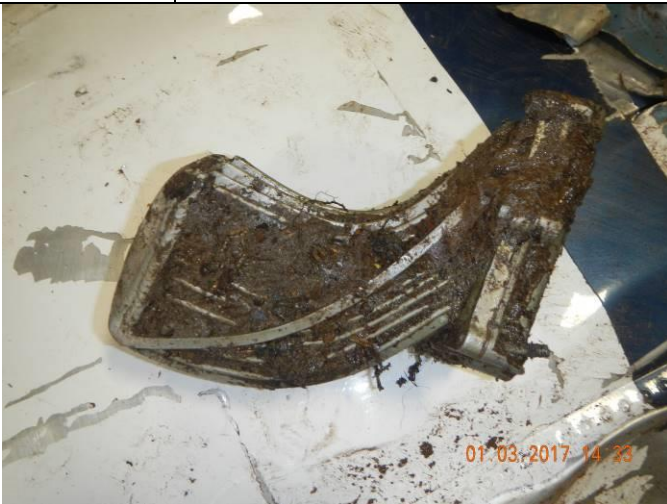
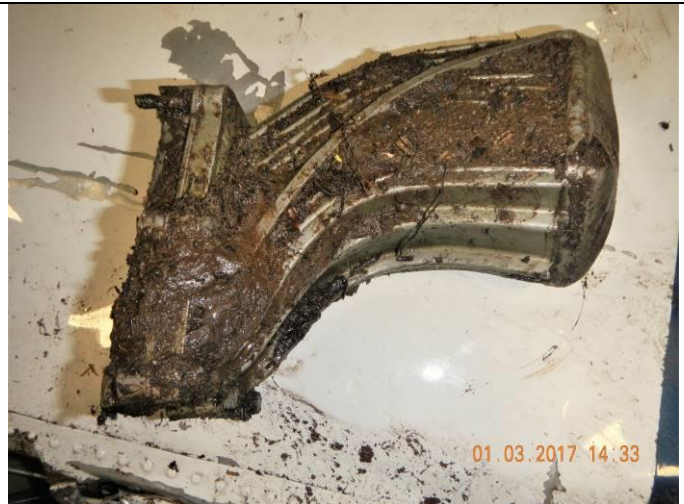
The oil cooler separated and was impact damaged.

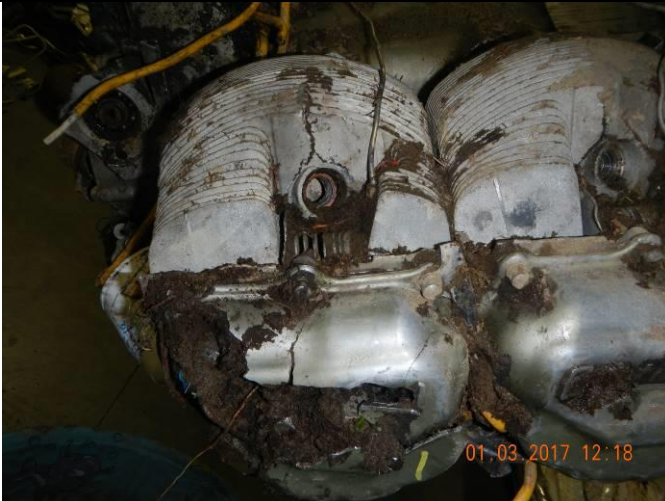
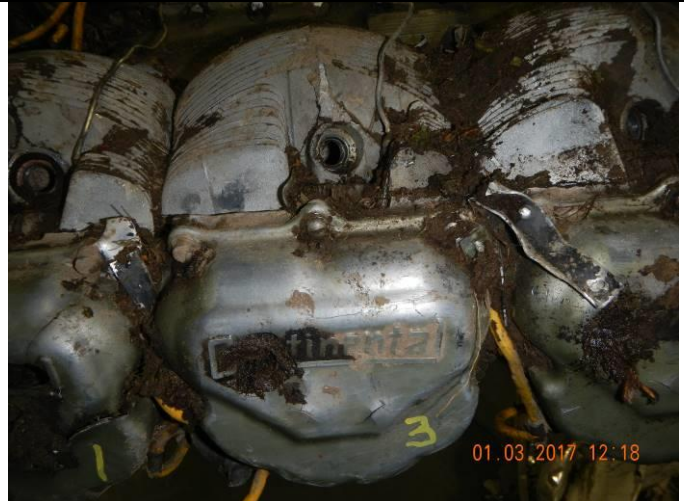
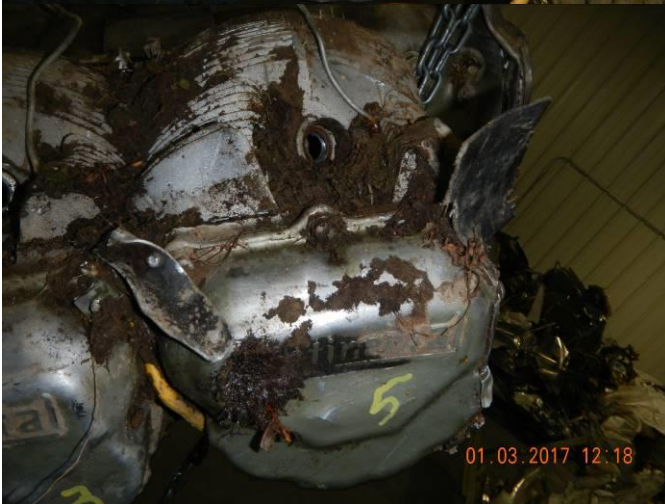
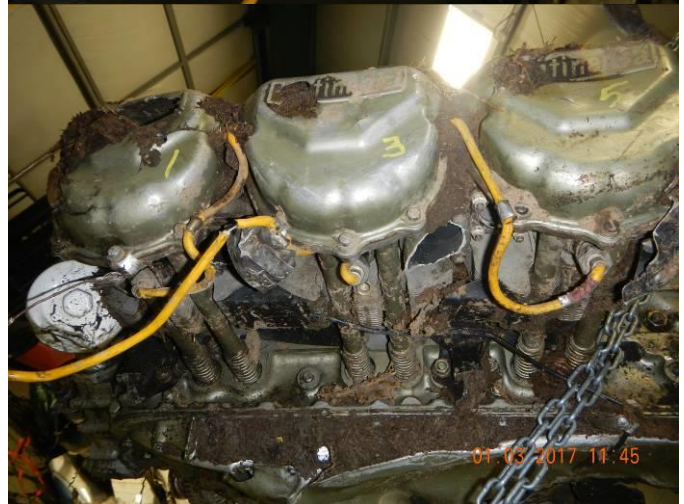
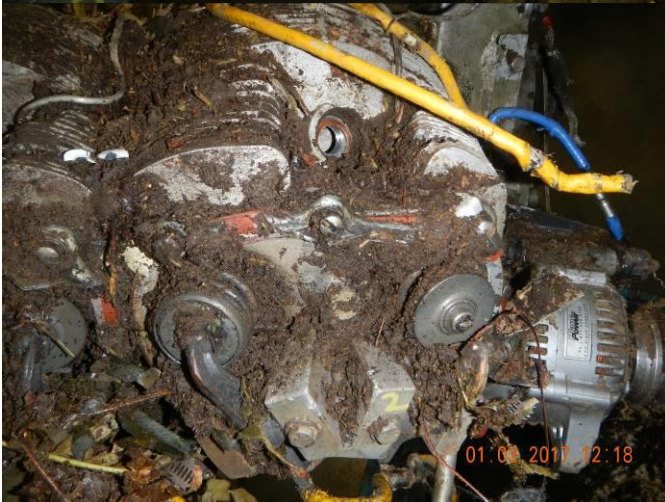
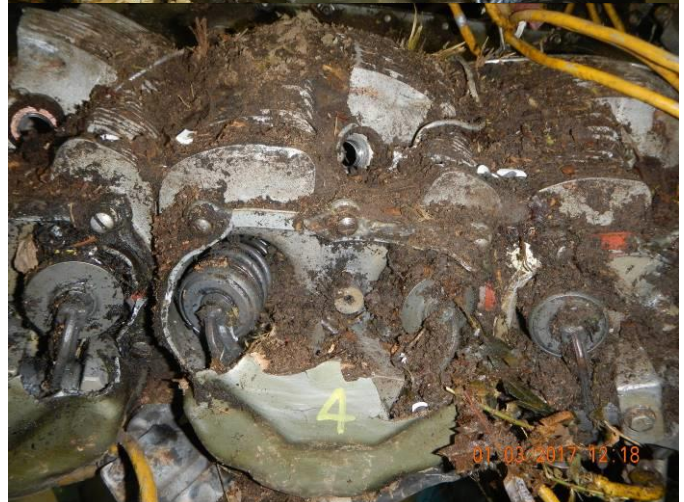
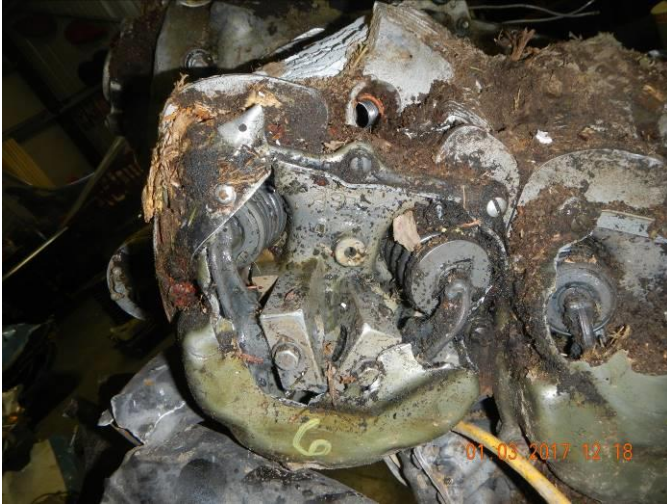
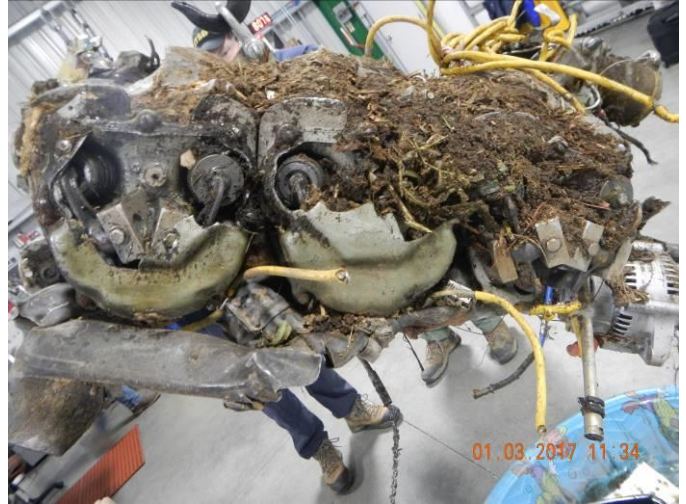
All six cylinders exhibited impact damage to cooling fins. Rocker box covers on all six cylinders were impact damaged allowing dirt and vegetative contamination. The push rod and push rod housing for cylinder # 2 (intake valve) had separated due to impact forces

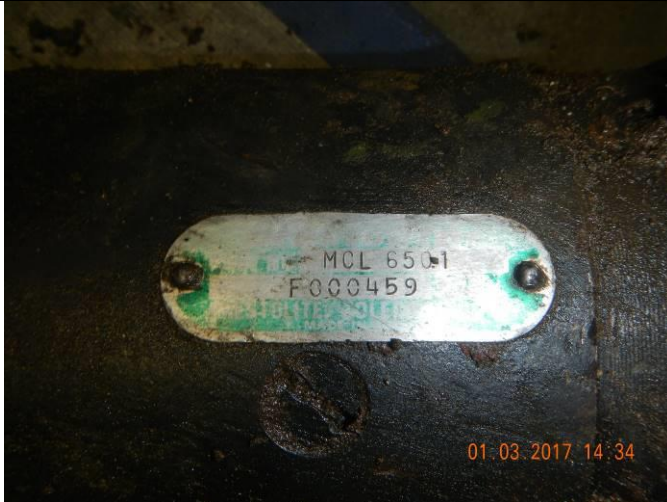
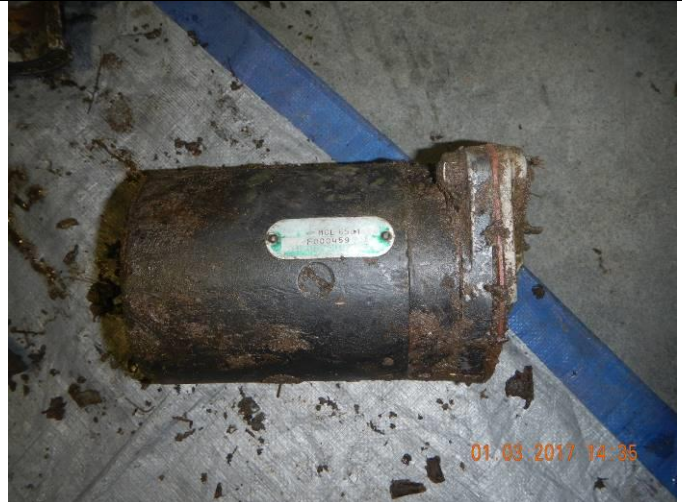
The starter separated but was recovered. The starter was intact and the drive could be rotated manually.

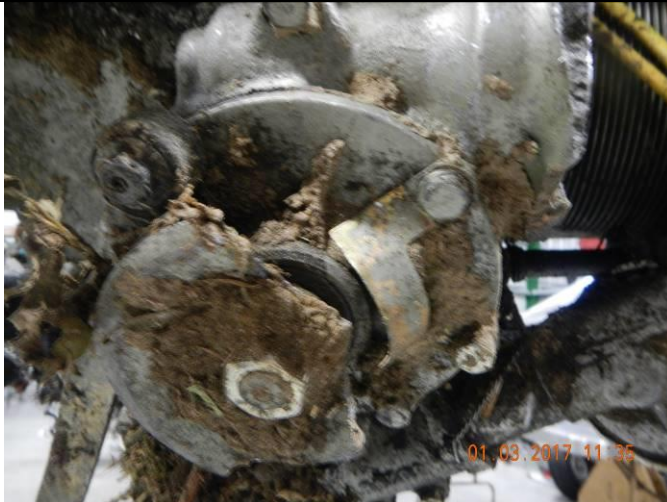
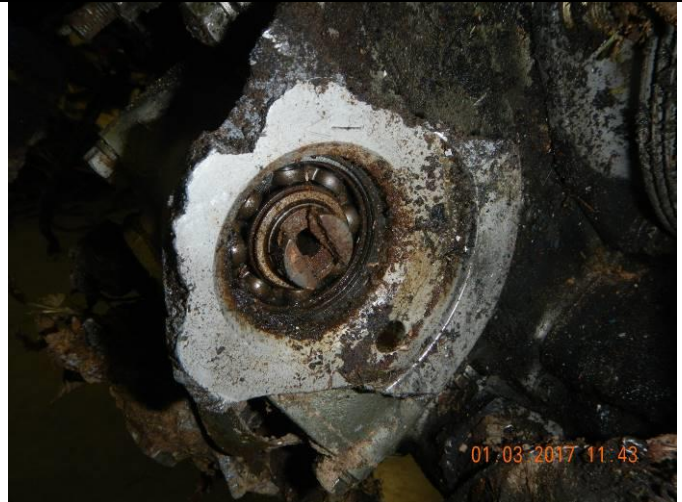
The starter adapter and PTO were impact damaged. The accessory pulley was broken and the starter mount was damaged.

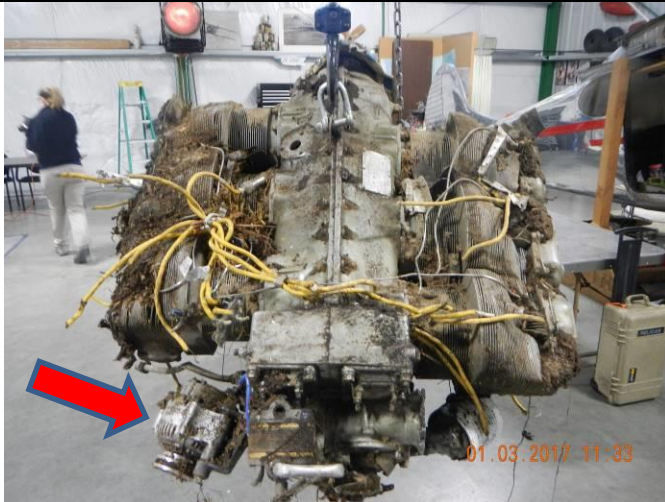
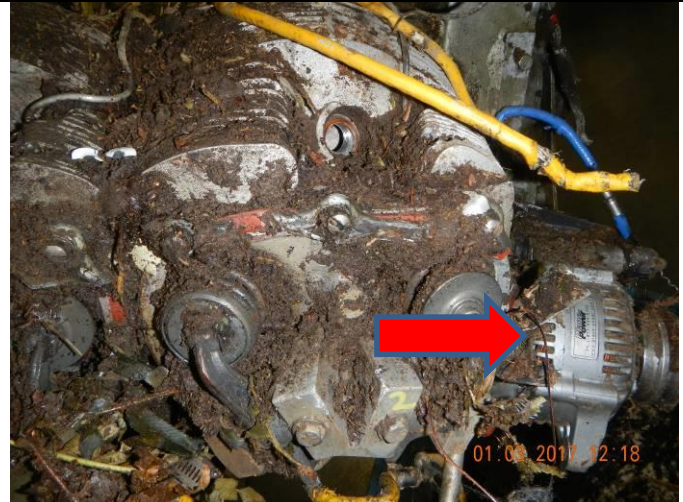
The alternator was partially separated due to an impact damaged mount. The alternator was contaminated with dirt and vegetative debris. The red arrow points to the alternator.

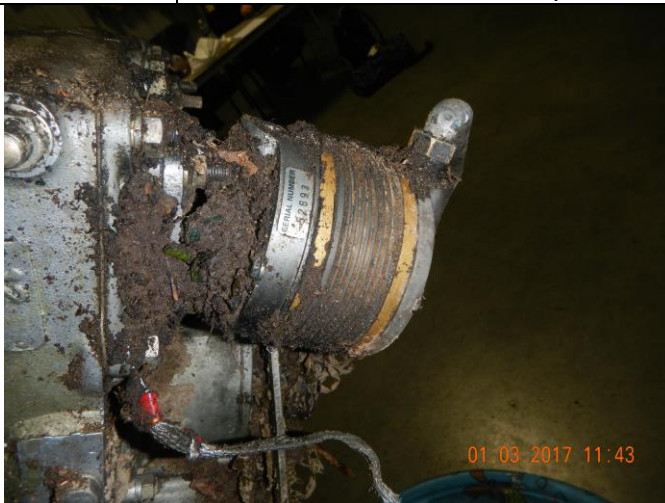
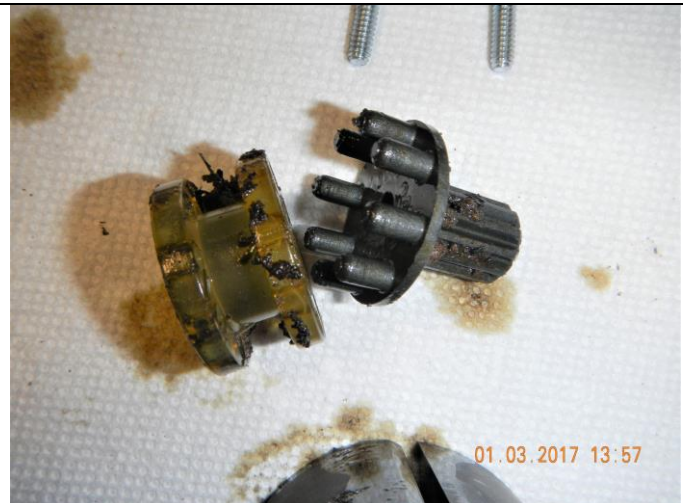
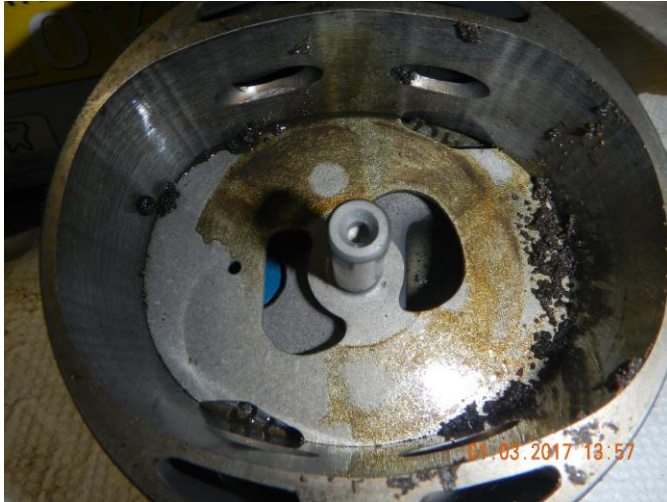
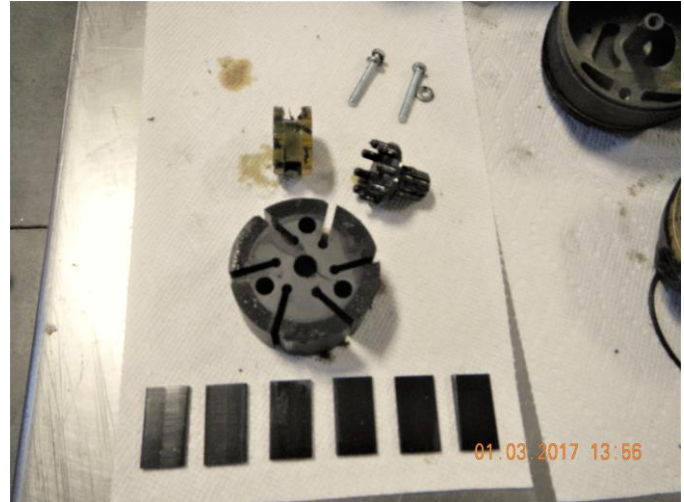
The vacuum pump remained intact with evidence of impact damage to the outer case. The pump drive rotated freely by hand. The pump was disassembled and inspected. The rotor and vanes were intact. The plastic shear drive was intact.

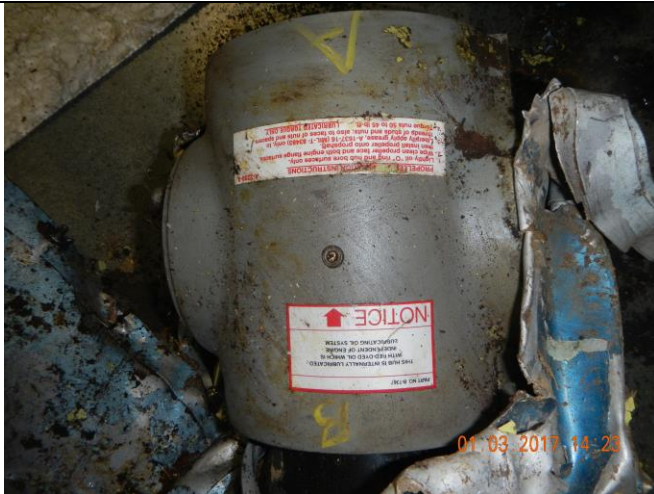
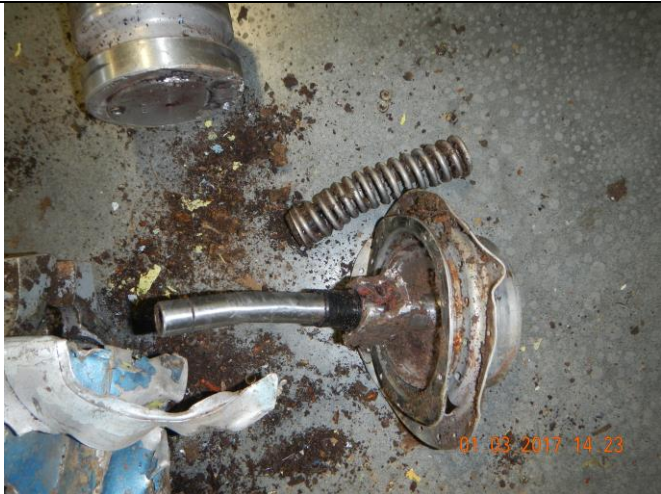
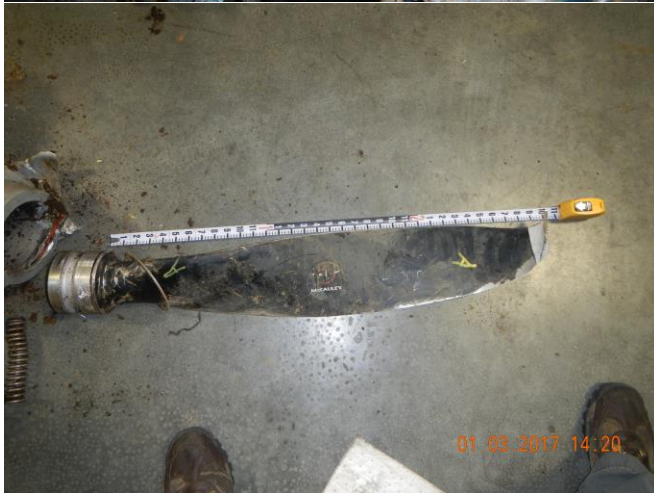
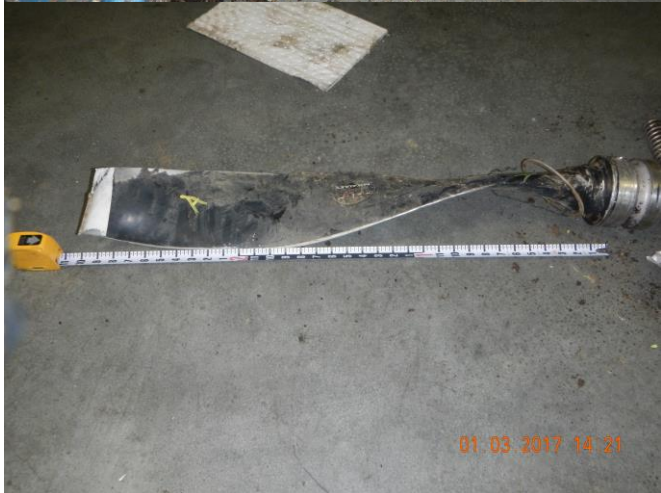
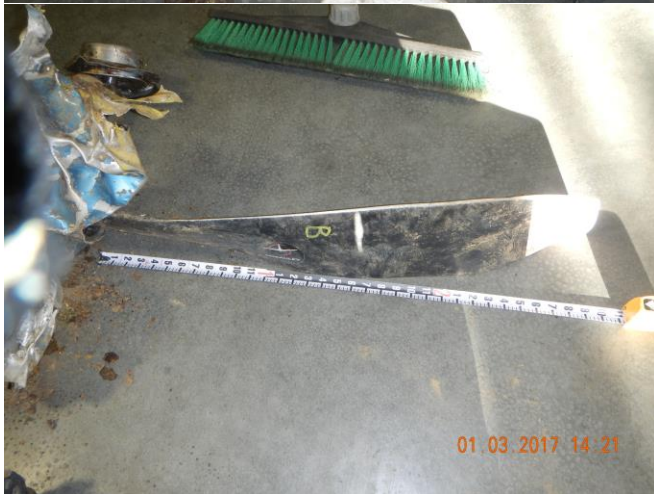
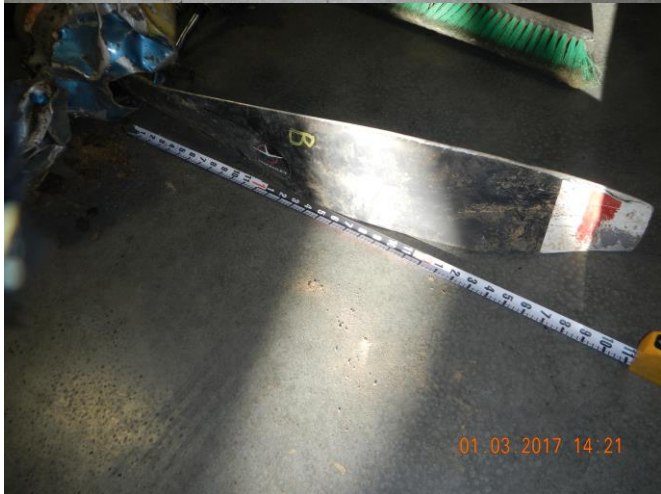
| Condition: | The propeller hub separated from the crankshaft propeller flange and was impact damaged. The hub was broken into several pieces and the propeller blades separated at the shank. A tree was severed by the propeller and a section was collected by the recovery crew and presented at the recovery examination. | | |
