## **NATIONAL TRANSPORTATION SAFETY BOARD**

### **AIRFRAME AND ENGINE EXAM REPORT**

WPR17FA047

Location: San Pedro, CA  
Date: January 4, 2017  
Aircraft: Robinson R22 Beta, Registration Number: N702JJ, Serial #: 3791  
NTSB IIC: Howard Plagens

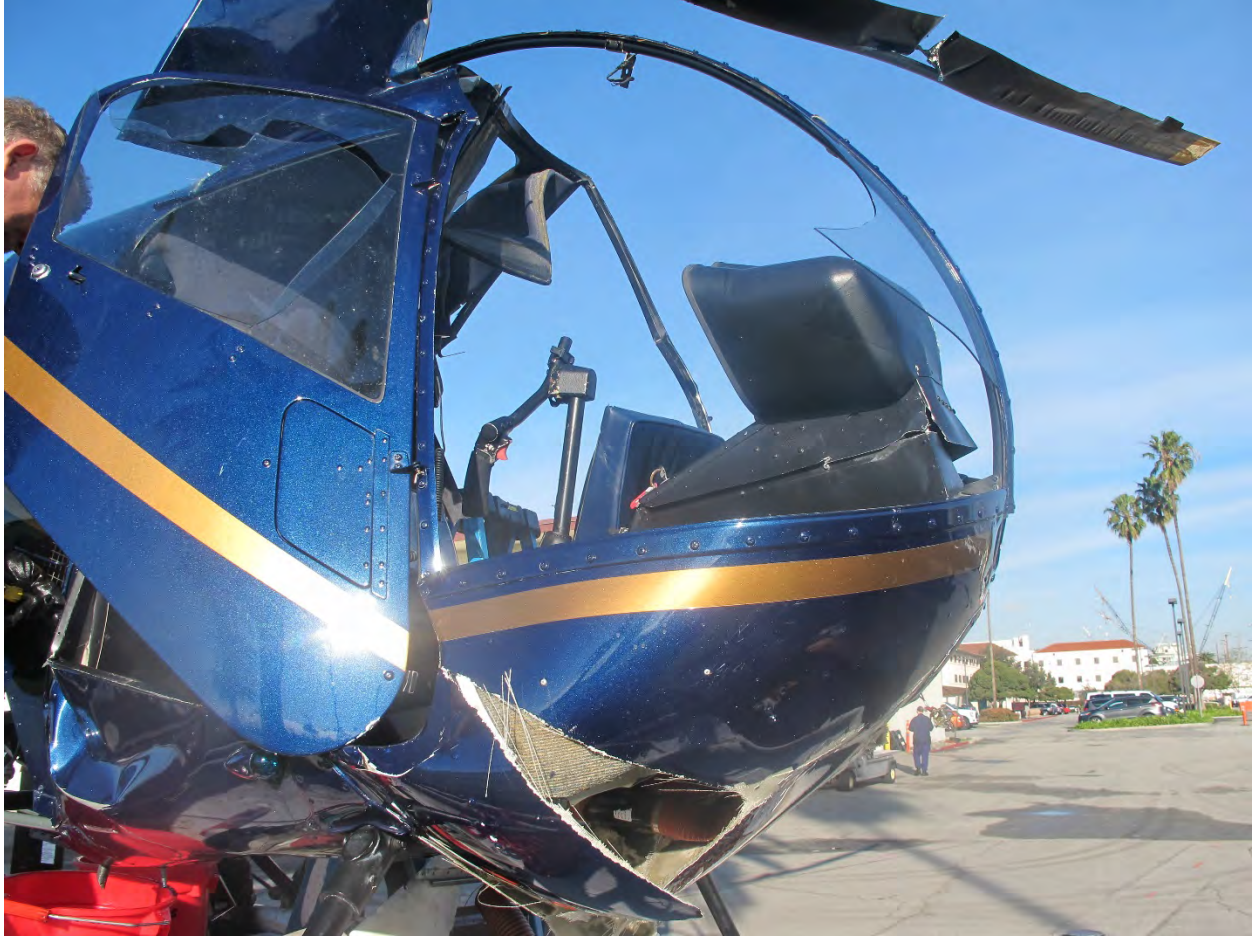
The left door was not installed for this flight. The left side of the cabin area sustained more damage than the right side; it was crushed up and in. Both windscreens were knocked out, and both seats were deformed down. First responder divers reported that the helicopter came to rest underwater on the skids in the upright position; both occupants were still strapped in their seats.

*Photo 1 Right Side of Cabin*

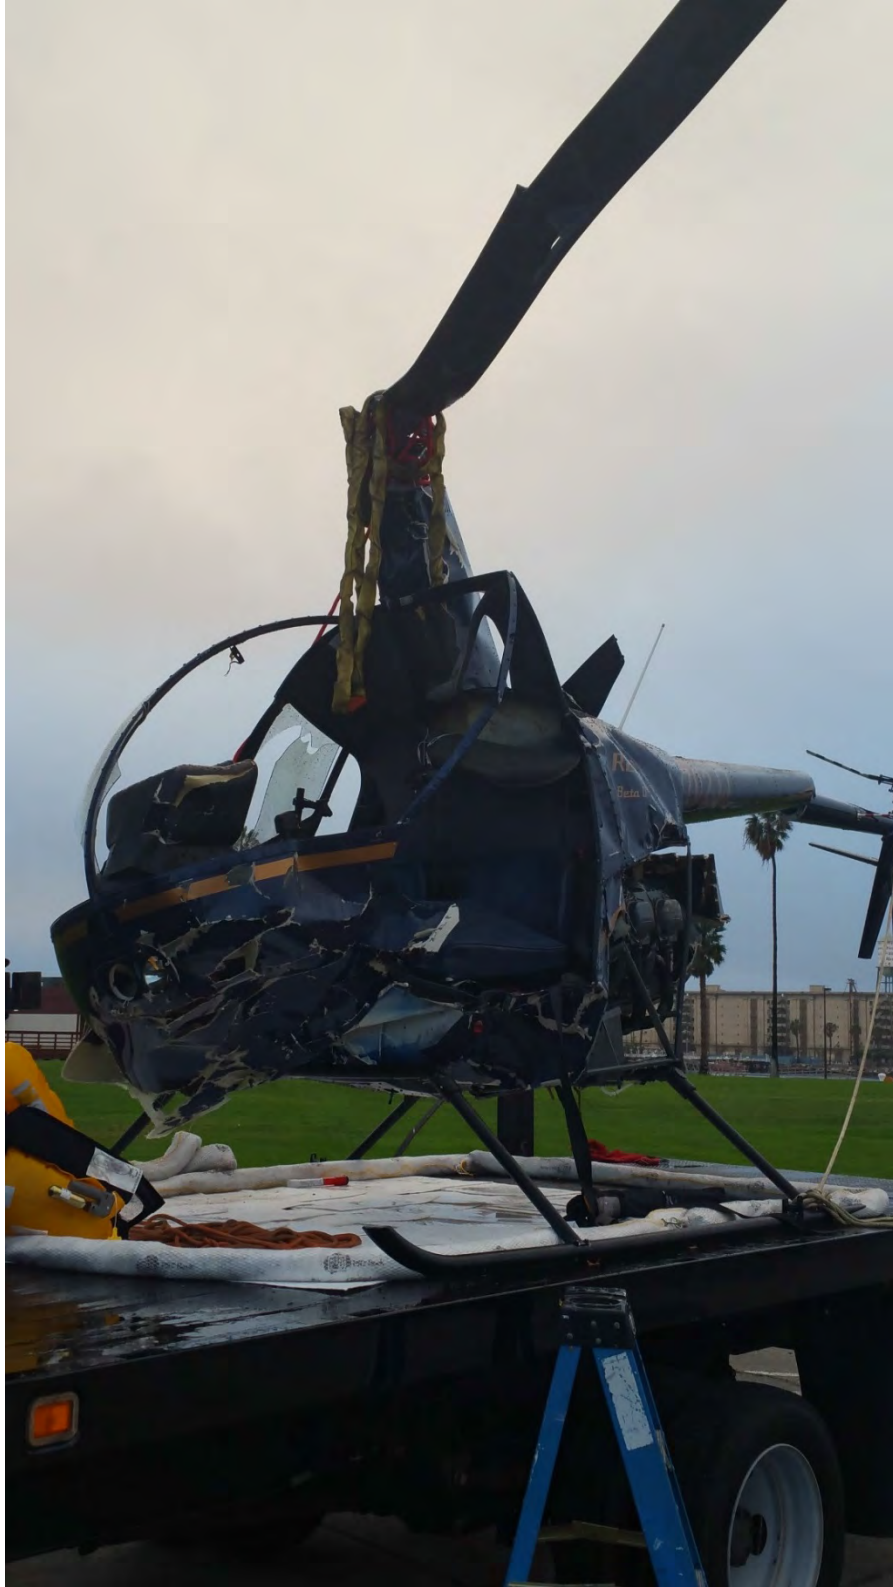
*Photo 2 Left Side of Cabin*

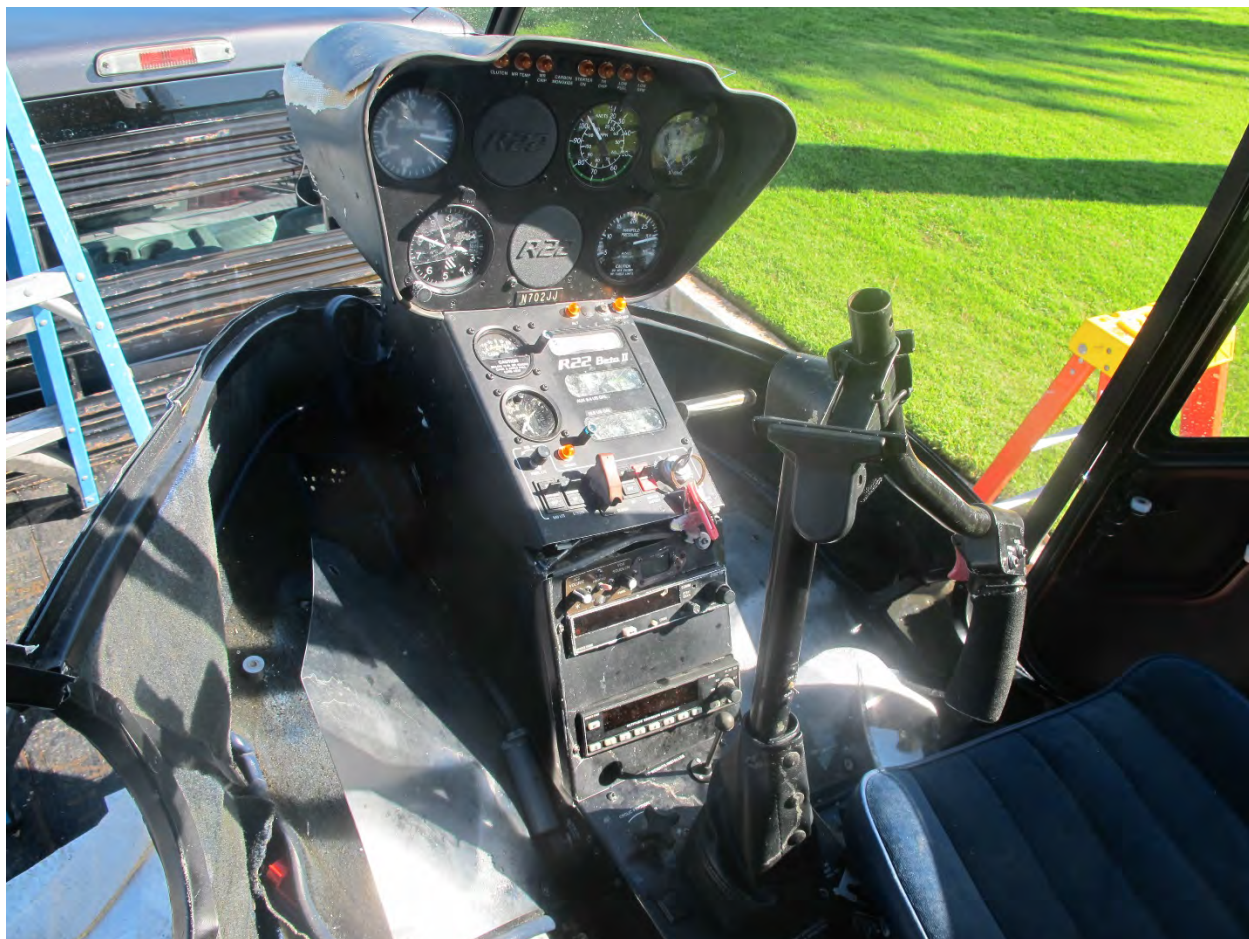
*Photo 3 Instrument Panel*

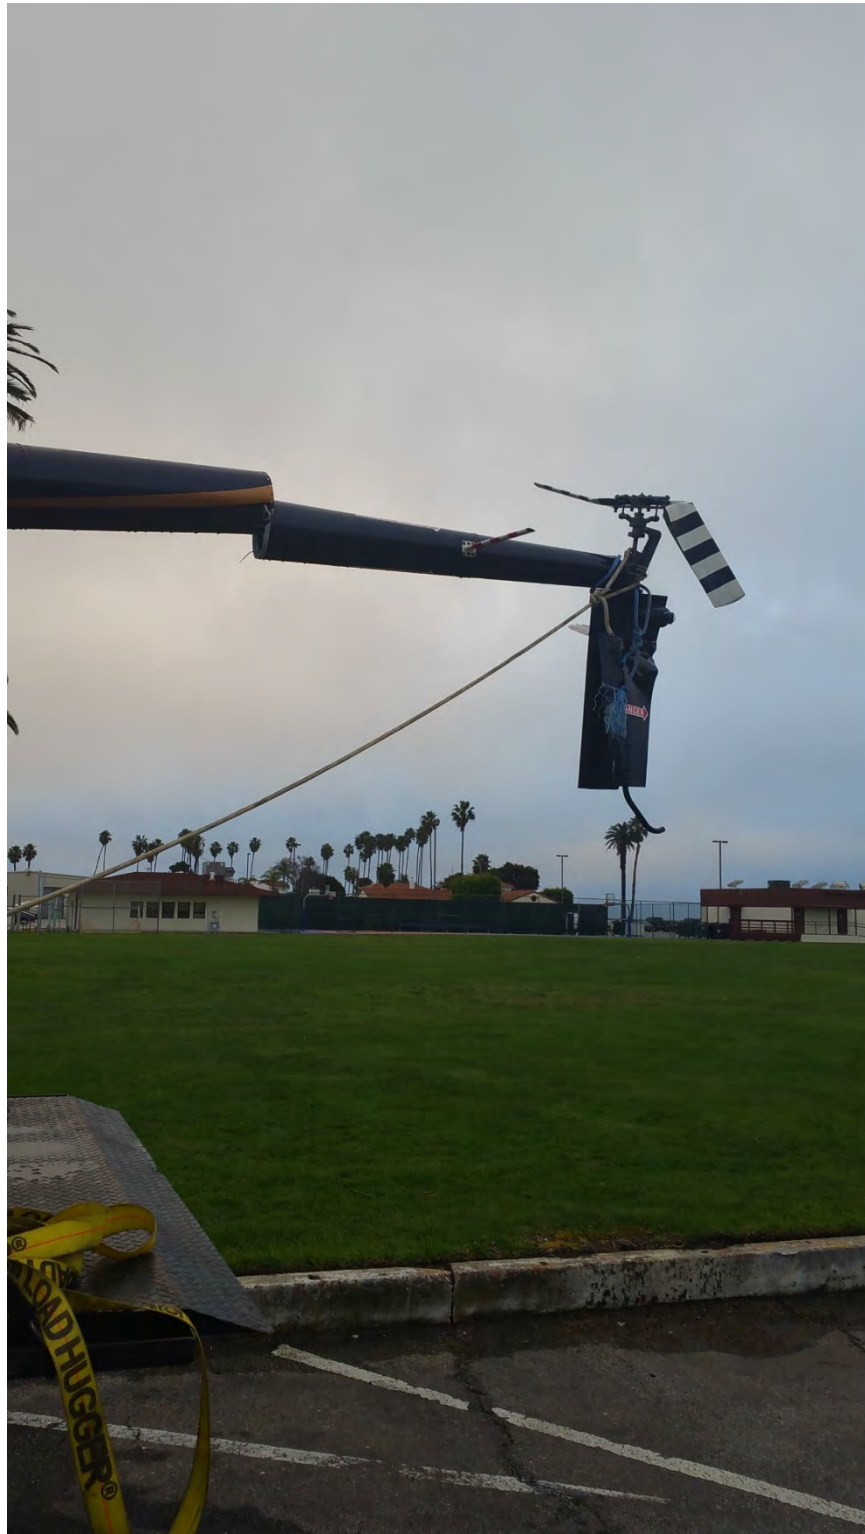
The tail boom separated between the number three and four bays of the tail cone. The lower portion of the vertical stabilizer was bent about 80 degrees counterclockwise.

*Photo 4 Aft Tail Boom*

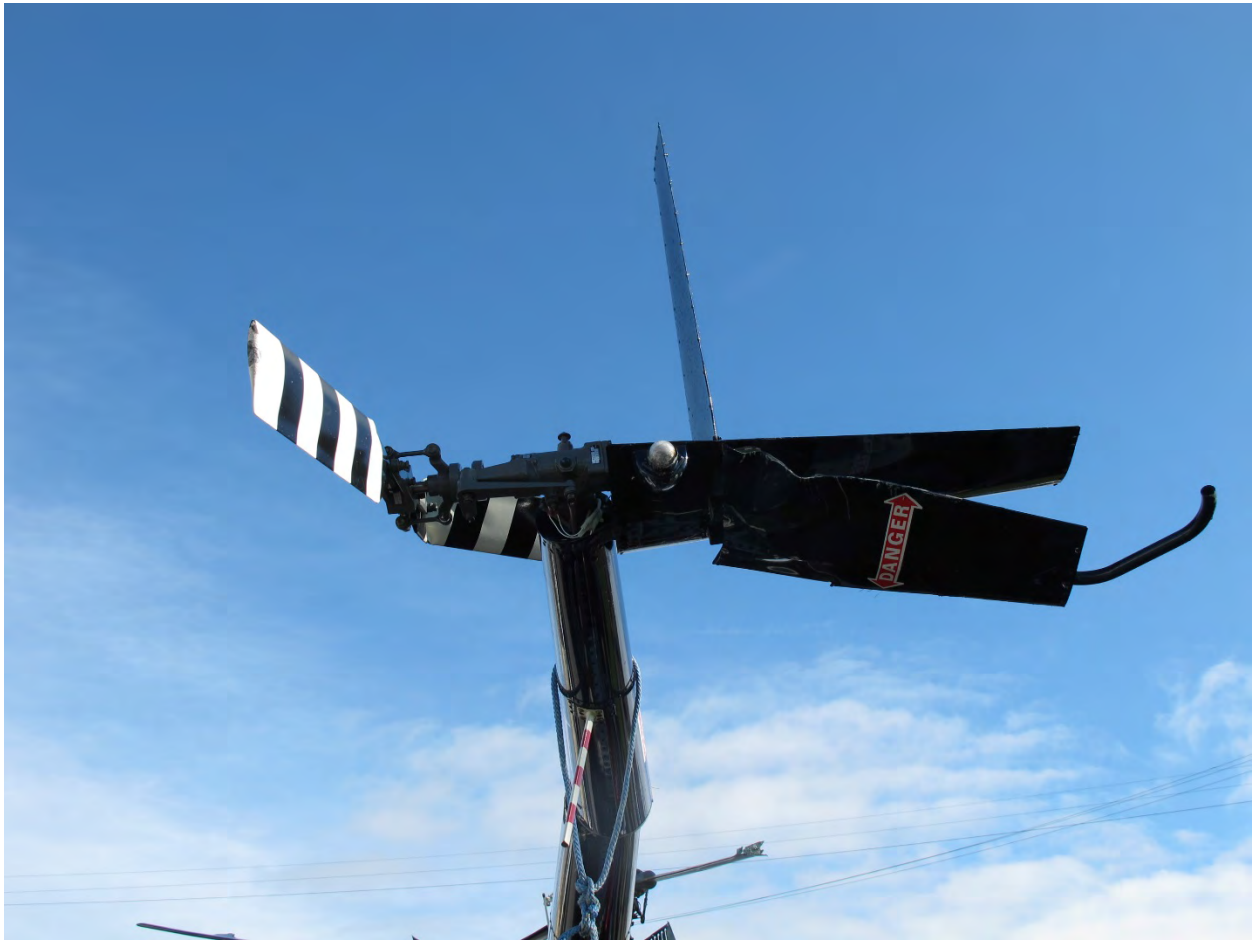
*Photo 5 Tail Rotor*

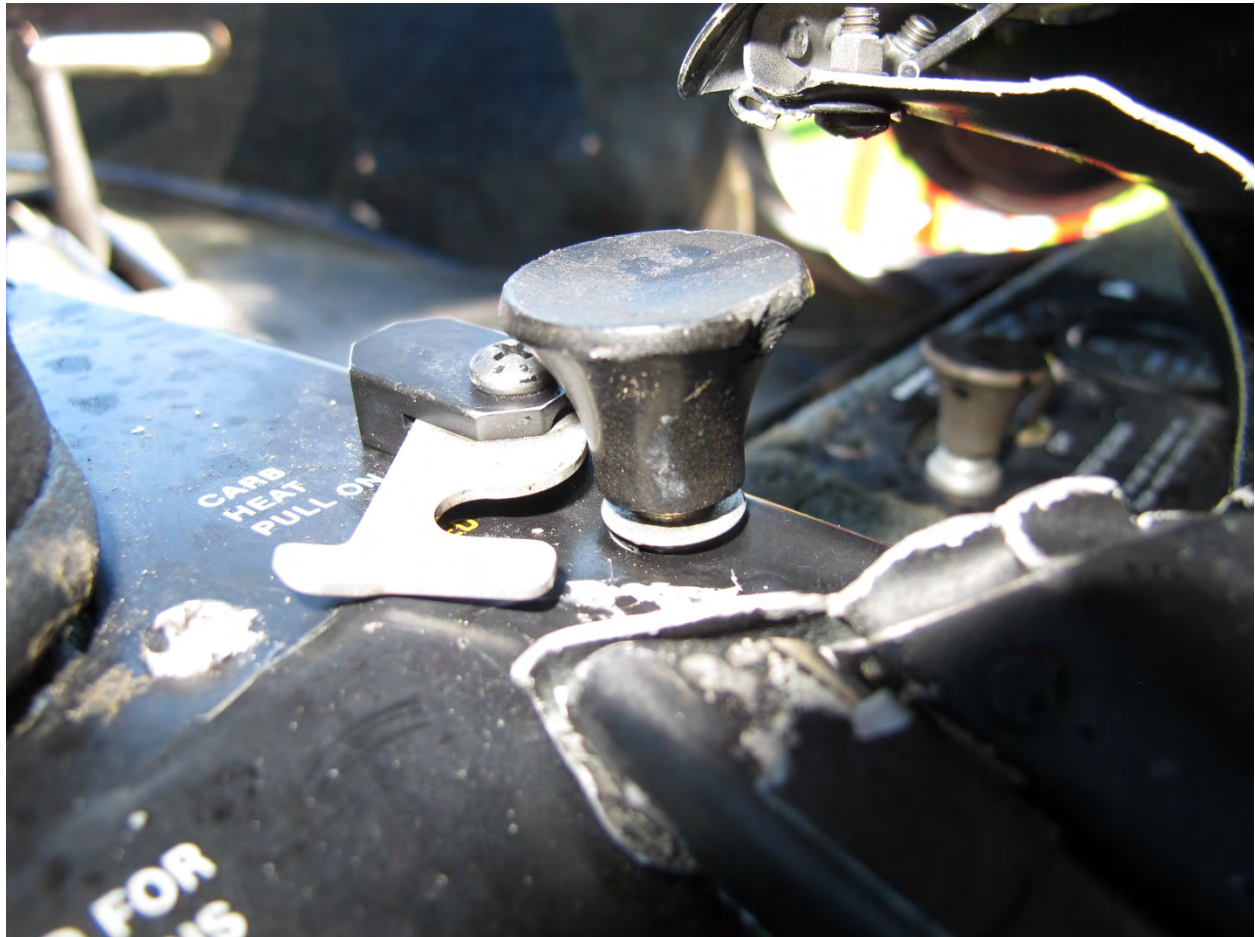
The carburetor heat knob was full down in the full OFF position and unlocked.

*Photo 6 Carburetor Heat Knob*

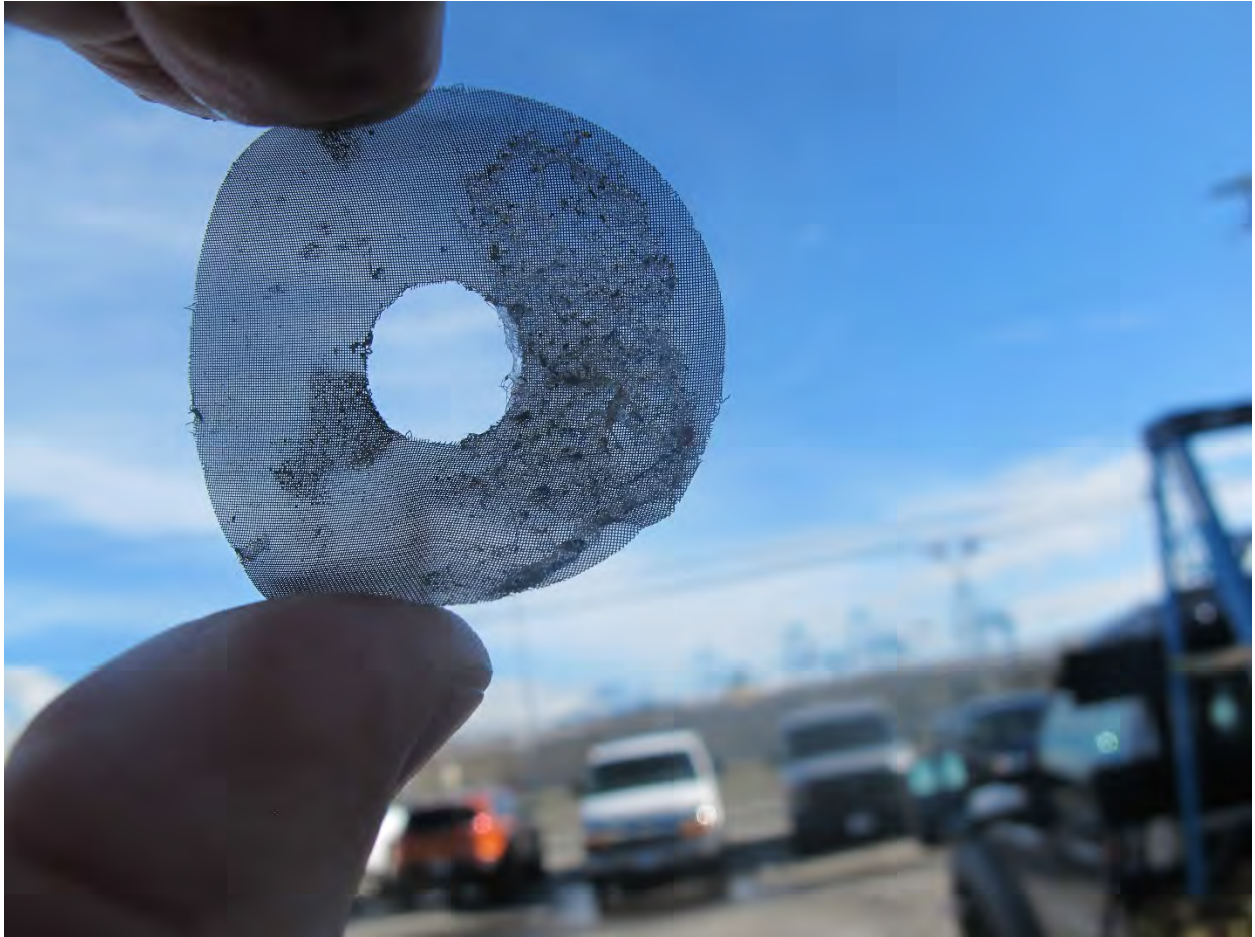
The gascolator contained a clear fluid; the screen was 30% debris covered.

*Photo 7 Gascolator Screen*

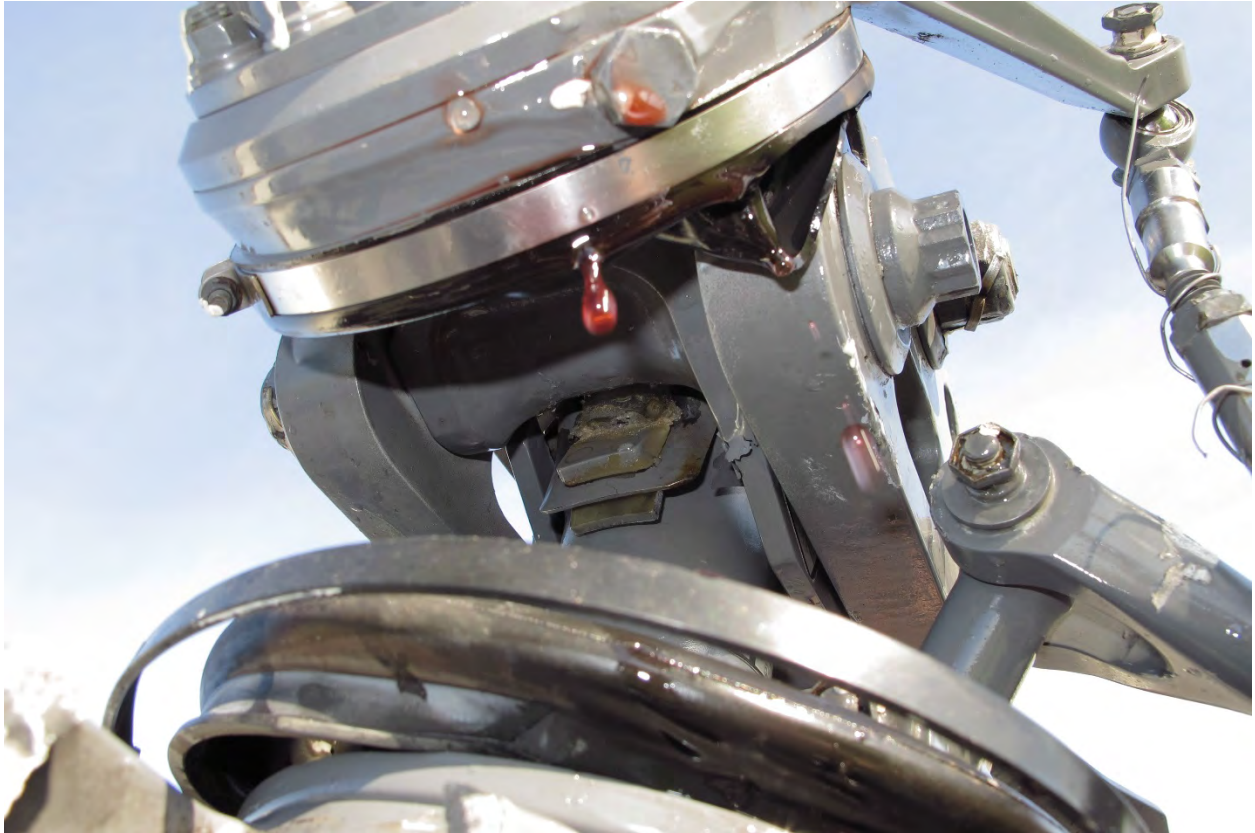
The teeter stops were both smashed across the centers.

*Photo 8 One of the Teeter Stops (Robinson Photo)*

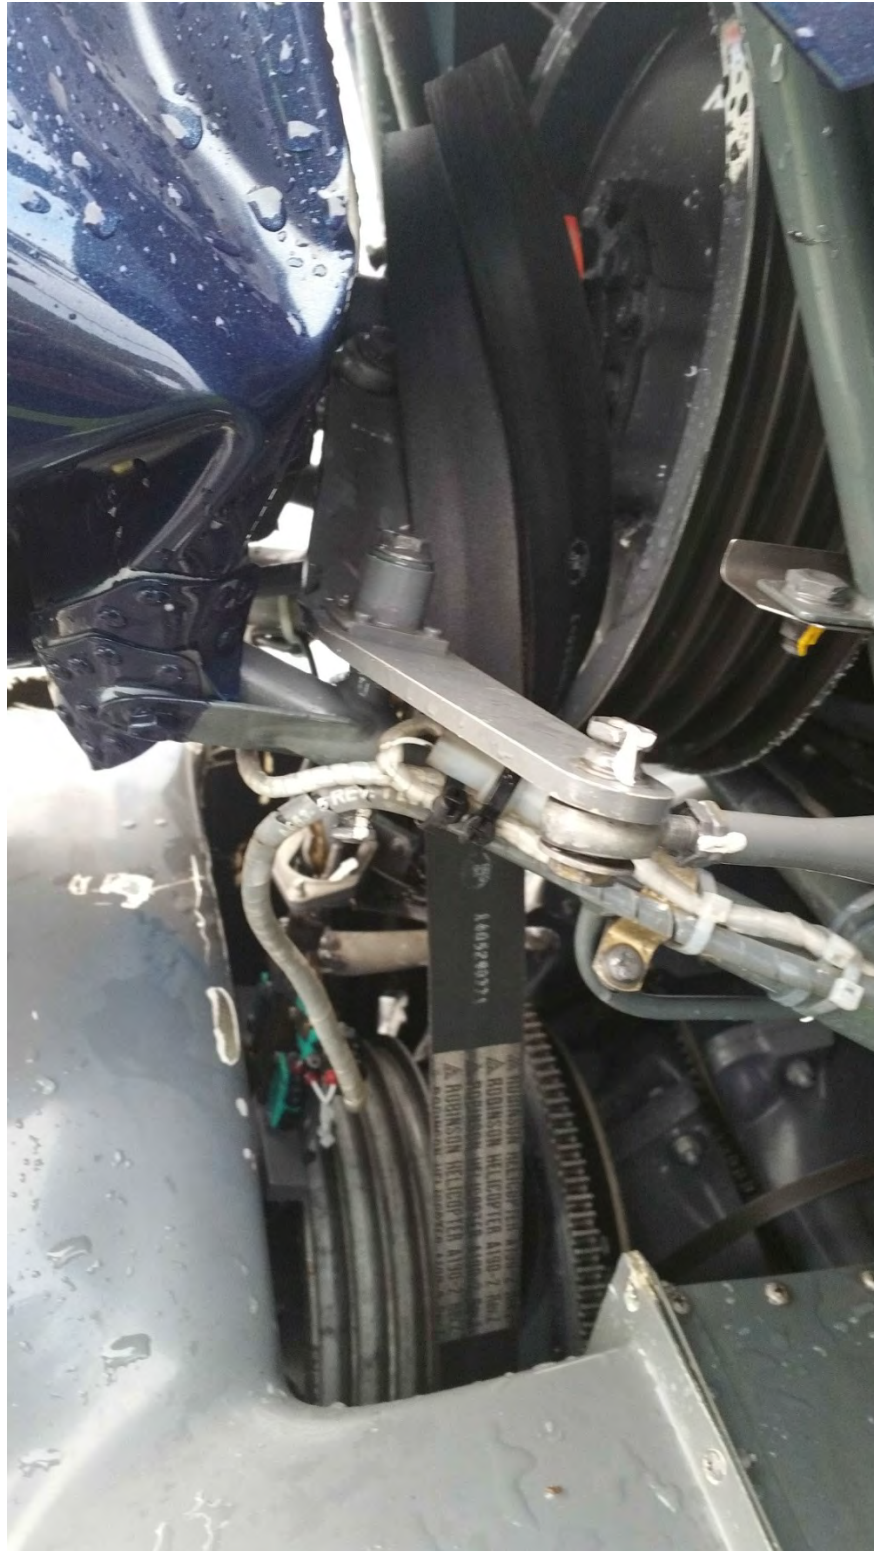
Both drive belts were in the helicopter, but were off the sheaves.

*Photo 9 Drive Belts*

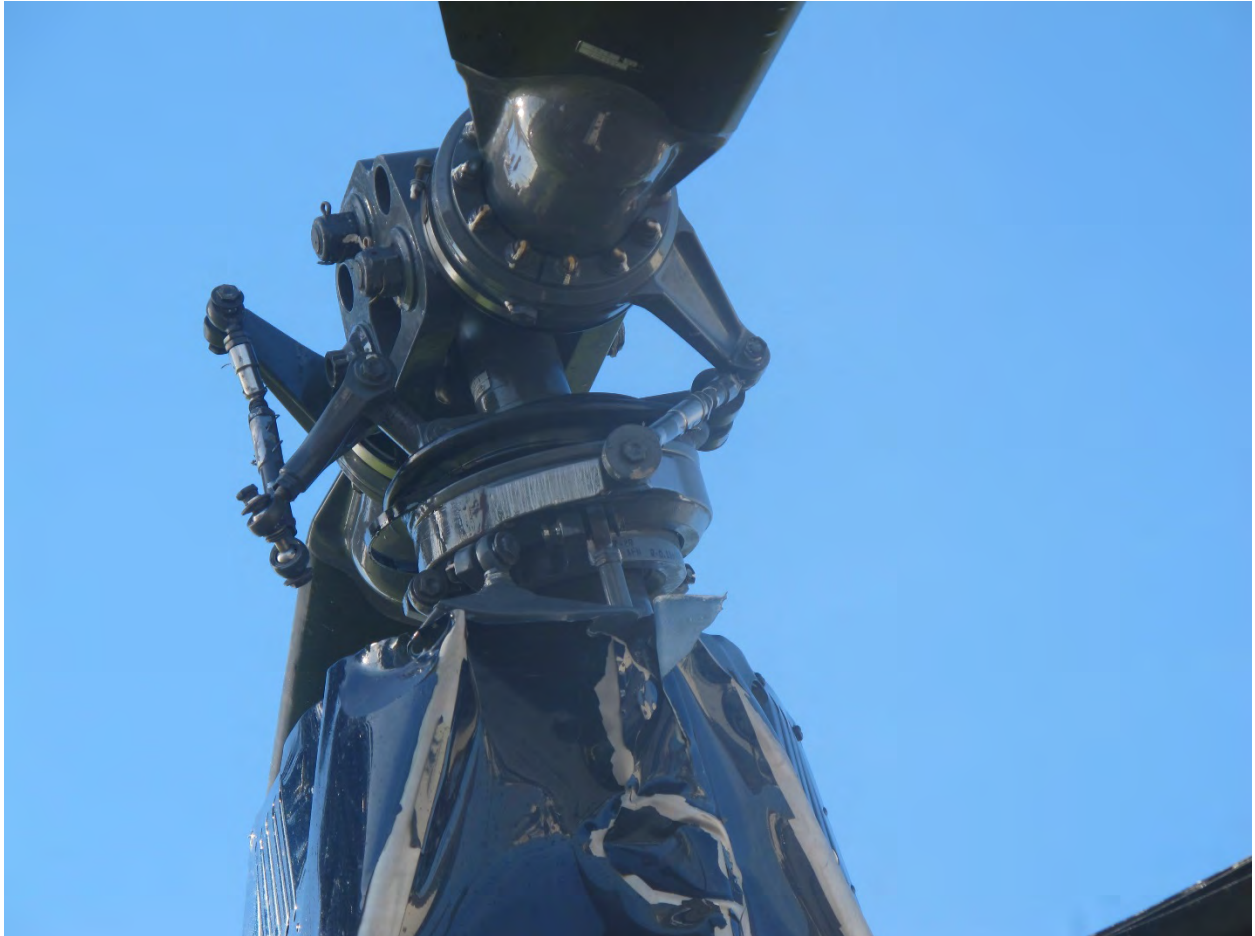
One ear of the swash plate for the main rotor flight controls was broken off. The pitch link remained attached to the main rotor blade.

*Photo 10 One Side of Hub*

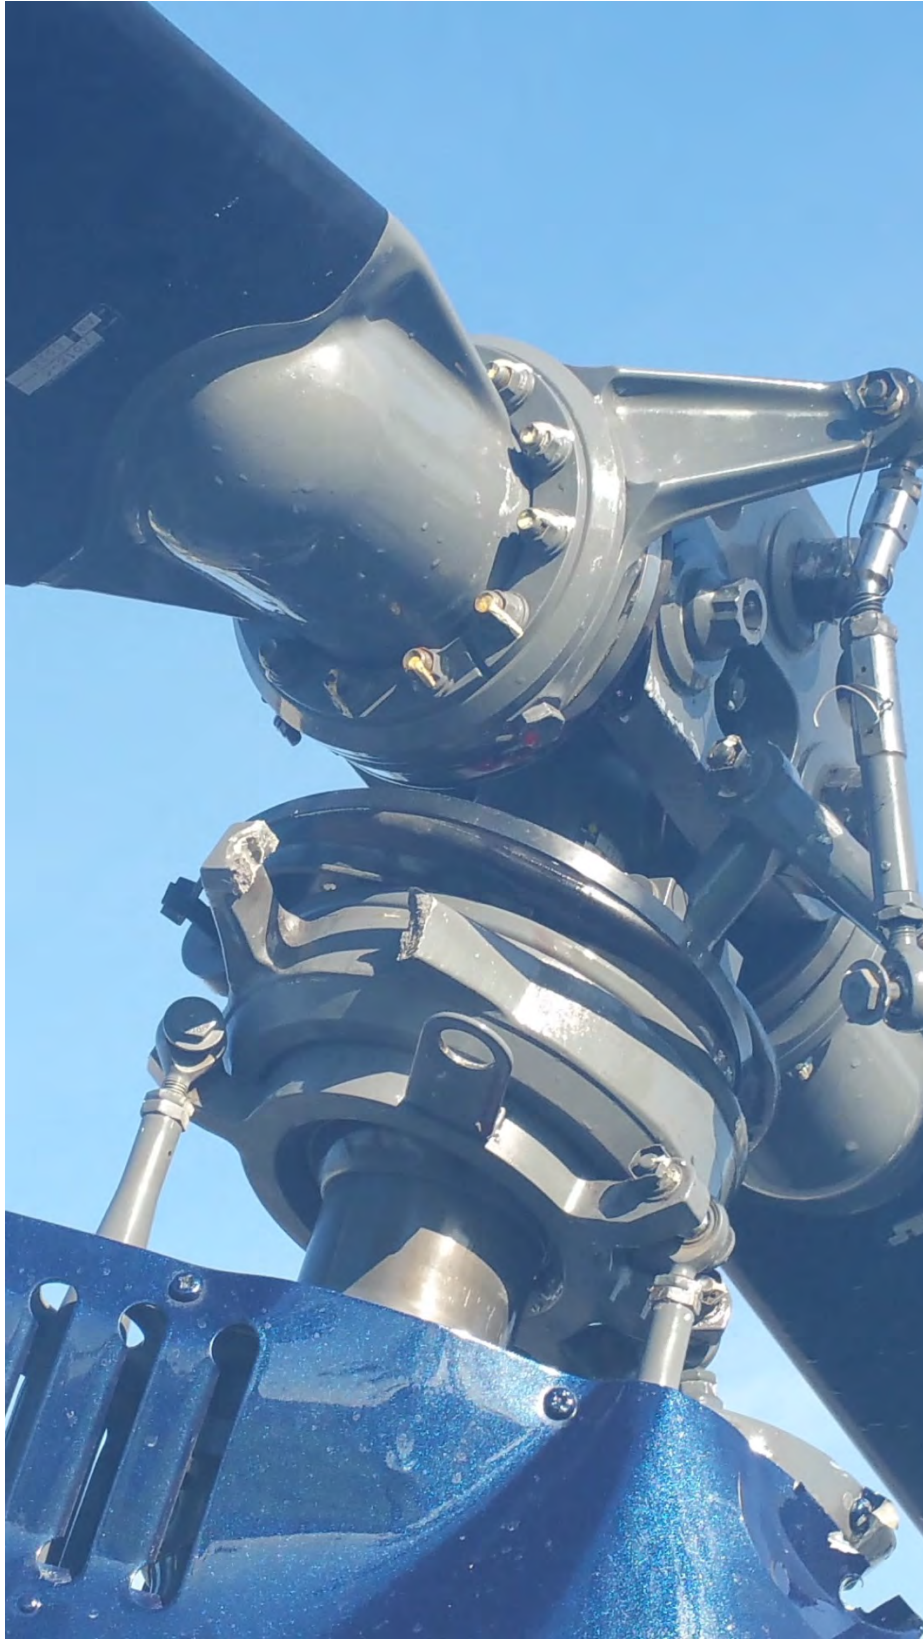
*Photo 11 Main Rotor Hub*

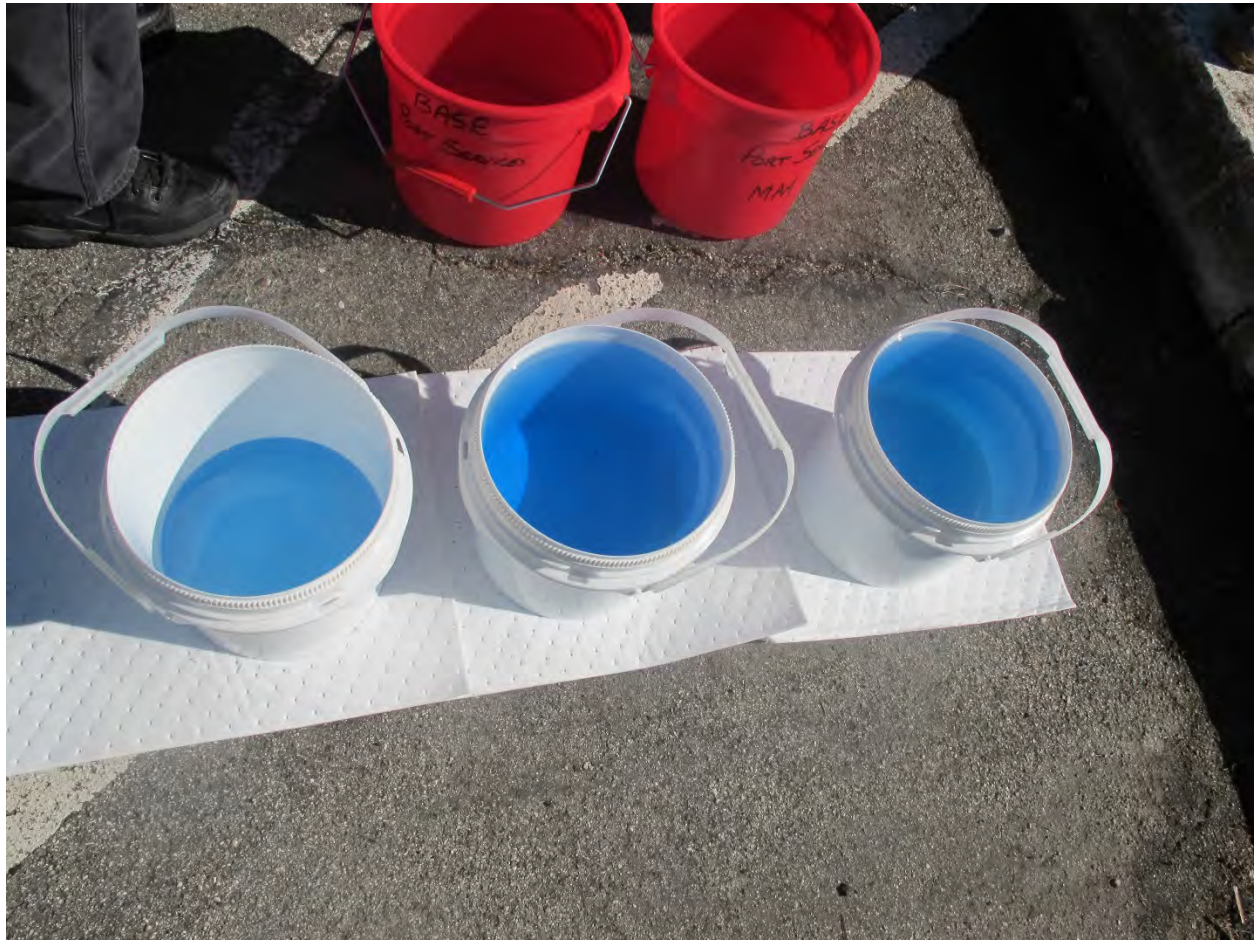
Investigators drained the fuel tanks. There was clear discoloration in the bottom of the buckets with blue fluid on top, and investigators estimated that there were 5 gallons of the blue fluid that looked and smelled like aviation 100-octane low lead fuel.

*Photo 12 Drained Liquid from Fuel Tanks*

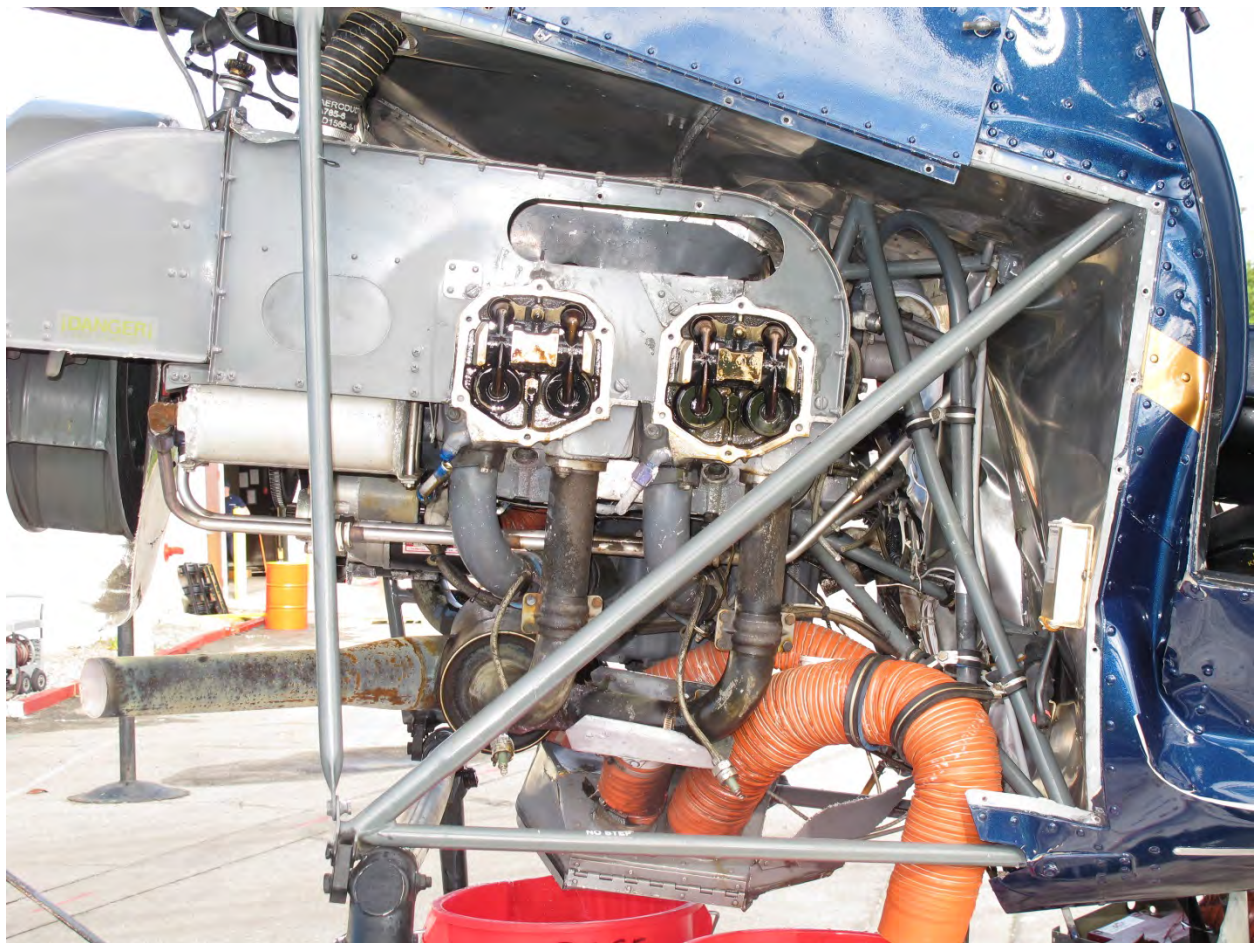
*Photo 13 Left Side of Engine (Right Side of Helicopter)*

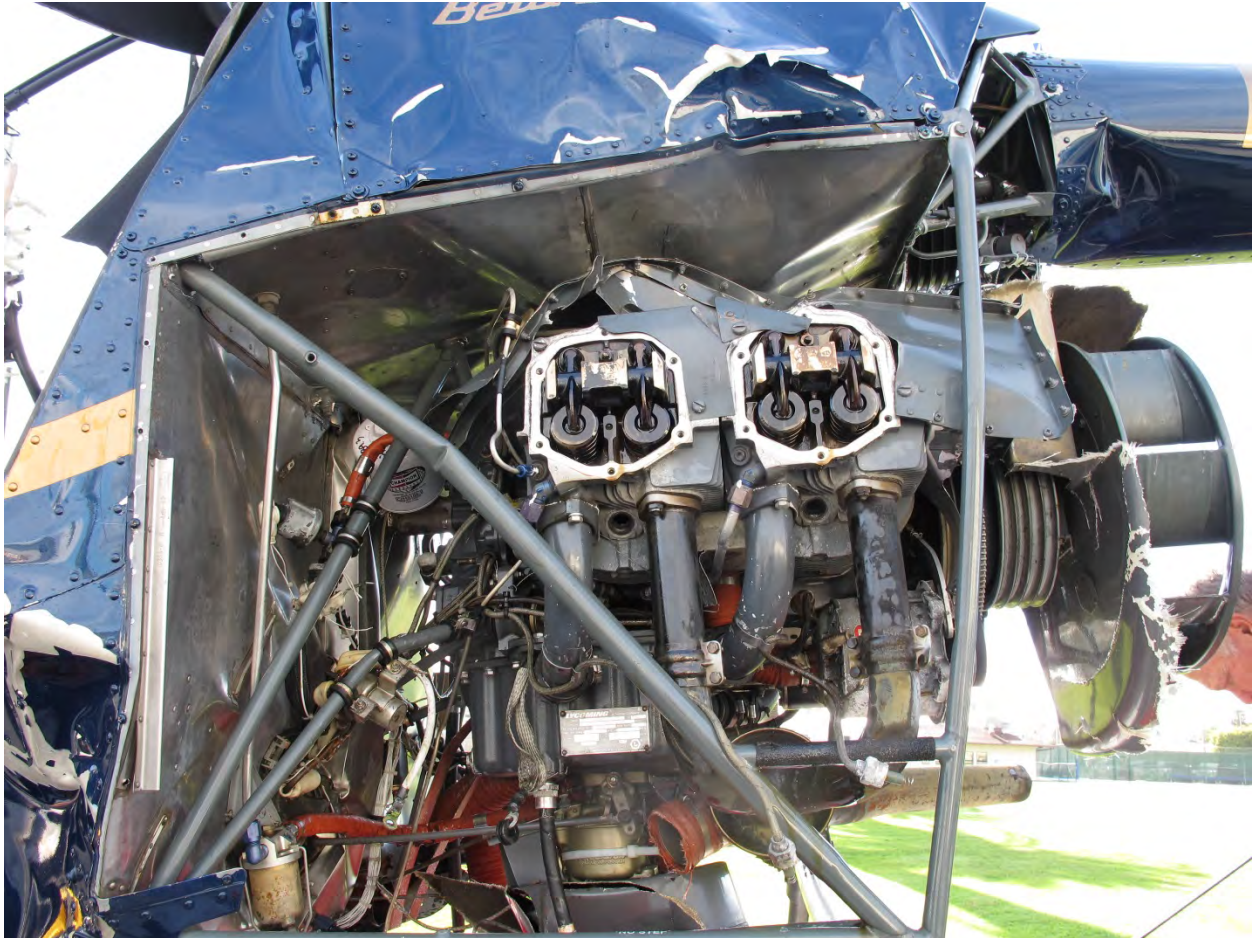
*Photo 14 Right Side of Engine (Left Side of Helicopter)*

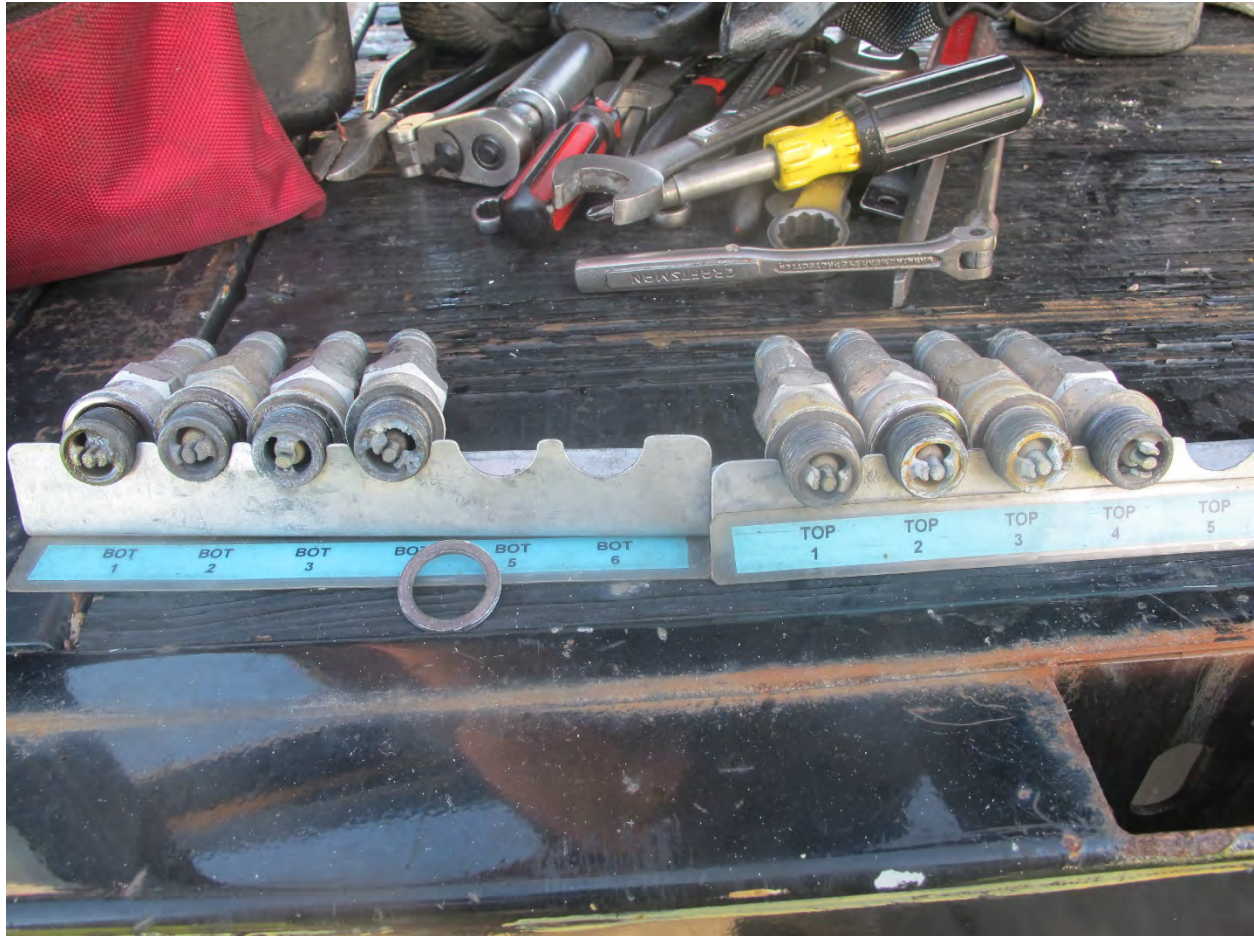
Investigators removed the spark plugs; all center electrodes were elliptical except the top plugs for cylinders one and three, which were circular. All electrodes were clean with no mechanical deformation. The spark plug electrodes were gray, which corresponded to normal operation according to the Champion Aviation Check-A-Plug AV-27 Chart.

*Photo 15 Spark Plugs*

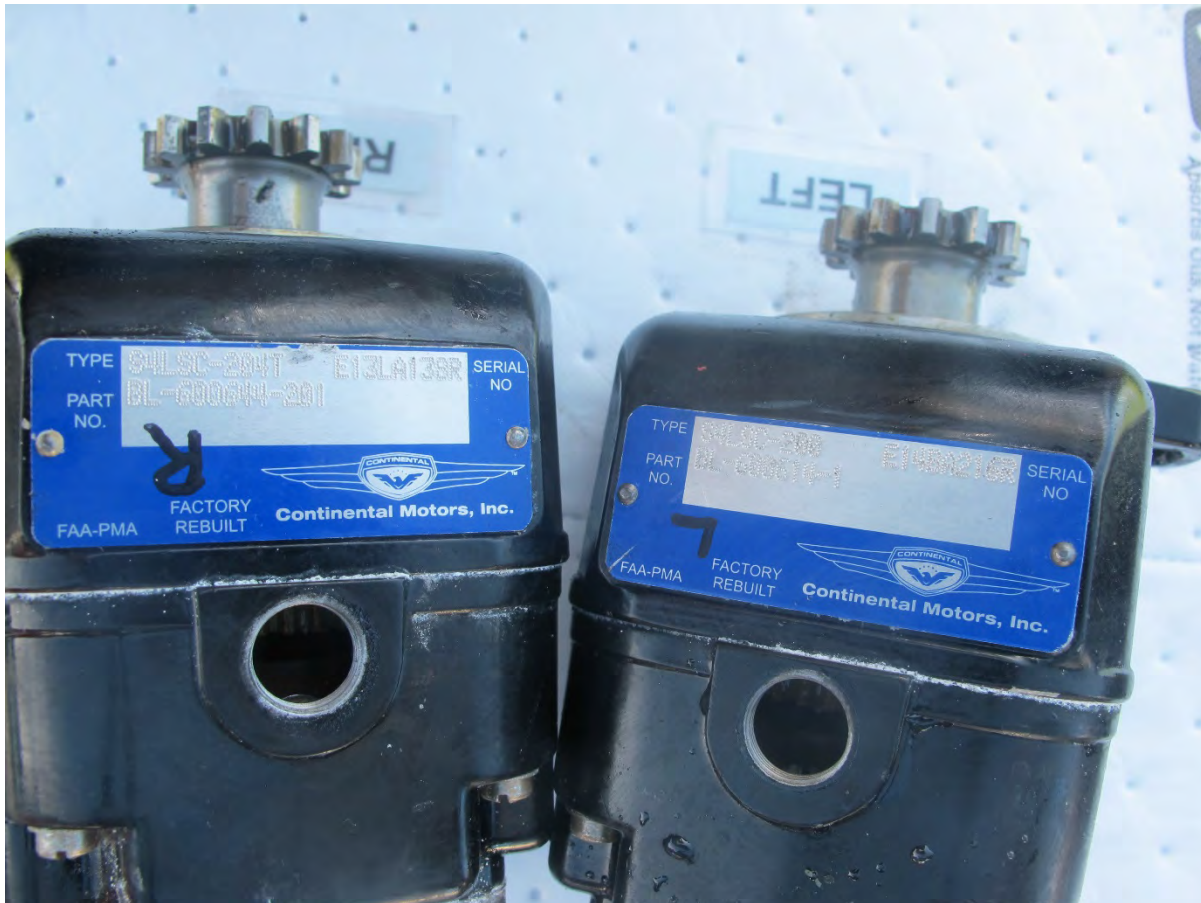
Both magnetos were secure at their respective pads with their mounts in place. Investigators removed them, and the drives were intact. Investigators manually rotated the magnetos, and both magnetos produced spark at all posts. Investigators could not establish engine to magneto timing. The E-gap appeared to be within manufacturer's specifications.

Photo 16 Magnetos

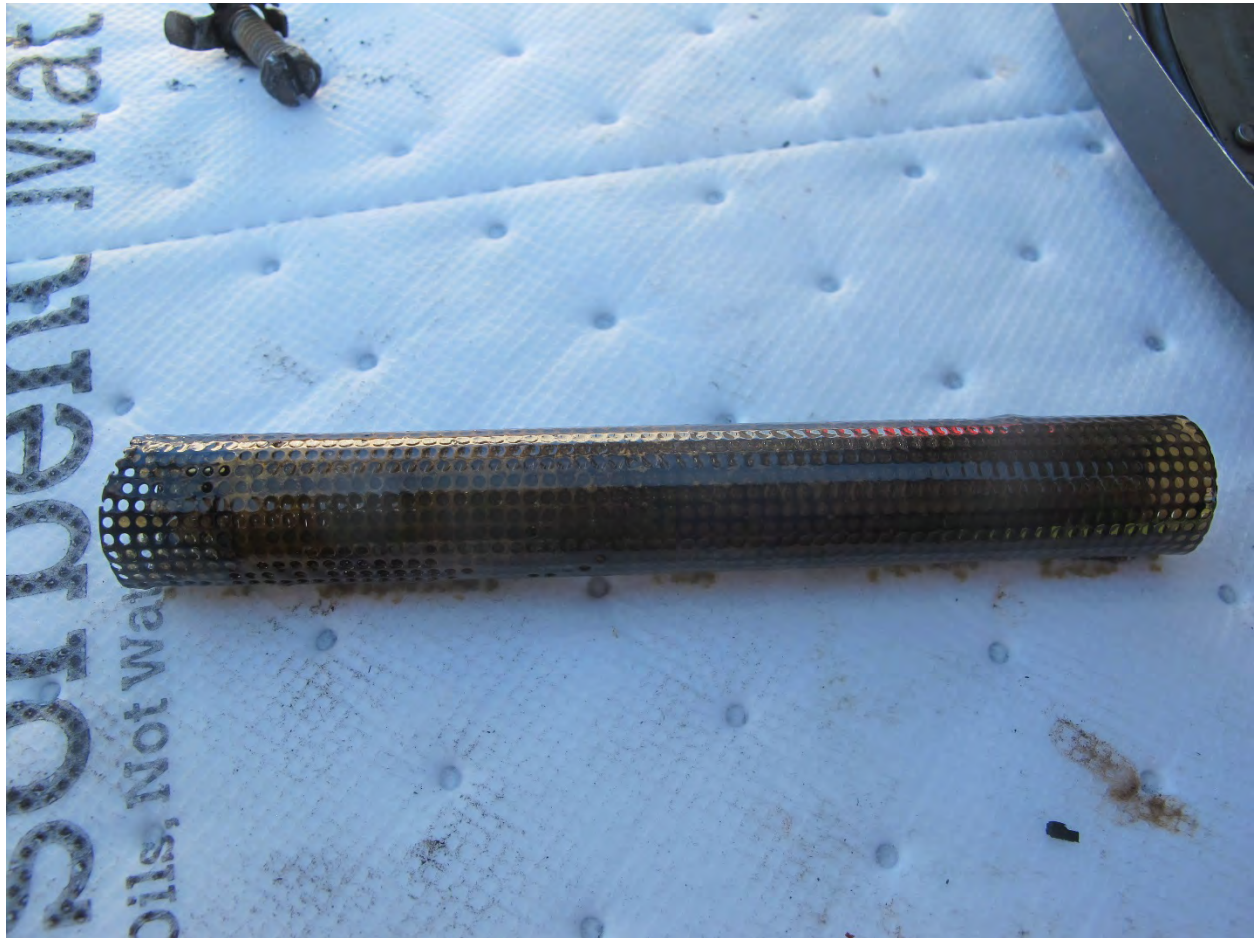
The oil suction screen was clean and free of visible contaminants.

*Photo 17 Oil Suction Screen*

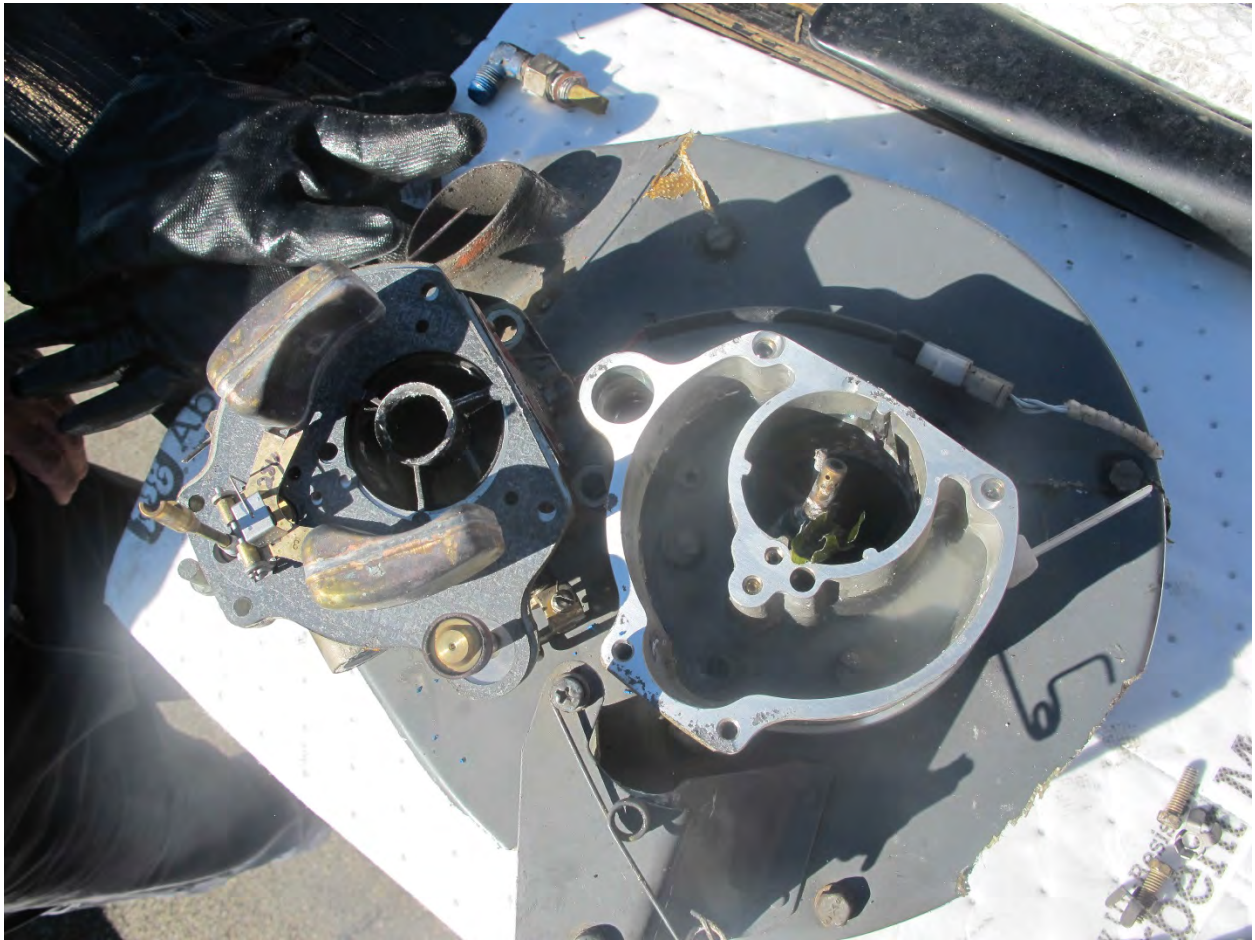
The carburetor was secure at its mount, and all lines were secure. Investigators disassembled the carburetor; the screen was clean, and the bowl contained a clear fluid. The metal floats were secure and intact, and exhibited no hydraulic crush damage. There were no obstructions to air passages.

*Photo 18 Carburetor*
