## **NATIONAL TRANSPORTATION SAFETY BOARD**

### **AIRFRAME AND ENGINE EXAM REPORT**

WPR17FA047

Location: San Pedro, CA  
Date: January 4, 2017  
Aircraft: Robinson R22 Beta, Registration Number: N702JJ, Serial #: 3791  
NTSB IIC: Howard Plagens

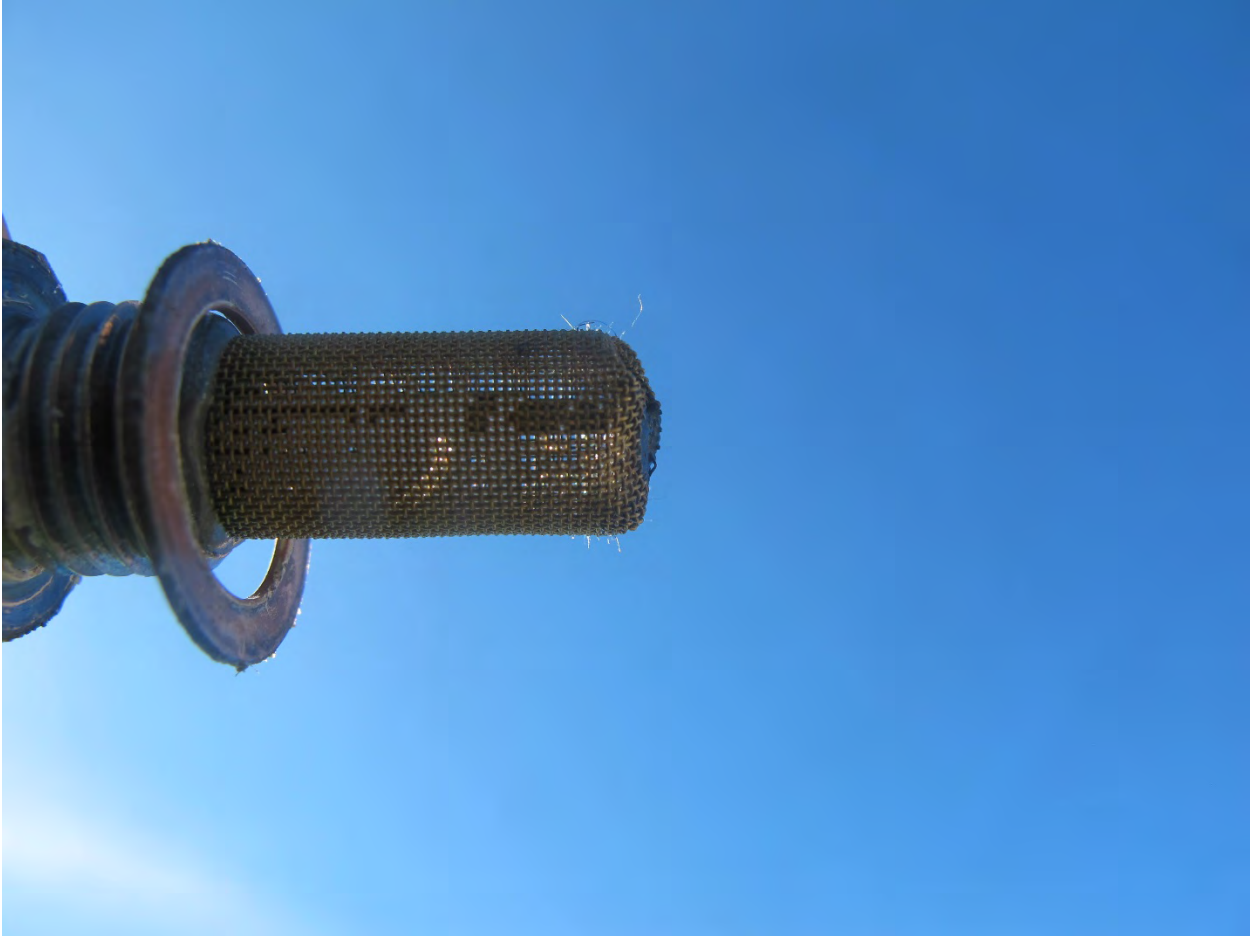
*Photo 19 Carburetor Screen*

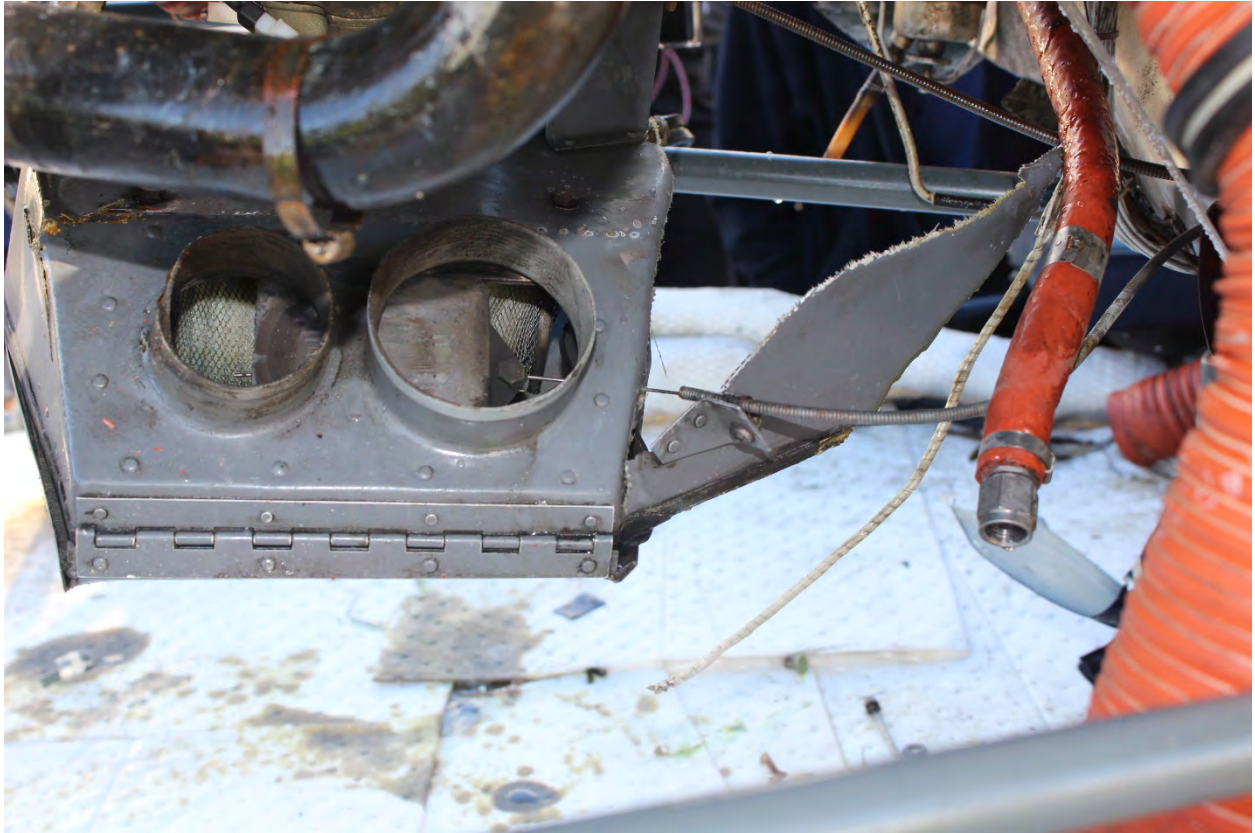
The carburetor heat slider on the airbox in was in a midrange position, but the airbox and control wire housing was deformed.

*Photo 20 Robinson Photo of Air Box*

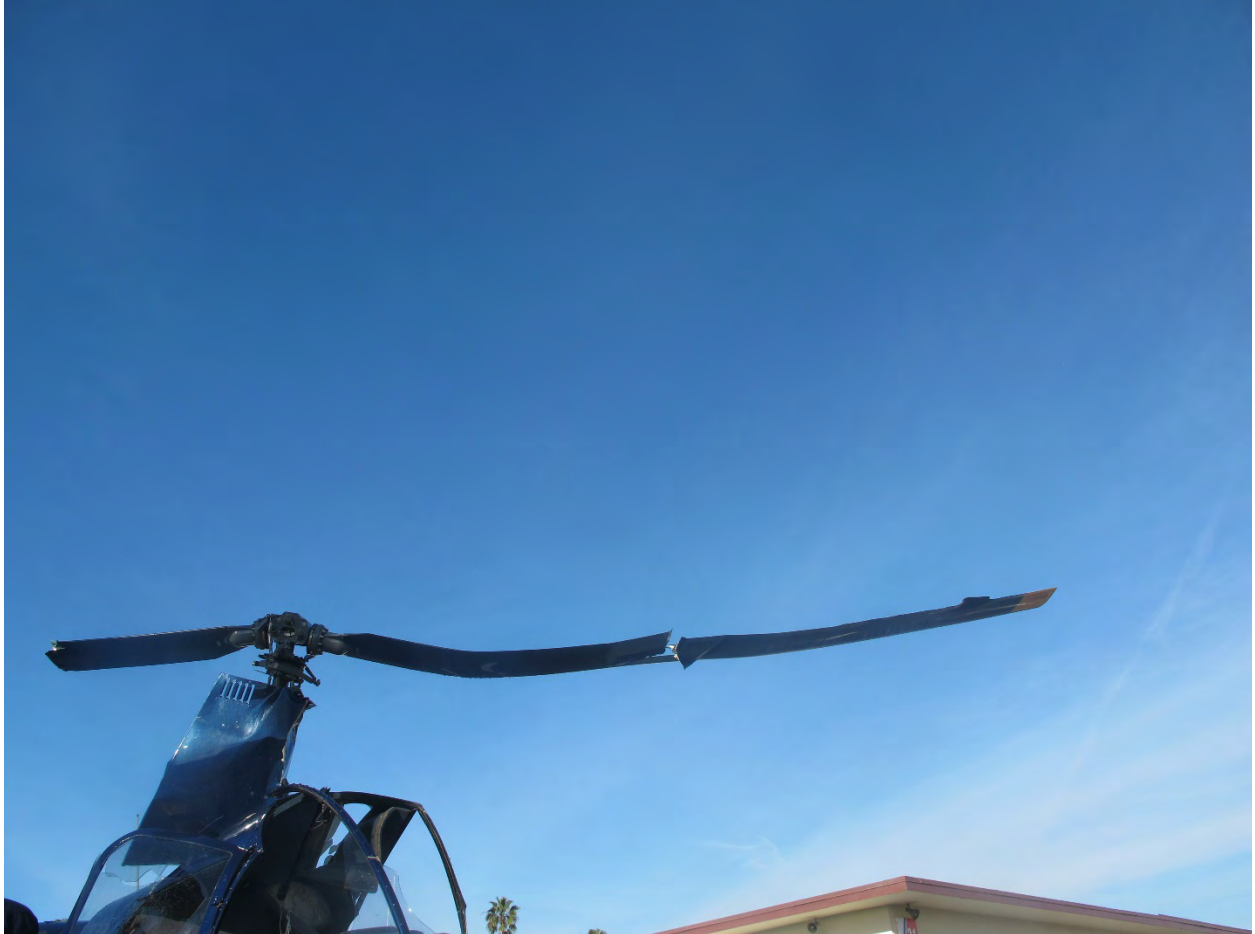
Both main rotor blades bent down at the hub, and then bent upward about 2 feet out. One blade separated at that point along a jagged angle. The other main rotor blade coned upward at that point, retained its full length, but had a tear at midspan from the trailing edge to the back of the spar.

*Photo 21 Main Rotor Blades*

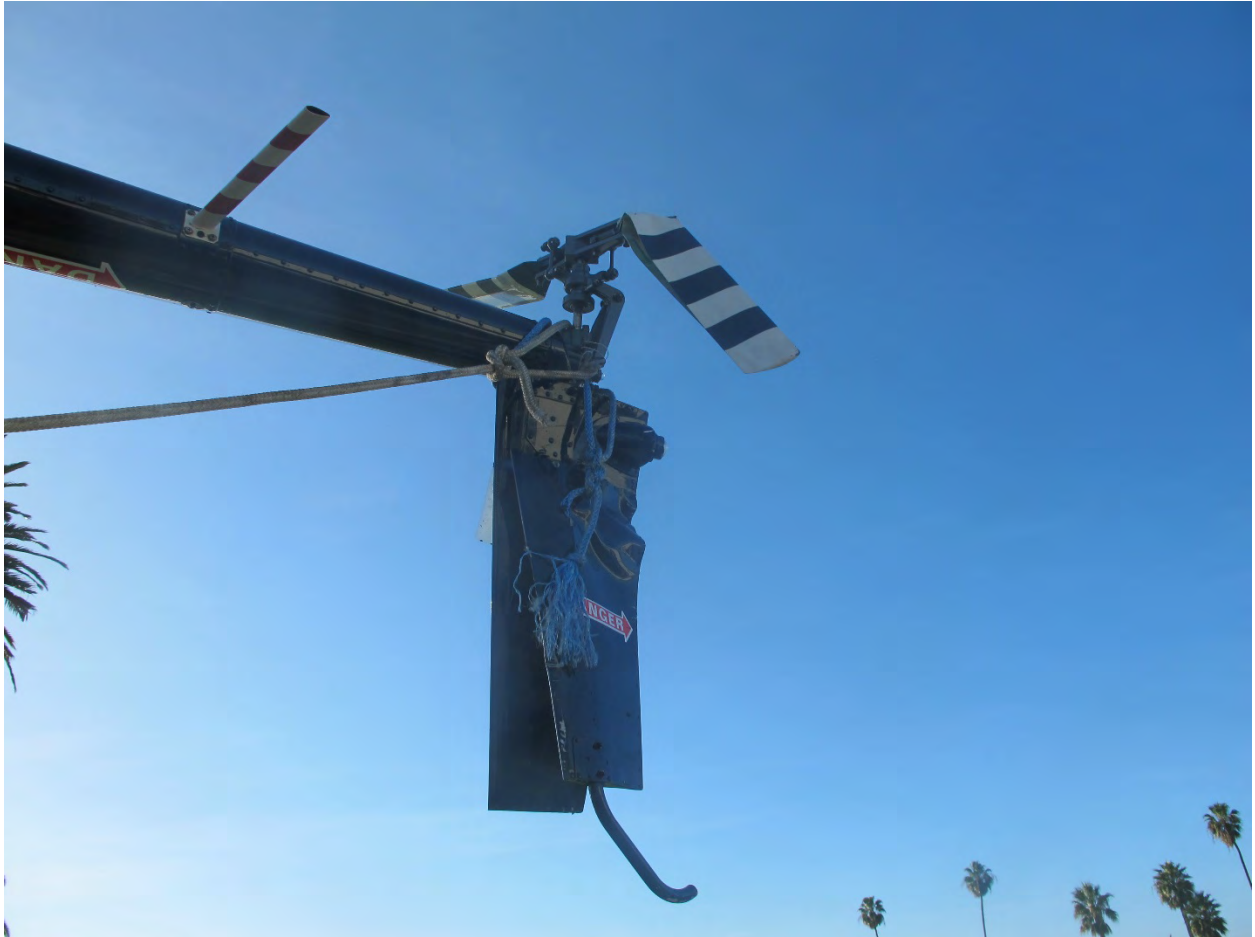
Both blades remained attached to the hub. One blade was bent inboard about 50 degrees, and split along the inboard half of the trailing edge.

*Photo 22 Tail Rotor*
