## **NATIONAL TRANSPORTATION SAFETY BOARD**

# **AIRFRAME AND ENGINE EXAMINATION SUMMARY**

**WPR17FA063**

| Aircraft: | N2179L; Cessna 172S |

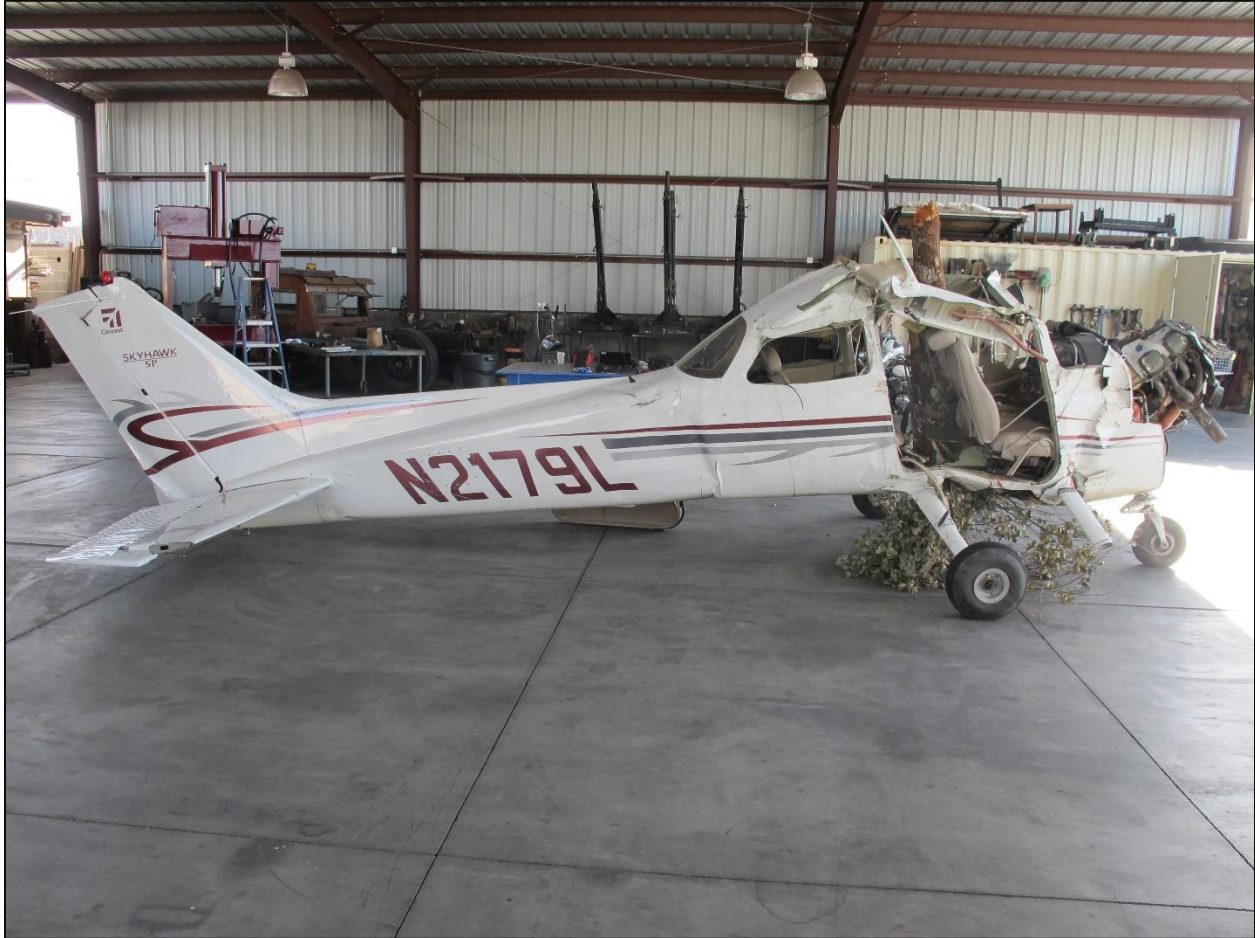
Figure 1-Main Wreckage

Examination of the accident site by a Federal Aviation Administration (FAA) inspector, revealed that the airplane impacted a large tree and steep terrain. The tree penetrated through the main cabin floor and roof. The main wreckage remained intact with the exception of the propeller assembly which was located near the main wreckage. The wreckage was relocated to a secure facility for further examination.

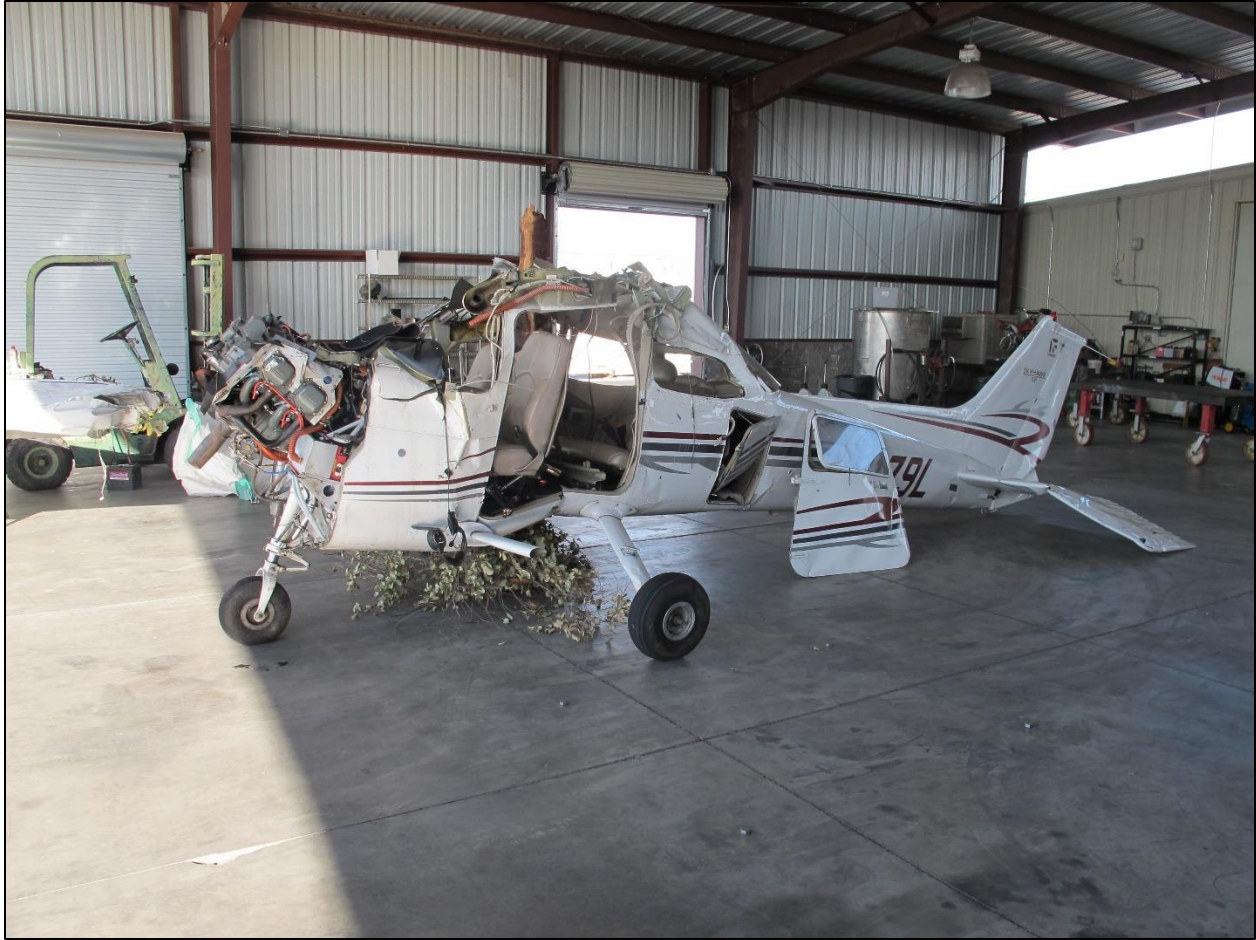
**Figure 2-Main Wreckage**

Examination of the recovered airframe revealed that a limb from a large tree protruded through the cabin floor continuing up through the cabin roof. The limb at the cabin floor was about 12 inches in diameter and about eight inches in diameter near the roof. The lower section of the limb located near the floor had several control cables protruding upwards over the limb, two of the cables revealed tension overload signatures. The limb was cut by recovery personnel about a foot below the fuselage and above the cabin roof. The tree section could not be removed from the wreckage. The fuselage was buckled in several areas. The engine, and the upper section of the firewall was pushed aft, resulting in the deformation of the instrument panel. The propeller assembly and attached crankshaft propeller flange separated from the engine. The cabin seats remained attached and undamaged. The right forward seat inboard aft section of the seat rail separated. Both entry doors separated from the wreckage. The wings had impact damage and were removed during the recovery process.

Control cable continuity was established through tension overload signatures on both elevator and right rudder control cables. Control cable continuity was also found forward of the limb location in the cabin.

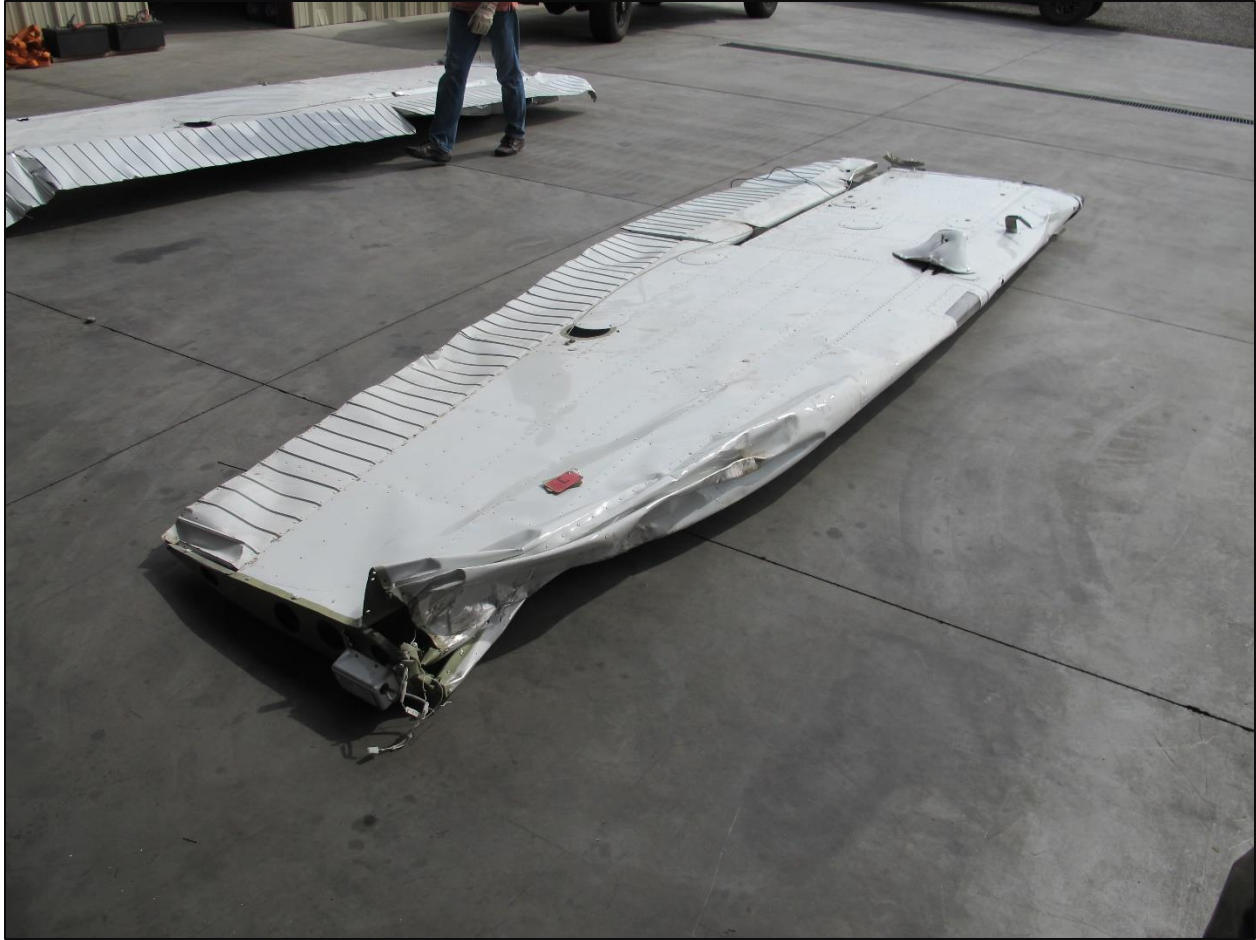
**Figure 4-Wings**

The wings were removed by recovery personnel. Both wing outboard sections had leading edge crushing and the fiberglass tips separated. The right wing lower leading edge section from the midsection of to the tip was crushed upwards. Per the flap jack screw, the flap position was found to be in the up position. The fuel caps on both wings had a missing vent seal. The right wing fuel cap was not attached to its lanyard, which was located and attached to the wing. The wings upper and lower surfaces were buckled. The wing struts were cut and separated during recovery efforts.

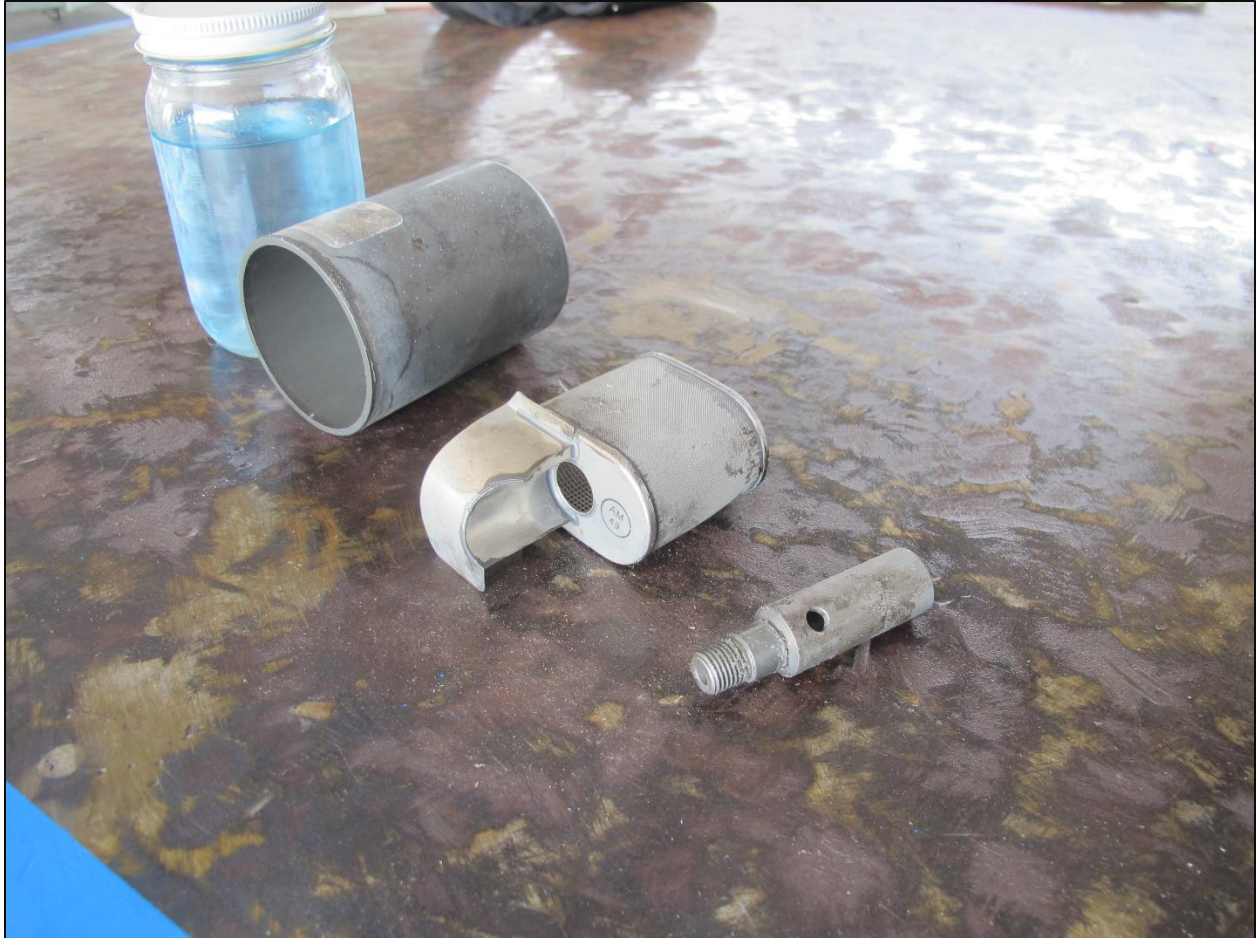
**Figure 5-Fuel Strainer**

About 2 ounces of fuel was drained from the fuel reservoir tank and was clear of debris. About 10 ounces of fuel was drained from the fuel strainer which exhibited light colored debris. The fuel strainer was disassembled and displayed on an examination table. An RTV type sealant was found on and near the attachment screw. The screen was clear of debris and the bowl had light sediment near the bottom. Black greasy fingerprints were found on the screen and a down tube.

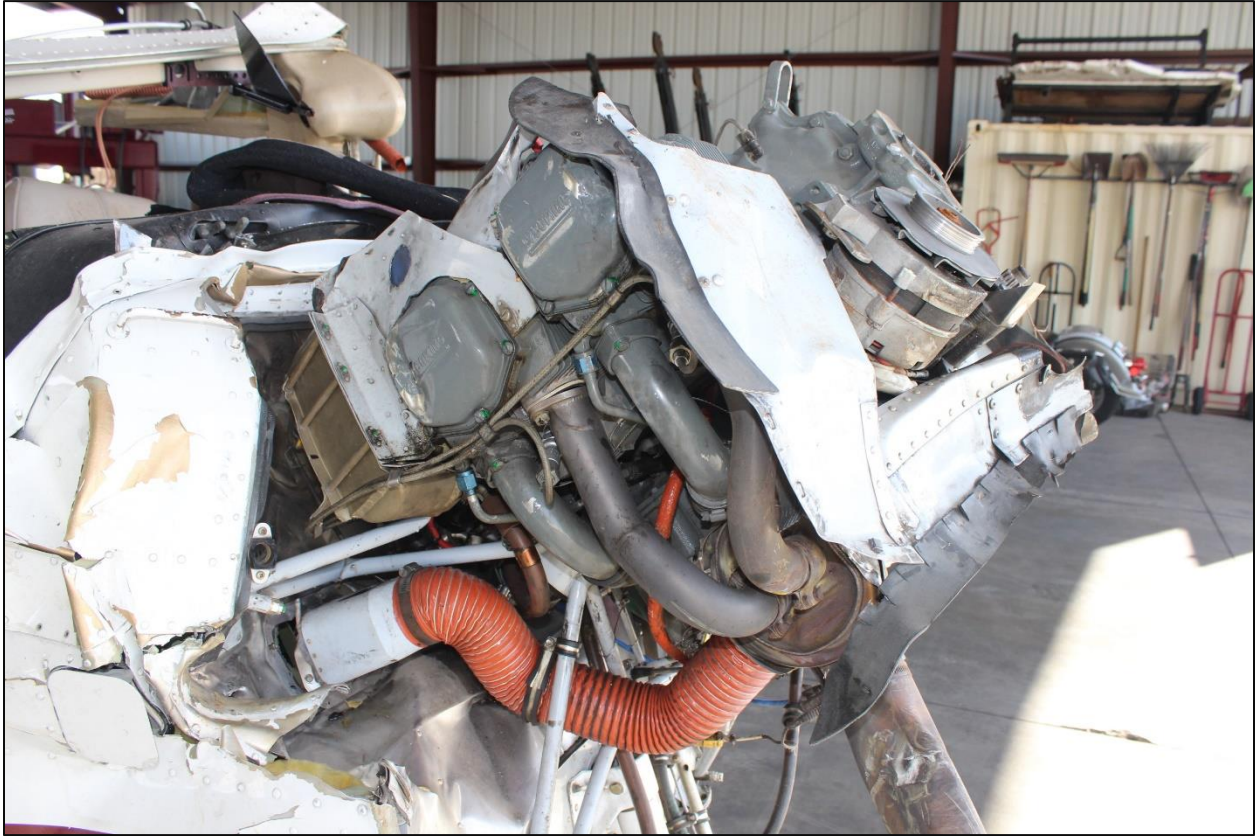
**Figure 6-Airframe and Engine**

The Lycoming IO-360-L2A engine remained attached to the airframe by the engine mount. The engine had sustained moderate impact energy damage at the exhaust system and engine mount. The propeller and attached crankshaft flange had been displaced. Visual examination of the engine revealed no evidence of pre-impact catastrophic mechanical malfunction or fire.

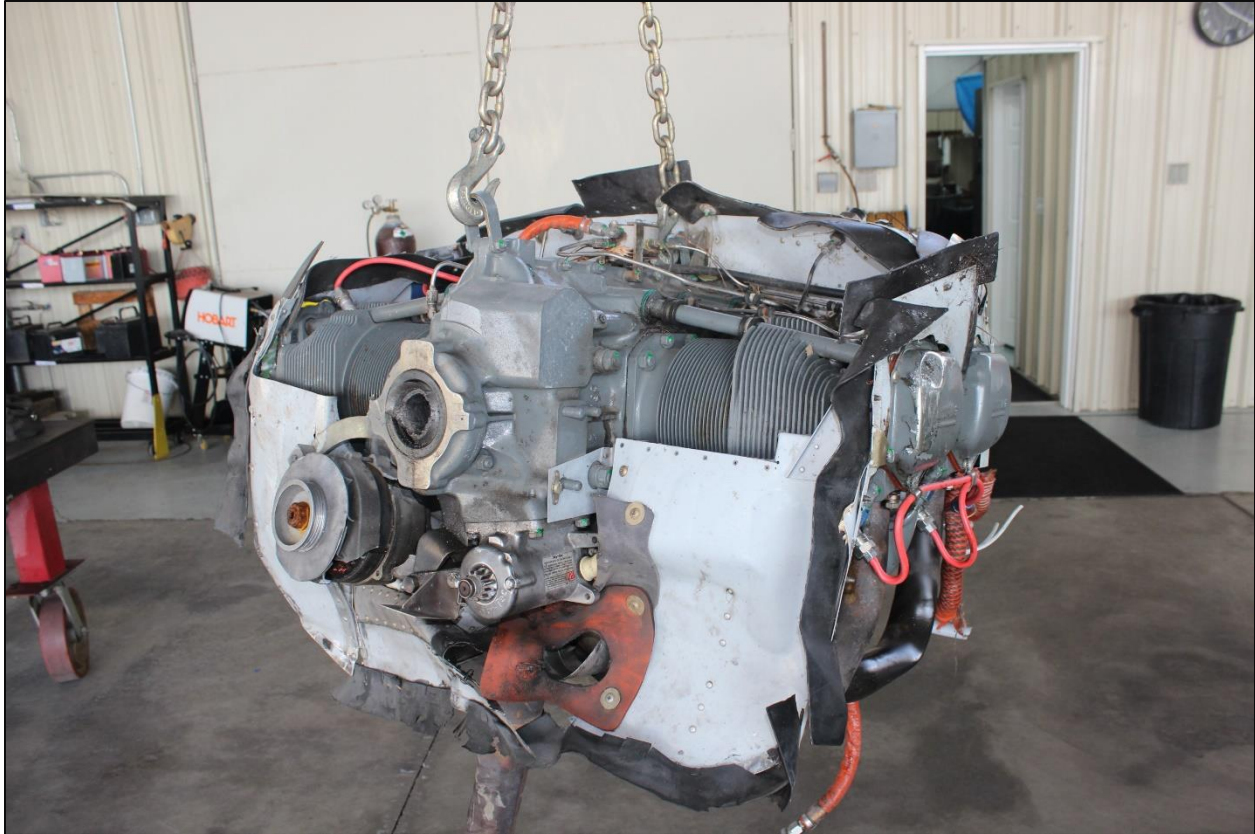
**Figure 7-Engine Examination, Forward Side**

The top spark plugs were removed, examined and photographed. The vacuum pump was removed, and the crankshaft was rotated by hand through the drive pad utilizing a drive tool. The crankshaft was free and easy to rotate in both directions. "Thumb" compression was observed in proper order on all four cylinders. The complete valve train was observed to operate in proper order, and appeared to be free of any pre-mishap mechanical malfunction. Normal "lift action" was observed at each rocker assembly. Clean, uncontaminated oil was observed at all four rockerbox areas. Mechanical continuity was established throughout the rotating group, valve train and accessory section during hand rotation of the crankshaft. The bottom spark plugs were removed, examined and photographed. The combustion chamber of each cylinder was examined through the spark plug holes utilizing a lighted borescope. The combustion chambers remained mechanically undamaged, and there was no evidence of foreign object ingestion or detonation. The valves were intact and undamaged. There was no evidence of valve to piston face contact observed. The gas path and combustion signatures observed at the spark plugs, combustion chambers and exhaust system components displayed coloration consistent with normal operation. There was no oil residue observed in the exhaust system gas path. There was significant ductile bending of the exhaust system components.

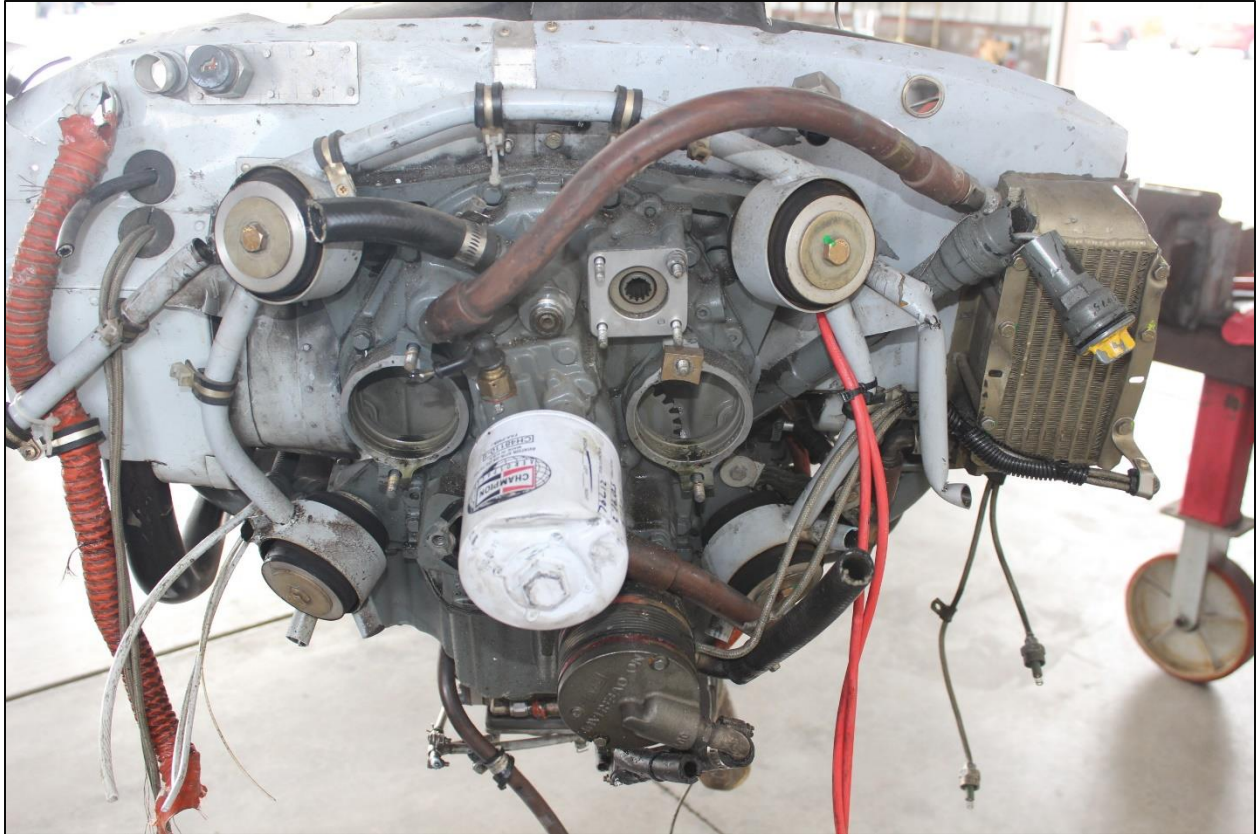
**Figure 8-Engine Aft Side**

The left and right magnetos remained securely clamped at their respective mounting pads. The ignition harness was secure at each magneto. Magneto to engine timing could not be ascertained, due to the displacement of the flywheel. The magnetos were removed for examination. Each magneto produced spark at the end of the respective spark plug lead, during hand rotation of the drive. The drives of each magneto remained intact and undamaged. The "P" lead at each magneto was secure at the electrical post. There was no evidence of pre-impact mechanical malfunctions observed during the examination of the engine.

The spark plugs were secure at each position with their respective spark plug lead attached. The spark plugs were removed, examined and photographed. The spark plug electrodes remained mechanically undamaged, and according to the Champion Spark Plugs "Check-A-Plug" chart AV-27, the spark plug electrodes displayed coloration consistent with normal operation. The static oil soaking of the spark plugs (as noted) was attributed to the engine positioning at the mishap site and post recovery.

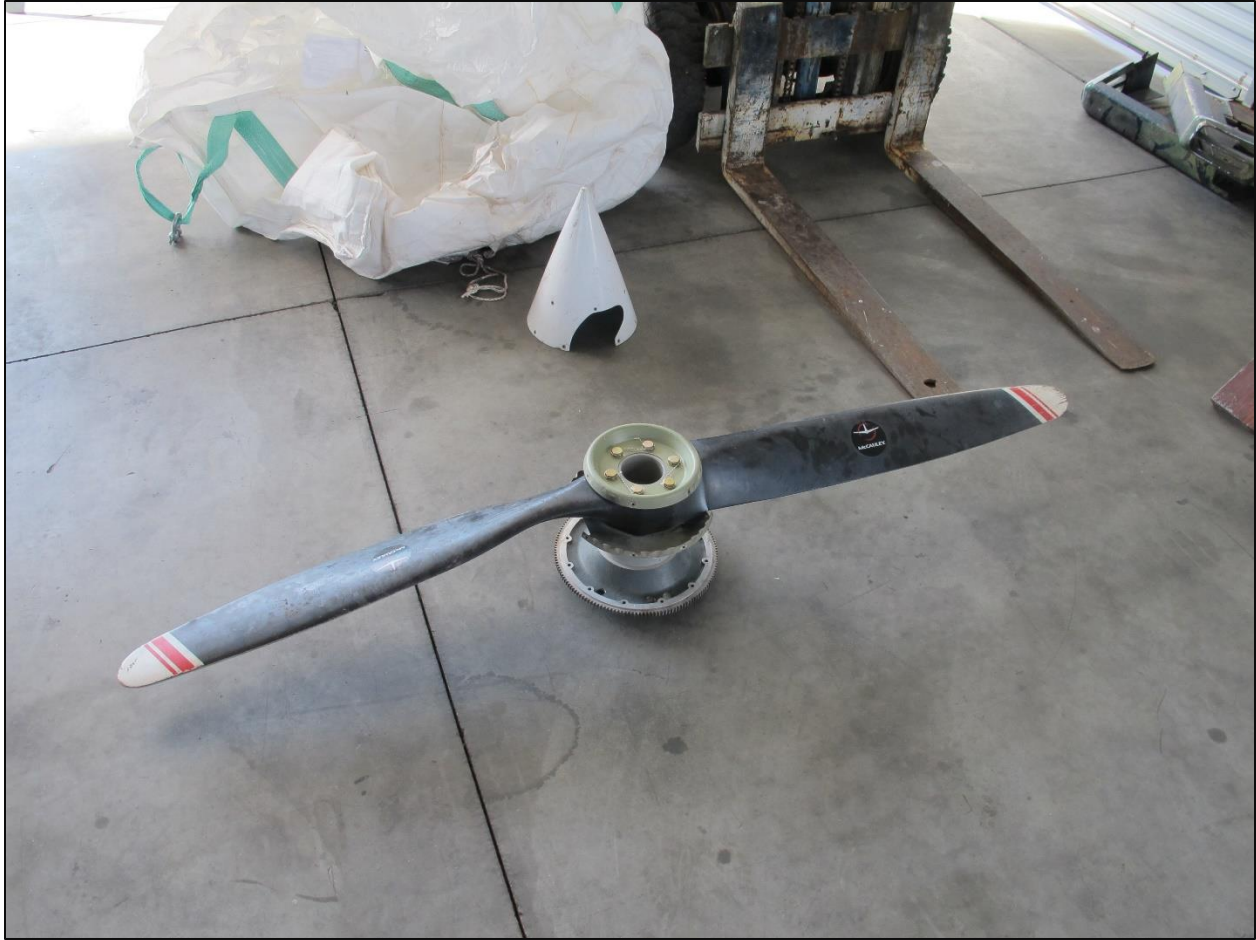
**Figure 9-Propeller Assembly**

The propeller assembly and the attached crankshaft propeller flange separated from the engine during the accident sequence. The crankshaft fracture surface exhibited signatures consistent with torsional overload due to the absorption of rotational energy. One blade was bent slightly aft and had light striations.

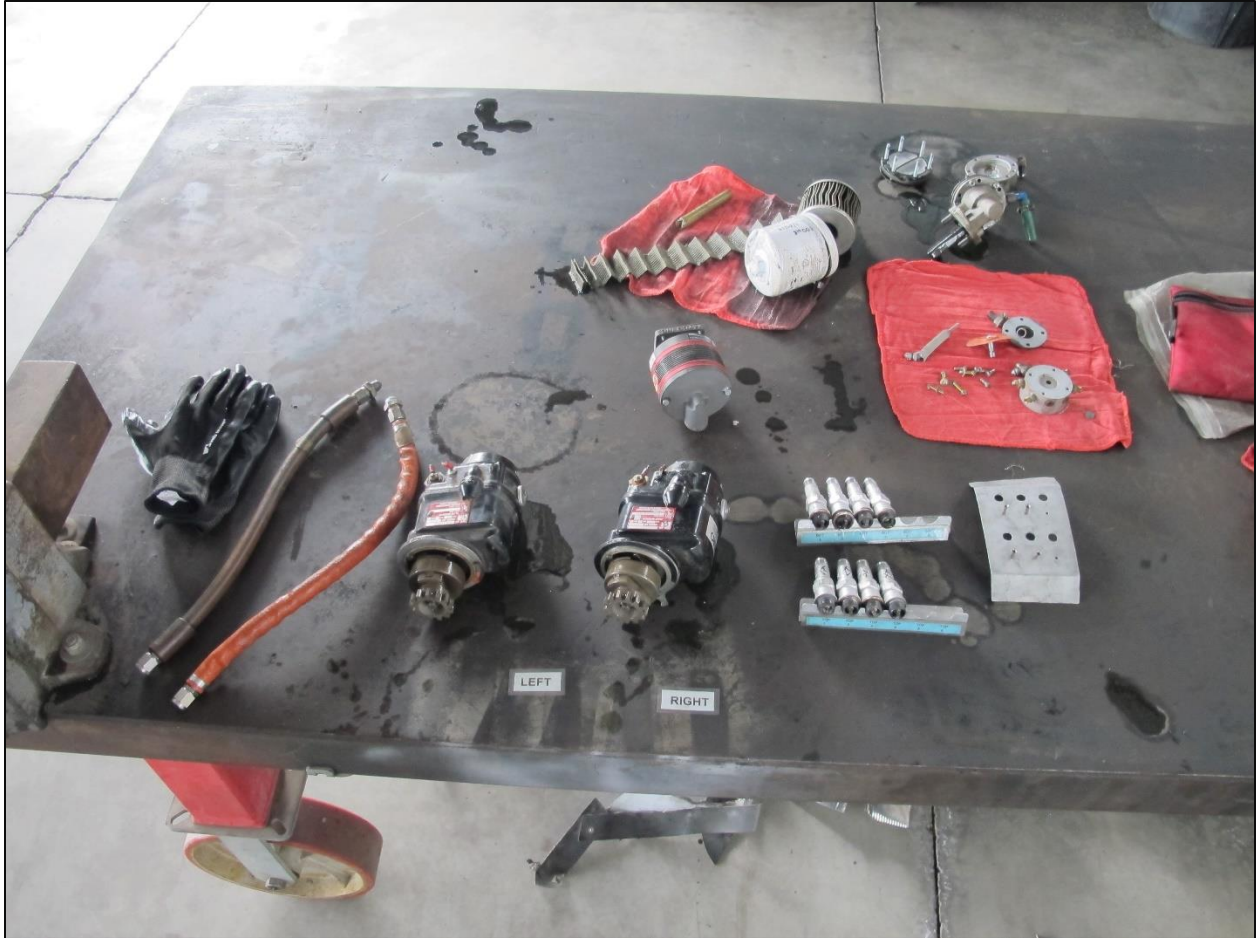
**Figure 10-Examination Table-Engine Components**

The fuel injection servo remained securely attached at the mounting pad of the plenum. The hex nut at the left rear stud was missing. The servo mounting flange had been displaced and cracked as a result of impact forces. The throttle/mixture controls were found securely attached at their respective control arm of the servo. The plug on the side of the injector body was secure with the safety wire in place. The servo fuel inlet screen fitting had been displaced from impact forces and was found free of contamination. The fuel injection servo and induction system were examined and observed to be free of obstruction.

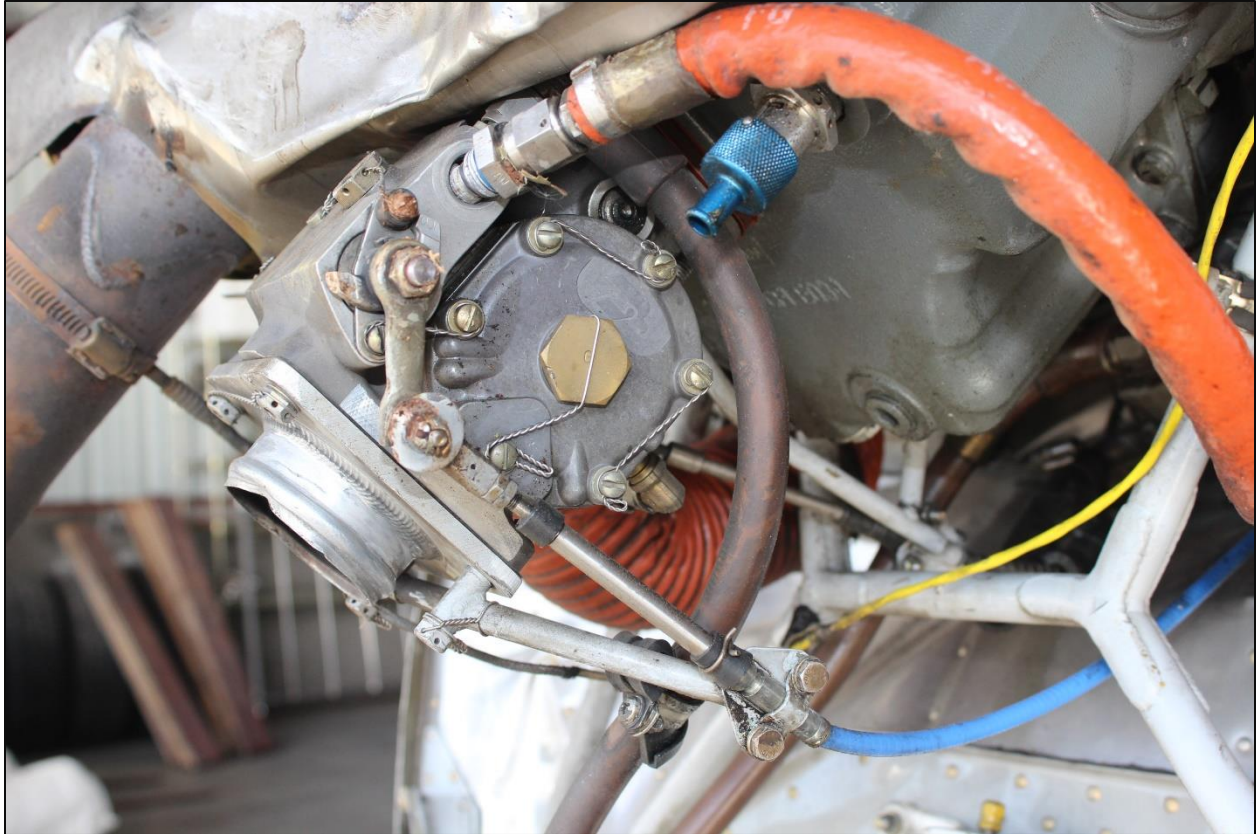
**Figure 11-Fuel Servo**

All engine compartment fuel lines were found to be in place and secure at their respective fitting of each fuel system component with the exception of the inlet fuel line to the fuel servo, where there is evidence of impact damage to the fitting. Fluid consistent with the appearance and odor of aviation fuel was found at key locations about the engine during the removal of various fuel system components.

The engine drive fuel pump top two castellated nuts were not safety wired. The fuel servo aft stud was missing nut; no fuel leak was detected.
