## **NATIONAL TRANSPORTATION SAFETY BOARD**

### **ONSITE EXAMINATION NOTES**

**WPR17FA089**

Location: Paso Robles, California  
Date: April 23, 2017  
Aircraft: N6190, Appleby Nieuport 28  
Serial # AA102  
NTSB IIC: Albert Nixon

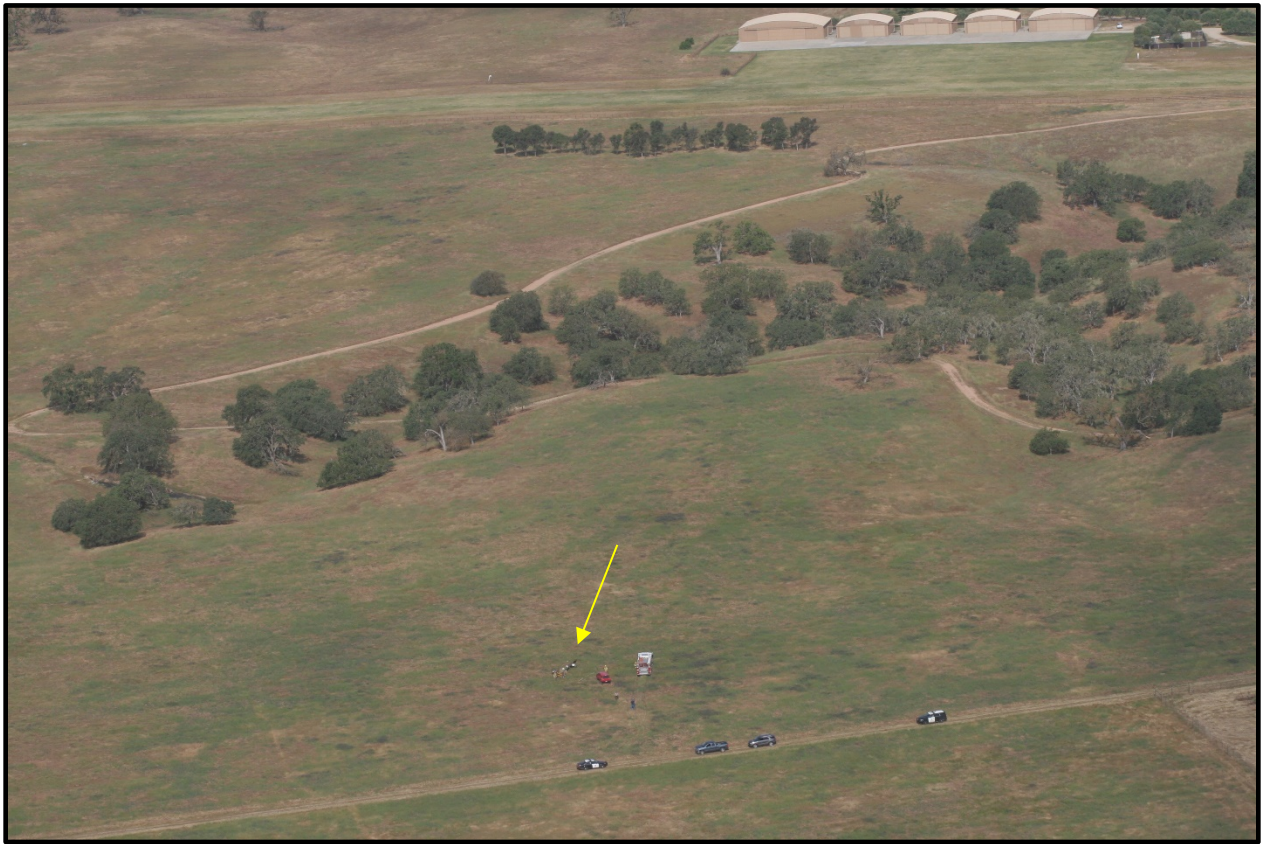
The fuselage came to rest inverted on a heading about 145° magnetic and was displaced to the left and folded over the top of the upper left wing, that was embedded in the terrain. Fuel was observed leaking near the center of the wreckage.

**Figure 1: Accident Site - Airplane Wreckage.**

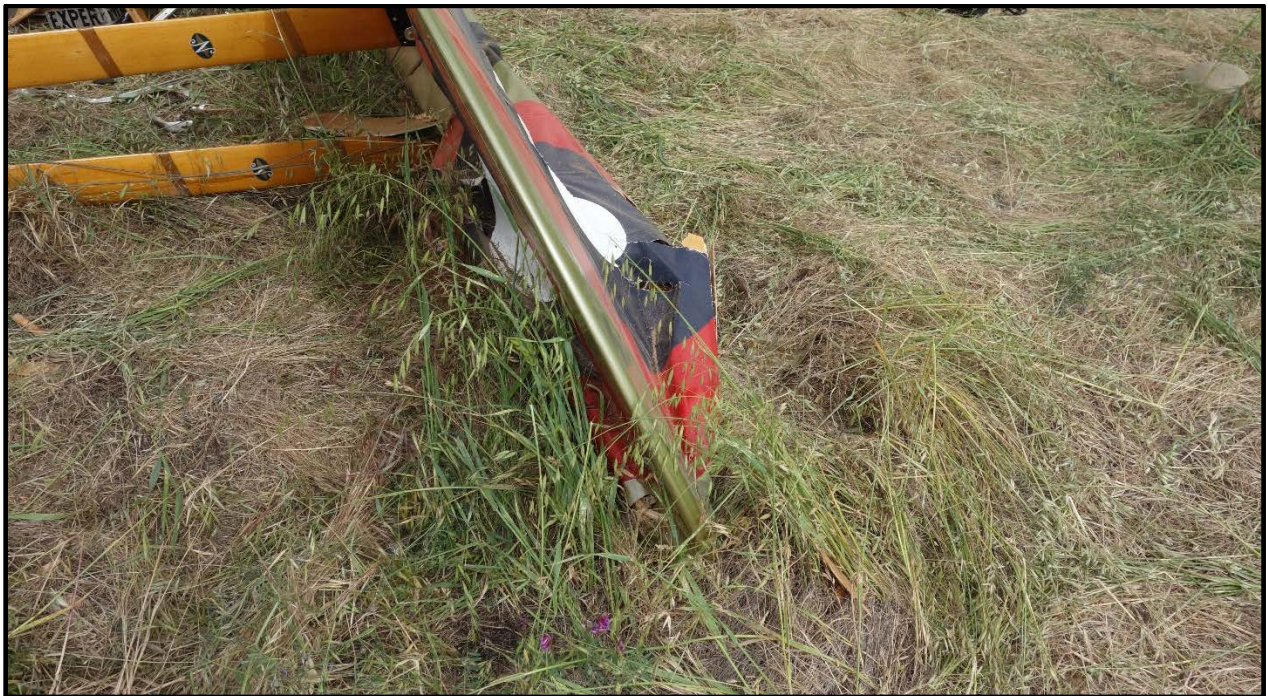
The upper and lower right wings remained partially attached to the main fuselage. The wings sustained damage about mid-span and leading-edge compression damage throughout the wing span. The right aileron was attached at all its respective points. The right main wheel was observed to be relatively intact.

**Figure 2: Right Wing Ground Impact.**

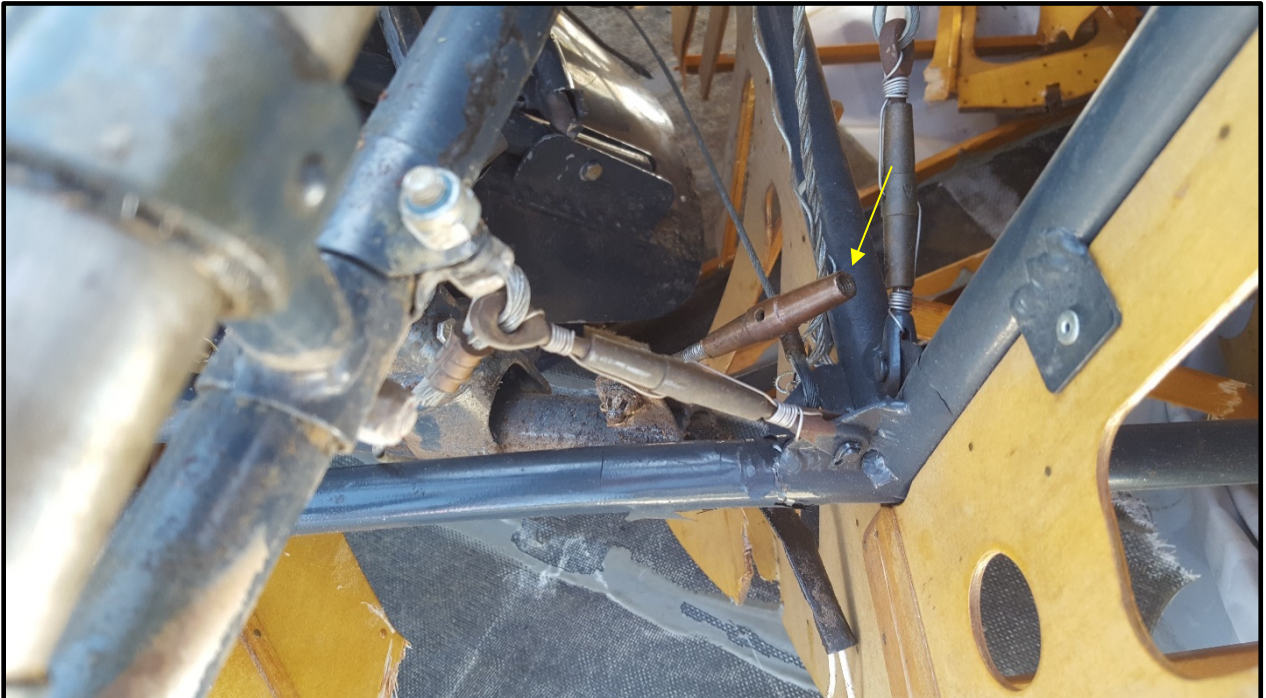
Several cables were visible in the cockpit section that were labeled 1 through 6. A turnbuckle was observed with no safety wire on the lower cable connection of the flight control assembly by an FAA inspector. Flight continuity was checked. The aileron system continuity was confirmed from the aileron through the torque tube to the wing root. Rudder continuity was established. The cables labeled 1 and 5, were the rudder control cables used for the rudder continuity check. The elevator control check revealed that continuity could only be established for one of the two elevator control cables. Continuity for cable 2, which operated the elevator in the trailing edge down direction was confirmed. However, continuity for cable 3, which was the cable that operated the elevator in the trailing edge up direction, was not established. A rod end from the that system's cable was found to have become disconnected from its turnbuckle connection. When cable 3, that was detached, was moved from the rod end where the turnbuckle was supposed to be attached, the elevator moved trailing edge up. Both the rod end that separated from cable 3 and the turnbuckle, were observed to be in good condition. The turnbuckle and separated cable 3 rod end were observed with no safety wire installed. All the remaining flight control turnbuckles were observed to be safety-wired to their respective cable rod ends. Additionally, the cables labeled 4 and 6 established continuity to the tail skid.

**Figure 3: Turnbuckle Assembly.**

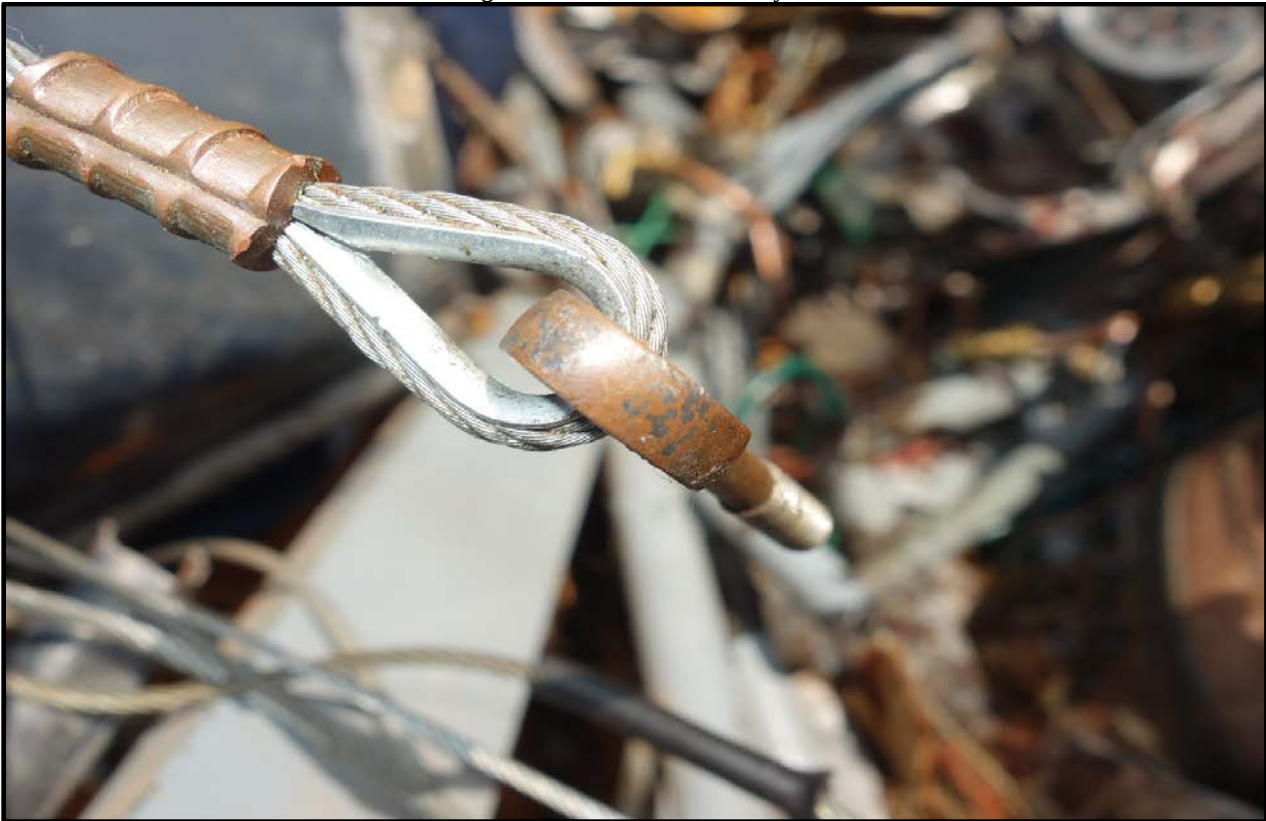
Examination of the airplane wreckage was conducted onsite on April 24, 2017, in a wheat field about 4 miles east of Paso Robles Municipal Airport. With the exception, of the elevator control cable connection being separated, no further evidence of preimpact mechanical failure was noted during the examination of the airframe.

**Figure 4: Disconnected Elevator Control Cable End Rod.**
