## **NATIONAL TRANSPORTATION SAFETY BOARD**

# **AIRFRAME AND ENGINE EXAMINATION REPORT**

**WPR17FA089**

| Aircraft: | N6190; Appleby Nieuport 28 |

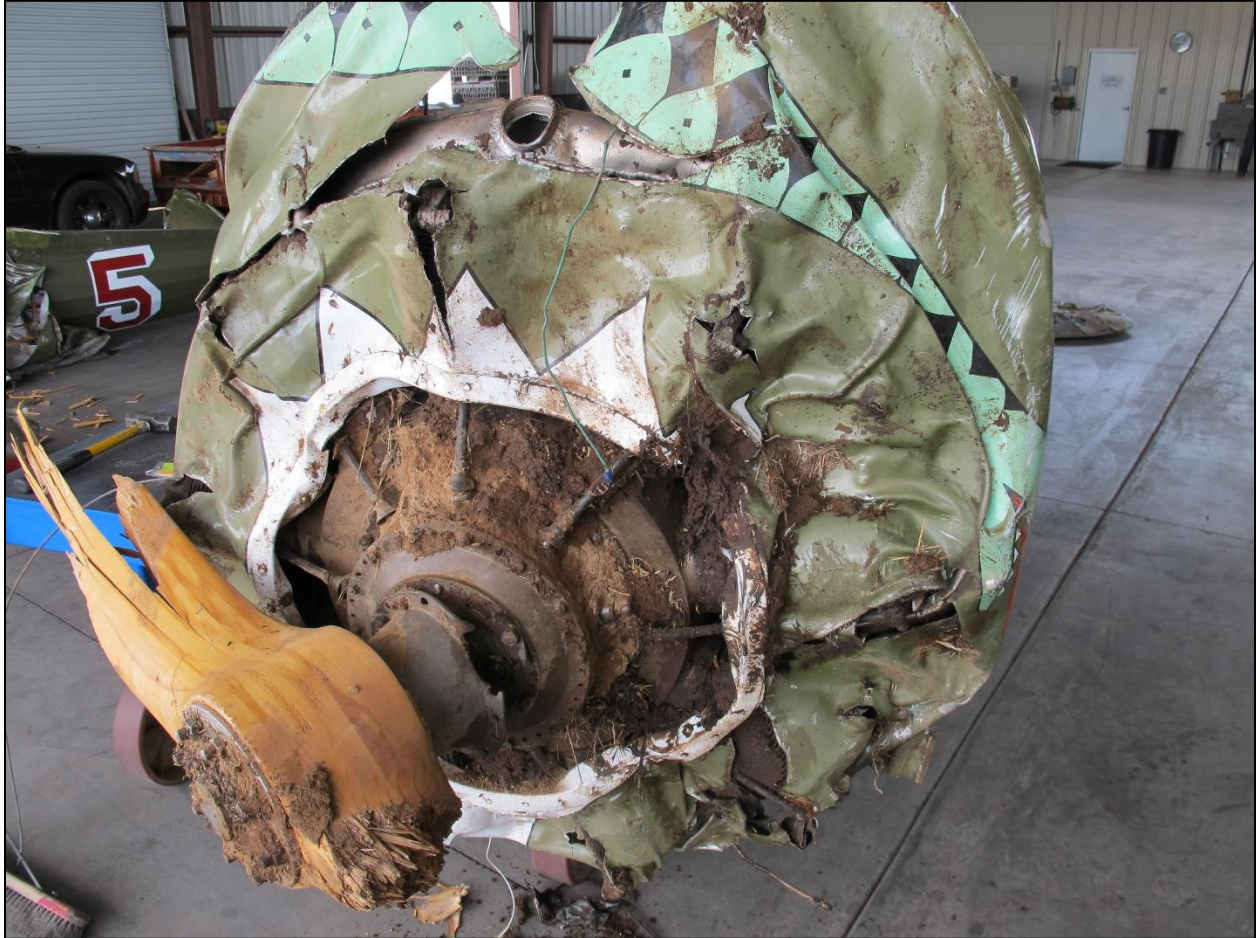
**Figure 1-Engine and Propeller Assembly.**

The engine separated from the main wreckage and had impact damage to the engine mounting assembly. The oil tank was breached, and the filler neck was deformed. The oil cap was found with the main wreckage. The ring cowling was crushed rearward into the cylinder areas. The propeller assembly had impact damage to both blades and remained attached to the propeller mounting flange. The propeller mounting flange was partially separated from the crankcase.

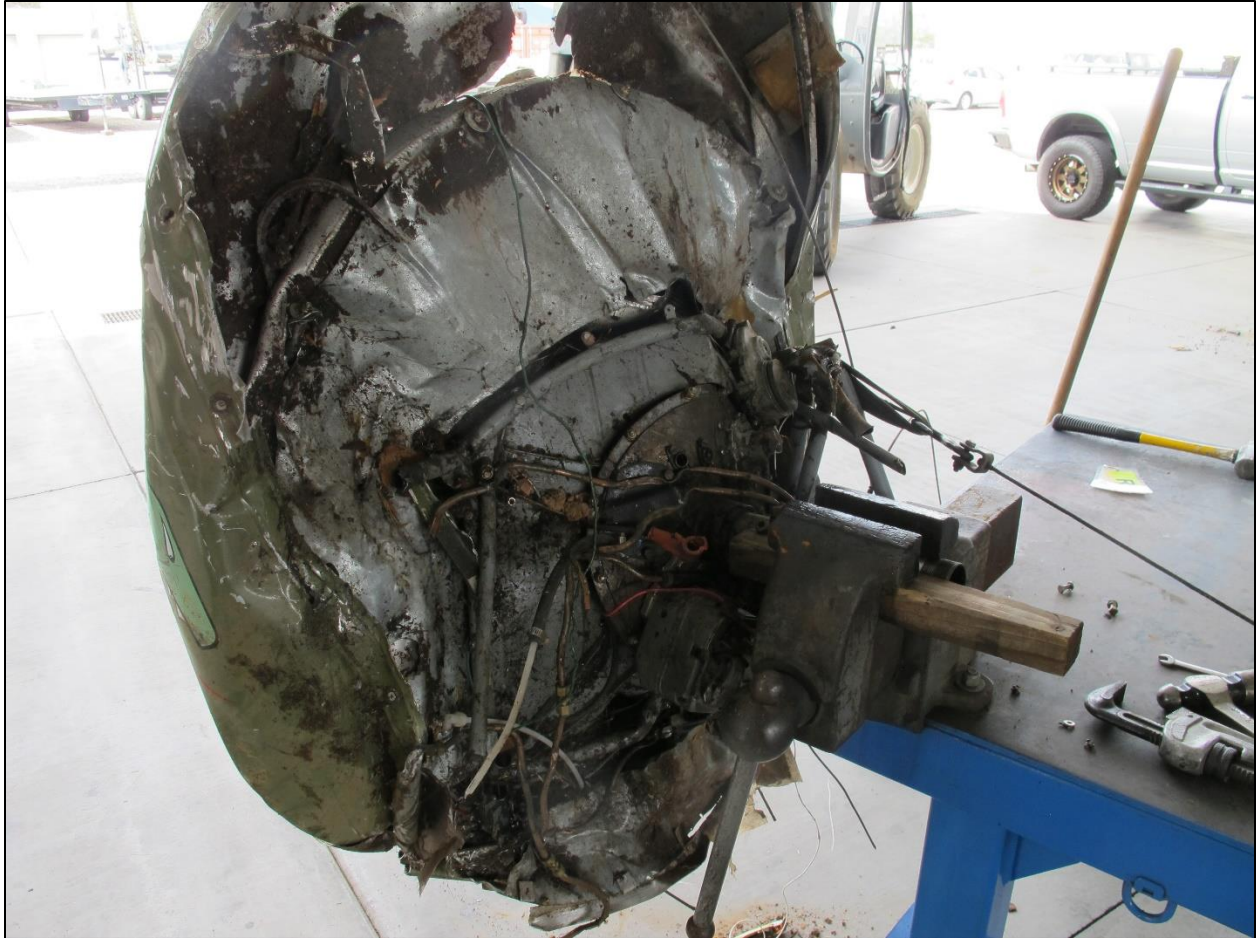
**Figure 2-Engine, Rear-side View.**

The non-rotating plate was bent forward and made contact with the adjacent accessory gears. The air pump and fuel pump separated from the non-rotating plate and was found with the main wreckage. The magnetos remained attached to the non-rotating plate and both had impact damage. The fuel and oil lines had impact damage and the fitting remained intact and secure with the crankshaft.

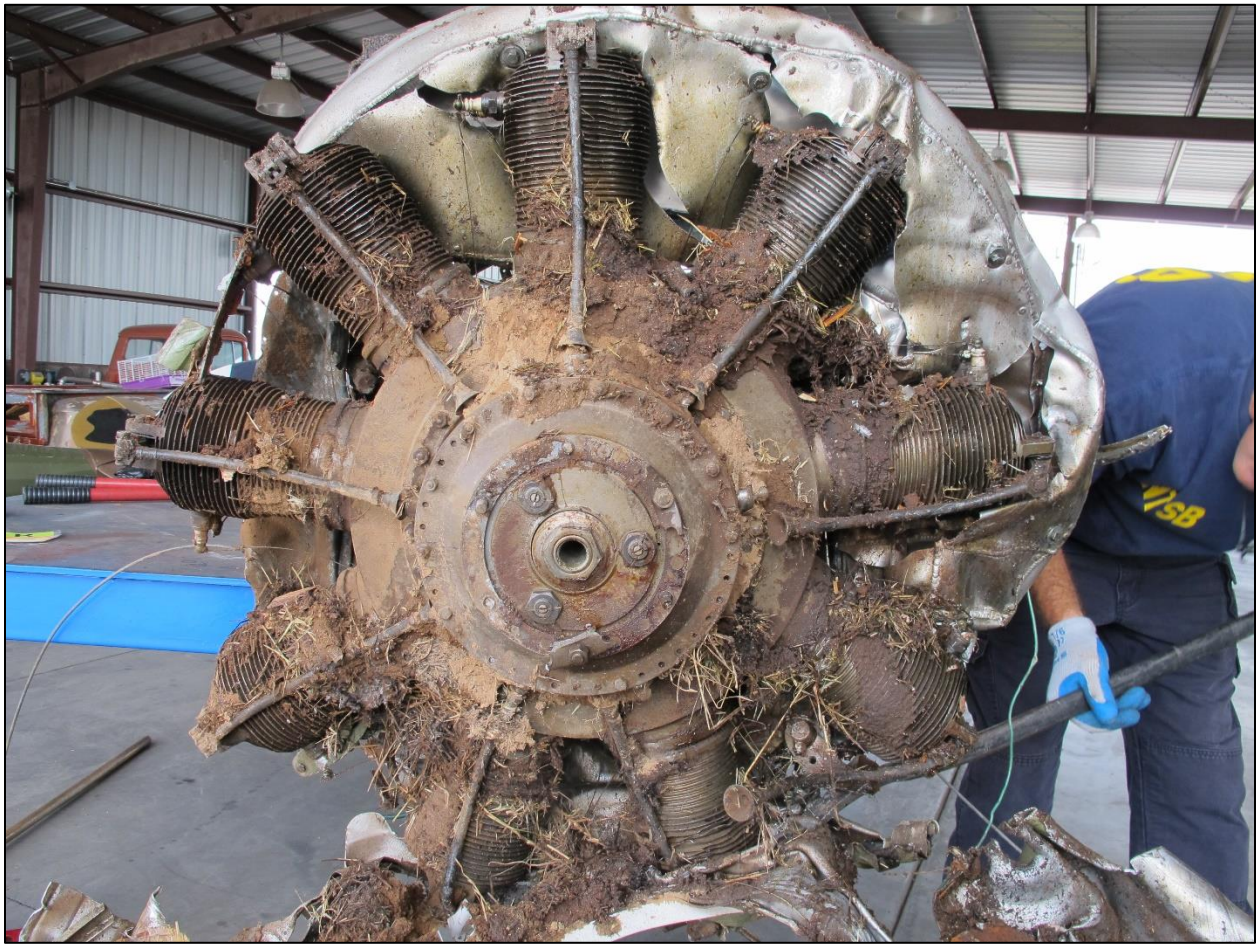
**Figure 3-Engine, Front-side View.**

The propeller assembly and ring cowling were removed, and dirt was found impacted in and around the cylinder base areas. The rocker actuators had impact damage, and several had bending consistent with crankcase rotation during ground impact. Several cylinders had impact damage to their cooling fins. Number 7, 8, and 9 cylinders were dislodged aft from their crankcase mounts.

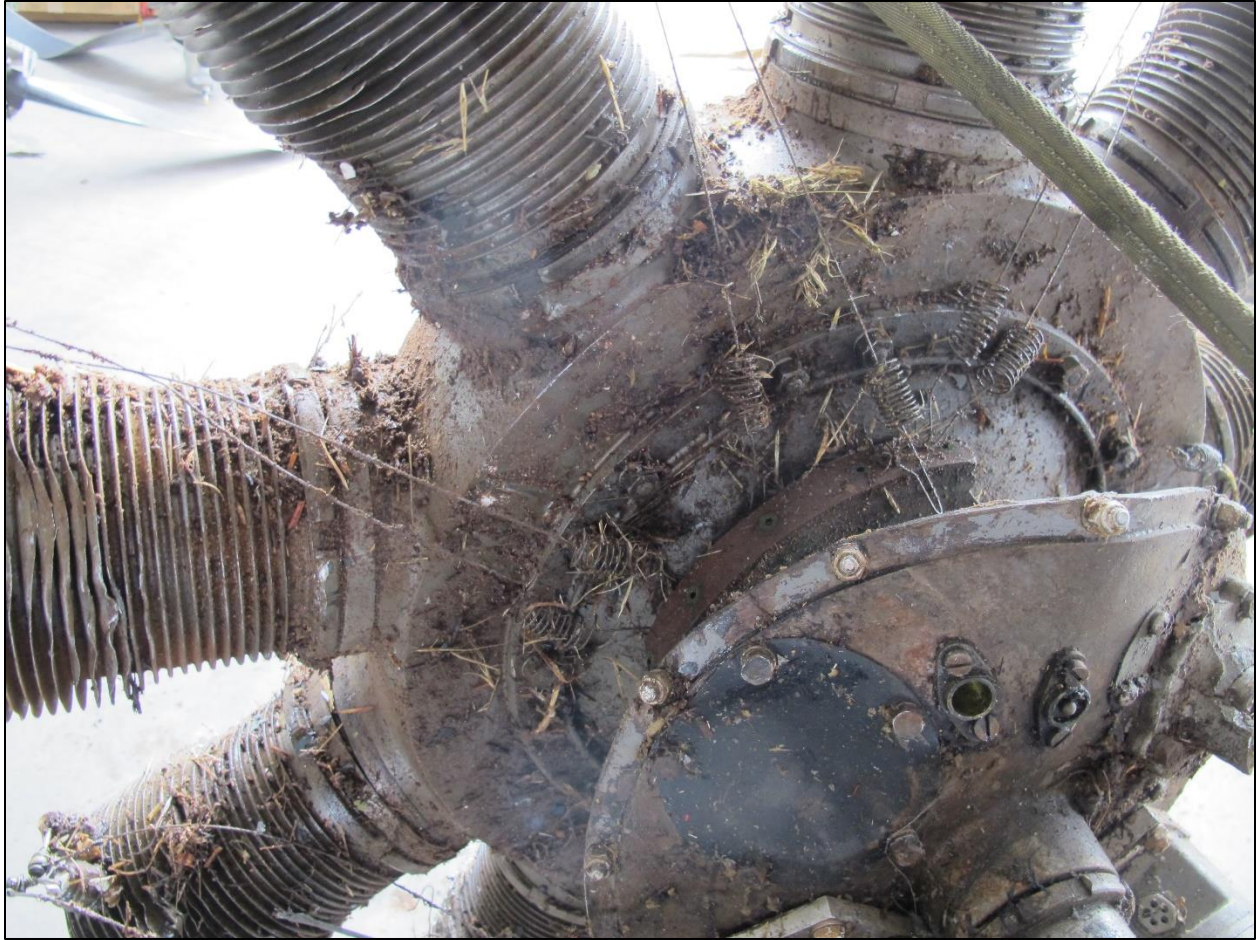
**Figure 4-Bakelite Distributer Block.**

The bakelite distributor block had impact damage and only a section remained attached to several ignition wires.

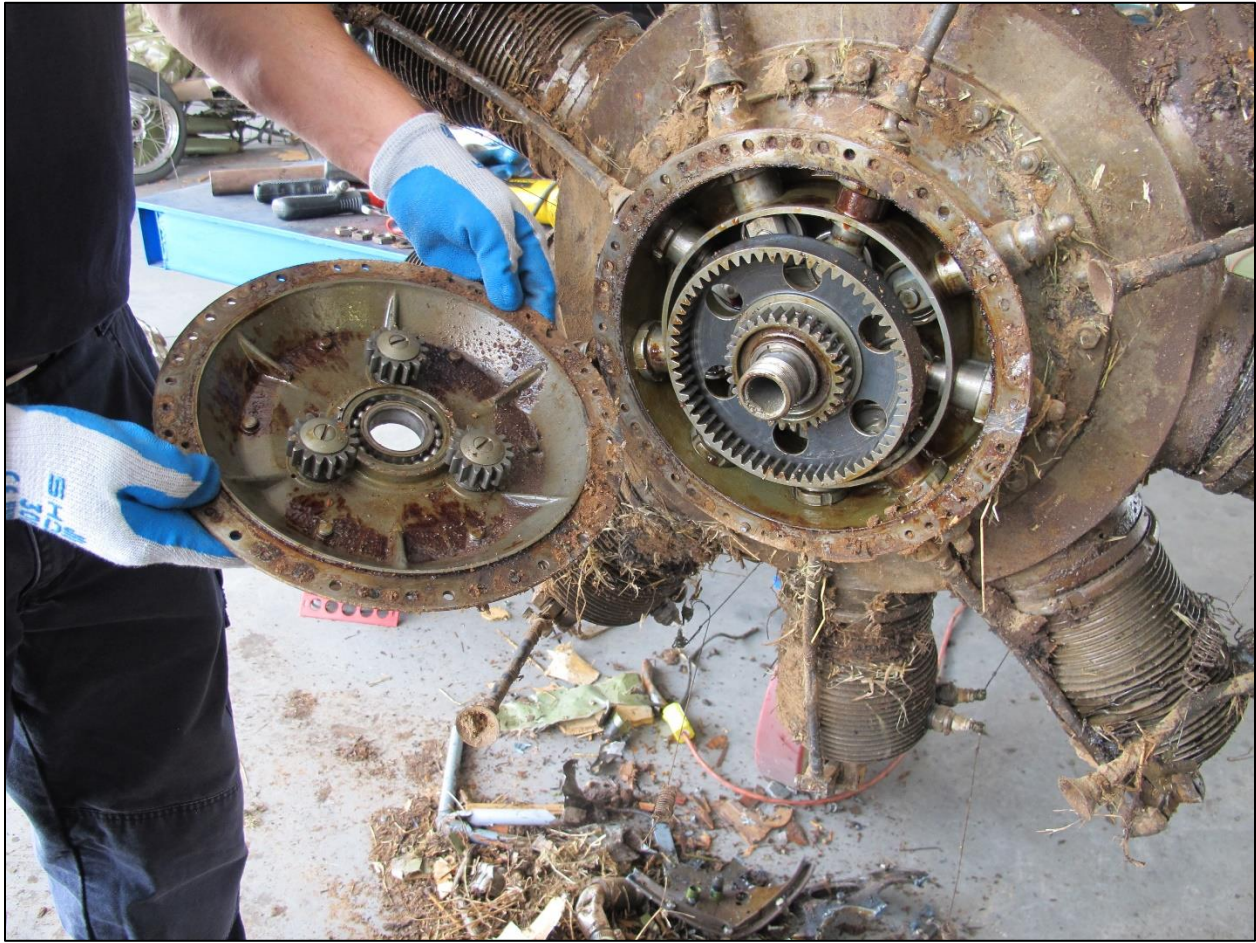
**Figure 5-Crankcase End Plate and Planetary Timing Gears.**

The crankcase end plate was removed from the crankcase and revealed the internal planetary timing gears and cam area. The valve plungers and cams were undamaged.

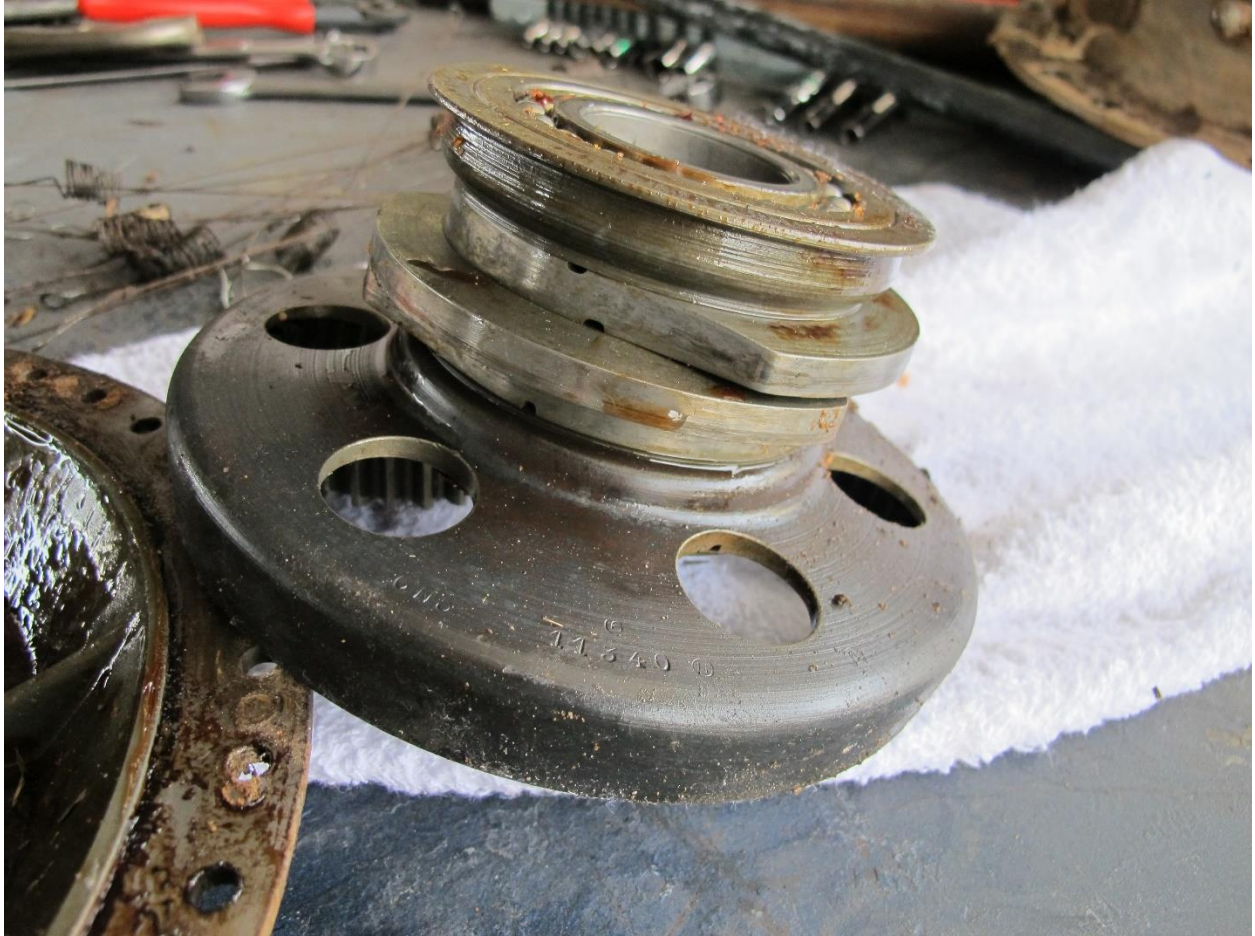
**Figure 6-Valve Plunger Cam.**

The valve plunger cam was removed from the engine and was undamaged.

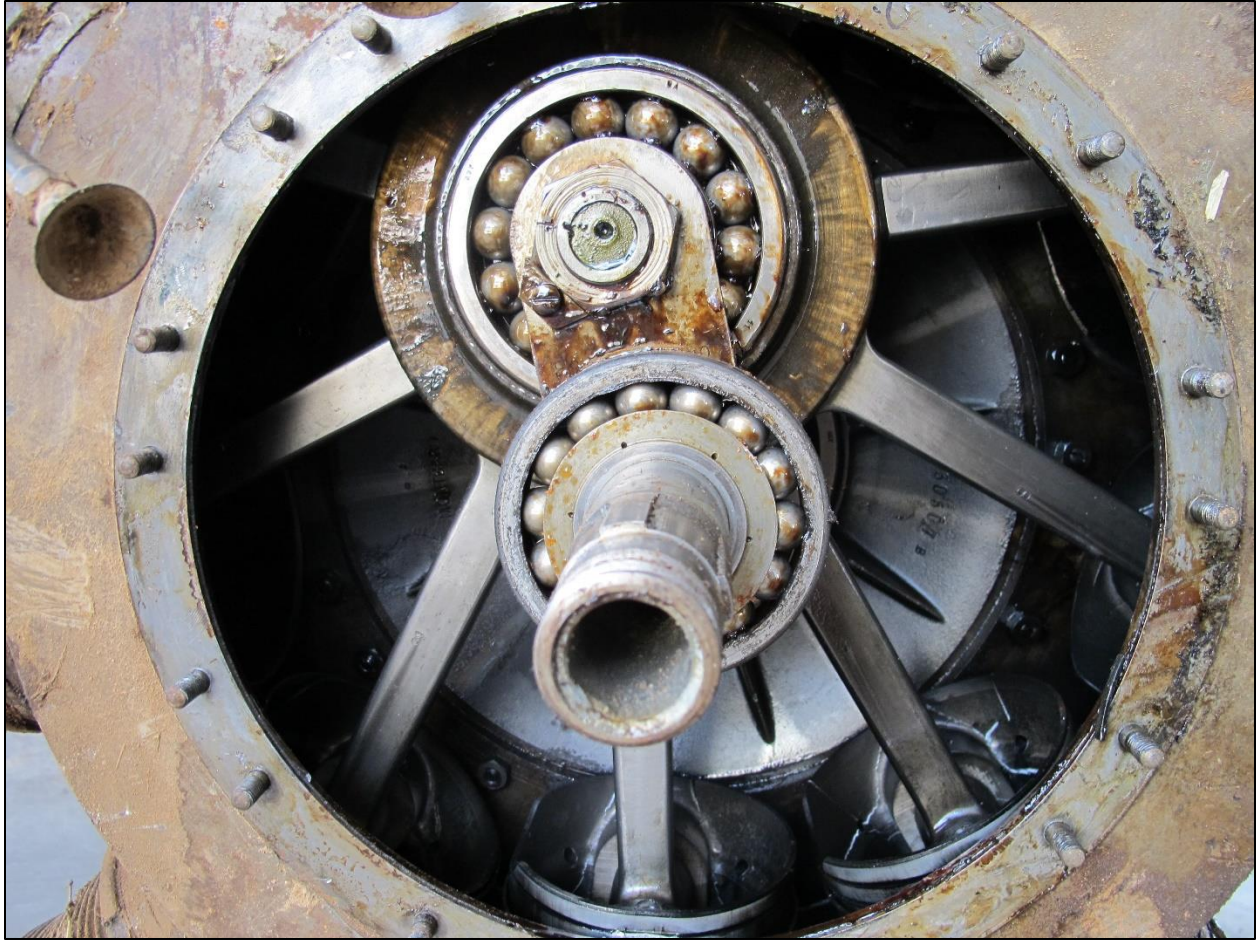
**Figure 7-Engine, Internal Components.**

The valve plunger assembly was removed from the crankcase revealing the main bearings, crankshaft, connecting rods, and pistons.

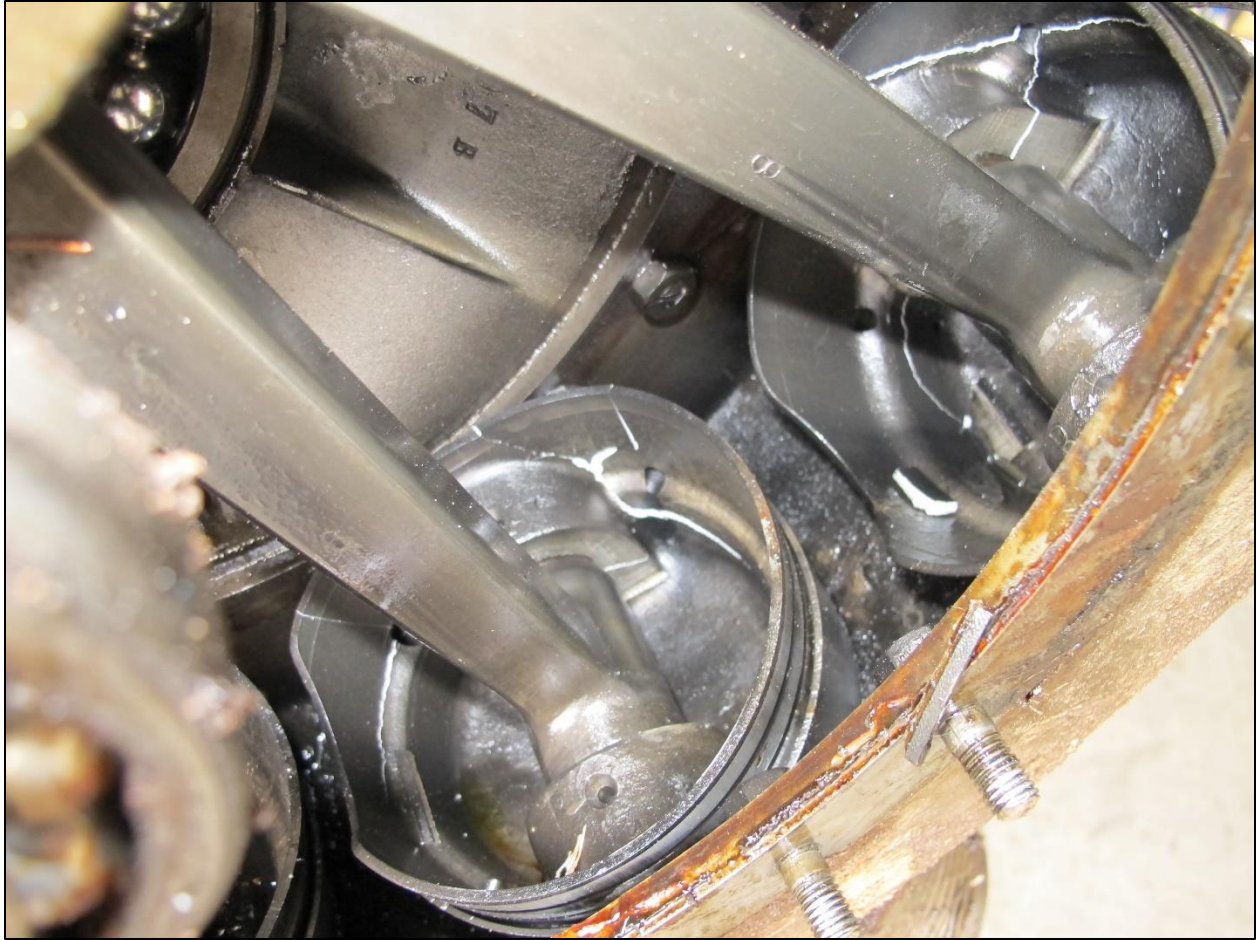
**Figure 8-Piston Skirt Damage.**

The number 1, 7, 8, and 9 piston skirts had impact damage. A thick layer of oily residue was found on the internal engine components.

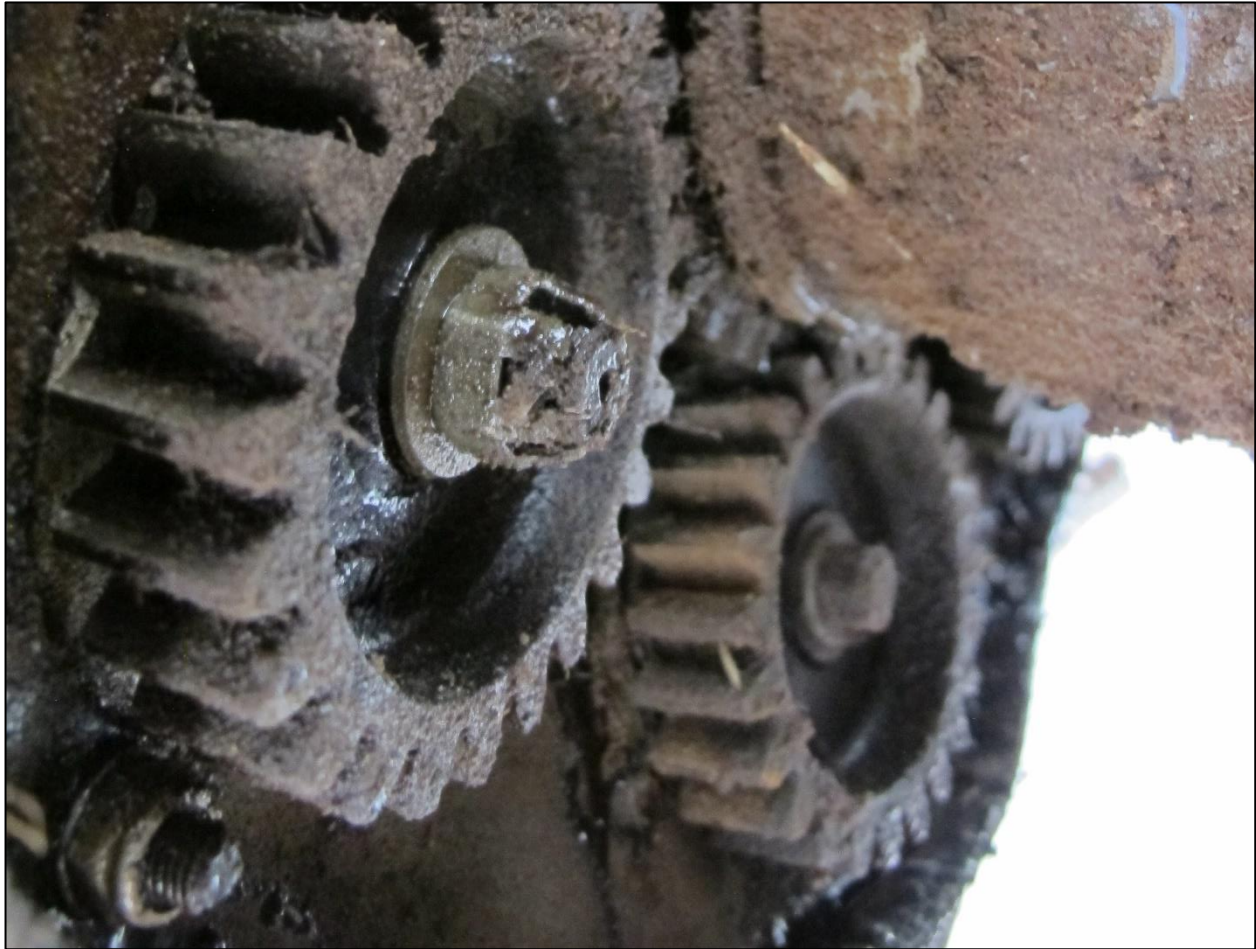
**Figure 9-Accessory Gears.**

The accessory gears were undamaged and revealed rotational scoring on the non-rotating plate. The non-rotating plate had impact damage and was bent forward from its original position.

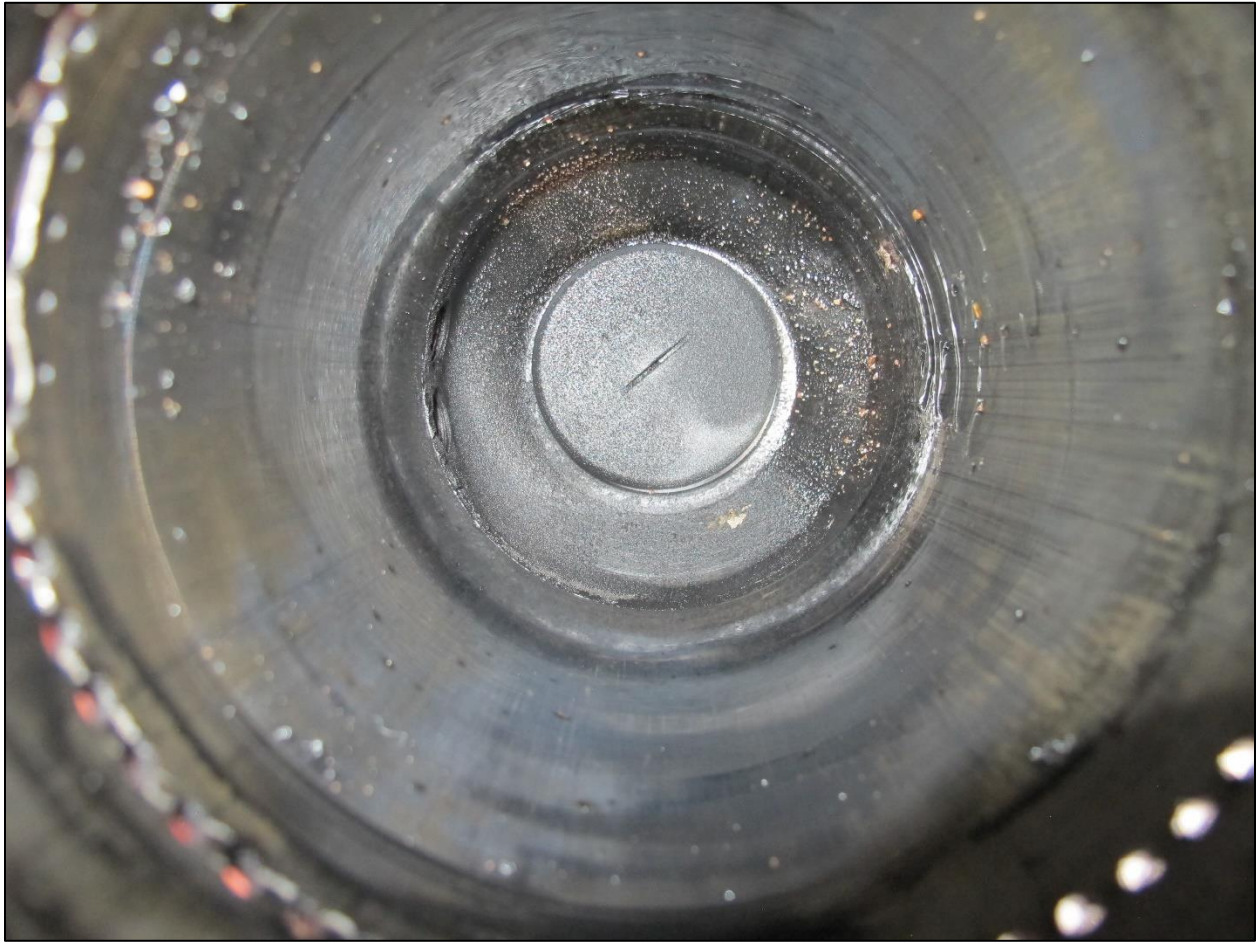
**Figure 10-No. 8 Cylinder Bore and Combustion Chamber.**

The number 8 cylinder was removed from the crankcase. The cylinder bore was undamaged, and the combustion chamber had an oily residue. The remaining cylinders were borescoped through the exhaust valve opening. All piston heads and combustion chambers were undamaged and had an oil residue.

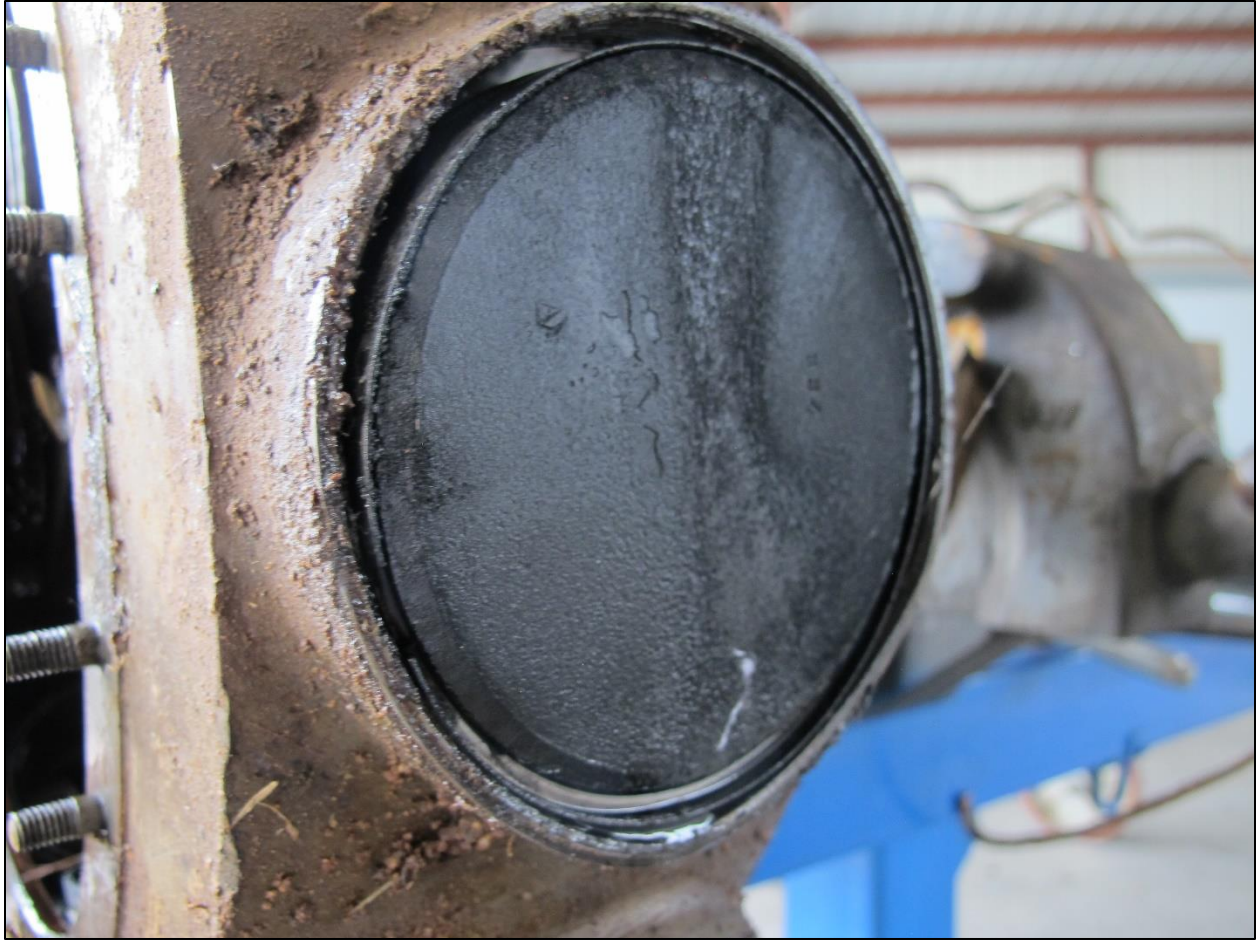
**Figure 11-Number 8 Piston Head.**

The number 8 piston head surface. The surface is dark with sooty type deposits.

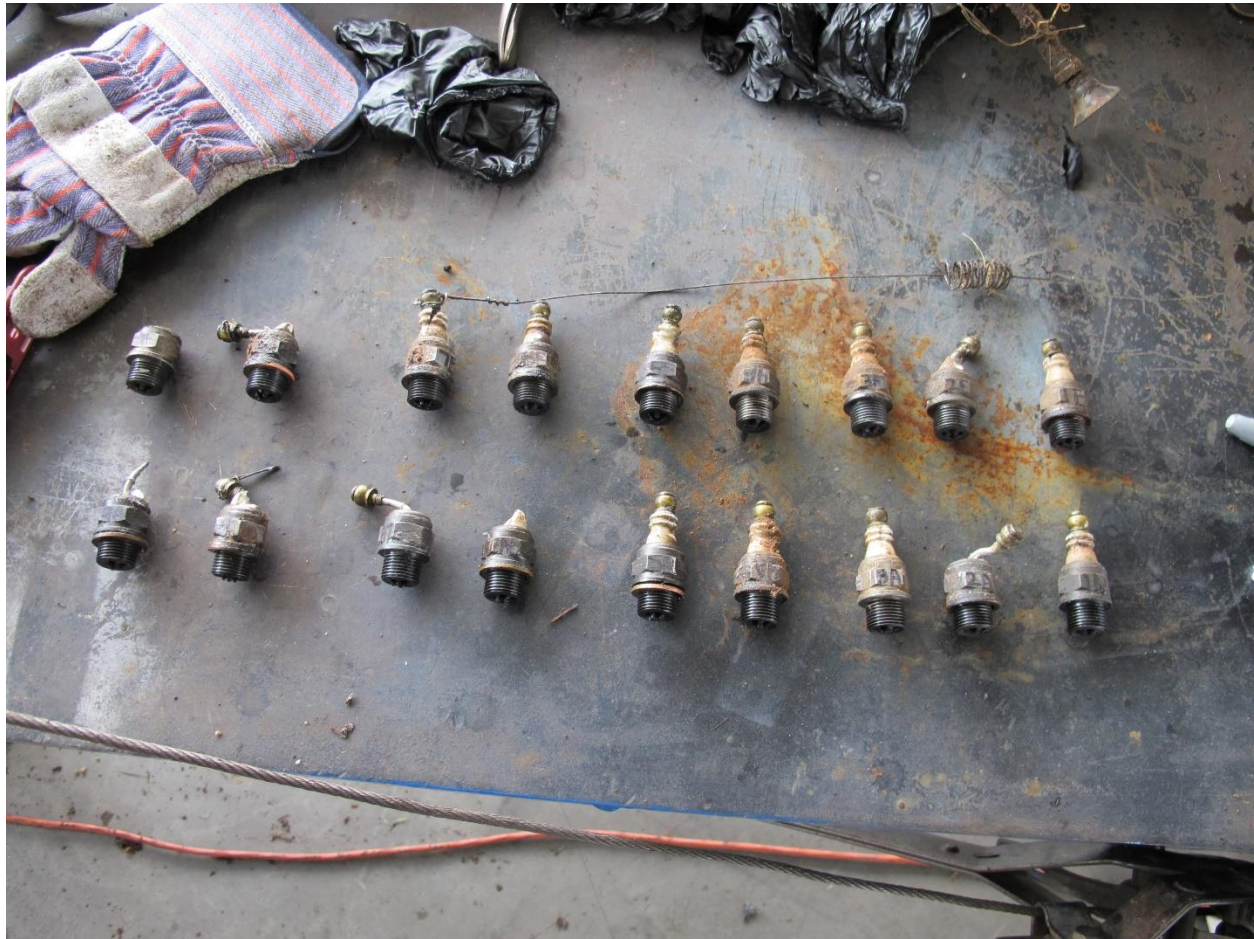
**Figure 12-Spark Plugs.**

The spark plugs were removed from the cylinders. The electrode areas had dark oily residue and (normal-worn out) wear conditions, when compared to a Champion AV-27 chart. Several spark plugs had impact damage.

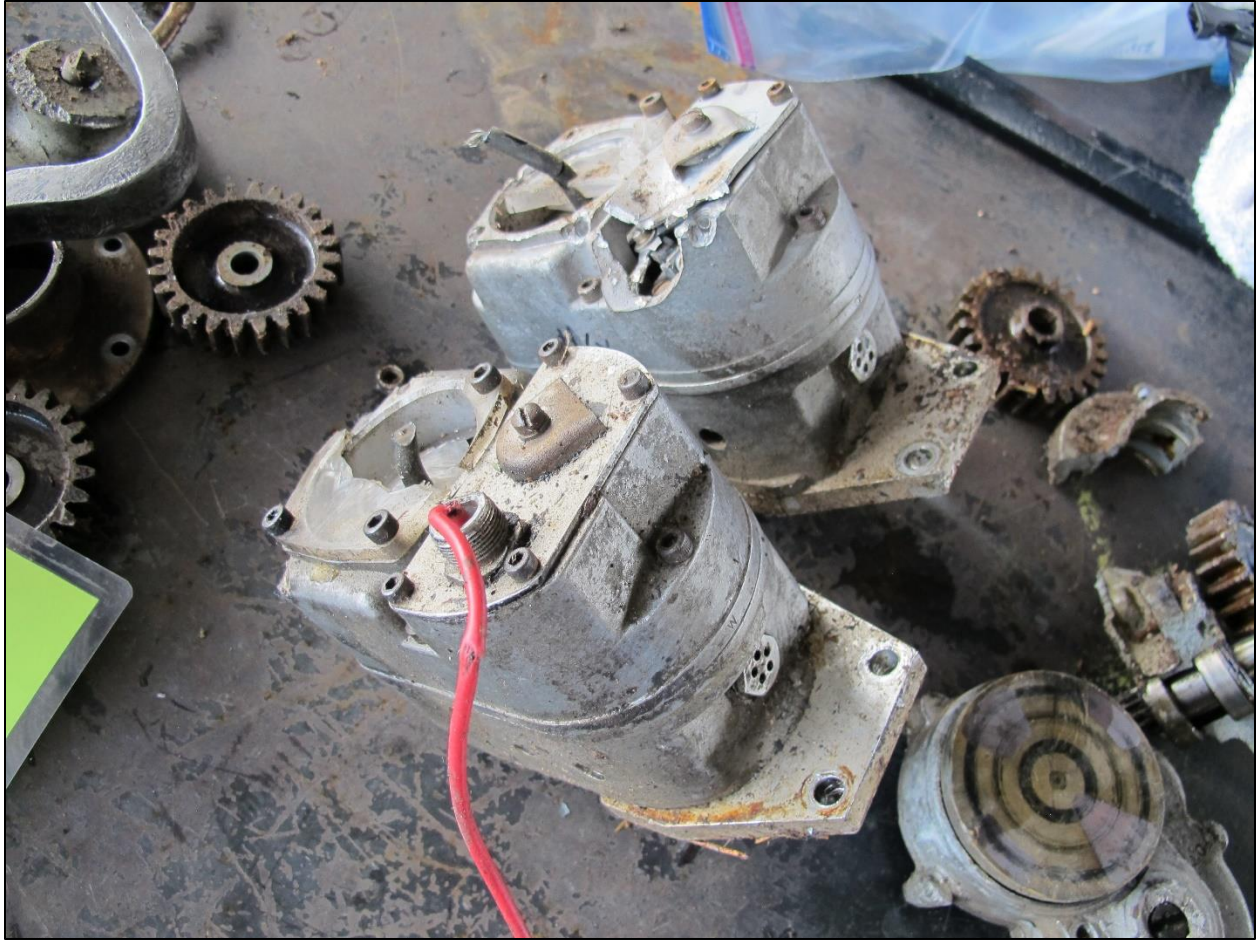
**Figure 13-Magnetos.**

The magnetos were removed from the engine and had impact damage. The magneto drive shafts rotated freely by hand and spark was obtained from the leads.

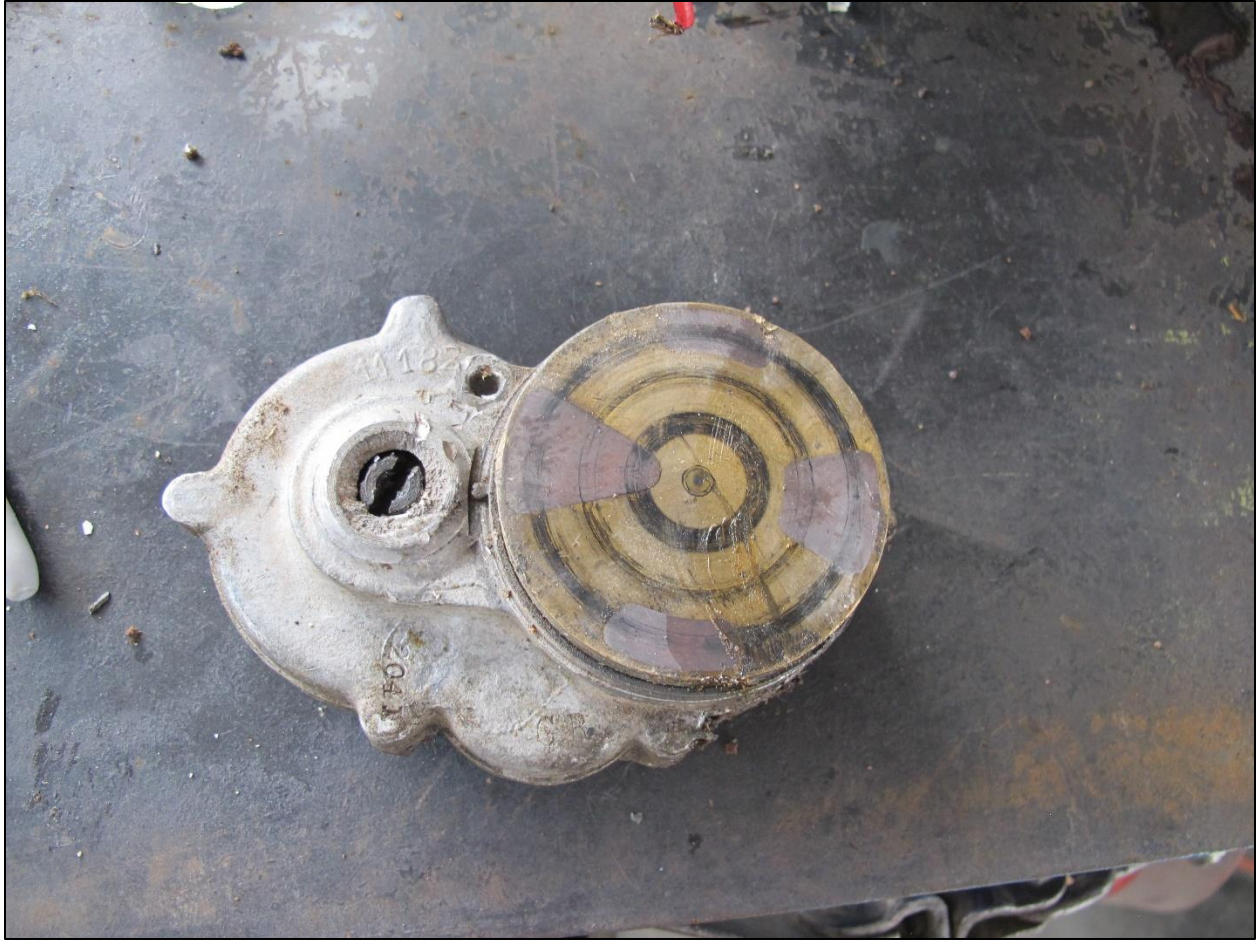
**Figure 14-Blip Switch Drive Unit.**

The blip switch drive unit separated from the engine and was found with the main wreckage. The drive's contact surface rotated freely by hand. The drive unit's contact assembly separated and was found in the main wreckage.

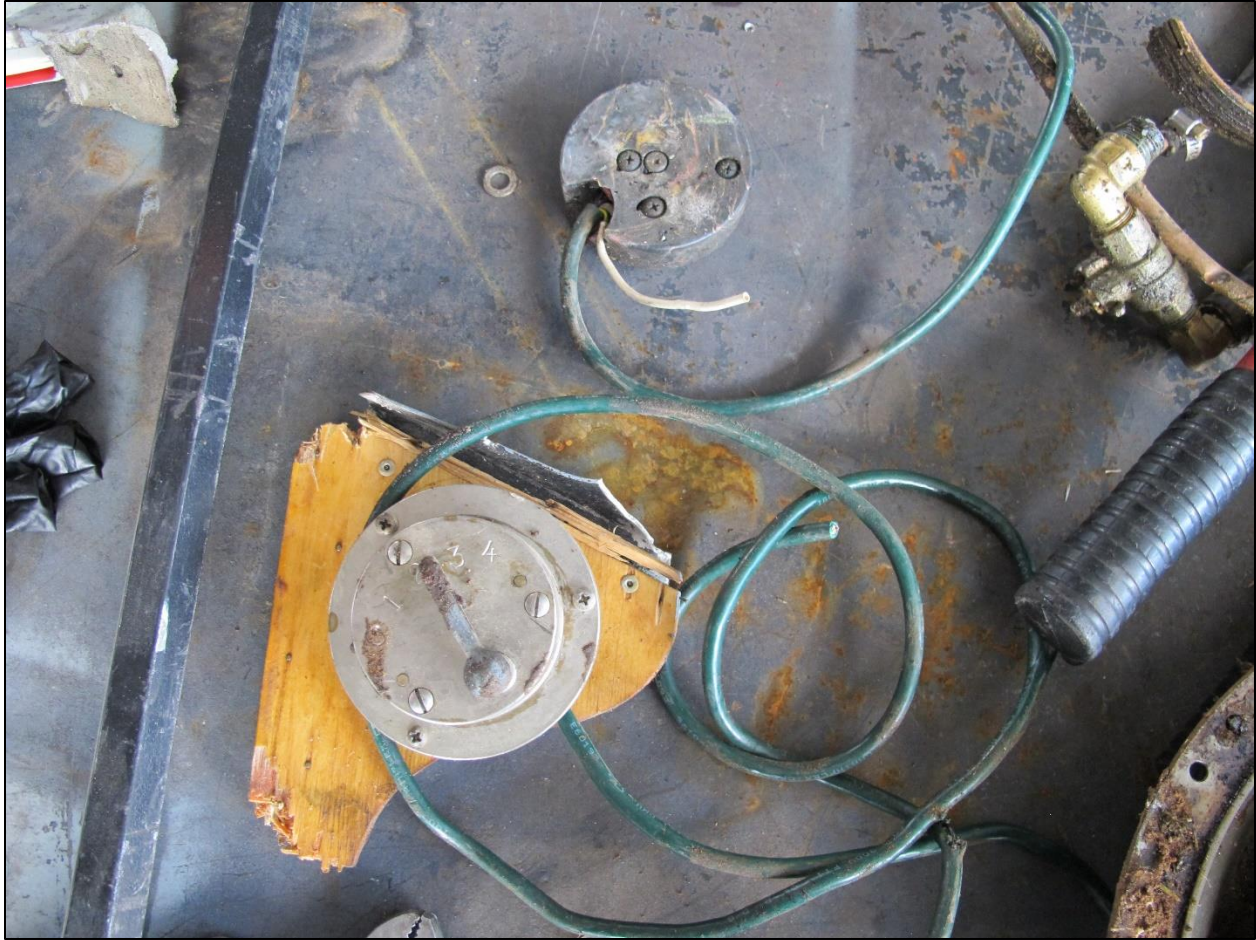
**Figure 15-Blip Switch.**

The blip switch and the blip switch drive unit contact assembly were found in the main wreckage.

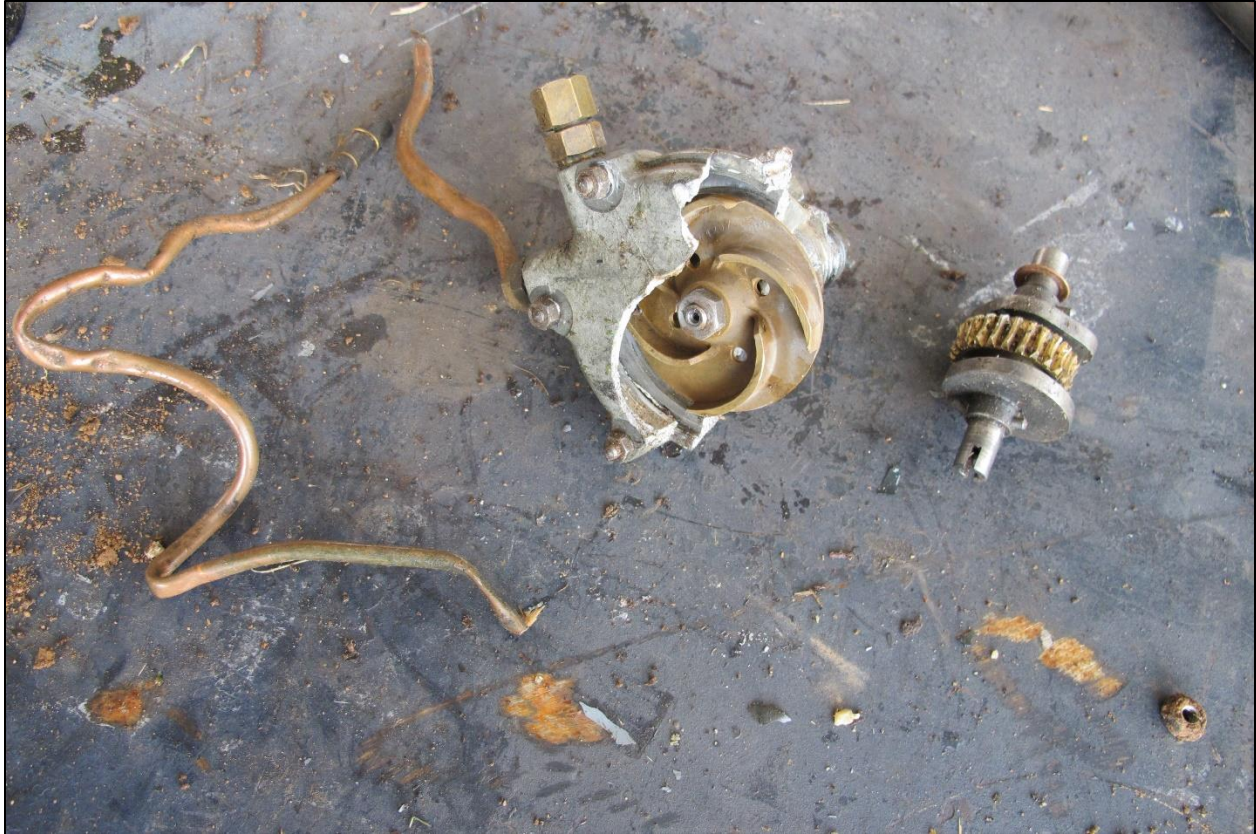
**Figure 16-Fuel Pump.**

The fuel pump separated from the engine and had impact damage.

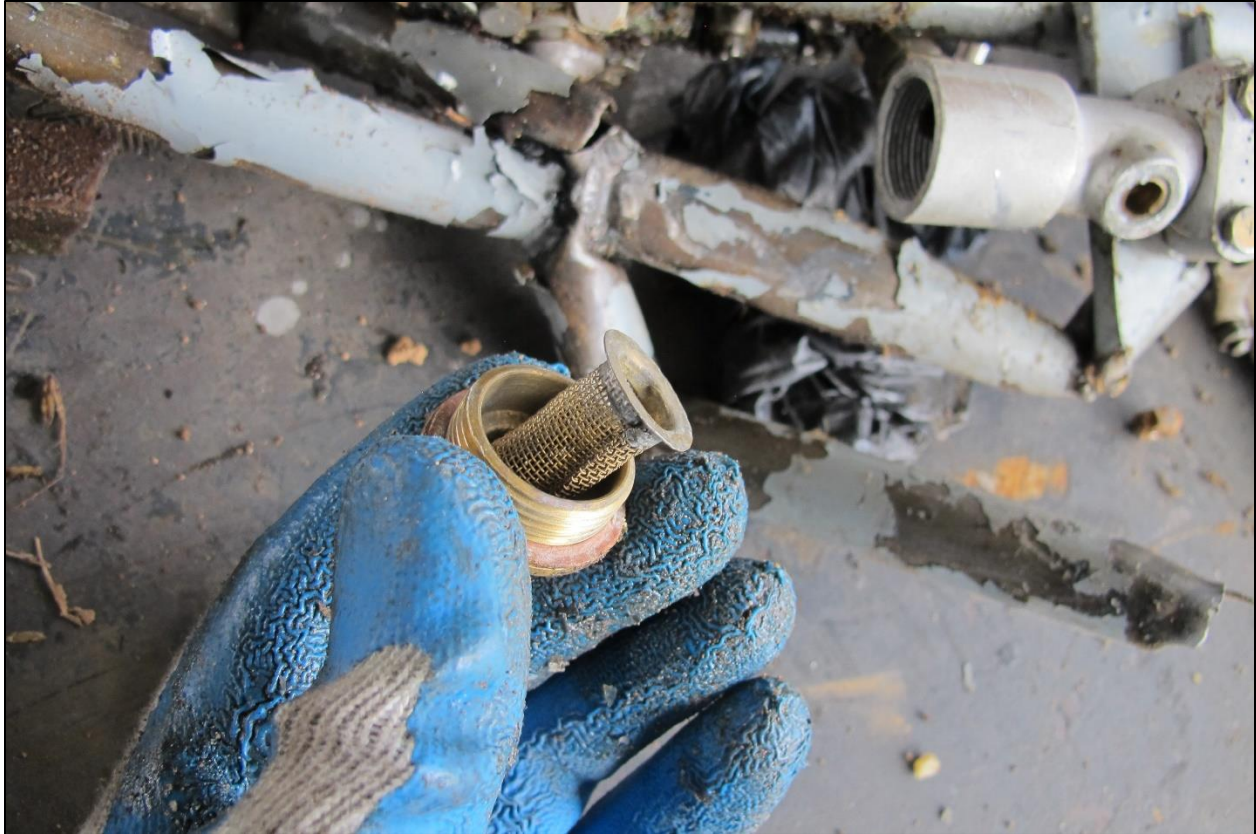
**Figure 17-Inline Fuel Screen.**

The inline fuel screen was removed from the fuel control valve and was free of debris.

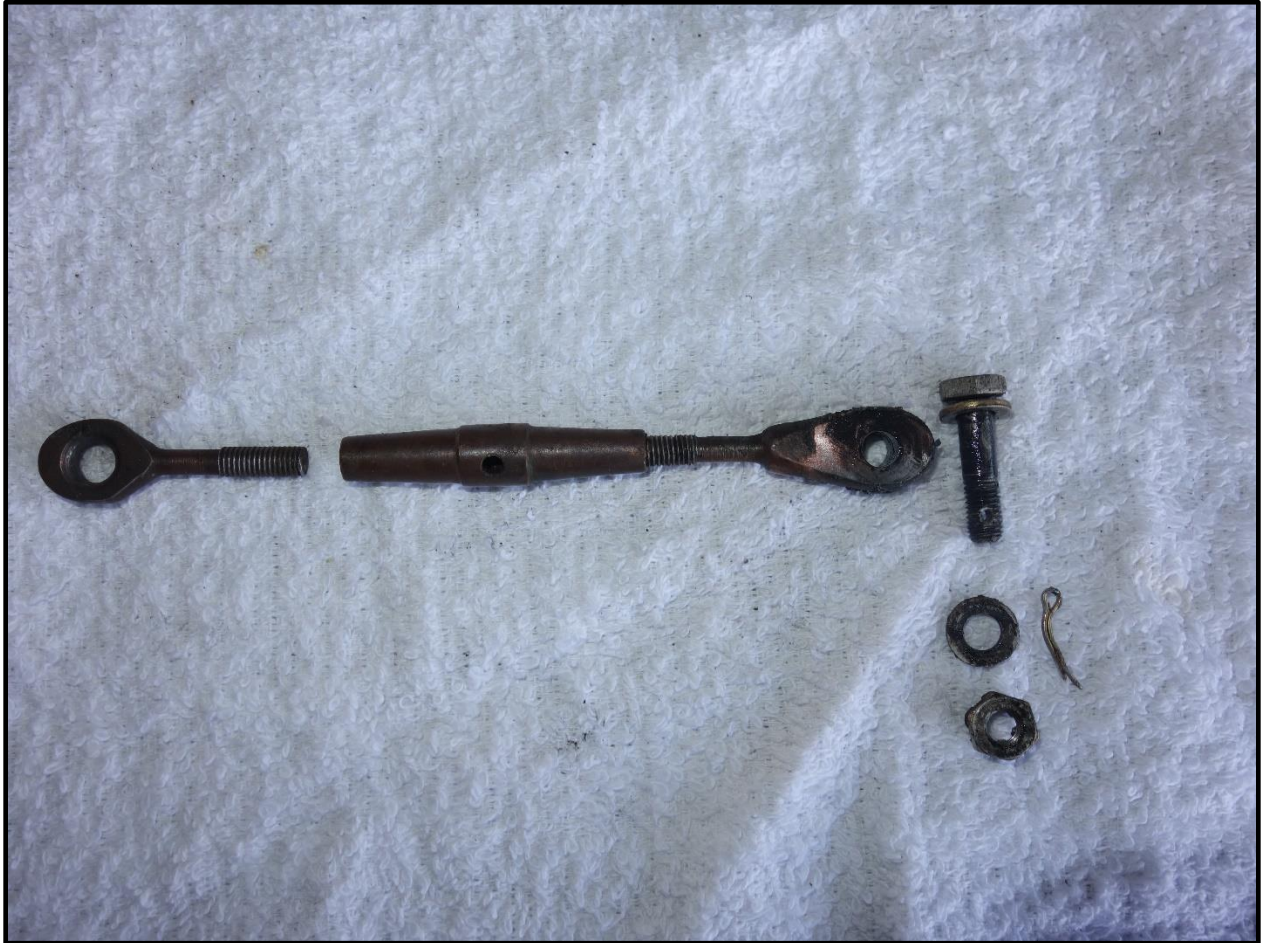
Figure 18 –Turnbuckle Assembly and Rod End.

Flight continuity was confirmed, except for continuity of the cable that operated the elevator in the trailing edge up direction, was not established. A rod end from that cable was found to have become disconnected from its turnbuckle connection. When the cable was moved from the rod end where the turnbuckle was supposed to be attached, the elevator moved trailing edge up. Both the cable rod end, and the turnbuckle it was supposed to be attached to, were observed to be in good condition. Further, the turnbuckle and separated cable rod end were observed with no safety-wire installed, nor with any remnants or marks from safety-wire.
