## **NATIONAL TRANSPORTATION SAFETY BOARD**

# **AIRFRAME AND ENGINE EXAMINATION REPORT**

**WPR17FA089**

| Aircraft: | N6190; Appleby Nieuport 28 |

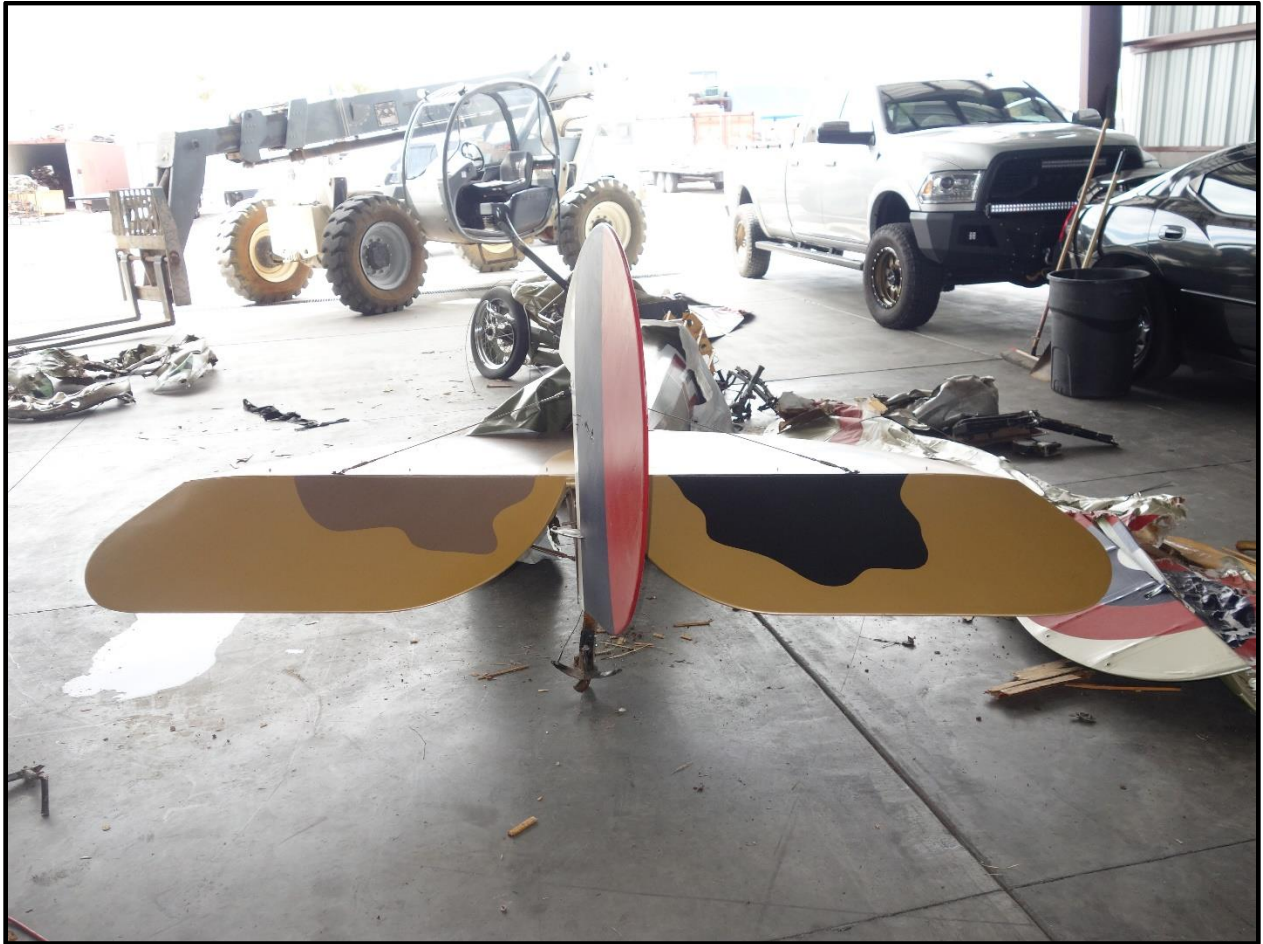
**Figure 19-Rear View of the Airplane's Tail and Fuselage.**

Airplane's elevators and rudder remained attached.
