## **NATIONAL TRANSPORTATION SAFETY BOARD**

# **ON SCENE EXAMINATION**

**WPR17FA107**

Location: Ephrata, WA  
Date: May 26, 2017  
Aircraft: Schleicher ASW 28-18E, Registration #63KR, Serial #28721  
NTSB IIC: Samantha Link

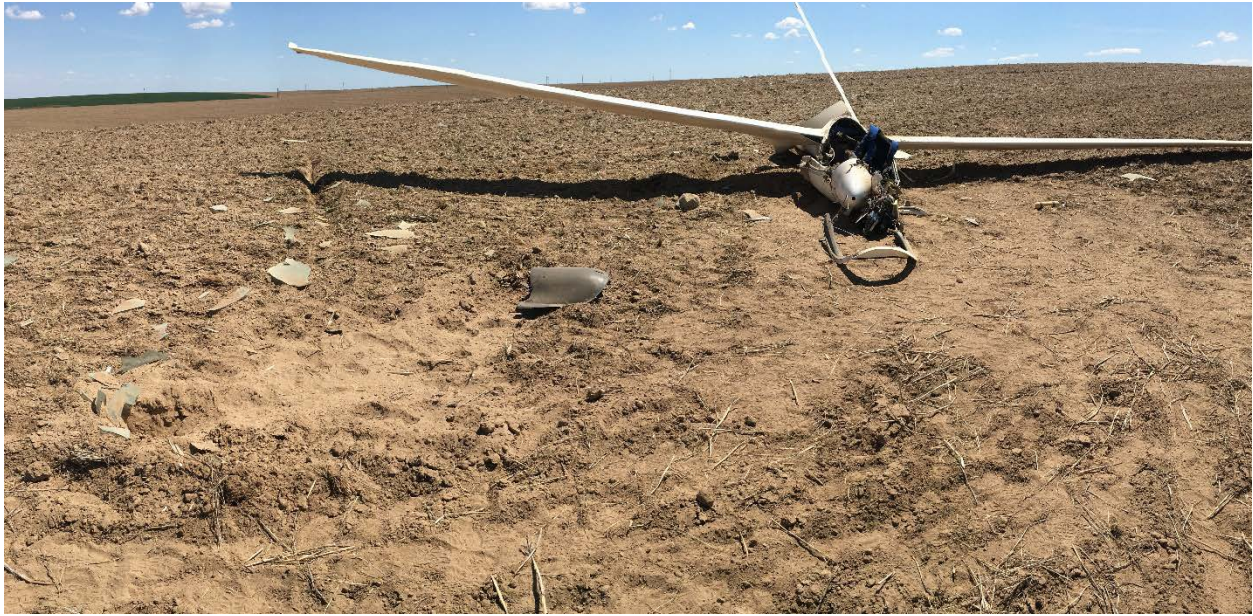
- The Initial point of contact was a small crater with shattered plexiglass around it. In addition, a narrow, straight trench was extending from the small crater consistent with nose and right wing impact.
- There was no disturbed dirt on the left side of the fuselage, nor anywhere else in the freshly plowed field.
- The airplane came to rest upright and was positioned in the same general direction as, and about 15 feet away from, these initial impact marks.
  - Just aft of the cabin, there was dirt splattered at a 45-degree angle along the top of the glider and the inboard left wing. The dirt was obviously damp, but with an unknown substance.

Figure 1: The First Identified Point of Impact in Relation to Glider

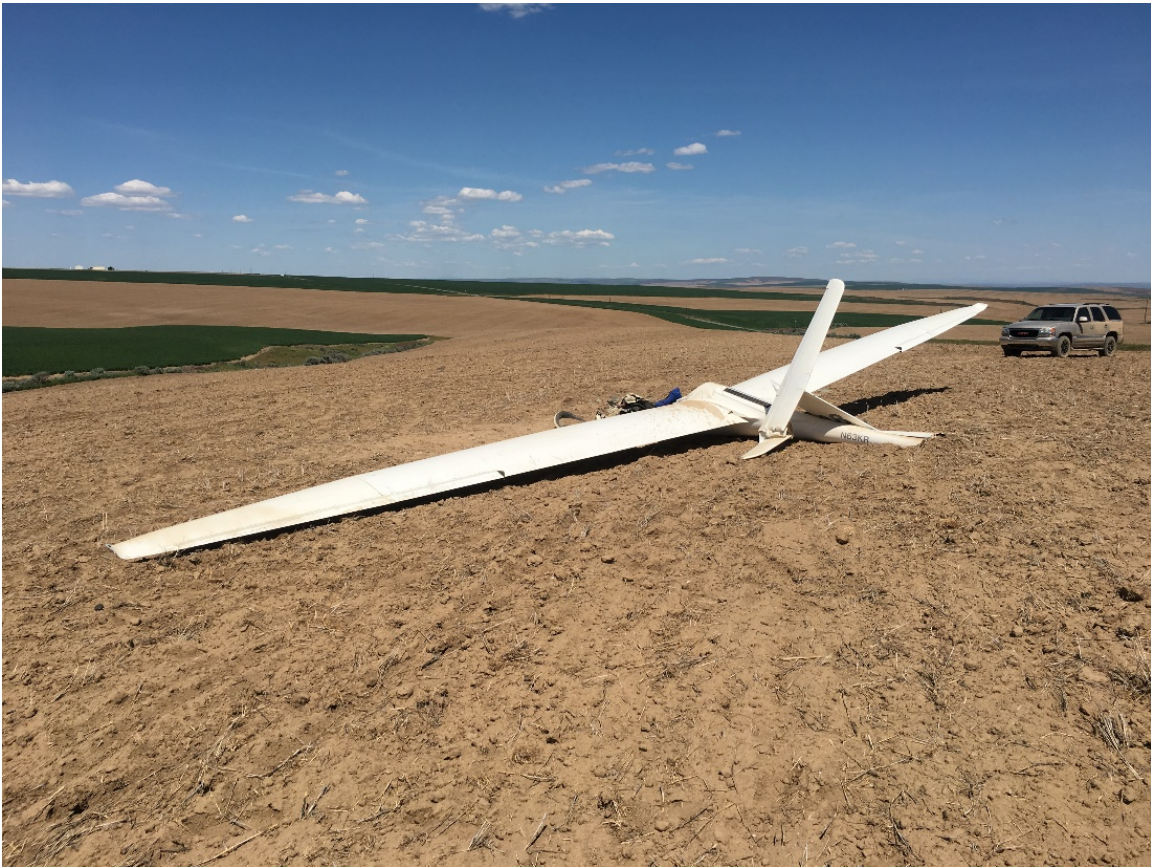
Figure 2: Glider with Surrounding Terrain

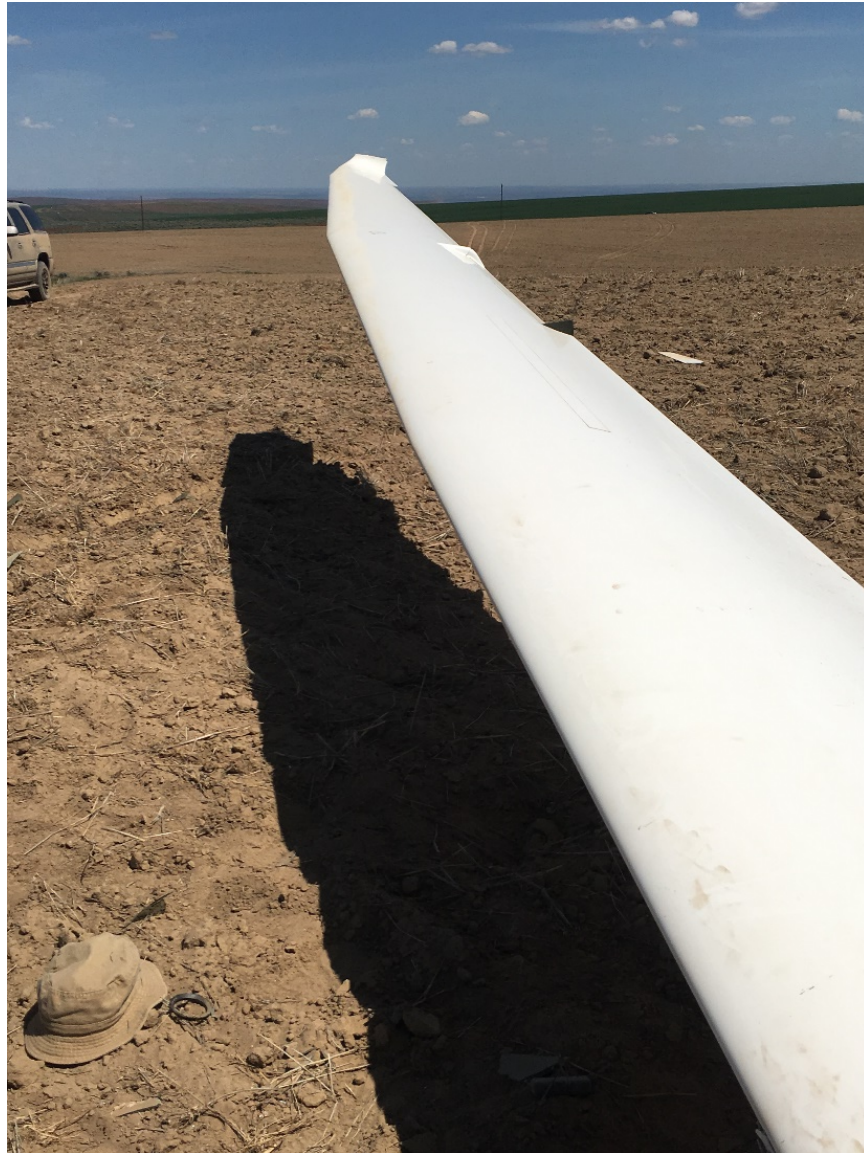
**Figure 3: Right Wing**

- The right wing was still secured to the fuselage and mostly intact
  - There was a dirt coding along the outboard leading edge of the right wing
  - The inboard trailing edge sustained delamination

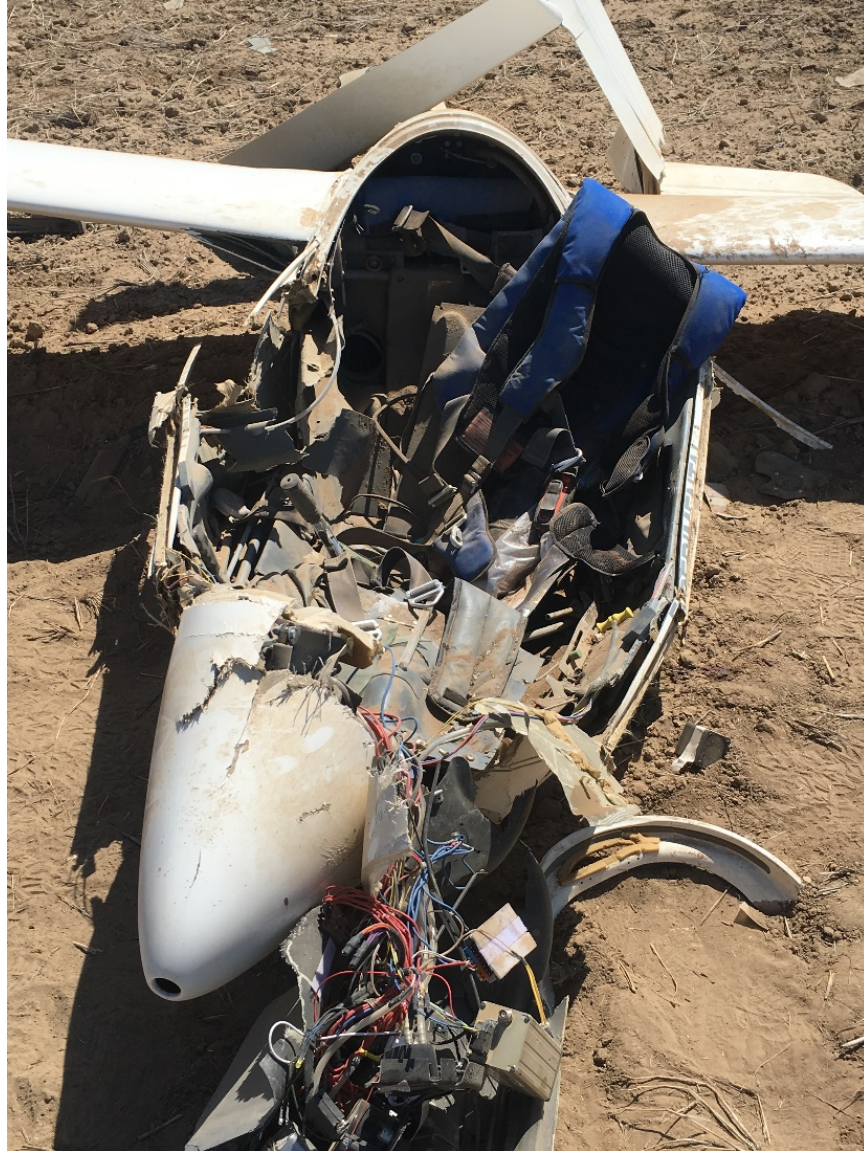
**Figure 4: Cabin Area**

- The cabin area was heavily damaged. The nose cone was intact, but the forward fuselage was crushed aft, and the cabin side walls were crushed outward.

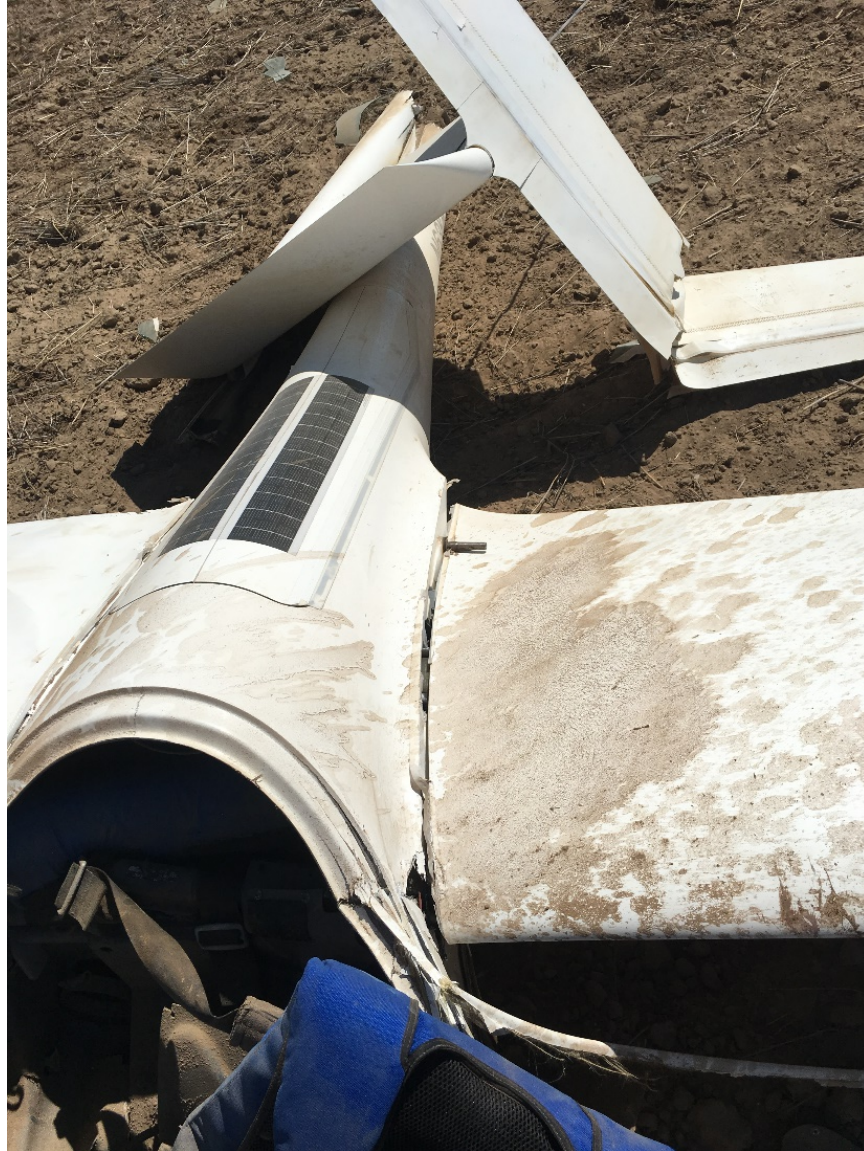
**Figure 5: Aft Cabin and Left Wing Root**

- The left wing was slid forward at its attachment point to the fuselage; otherwise it was mostly intact and exhibited limited visual damage.
- Both the left- and right-wing winglets departed the airframe and were present in the vicinity of the wreckage.

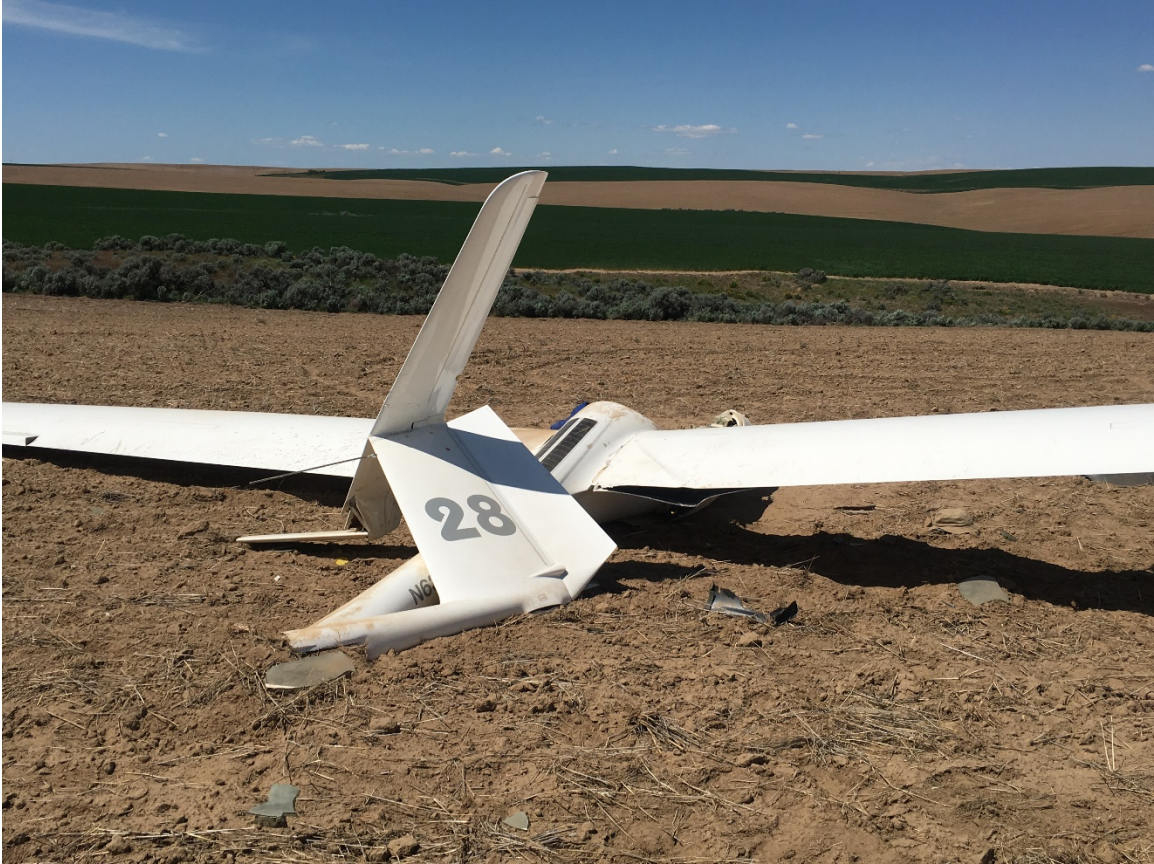
**Figure 6: Empennage**

- The aft fuselage, just before the empennage, was almost completely severed. The empennage was folded sideways next to the forward portion of the aft fuselage, with the rudder and elevator closest to the front of the glider.

- Where the aft fuselage folded, there was a small mound of dirt. In addition, there was dirt located within the fuselage.
- The vertical stabilizer and rudder were intact, secured, and exhibited limited visible damage.

- The rudder was manipulated and the rudder pedals within the cockpit moved
- The right horizontal stabilizer/elevator were fractured slightly inboard of center

- The left horizontal stabilizer/elevator was mostly undamaged
- The elevator surface was moved, and control continuity was established to a break in the aft fuselage.

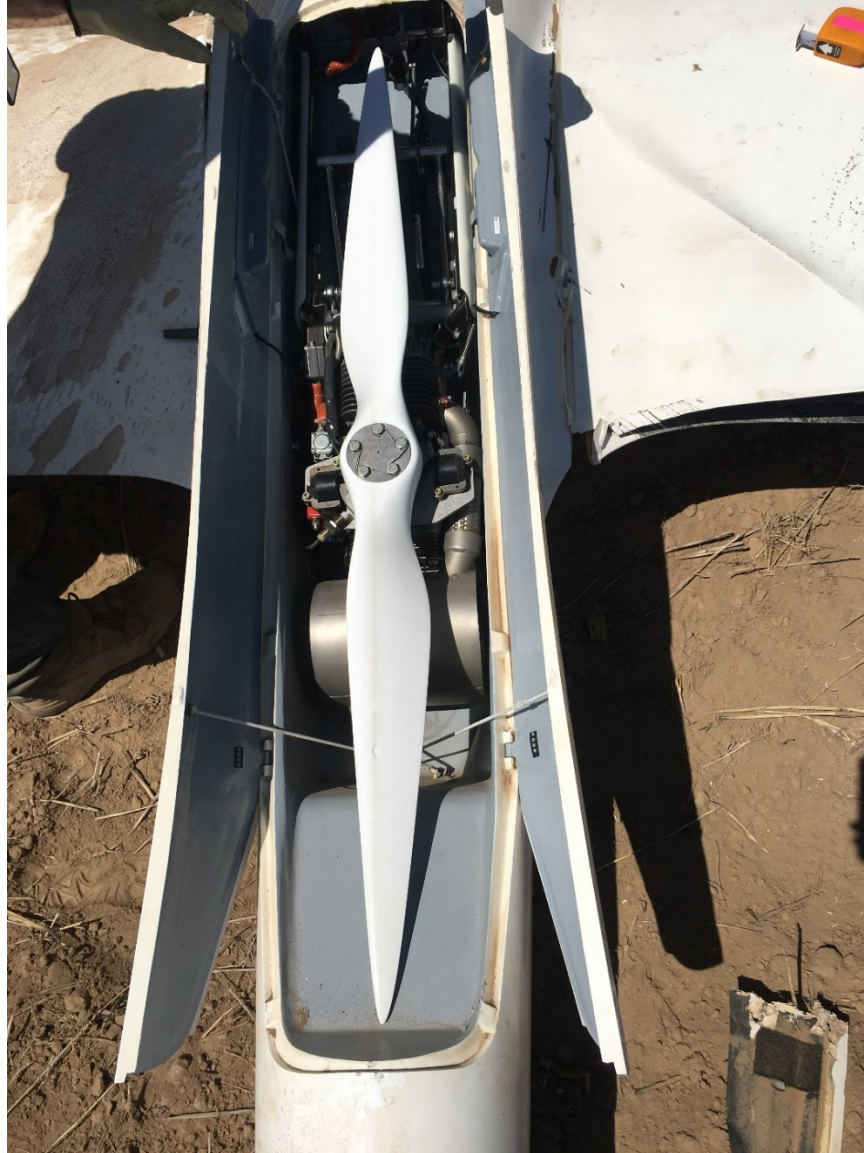
Figure 7: Engine Compartment

- The engine was found in the retracted, secured, and locked position
  - Engine compartment was extremely clean and pristine
  - The hinges that extend the engine sustained no visible damage
  - The forward engine stop was undamaged
  - There was a line of dirt along the propeller consistent with the seam of the engine compartment doors when they are closed
- The propeller was moved from side to side and it moved freely with no binding or grinding noted
