## **NATIONAL TRANSPORTATION SAFETY BOARD**

# **ACCIDENT SITE EXAMINATION SUMMARY**

**WPR17FA108**

Location: Haines, Alaska  
Date: May 27, 2017  
Aircraft: N7376Y; Piper PA-30  
NTSB Investigator-in-Charge: Andrew Swick

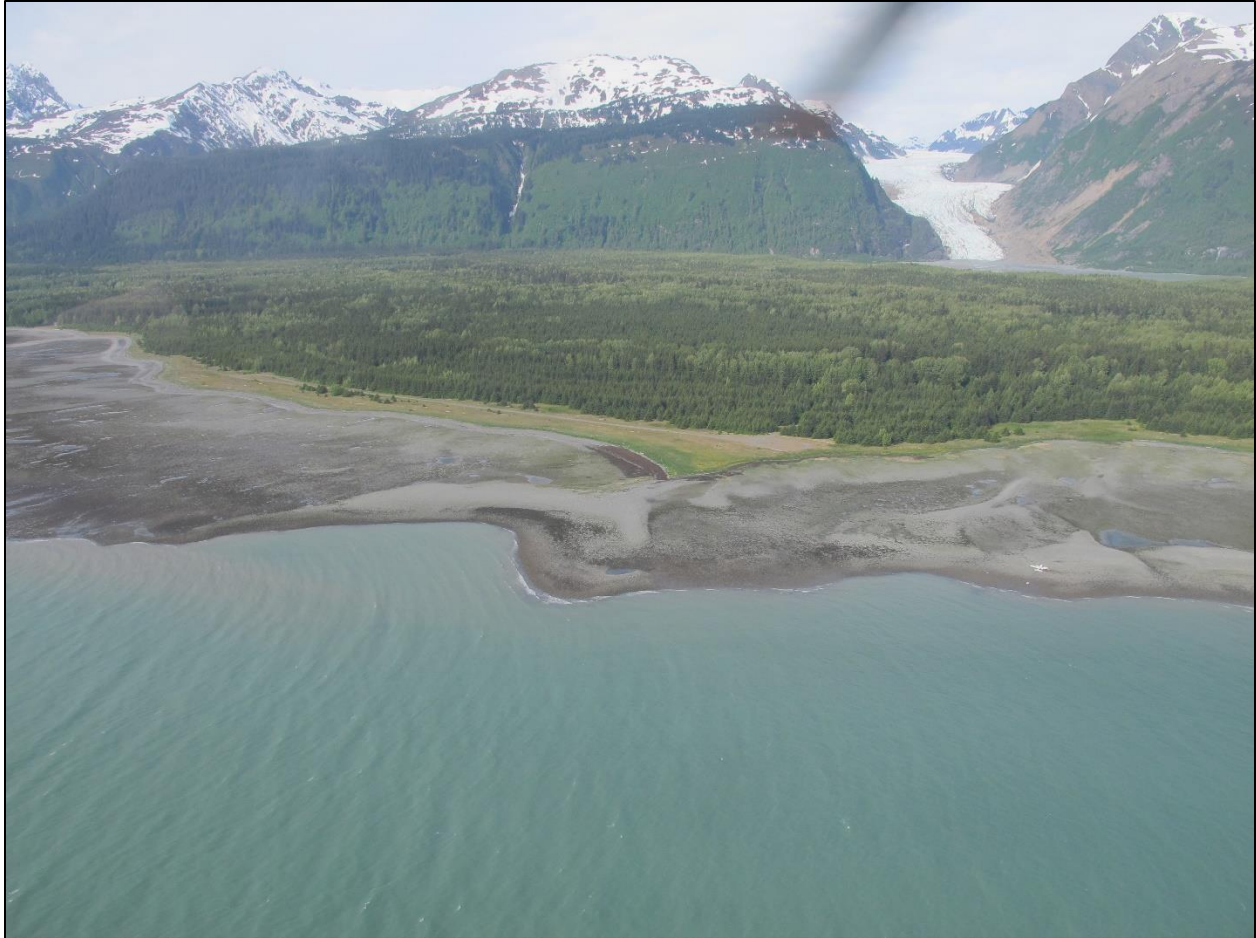
**Figure 1-Aerial View of the Accident Site**

Examination of the accident site was conducted on May 29, 2017, by the NTSB-IIC, FAA-IIC and Alaska State Troopers. The examination revealed that the wreckage was located on the tidal flats near an airstrip at Glacier Point about 12 miles south of Haines, Alaska. The main wreckage was substantially damaged by impact forces and was moved from its original location away from the tidal water. Prior to the main wreckage being moved, it was contained within a small debris field of about 100 feet in length and 50 feet wide. The first identified point of contact (FIPC) was an area of disturbed rock covered beach containing three small craters all measuring about 3 feet in diameter and about 1 foot deep. The craters were about 5 feet apart from each other. The direction of the wreckage debris field was oriented on a heading of about 360 degrees magnetic from the FIPC to the separated airplane battery. Broken plexi-glass, fiberglass and bent aluminum structure was found near the FIPC. A large section of the aircraft nose was found about 100 feet from the FIPC in the tidal water. The forward right side was crushed aft.

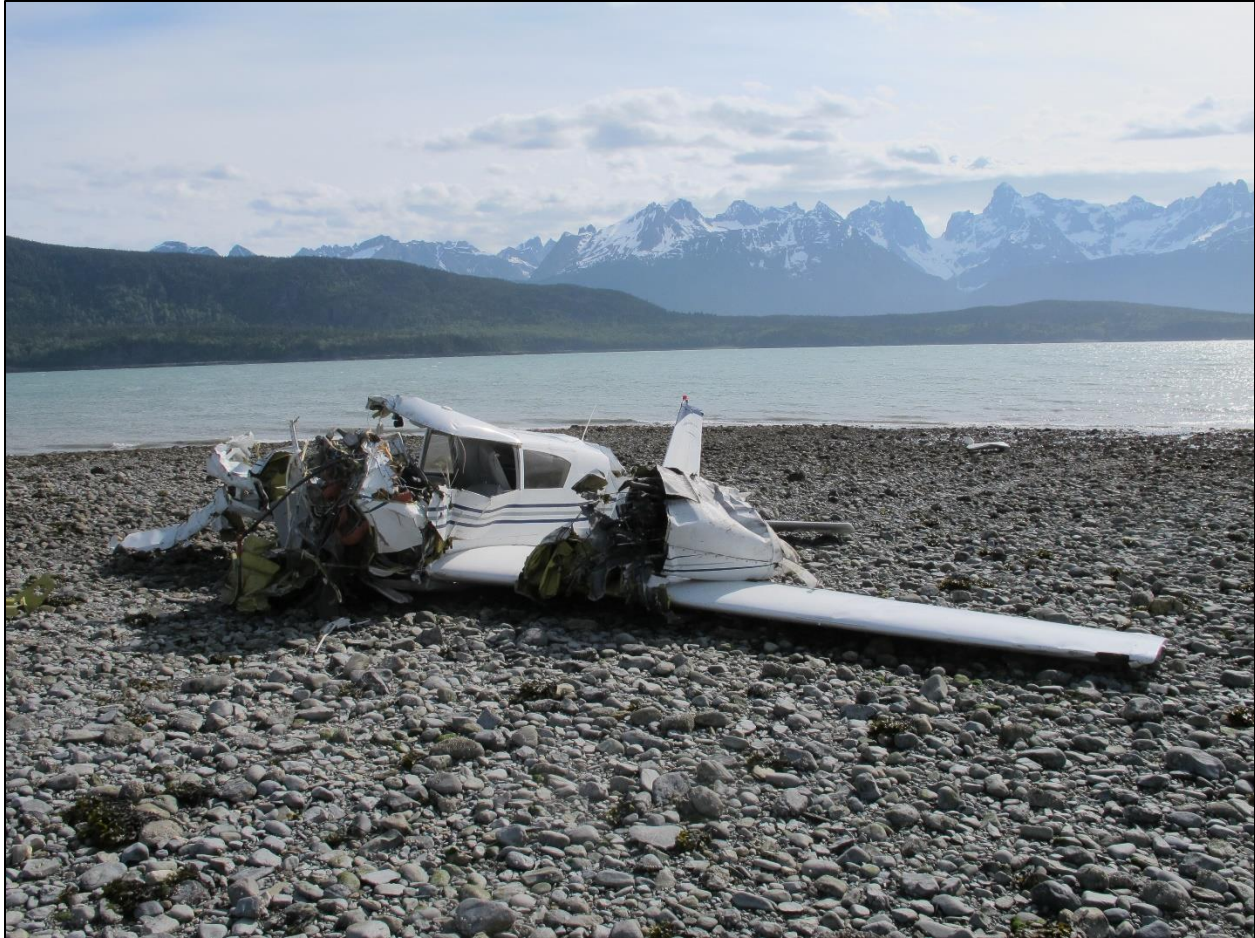
**Figure 2-Main Wreckage, Left Forward View**

The cabin area roof was cut by first responders at the forward window posts to gain access during the recovery of the survivor. The forward cabin area including the instrument panel and floor structure was substantially damaged and crushed rearward into the cabin area. The pilot seat inboard structure was not attached to the seat rail.

Both yokes separated from the control columns. The glare shield separated from the instrument panel and was found near the FIPC. The instrument panel was distorted and most of the instruments remained attached. Most instruments had various degrees of damage. The right-side instrument panel gage cluster was damaged and readings were unreliable. The landing gear toggle switch was broken from the panel and was found in the down position. The emergency landing gear extension handle was removed from its stowed position and installed in a socket on the emergency disengage control. The flap switch remained attached to the panel and was found in the down position. The circuit breaker row separated from the panel mount and the HSI circuit breaker was out. The center instrument panel had separated components. The engine control quadrant remained attached to the instrument panel. The left engine throttle lever was in the full forward position. The right engine throttle lever was in the midrange position. The left propeller lever was in the midrange position. The right propeller lever was in the feathered position. The left and right mixture lever was in the midrange to rich position. The left cowl flap knob in the open (out) position and the right cowl flap was in the closed (in) position. Rudder trim indicator

was in the left of center position. The elevator trim indicator was unreliable. The right fuel selector valve handle was in the 'main' position. The left fuel selector valve handle was in between the 'aux' and 'main' positions.

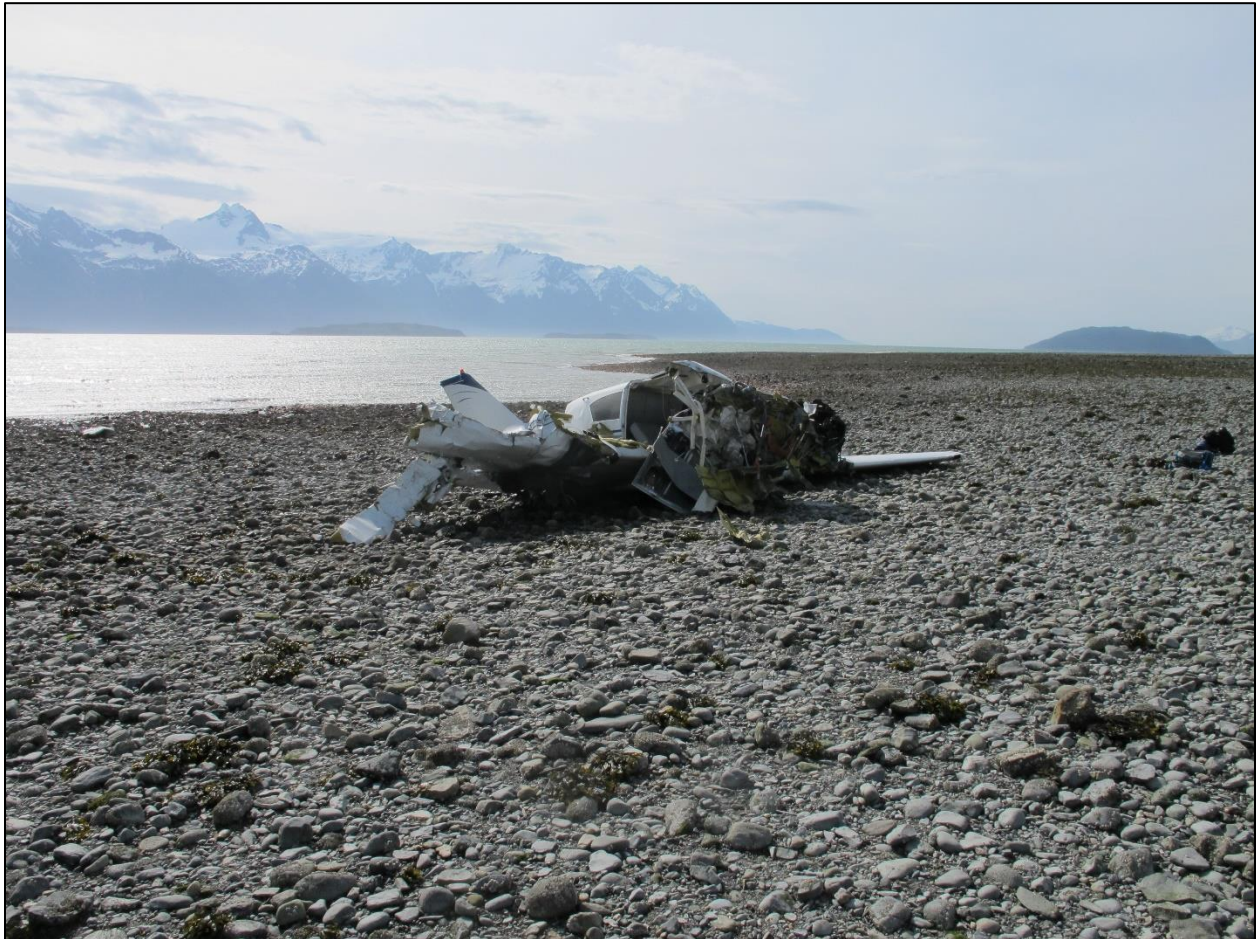
**Figure 3-Main Wreckage, Right Forward View**

The right wing outboard section including the midsection to the tip separated from the main wreckage. A small outboard section of the aileron, about 1 foot in length, remained attached to the separated outboard wing section. The inboard section of the aileron remained attached to the main wreckage. Flight control cable continuity was established from the right aileron to the forward fuselage area. The outboard section of the flap and adjacent wing structure was crushed forward. The flap was buckled and twisted about 180 degrees at the outboard end. The right engine was located on the upper surface of the wing, inverted. The engine separated from the engine mount and remained attached to various cables, wires and tubing. The propeller spinner cap separated and was found near the FIPC. The propeller spinner dome was crushed rearward and made contact with both propeller blade shanks. The blades were found in the feathered position. One blade was bent aft near its midsection and the other was undamaged. Due to the engines position, the cowling was not removed. The landing gear was found partially removed from the retracted position. In first responder photographs, the main wreckage was supported upright by the main landing gear and empennage.

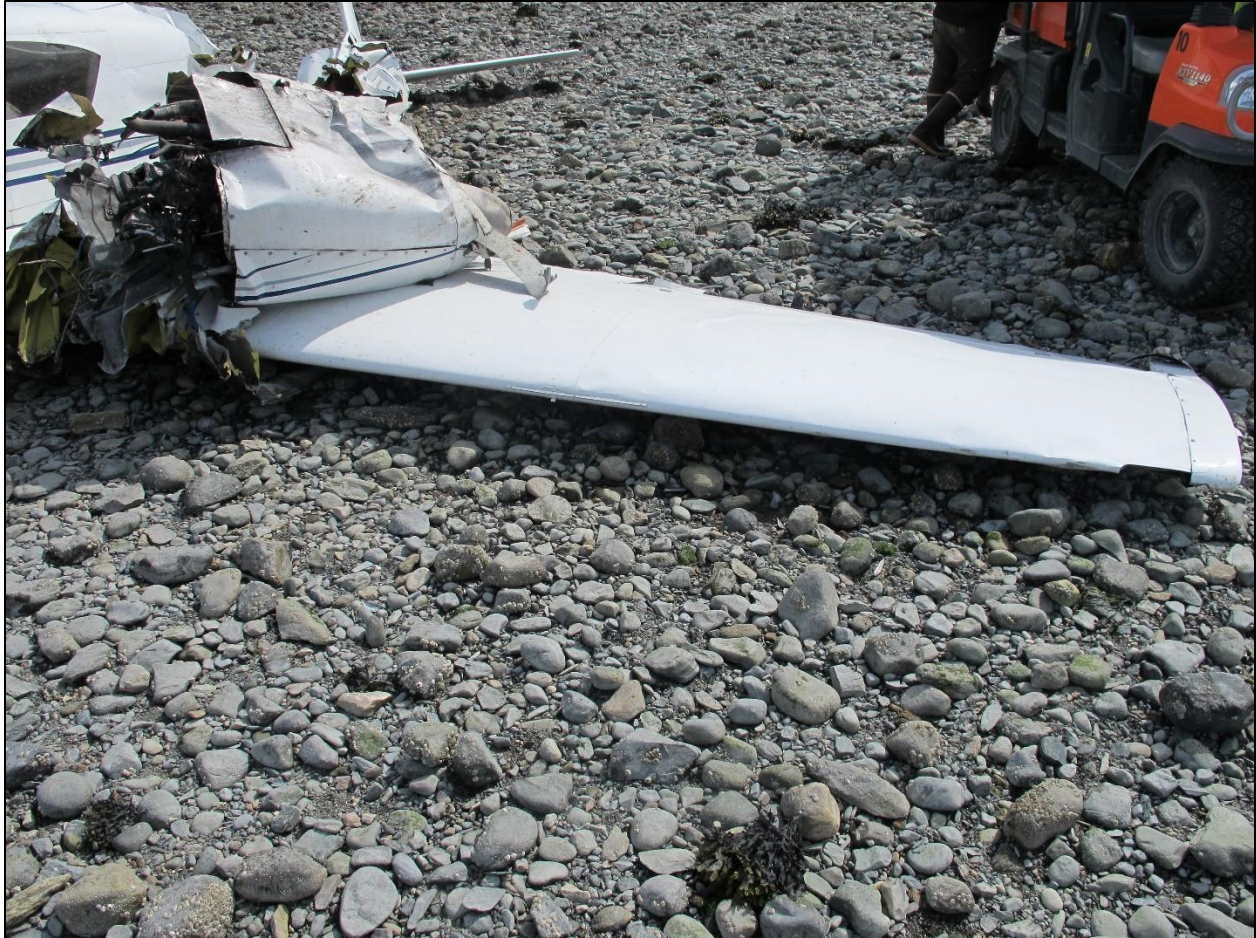
**Figure 4-Left Wing**

The left wing was intact and the upper surface appeared to be undamaged. The flap was in the retracted position and had minor damage from the lower side. Flight control cable continuity was established from the left aileron to the forward fuselage area. The left engine was located on the upper surface of the wing, inverted. The engine separated from the engine mount and remained attached to various cables, wires and tubing. The propeller spinner dome was crushed rearward and made contact with both propeller blade shanks. The blades were found in a near feathered position. The propeller blades revealed gouging, twisting near the tips. One of the blade's tip separated and was found near the FIPC. The landing gear was found partially retracted. In first responder photographs, the main wreckage was supported upright by the main landing gear and empennage.

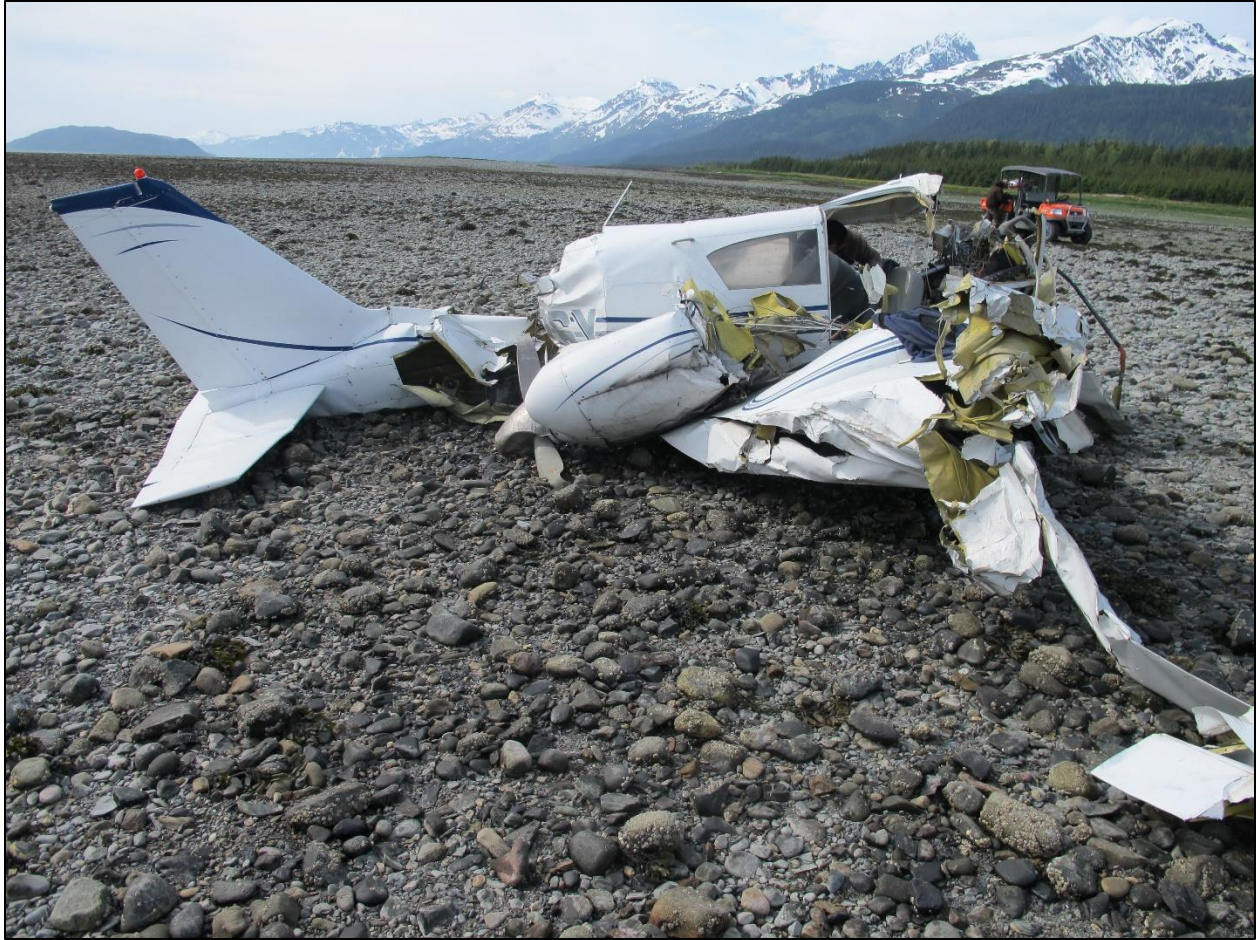
**Figure 5-Main Wreckage, Right Side View**

The empennage remained attached to the main wreckage by cables and wires. The empennage was separated from the fuselage structure aft of the baggage compartment. The structure was buckled and twisted. The rudder and elevators remained attached and had minor damage. Flight control cable continuity was established from the rudder and elevators to the forward fuselage area. The elevator trim actuator was examined and was undamaged. There were no threads showing on the top side of the trim actuator. The ELT separated from the main wreckage and was found in the debris field. A section of the ELT housing remained attached to the antenna wire in the main wreckage.
