## **NATIONAL TRANSPORTATION SAFETY BOARD**

# **WRECKAGE EXAMINATION SUMMARY**

**WPR17FA108**

Location: Haines, Alaska  
Date: May 27, 2017  
Aircraft: N7376Y; Piper PA-30  
NTSB Investigator-in-Charge: Andrew Swick

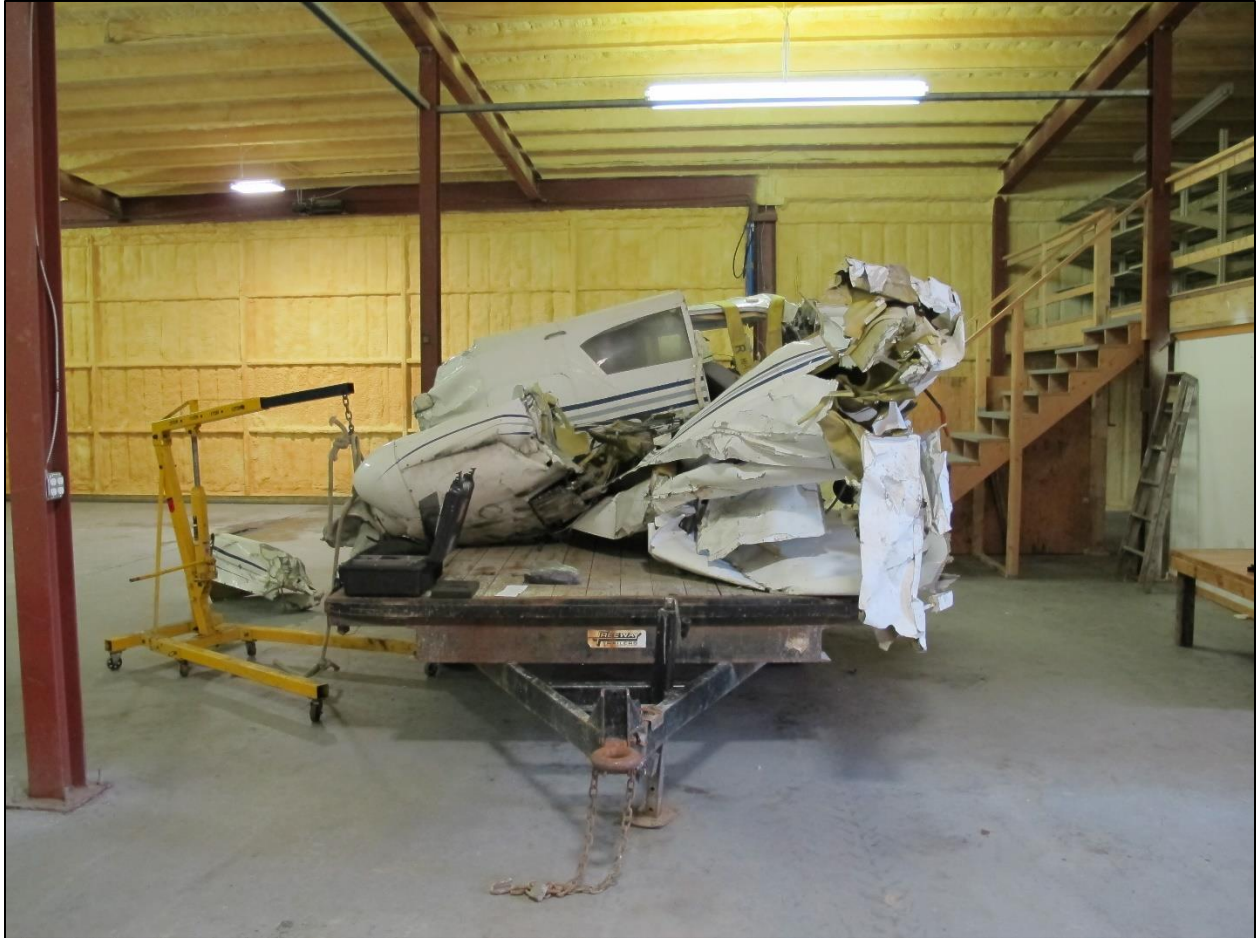
**Figure 1-Main Wreckage**

The wreckage was positioned on a flatbed trailer in a secured hangar prior to the examination. Both engines separated from their engine mounts and were positioned on top of the wings and remained attached to their control cables, lines and tubes. The wreckage appeared to remain in the same physical relative arrangement as it was found during the accident site examination.

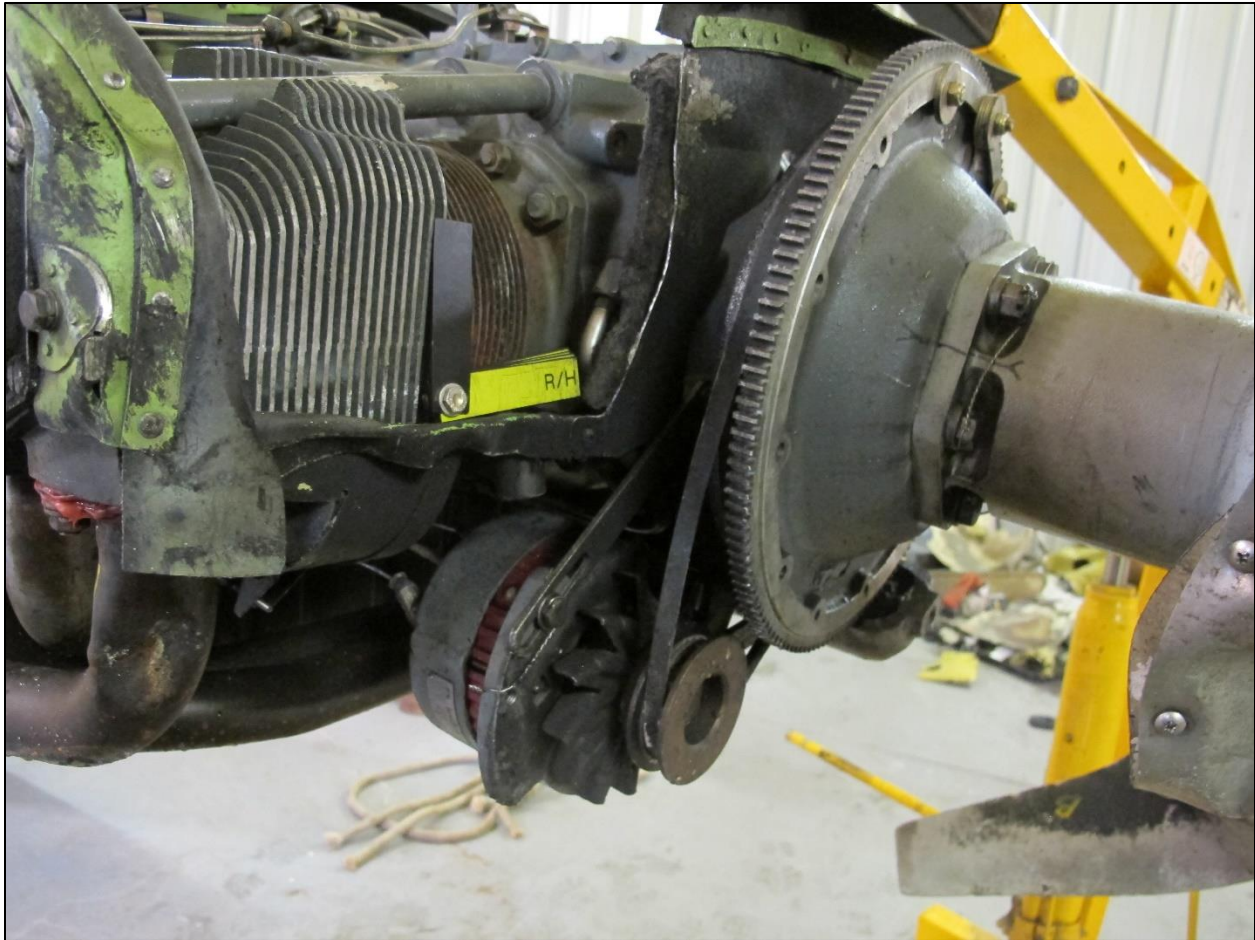
**Figure 2-Right Engine, Alternator Drive Belt**

The right engine was removed from the main wreckage by cutting cables, lines and tubes. The cowling was removed from the right engine. The crankshaft propeller flange was bent to one side and the rocker covers had impact damage. The engine's exterior surfaces had a dark oily residue. Oil residue was observed in the area of the alternator pulley and belt. The Lycoming representative opined it appeared the crankshaft oil seal had been leaking over an extended period of time. The number 4 exhaust stack was loose from the cylinder head and only one nut remained loosely attached to the stud. Thermal signatures were present on the cylinder head and cowling, adjacent to the exhaust stack. The lower spark plugs were removed and water drained from a couple of the cylinders. The spark plug electrodes remained free of mechanical damage. The crankshaft rotated by hand and gear continuity was attained from the propeller assembly to the accessory section.

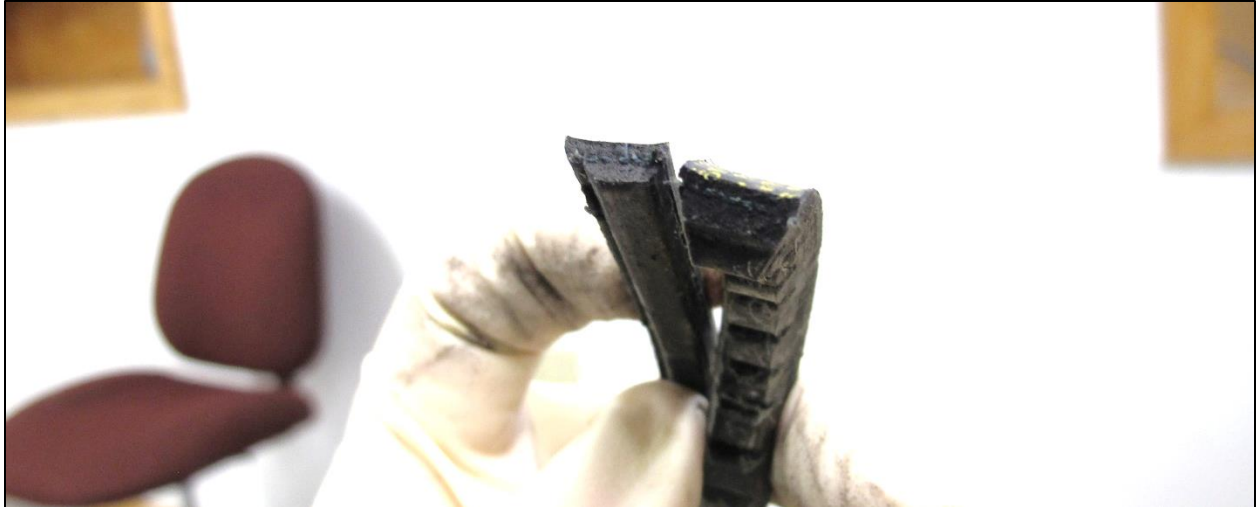
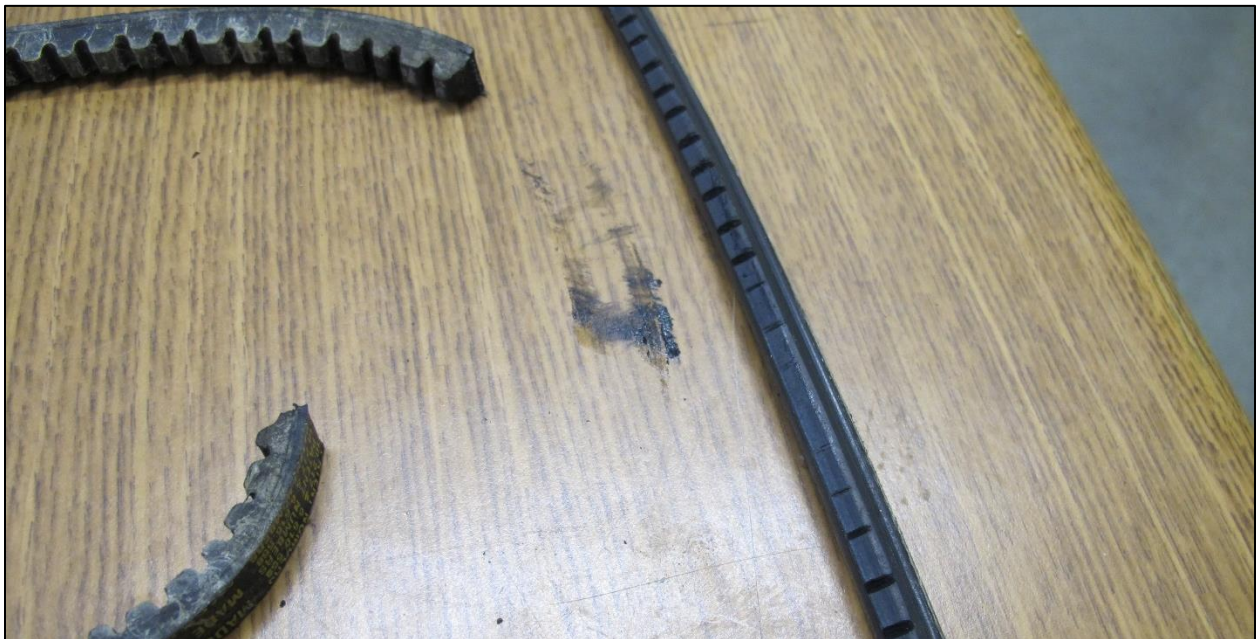
**Figure 3-Right Engine Alternator Drive Belt**

The alternator was undamaged and secure and no signatures appeared to suggest that the alternator repositioned during the accident sequence. The alternator drive pulley rotated freely by hand, while the drive belt remained stationary with the crankshaft. The alternator drive belt was loose when examined and was removed from the engine. The belt was excessively worn on the pulley contact area. An extra belt was attached to the engine and was removed. The photos provided shows a comparison between the two belts. Both belts share the same part numbers.

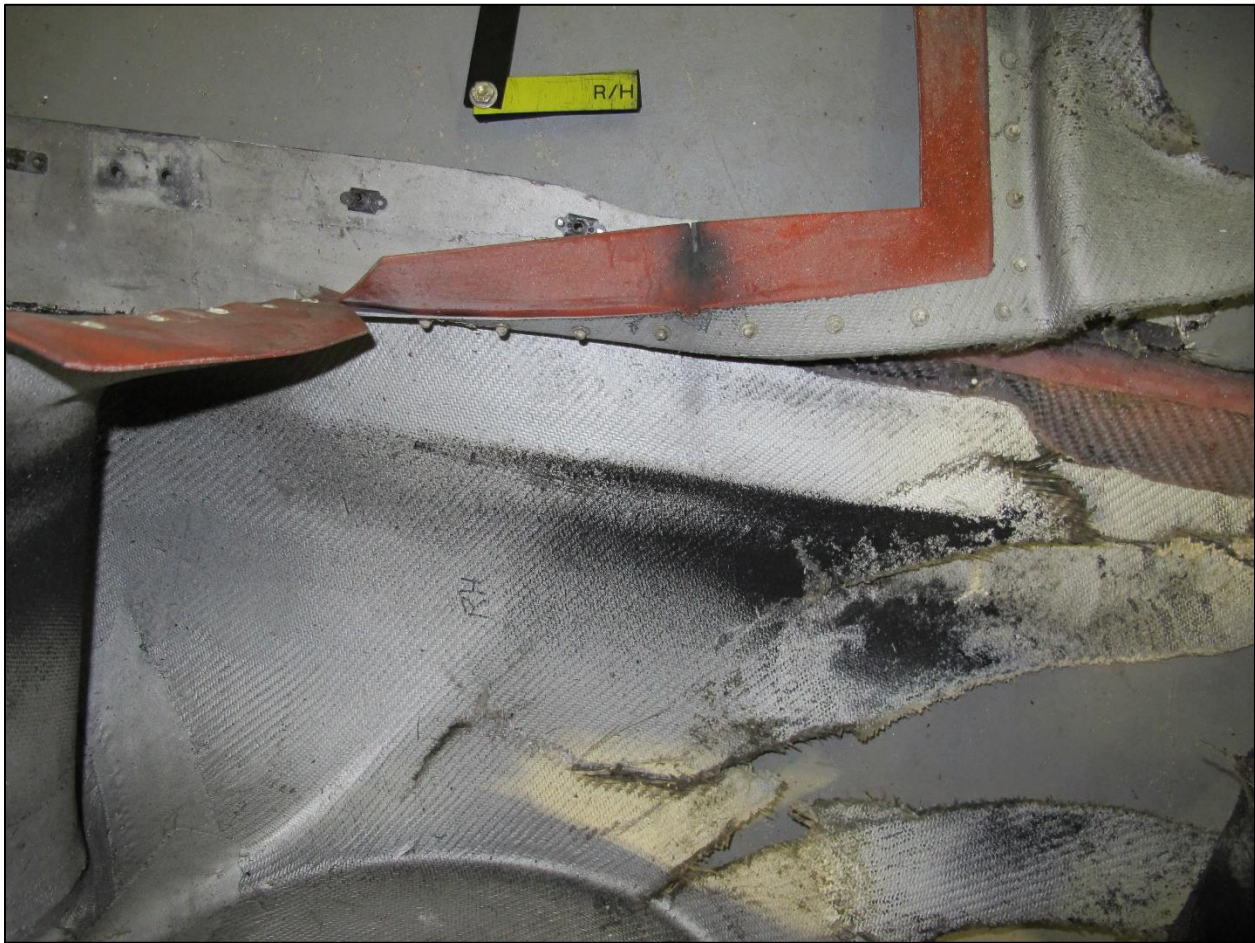
**Figure 5-Right Engine Inlet Cowling**

The right engine inlet cowling had rubber filings in the forward right interior surface. Rubber filings were also found on the back side of the starter ring gear and surrounding areas.

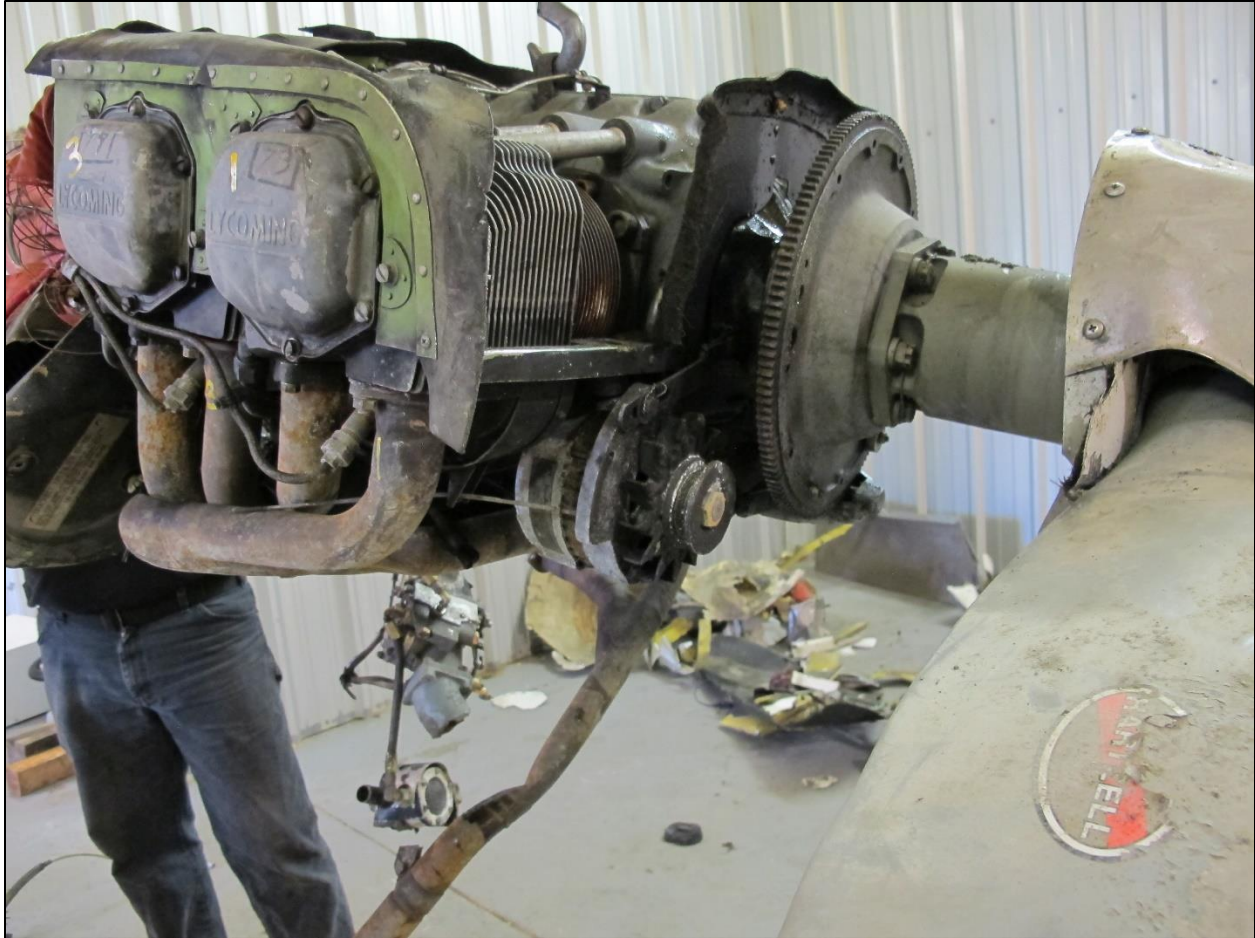
**Figure 6-Left Engine**

The left engine was removed from the main wreckage by cutting cables, lines and tubes. The cowling was removed from the left engine. The accessory section and several components had impact damage. The crankshaft propeller flange was bent to one side. The number 4 exhaust stack was loose from the cylinder head. An attachment stud for the number 4 exhaust stack was missing from the cylinder head and no nut was attached to the second attachment stud. Thermal signatures were present on the cylinder head and cowling, adjacent to the exhaust stack. The lower spark plugs were removed and water drained from a couple of the cylinders. The spark plug electrodes remained free of mechanical damage. The crankshaft rotated by hand and gear continuity was attained from the propeller assembly to the accessory section.

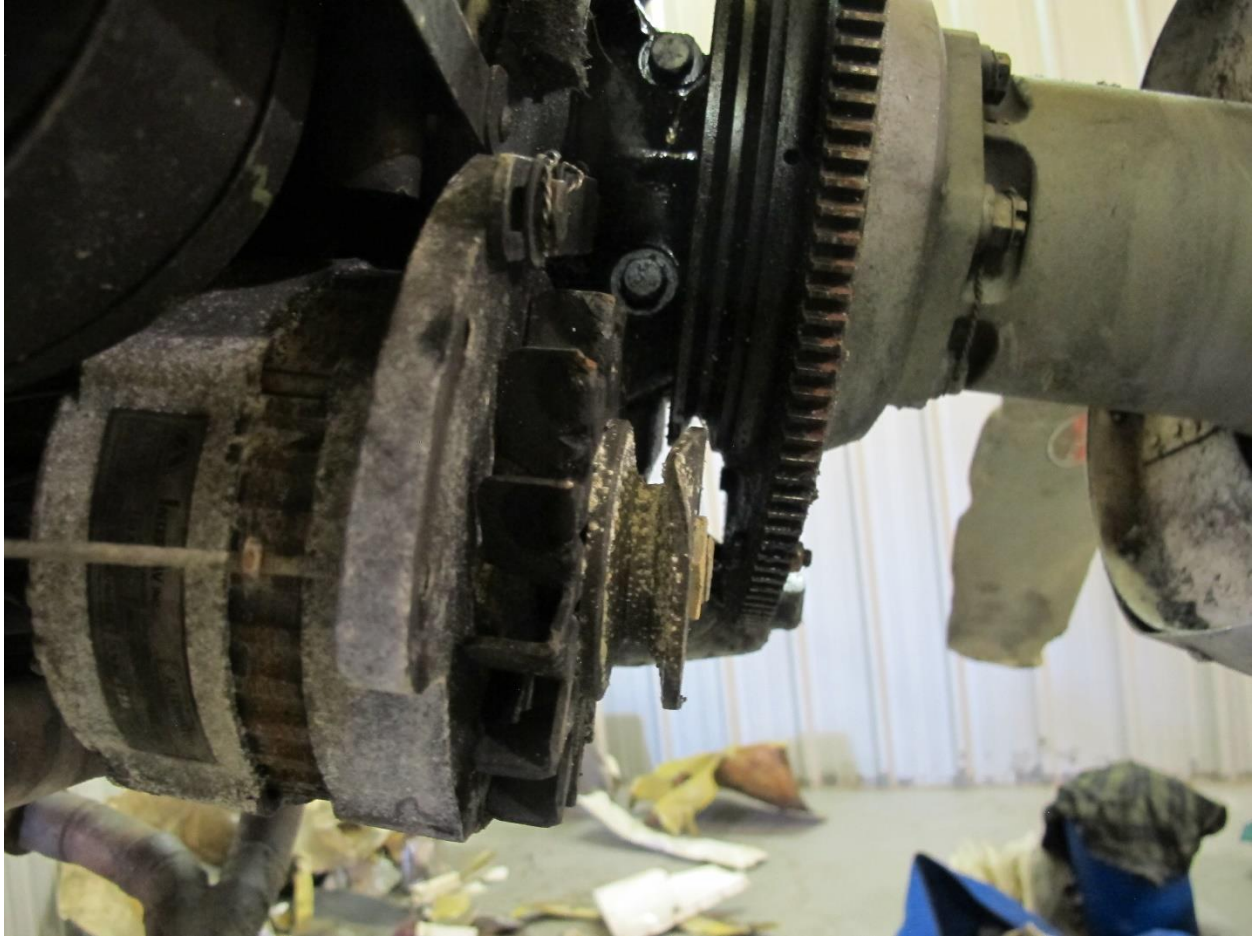
**Figure 7-Left Engine, Alternator**

The alternator was undamaged and secure and no signatures appeared to suggest that the alternator repositioned during the accident sequence. The alternator electrical wiring remained secure at their respective terminals. There was no belt attached to the alternator and no belt recovered from within the confines of the engine cowling. The alternator housing was covered in surface corrosion consistent to being submerged in salt water. The alternator drive pulley forward face had impact damage, bending the edge of the forward face aft, into where the drive belt would be positioned. There was no corresponding damage to the engine cowling in the area of the alternator pulley that would have resulted in damage to the alternator pulley. The alternator drive shaft rotated freely by hand.

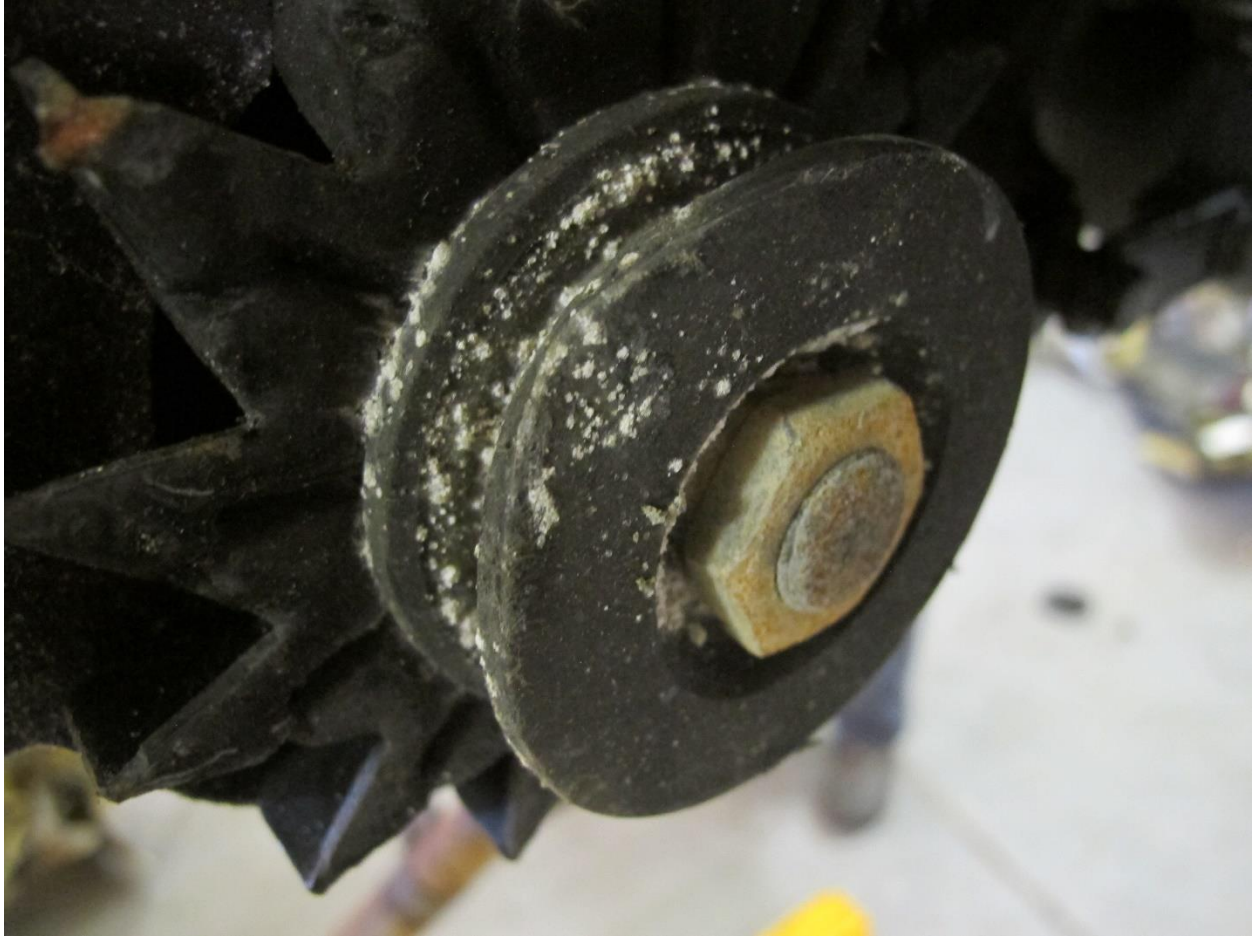
**Figure 8-Left Engine Alternator Drive Pulley**

A dark residue covered the forward side of the alternator and the drive pulley. The belt contact area in the alternator drive belt pulley and the crankshaft pulley was also covered in a dark residue. The subject airplane had been modified with LoPresti front engine cowls. The cowling configuration would not permit visual inspection of the alternator belts during a preflight inspection.

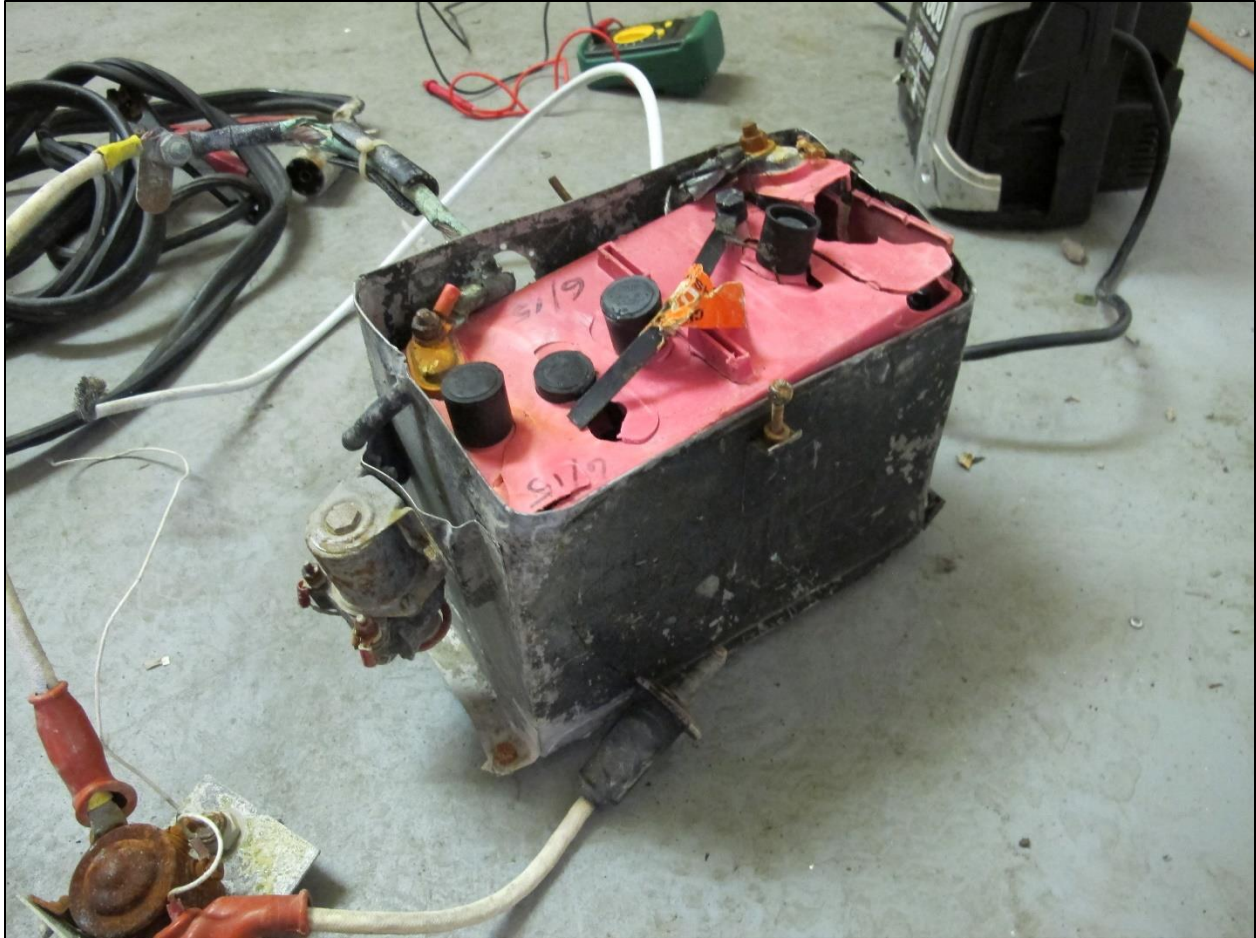
**Figure 9-Aircraft Battery**

The aircraft battery separated from the main wreckage and remained in the battery case. The battery housing had impact damage revealing internal surfaces. The terminal connections remained attached to the battery. A date of "6/15" was written on the top of the battery.

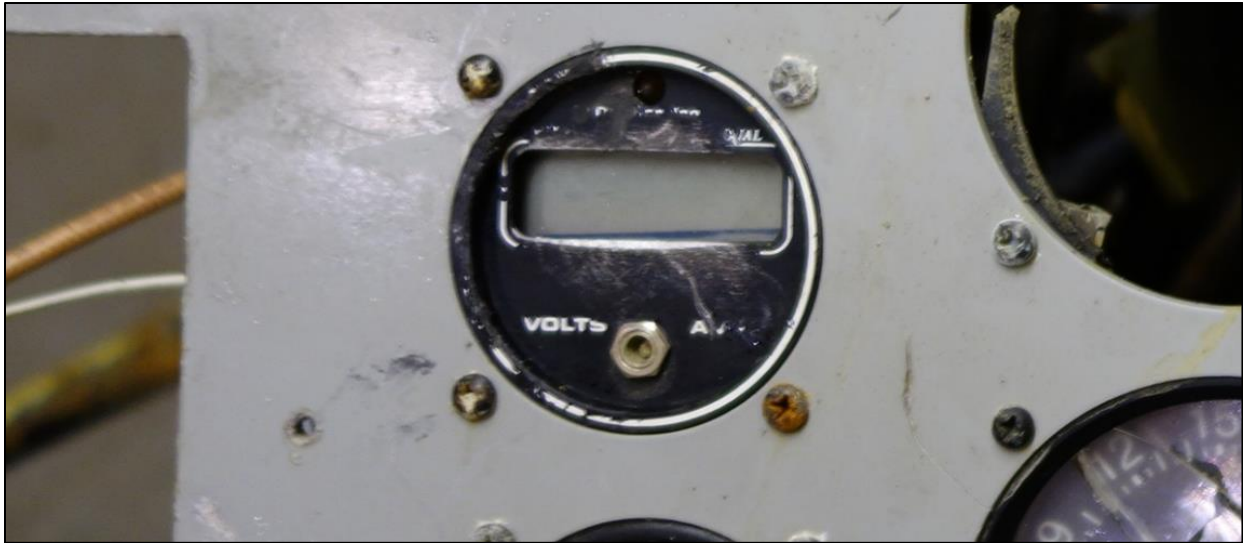
**Figure 10-Amp and Volt Meter**

The amp and volt meter was removed from the instrument panel. The amp/volt selection toggle switch was damaged and found in the amp position. The meter reads electrical system bus volts/amps and not individual alternator output.

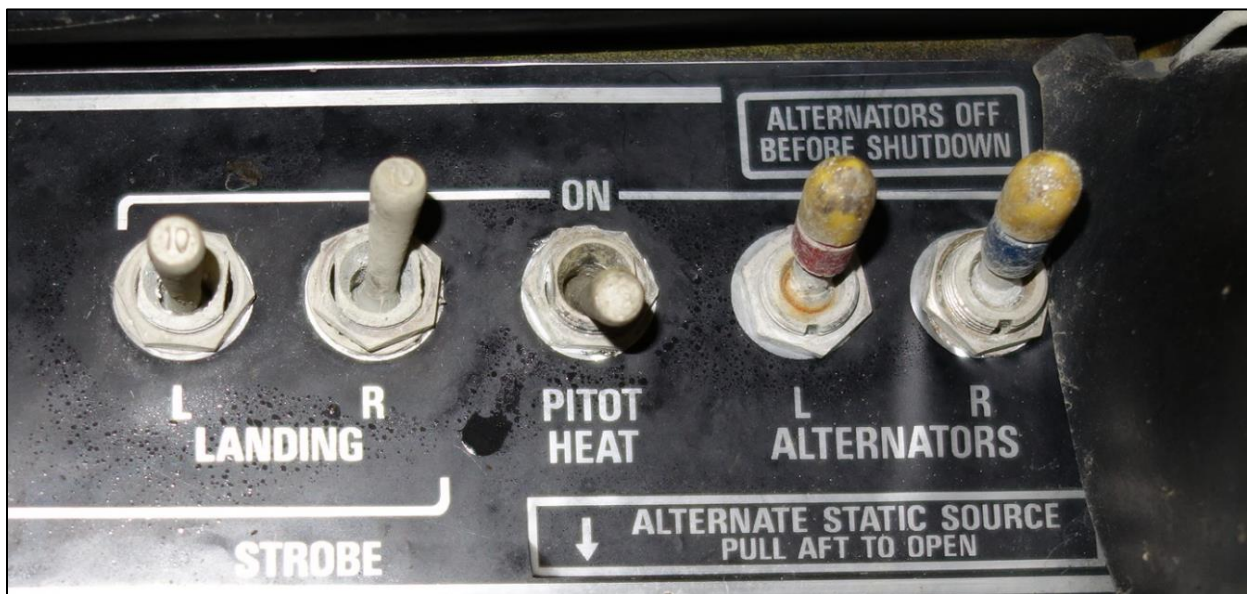
**Figure 11-Alternator Isolation Switches**

The alternator isolation switches were found in the “ON” position. There were no annunciator lights or warning system observed which would indicate either alternator had dropped off line during operation.
