# **National Transportation Safety Board**

## **Performance Study**

### **Specialist Report**

| Airplane: | Cessna 180, N3683C |

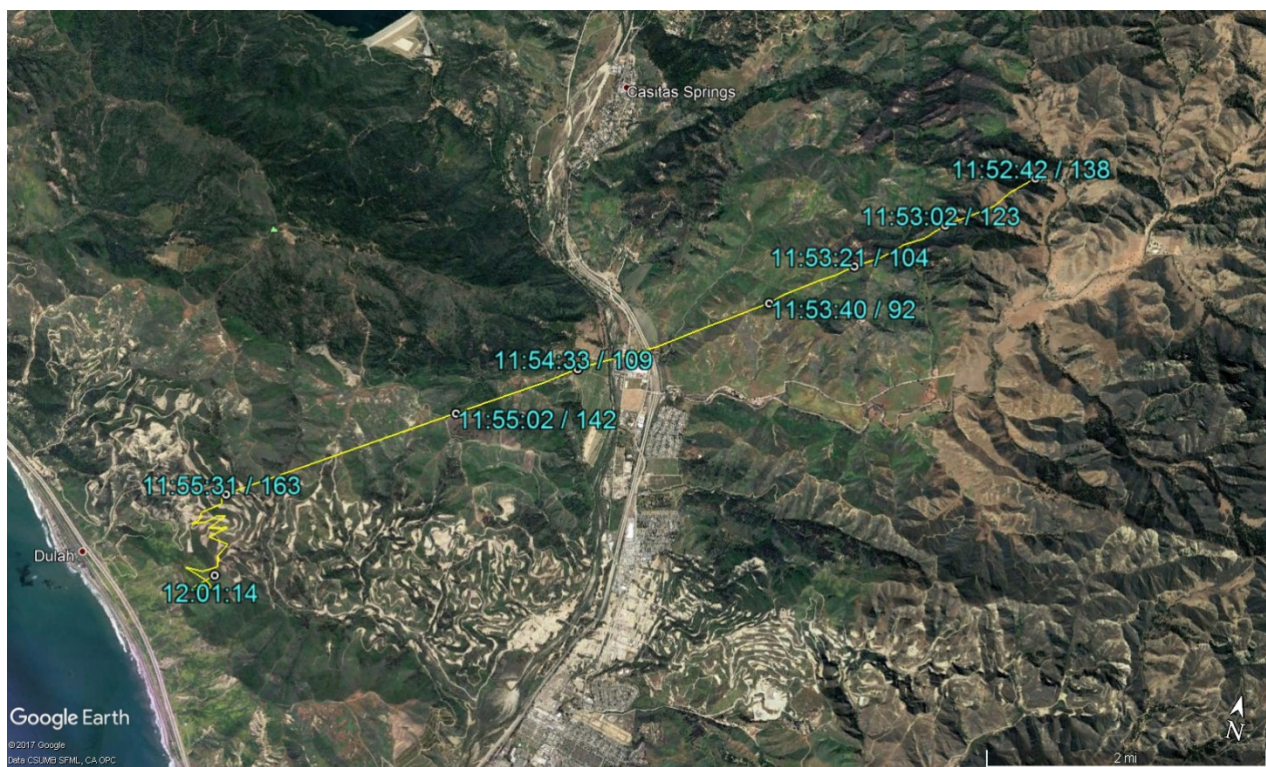
The radar path is shown in Figure 1 and Figure 2. The airplane's track from 11:52:42 to 11:55:31 was between  $230^\circ$  and  $240^\circ$ . After 11:55:31 the calculated track deviates considerably. The final radar points and the wreckage field are shown in Figure 3. The wreckage field is consistent with an in-flight breakup of the airplane and the radar points after 11:55:31 could be primary radar returns from individual pieces of the airplane after the in-flight breakup.

**Figure 1.** Aircraft flight path shown in yellow. Labels in blue indicate the time (PDT) and calculated groundspeed in knots.

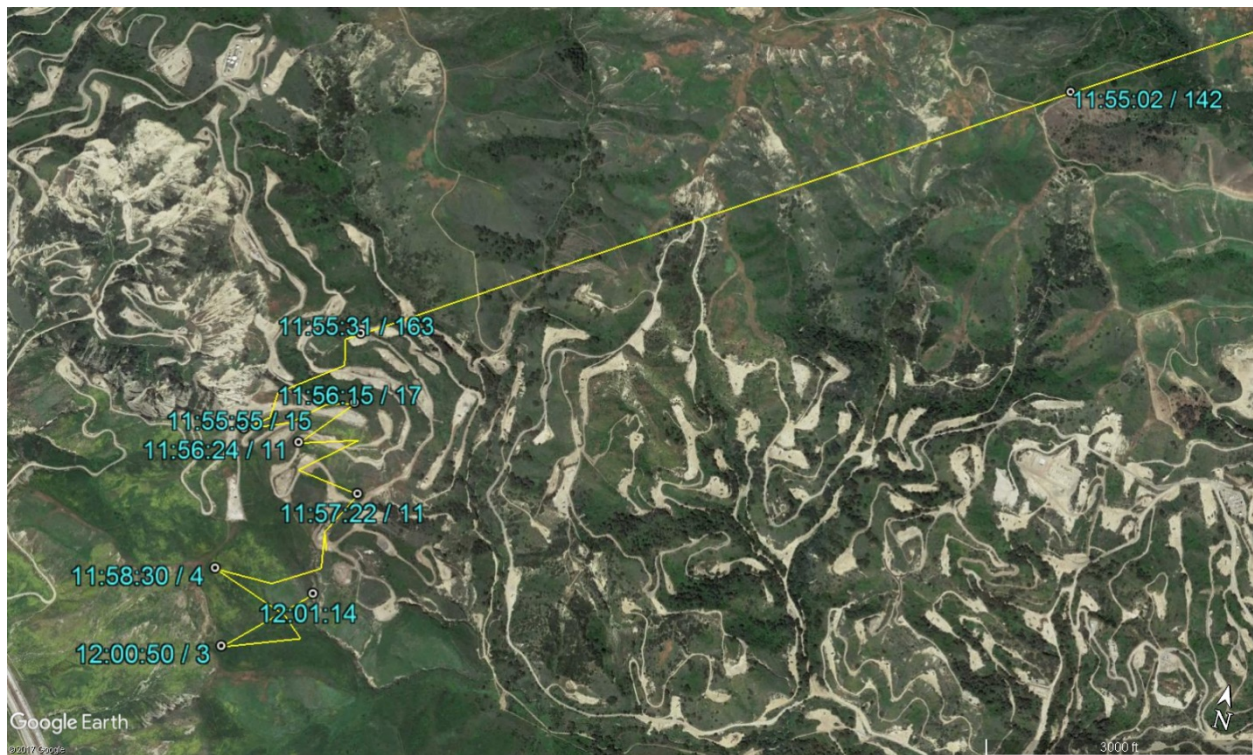
**Figure 2.** End of flight path. Last point is at 12:01:14. Radar points at the end of the flight path and wreckage locations.

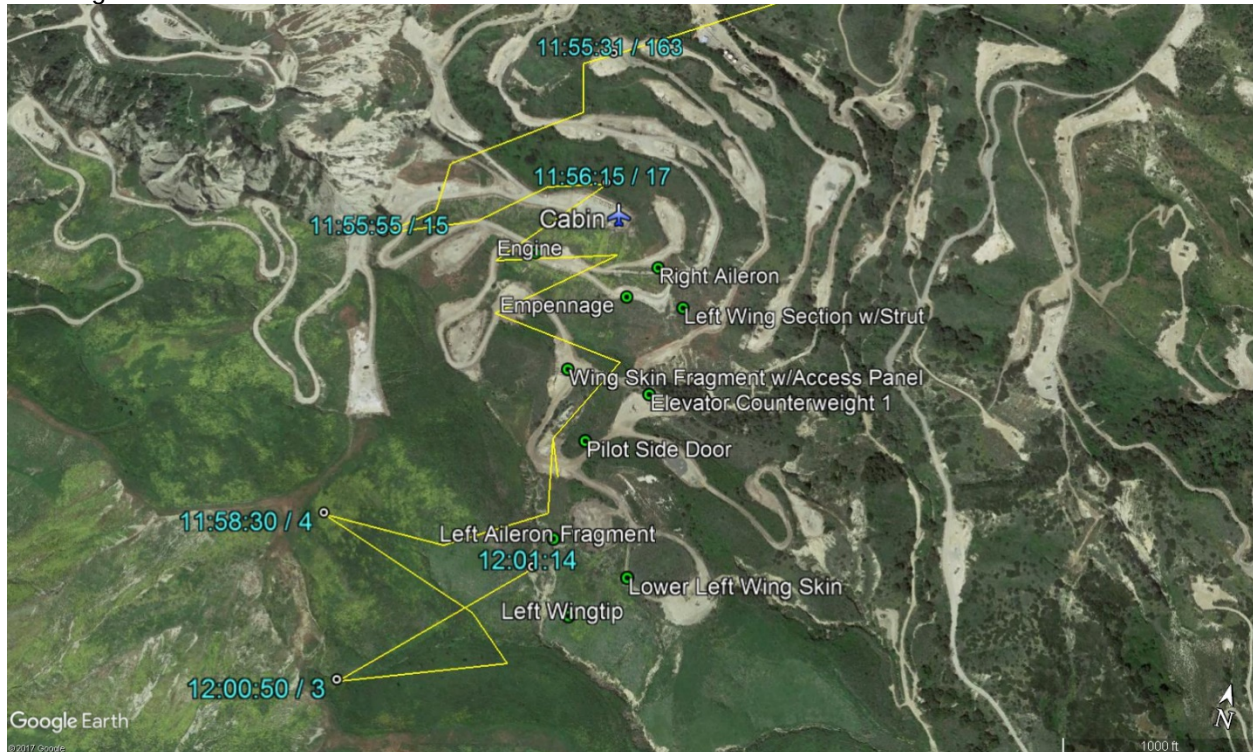
**Figure 3.** Radar points at the end of the flight path and wreckage locations.

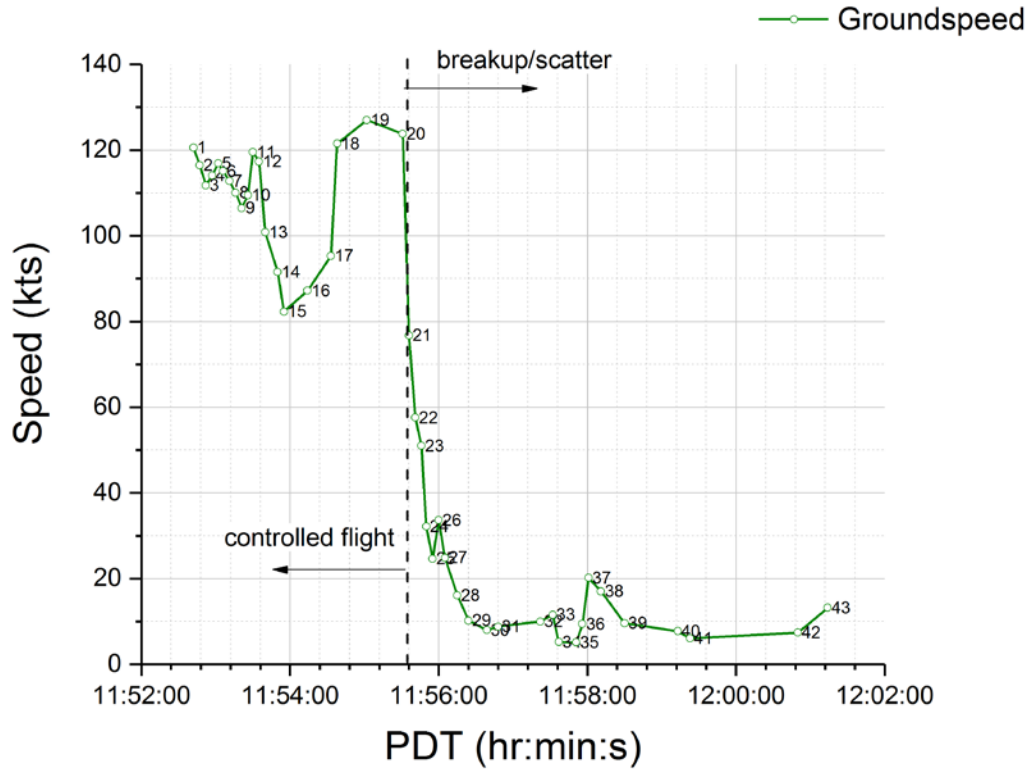
Groundspeed was calculated from the radar position data. Figure 4 shows the calculated groundspeed at each radar point, which are numbered sequentially. Points 1-20 show groundspeeds consistent with flight. After point 20 (11:55:31) the groundspeed drops significantly from 124 kts. Figure 5 shows the radar path of points 20-43. Points 20 and 21 were on the same heading as the first 19 points recorded by radar. However, points 22 through 43 do not describe a flight path and when paired with the wreckage shown in Figure 3 are likely primary radar returns from individual pieces of the broken-up airplane. This would also be consistent with the sudden drop in groundspeed as the individual pieces would no longer be propelled by the airplane's engine.

**Figure 4.** Calculated groundspeed from radar. Points are labeled 1-43.

The airplane's maximum groundspeed was calculated to be 127 kts at about 11:55:02, 30 seconds before the sudden loss of groundspeed between points 20 and 21 (Figure 4). Using the possible winds, the true airspeed at this point could be between 115 kts and 134 kts. The calibrated airspeed at each of these points would be a function of altitude and true airspeed and were estimated to be 112 kts at 1700 ft and 121 kts at 8000 ft. However, the actual calibrated airspeed could be higher or lower depending on the combination of altitude and true airspeed.

The primary radar data allowed for a calculation of the airplane's groundspeed. Between radar points 20 and 21 (11:55:31 and 11:55:36) there was a significant loss of groundspeed. Points 1 – 21 (11:52:42 to 11:55:36) were on a relatively constant track between 230° and 240°, but after point 21 the track does not reflect a coherent flight path. The loss in groundspeed and change in track along with the subsequent scattered radar returns and the widely dispersed wreckage field indicates that the airplane experienced an inflight breakup.

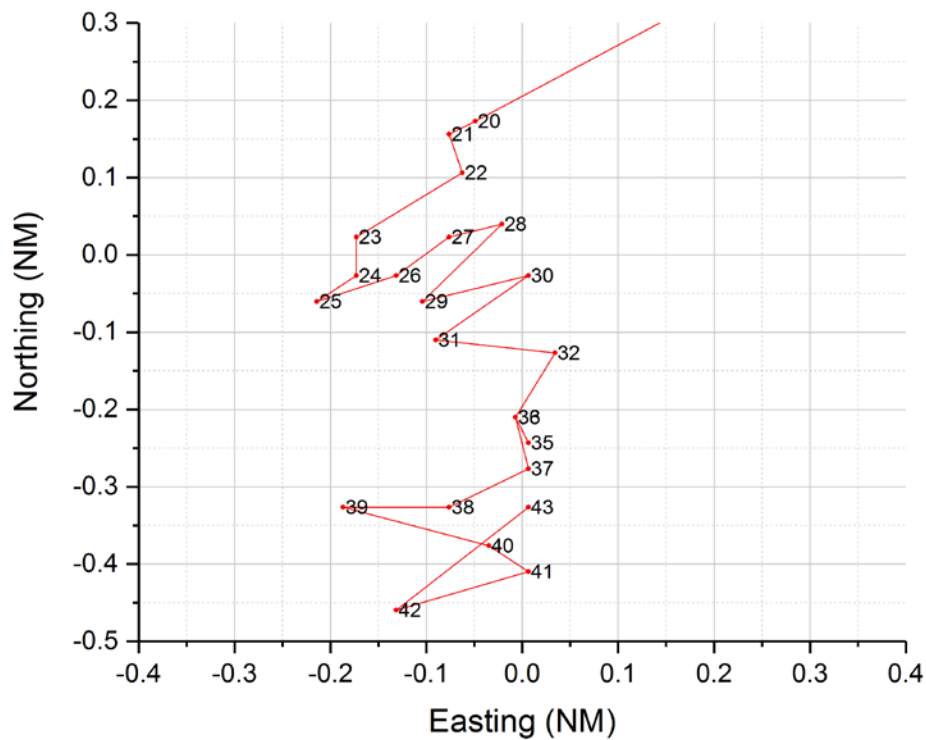
**Figure 5.** Radar path. Points 20-43 are shown.

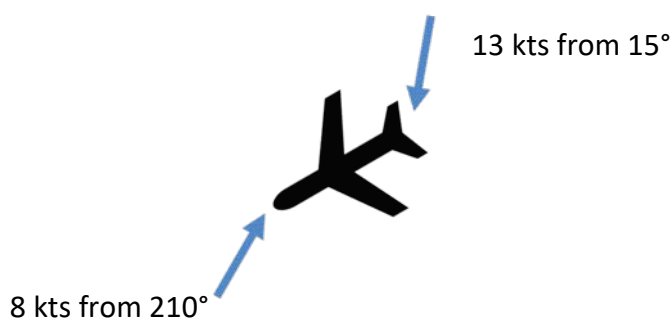
Starting at 11:53:55 the airplane gained groundspeed from 82 kts to 127 kts in 67 seconds. While the airspeed cannot be calculated with accuracy since the altitude is not known, the winds aloft data in Table 1 can be used to bracket possible airspeeds. The terrain the airplane was flying over had peak elevations between 1000 and 1500 ft. Winds over 1500 ft vary from 8 kts from 210° at 1700 ft to 13 kts from 15° above 8000 ft and are shown in Figure 6 in relation to the airplane on a heading of 235°. These winds translate into a possible 7 kts headwind at 1700 ft to a 12 kts tailwind at 8000 ft.

**Figure 6.** Wind direction and magnitude and airplane.
